Stream and Wetland Restoration at Rendezvous Mountain Educational State Forest

North Carolina Forest Service Rendezvous Mountain Educational State Forest Wilkes County, NC, USA

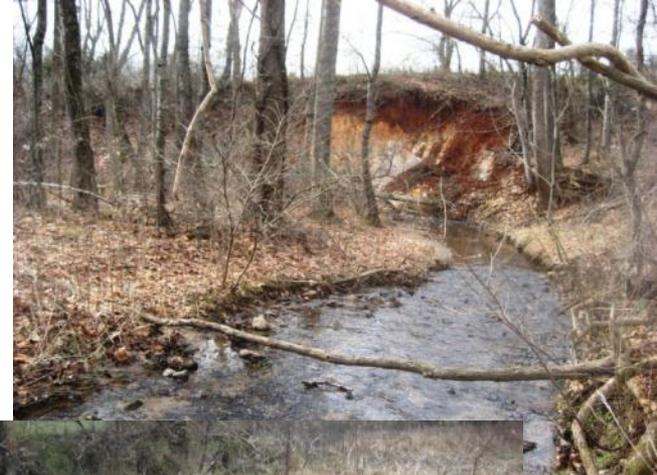
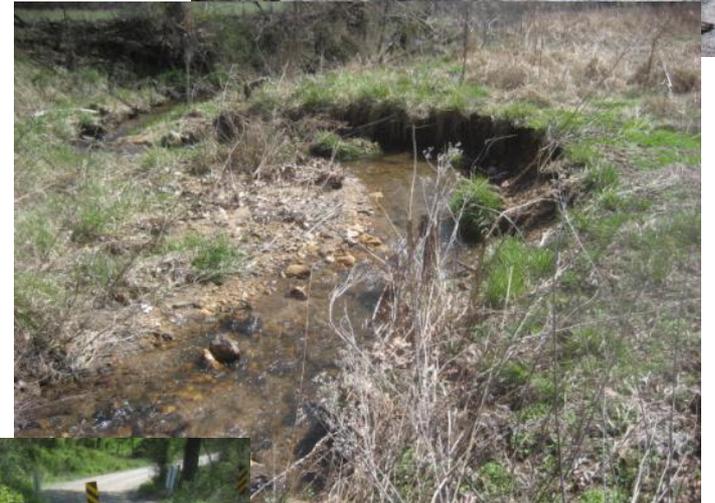
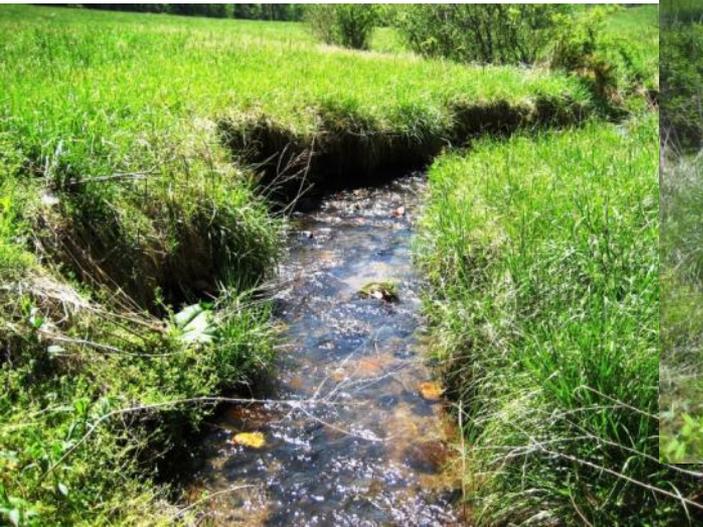
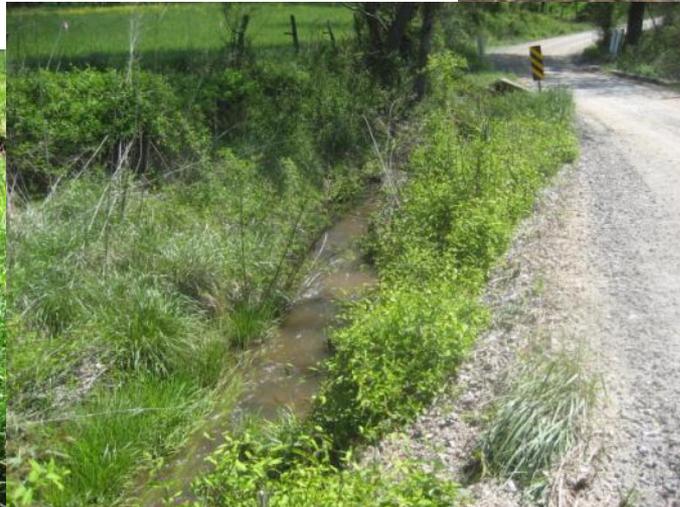
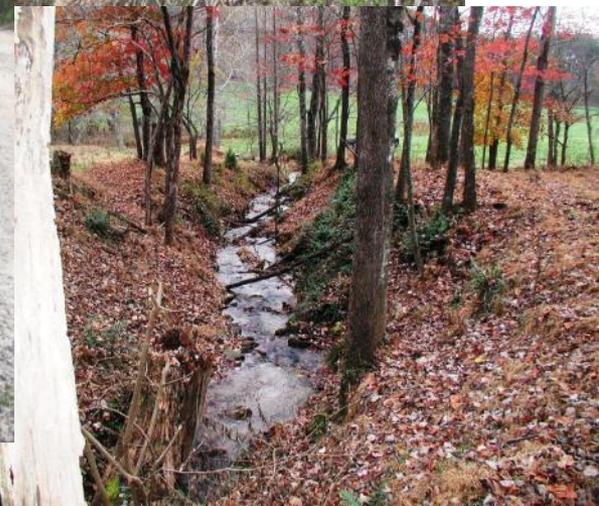
Problems

1. Streambank erosion
2. Cattle access
3. Lack of riparian buffer
4. Incised channel
5. Channel in road ditch
6. Drained riparian wetlands

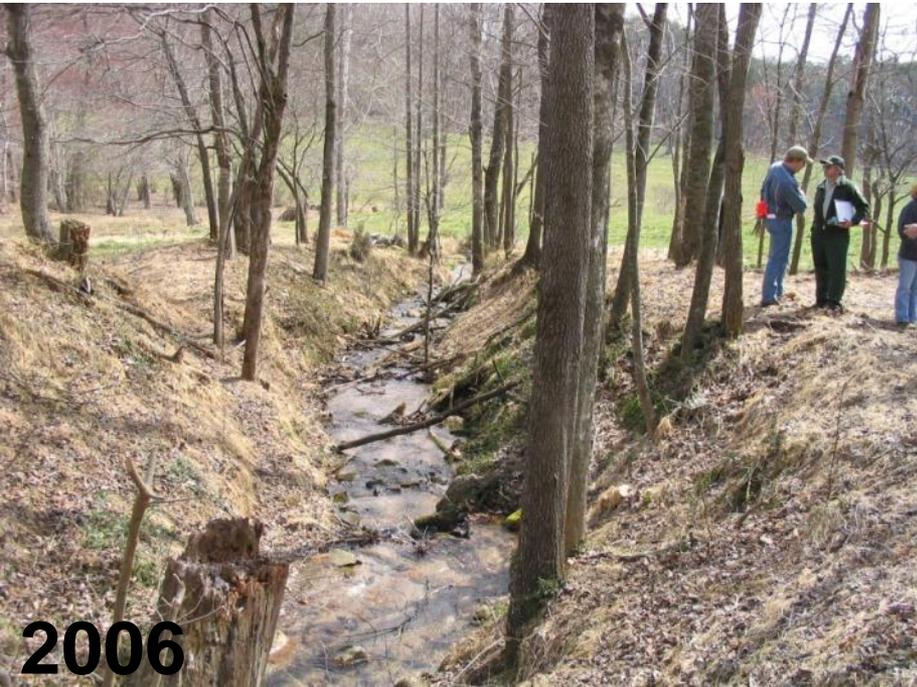
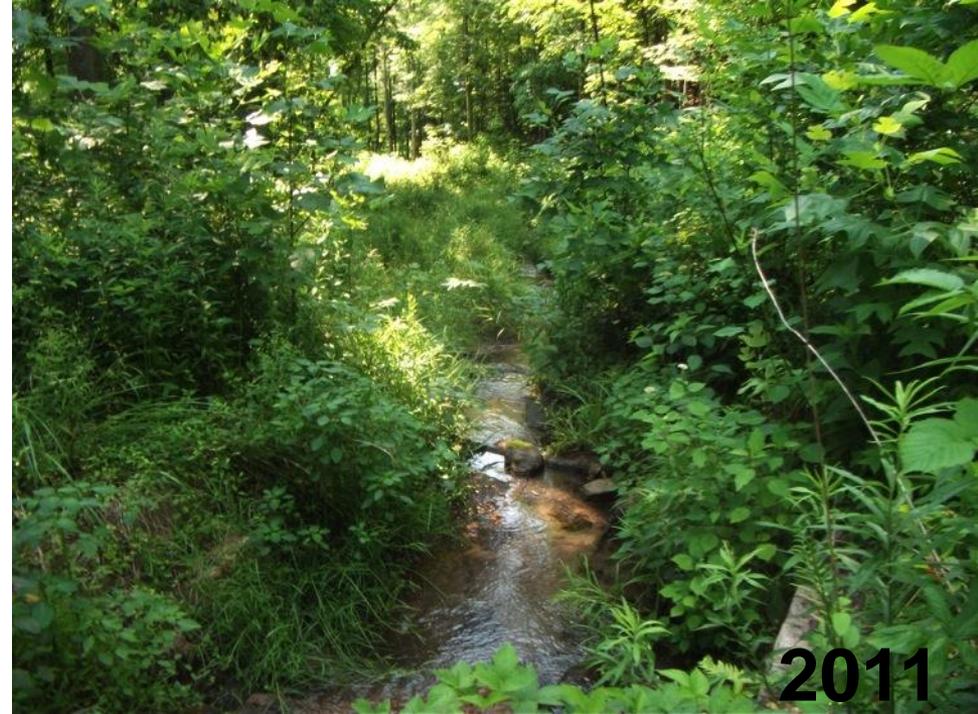
Phase 1 Stream Restoration (2006)

- Realign 600 ft channel
- Lift channel to provide floodplain connection
- In-stream habitat structures
- Culvert replacement to enhance connectivity
- Native riparian vegetation

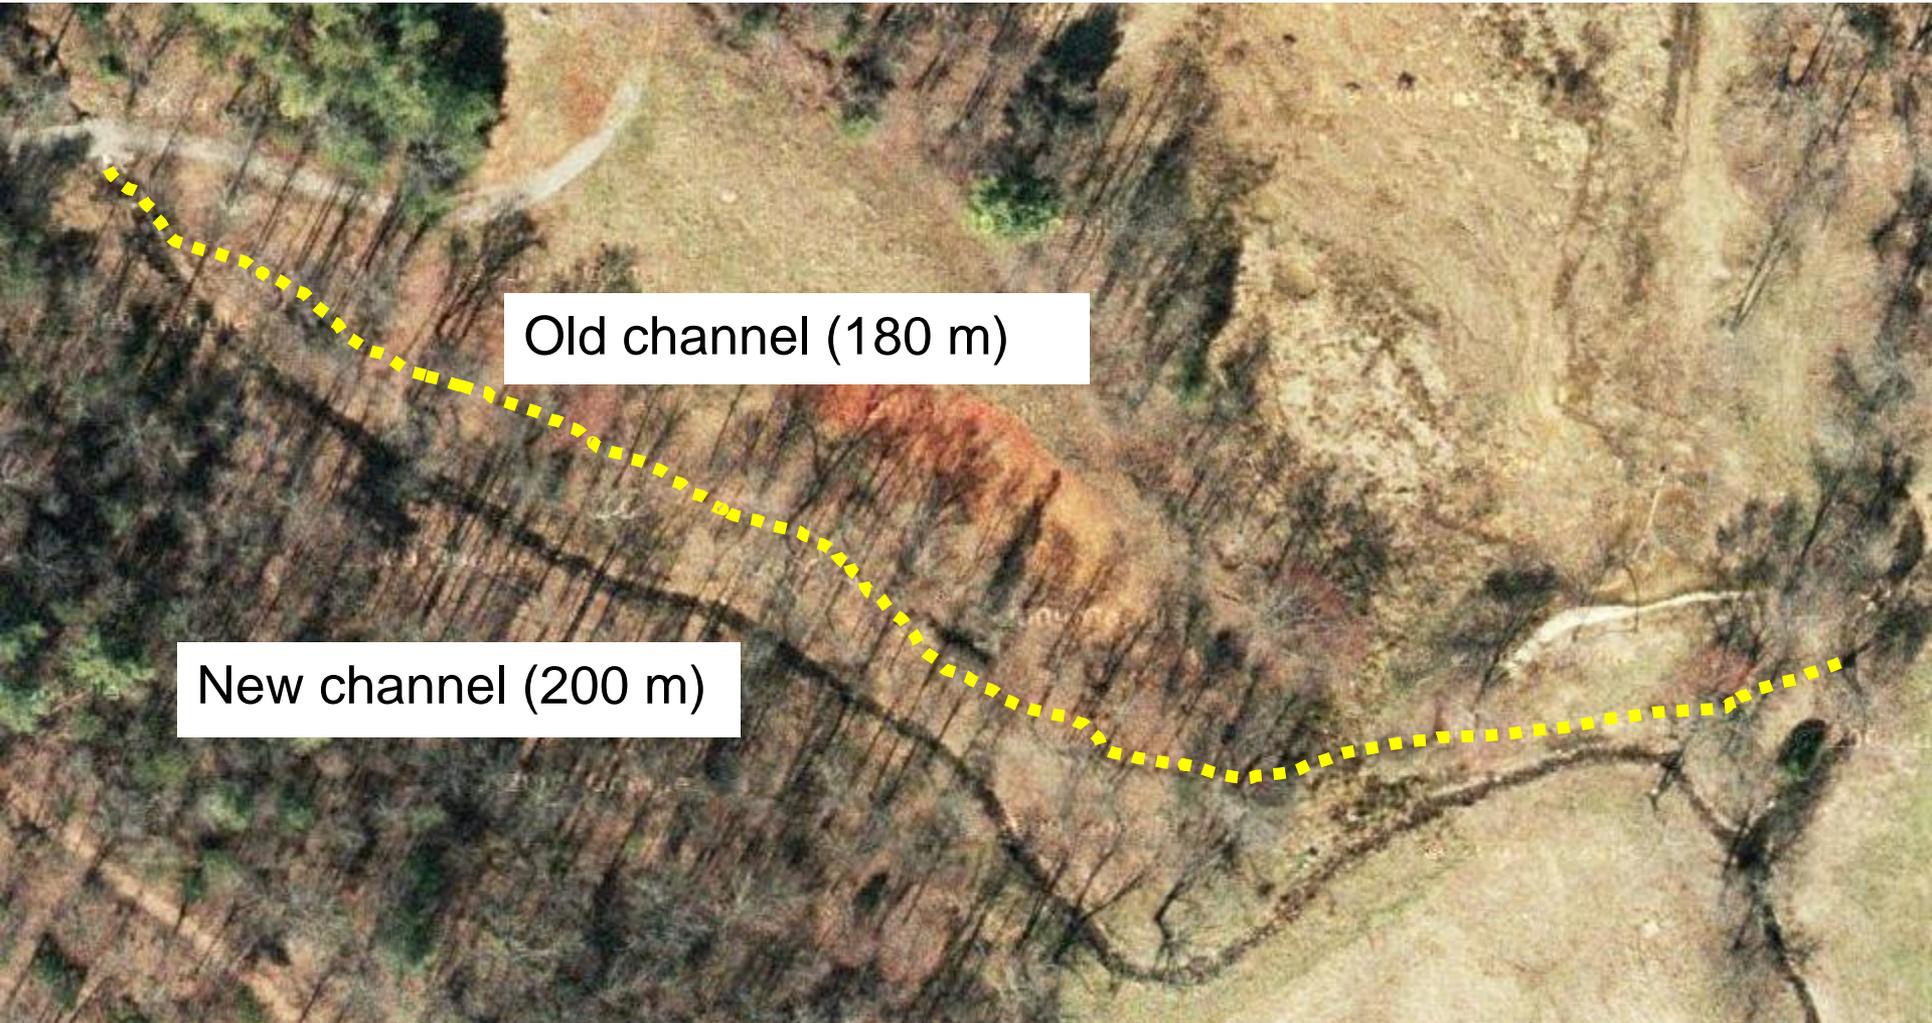
Phase 1 Stream Restoration

- Realign channel to follow valley thalweg

Old channel (180 m)

New channel (200 m)

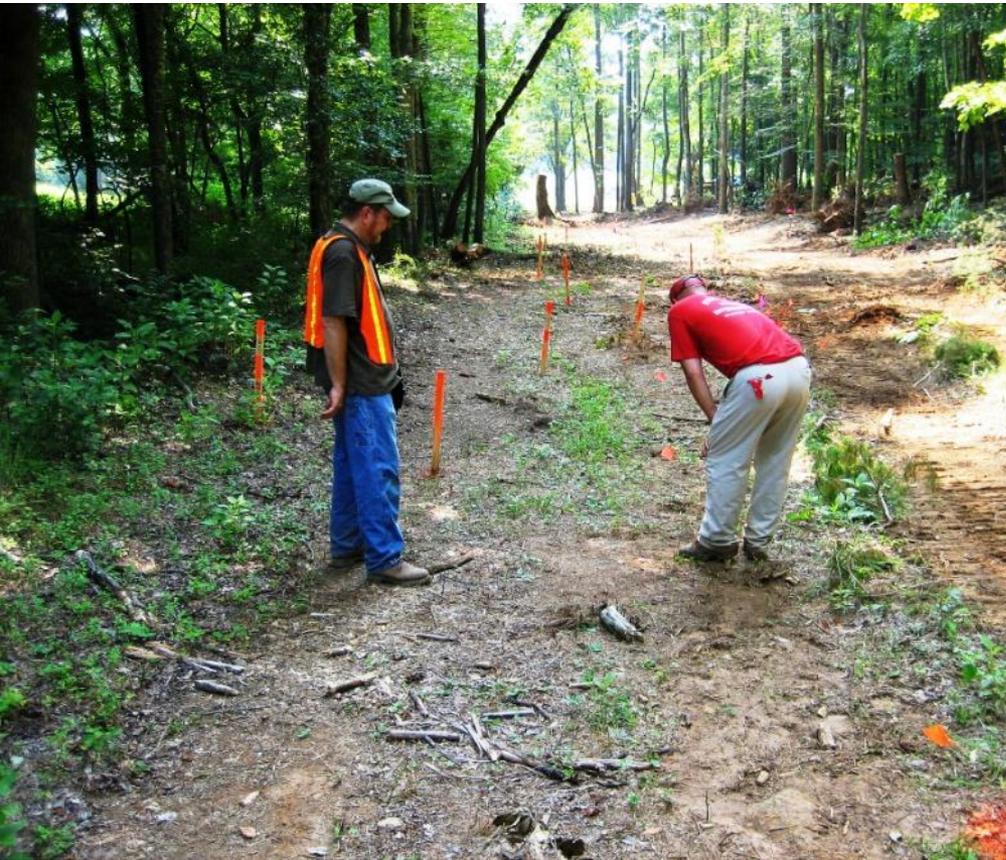
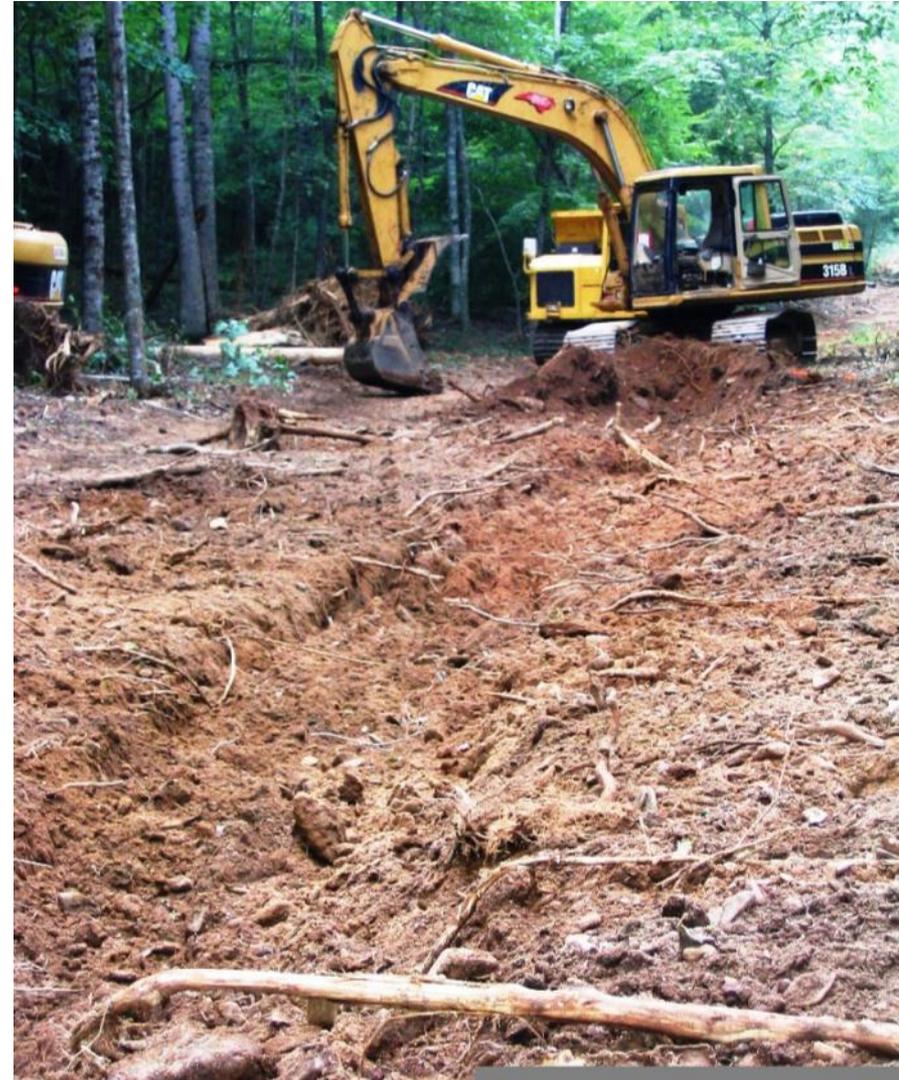
Phase 1 Stream Restoration

- Excavate new channel in valley thalweg (6% valley slope)

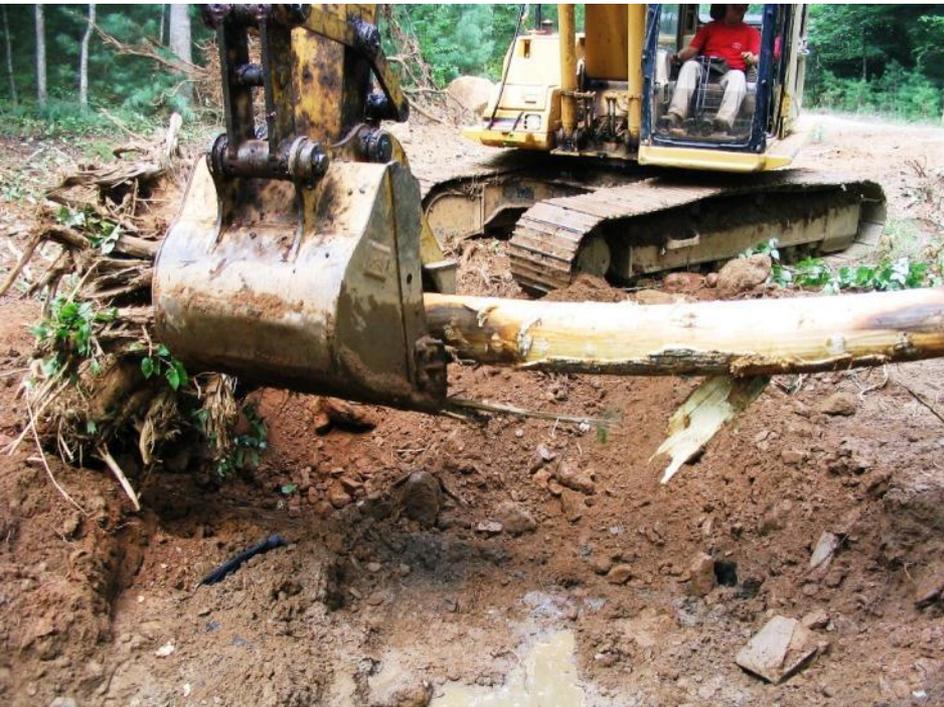
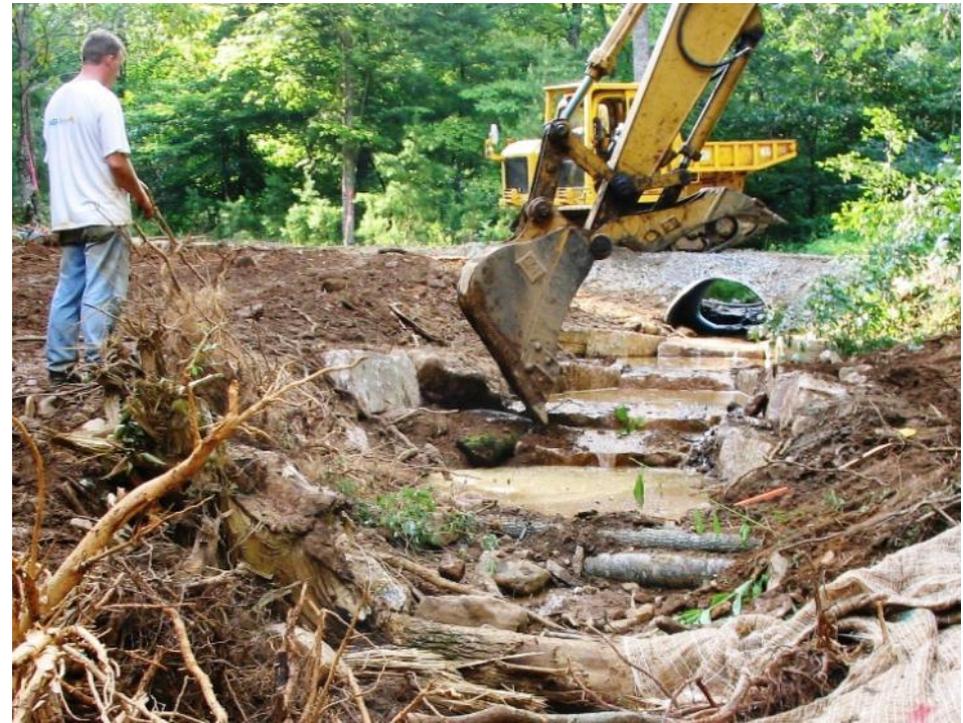
Phase 1 Stream Restoration

- In-stream log/rock structures for habitat and grade control

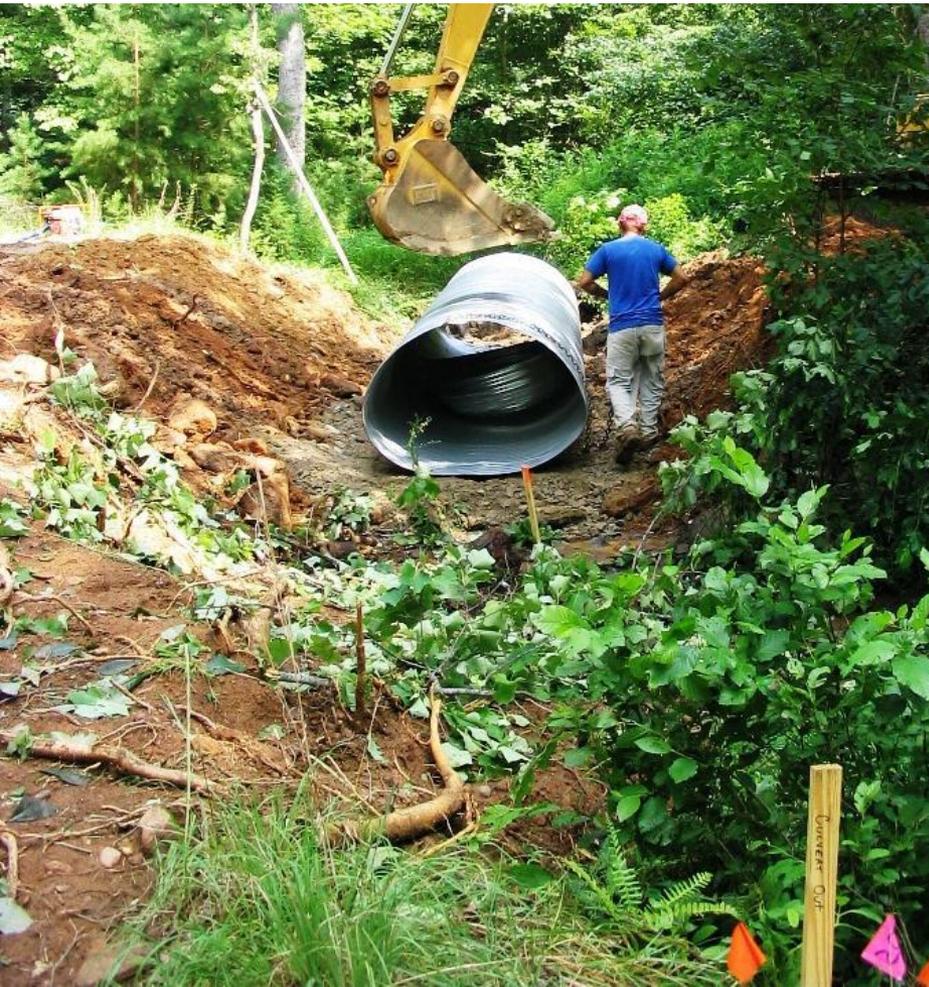
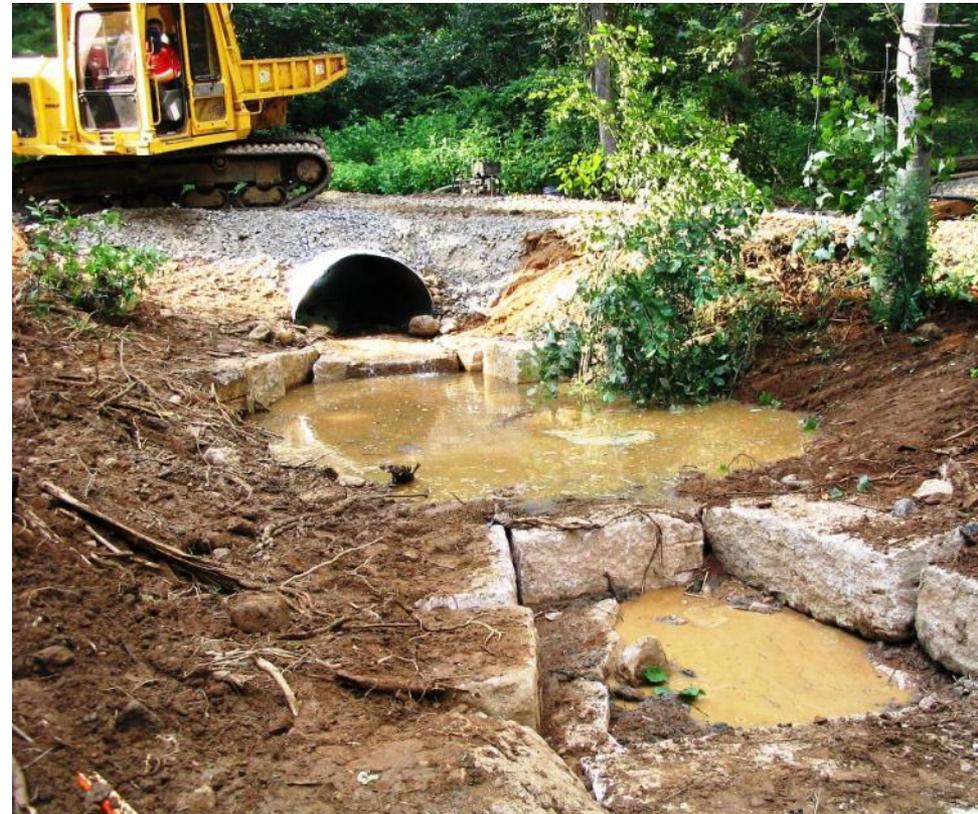
Phase 1 Stream Restoration

- Culvert replacement to maintain natural bed conditions

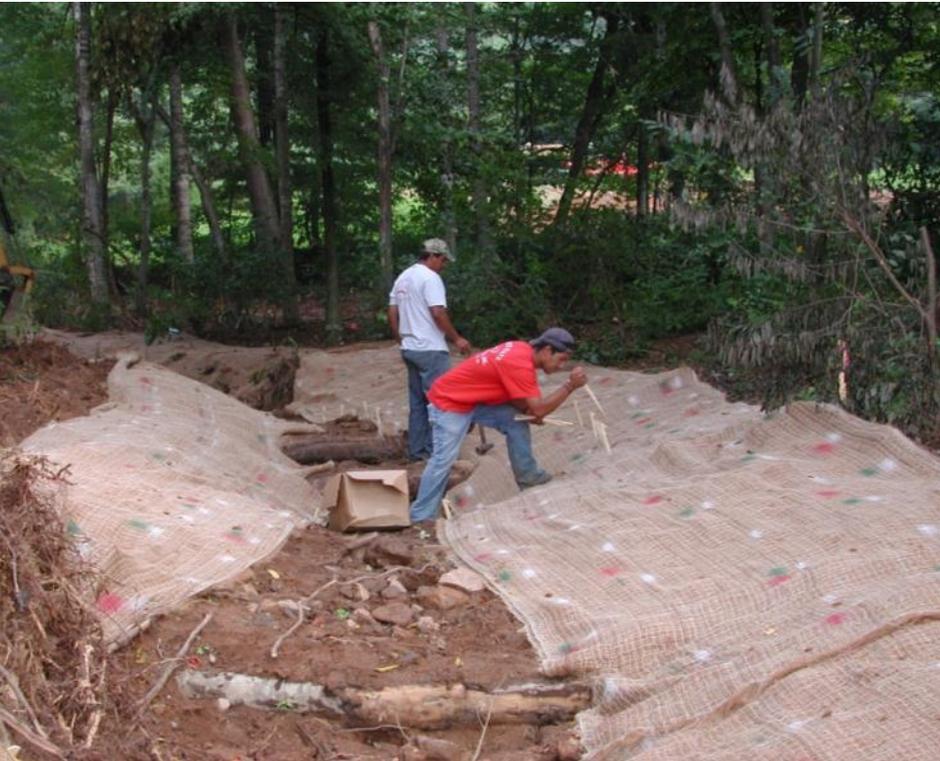
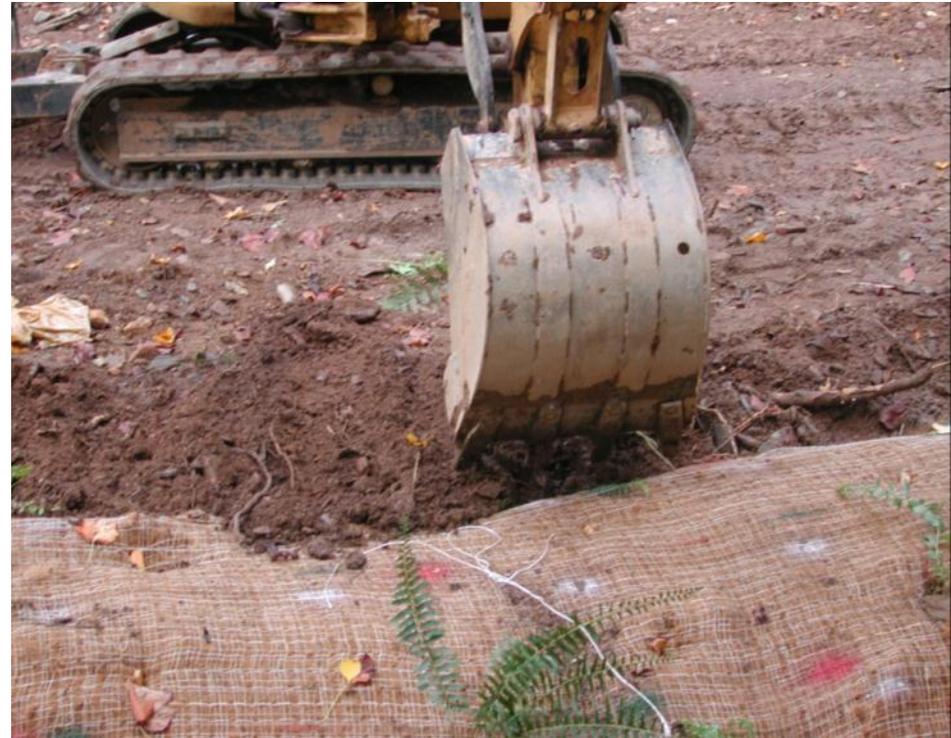
Phase 1 Stream Restoration

- Temporary erosion control matting (coir 700g)

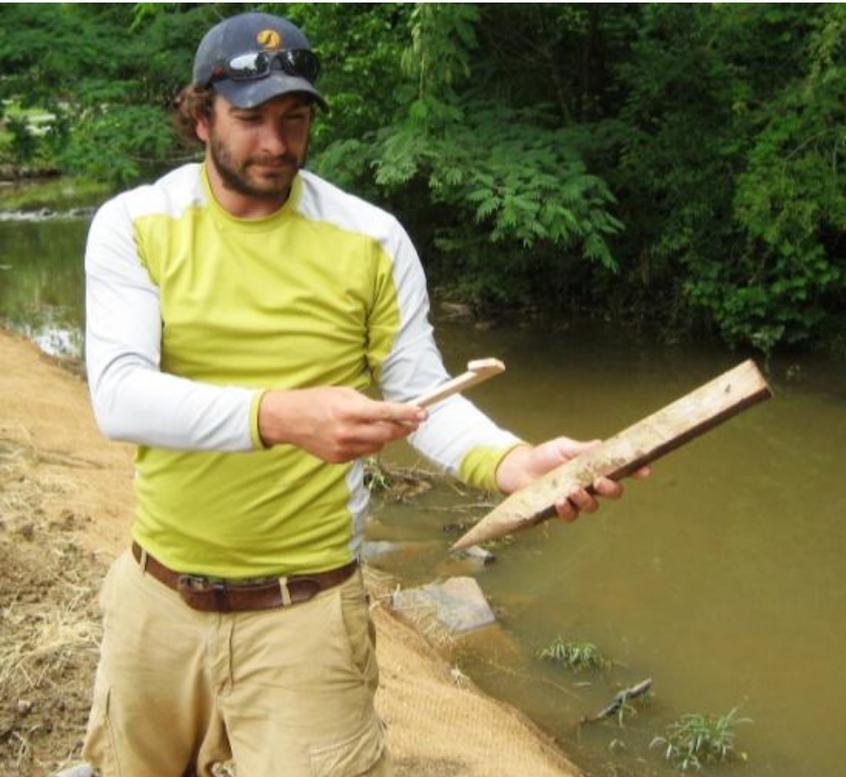
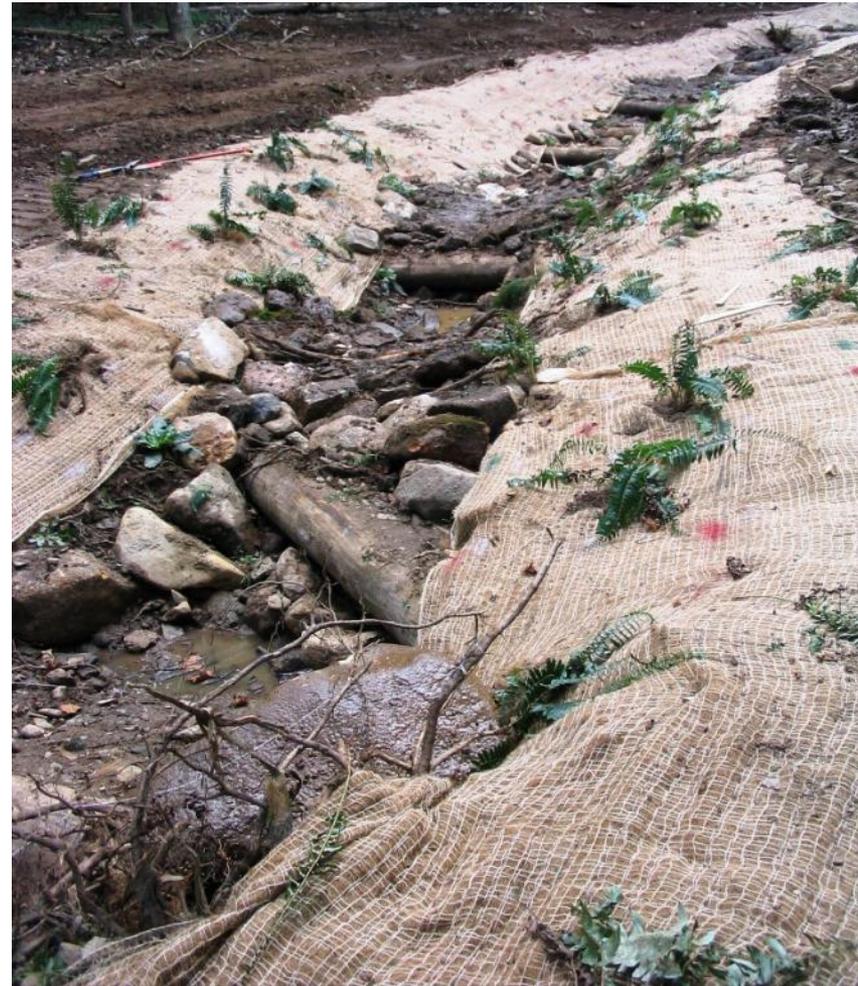
Temporary Matting

- Biodegradable (coir, jute, excelsior)
- Stakes: wood or biodegradable plastic
- Seed and straw UNDER mat
- Keep matting relaxed
- Key in at top

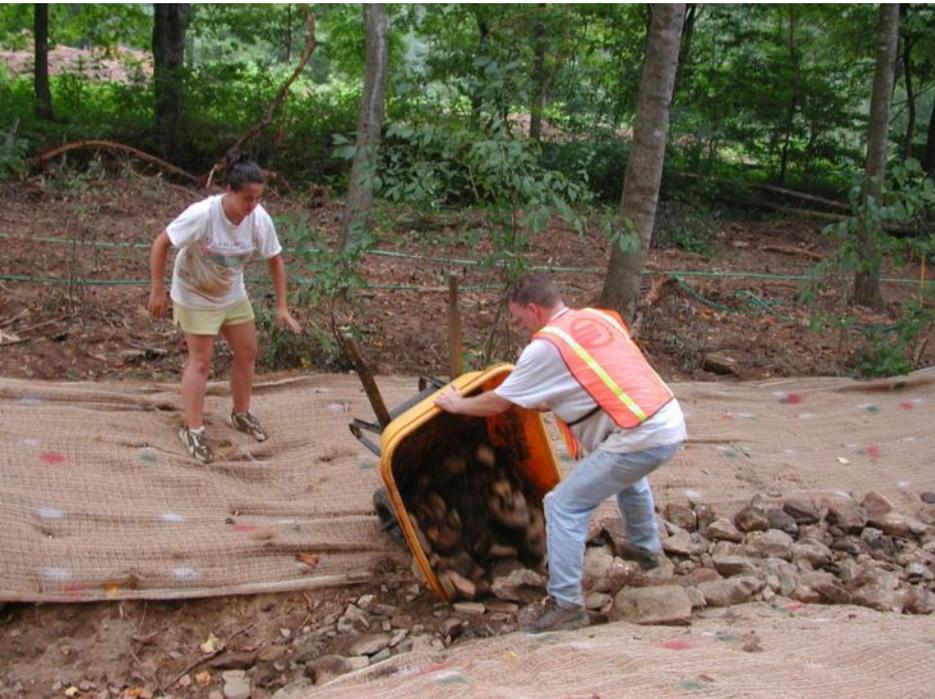
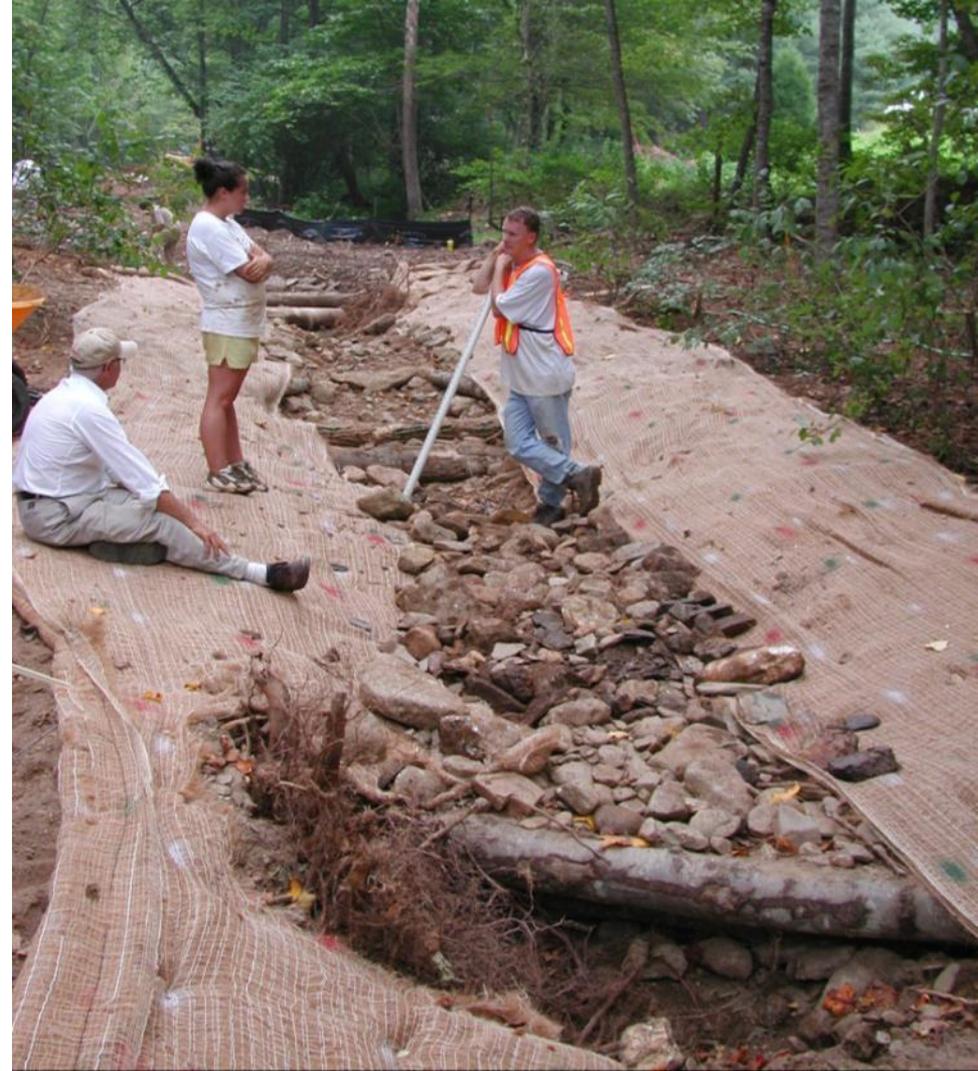
Phase 1 Stream Restoration

- Substrate transfer from old channel to new channel

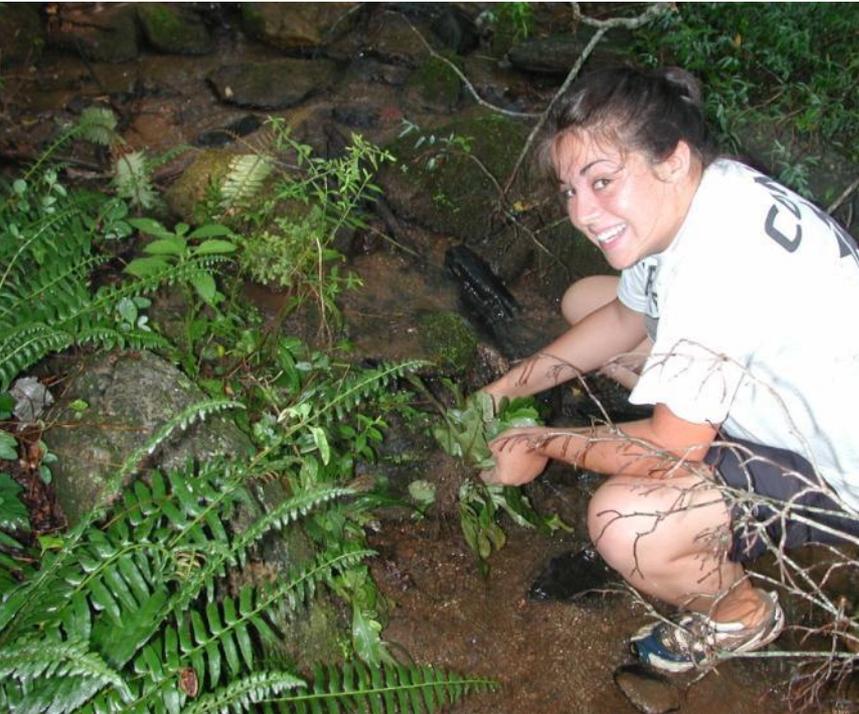
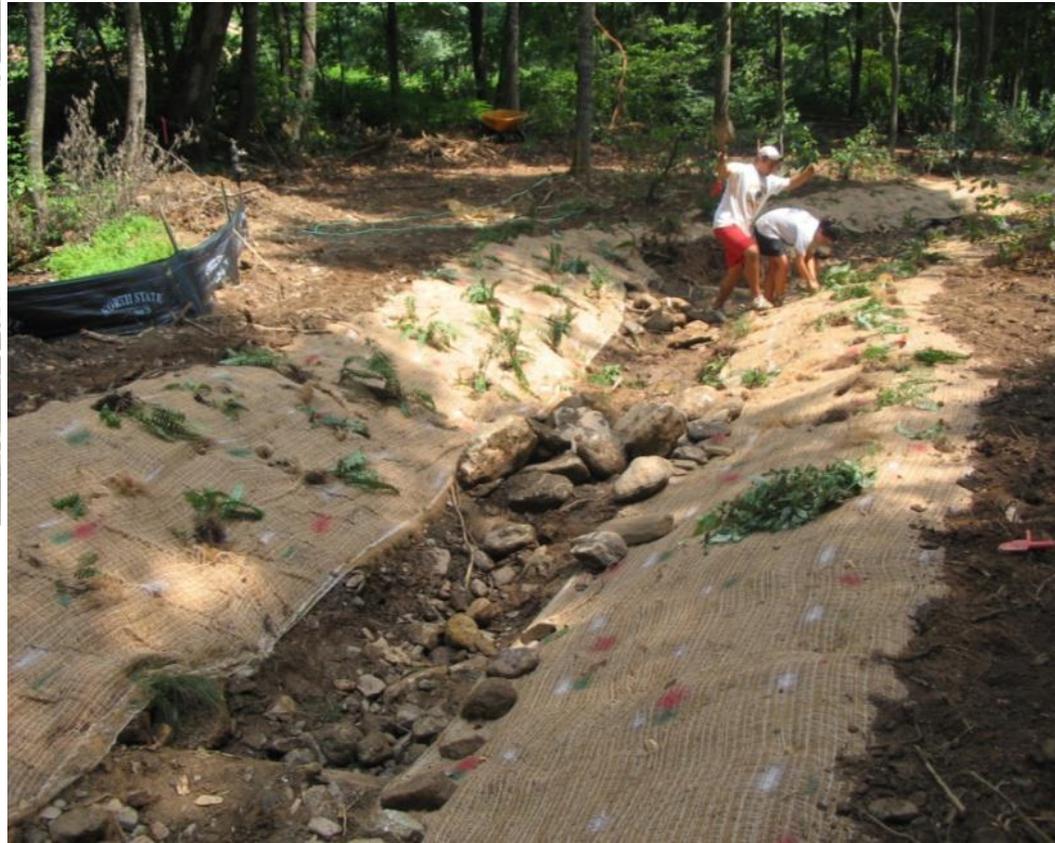
Phase 1 Stream Restoration

- Transplant native riparian vegetation

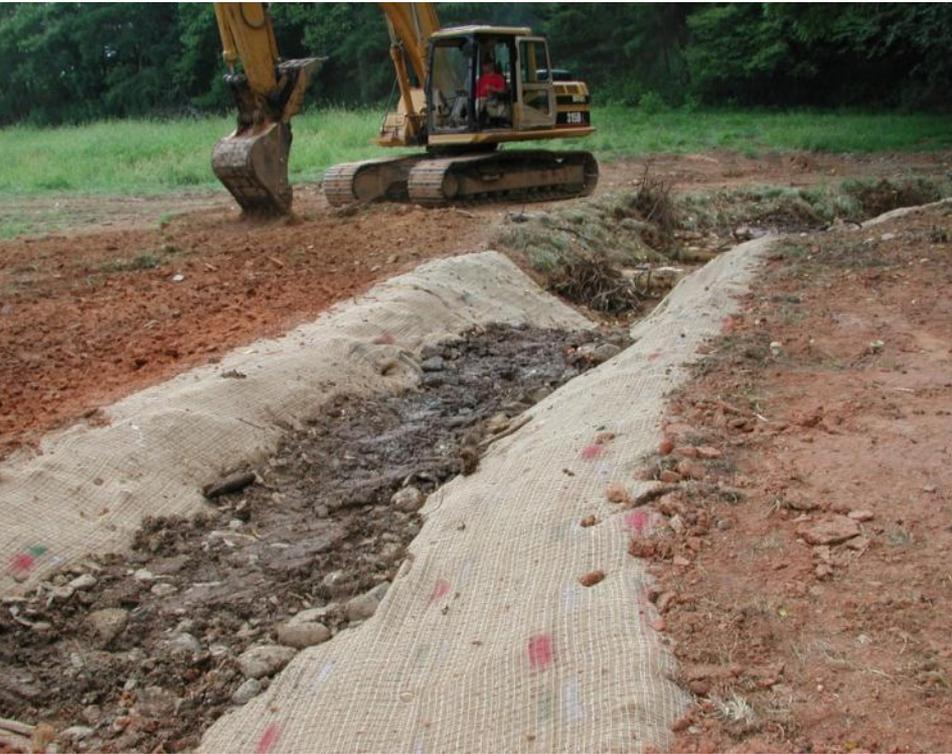
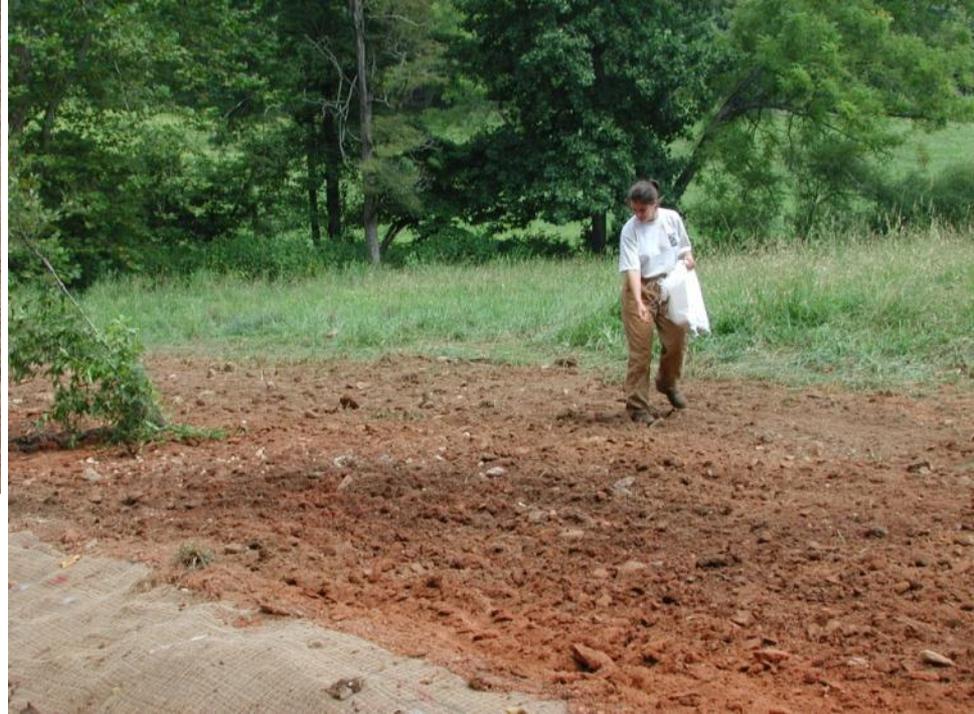
Phase 1 Stream Restoration

- Floodplain soil preparation and seeding

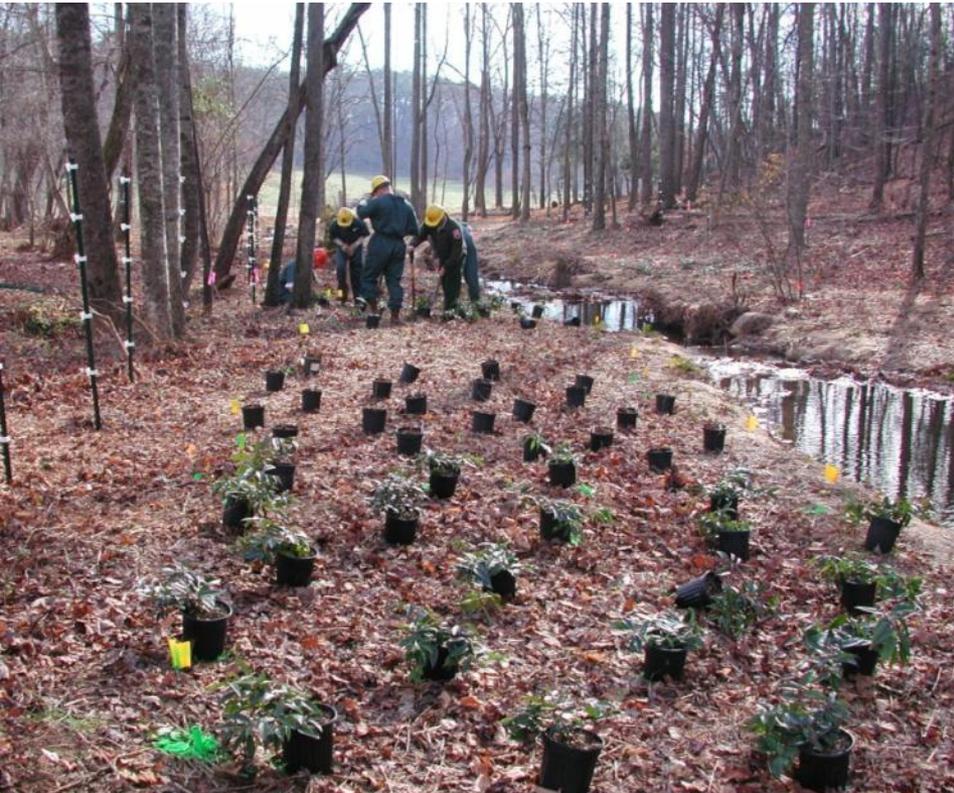
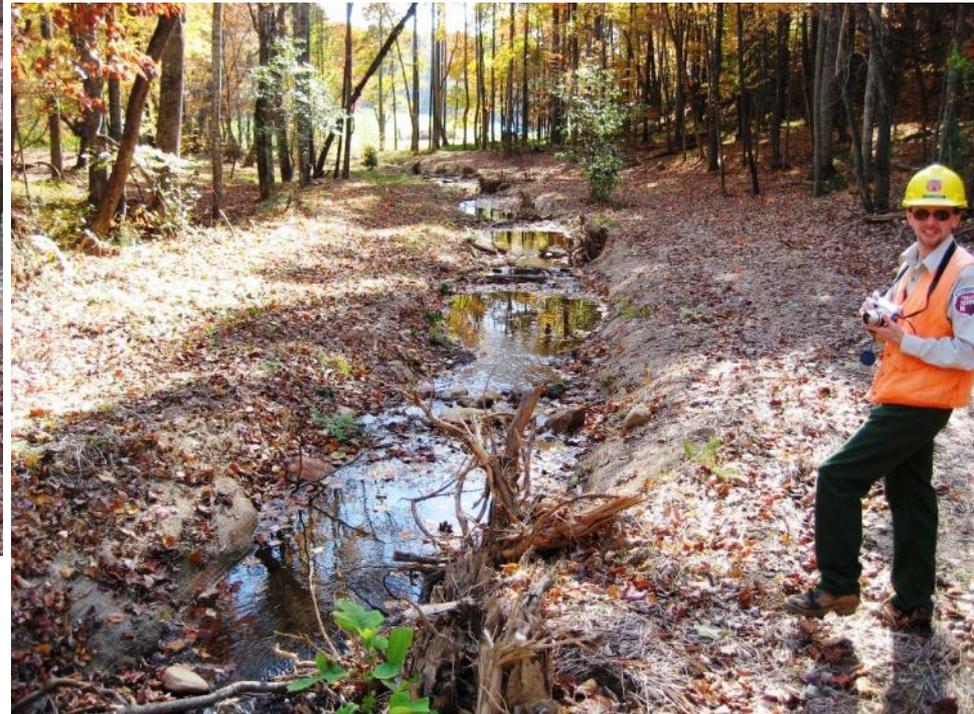
Phase 1 Stream Restoration

- Tree and shrub planting in winter

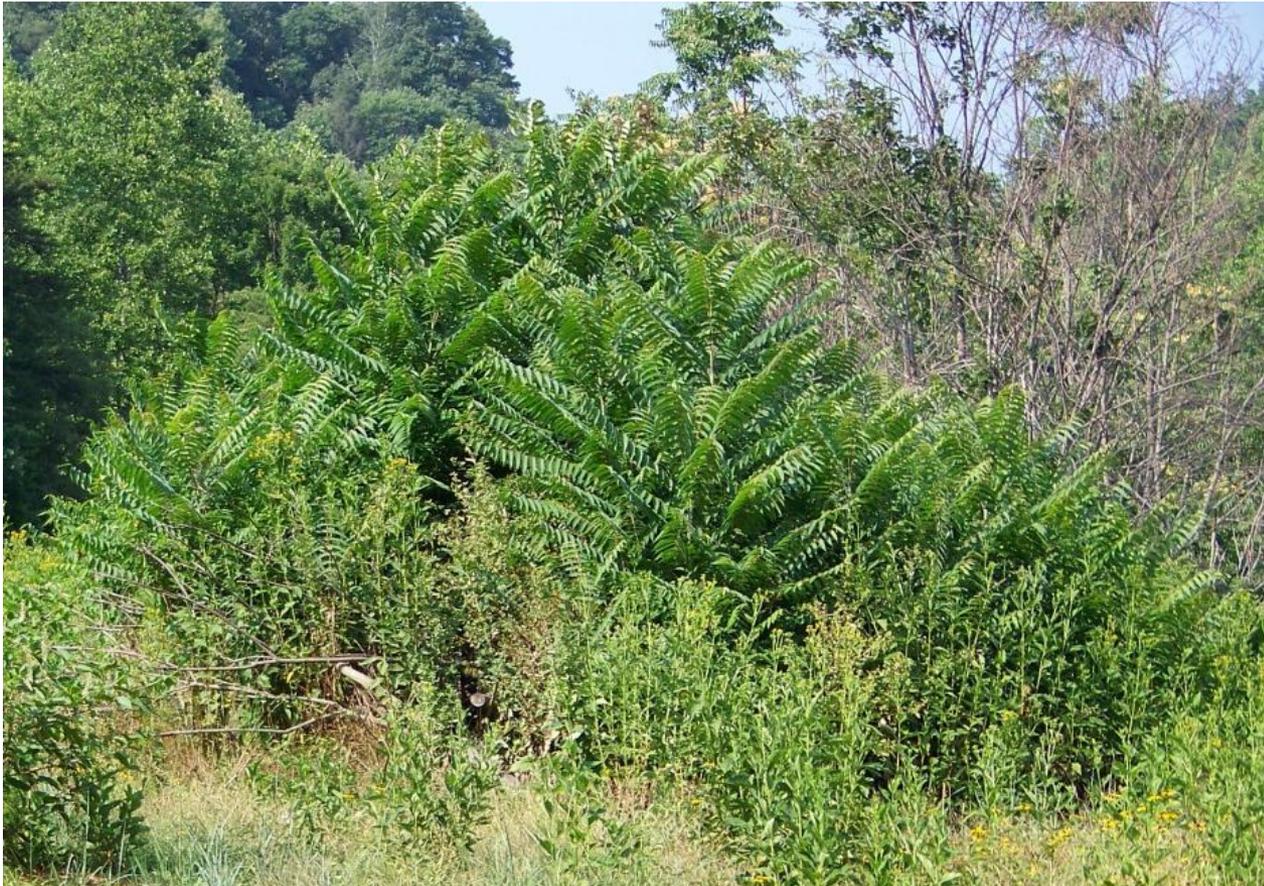
Phase 1 Stream Restoration

- Invasive plant removal (stilt grass, tree of heaven, fescue)

Ailanthus altissima (tree of heaven)

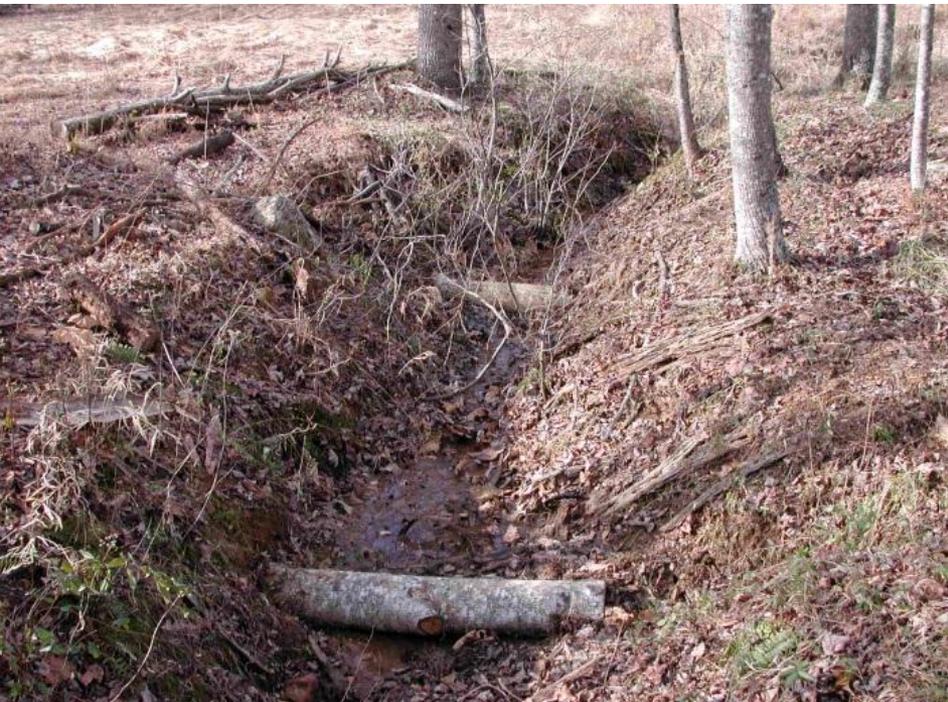
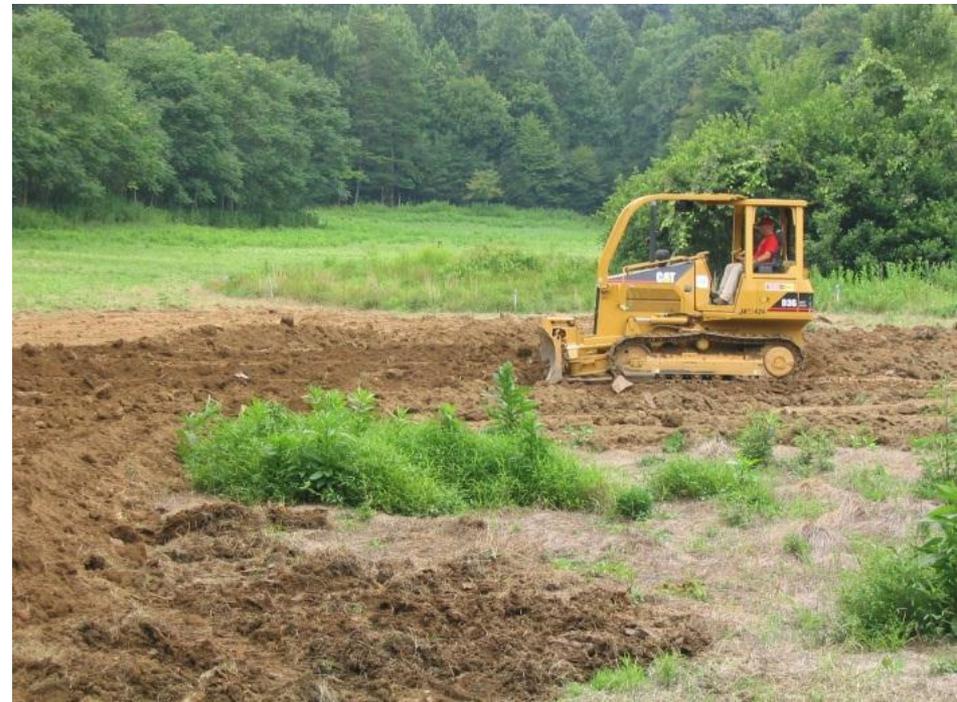
Phase 1 Wetland Restoration (2006)

- Bog turtle surveys
- Invasive plant eradication
- Seeding with native wetland plants
- Restore hydrology by plugging ditches

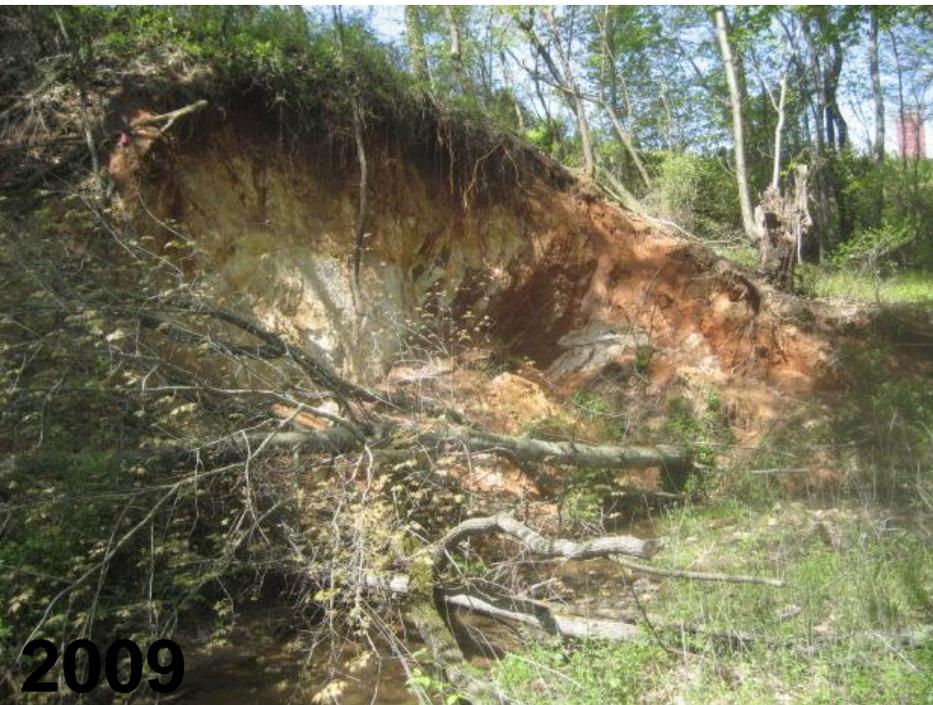
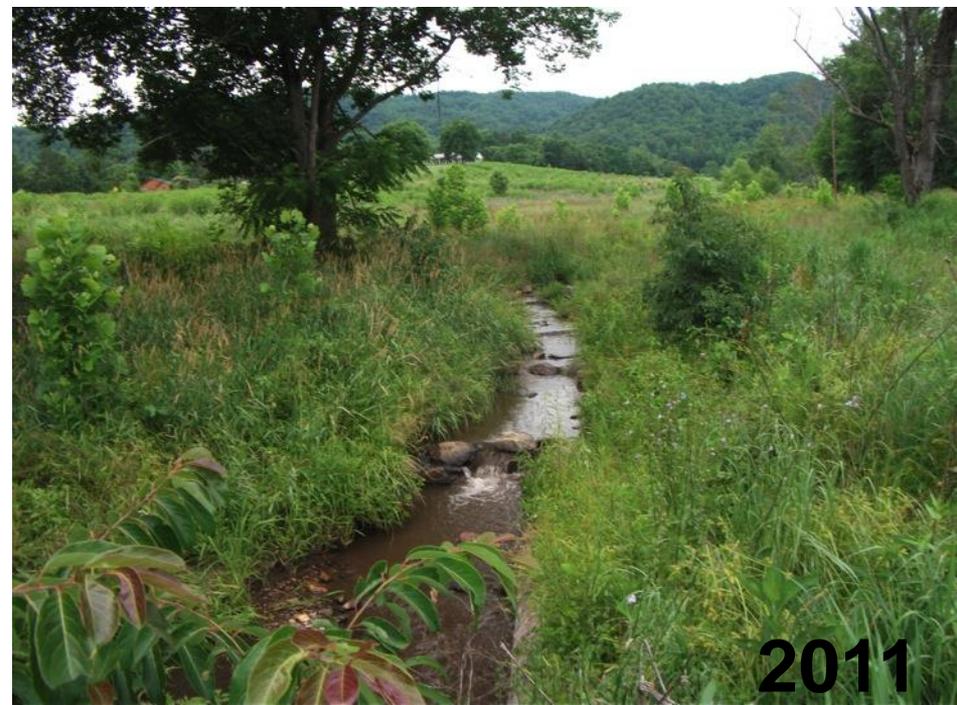
Phase 2 & 3 Stream Restoration (07-09)

- Enhance 1800 ft upstream
- Realign 3300 ft downstream
- Lift channel to provide floodplain connection
- In-stream habitat structures
- Native riparian vegetation
