Stream and Wetland Restoration at Rendezvous Mountain Educational State Forest

North Carolina Forest Service Rendezvous Mountain Educational State Forest Wilkes County, NC, USA

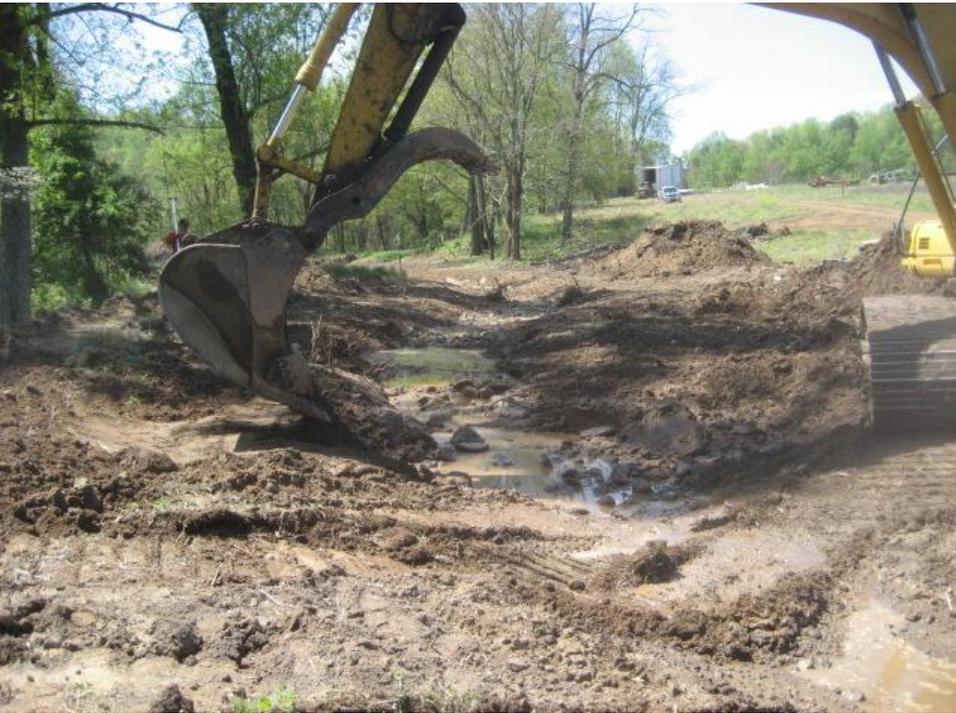
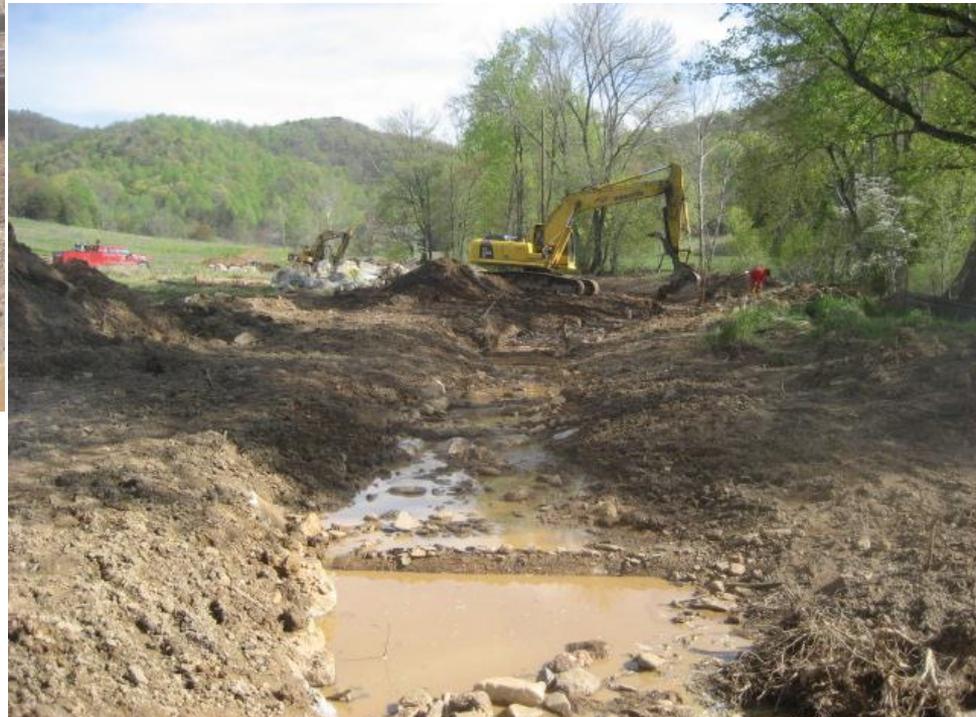
Phase 2 & 3 Stream Restoration

- Excavate new channel in valley thalweg (3% valley slope)

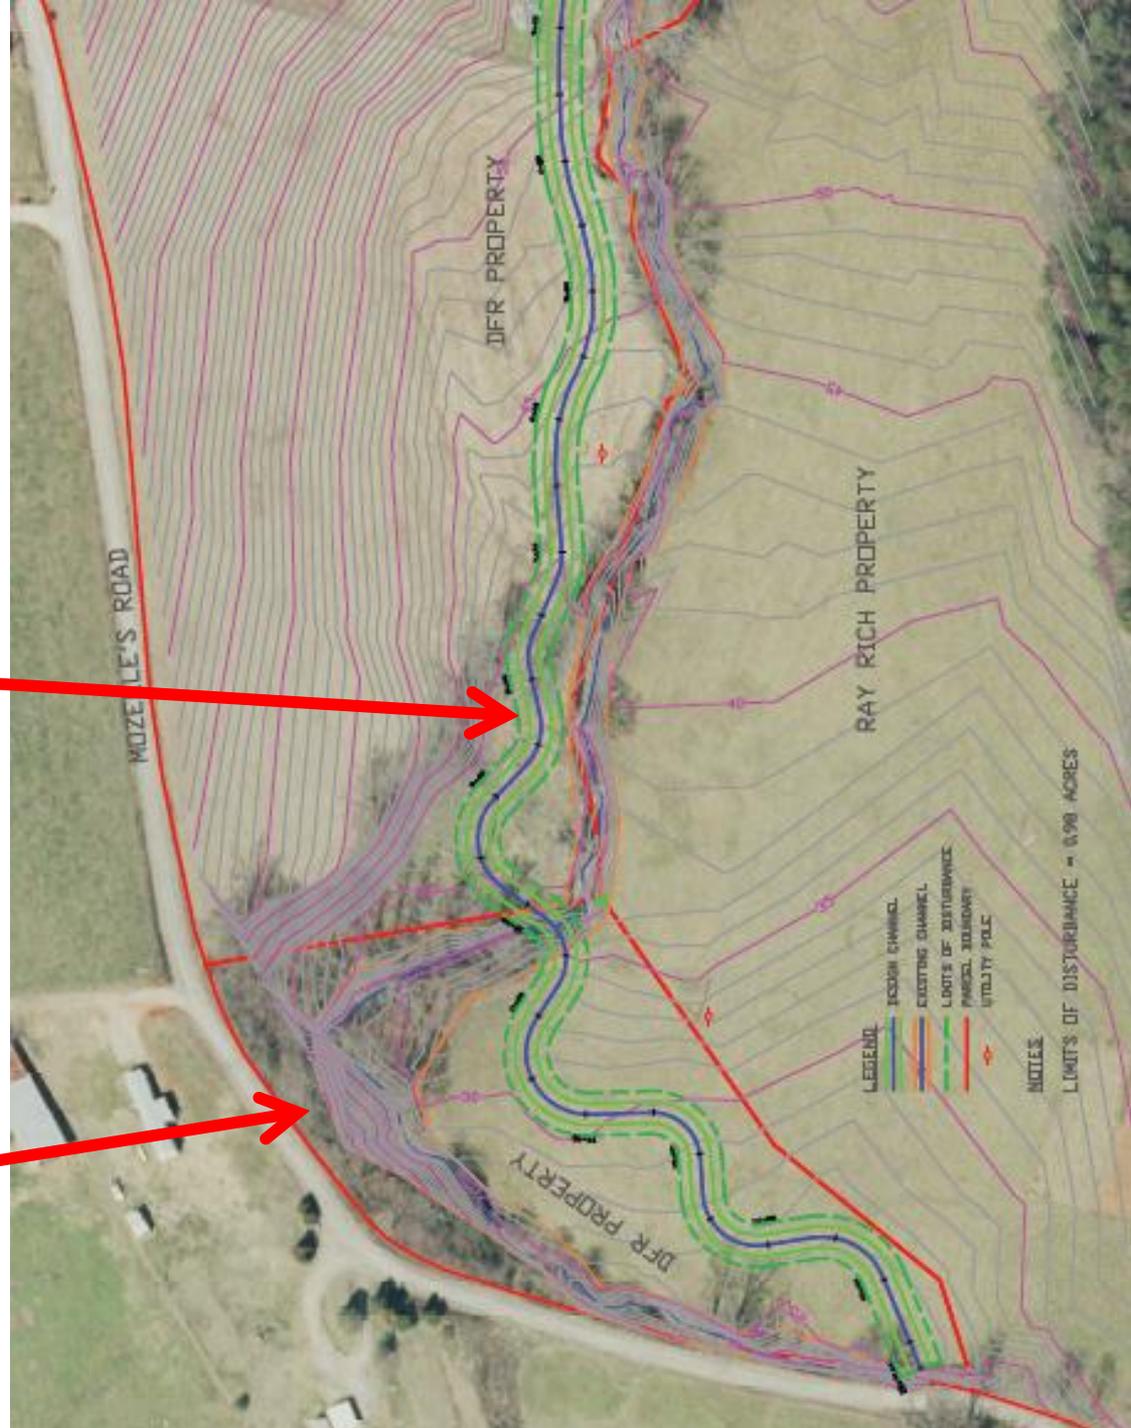
Phase 3 Stream Restoration: Realign channel to follow valley thalweg (3%)

New channel

*Old channel
(600 ft in road ditch)*

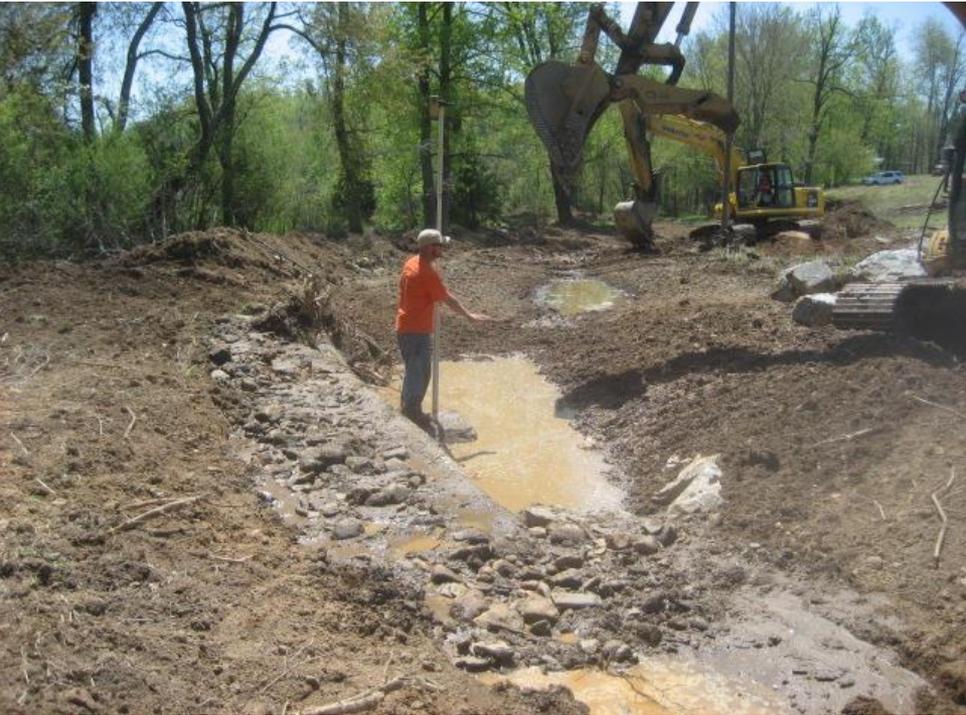
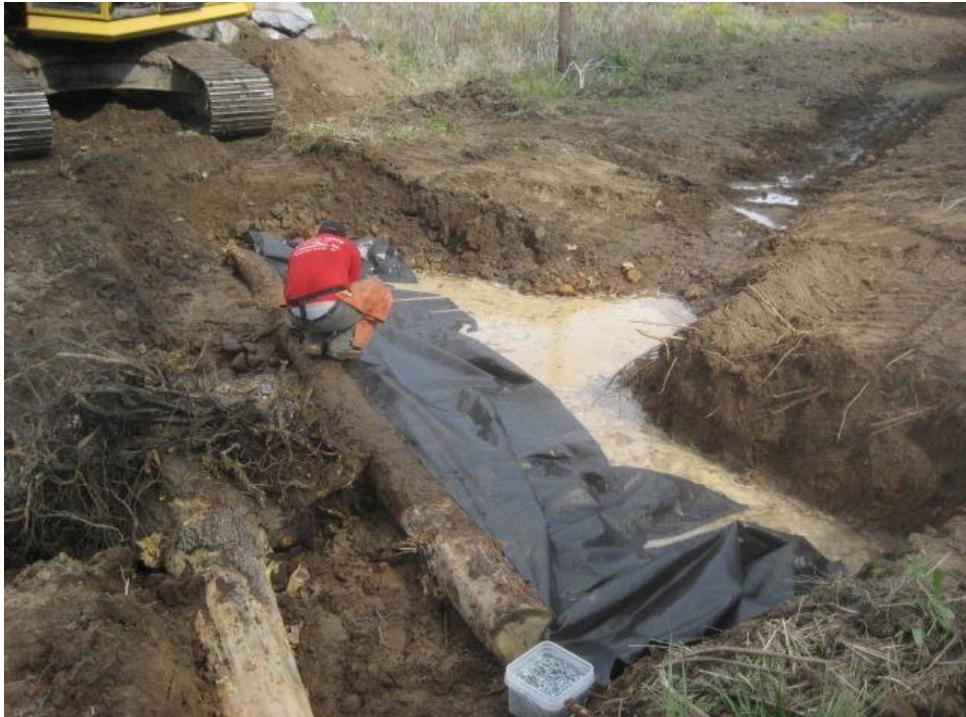
Phase 2 & 3 Stream Restoration

- In-stream log/rock structures for habitat and grade control

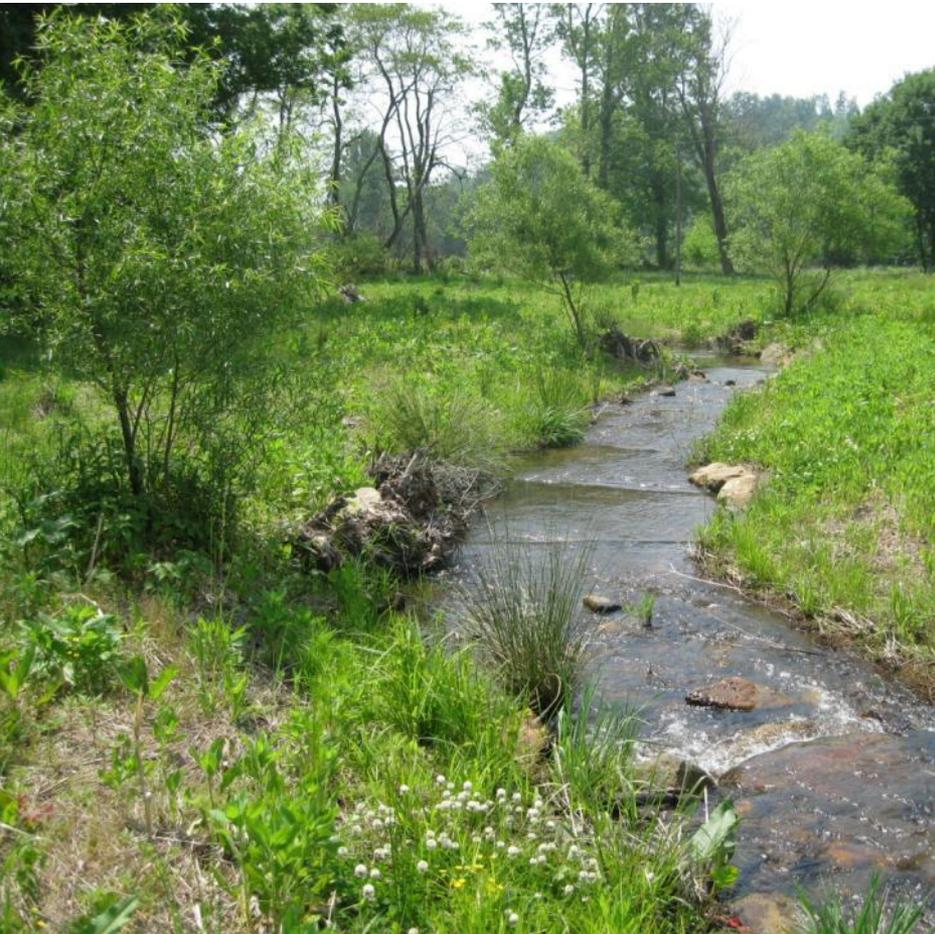
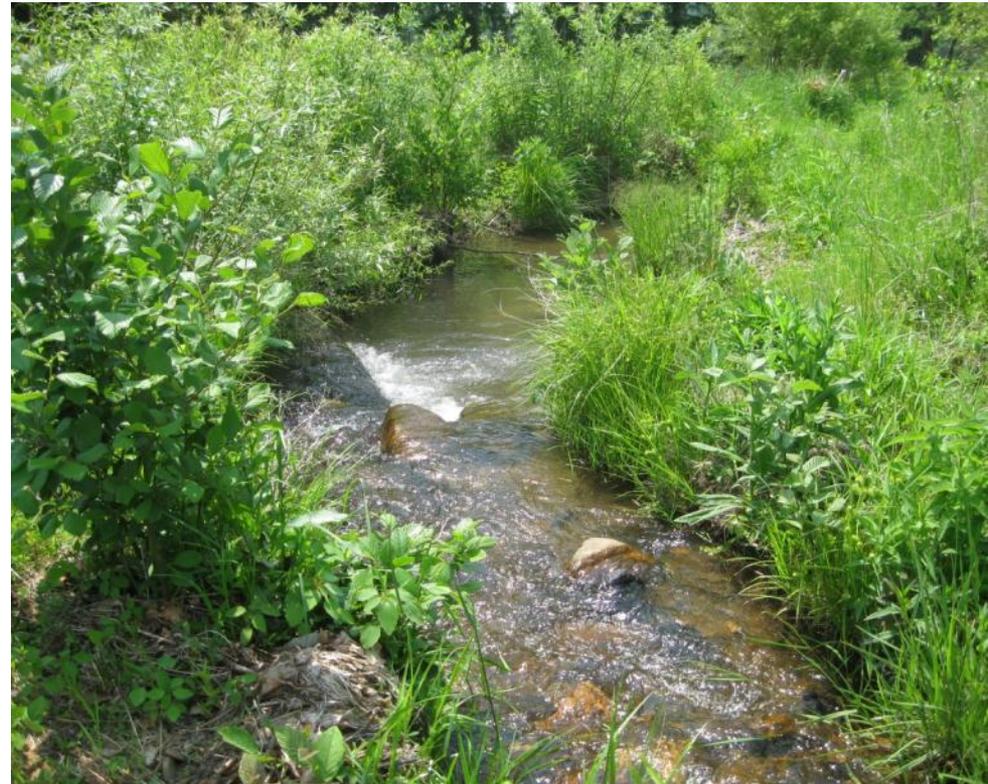
Phase 2 & 3 Stream Restoration

- Riparian vegetation:
 - transplanted juncus, willow, alder
 - tree seedlings

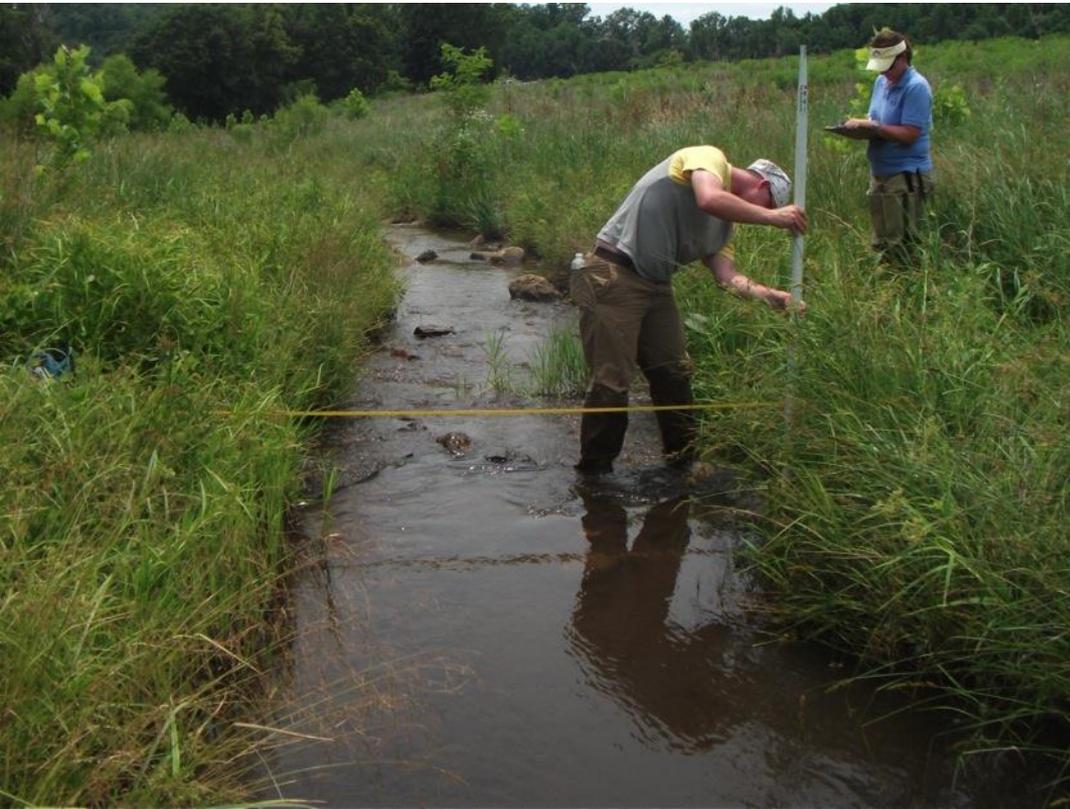
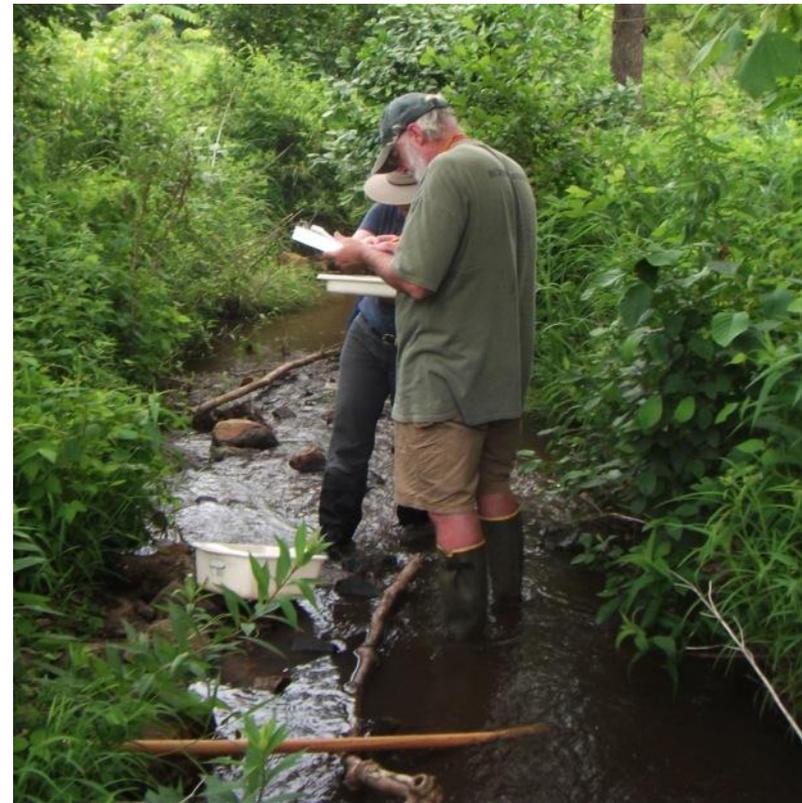
Monitoring

- Morphology surveys – *stable*
- Vegetation surveys – *good early growth*
- Water quality – *upstream sediment*
- Macroinvertebrate populations – *recovering slowly*
