Clear Creek Dam Fish Passage Assessment

FINAL REPORT

Final
April 1, 2016

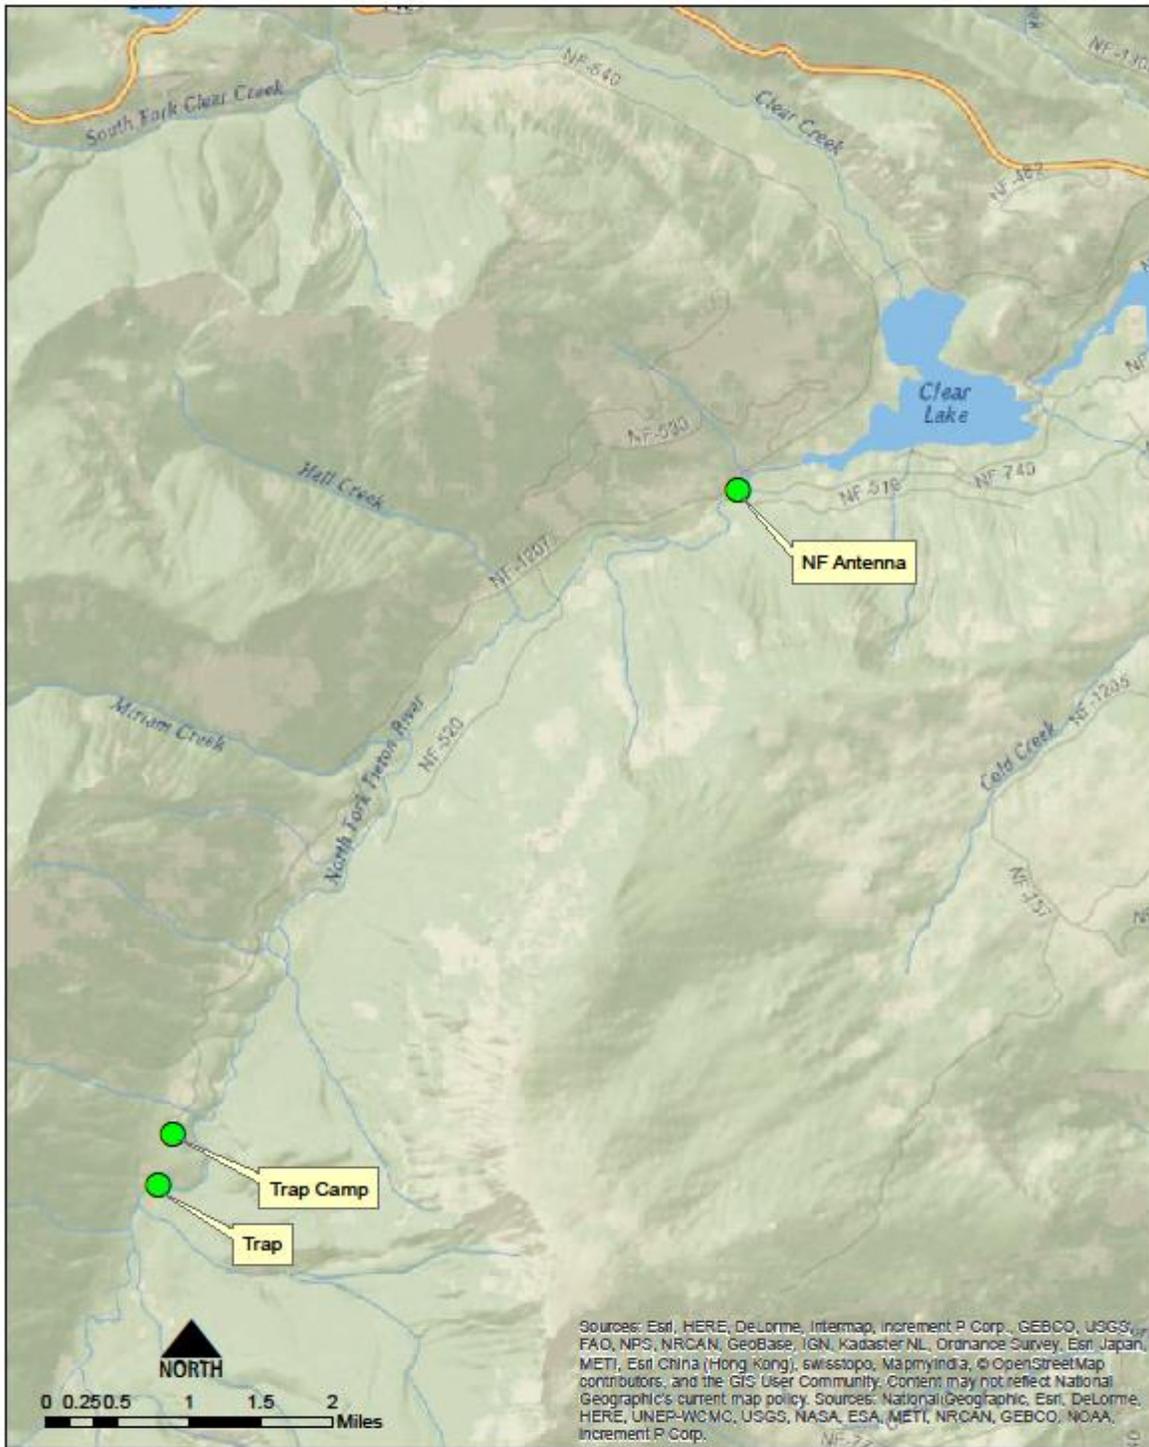
Figure 2. Location of the PIT tag detection array (antenna) established in the North Fork Teton River 0.75 mile upstream of Clear Lake and the trap used to capture bull trout which was 6.75 miles upstream of the lake.

Figure 2. Location of the PIT tag detection array (antenna) established in the North Fork Tieton River 0.8 mile upstream of Clear Lake and the trap used to capture bull trout which was 6.75 miles upstream of the lake. 9

The hydraulic characteristics of the river at the trap site were nearly perfect at normal base flows. The channel was approximately 32 feet wide, gently sloping horizontally from the stream margins and nearly flat for a distance of about seven feet near the middle of the channel. Substrate materials consisting primarily of small cobbles (2-3 inch diameter) and gravels. The maximum water depth in the thalweg was 18-24 inches and maximum water velocities, although not measured, appeared to be between 1.0 and 1.5 feet per second.

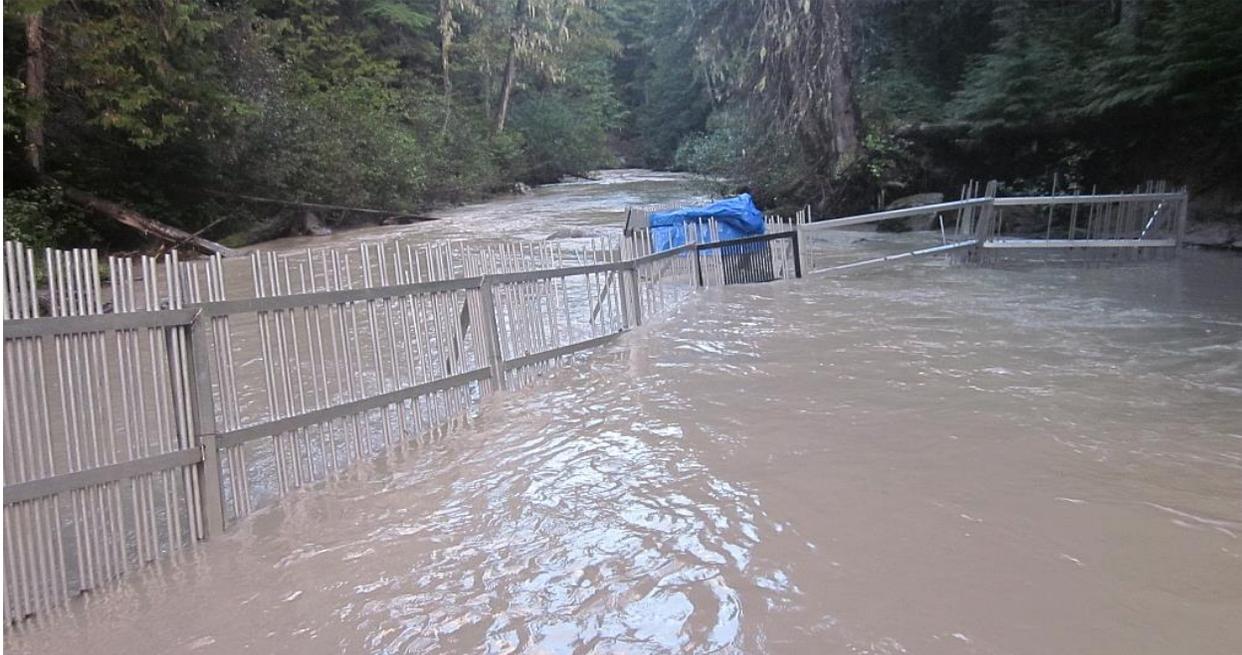
Figure 3. NF Tieton River fish trap after the high flow event on September 22, 2013. The photo was taken the next day after the river had receded.

The second high flow event began the afternoon of September 27. The river rose gradually until the early morning hours of September 29 when, fed by over a day of heavy rainfall, the stage began to rise rapidly. Efforts to save the trap in the pre-dawn hours were halted because of dangerous conditions and a few hours later the trap disintegrated and washed downriver (Figure 4). All of the weir and trap box components were recovered from as much as 200 yards downstream a few days later after the stage had receded.

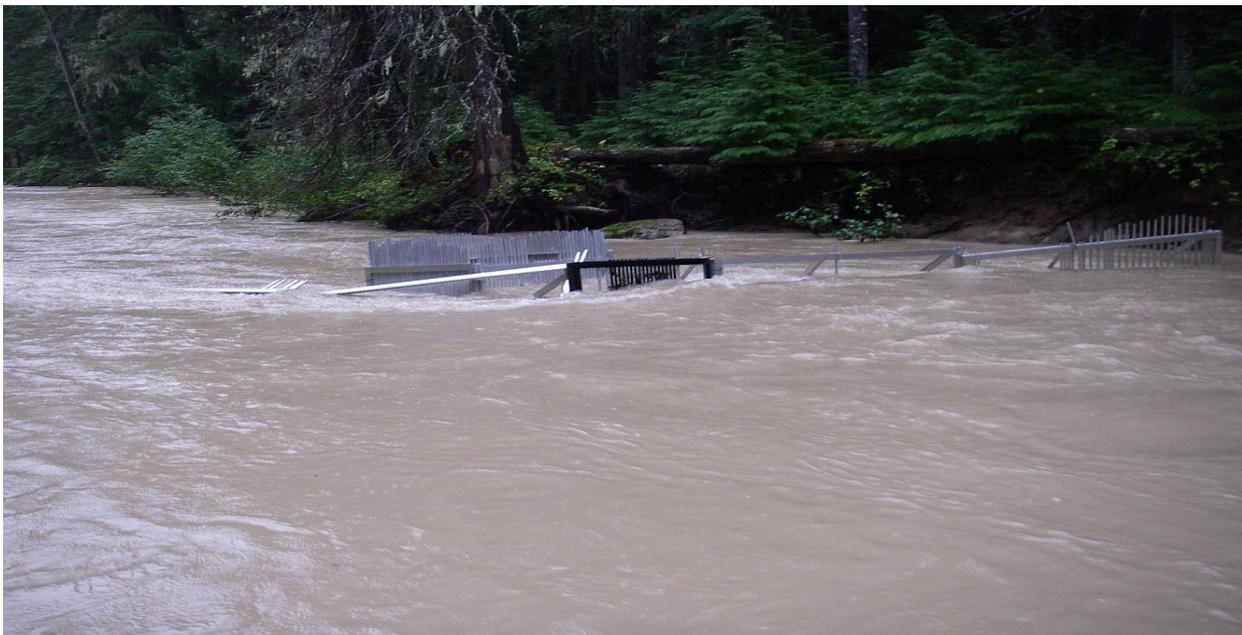
Figure 4. NF Tieton River fish trap during the high flow event which occurred at the end of September, 2013. This photo was taken the morning of September 29.

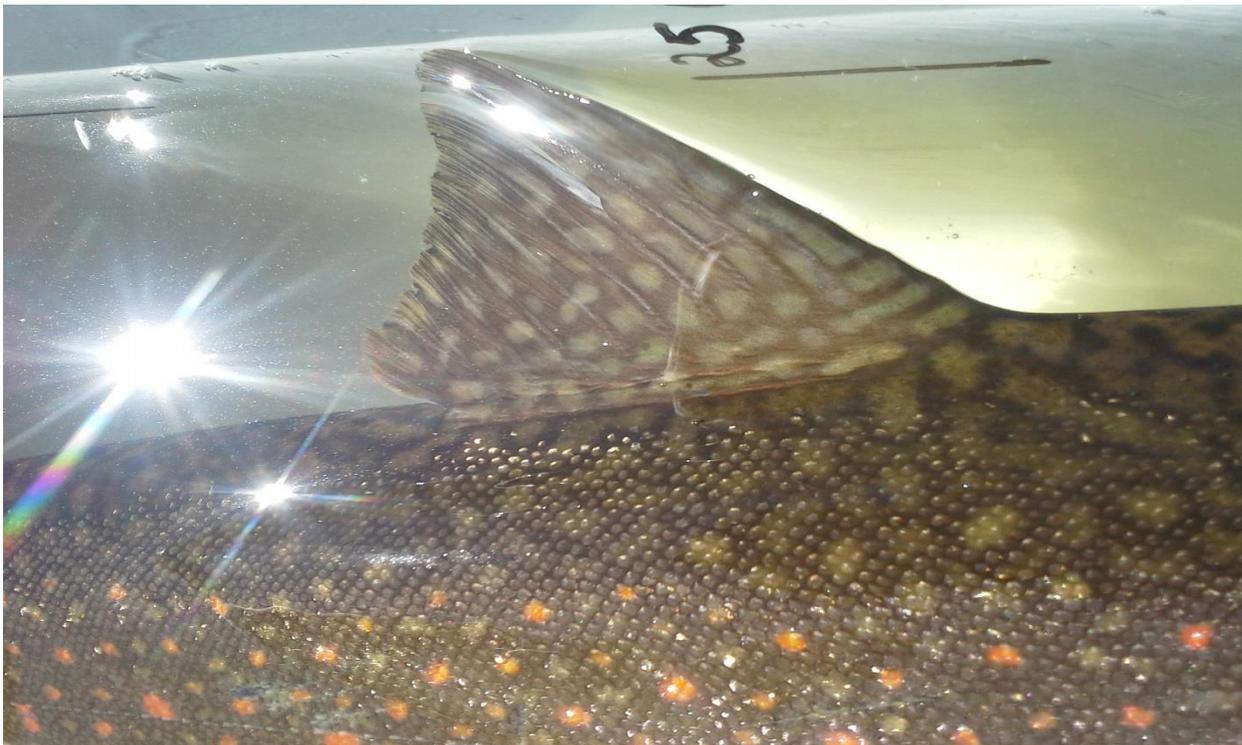
Figure 5. Dorsal fin of an adult Bull Trout suspected of being a hybrid (Bull Trout x Brook Trout) which was caught below Clear Creek Dam on July 2, 2015. Note the spots on the fin. The dorsal fin of a genetically pure Bull Trout would be clear. Genetic analysis revealed that this fish was a hybrid. Another with similar markings was not.

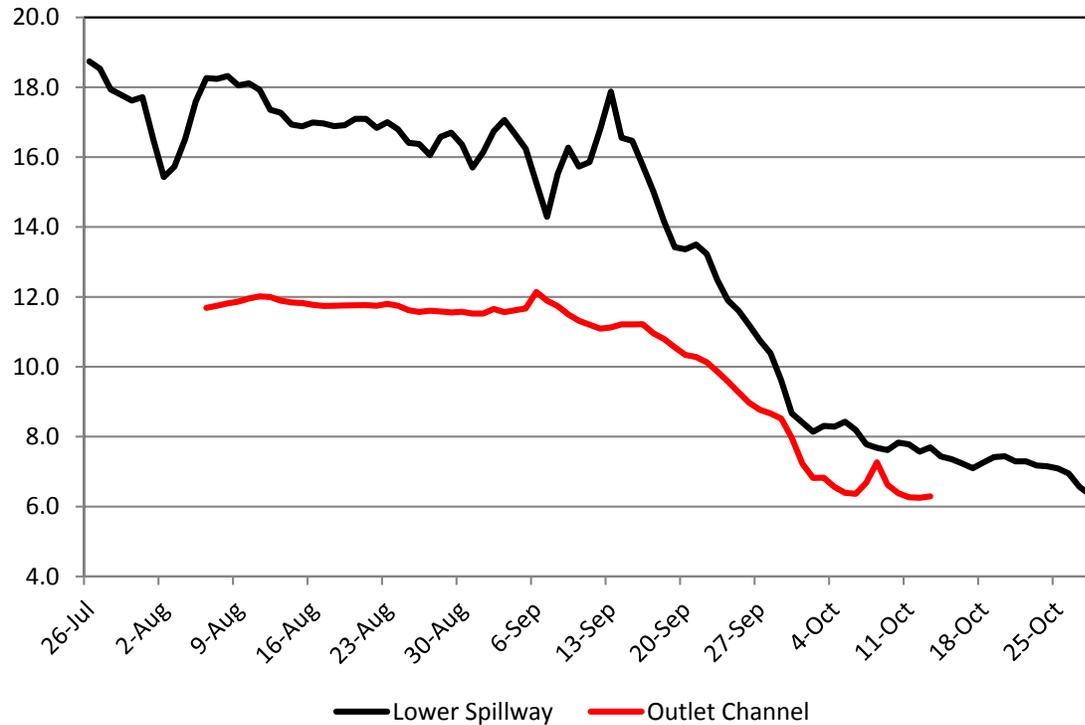
Figure 6. Average daily water temperatures (°C) from late-July through the end of October, 2013 in the spillway and outlet channels of Clear Creek Dam on the lower NF Tieton River

Water temperatures at the top of the spillway (i.e. the upper ladder) and the bottom tracked closely and will not be differentiated here. On July 25 the mean daily water temperature in the spillway channel exceeded 18°C. The mean remained above 15°C, the temperature believed to limit Bull Trout distribution (Allan 1980; Brown 1992; Fraley and Shepard 1989; Goetz 1991), until September 17 before beginning a steady decline (Figure 6). Temperature data for the outlet channel were more limited because high releases from the dam had washed the data logger closer to the stream bank and it was left in the dry after October 13. However, by that time average water temperatures in both the outlet and spillway channels were fairly similar and below 8°C. This was not the case through August and most of September when temperatures were much cooler in the outlet channel. The logger in the NF Tieton River only collected data for 19 days. It ran out of storage space on August 19 because it had mistakenly been set to record data every minute. The data that were collected showed average daily water temperatures ranging from 10-11.5°C.

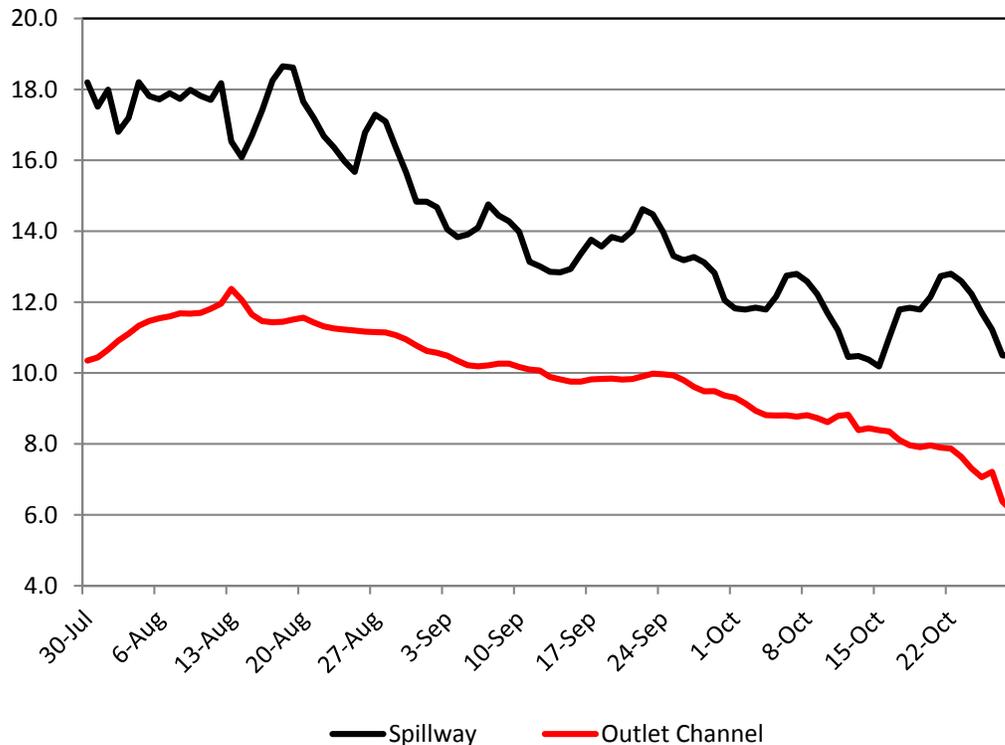
Figure 7. Average daily water temperatures (°C) from August 1 through the end of October, 2014 in the spillway and outlet channels of Clear Creek Dam on the lower NF Tieton River

Between July 30 and October 28 average daily water temperatures in the NF Tieton River ranged from 4.7-11.9°C with the highest temperatures ($\geq 11^\circ\text{C}$) generally occurring the middle

two weeks of August. After September 1 average daily temperatures were below 10°C for all but one day.

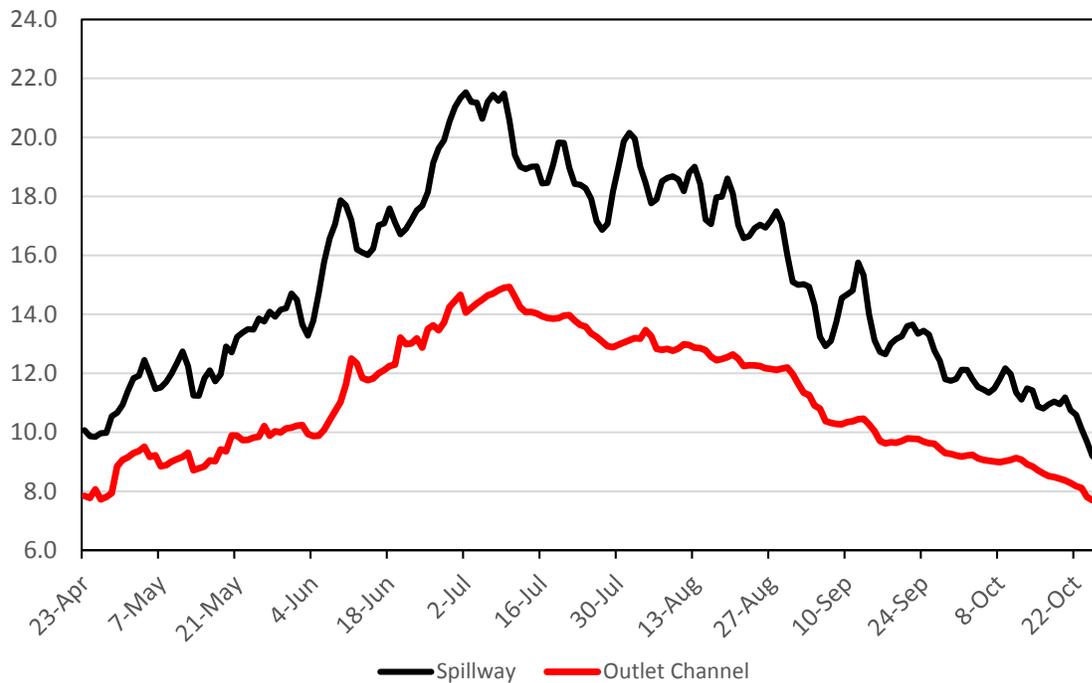
Figure 8. Average daily water temperatures (°C) from April 23 through the end of October, 2015 in the spillway and outlet channels of Clear Creek Dam on the lower NF Tieton River

In 2015, the mean daily water temperature in the spillway channel first exceeded 15°C on June 6 where it remained until August 31. This temperature was also exceeded for two days in mid-September and not until September 14 did the mean drop below 15°C for good. During this period mean daily water temperatures in the spillway channel exceeded 20°C for 12 consecutive days in late-June and early July, topping out at 21.5°C on both July 2 and July 9. In contrast, the mean daily water temperature in the spillway never exceeded 15°C (Figure 8). From June 6 through September 14 temperatures in the outlet channel were 5.1°C cooler on average, the difference ranging from 2.4°C late in the period to 7.5°C in early July. The lowest mean daily temperature reached in the spillway, 9°C on October 27, was present in the outlet channel for 33 days including almost the entire month of October.

Mean daily water temperatures in the NF Tieton River ranged from 4.9 - 13.7°C. The high end of this range was about 2°C higher than the two previous years owing to the fact that 2015 was extraordinarily warm, a near historic drought year with significantly diminished stream flows. The average monthly water temperatures (°C) in the river for the months of May, June, July, August, September and October were 7.8, 10.3, 12.5, 11.8, 8.9 and 7.5, respectively.

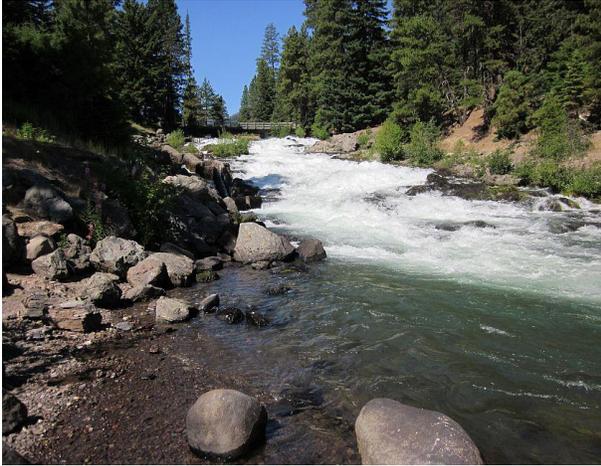
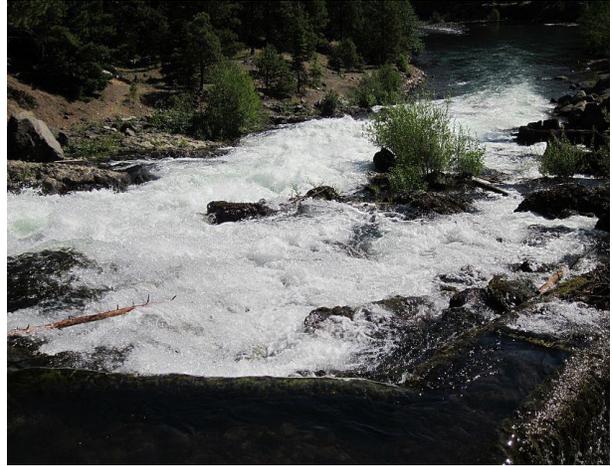
Lower spillway channel at Clear Lake elevation of 3011.8 feet

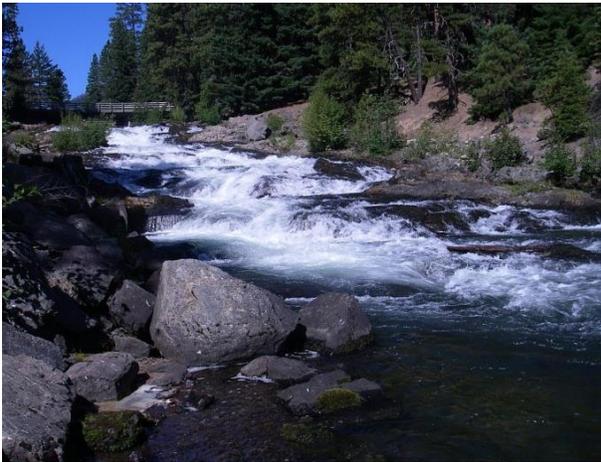
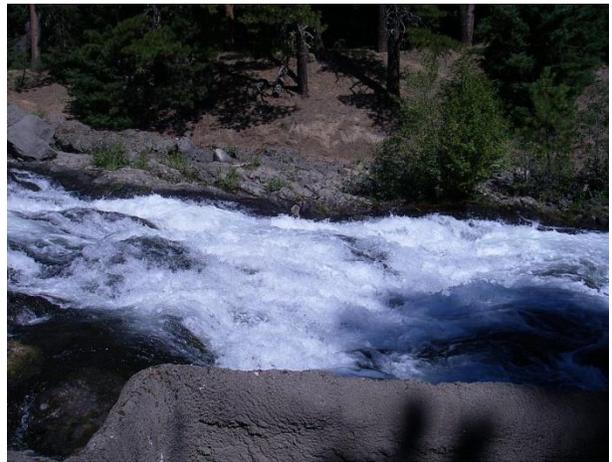
Lower spillway channel at Clear Lake elevation of 3011.6 feet

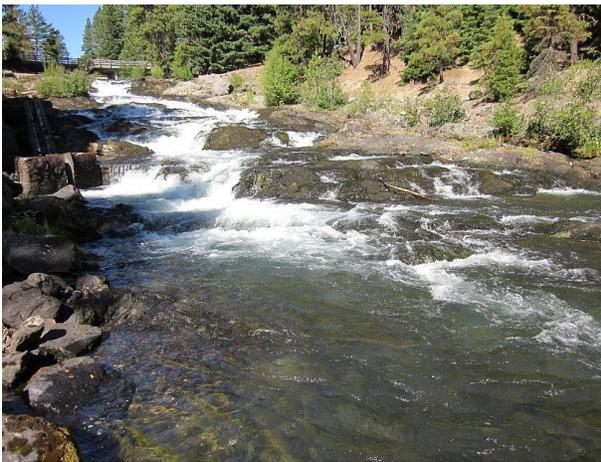
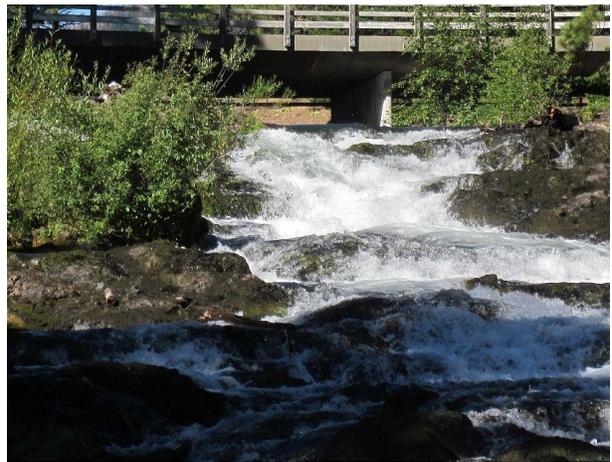
Lower spillway channel at Clear Lake elevation of 3011.4 feet

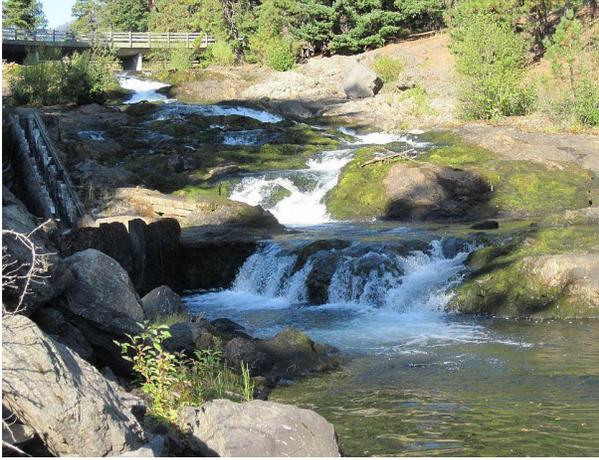
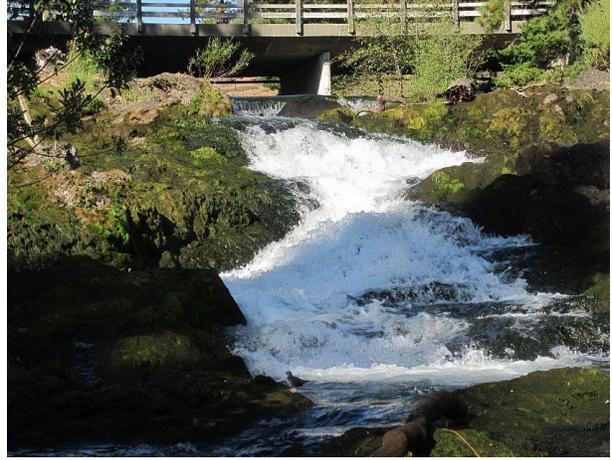
Lower spillway channel at Clear Lake elevation of 3011.0 feet (spillway weir crest elevation)

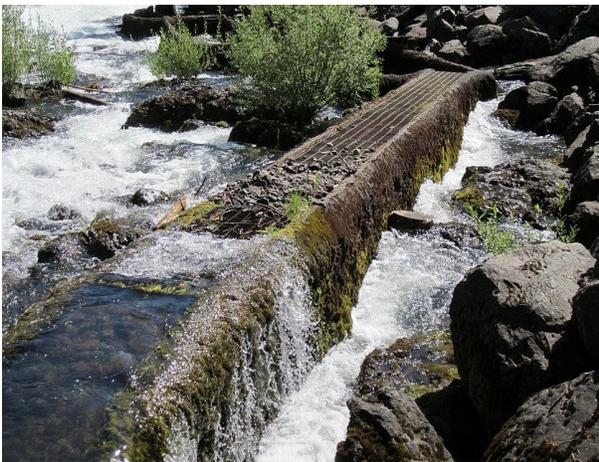
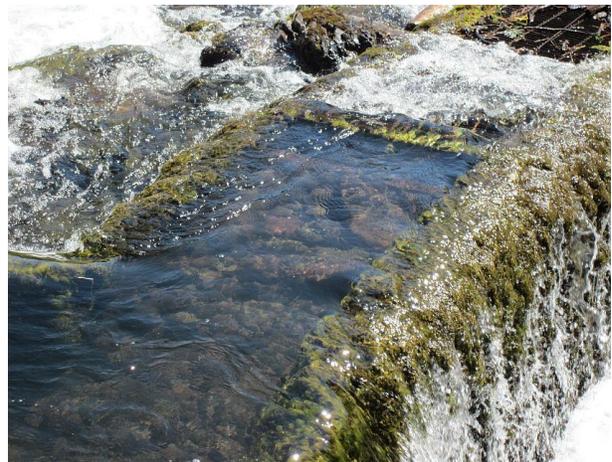
Upstream terminus of the Denil ladder completely clogged with cobble and gravel

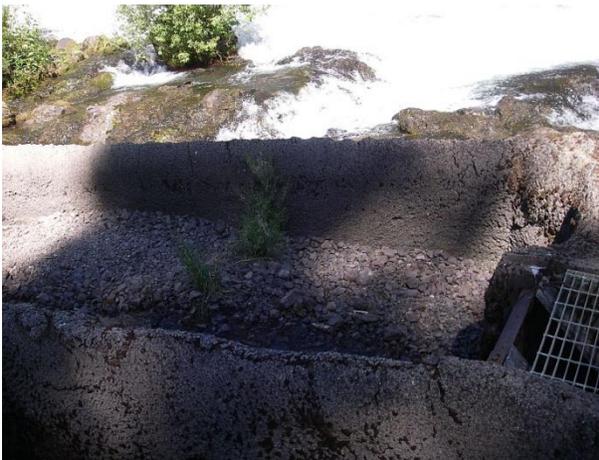
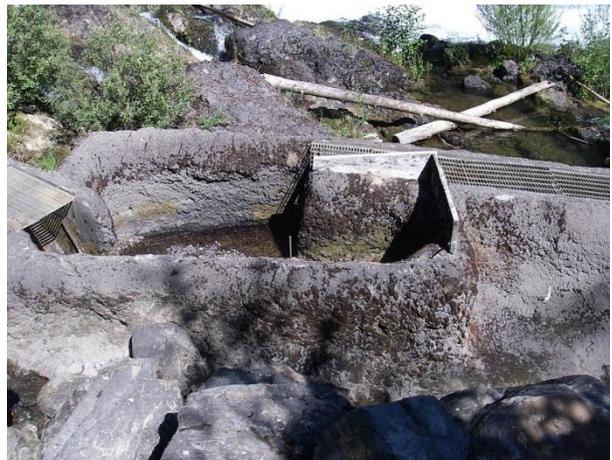
Totally dewatered downstream sections of the Denil ladder

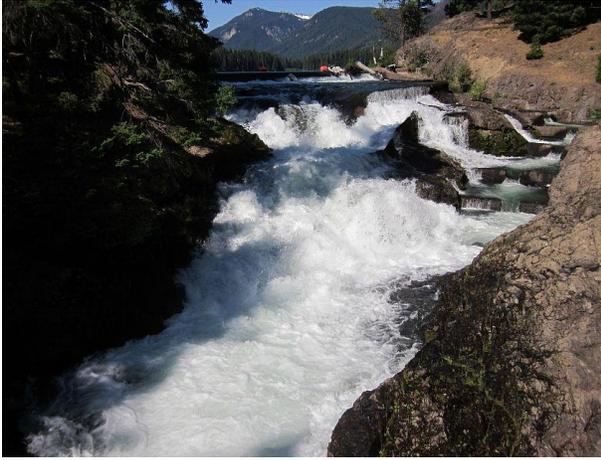
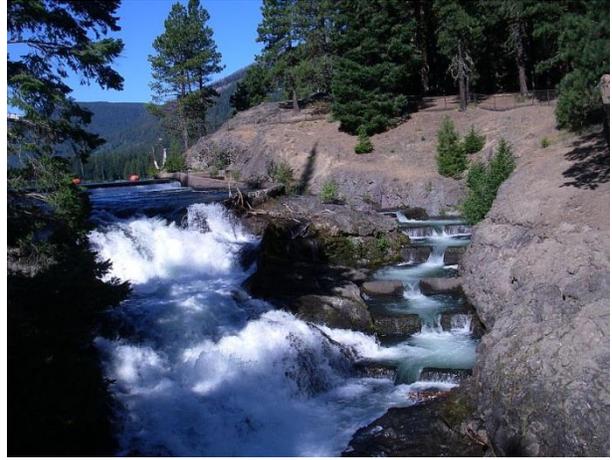
Upper spillway channel at lake elevation 3012.2 feet (left) and 3011.6 feet (right)

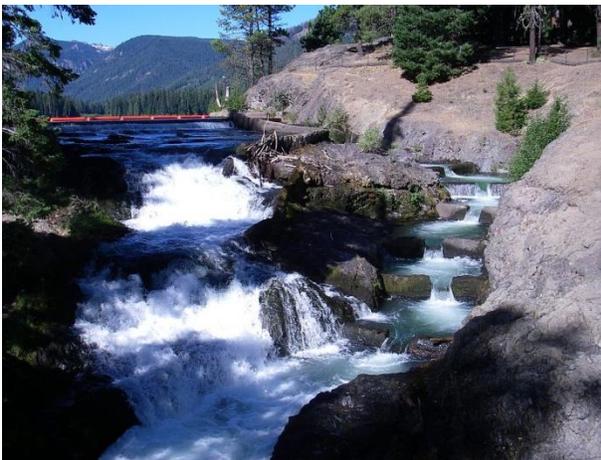
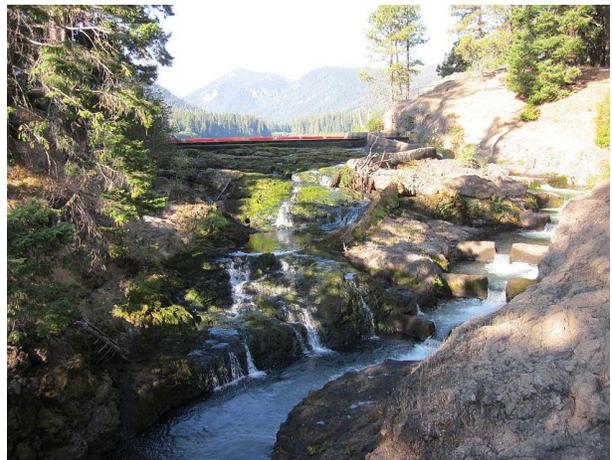
Upper spillway channel at lake elevation 3011.4 feet (left) and 3011.0 feet (right)

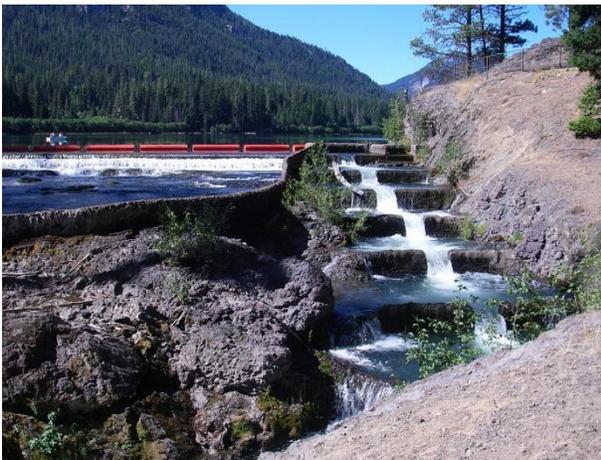
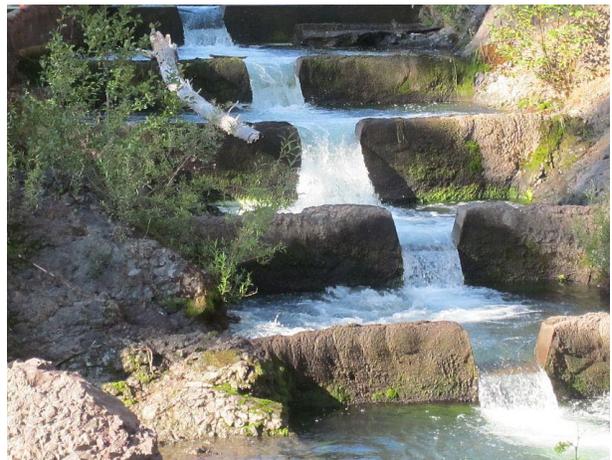
Pool-and-weir fish ladder in upper spillway channel

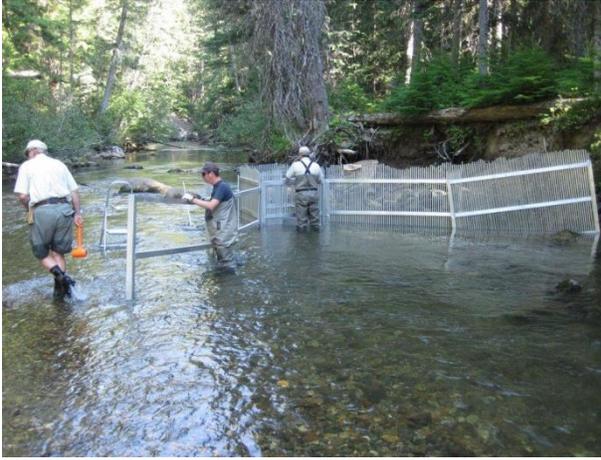
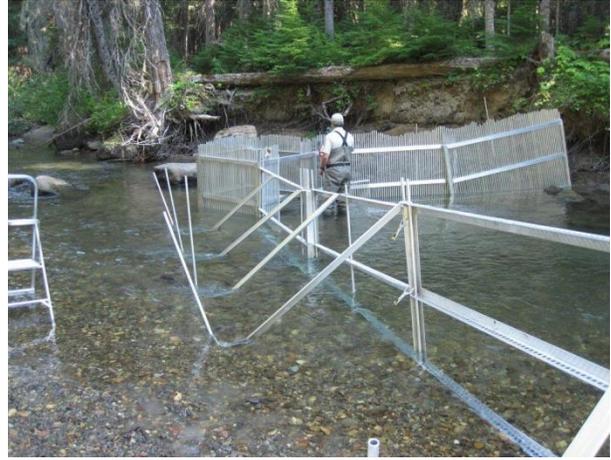
Weir and trap installation on the North Fork Tieton River (September 17, 2012)

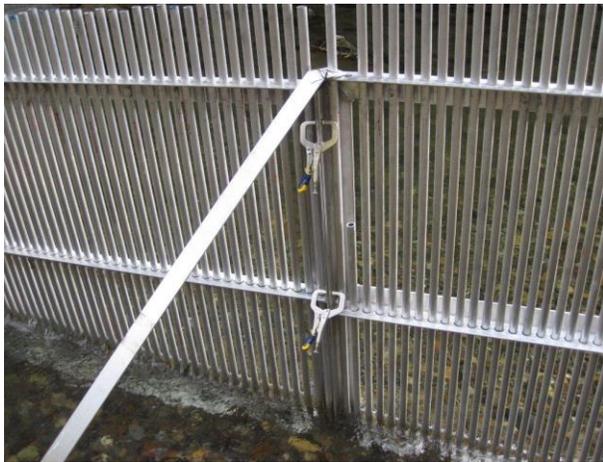
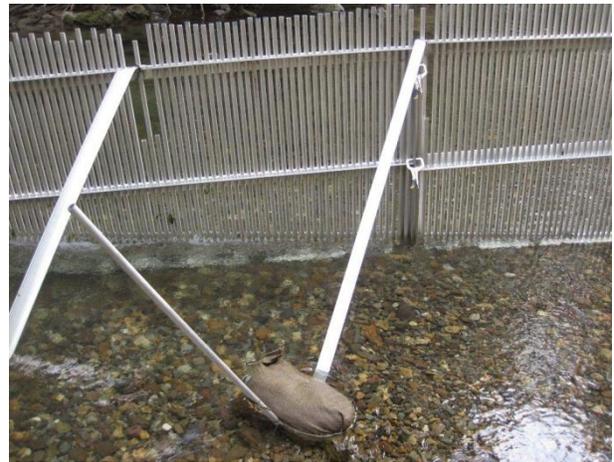
Weir and trap installation on the North Fork Tieton River (September 17, 2012)

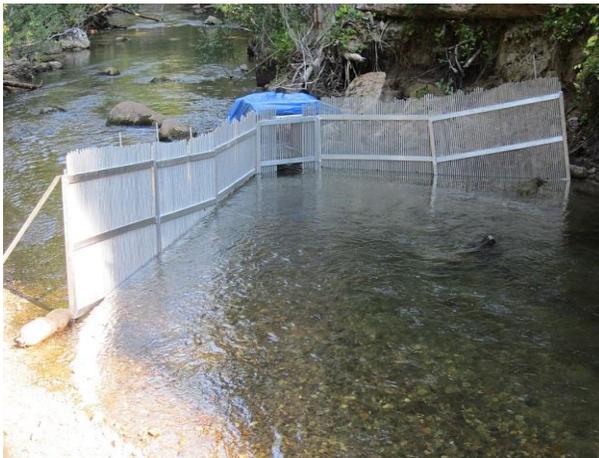
Completed picket-weir and box trap

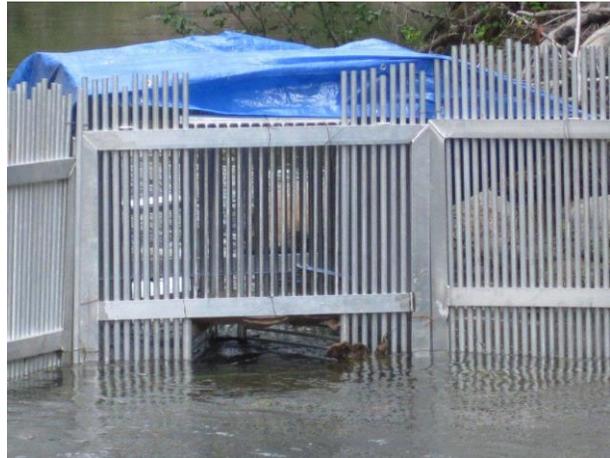
The capture box

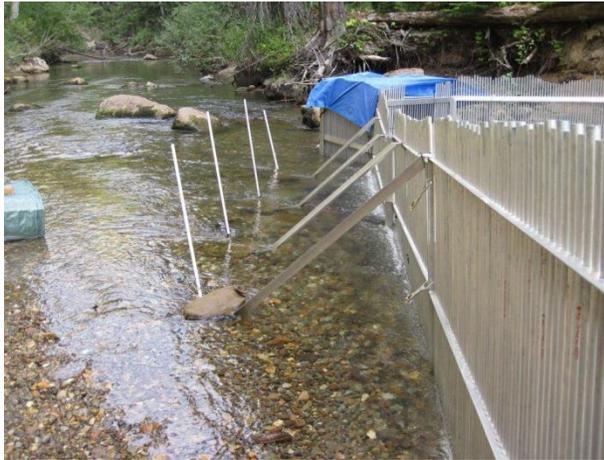
Downstream side of trap

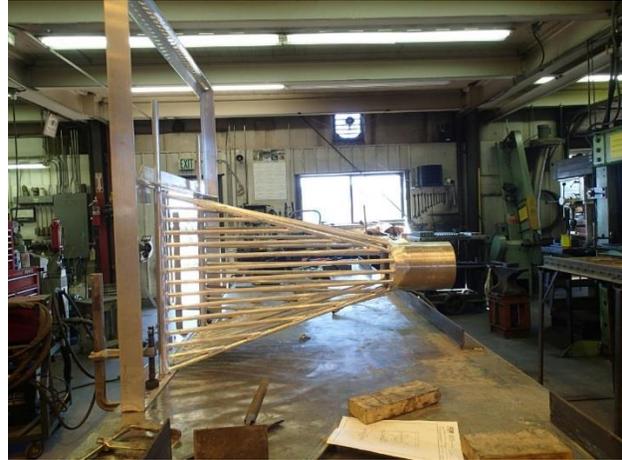
Modification to the trap entrance in 2013

Having noted the escape of two Bull Trout from the capture box during the first year the trap was deployed (2012) and avoidance behavior (trap shyness) displayed by a few Bull Trout approaching the trap entrance, the trap was modified for use in 2013. The original trap box was directly connected to adjacent weir panels. The entrance to the trap was flat and perpendicular to the current with two wings extending into the trap where fish would pass through a vertical opening 4-5 inches wide. It was thought that trapped fish would be disinclined to go back through this opening but that turned out to be false on at least a couple of occasions. The entrance was modified so that a caged cone extended about three feet back from the entrance. This cone led to a 10-inch diameter opening to which a four-foot section of PVC pipe was attached. This pipe extended about two feet into the trap and was approximately six inches above the stream bed inside it. A burlap sleeve was then affixed to the end of the pipe to further dissuade captured fish from finding the opening. The entrance to the trap was painted flat black to minimize avoidance behavior (all modifications were done WDFW's Region 3 screen shop). Also, in response to higher streamflows observed after the first year of the study,

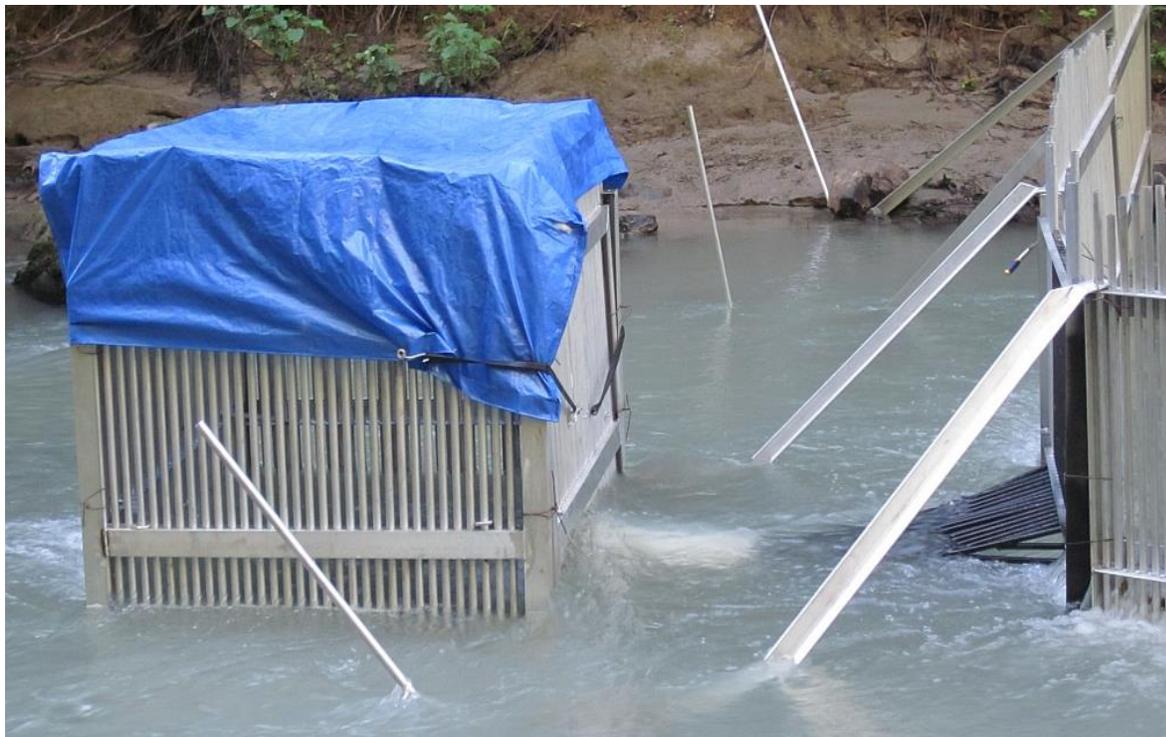
The modified configuration of the trap used in 2013. Note the modified entrance leading to the PVC pipe extending into the trap. The trap itself sits about five feet from the entrance.

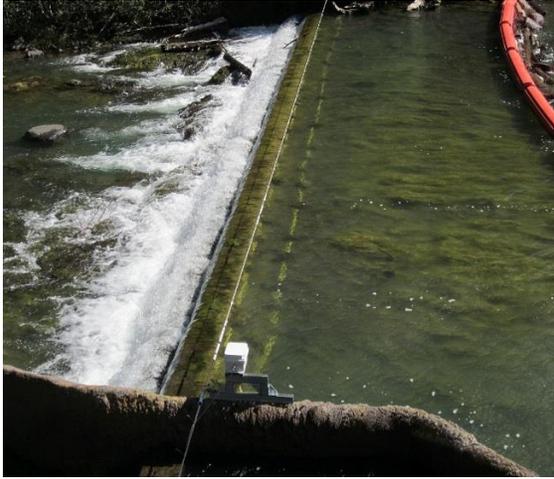
Upper spillway PIT tag detection antenna

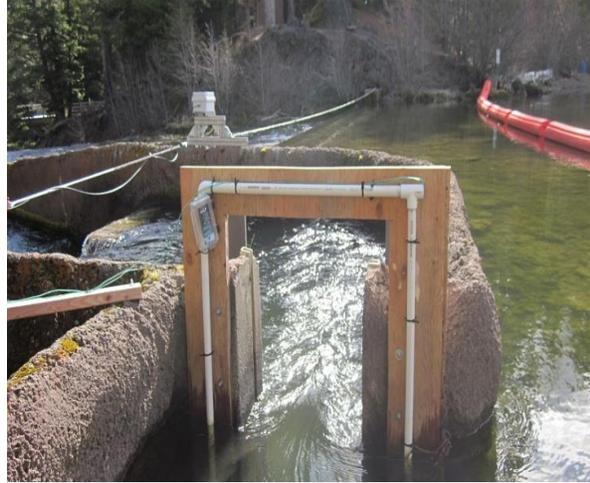
Upper ladder PIT tag detection antenna

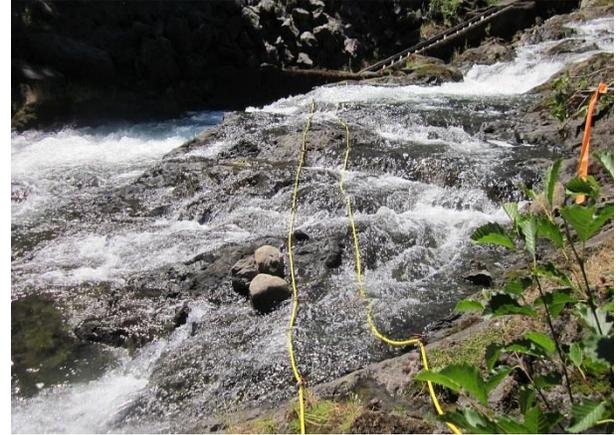
Lower spillway PIT tag detection antenna

The lower spillway antenna utilized a flat-plate, or pass-over, design and was first installed on July 9, 2013. The antenna was constructed using a continuous length of General Cable Carol Super-VU Tron Supreme power cable (12 gage with 4 strands) strung across the channel and doubled back. After the lake level was lowered and the ladder was boarded up the antenna was attached to the dewatered bedrock channel using stainless steel anchor bolts with eye nuts attached. The antenna wire was run through the eyes and secured with zip ties for stability. This antenna measured 54 feet long by about 2 feet wide. It operated on 12 volt DC current supplied by two deep-cycle batteries recharged by two solar panels installed at the site.

This PIT tag interrogation site presented many challenges. The antenna had to endure extreme hydraulic stress and there were numerous problems encountered. The antenna wire broke in late-September 2013 which we believed was the result of friction where it contacted the eye nuts. A new antenna was installed late-April, 2014. Fourteen new stainless steel anchor bolts with eye nuts were installed in the bedrock to augment those installed previously. A 3/8-inch diameter non-stretch marine rope was strung through the eyelets, looped back on the right bank, and stretched tightly with turnbuckles installed on the left bank. Rather than stringing the antenna wire through the eyelets the wire was affixed to the rope using over 100 heavy duty cable ties. Unfortunately, about two weeks later the antenna was broken again. It was subsequently discovered that an animal, probably a beaver, had gnawed through both the rope and the wire. A new design was developed that would not only be durable enough to withstand extreme hydraulic conditions but gnawing animals as well. After waiting out the spring runoff, the antenna was reinstalled on July 9, stringing the rope and antenna wire through semi-flexible 1.5-inch HDPE pipe that was custom cut and fit between the anchors. The successful reinstallation lasted until late October when the antenna broke again under the force of high flows. Utilizing the same "beaver resistant" design employed previously, the antenna was once again reconstructed on April 21, 2015 and operated without incident until it was decommissioned for the season on October 27. A few days later the antenna was destroyed again by extreme flows. After losing four antennas in just over two years it is very doubtful that this PIT tag interrogation site will be utilized in any future monitoring activities.

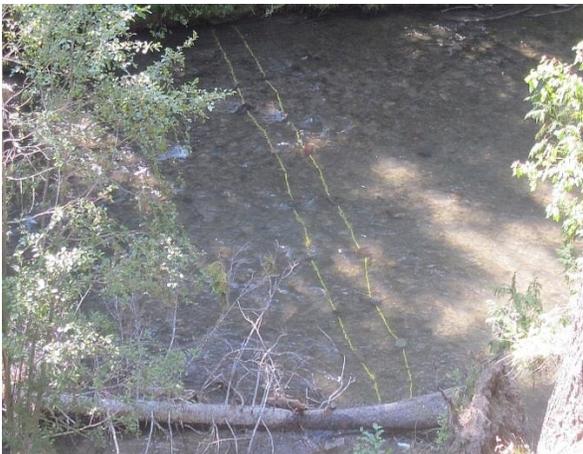
NF Tieton River PIT tag detection antenna

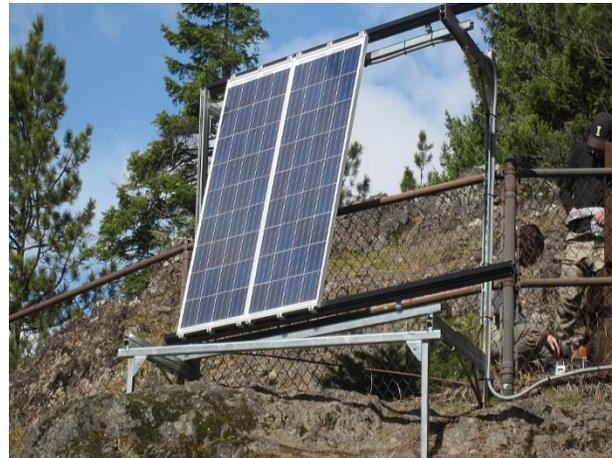
Solar panels at upper spillway/ladder site

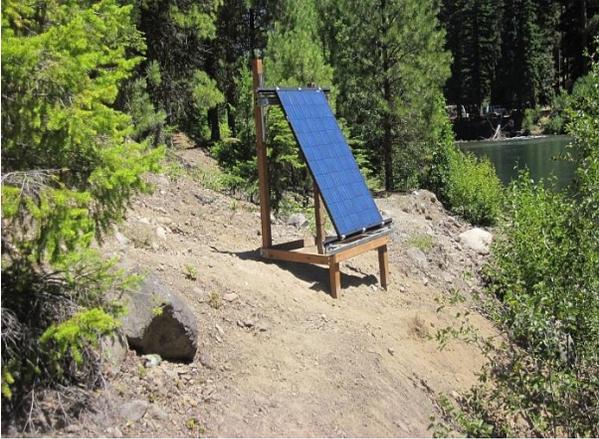
Solar panels at lower spillway site

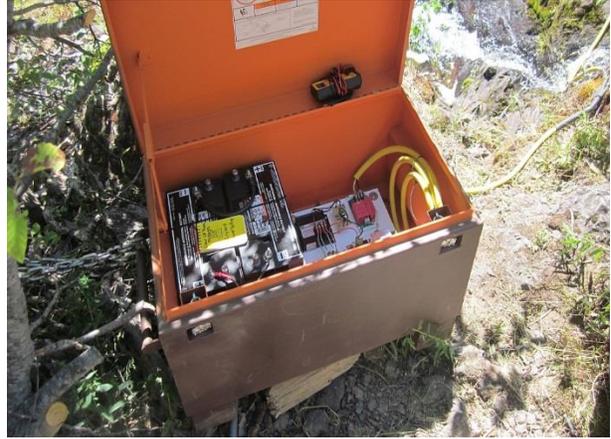
Batteries and readers kept inside locked job boxes

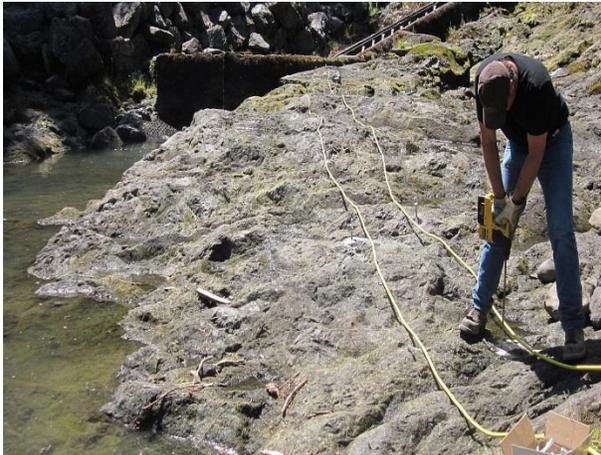
Drilling into bedrock on the lower spillway site

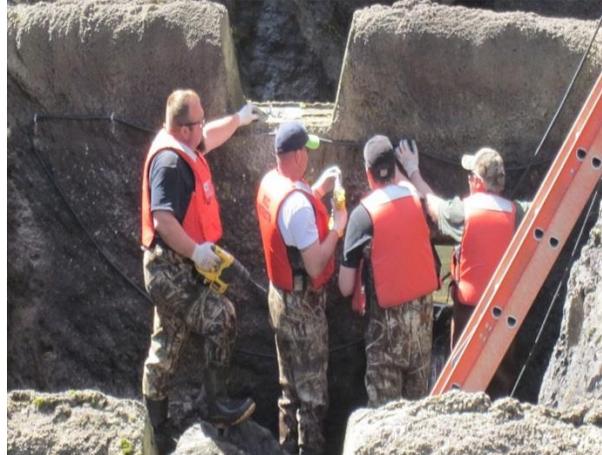
Installing the lower ladder antenna in 2014

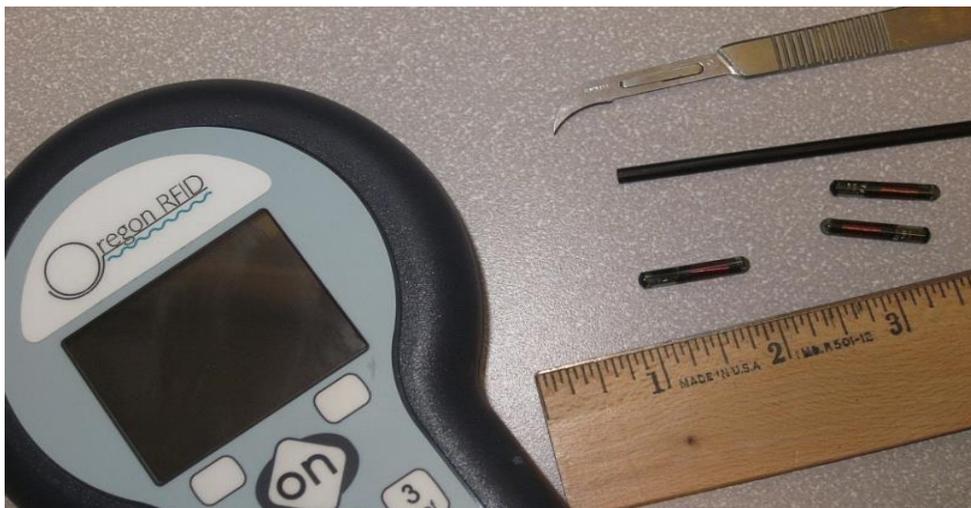
HDX PIT tags, scalpel, insertion straw and Oregon RFID® portable tag reader
