Passage of Radio-tagged Adult Pacific Lamprey at Yakima River Diversion Dams

2012 Annual Report

Andy Johnsen, Mark C. Nelson, Daniel J. Sulak, Cal Yonce, and R.D. Nelle

U.S. Fish and Wildlife Service
Mid-Columbia River Fishery Resource Office
Leavenworth, WA

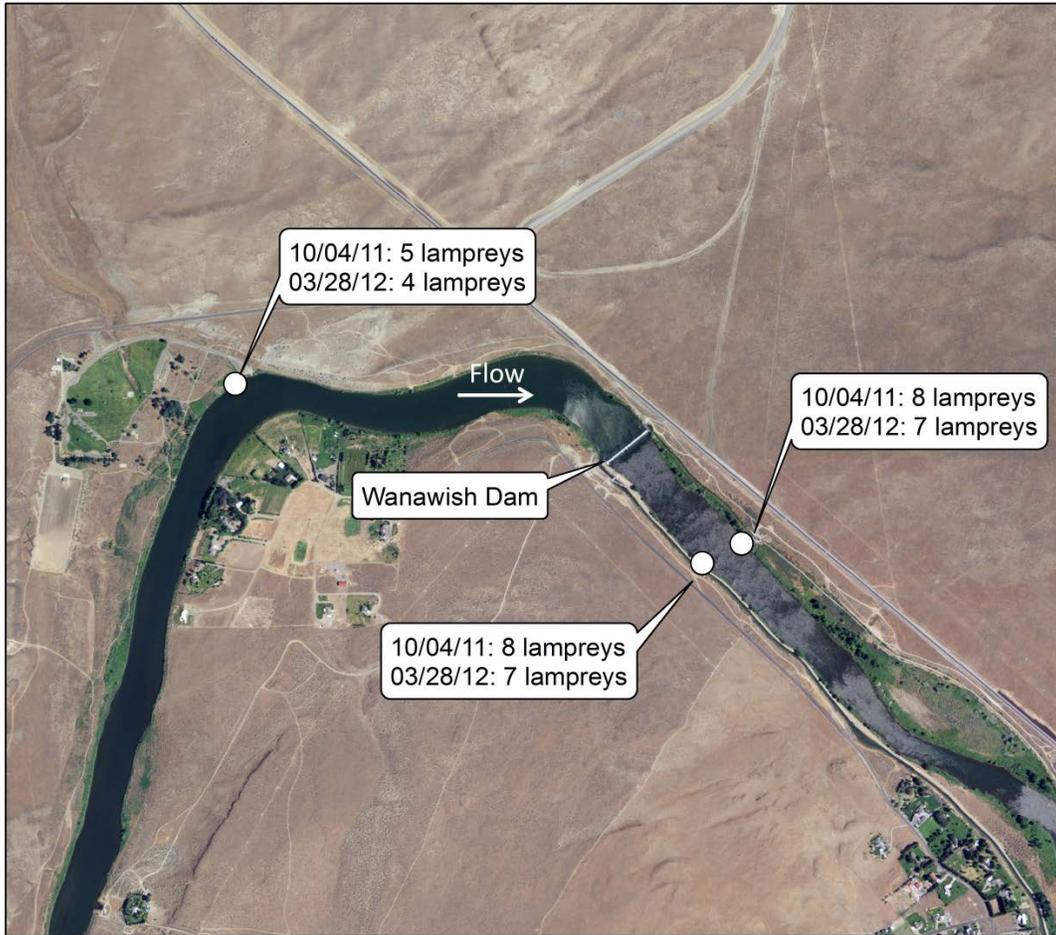
Figure 11. Aerial photograph showing the release locations of radio-tagged adult Pacific lampreys in the vicinity of Wanawish Dam on October 4, 2011 and March 28, 2012.

Fall release- A total of 41 tagged lampreys were released on October 4, 2011. Five were released from the left bank 1.2 km upstream of Wanawish Dam; sixteen were released 0.45 km downstream of the dam, eight on each bank (Figure 11). The upstream release location was in a slow water area consisting of submerged grasses and an undercut bank. The downstream release locations were in areas consisting of various sized cobbles. Sixteen lampreys were released on the left bank 0.30 km downstream of Prosser Dam amongst large boulders in a slow, deep pool. Four lampreys were released 1.1 km upstream of the dam on the right bank in a slow water area with boulders and floating debris (Figure 12).

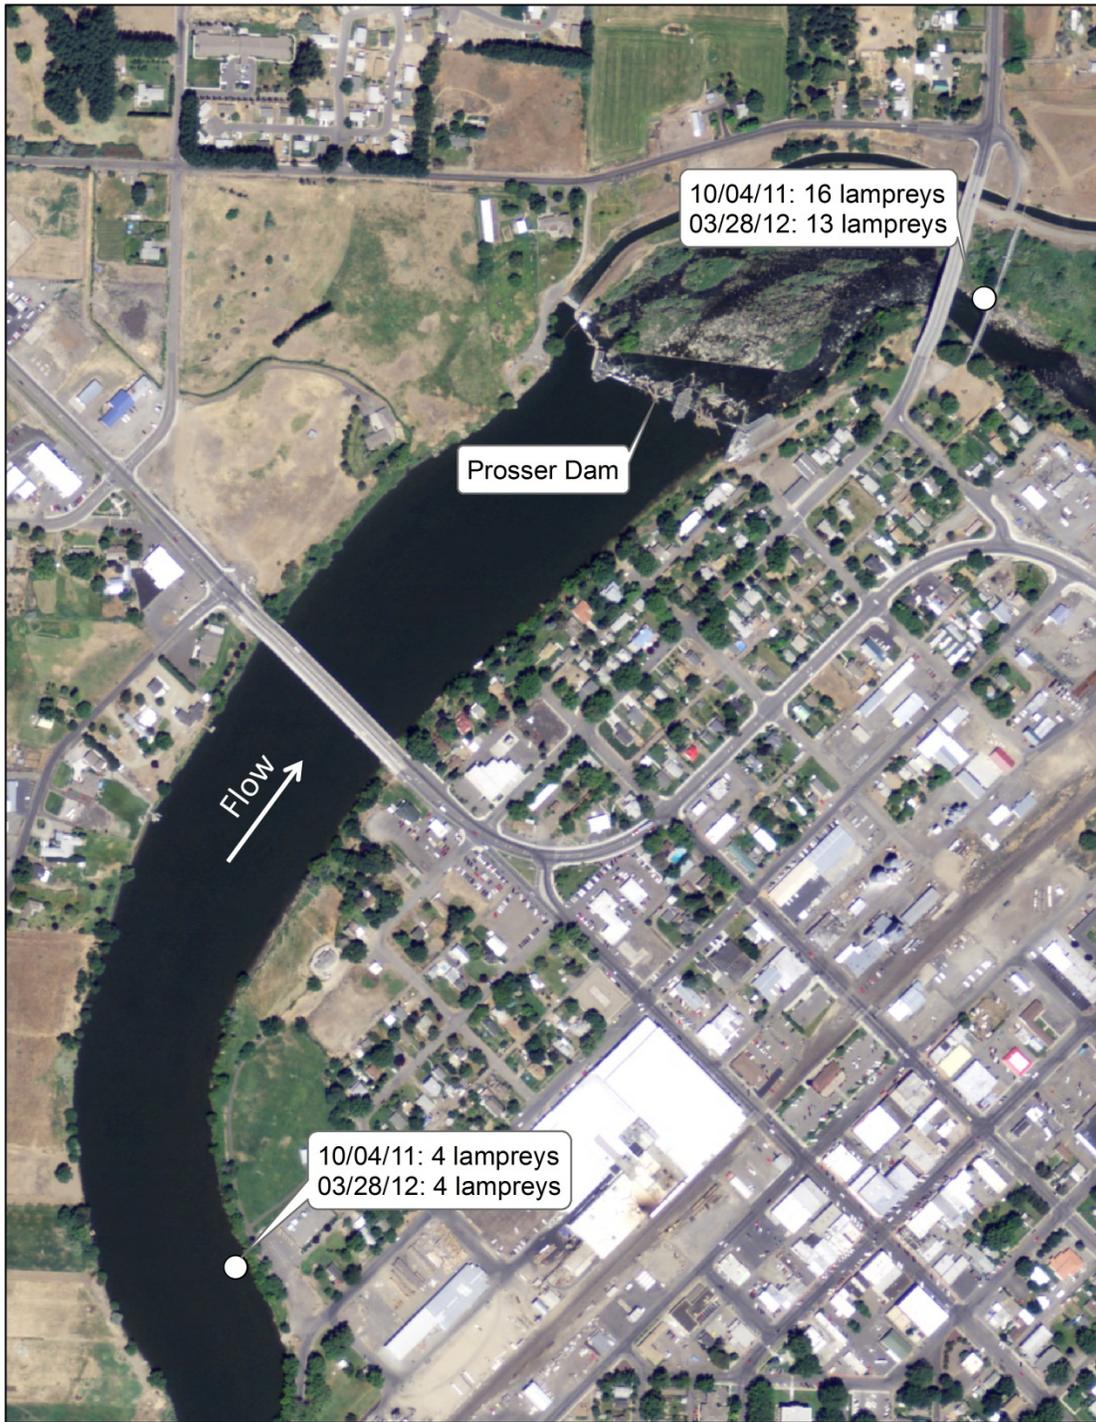
Figure 12. Aerial photograph showing the release locations of radio-tagged adult Pacific lampreys in the vicinity of Prosser Dam on October 4, 2011 and March 28, 2012.

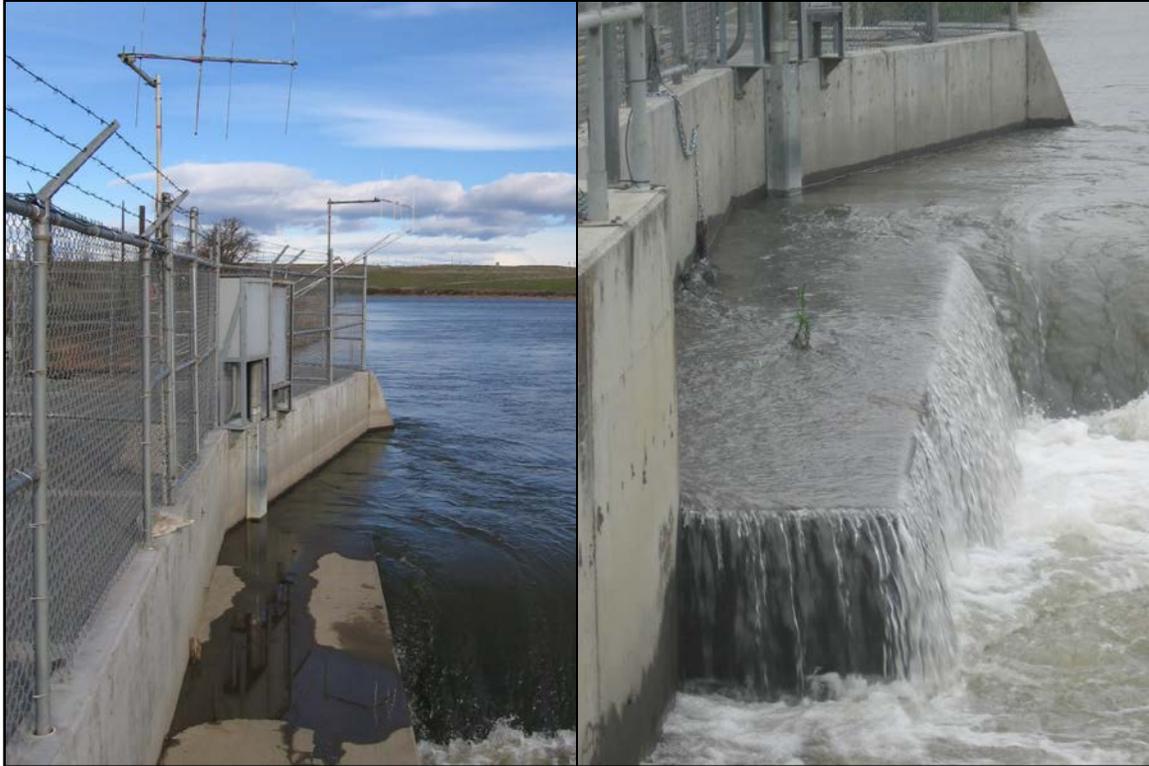
Figure 15. The ledge on the right bank of Wanawish Dam that it appears most Pacific lampreys used to pass upstream. The flow is approximately 5,500 ft³/s in the left picture and 10,500 ft³/s on the right. The entrance to the fishway is just out of the picture on the left hand side.

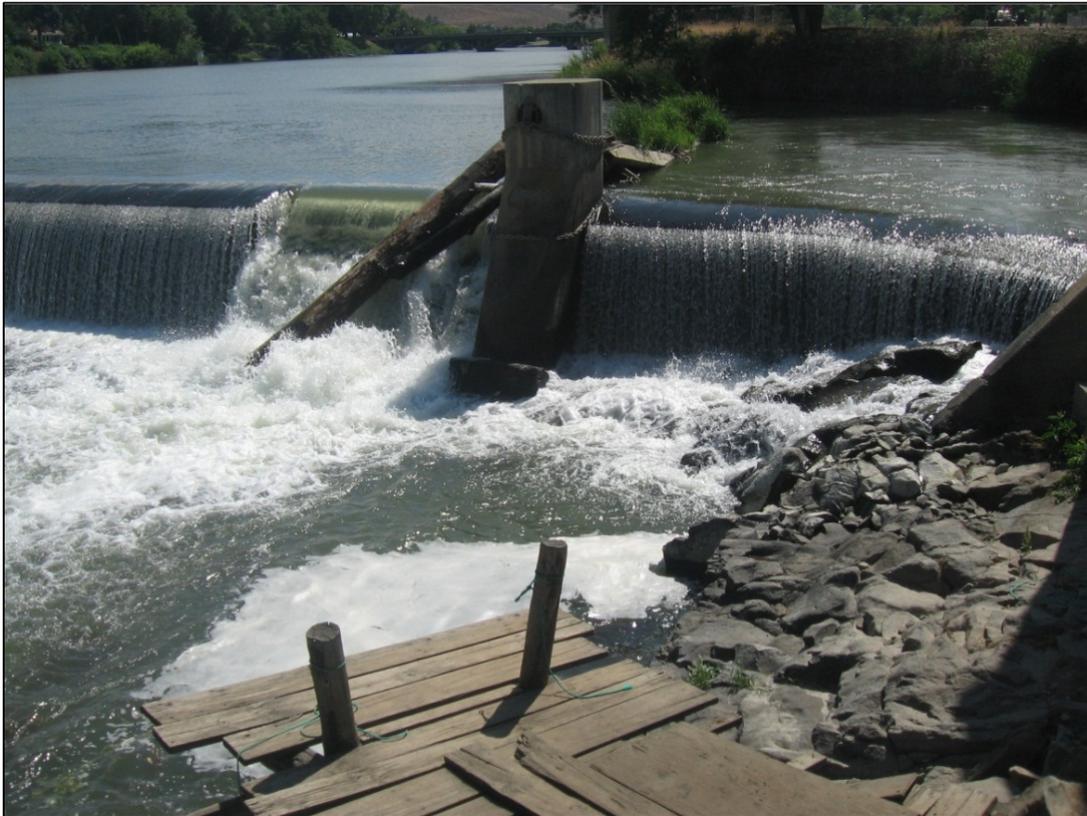
Figure 21. Pool and whitewater along the left bank of Prosser Dam where the majority of Pacific lampreys held during the day and night hours.

Lampreys were detected on all three stations at Prosser Dam while they searched for upstream passage with the greatest number occurring on the left island antennas (Figure 20). Unlike at Wanawish Dam, lampreys spent little time near the face of Prosser Dam during holding periods or daylight hours, residing instead just downstream of the bedrock ledge the dam was built upon. The greatest concentration occurred in a pool along the left bank (Figure 21). This area included a boulder filled pool and areas of whitewater coming off the face of the dam. Pacific lampreys were consistently detected in this area during both day and night hours. Night observations during July showed tagged lampreys attempting to climb over the dam using the bedrock at face of the dam along the left bank (Figure 22). High velocities over the dam and the overhanging crest prevented these lampreys from being successful in their attempts.

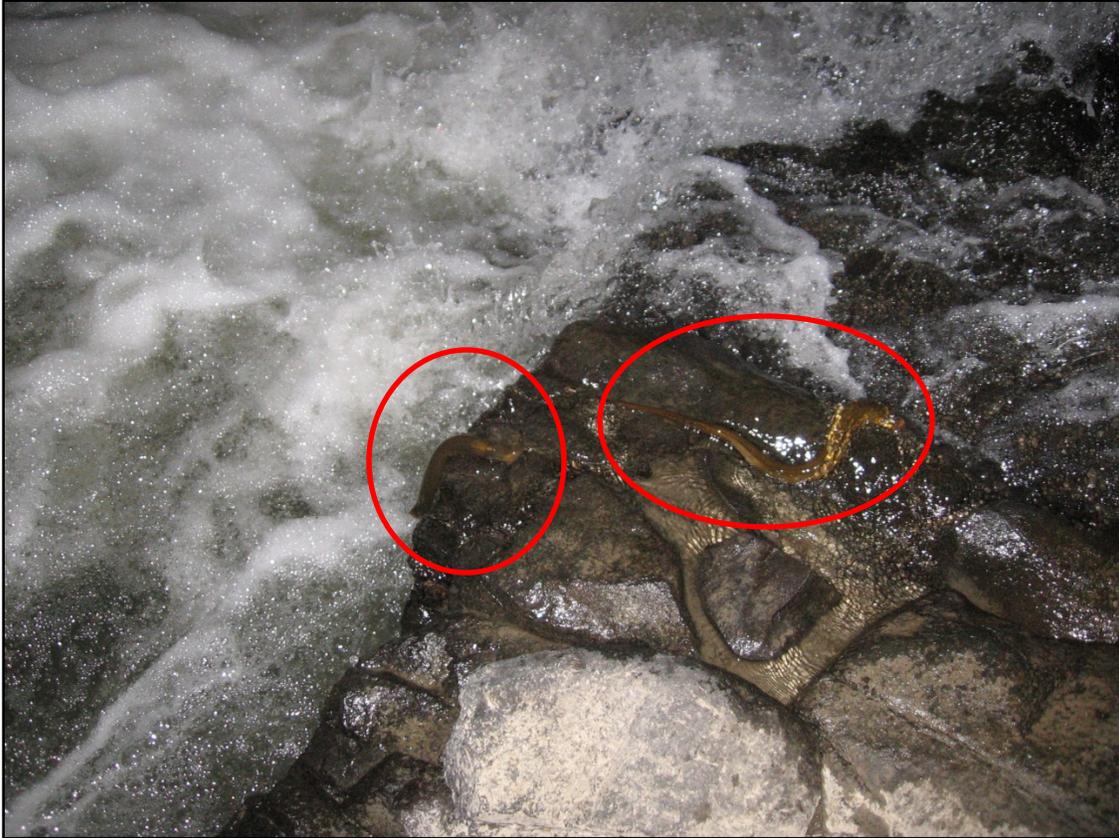
Figure 22. Radio-tagged Pacific lampreys (circled in red) attempting to climb over Prosser Dam by way of the dam face and exposed bedrock, July 3, 2012.

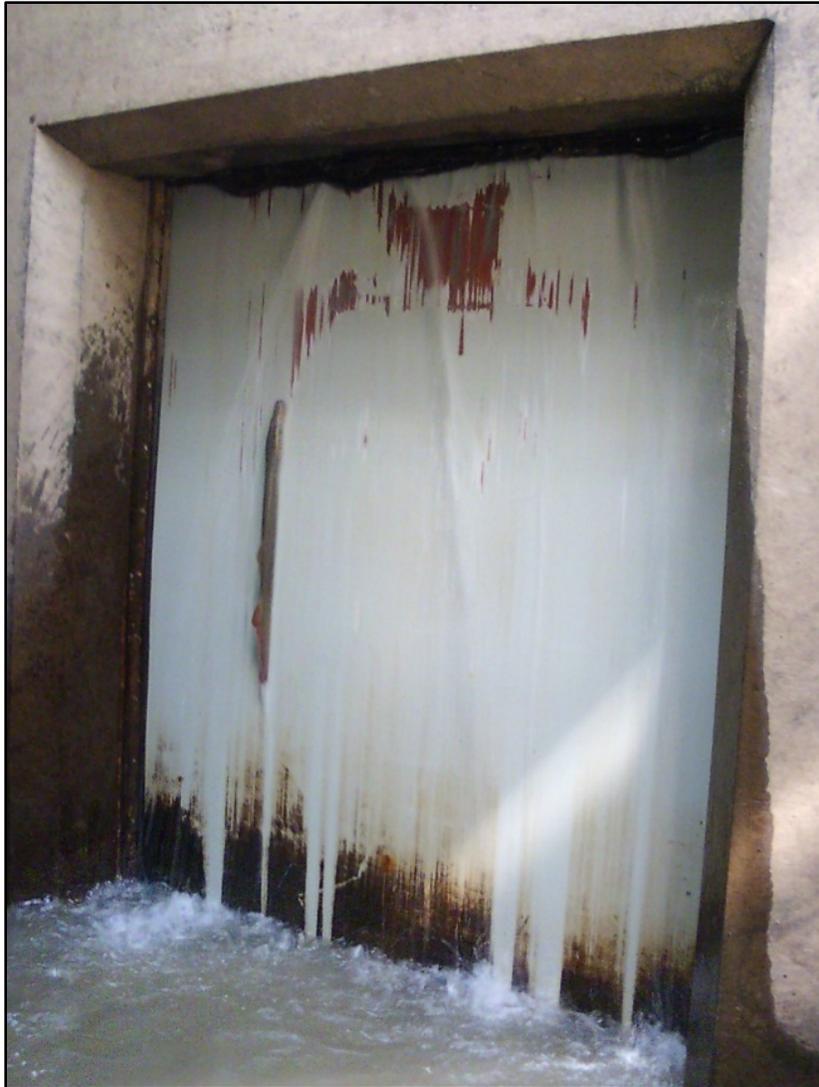
Figure 23. Radio-tagged Pacific lamprey code 69 attempting to exit the right bank fishway at Prosser Dam by climbing the closed headgate, April 30, 2012.

On the cover: Pacific lamprey code 69 attempting to climb the closed headgate in the right fishway at Prosser Dam, April 30, 2012. Photograph by Cal Yonce, USFWS.

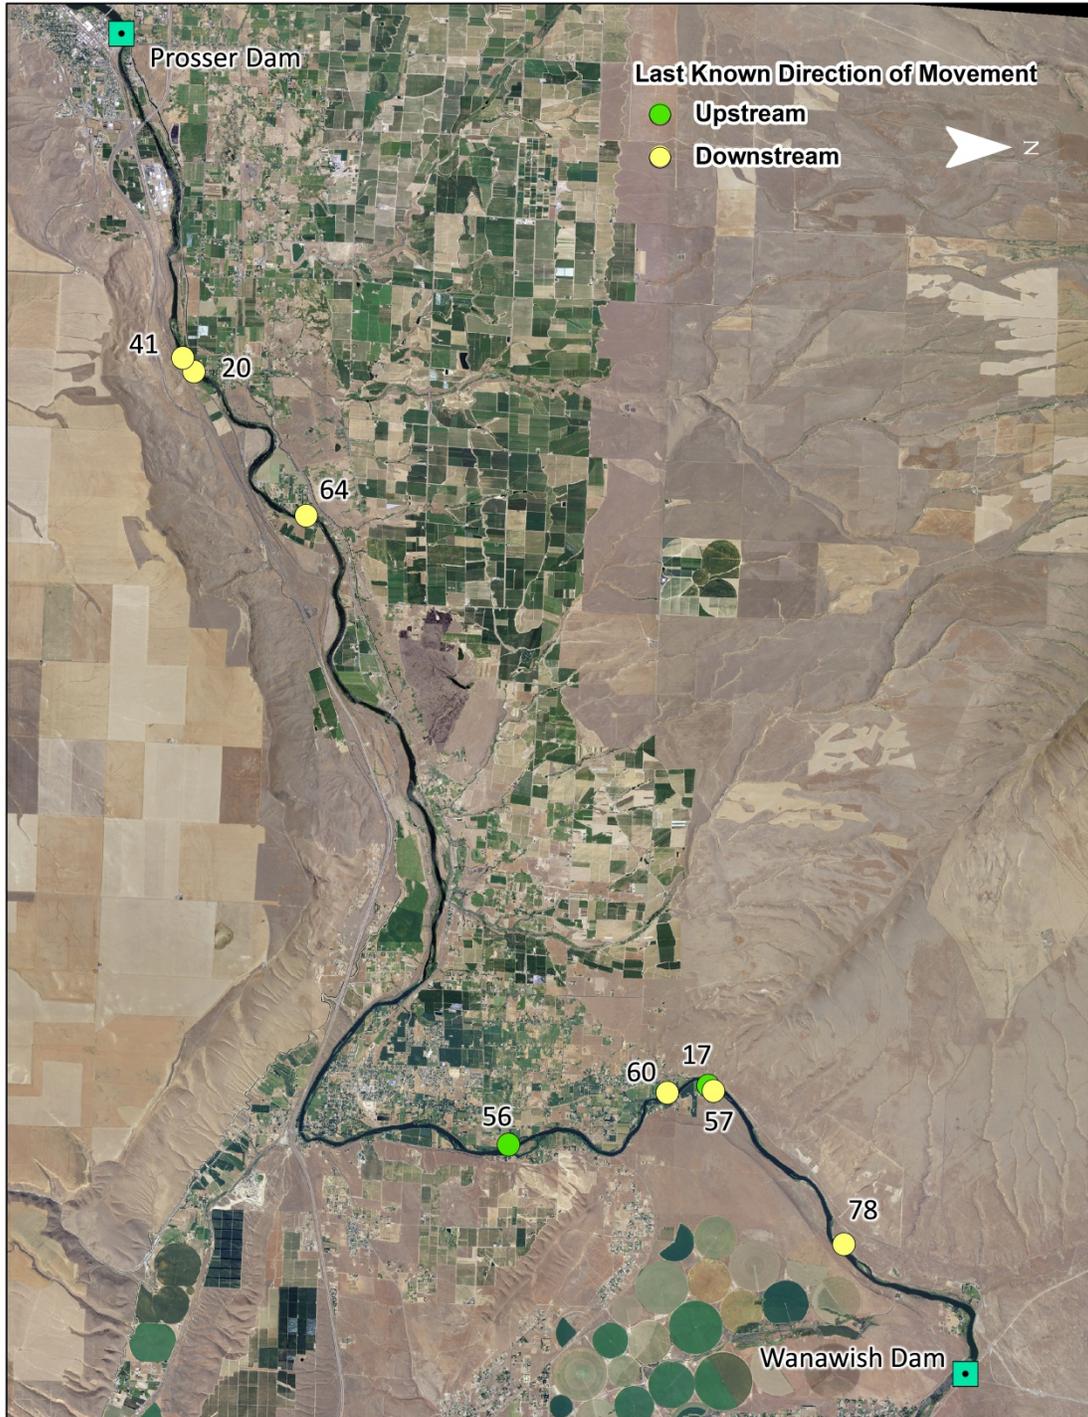
Figure 40. The last known locations of radio-tagged Pacific lampreys between Wanawish Dam and Prosser Dam on the Yakima River, 2011-2012. The number represents the code of each radio tag.

Not all lampreys that passed a dam continued their migrations upstream to the next dam. These “dropouts” consisted of both lampreys that passed a dam and never arrived at the next and also those that were unsuccessful at passing a dam and ultimately moved back downstream. Last known locations between dams were obtained for thirty of these individuals. Eight lampreys were present between the mouth of the Yakima River and Wanawish Dam (Figure 39). Eight lampreys were between Wanawish and Prosser dams (Figure 40), including six that approached Prosser Dam and then moved downstream and two that moved upstream from Wanawish but never reached Prosser Dam. In the reach between Prosser Dam and Sunnyside Dam a total of fourteen last known locations were recorded (Figure 41). Six were lampreys that had moved downstream from Sunnyside Dam. Eight ceased their upstream migrations and never reached Sunnyside Dam. No lampreys were in between Sunnyside and Wapato dams at the end of the study period. In addition to these known locations, another twenty-six lampreys dropped out in the reaches between the lower four dams (Table 12). Lampreys released in the spring upstream of Prosser Dam had the highest rate of dropouts with 100%. Percentages for all other releases were between 69% and 80%.

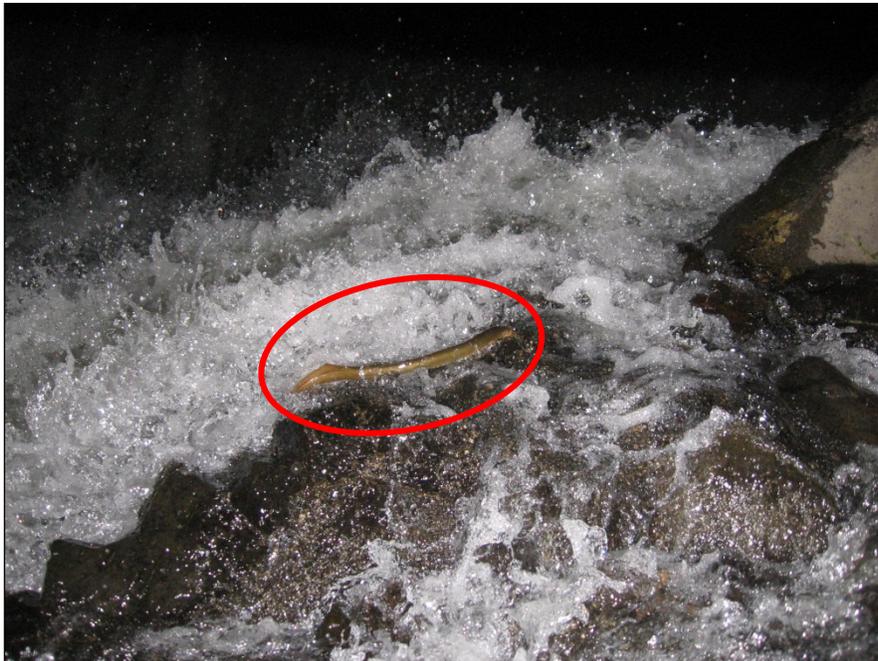
Figure A-1. Pacific lamprey (circled in red) climbing bedrock on left bank at base of Prosser Dam.

Telemetry data show that lampreys gather and hold in the pool area at the left bank of the dam. Adults have been observed attempting to move upstream by climbing the bedrock there (Figure A-1).

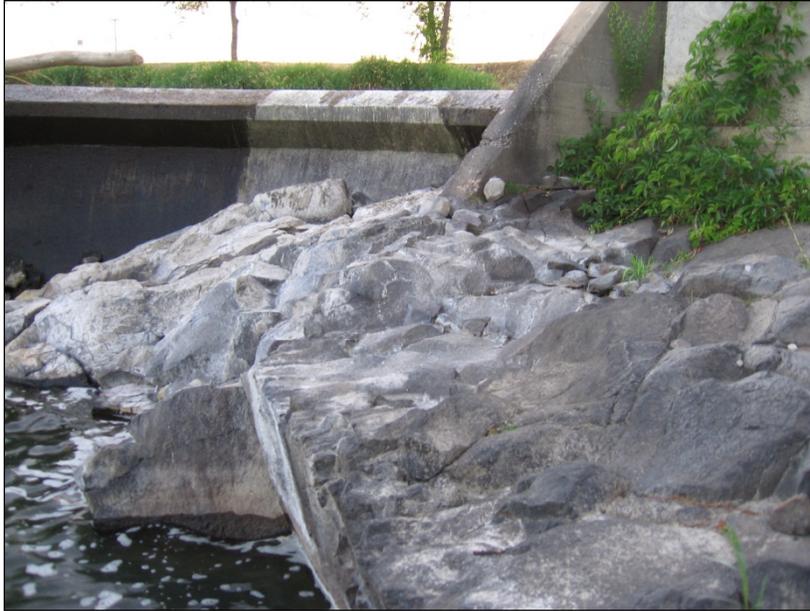
Figure A-2. Proposed site of LPS on the left bank of Prosser Dam at low flow.

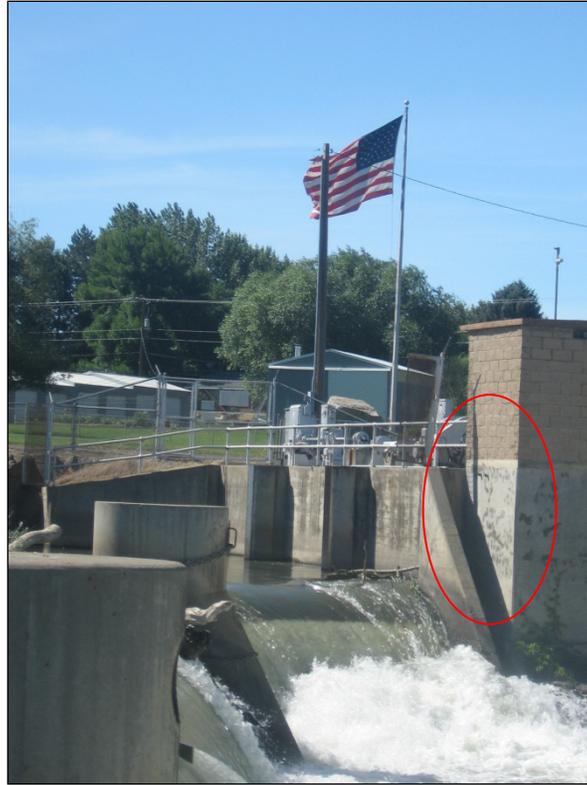
Figure A-3. Prosser dam and the head of the Chandler Canal. The ramp would be placed in the space (circled in red) between the gate house and the slanted wall at the left bank of the dam.

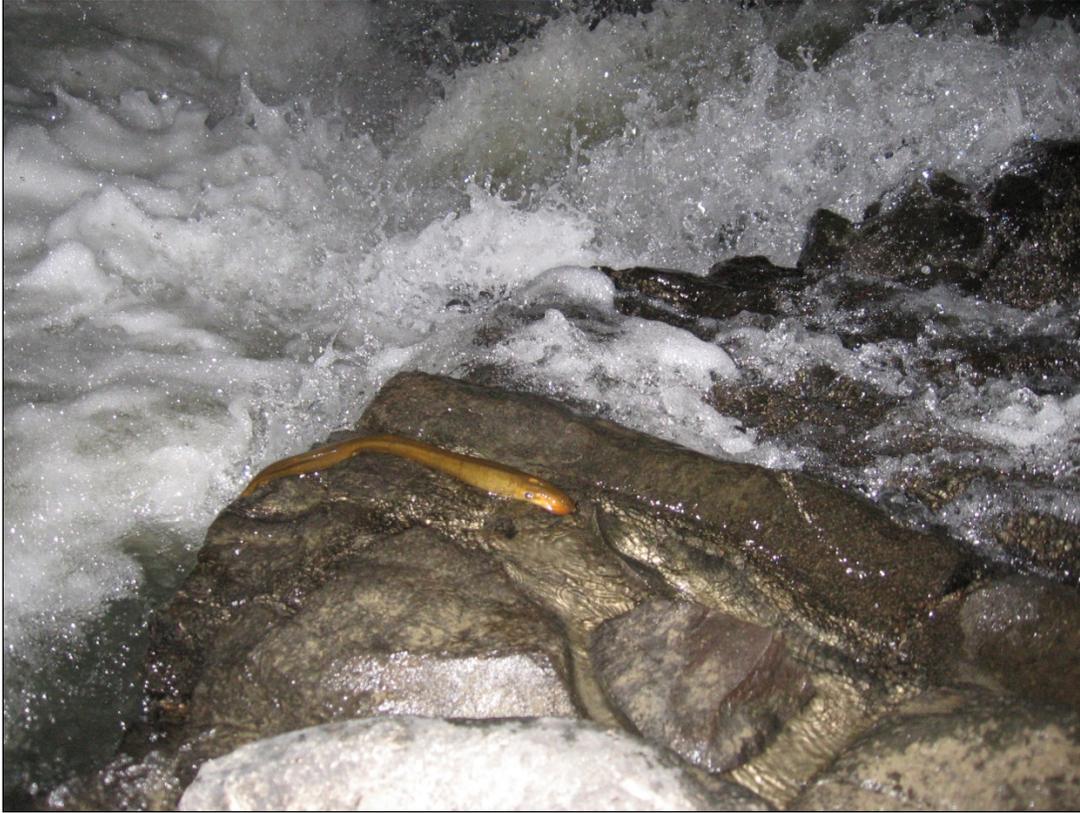
Figure A-6. Pacific lamprey climbing bedrock at the base of Prosser Dam.

Provided suitable surfaces to hold onto, Pacific lampreys have the ability to climb over steep and turbulent sections of river. For example, Pacific lampreys are known to climb Willamette Falls (Clemens et al. 2011). We observed lampreys at Prosser Dam attempting to move upstream by climbing natural bedrock but the rock does not extend up to the dam crest (Figure A-6).

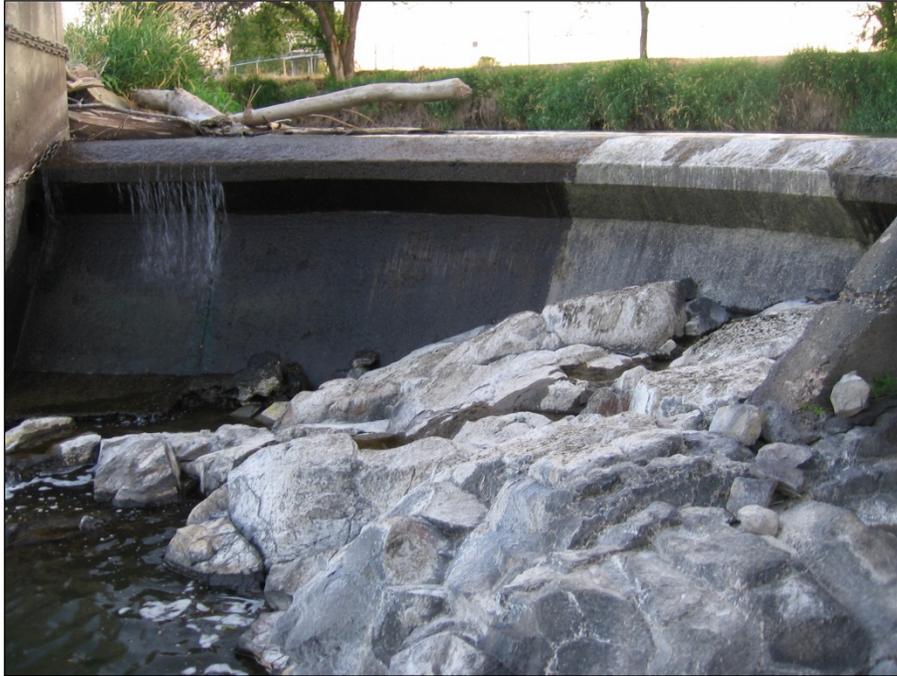
Figure A-7. Proposed site at Prosser Dam of rock ladder showing bedrock at low flow. The head of the Chandler Canal is just right of the edge of the frame.

The bedrock on the left bank of Prosser Dam is the best location for the rock ladder (A-7). Lampreys have been observed climbing bedrock in the area and telemetry data show that lampreys congregate there. Additionally, a log boom just upstream of the dam in the area reduces debris going over the dam face at that location.

The construction of a rock ladder would require placing large rocks and boulders at the base of the dam and building them up to the crest. This construction would use the bedrock as a base with the added rocks cemented or otherwise secured to ensure that they stay in place during high flow events. The rock ladder needs to be designed so that there are areas of varying velocities and that water is flowing over the rocks at a wide range of discharges. This would provide a variety of paths for the lampreys to take over the dam as conditions change.
