## **APPENDIX D: Bridge/Structure Assessment Guidance**

### **Federal Transportation Agency/State Department of Transportation (DOT) Preliminary Bat Assessment Guidelines for Bridges/Structures**

#### **DOT Environmental Division**

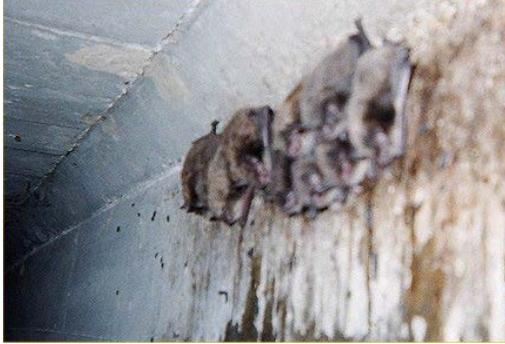
Photo 1: Bats hanging from cracks along support beams

Cracks in the concrete are used by bats as a foothold in roosting (Photo 1). In addition, some bats may be hidden from sight in wider cracks in the concrete and behind deteriorating concrete sections in the ceiling or walls. Look for cracking along support beams and inner walls especially below a fillet (a concrete filling between ceiling and vertical beam). During inspection, sounds may be heard coming from behind such cracks and/or expansion joints.

**Day:** Look for bats flying or roosting (hanging) during the assessment (Photo 1, 2, & 8). A flashlight or headlamp will be needed and binoculars may be necessary when viewing higher areas. If bats are present; record numbers as best as possible and their locations. Note any dead or injured bats. A sketch map would be helpful (use bridge plan sheet as base for sketch).

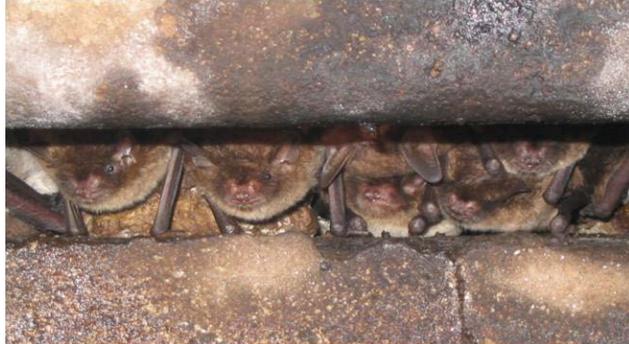
Photo 2: Visible bats within an expansion joint

Expansion joints can provide protected cover for bats (Photos 2 and 5), but do not always provide habitat, depending upon whether they are obstructed by road debris or other blockages. If possible during the assessment, individuals should use a flashlight to look into expansion joints or cracks. Guano may be present under joints if being used by bats (Photos 7 and 8).

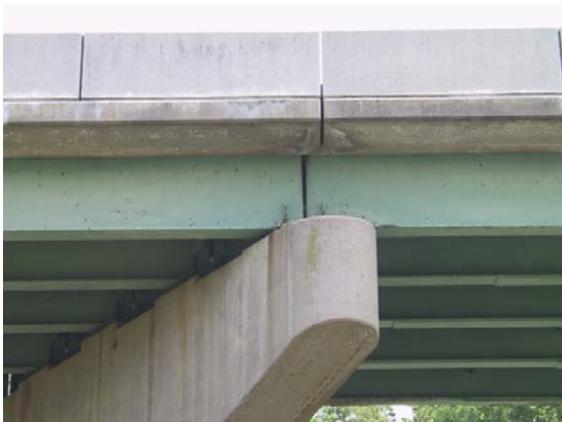
Photo 3: Example of open concrete joint used by bats

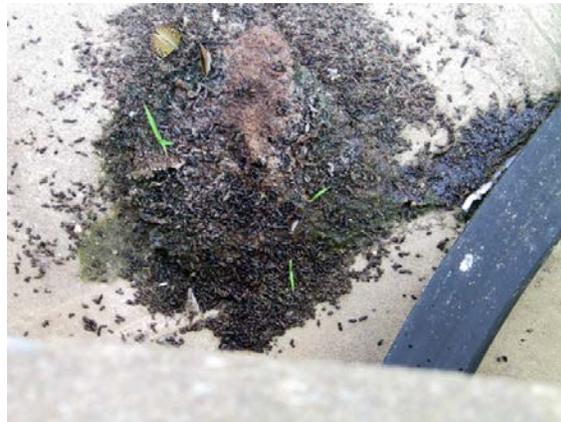
Photo 4: Guano deposits visible from bridge deck, on top of pier

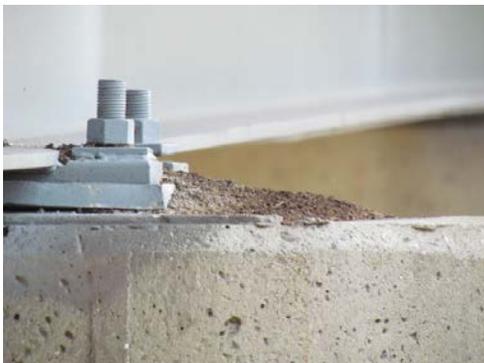
Photo 5: Guano deposit on pier, obscuring structural features.

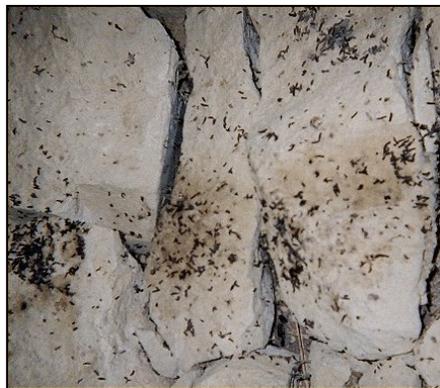
Photo 6: Bat Guano on Riprap

Bat droppings are small (mouse-like in appearance but less regular) brown or black pellets (Photos 6 - 8). Older droppings may be gray in color. These droppings will accumulate on the ground, floor of a covered bridge or on structural components below where bats roost. Droppings may also adhere to support beams and walls below roosts.

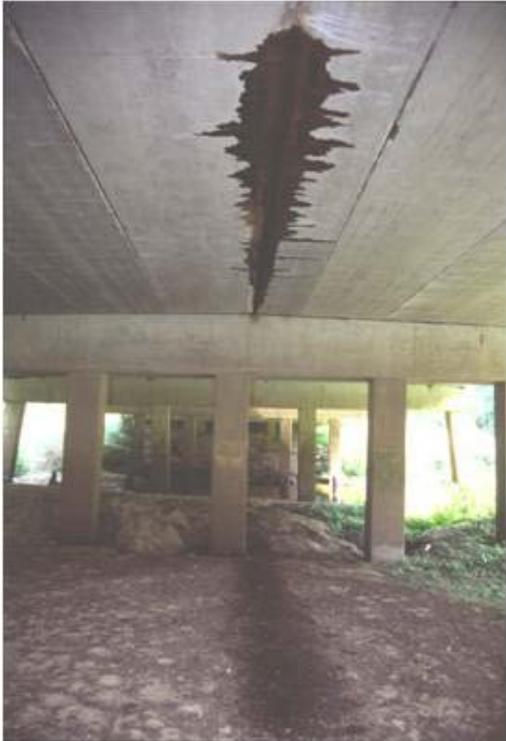
Photo 7: Staining along longitudinal joint.  
Guano deposits on the ground.

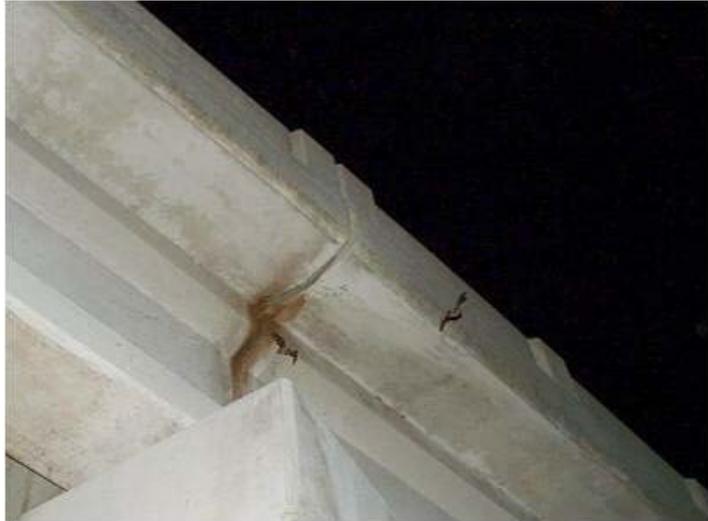
Photo 8: Staining on underside of expansion joint from bat use.

Stains may appear wet and are usually found in dark places. Look for four to six inch wide dark stains located on concrete support beams and walls immediately below the ceiling of the bridge, and beneath joints (Photos 8 - 11).

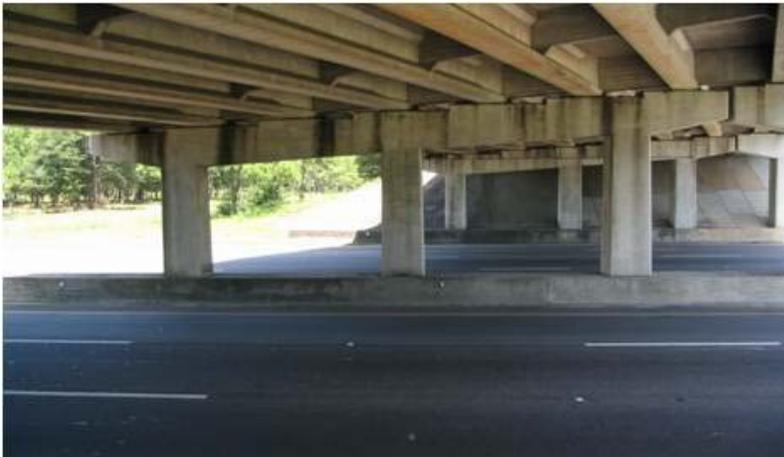
Photo 9: Staining on sides of pier caps

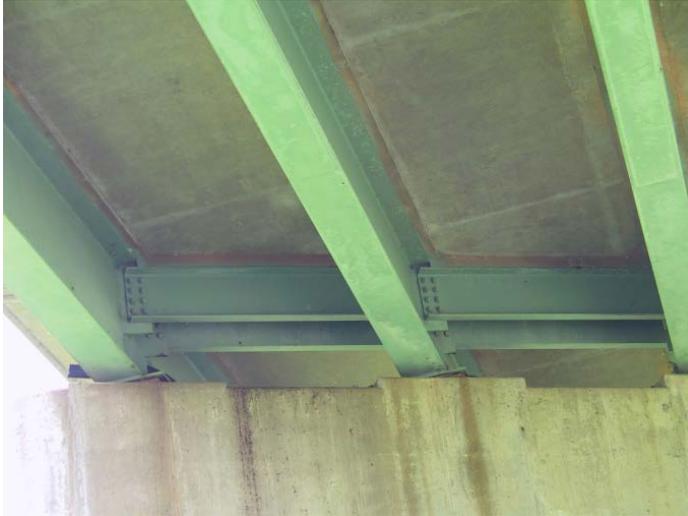
Photo 10: Guano staining on side of pier

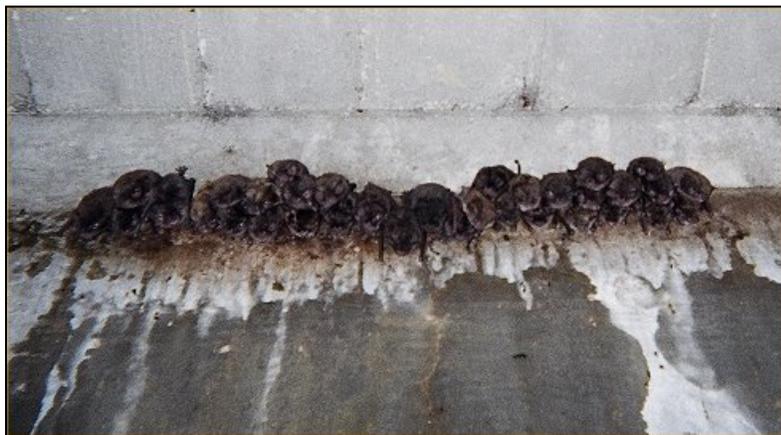
Photo 11: Bats roosting & associated staining

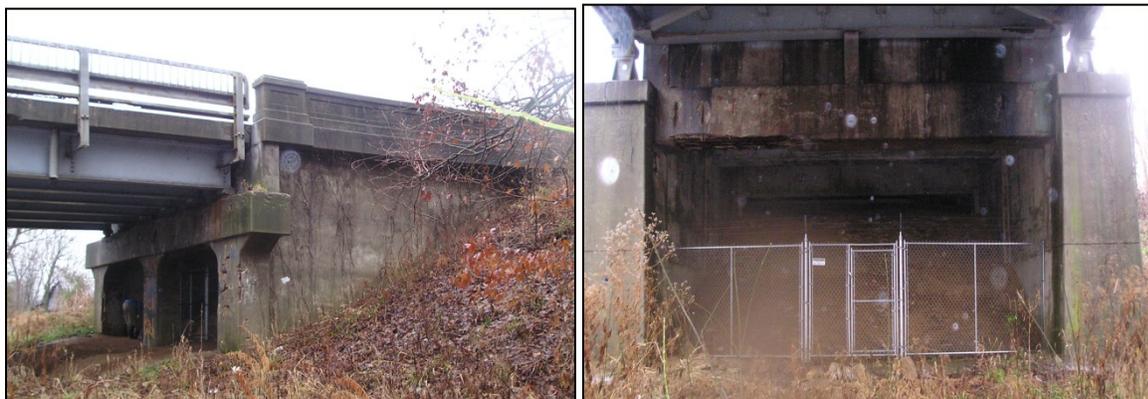
Photo 12 and 13: Bridge design mimicking "cave-like" atmosphere

While assessing bridges or structures, look for dark environments that mimic cave-like conditions such as under the deck in the case of a bridge (Photos 12 and 13) or an attic in the case of a structure. This may involve crawling under low areas so a hard hat is recommended. Such places (e.g., a concrete bunker secreted into a hillside with an open front) provide protection from wind, rain, sleet, hail and predators. Bats do not roost near the ground where predators (cats, raccoons, etc.) can reach them. Roosting is usually at least 4 ft. from the ground.

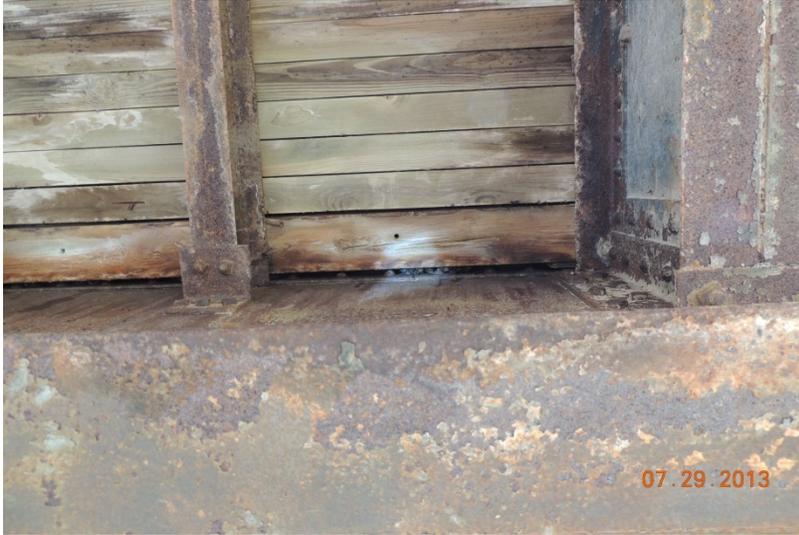
Photo 14: NLEBs roosting under a timber decked bridge
