# Great Lakes Fish and Wildlife Restoration Act

## FINAL Project Report Template

**\*Project Title:** Brook Trout Habitat Protection and Restoration in the Salmon Trout River Watershed, Marquette County, Michigan

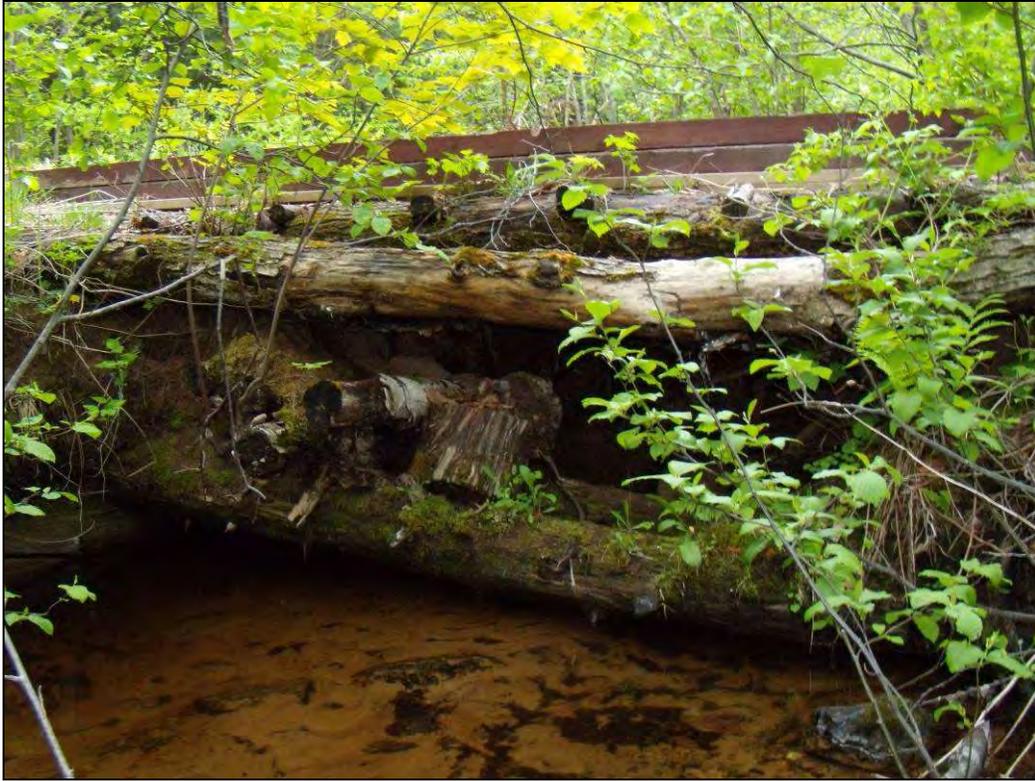
Photo 1 Looking upstream at existing timber bridge (before).

- Removed failing timber structure. Existing bridge characteristics: Length of span (upstream/downstream): 18 feet; Width of span (bank to bank): 10 feet. Structure consisted of original corduroy structure installed in the 1940s with multiple layers of timbers that had been placed over the top. The waterway opening above streambed (approx. 29 square feet) was severely impeded by falling timbers. The timbers also blocked passage for native fish (brook trout).

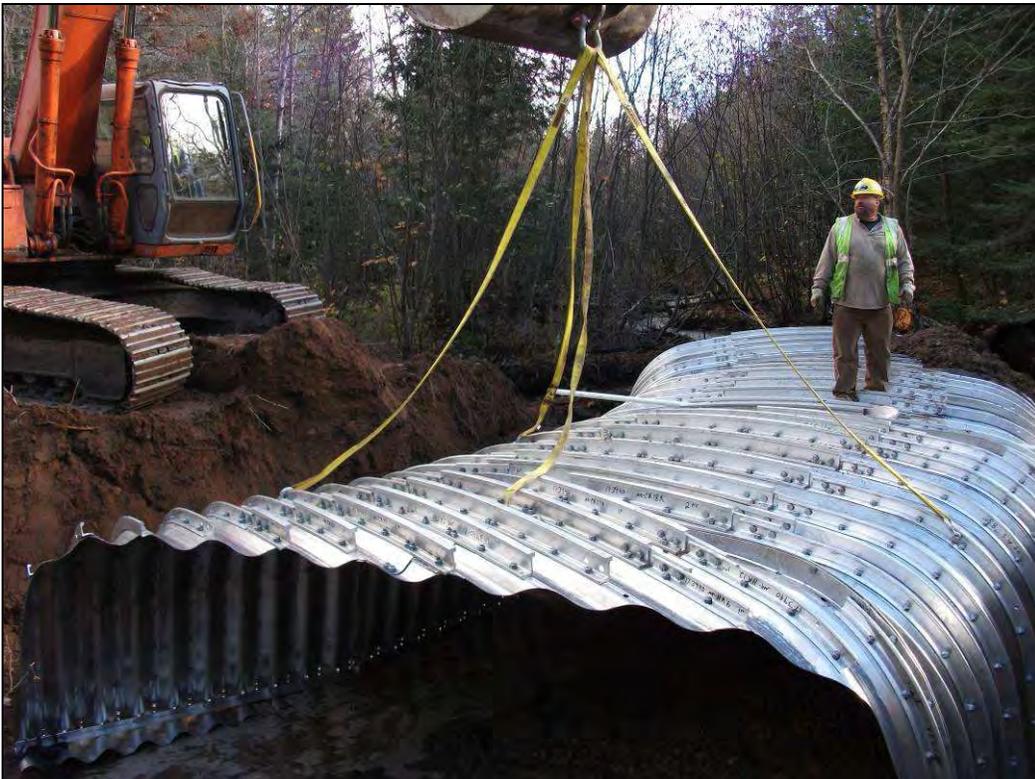
Photo 2 Looking downstream at new culvert during construction.

- Installed new bottomless culvert. New culvert characteristics: One bottomless arch culvert (13’ 10” span x 5’ 5” rise x 31.5’ long) spanning the stream channel and designed for HS-25 loading (to accommodate logging trucks). Material: aluminum, estimated life span: 50 years; Total structure waterway opening above streambed: 45 square feet. The culvert was constructed with a curve to fit a bend on the upstream side of the crossing.

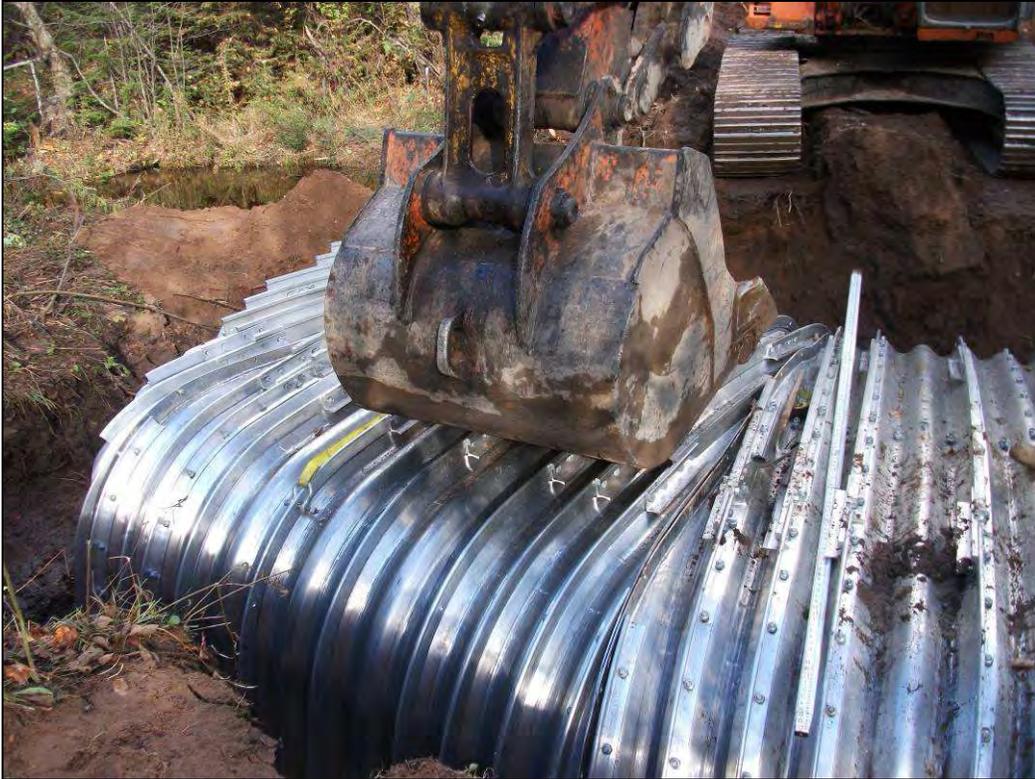
Photo 3 Looking at upstream section of new culvert during construction.

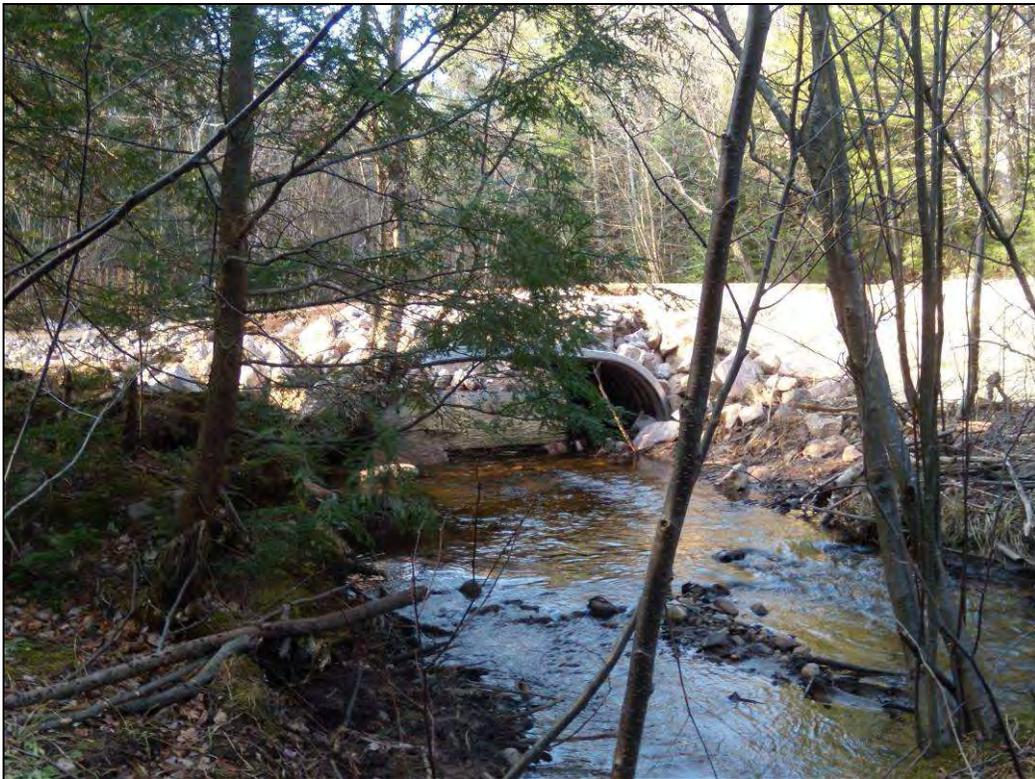
Photo 4 Looking upstream at new culvert outlet after construction.

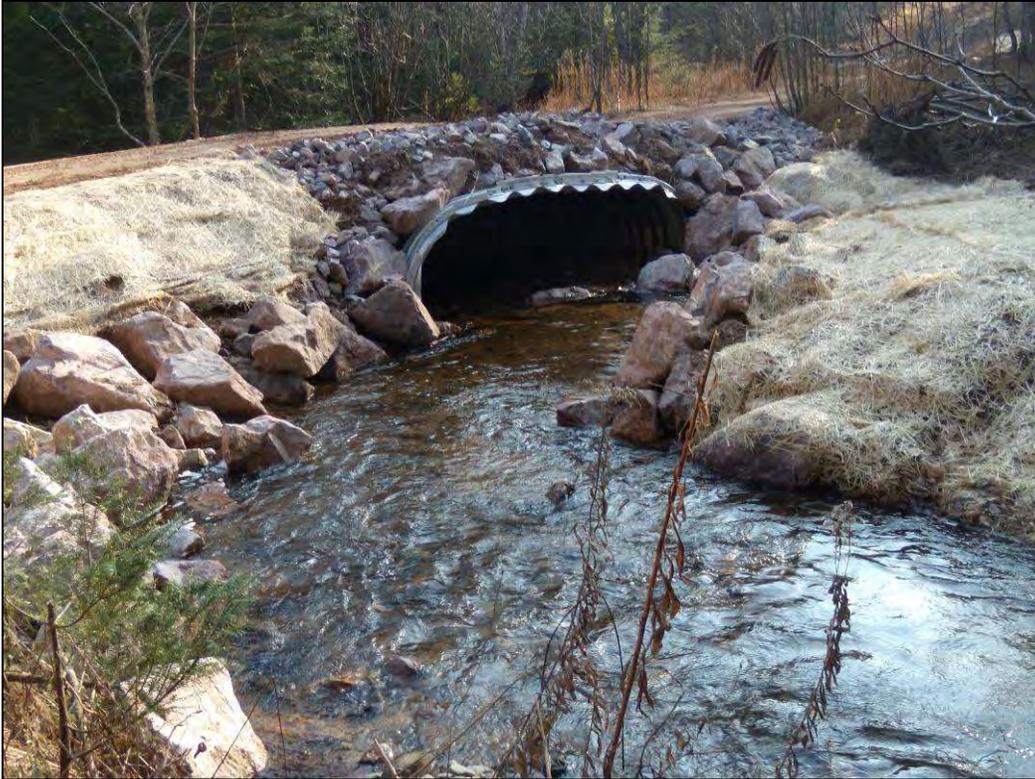
Photo 5 Looking downstream at new culvert inlet after construction. Note: A native brook trout (10-12") was observed passing through the culvert immediately after construction.

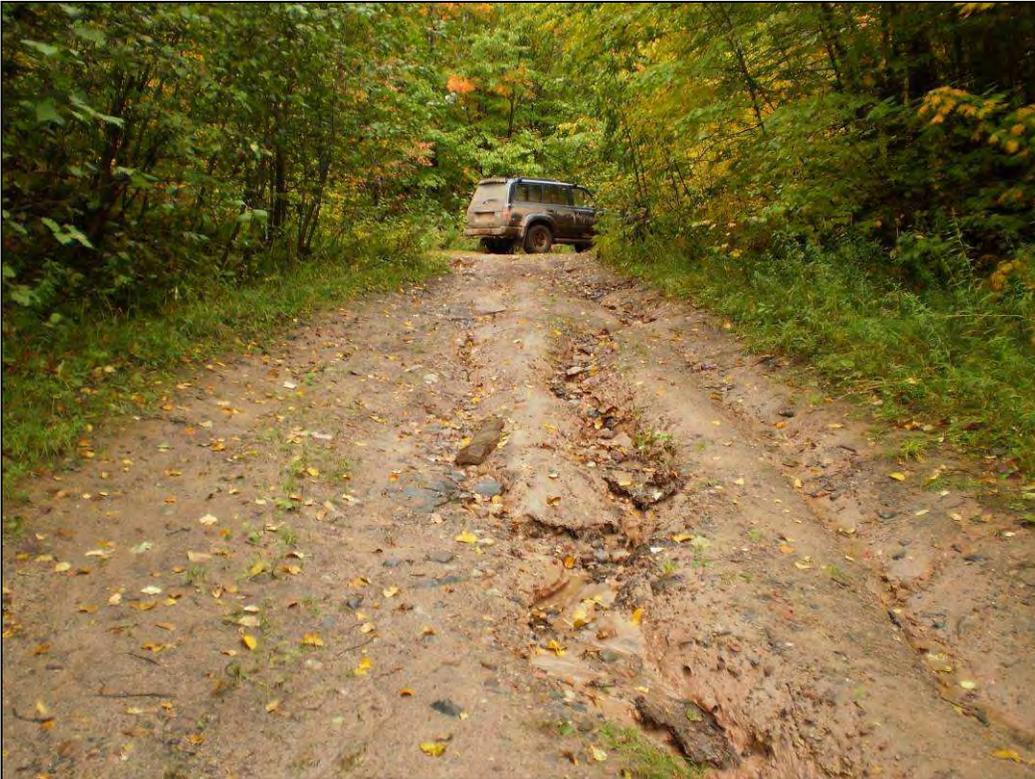
Photo 6 Example of erosion on road approaches before improvements.

- Completed site work (grading) on road approaches, installation of 6 road turnouts/storm water detention areas including two turnouts on the east approach and three on the west approach, site stabilization including seeding and mulching of disturbed and bare soil areas, and installation of riprap on upstream and downstream culvert embankments and road approach turnouts.

- Reduced an estimated 73 tons of sediment input to the Salmon Trout River from the road approaches at the priority road/stream crossing site. The USFWS Coastal Program (Ted Koehler, Ashland FWCO) was a partner on the project and Coastal Program funds (not included as project match) were leveraged to complete road approach work, making this a cooperative demonstration project.

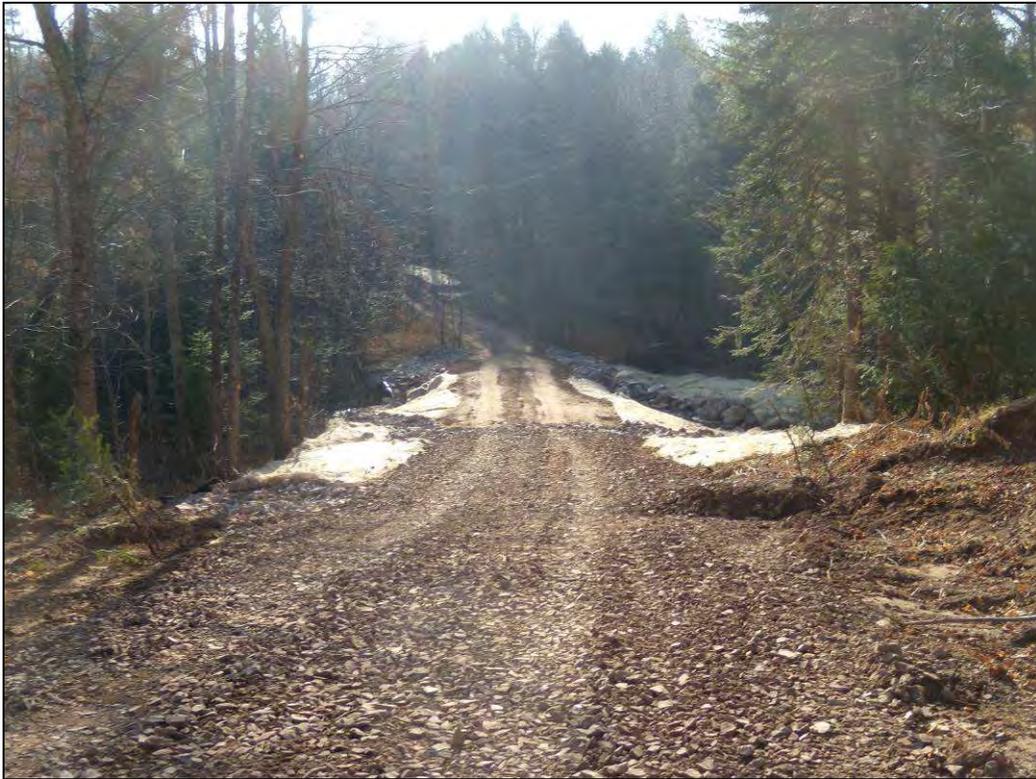
Photo 7 Looking southeast at road approaches immediately after improvements.

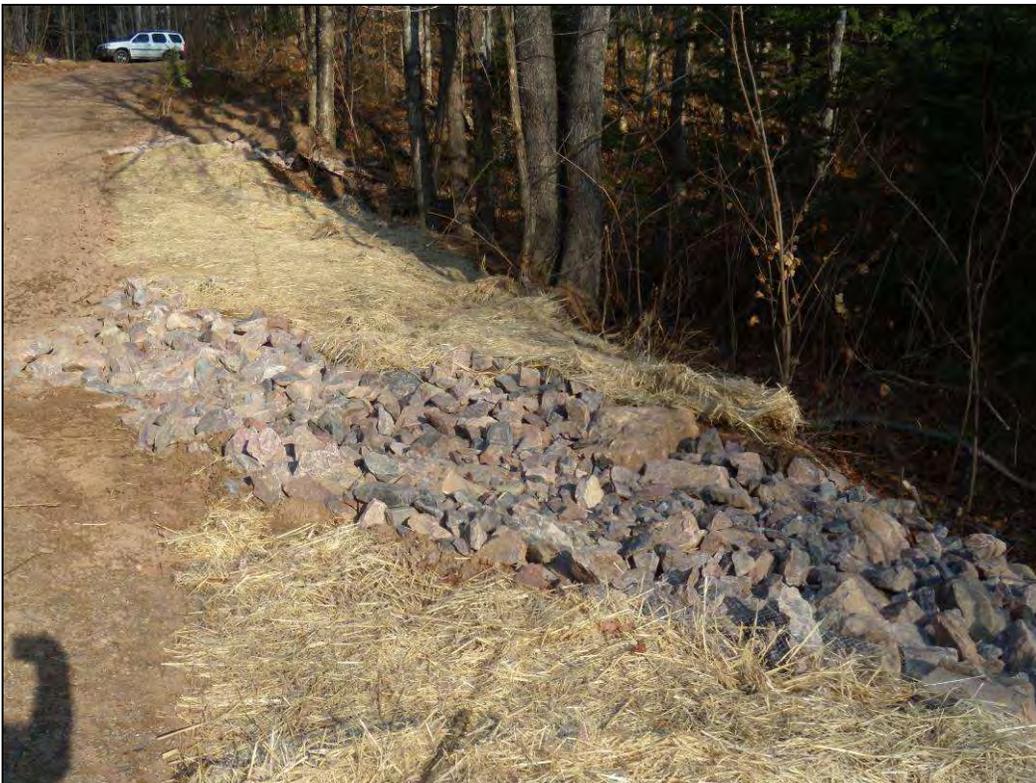
Photo 8 Close up of road turnouts/drainage basins installed on road approaches.

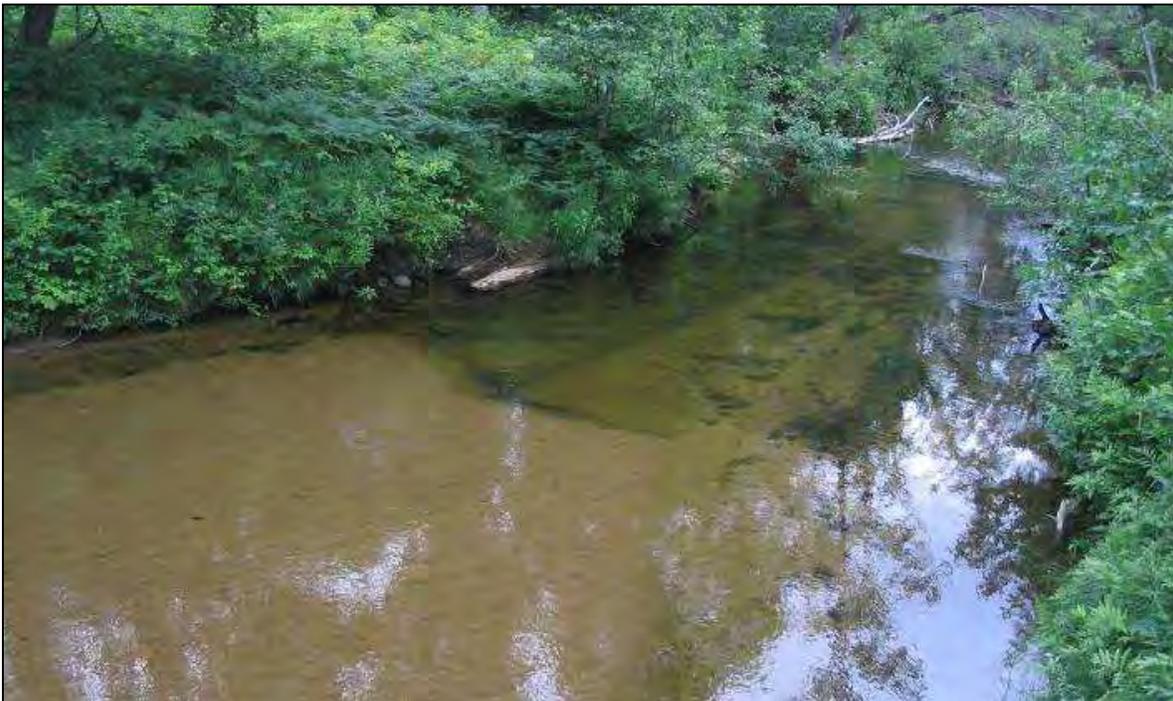
Photo 9 Head of sand plume moving downstream in the Salmon Trout River.  
Photo by Dr. Casey Huckins, Michigan Technological University, July 13, 2007.

- Conducted in-stream surveys in the lower Salmon Trout River at 4 previously established sites. Adopt-a-Station protocol was used to characterize physical stream characteristics including stream width, water depth, sand depth, and substrate conditions.
- In-stream surveys of the lower Salmon Trout River included data collection at 4 sites rather than the 8 sites that were proposed. Data collection at 4 sites was determined to be sufficient for evaluating the large sand plume moving down the river (approx. 2 miles of stream).

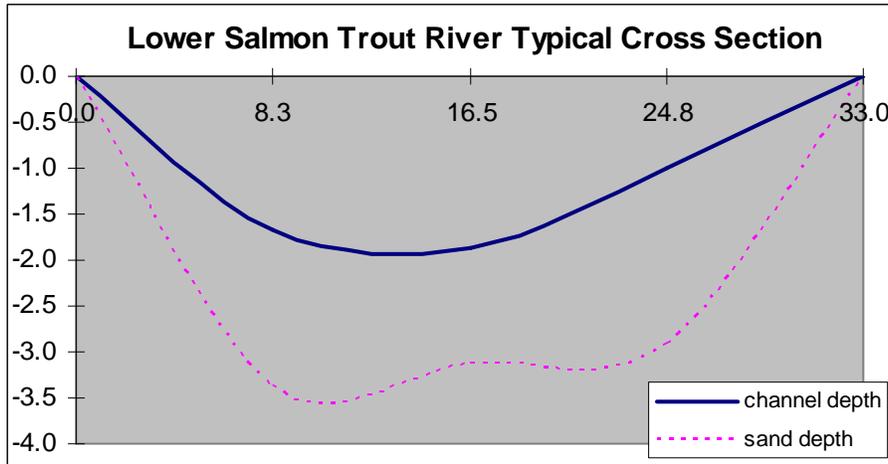
Figure 1 Typical cross section profile of the lower Salmon Trout River
