# Delineation of Waters of the U.S.

## Hammer Diversion on South Fork Cottonwood Creek Fish Passage Improvement Project

Tehama County, California  
January 2014

**TEHAMA**  
ENVIRONMENTAL SOLUTIONS, INC.

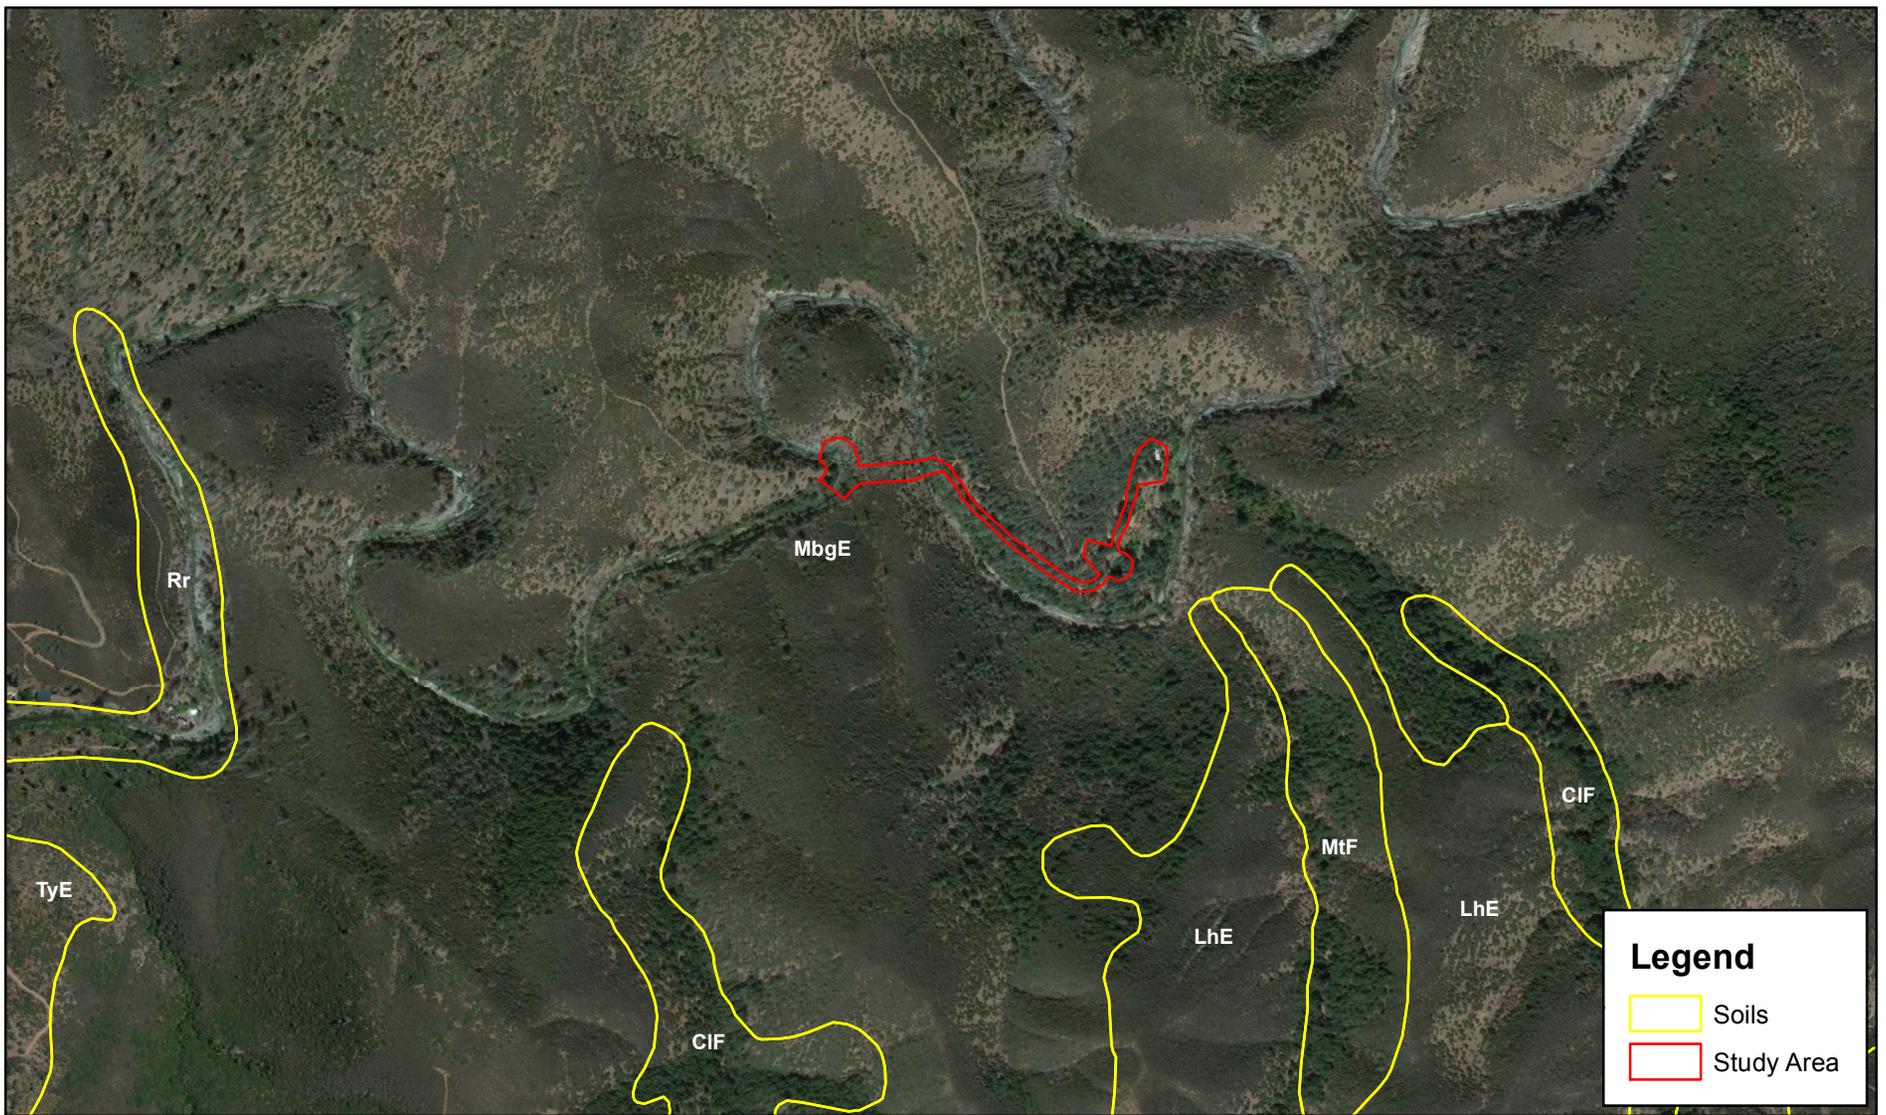
FIGURE 3  
 Soil Survey Map

One soil map unit occurs within the study area (Figure 3) according to the local soil survey (USDA-SCS et al. 1967). The one identified map unit is listed below:

### Maymen and Lodo gravelly loams, 30 to 65 percent slopes (MbgE)

This soil map unit exists in the mountainous areas of the western part of the county. It is composed of Maymen gravelly loam, 30 to 65 percent slopes and Lodo shaly loam, 30 to 65 percent slopes, eroded. The depth to the broken and weathered rock is from 6 to 20 inches in the Maymen soil and is 6 to 10 inches in the Lodo. The erosion hazard is severe to very severe. The soil is not listed as hydric on the state hydric soils list (USDA-NRCS 1995). The soil is also not listed as hydric on the local hydric soils list (USDA-NRCS unknown date). The series is not classified taxonomically by higher categories in the soil survey. According to the USDA-Natural Resources Conservation Service (NRCS) Official Soil Series Descriptions (USDA-NRCS website), the Maymen soil series is classified as a loamy, mixed, active, mesic, shallow Typic Dystrochrept. The Lodo soil series is classified as a loamy, mixed, superactive, thermic Lithic Haploxeroll.

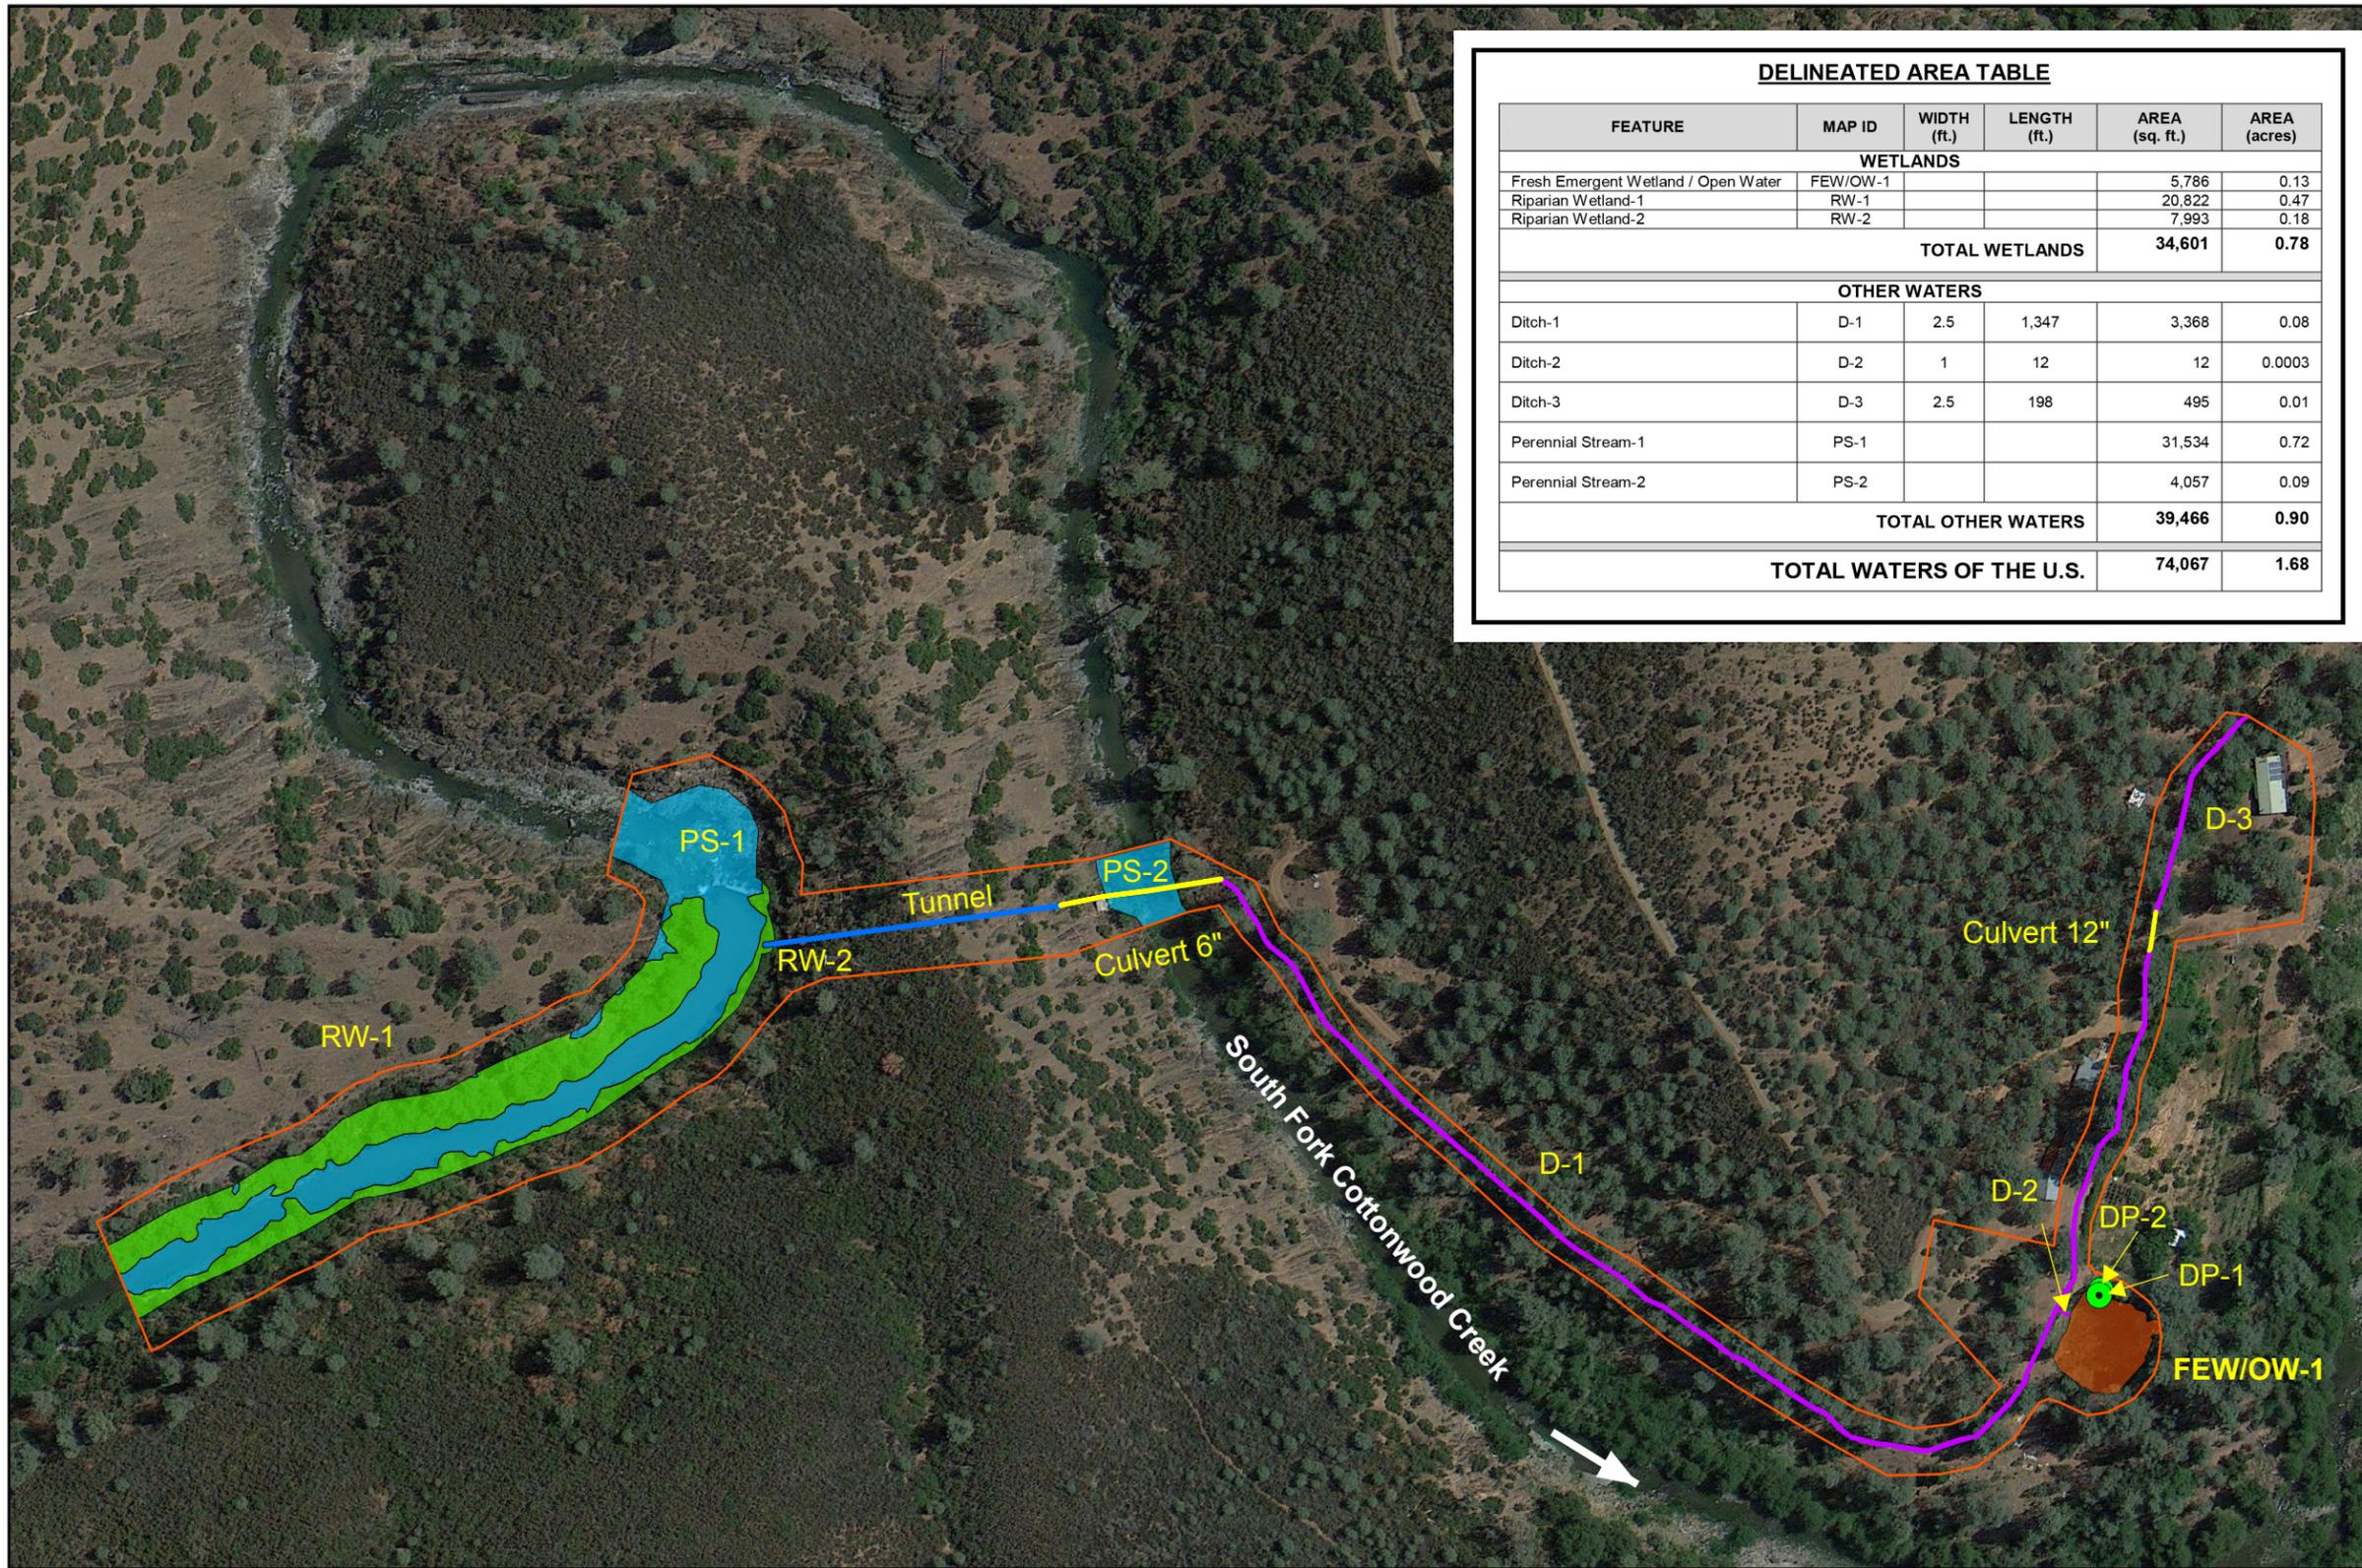
**FIGURE 4**  
Preliminary Delineation Map

Once delineated, the boundaries of all identified wetlands and other waters of the U.S. were then marked in the field with pin flags or field flagging, along with the location of all data points. The boundaries of all identified wetlands and other waters, and the locations of all data points, were then mapped using a Trimble GeoExplorer 6000 series Global Positioning System (GPS) unit, capable of sub-meter accuracy. All area features less than two meters in width/diameter were collected as points or lines. Point features were physically measured to determine area data, while line features were assigned an average width and multiplied by the GPS-measured distance. These features and measurements are shown in Figure 4.

It should be noted that the collection of accurate GPS data for several features including D-2, D-3 and FEW/OW-1 proved to be difficult, likely due to the combination of the location of these features in the bottom of a steep canyon and under heavy vegetation canopy cover which limited satellite access. Multiple GPS polygon and line features were collected and manually adjusted using aerial photography to reflect the actual conditions as accurately as possible. For this reason, the location and acreage information for these features is likely less than the sub-meter accuracy normally achieved with resource-grade GPS equipment.

It should also be noted that the Riparian Wetland features were delineated by mapping the drip line of riparian vegetation within the boundaries of the OHWM. While the entire area within the Riparian Wetland features are likely jurisdictional due to the fact that they lie within the OHWM boundaries, the entire mapped area may not meet the definition of a wetland in that all three wetland parameters may not be present in areas nearest the OHWM boundary.

Features PS-1 and PS-2 (Figure 4) meet the definition of a Relatively Permanent Water (RPW) as defined by the *U.S. Army Corps of Engineers Jurisdictional Determination Form Instructional Guidebook* (guidebook) (U.S. Army Corps of Engineers and Environmental Protection Agency 2007) and the revised Rapanos/Carabell guidance (U.S. Army Corps of Engineers and Environmental Protection Agency 2008). The constructed tunnel may not be jurisdictional as it is essentially the equivalent of a culvert. Features D-1, D-2, D-3 and FEW/OW-1 may, or may not be jurisdictional. All of these features are connected at the upstream end to the South Fork of Cottonwood Creek, however it is unclear whether these features surface flow directly back to the South Fork of Cottonwood Creek.

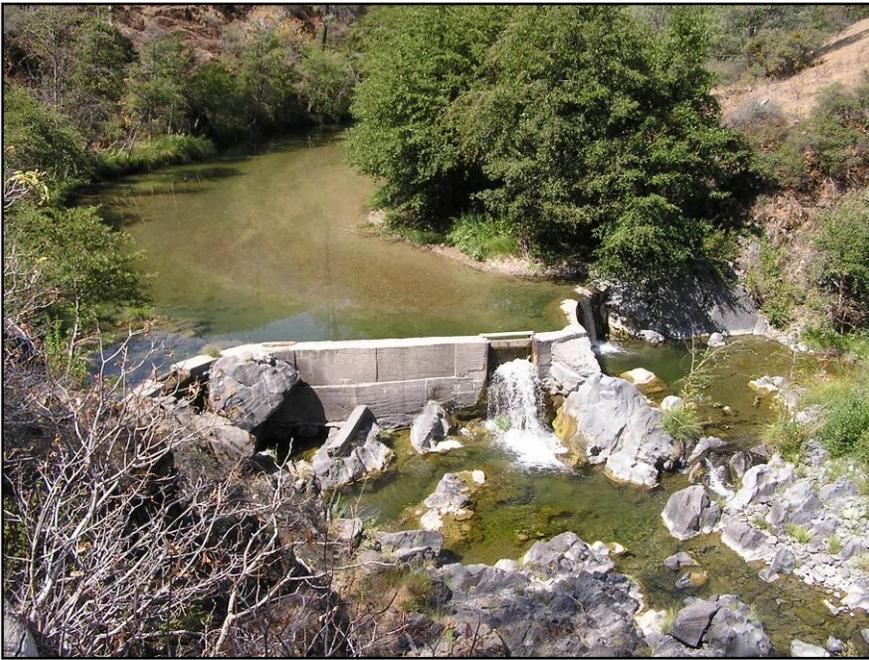
**Photo 1.** View of the Hammer diversion, looking southwest. Features RW-1 and RW-2 can be seen along the stream banks upstream of the dam. Photo date: August 9, 2013.

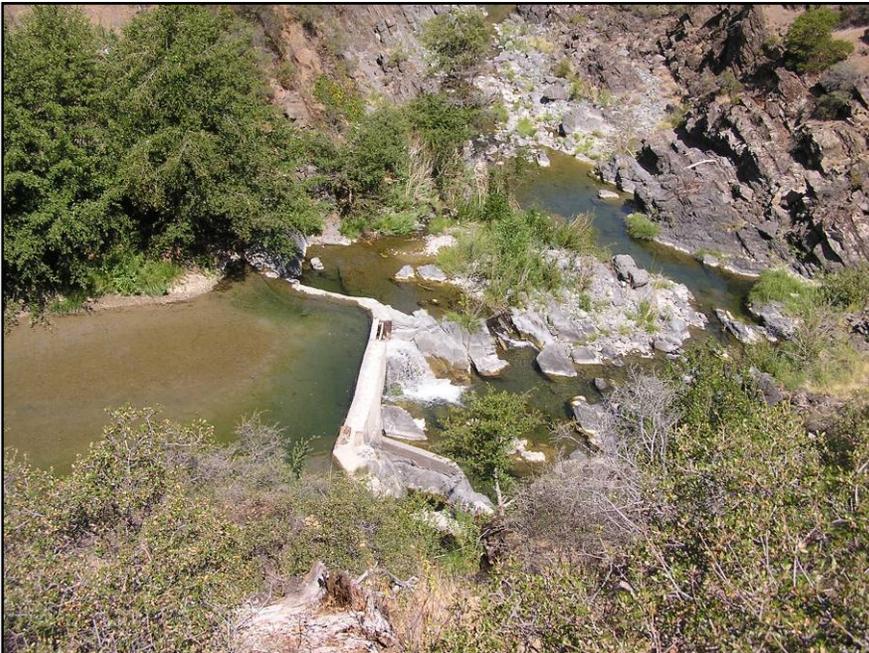
**Photo 2.** View of the area downstream of the Hammer diversion, looking northwest. Feature PS-1 can be seen in the channel upstream and downstream of the dam. Photo date: August 9, 2013.

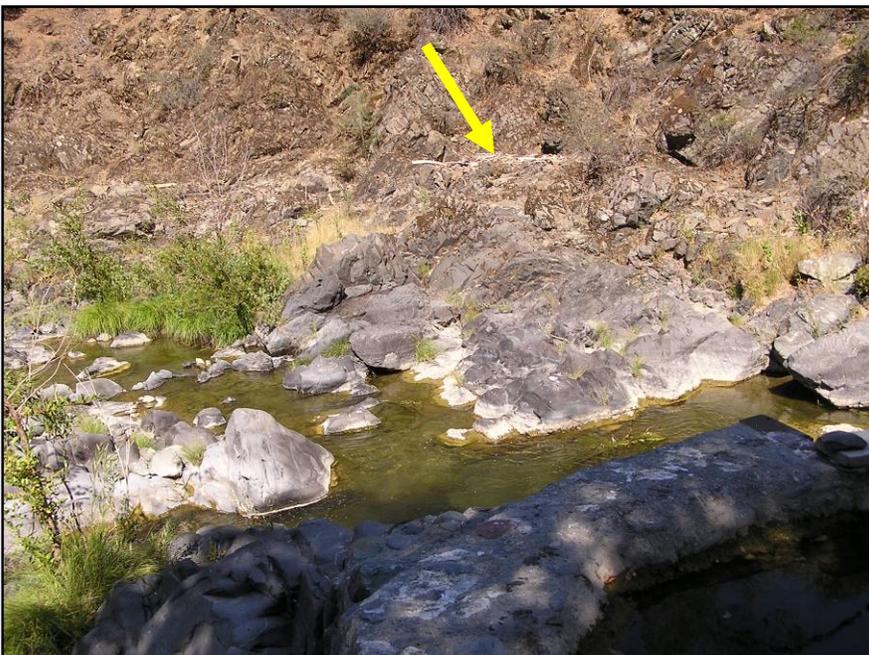
**Photo 3.** View of feature PS-1 below the Hammer diversion, looking northeast. The arrow indicates the delineated OHWM. Photo date: August 14, 2013.

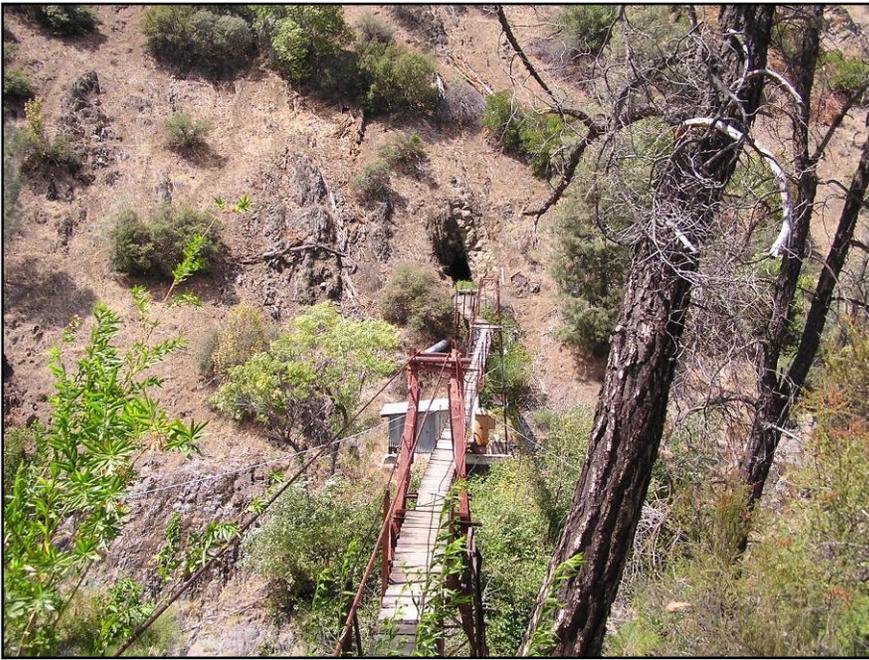
**Photo 4.** View of suspension bridge that supports an attached 6-inch culvert that carries irrigation water from the tunnel to feature D-1, looking northwest. Photo date: August 9, 2013.

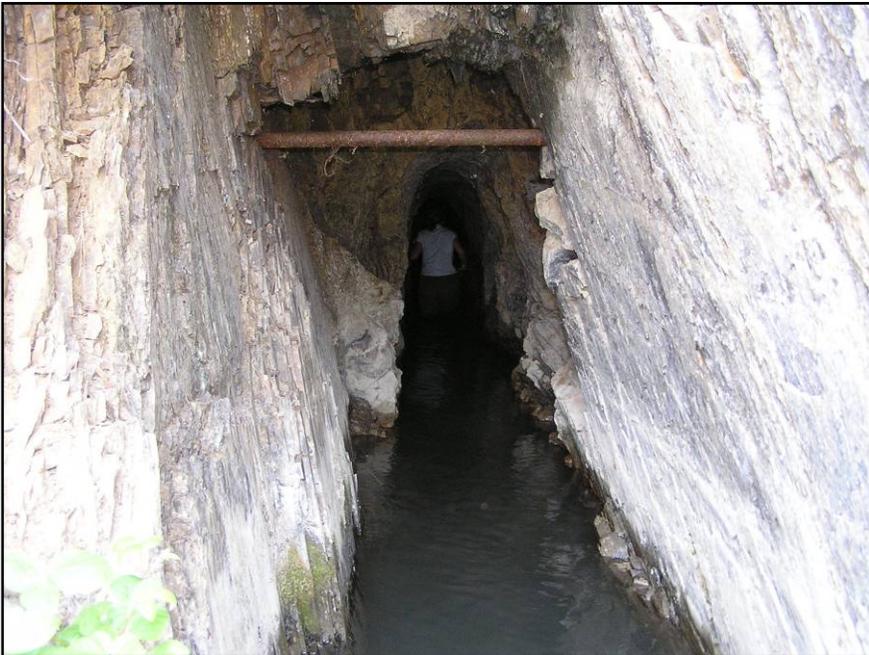
**Photo 5.** View inside of the water conveyance tunnel, looking northwest. Photo date: August 9, 2013.

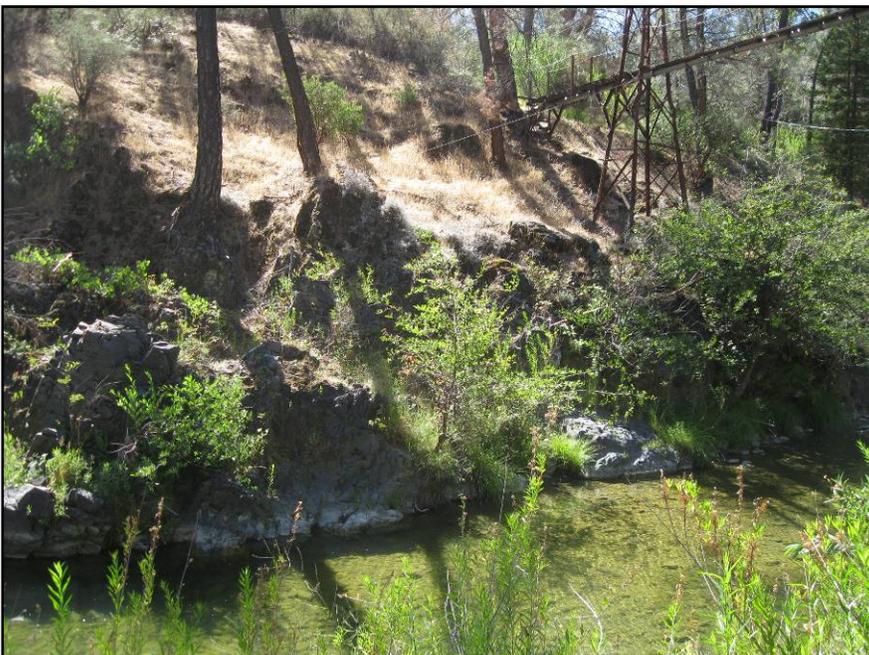
**Photo 6.** View of feature PS-2 below the suspension bridge, looking southeast. Photo date: August 16, 2013.

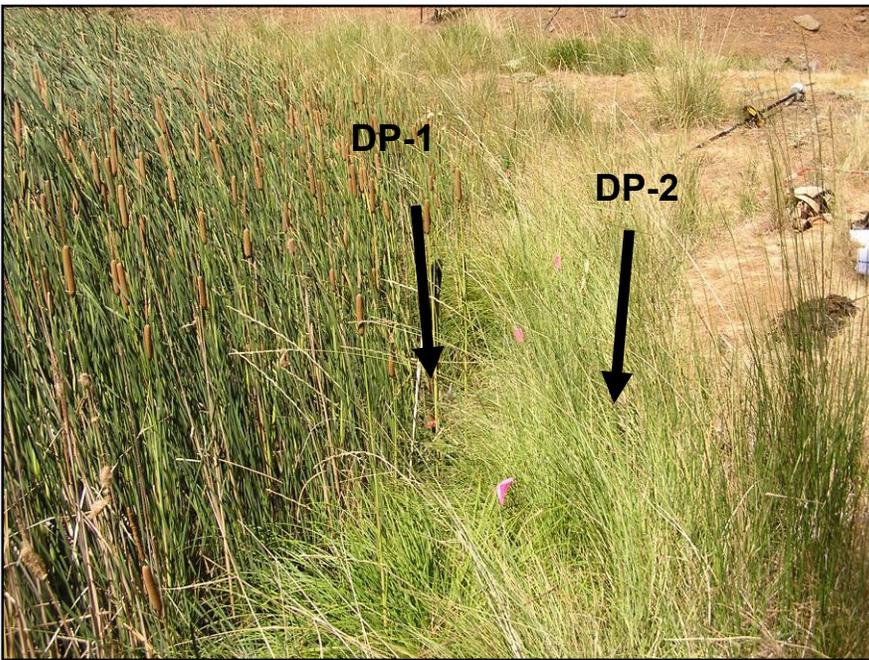
**Photo 7.** View of feature FEM/OW-1. The pink flags show the delineated wetland boundary. The arrows indicate the locations of DP-1 and DP-2. Photo date: August 16, 2013.

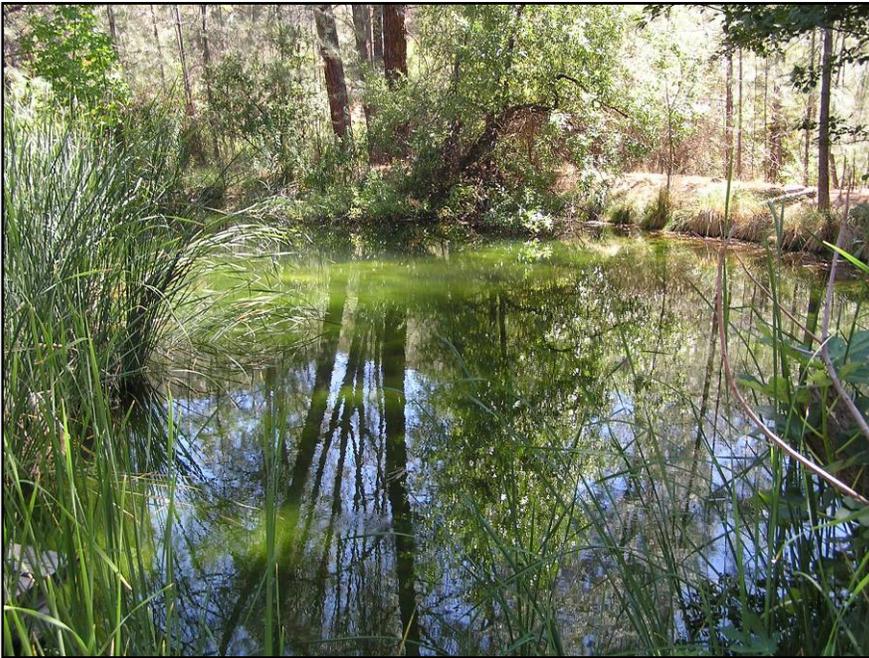
**Photo 8.** View of open water portion of feature FEW/OW-1. Photo date: August 29, 2013.

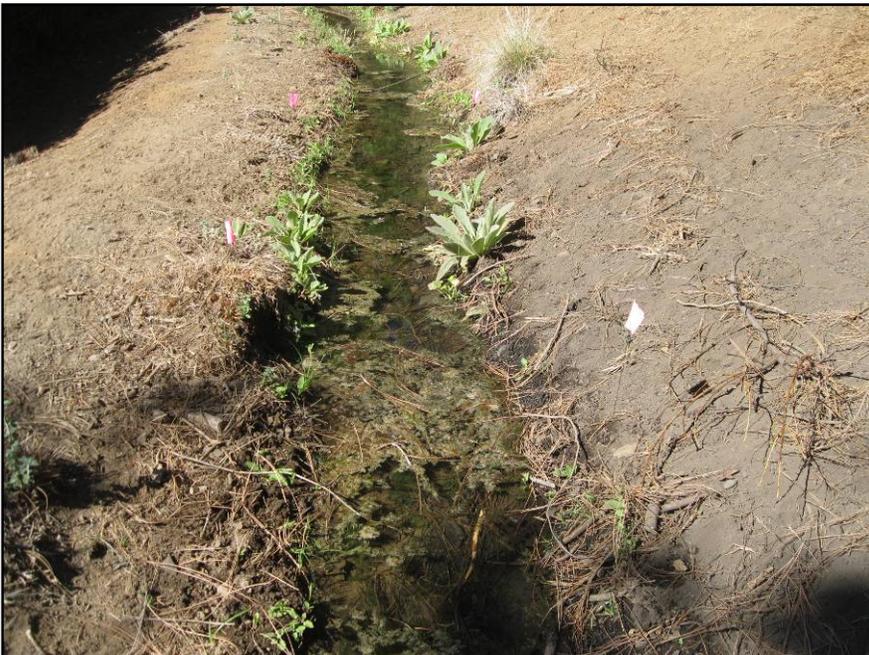
**Photo 9.** View of feature D-1. The pink flags indicate the delineated OHWM. Photo date: August 16, 2013.
