Delineation of Waters of the U.S.

Mill Creek Fish Passage Restoration Project

Tehama County, California
March 2015

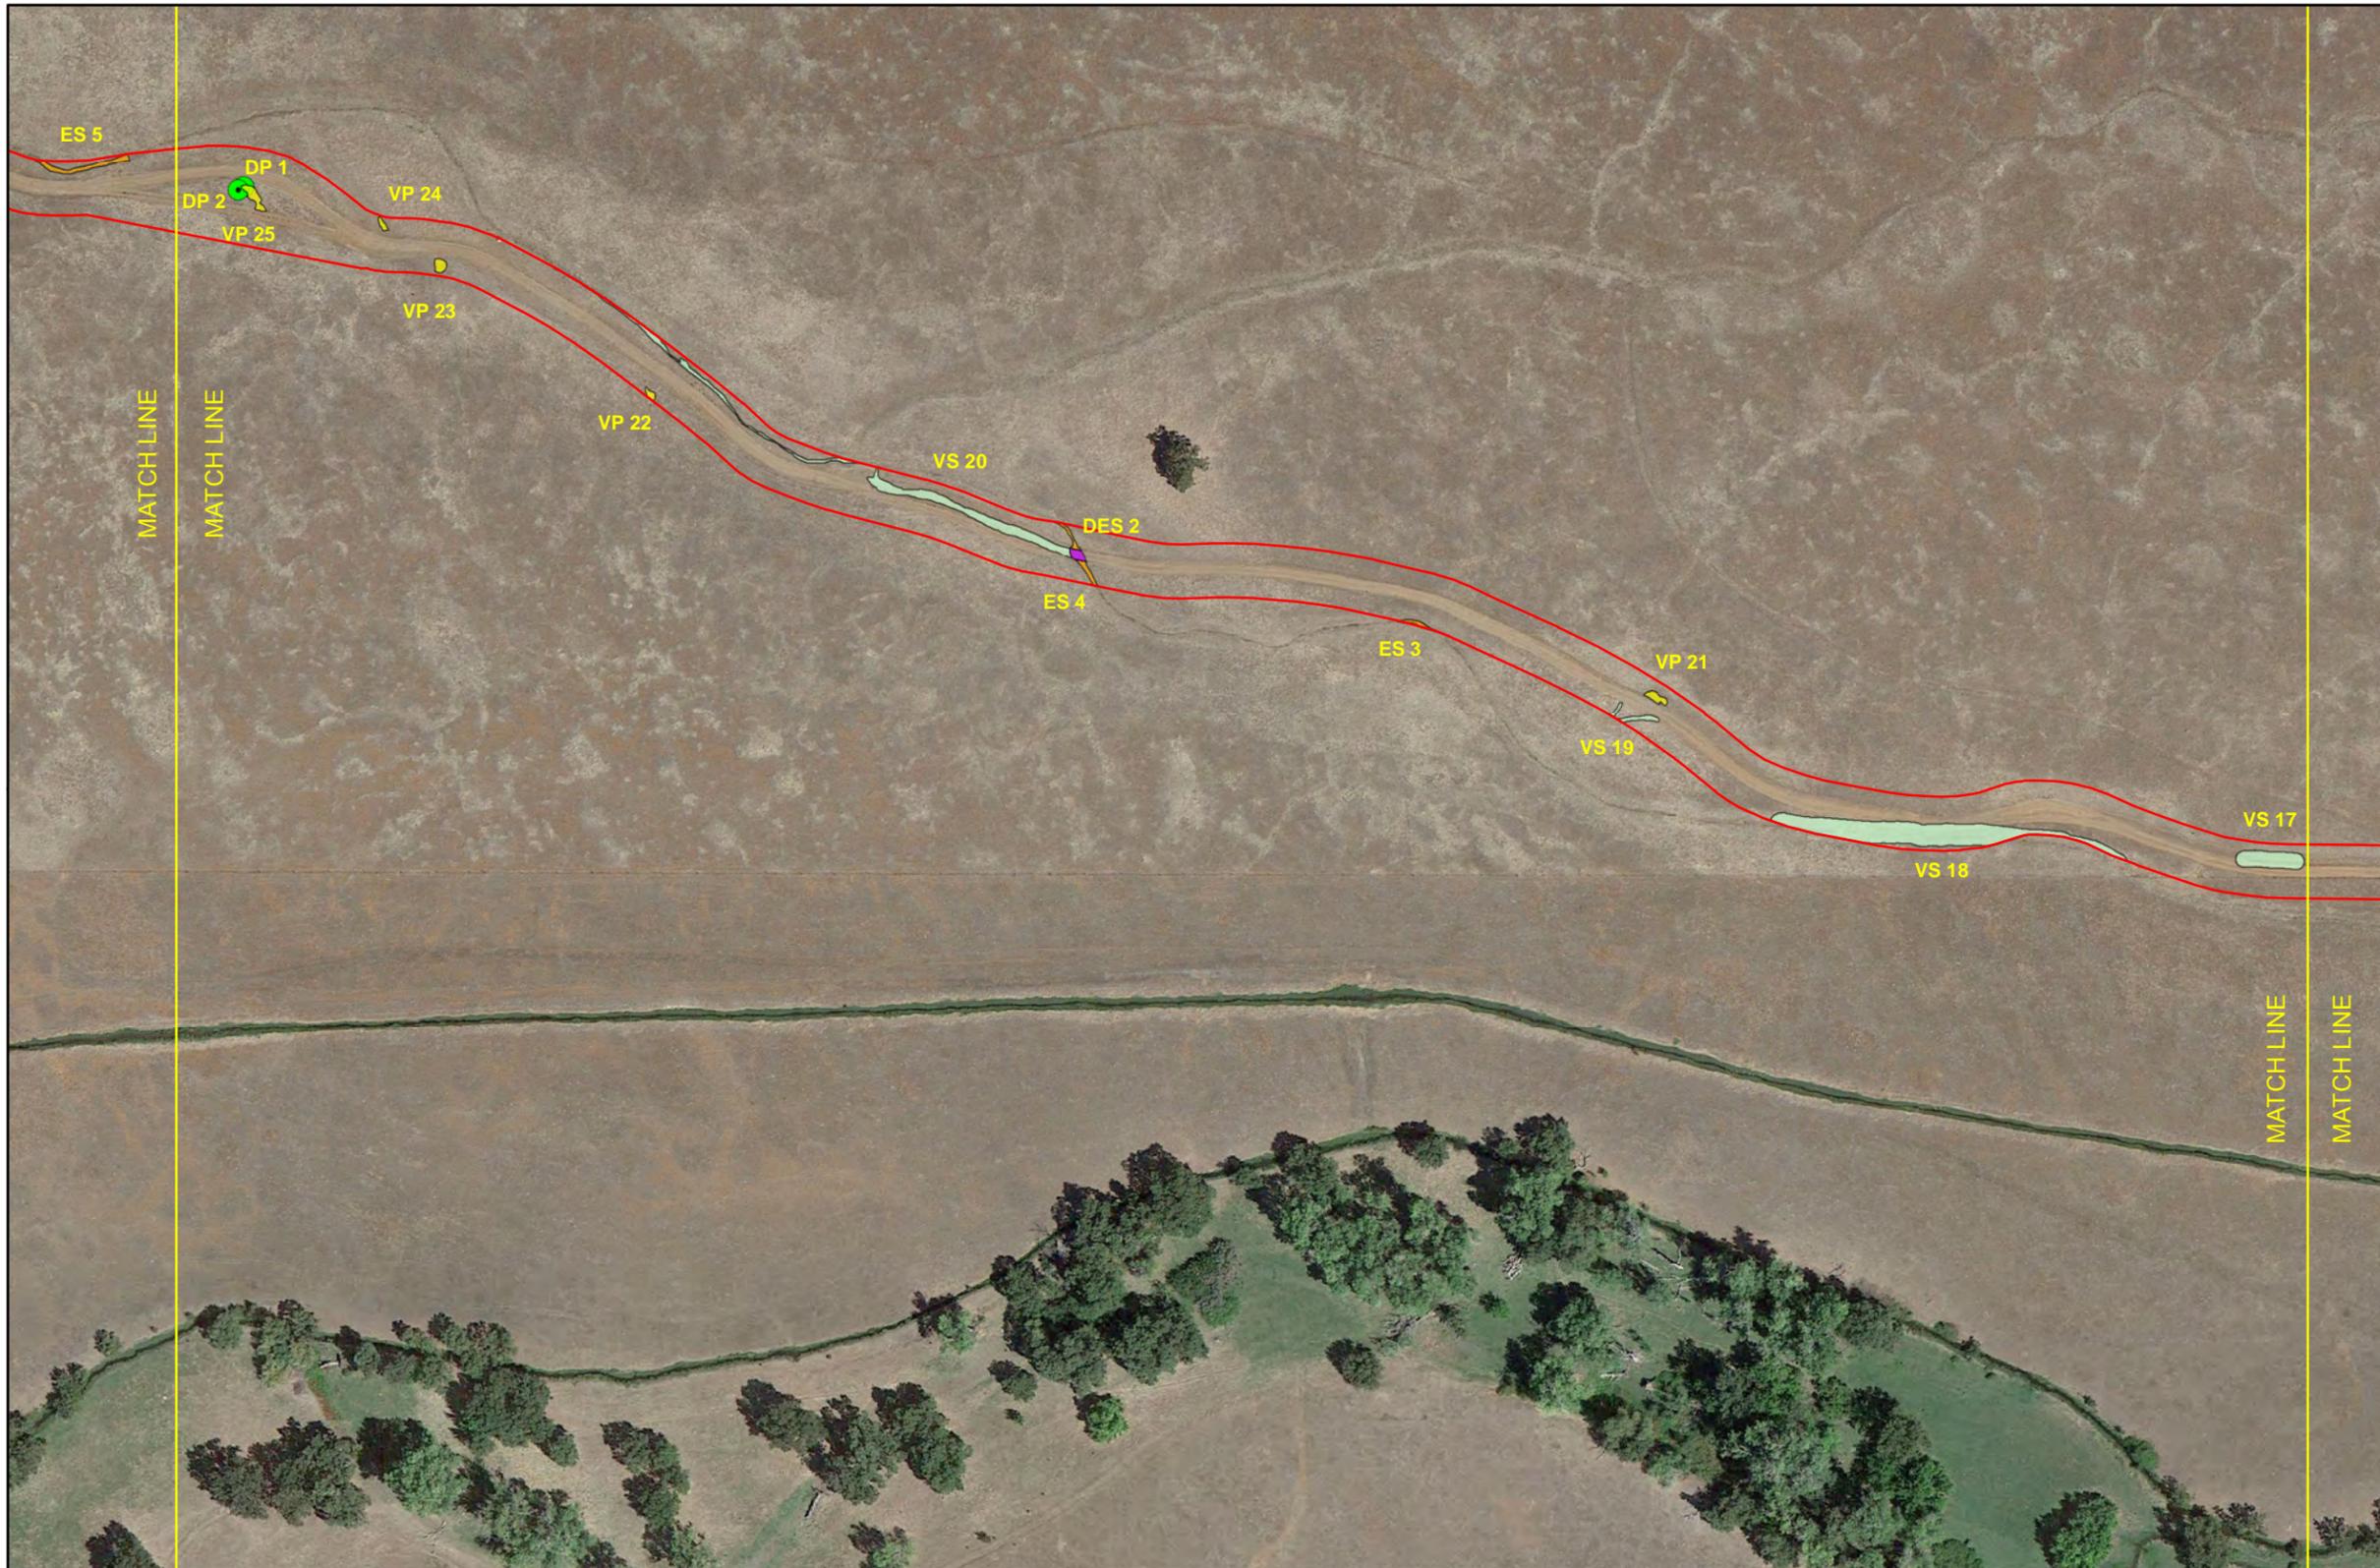
FIGURE 8
Preliminary Delineation Map
Upper Dam

Trimble GeoExplorer 6000 series Global Positioning System (GPS) unit, capable of sub-meter accuracy. All area features less than two meters in width / diameter were collected as points or lines. Point features were physically measured to determine area data, while line features were assigned an average width and multiplied by the GPS-measured distance. These features and measurements are shown in Figures 4 - 10.

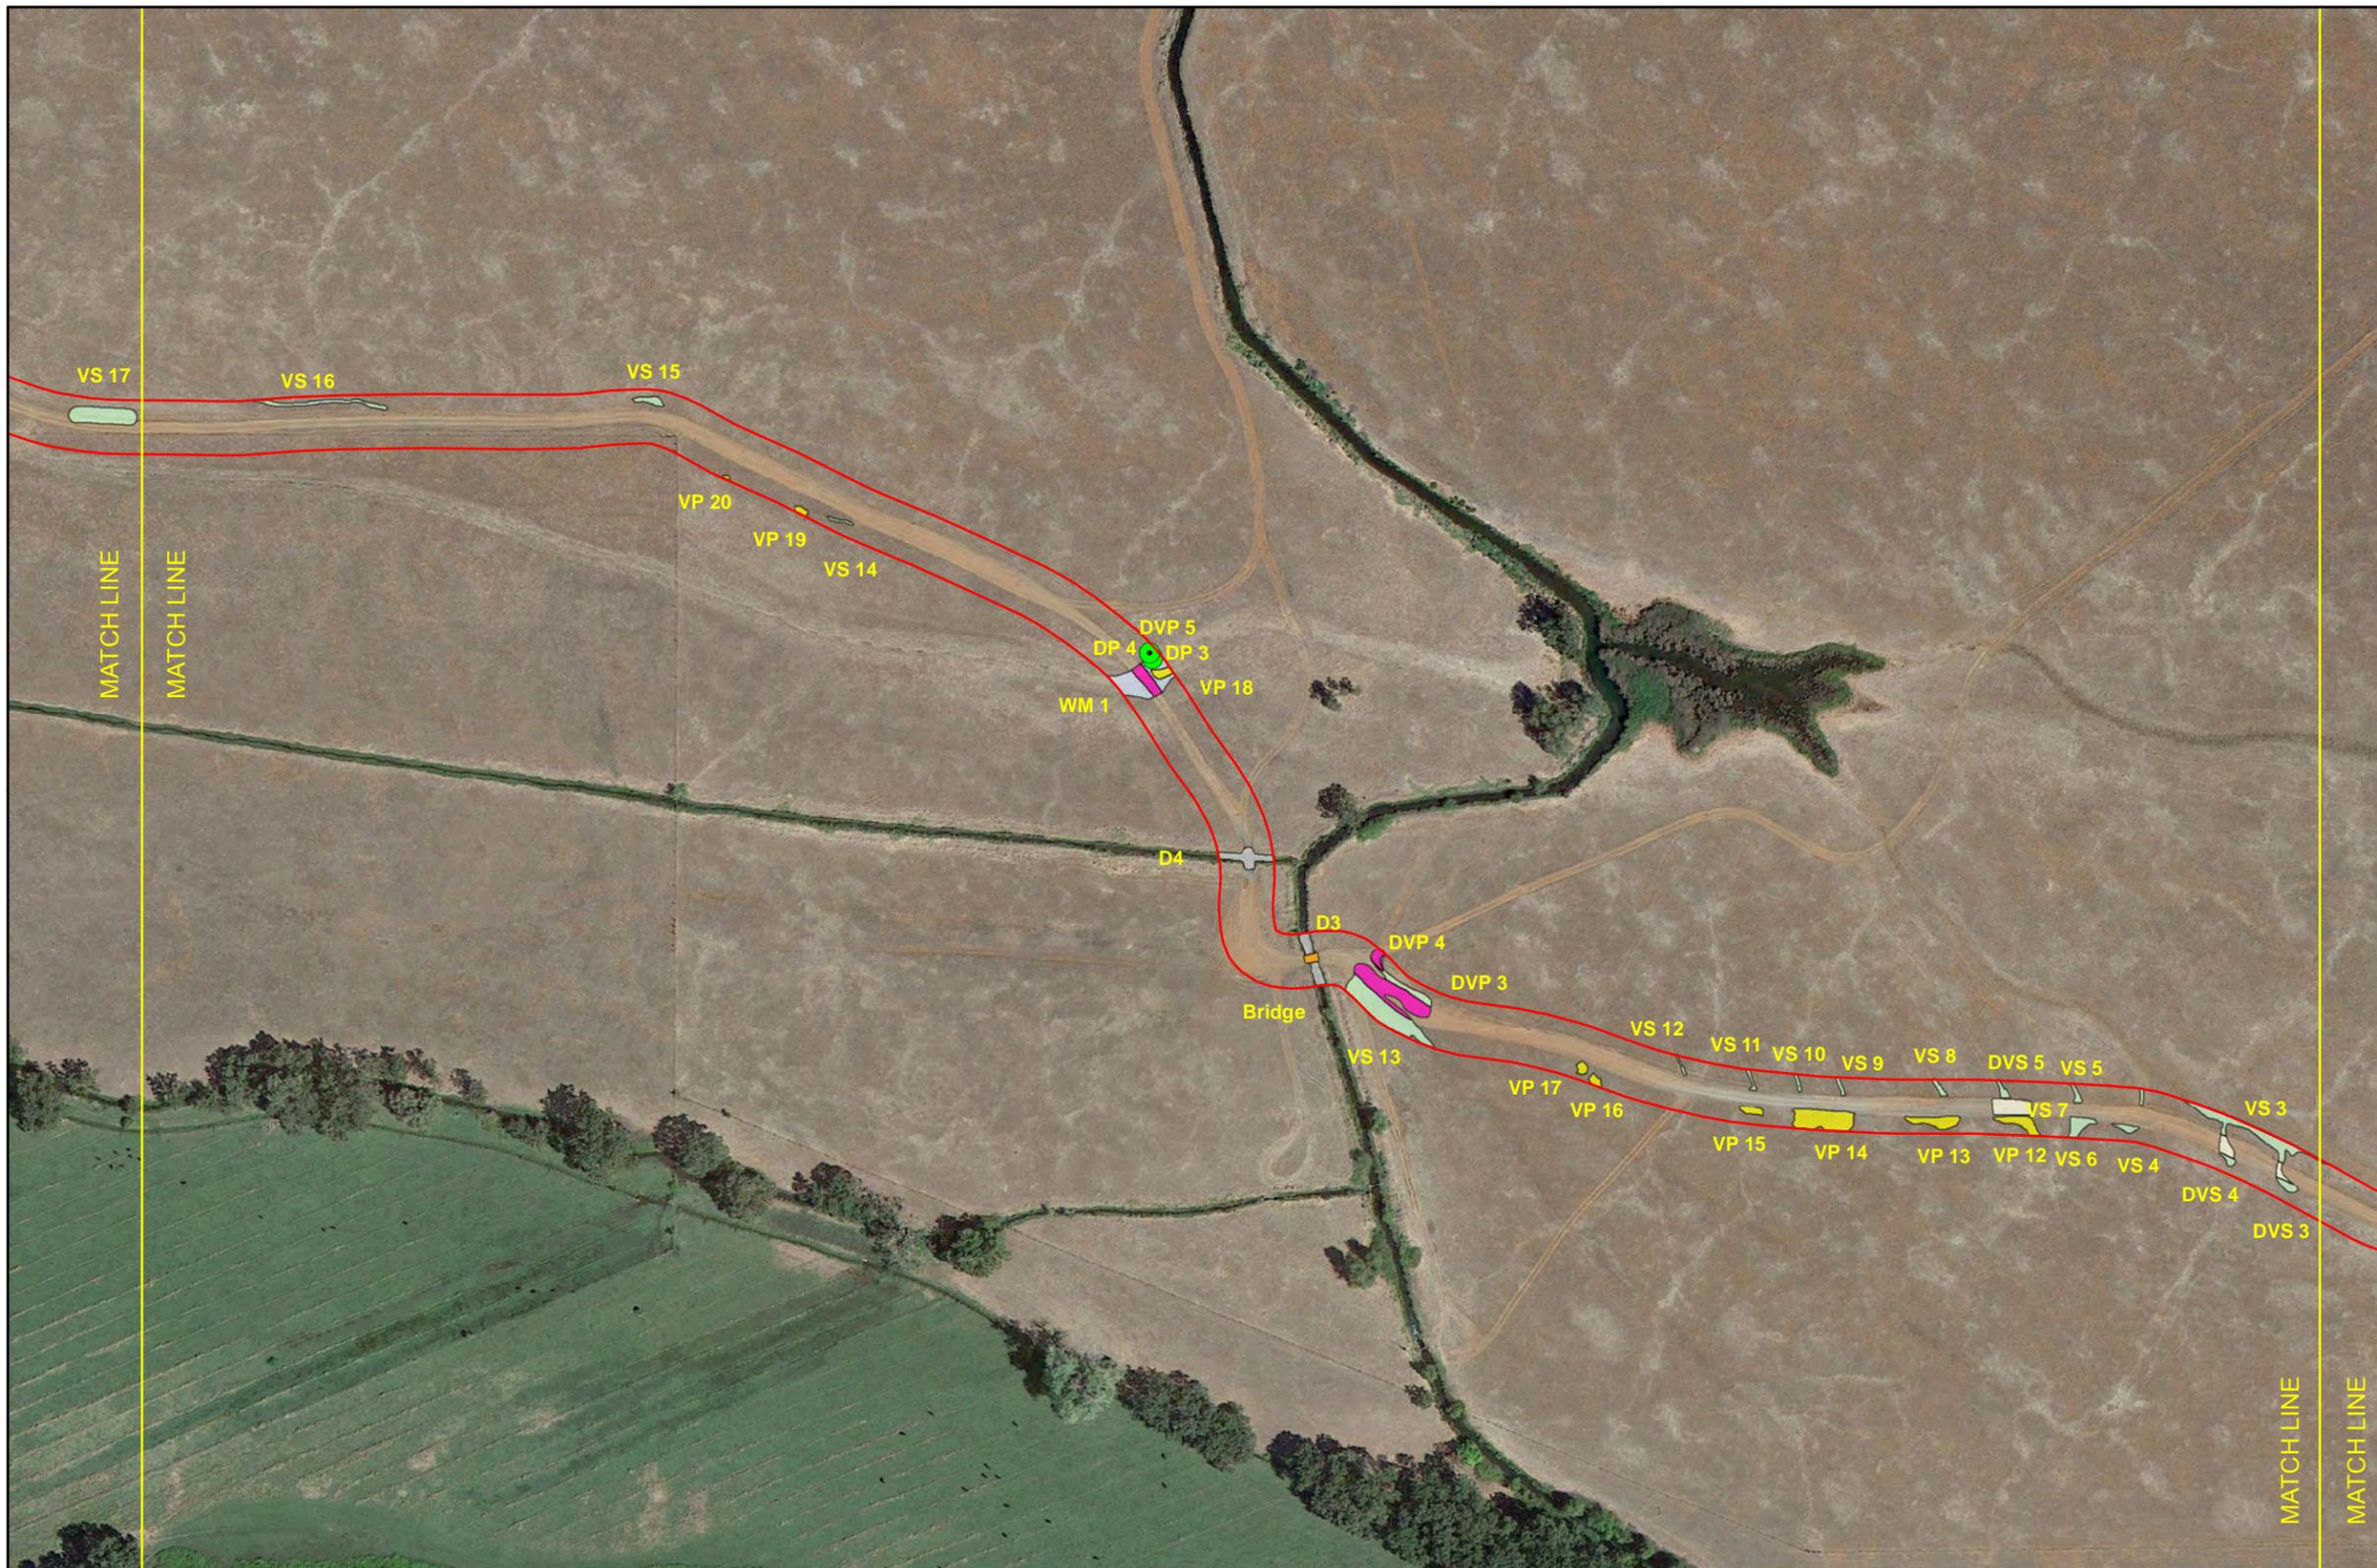
FIGURE 9
Preliminary Delineation Map
Upper Dam

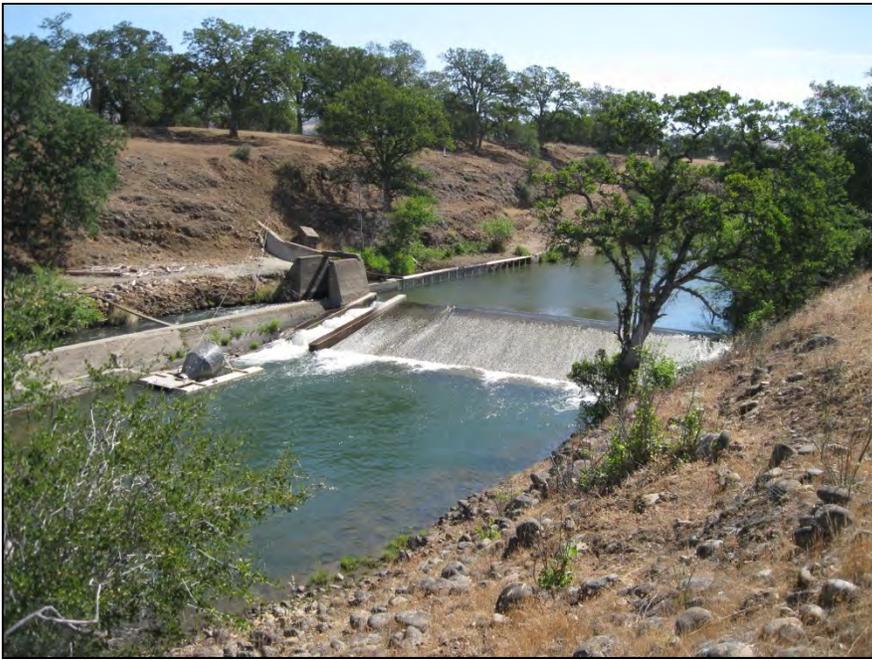
Photo 1. View of the Upper Dam, looking northeast. Photo date: May 22, 2014.

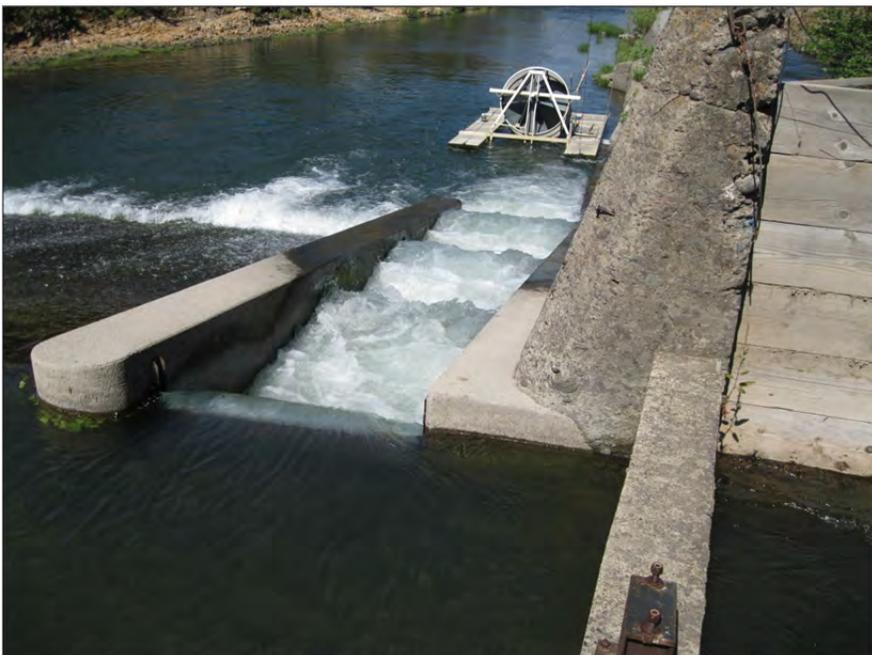
Photo 3. View of the fish ladder located on the north side of the Upper Dam, looking southwest. Photo date: May 22, 2014.

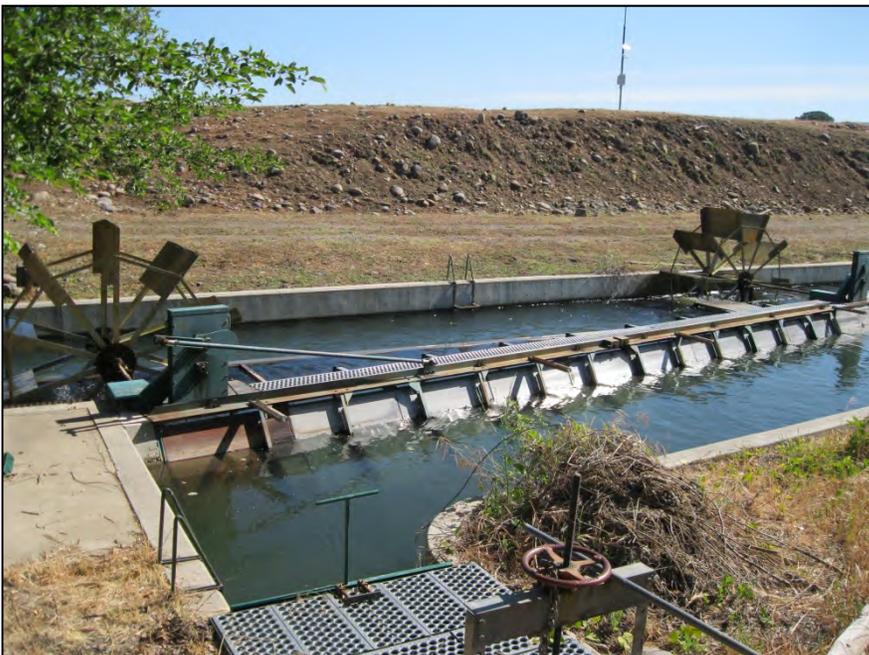
Photo 6. View of Upper Dam fish screen in downstream irrigation canal, looking northeast. Photo date: August 9, 2014.

The Upper Dam diversion has an appropriative water right for 90 cfs. Water from the Upper Dam diversion is conveyed through a constructed canal which has a fish screen. A bypass return pipe allows for some water and any fish entrapped in the canal to return to Mill Creek. Diverted water that is passed through the screen is conveyed through a series of unlined ditches until it reaches a number of LMMWC customers as irrigation and stock water.

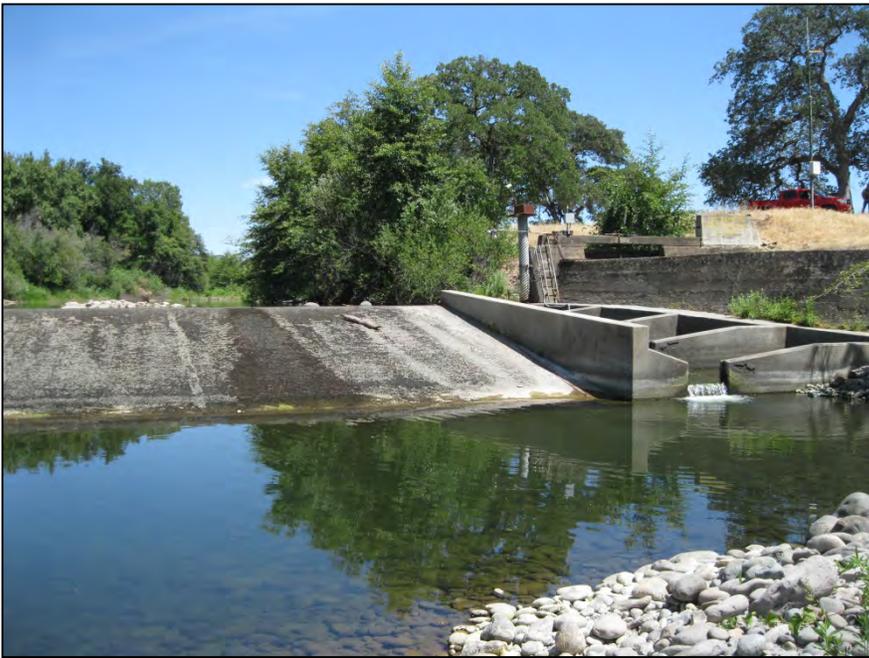
Photo 7. View of Ward Dam and fish ladder, looking southeast. Photo date: June 30, 2014.

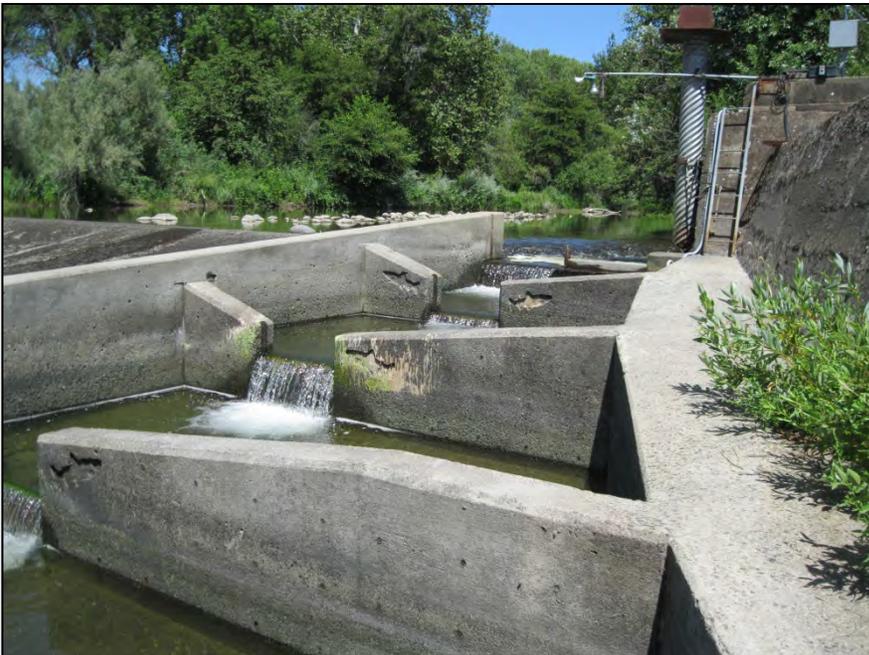
Photo 8. View of fish ladder located on the south side of Ward Dam, looking east. Photo date: June 30, 2014.

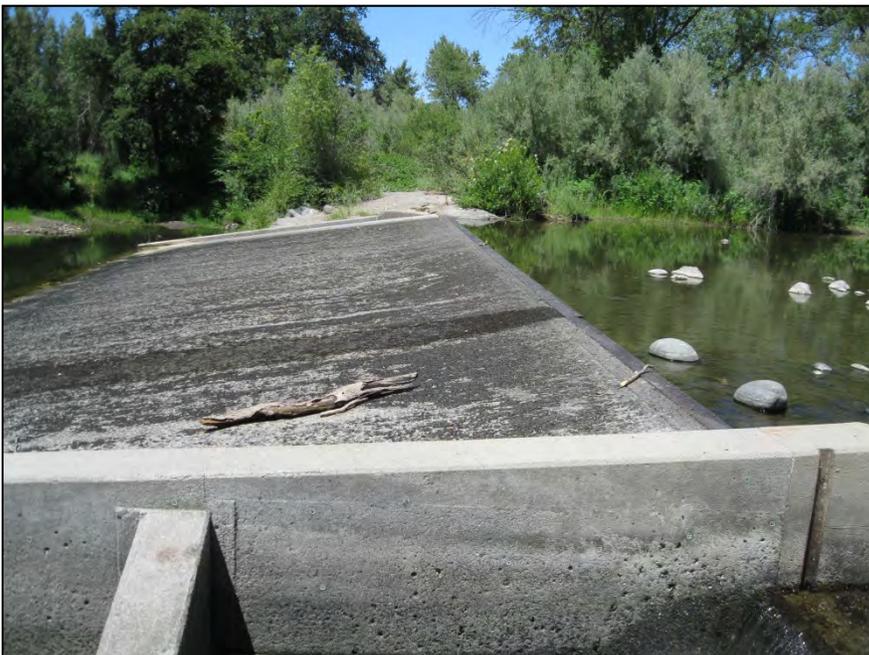
Photo 9. View Ward Dam, looking north. Photo date: June 30, 2014.

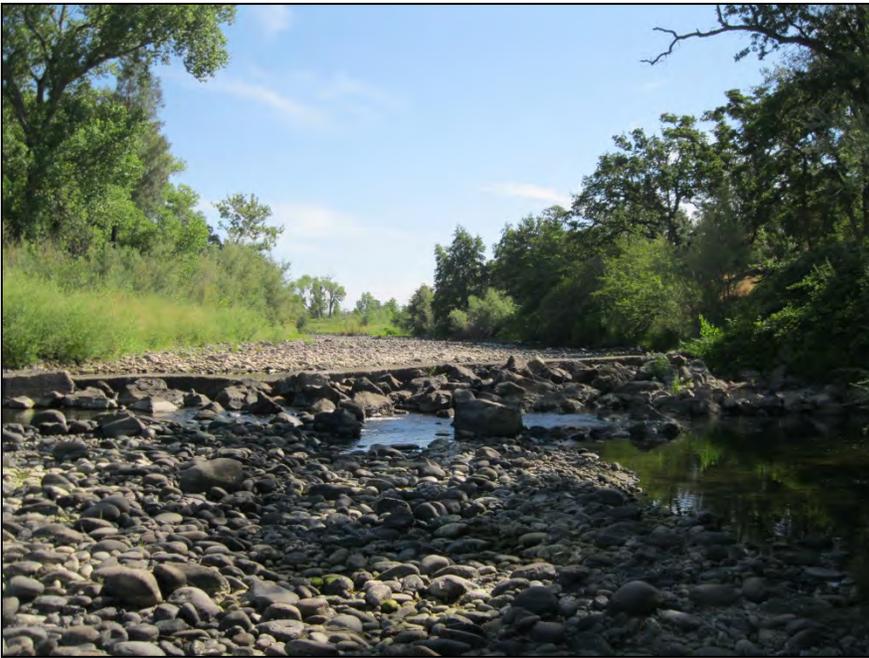
Photo 10. View of Exposed Siphon, looking east and upstream. Photo date: July 1, 2014.

The Exposed Siphon is downstream of the Ward Dam. The Exposed Siphon crosses Mill Creek at approximately 0.5 miles above the Shasta Boulevard Bridge and approximately 4,000 feet downstream from the Ward Dam. The Exposed Siphon is an underground pipe with a concrete cap which was exposed during a large flood event. The concrete cap is now about two feet higher in elevation than the channel bed elevation. A scour hole downstream of the Exposed Siphon near the south bank, formed as a result of the skewed alignment of the exposed pipe and concrete cap, directs flows towards this bank.

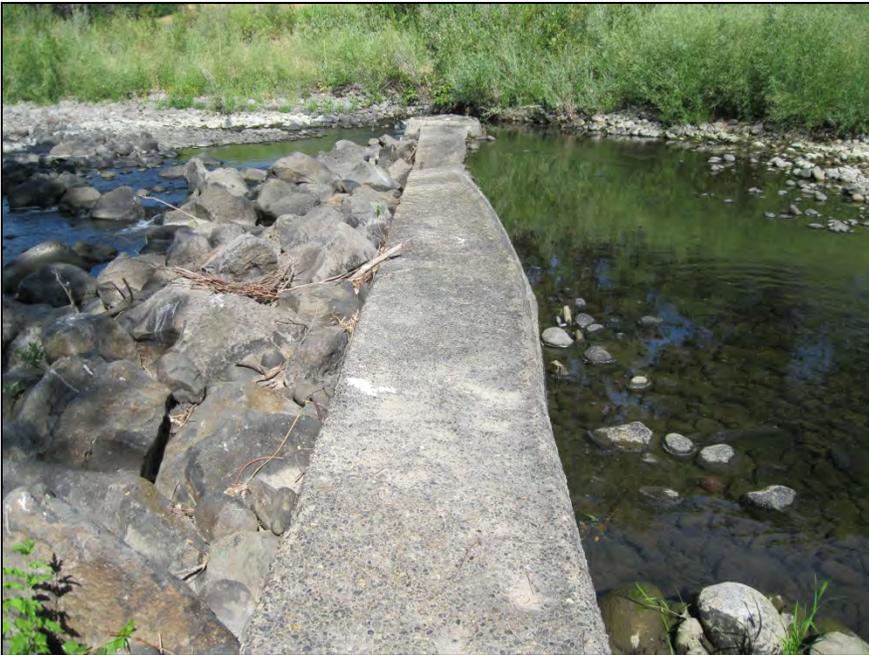
Photo 11. View of siphon cap, looking from south bank to the north bank of Mill Creek. Photo date: July 1, 2014.
