**COLORADO RIVER RECOVERY PROGRAM
FY-2011 ANNUAL REPORT**

Project 146

Stationary PIT detection system in the Maybell Canal, Yampa River, CO

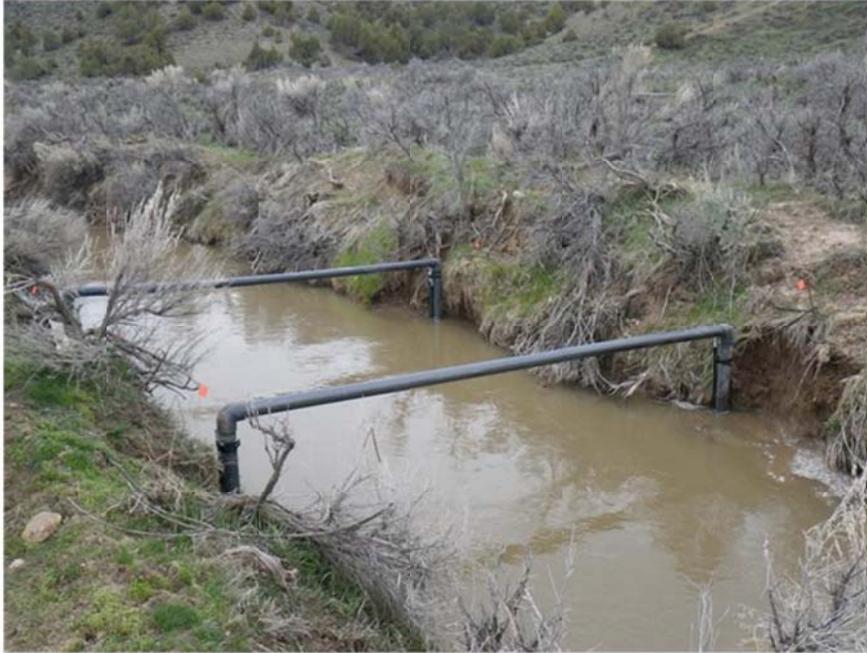
Figure 1. Passive PIT detection system antennas in the Maybell Canal near Maybell, CO immediately following installation on April 21, 2011.

Principle investigators installed the PIT system on April 20-21, 2011. Personnel from CSU assisted with the installation and were briefed on the system's operation and minor operation and maintenance tasks. The system consists of two 4' x 16' rectangular antennae loops housed in schedule 80 PVC pipes which are installed upright in the canal and anchored to the canal streambed with duck-bill anchors and to the canal's banks with t-posts and webbing (Figure 1). The antennae are operated with a Destron-Fearing FS1001M multiplexing PIT reader, and the entire antennae system is powered by two 160 Watt solar panels with a 256 amp hour battery bank. This configuration affords continuous operation for 5 days without solar input. The system is monitored remotely by satellite uplink, which allows data downloads as well as system diagnostics to be performed. All electronics are enclosed in a locked steel job box and together with the solar panels is fenced with barbed wire to exclude cattle (Figure 2).

When the canal began flowing on May 2nd, we visited the site to evaluate the physical configuration of the antennae and remove debris entrained on them by the initial pulse of water. We reconfigured the antennae from "hybrid" positions (i.e., deployed at an angle with only the bottom antenna beam anchored) to an upright, "pass-through" configuration that would pass any additional floating debris. On June 8, we received a report that the extreme upper portion of the Maybell Canal had been breached by high water. To evaluate any potential impacts to the system, Peter Mackinnon visited the system on that day but reported no impacts to the system or the job site. Colorado State University personnel visited the system in September 2011 to inspect the system and reported no or minimal damage due to cattle encroachment, debris entrainment in the canal or erosion. They straightened up cables, rebar and other components, but otherwise reported that the system appeared much as it did immediately following installation.

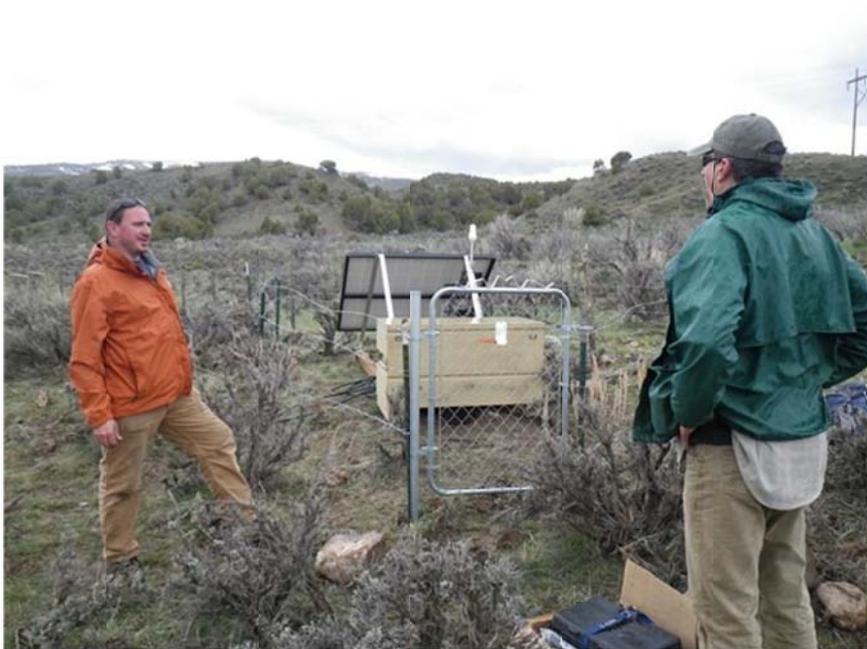
Figure 2. Electronics enclosure and solar panel array for Maybell PIT system.
