ANNUAL REPORT
2007
Roosevelt Habitat Conservation Plan
Salt River Project

**U.S. Fish and Wildlife Service
Arizona Ecological Services Field Office
2321 W. Royal Palm Road, Suite 103
Phoenix, Arizona 85021-4951**

**Salt River Project
Environmental Services Department
Siting and Studies
PAB 352
P.O. Box 52025
Phoenix, Arizona 85072-2025**

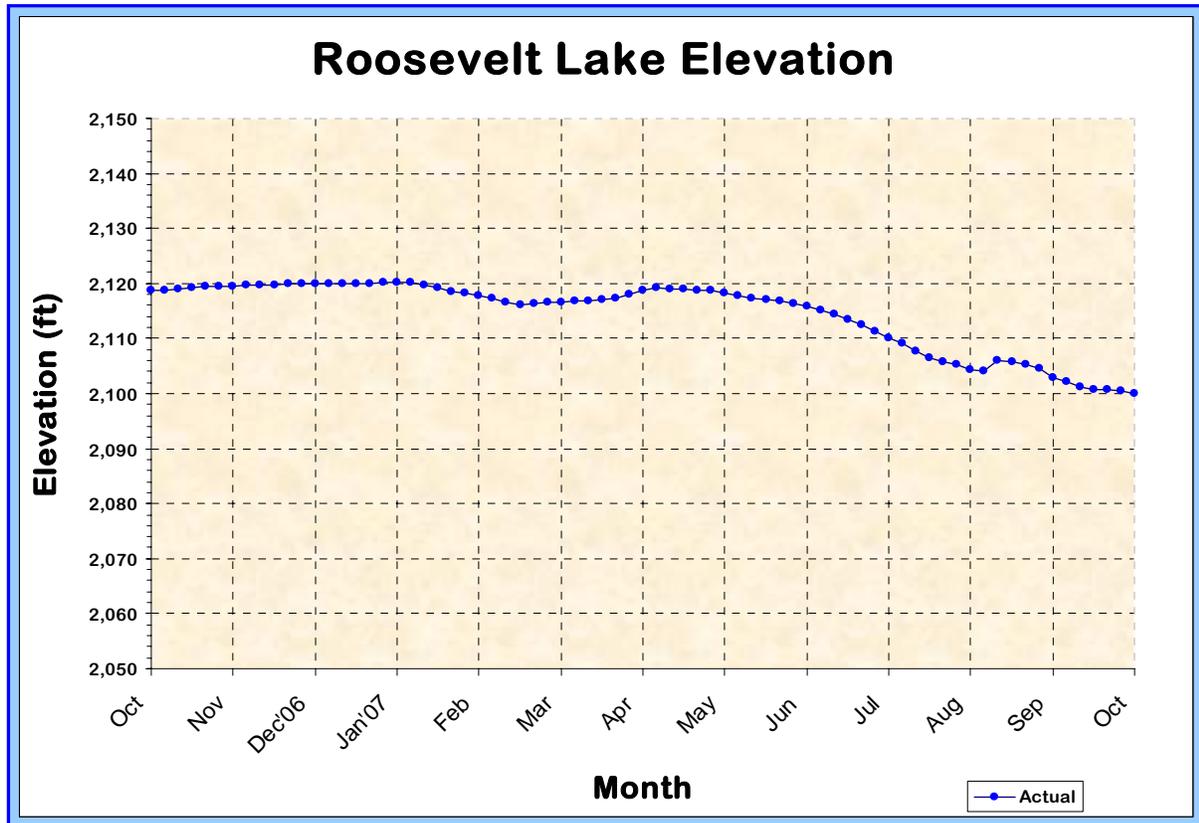
Figure 1. Roosevelt Lake elevations, October 1, 2006 through October 31, 2007.

No fill event occurred in 2007 and lake elevations remained well below the 2151' level. Lake elevations fell from 2118' at the beginning of the breeding season to a low of 2104' in early August (see Figure 1). Lake levels are still well above the lows experienced in 2002 when the water elevation fell below 2040' (see Figure 2).

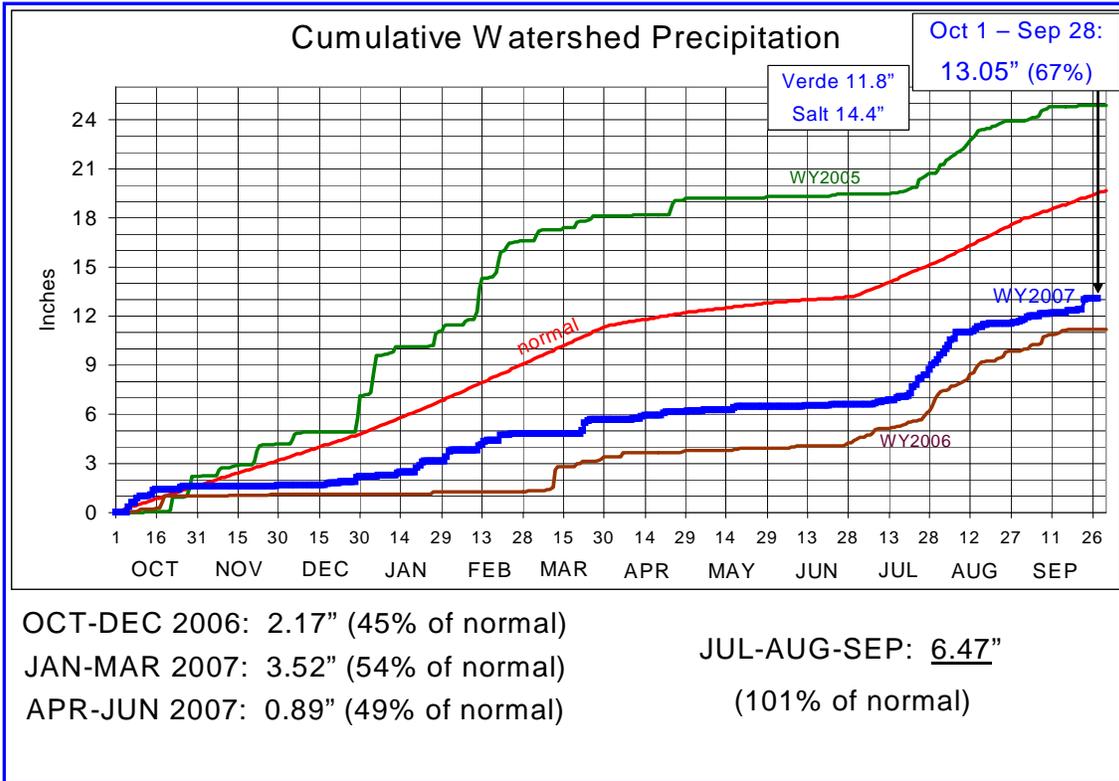
Figure 3. Cumulative Salt and Verde watershed precipitation, Oct. 2006 through Sept. 2007.

Sea surface temperatures across the Equatorial Pacific during the Fall of 2006 were warmer than normal indicating that the Southern Oscillation was in a weak-to-moderate El Nino phase going into the Winter of 2006/2007. Although this condition is typically associated with normal-to-above normal precipitation across the Southwestern United States, several strong storm systems tracking over the region from December through March failed to produce even half the normal seasonal precipitation total on the Salt/Verde Watershed. Several of these systems brought some of the coldest air to Arizona that has been observed in decades, but available moisture in the region remained limited throughout the winter and resulted in much less widespread, significant precipitation during their passages than might otherwise be expected. For the December 1, 2006, through March 31, 2007 period, the Verde side of the watershed averaged an accumulation of only 3.54" or 43% of normal, whereas the Salt side, which experienced slightly more productive storms, received 4.55" or 55% of normal to bring the combined watershed average accumulation to 4.03" or 48% of normal.

Although westerly flow aloft over the Southwestern United States began to weaken during late June and early July, a reversal in the prevailing wind direction aloft from west to east waited until mid-July to occur in earnest. Only limited amounts of moisture flowed into Arizona during the first half of July, but deep sub-tropical moisture followed the change in the prevailing wind direction and set the stage for widespread thunderstorms and significant precipitation in Arizona during late July and early August. A watershed average accumulation of less than a half inch from June 1 through July 21 was followed by an average accumulation in excess of 4" from July 22 through August 7 when the season's first "break" was initiated by the return of deep westerly flow to the region. Although easterly winds aloft returned by mid-August, the pattern was not persistent enough to re-establish a deeply moist flow into Arizona before westerly flow aloft regained its dominance in early September. Incursions of moisture associated with decaying tropical cyclones interacting with disturbances in the westerlies led to a couple of episodes of widespread, significant precipitation during September which brought the June-September average watershed accumulation up to 6.49" or 94% of the normal for this time frame. For the water year, October 1, 2006 through September 30, 2007, the Salt/Verde watershed average accumulation was 13.05" or 67% of normal (see Figure 3).

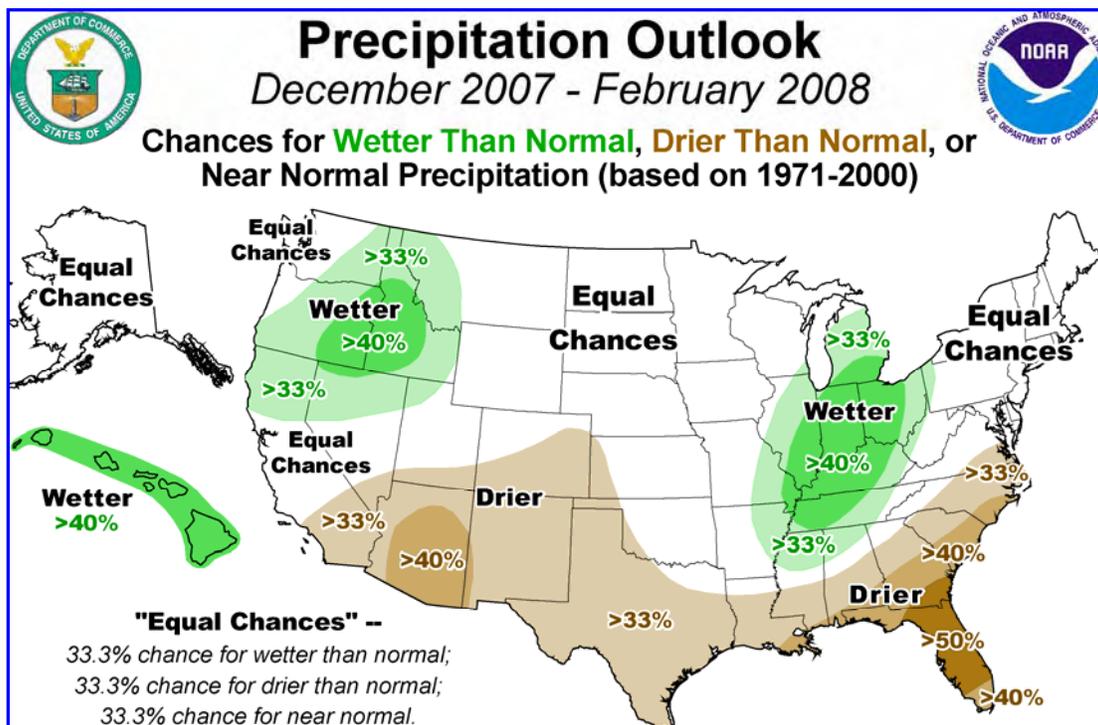
Figure 4. Precipitation outlook for the United States, December 2007 through February 2008

The Climate Prediction Center of the National Weather Service believes the current weak-to-moderate La Niña will persist through the winter. The odds continue to favor a drier than normal winter for the Valley and the watershed; for December 2007 through February 2008, a greater than 40 percent chance of drier than normal conditions exists (see Figure 4).

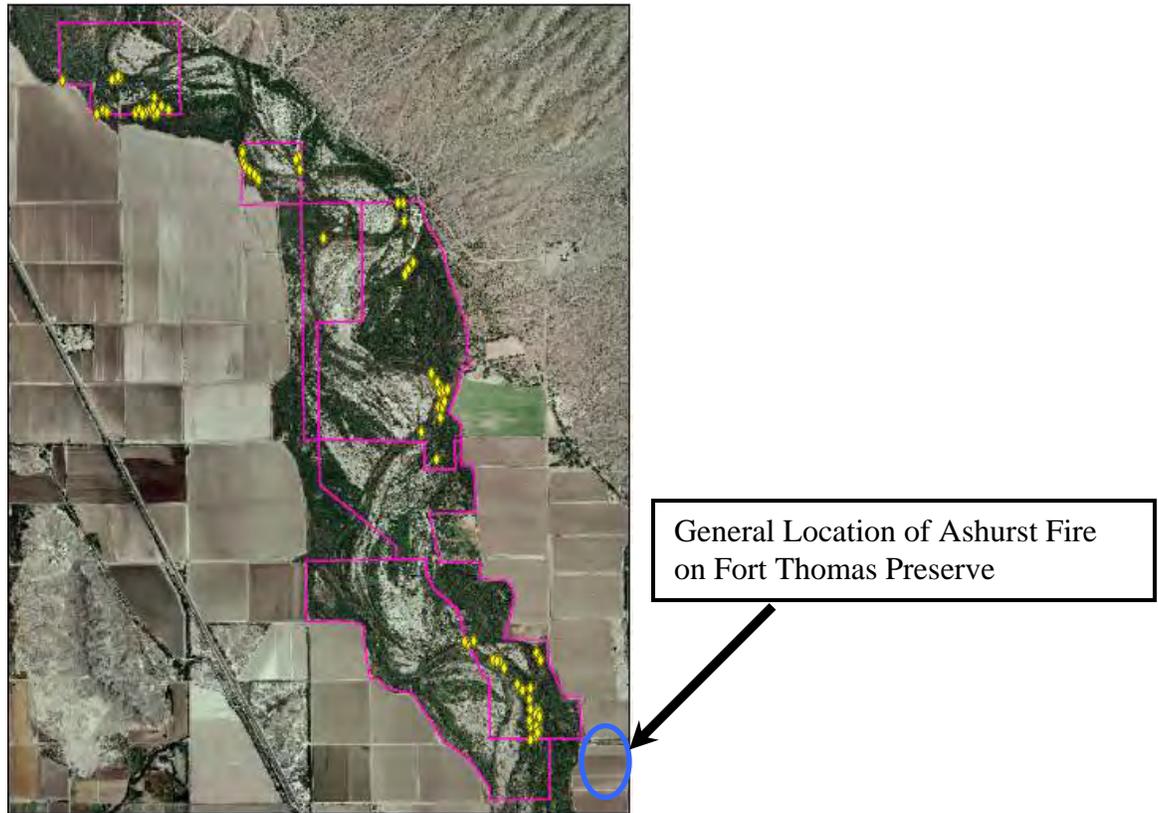
Figure 9. Aerial photograph showing boundary of Fort Thomas Preserve and general location of the Ashurst Fire.

Wildfire Abatement: On May 31, 2007, a fire broke out on the USBR Hancock parcel of the Fort Thomas Preserve. The Ashurst Fire, as it came to be called, burned about 18 acres of suitable flycatcher habitat, including one territory (see Figures 9 and 11). There was a delay in response to this fire because the local, state and federal agencies did not have updated maps showing current federal ownership. The Fort Thomas fire crew responded to the fire on May 31, but they are trained in structure fire response rather than wildfire and assumed the fire was out. Fortunately, Ecoplan's biologists were on site early morning on June 1st and

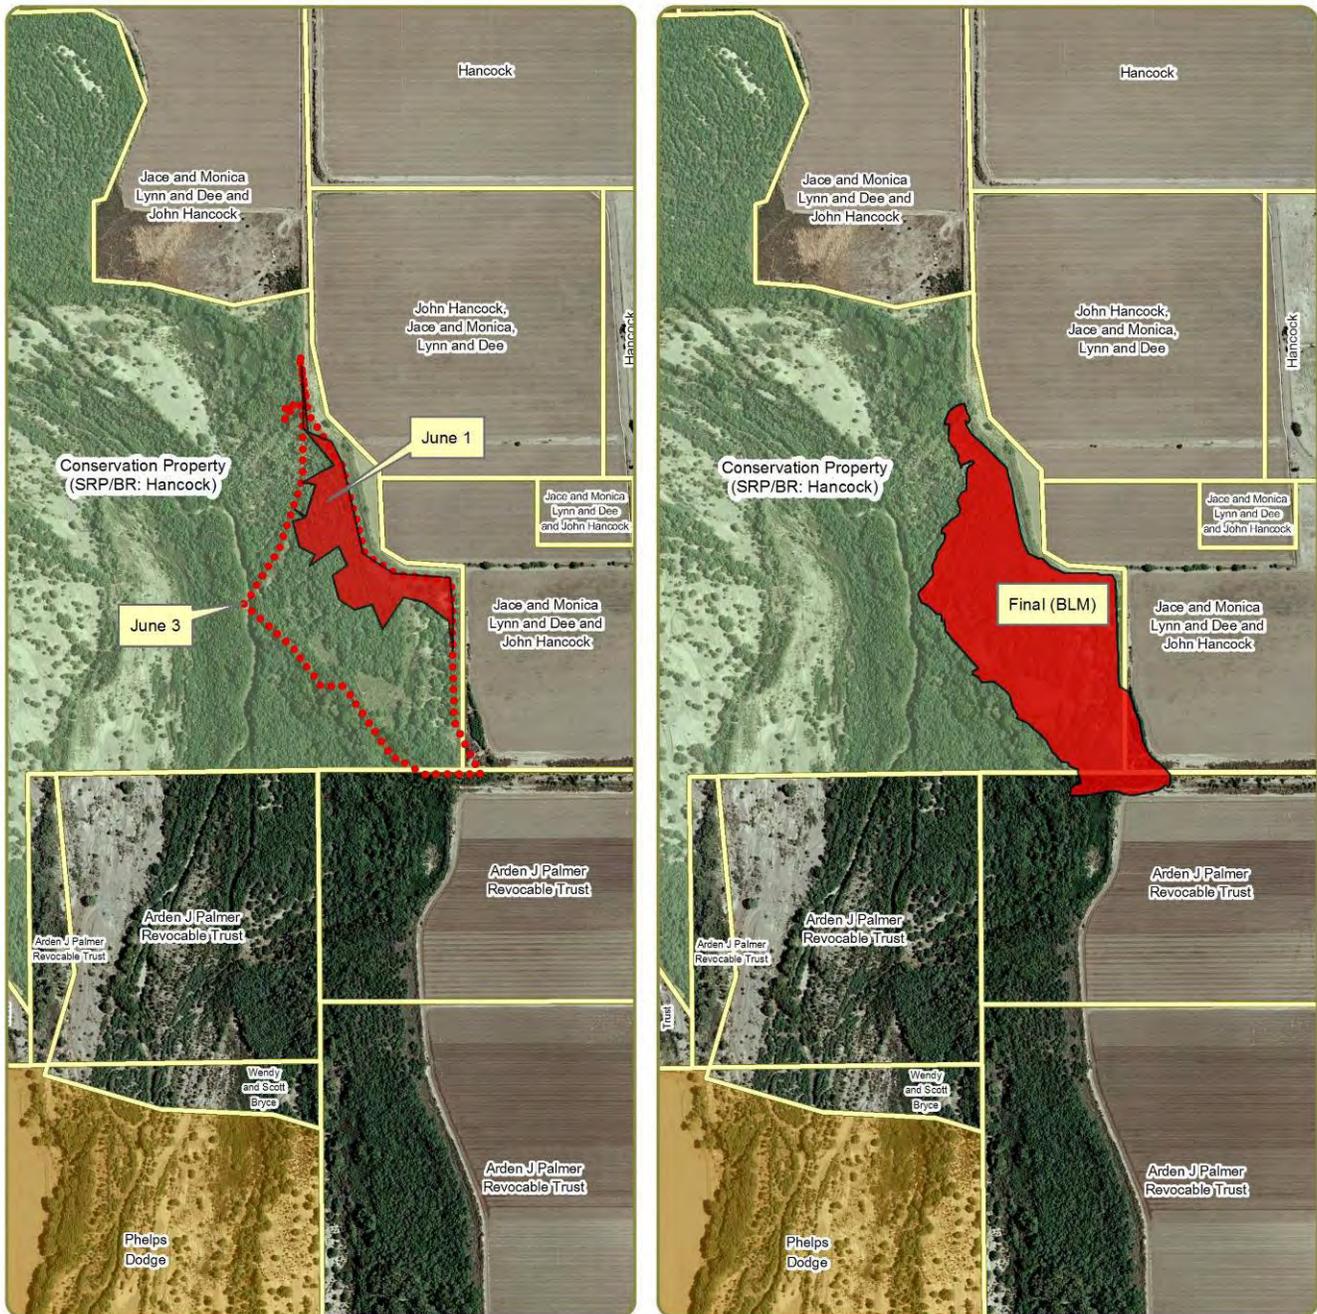
ASHURST FIRE PERIMETERS - FORT THOMAS MAY 31- JUNE 2 2007

EcoPlan Field Crew June 1, June 3 2007
 June 1: 4.4 acres
 June 3: 17.4 acres

BLM Final Fire Track June 2 2007
 June 2: 18.6 total acres

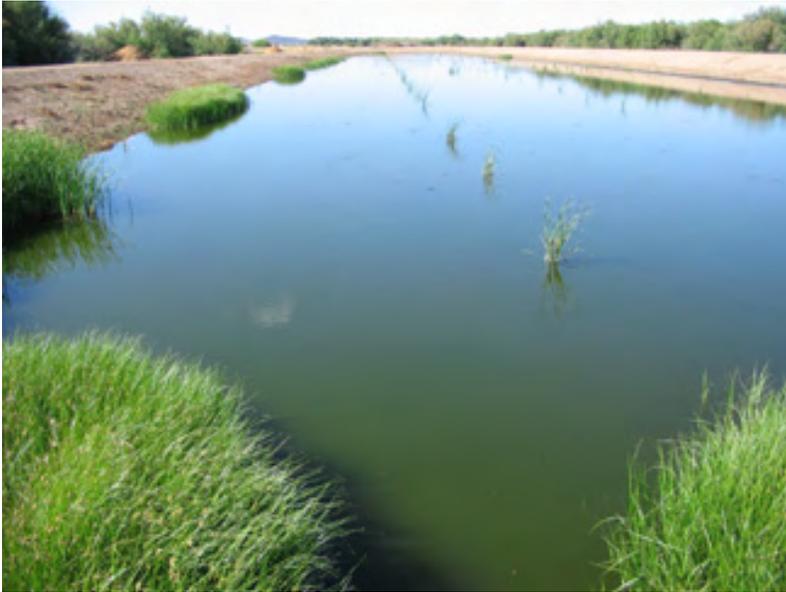
Figure 12. Arlington Wetland taken April 24, 2007

Action: Clapper rail habitat at SRP's created wetland at the Arlington WMA site is still developing (see Figures 12 through 15). However, AGFD and Audubon have been monitoring their populations at this site for a number of years. SRP will continue to coordinate with AGFD on monitoring of clapper rails and marsh conditions at the Arlington site.

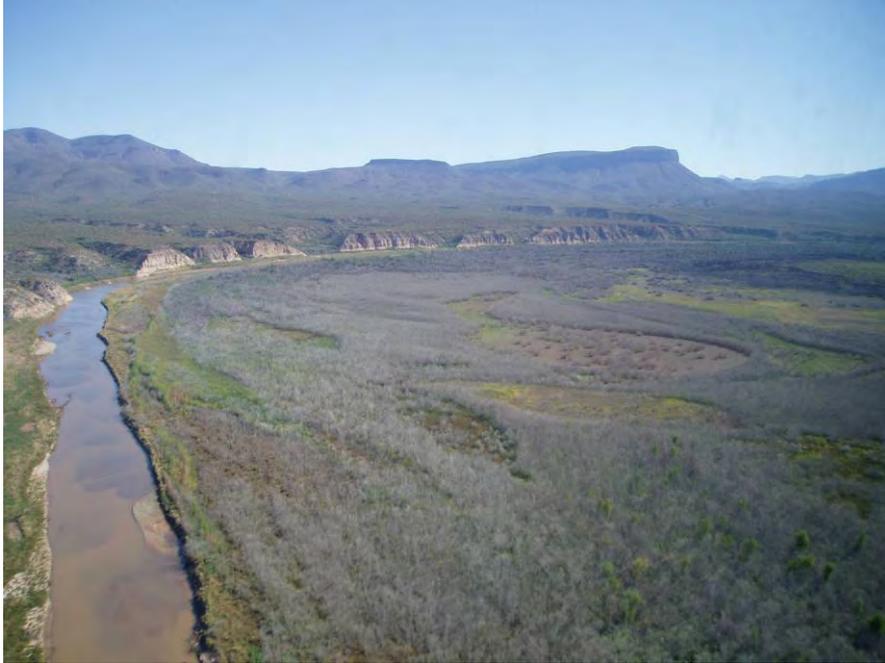
Much of the mature tamarisk that was inundated in 2005 is dead, especially on the Salt River arm. However, dense stands of young Goodding’s willow and tamarisk were observed on newly exposed sediment on both the Tonto Creek and Salt River arms (see photographs in Appendix C). Soil moisture remained high throughout the summer in areas that were recently exposed by falling reservoir levels, thus helping to support riparian vegetation there. The type of vegetation that survives into the future will depend on whether the lake rises or falls, with rising levels favoring willow and falling levels favoring tamarisk.

Dead tamarisk at Salt River Inflow “Campaign Bay.” Photo taken October 11, 2007.

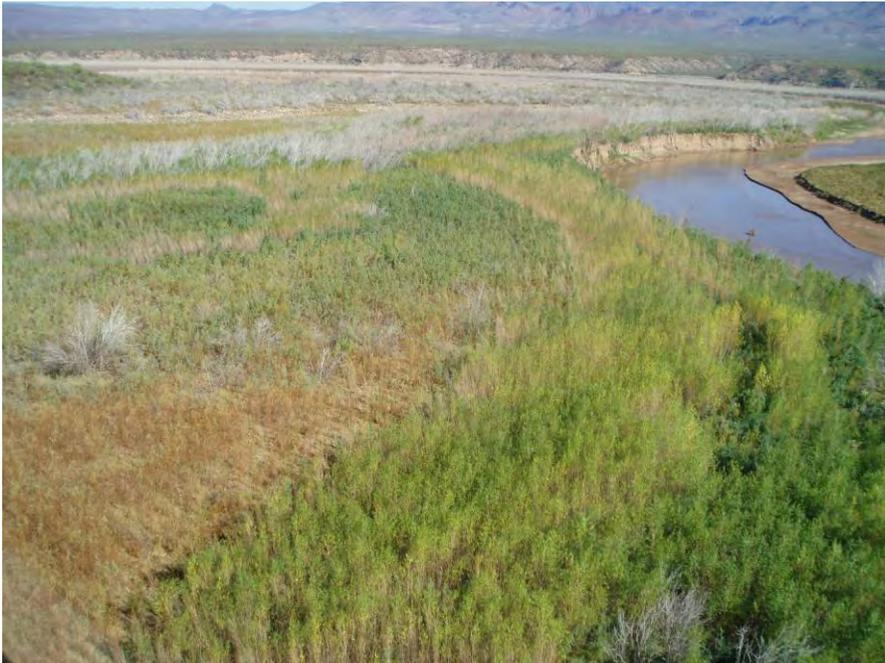
Young willows at Salt River Inflow “Schoolhouse Point South, Location 1.”

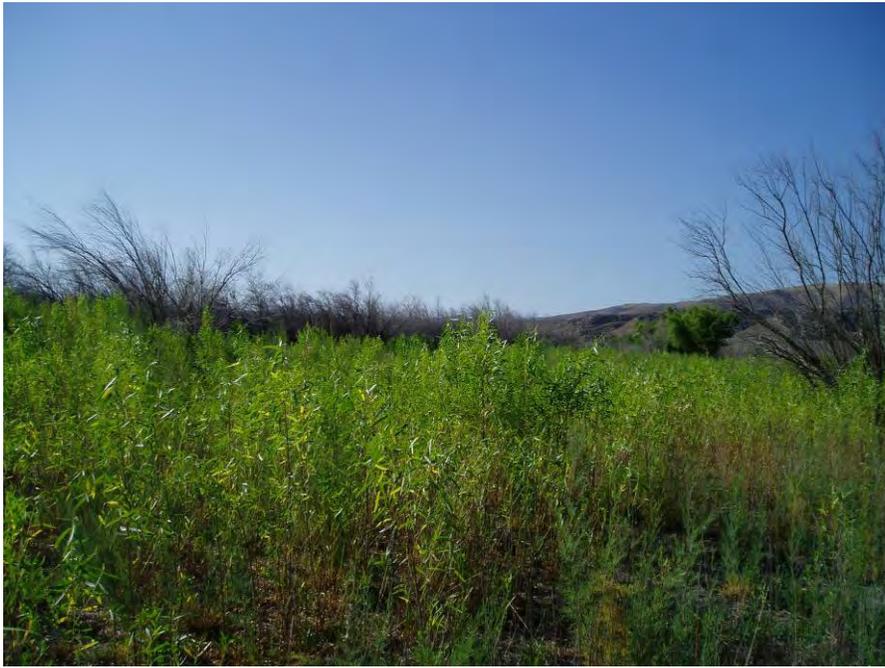
Stand of young Goodding's willow, Tonto Creek Inflow "The Condos" breeding area.
Taken at AGFD's photo point 2B on June 12, 2007.

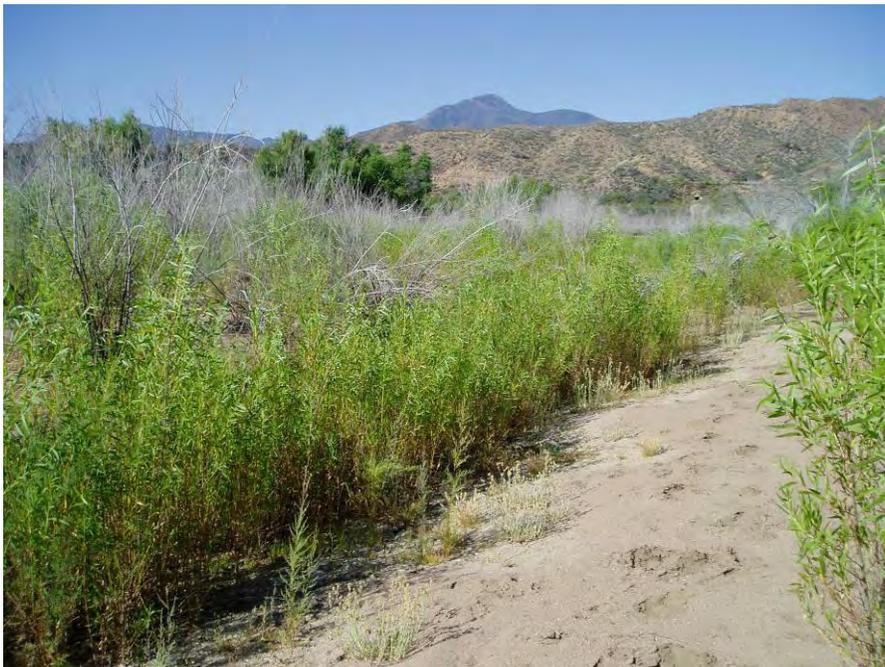
Stand of young Goodding's willow and tamarisk, Tonto Creek Inflow.
Taken at AGFD's photo point 3A on June 12, 2007.

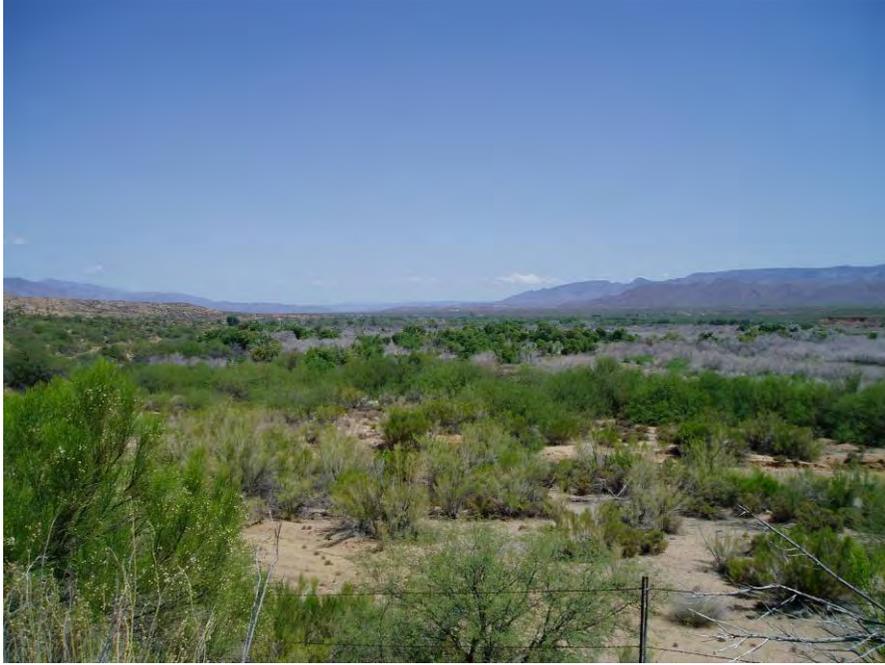
Tonto Creek Inflow looking upstream toward “The Rookery” and “The Condos” flycatcher breeding areas. Photo taken at AGFD’s photo point 1A on June 12, 2007.

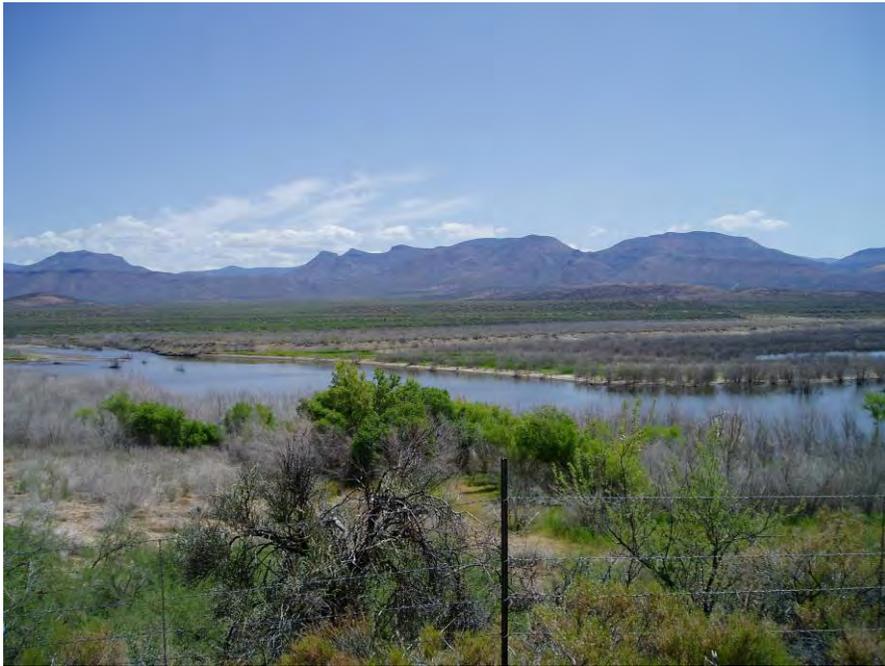
Tonto Creek Inflow “Orange Peel Campground” flycatcher breeding area. Photo taken at AGFD’s photo point 12A on June 12, 2007.

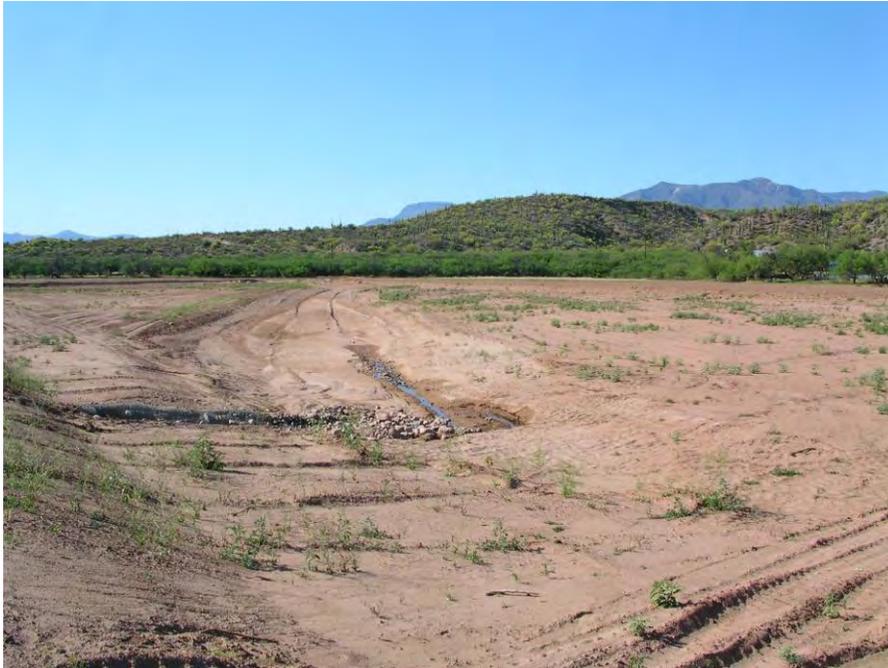
Rockhouse Photo Point Record
Photo Point 5- View 2

May 3, 2004

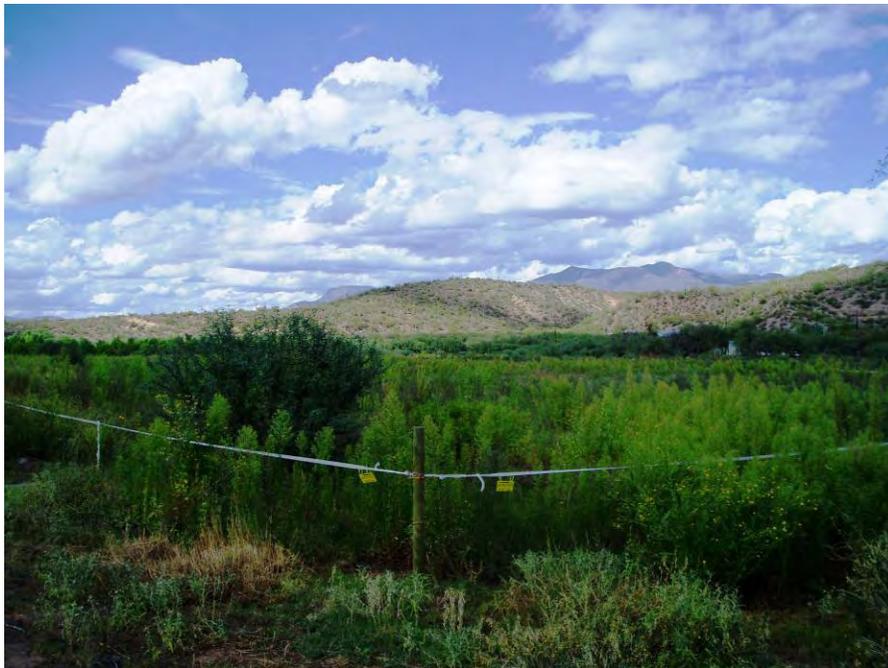
October 4, 2007
