Results from the Cottonwood Creek video station for years 2007-2011 for fall-run Chinook salmon escapement

By
Douglas Killam and Kate Merrick
California Department of Fish and Game
Red Bluff Fisheries Office

RBFO Technical Report No. 01-2012

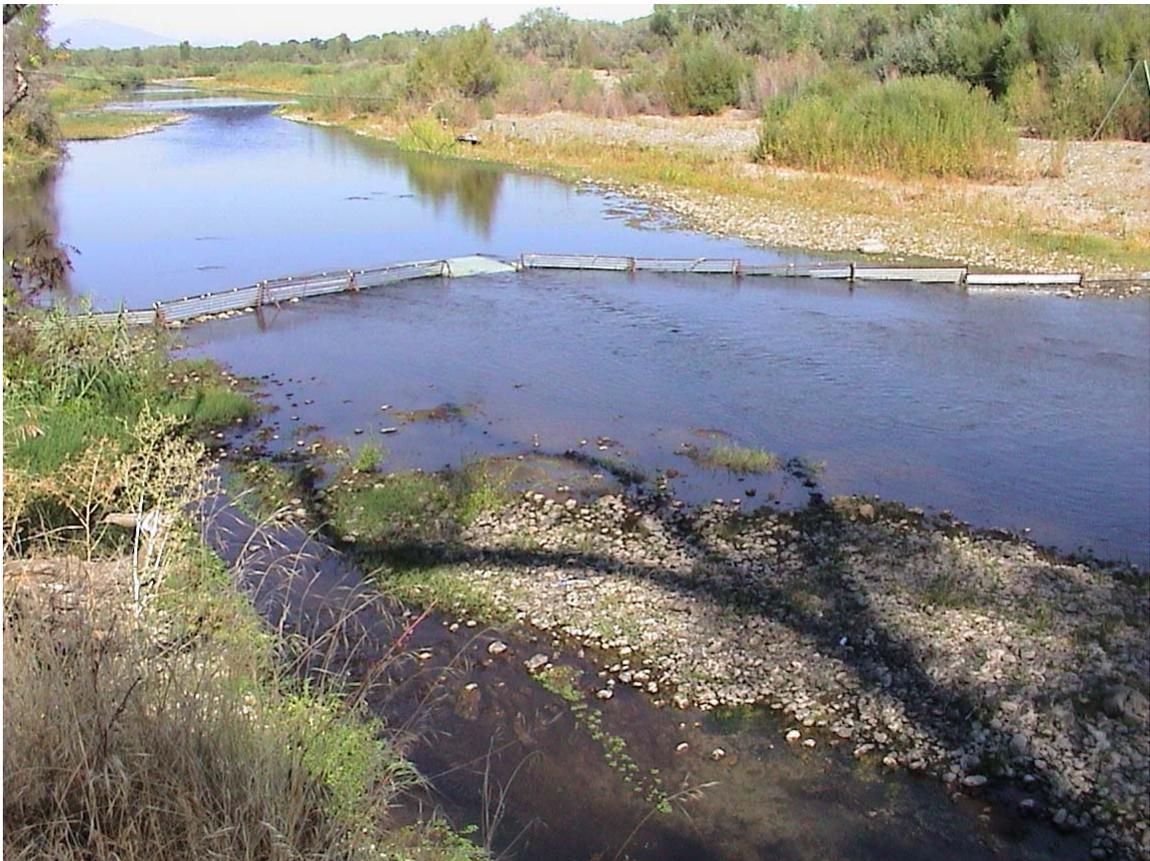
Cover Photo: Image of Cottonwood Creek Video Station in 2009

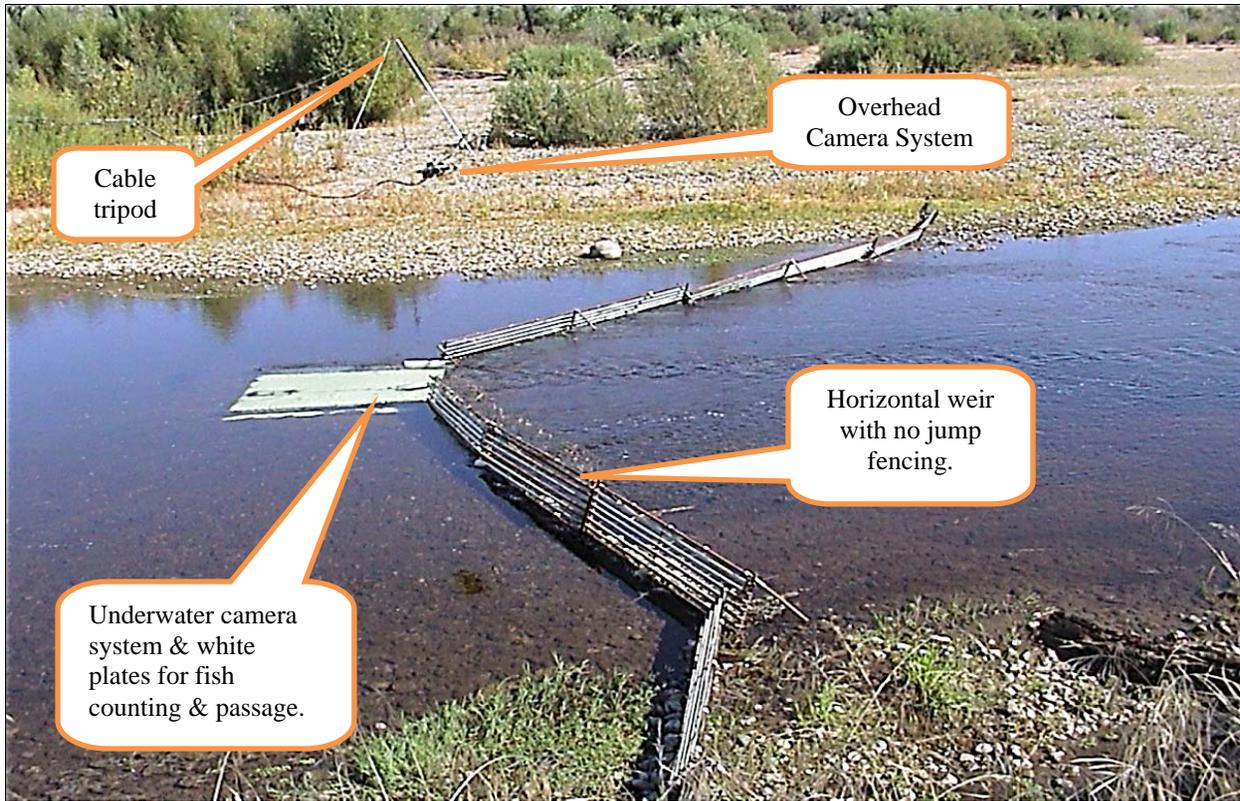
Up to four white, high-density polyethylene (HDPE) plates, measuring ¼-inch thick x 5 x 10-feet (6 mm x 1.2 m x 3 m) were staked to the creek bottom below the overhead camera to create a white background for better visibility of passing fish. The plates overlay each other slightly and have ¾-inch (1.9 cm) holes drilled around the perimeters to allow staking and a metal strip, also with holes, and measuring ¼-inch thick and four-inches wide (6 x 100 mm) is bolted to the upstream edge of all plates prior to placement in the creek to assist in installation and anchoring. Concrete form stakes, of various lengths with a two-inch (5 cm) washer welded to their tops were driven through the holes and into the stream bottom to secure the plates to the bottom. Components of each year’s weir setup are shown in Appendix Table A1. Prior to 2010 two plates were used and provided a 10 x 10 foot (3 x 3 m) viewing area for monitoring salmon.

Figure 2. The 2009 Cottonwood Creek video station with camera box, lights, weir, and passage opening with white plates visible.

In 2010 three plates were used to create a 15 x 10 foot (4.6 x 3 m) viewing area. In 2011 four plates were laid end to end in a 5 x 40-foot (1.5 x 12.2 m) design to allow higher flows to pass the video station without impacting the weir.

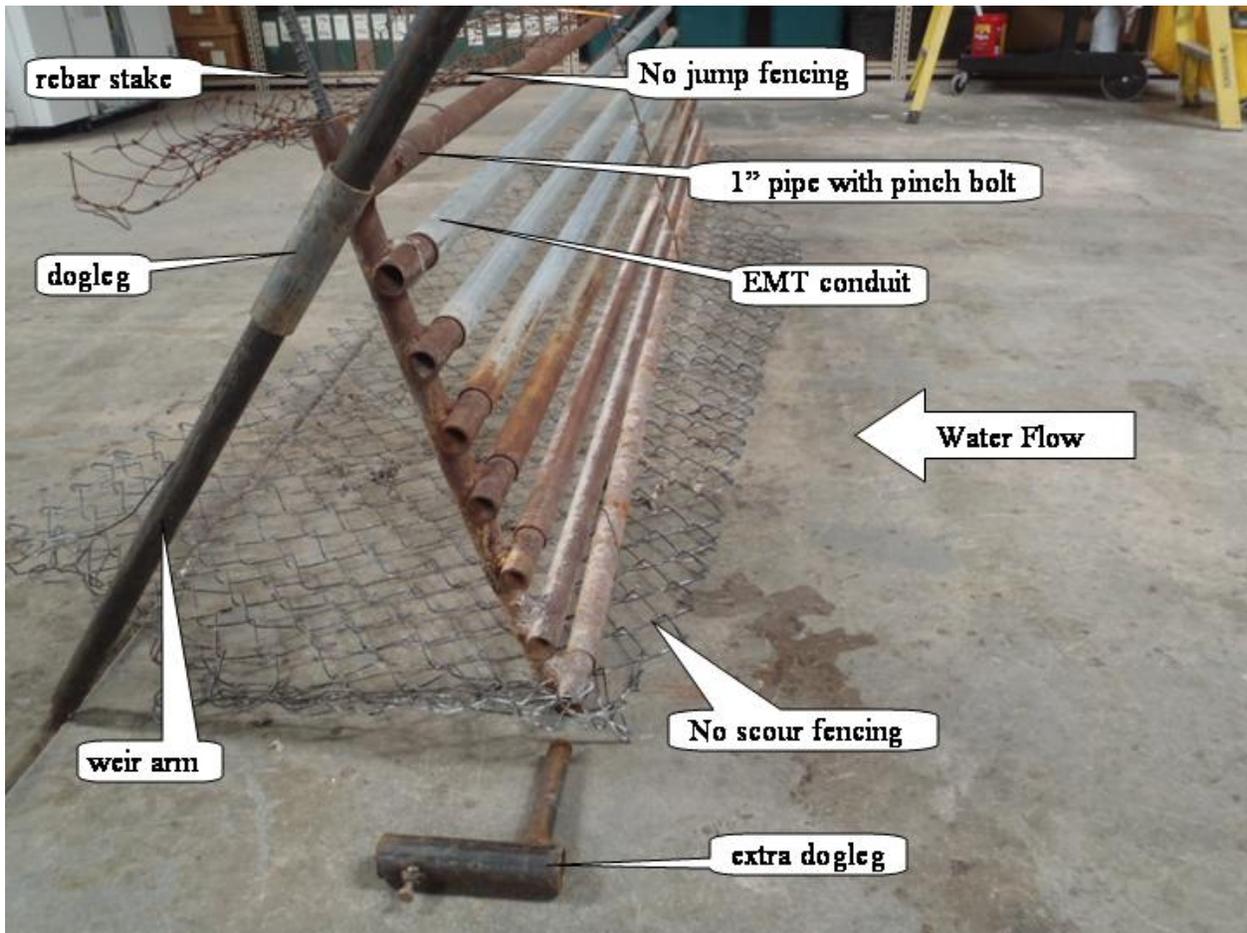
In sandy areas or areas susceptible to undercutting, a three-foot wide (0.9 m) chain link fencing, or other suitable fencing material underlay the weir panels to prevent scour during high flows. The weir bottom fencing was situated so that about six-inches (15.2 cm) of fencing protruded upstream of the weir bottom pipe and the remainder was downstream of the weir. This locked in smaller rocks that could be swept away in higher flows. Two upstream facing weir panels were placed along the outside edges of the white bottom plates just below the water surface to act as guidance panels at the fish passage opening to prevent fish from skirting around the ends of the weir and allow for easier counting. On some weir panels a “no jump” fence was wired along the top of the panel and rested facing downstream (Figure 3) to prevent salmon from jumping over the weir in deeper water. The no jump fence was typically animal pen fencing with two-inch square (5.1 cm²) openings cut to 18-inch (45.7 cm) wide and 10-foot (3.0 m) lengths.

Figure 3. Image of typical RBFO video station weir panel and its components.

The two cables, about 300-feet (91.4 m) each, stretched across the creek and were anchored to a tree and to two large pipe tripods (Figure 3) positioned on each side of the stream. The tripods were constructed from 2.5-inch (6.3 cm) galvanized metal pipes 16 feet in length, and anchored in place using fence posts driven into the ground and cabled to the legs of the tripod. The end of the main cable closest to the DVR-battery box was designed to allow easy movement up and down with a mechanical “come-along” so the camera could be raised or lowered to adjust for proper orientation and when camera maintenance or cleaning was required. During construction the cables and white plates were carefully positioned so that the overhead camera was directly overhead of the downstream edge of the middle of the white plates. Camera height above the plates was about 15-feet (4.6 m) allowing the entire white plate area to be in the field of view of the camera. The camera box was attached by ropes to the cables, which reduced vibration caused by inclement weather. Power cords and camera co-axial cables were wired to the support cables with short plastic coated utility wire and were run from the overhead stream camera box shown in Figure 5 to the station’s electronic lock box seen in Figure 4. In years 2007 through 2010 a single overhead camera was used to record fish passage. In 2011 two overhead cameras were used over a wider opening in an attempt to maximize the size of the opening available for fish passage.

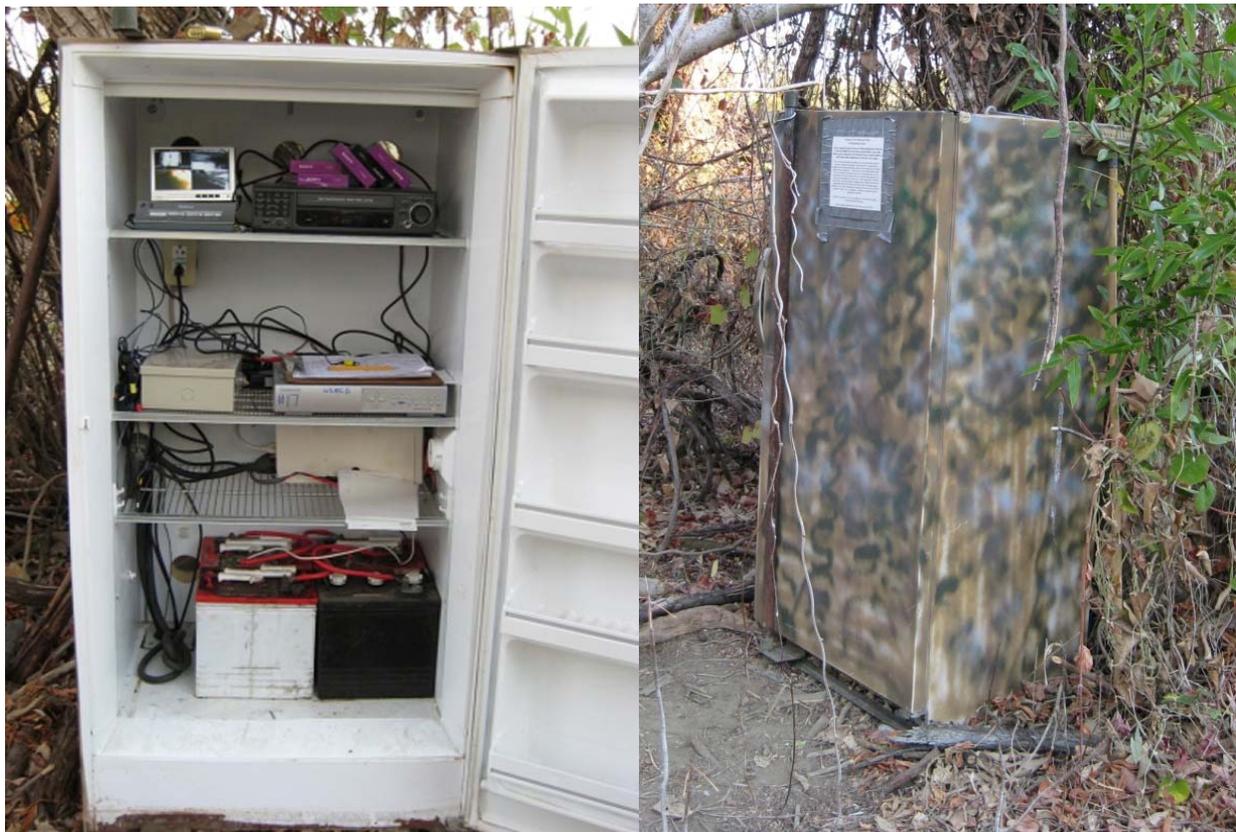
From October 2008 on, DVR’s were used to record data, and were housed in a refurbished locking refrigerator to secure and shelter the station’s video equipment, electrical accessories and batteries as shown in Figure 4.

Figure 4. Image of the camouflaged lockable refrigerator in 2009 containing DVR equipment, TV monitor, power supply and battery backup for the Cottonwood Creek video station.

A back-up power supply was used to provide power for a 1-2 day period should a power outage occur in the regular power supply. The backup power supply consisted of four 6-volt “golf cart type” linked batteries providing a 12-volt direct current (DC) power supply to the UPS to ensure continual video coverage in the event of a power failure.

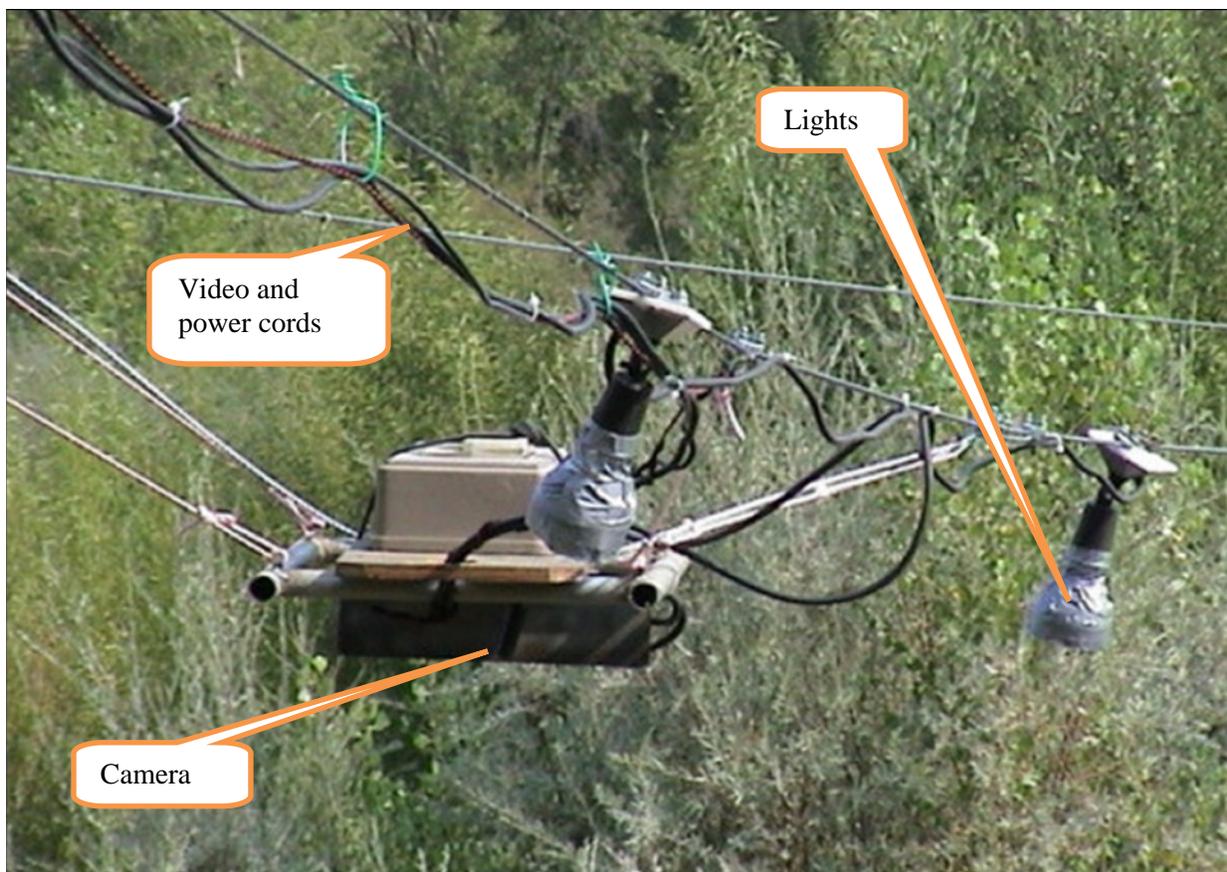
The overhead camera used to count fish passage was a weatherproof black and white camera (Supercircuits Inc. Model # PC88WR) and was chosen to provide a high quality image in various lighting conditions. The camera attached to the bottom of a specialized RBFO designed box containing remote lighting and other wiring hookups. The camera box was suspended from two ¼-inch (6.3 mm) galvanized steel cables directly over the white plates where salmon passed as they migrated upstream.

Figure 5. Image of over-head camera box with power cords, lights and camera box suspended over the Cottonwood Creek video station.

Lighting for the video cameras at night was provided by two compact outdoor fluorescent spotlights mounted on an overhead cable system (three 90-watt bulbs in 2011) as shown in Figure 5. A photocell sensor, similar to those used on streetlights, turned the lights on at dusk and off at dawn. During daily station checks crews checked the lights for proper operation by reviewing the video footage from the previous early morning hours to determine if lights were functioning properly.

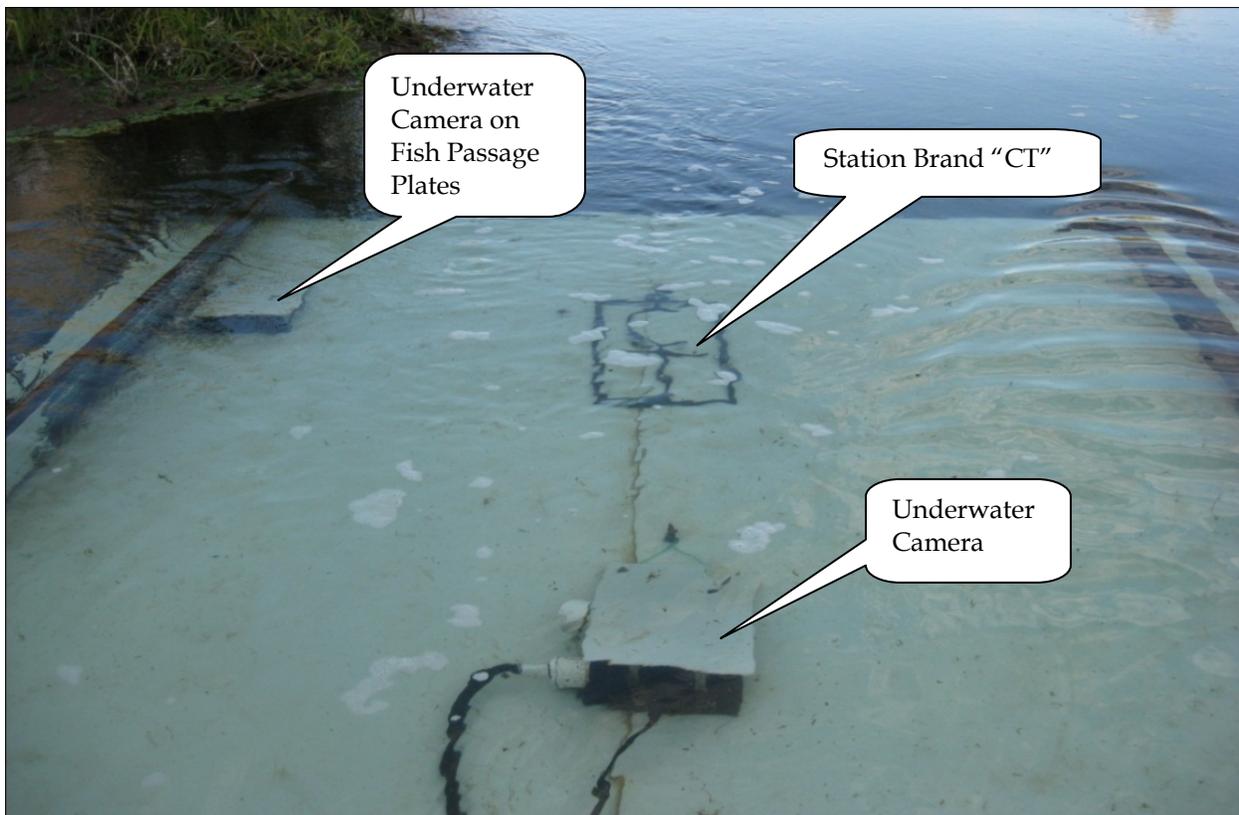
Figure 6. Image of underwater camera system on Cottonwood Creek with white plates and station measuring brand with creek identifier “CT”. Three camera set-up with two in the middle facing opposite directions and one at the top left.

In response to the need for identifying passing fish species at video stations the RBFO staff developed low-cost underwater camera housings that enabled video readers to view fish from underwater views. Commercially available underwater cameras proved expensive and unreliable in identifying passing fish. RBFO staff designed and built enclosures to house economical, wide angle retail cameras that proved suitable for video station needs. Four Supercircuits brand models of cameras were used in the underwater camera housings on various video stations including: PC164, PC222, PC165HR, and PC221-models. All were low light capable and models PC165HR and the PC221-HR were color cameras that were used to help identify rainbow trout (*Oncorhynchus mykiss*) and other species at the video stations.

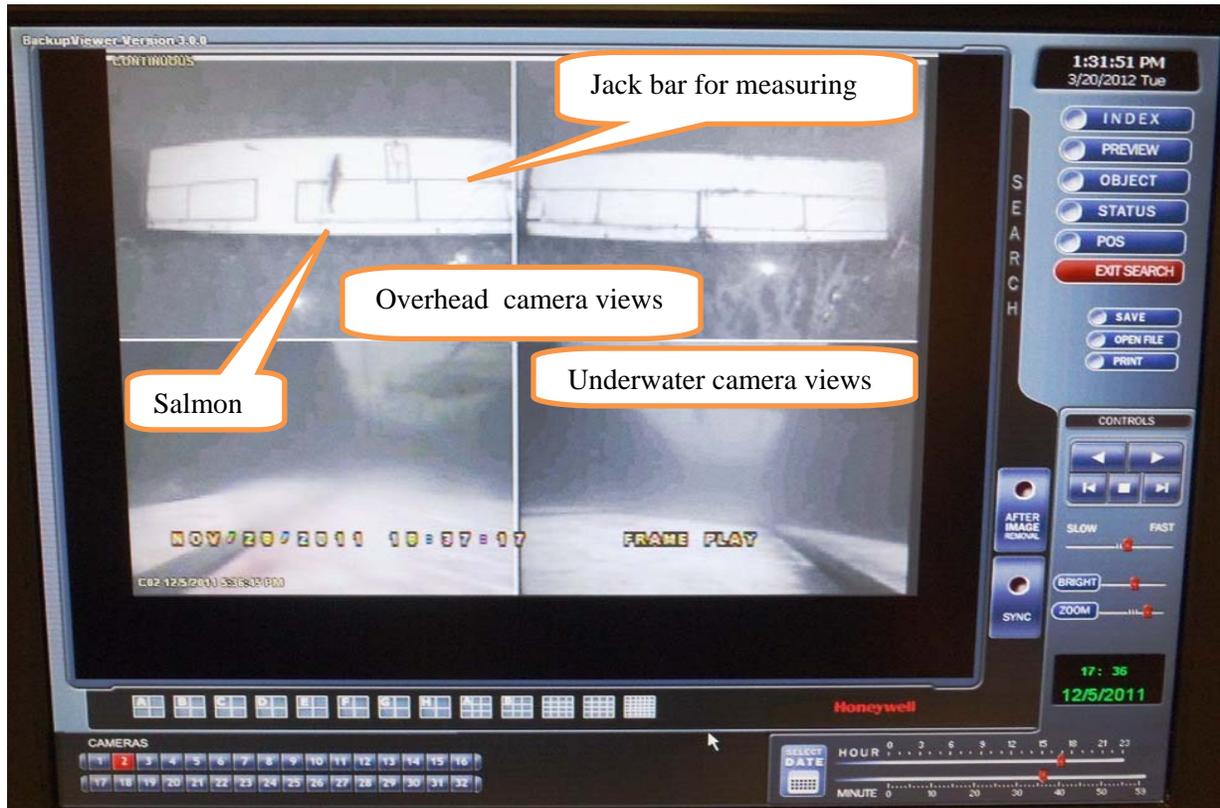
Figure 7. Image of Honeywell DVR computer screen with 2011 Cottonwood Creek video station footage uploaded for fish passage reading.

The second log was used to keep track of the identification of the numerous external hard-drives (LaCie model 301304U) that the Honeywell DVR, stored the recordings on. This log (shown in Appendix Figure B8) was the primary tool used by readers to find the external hard-drive that contained the footage they were searching for to complete the fish counts for each day. Each external hard-drive was individually numbered and labeled as to what creeks and dates it contained. Readers would use the logs to select a hard-drive from the storage shelf then plug it into one of a number of desktop computer workstations via a universal serial bus (USB) cable. The Honeywell “Proprietary Viewer” software (Figure 7) was then opened and reading would commence.

Each day was divided into 48 half-hour long viewing periods. Reader personnel reviewed recorded footage and any salmon or other species that passed up or downstream of the upper end of the white plates were counted as shown in Figures 7 and 8.

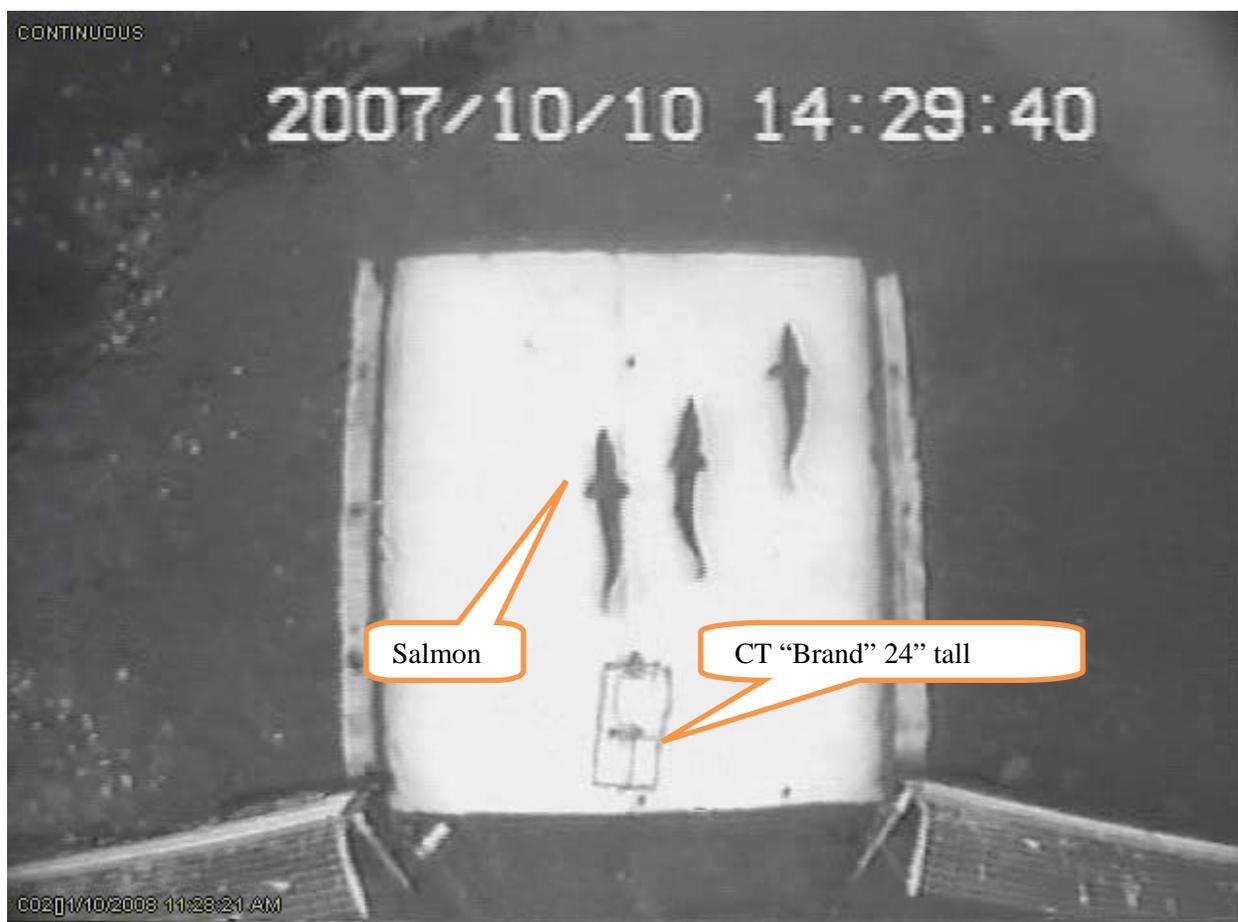
Figure 8. View from the overhead camera looking down on the fish passage opening of the 2007 Cottonwood Creek Video Station.

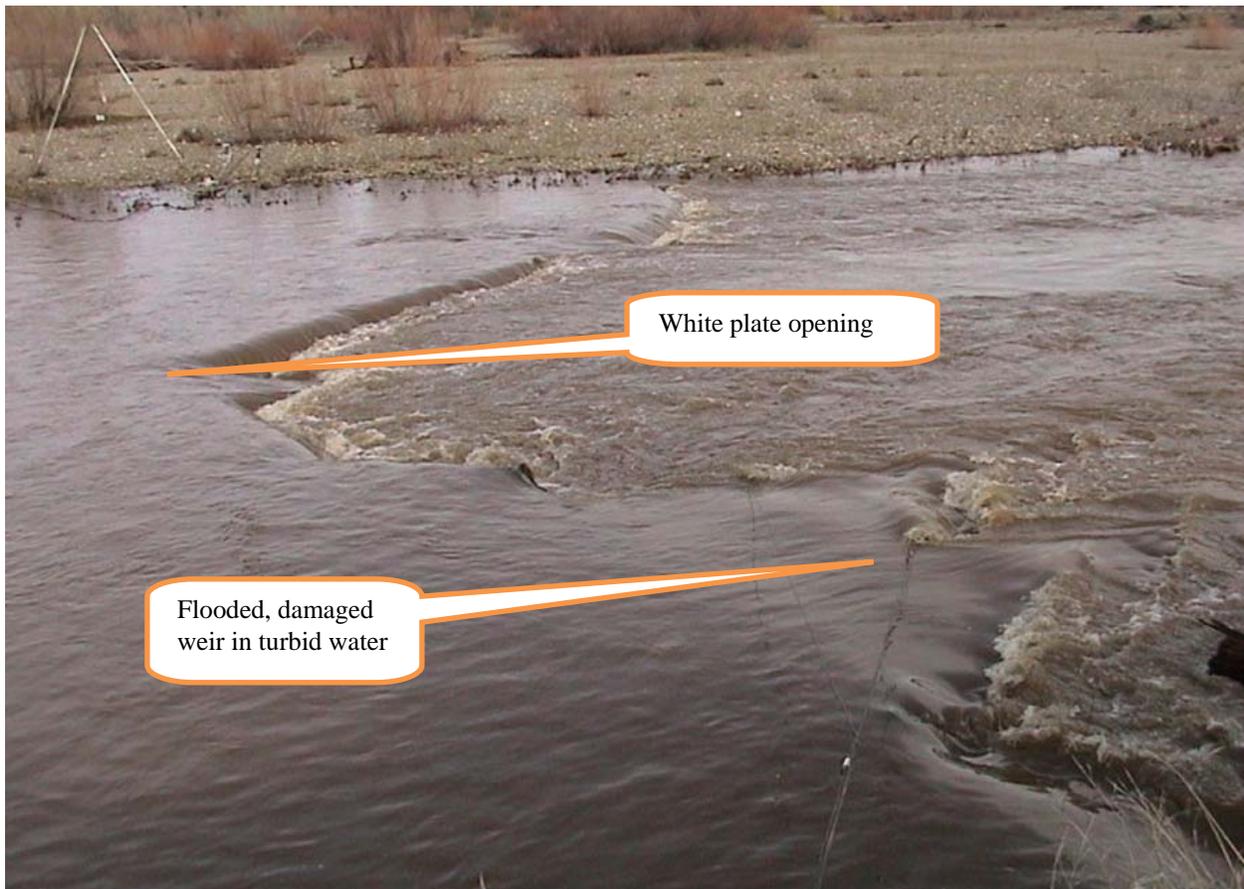
Figure 9. Image of weir during period of turbid water and minor flooding during the 2009 season at Cottonwood Creek. Weir was rebuilt and continued operation after this flood.

At any time when a major storm was forecast, a decision to remove the weir had to be considered. Concern for damage as shown in Figure 9 or loss of the weir and other in-stream

- There were five redds found below the weir resulting in ten salmon added to the final adjusted count.
- Damage to the weir occurred early during the 2009 season on 19 October when the flows reached 465 cfs and some weir panels were washed just downstream by the high flows shown in Figure 9.

- Once the first storm had saturated the watershed additional storms brought rapid flooding. The station site was flooded three additional times during this year but partial lowering of the weir helped avoid similar damage to that of 2009 shown in Figure 9.

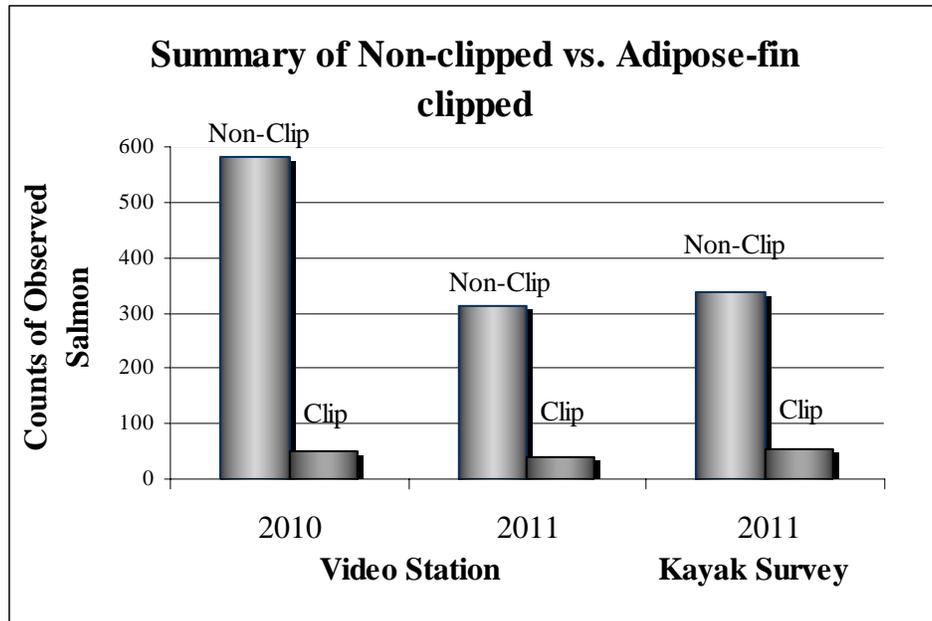
Figure 10. Video station and kayak survey adipose fin-clip data for years 2010 and 2011 on Cottonwood Creek.

The biological data collected by the cameras at the video station is of greater utility when analyzed with other data sources. In 2011 the USFWS Comprehensive Monitoring Program funded the PSMFC to conduct kayak surveys of Cottonwood Creek overseen by the USFWS Red Bluff Fish and Wildlife Office. The results of this survey are detailed in a separate USFWS report, in progress, (R Null, USFWS, personal communication) and are provided in summary in here. The kayak carcass surveys were completed between 12 October and 14 December, 2011. During 30 surveys, a total of 339 non-clipped and 54 adipose fin-clipped salmon (13.7%) were observed. In comparison, the video station observed 312 non-clipped and 38 adipose fin-clipped salmon (10.9%), (see Table 4 and Figure 10). The similarity in results between the two independent surveys in Figure 10 demonstrates the effectiveness of the underwater camera imaging in documenting adipose fin-clips at the video station.

The kayak surveys allowed crews to retrieve coded-wire tags, scales, and other useful information on the spawning population in Cottonwood Creek that the video station alone could not. The data on the adipose fin-clipped salmon from the kayak surveys and video station was important because it provided information on the management of hatchery programs designed to increase the overall knowledge of how hatchery salmon are interacting with natural-origin salmon populations in California.

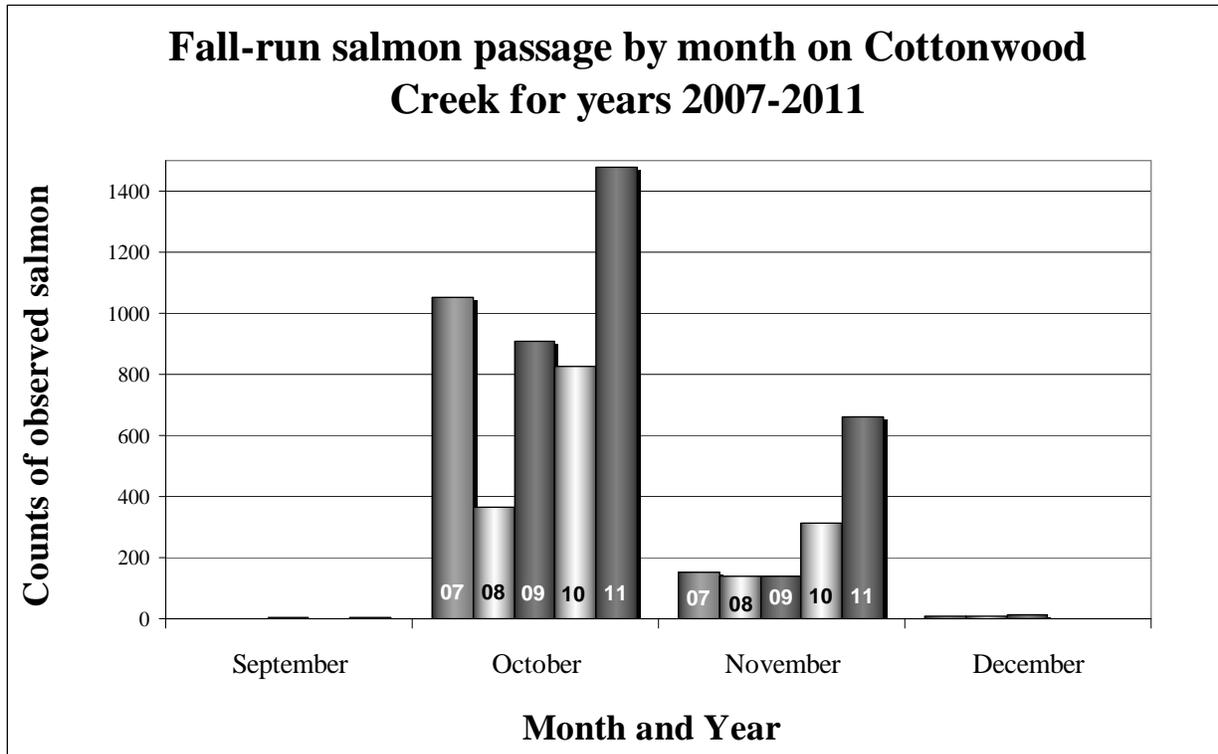
A summary of the passage count by month is provided in Figure 11. Peak passage occurred in the October of each year with nearly 100% of fall-run salmon passage taking place in the months of October and November each year. Fall-run salmon begin migrating into the Upper Sacramento River Basin as early as June of each year, (Killam 2009) but these fish do not enter Cottonwood Creek until later in the year. In a typical year the flows in Cottonwood Creek are at a yearly minimum by late-August and the water temperatures at the mouth of the creek are in the 70+ degree Fahrenheit range (>21° Celsius). These high water temperatures combined with low flows preclude fall-run from entering into Cottonwood Creek. As air temperatures cool in the late-summer and early fall the first fall-run begin to enter into the creek. Daily passage by year can be found in Appendix Table A2. This table shows that few salmon migrate into the creek before the first of October. The trigger for the upstream fall-run migration in Cottonwood Creek to begin is likely due to cooling water temperatures and to a lesser extent higher water flows.

Figure 11. Fall-run Chinook salmon counts by month at the Cottonwood Creek video station for years 2007-2011.

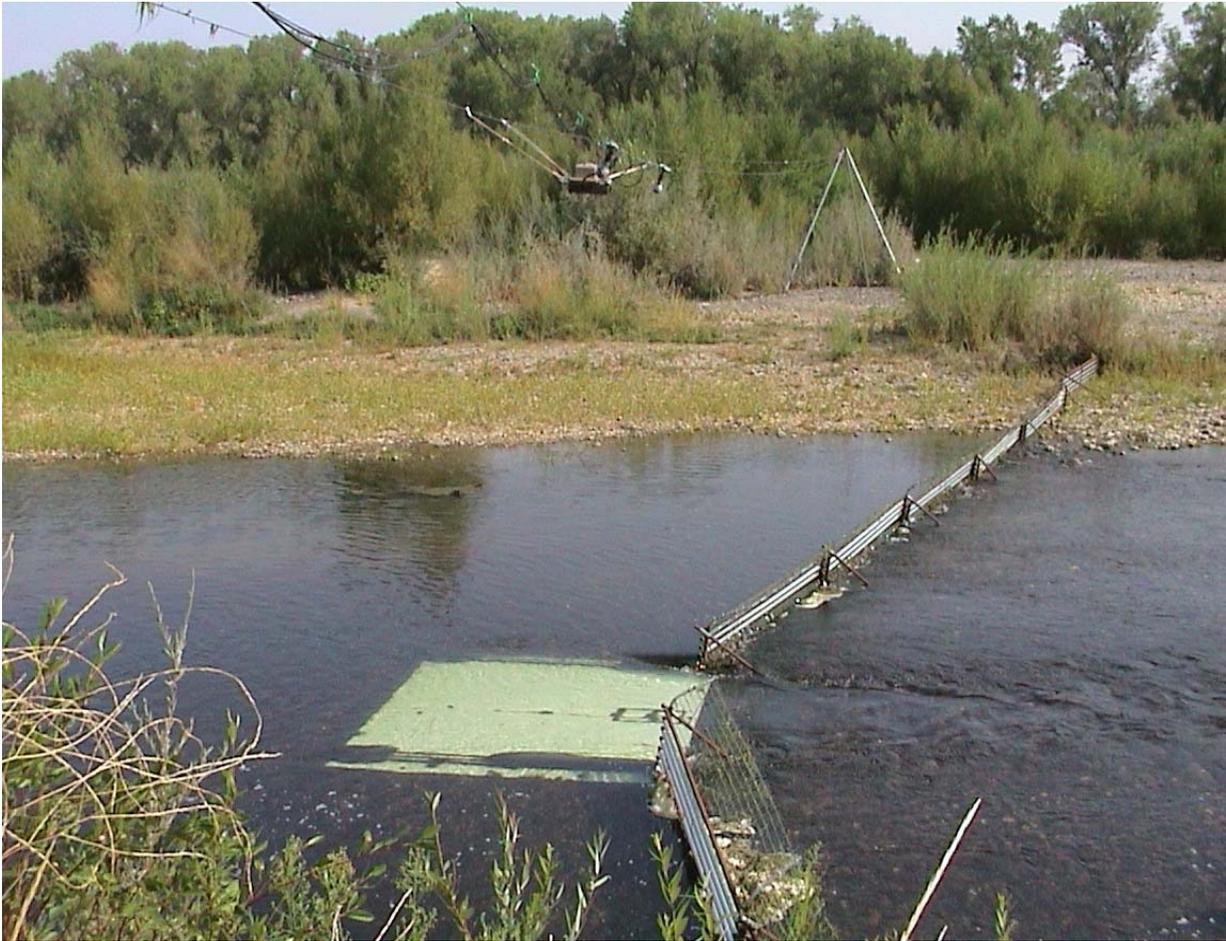
Appendix Figure B1. Photograph of 2007 Cottonwood Creek video station.

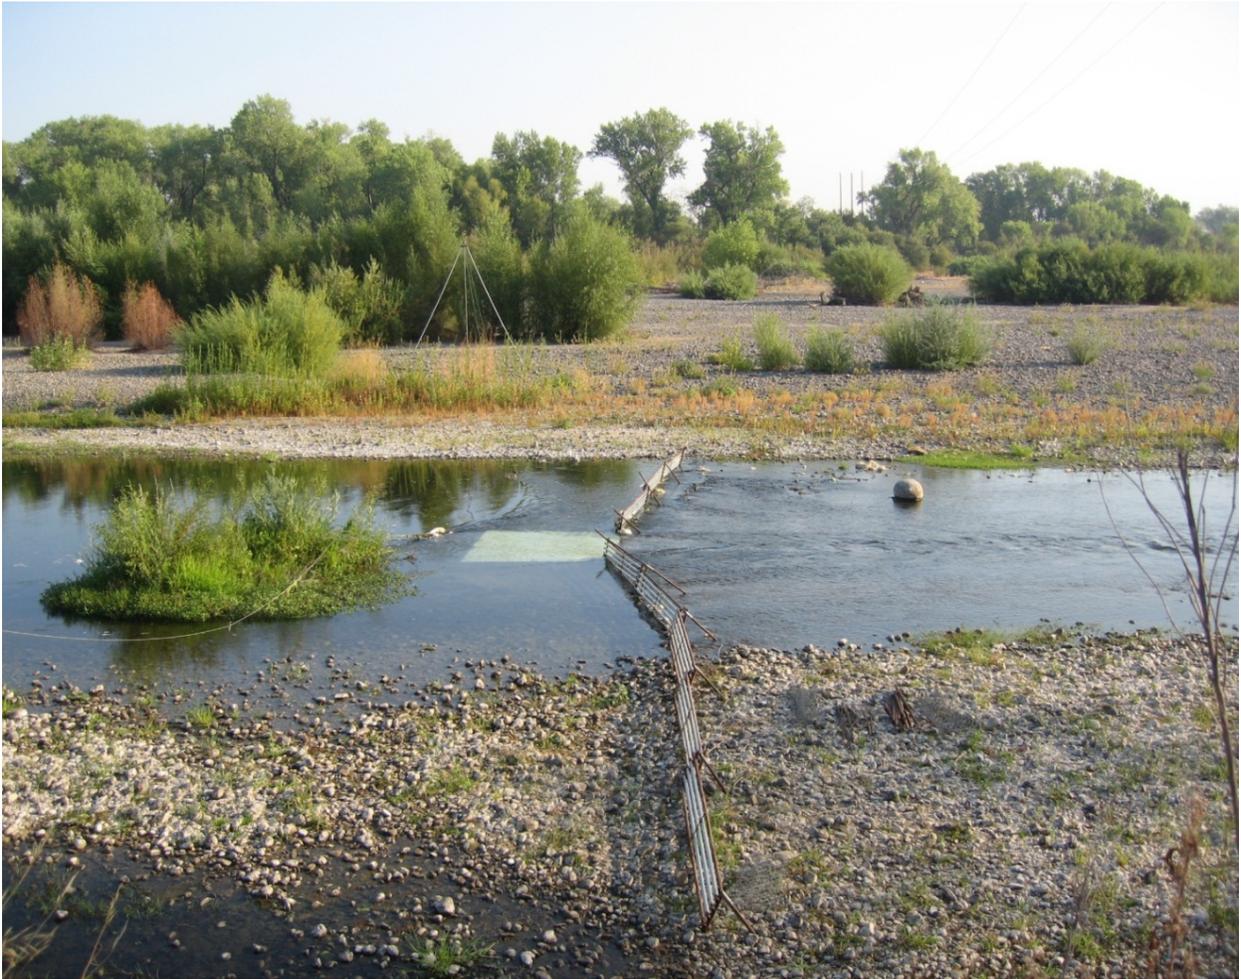
Appendix Figure B2. Photograph of 2008 Cottonwood Creek video station.

- In 2008, flows reached 393 cfs on 4 November. Fish passage could not be observed due to muddy water at this time.
- Appendix Figure B2 illustrates the 2008 video monitoring station on Cottonwood Creek.

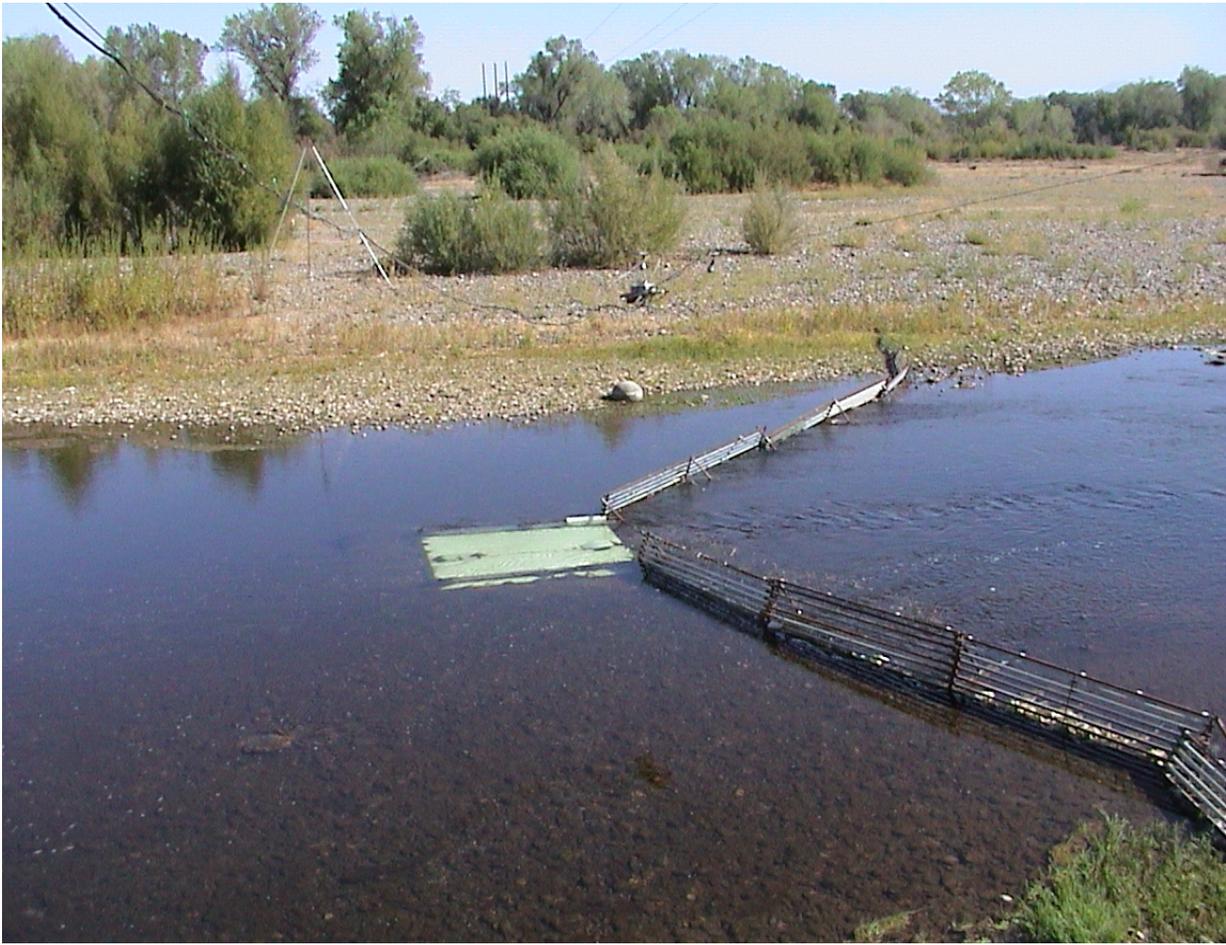
Appendix Figure B3. Photograph of the 2009 Cottonwood Creek video station.

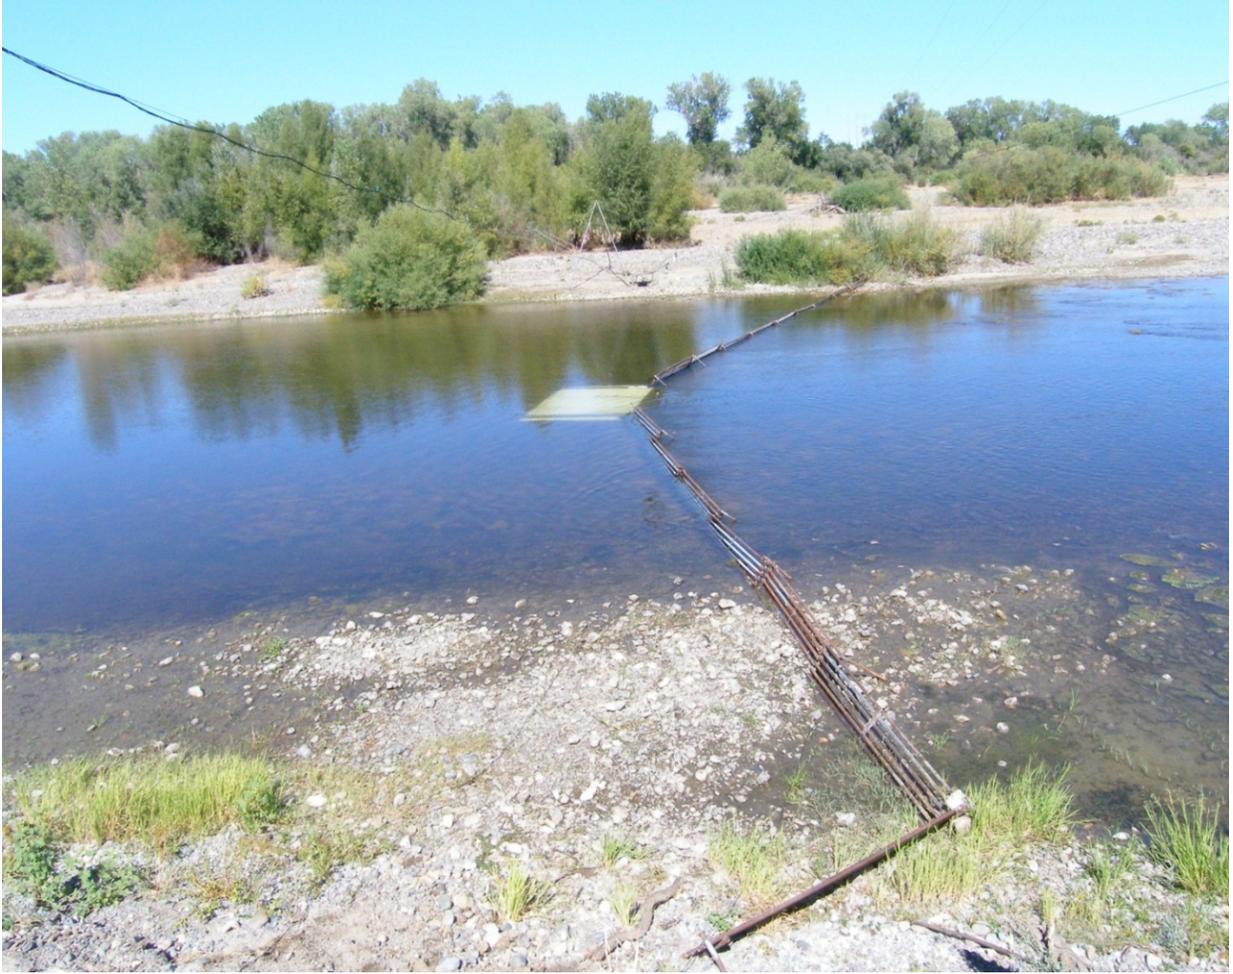
Appendix Figure B4. Photograph of the 2010 Cottonwood Creek video station.

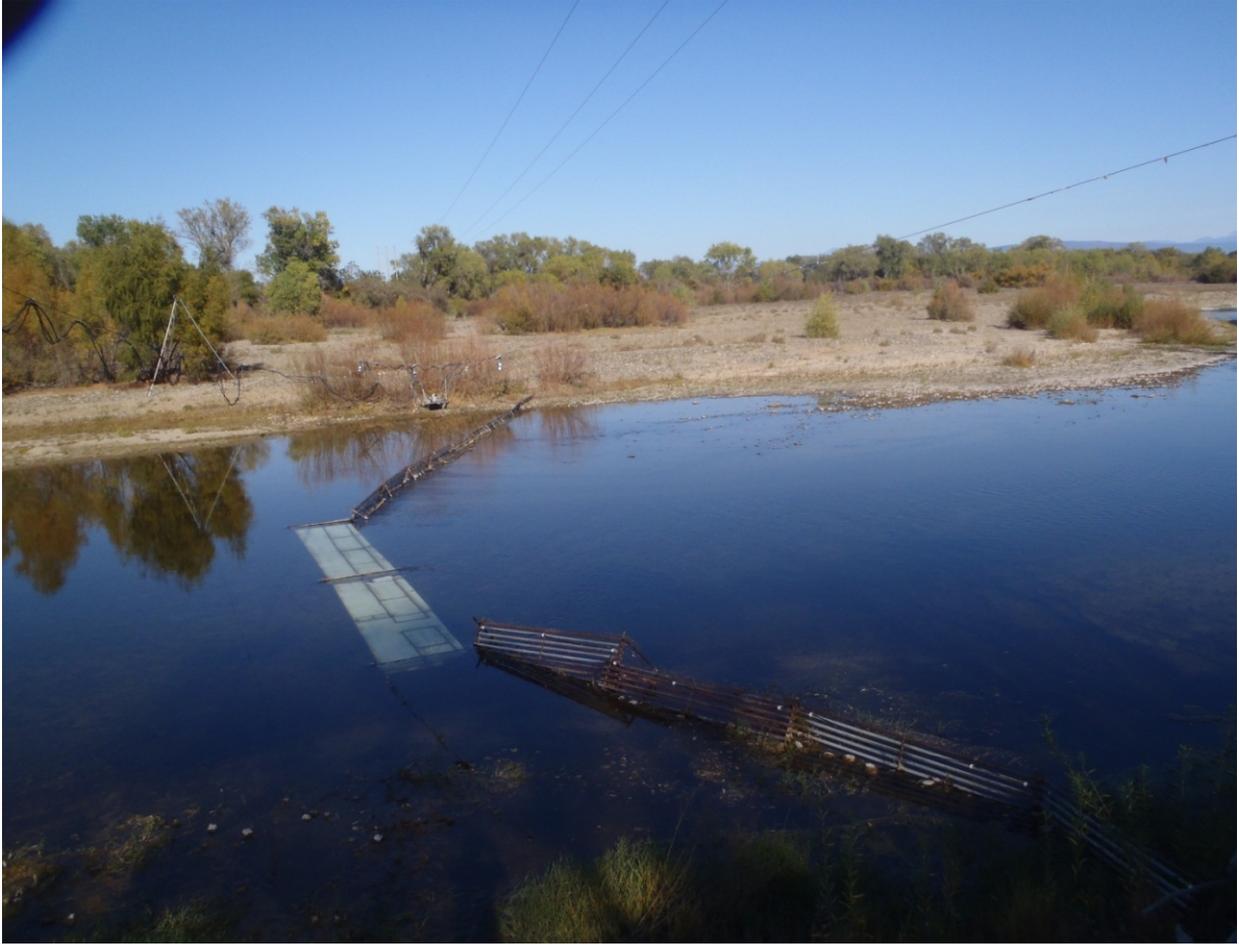
Appendix Figure B5. Photograph of the 2011 Cottonwood Creek video station.

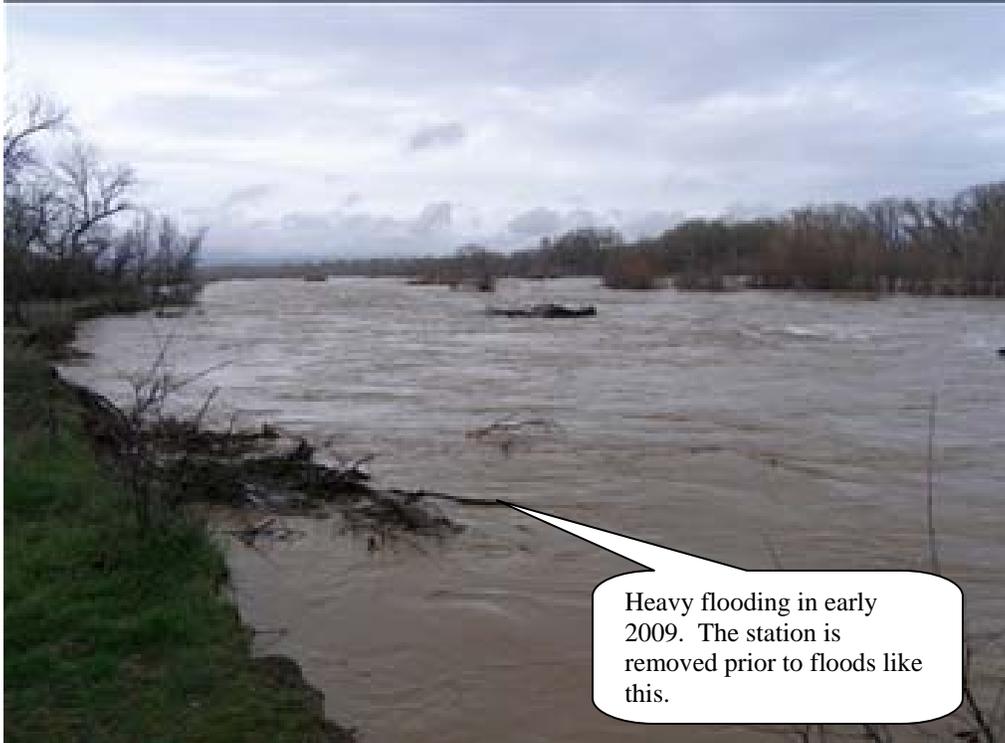
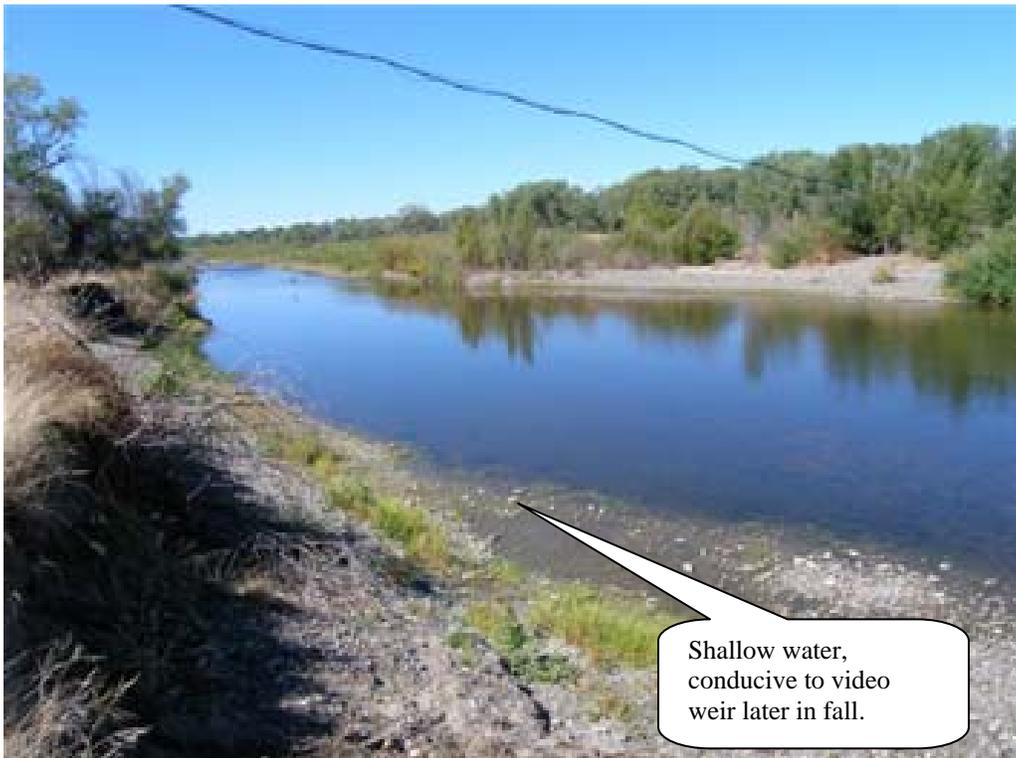
Appendix Figure B10. Upper image is of Cottonwood Creek during major flooding. Lower image is of Cottonwood Creek during typical flows for operation of the video station.

Creek flows are measured in cubic-feet-per-second (cfs) and can typically reach levels of 300-500 cfs from one storm over a few days. Large floods and high flows (>1000 cfs) are typical for Cottonwood Creek in mid-winter. In most years, during periods of fall-run migration, mild autumn weather patterns cause flows and turbidity to rise and fall within a day or two enabling successful video station recordings. Appendix Figure B10 provides an example of the flow differences that can be observed at the video station during the year.
