ANNUAL REPORT
2008
Roosevelt Habitat Conservation Plan
Salt River Project

Salt River Project
Environmental Services Department
Siting and Studies
PAB 352
P.O. Box 52025
Phoenix, Arizona 85072-2025

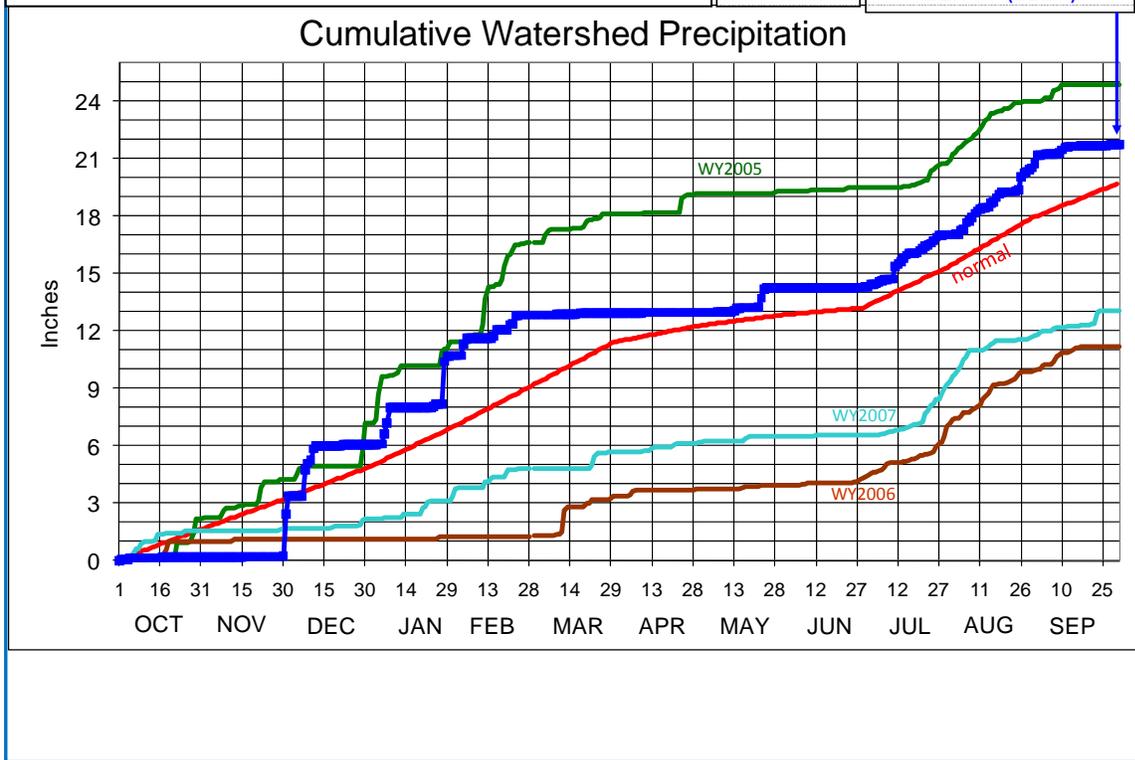
Figure 1. Cumulative Watershed Precipitation, October 1, 2007 through September 30, 2008

Verde 18.8"	WY08: Oct 1–Sep 30:
Salt 24.8"	21.73" (111%)

For the water year, October 1, 2007, through September 30, 2008, the Salt/Verde Watershed average accumulation was 21.73" or 111% of normal with the Salt side receiving 24.82" or 126% of normal versus the Verde's 18.83" or 96% of normal.

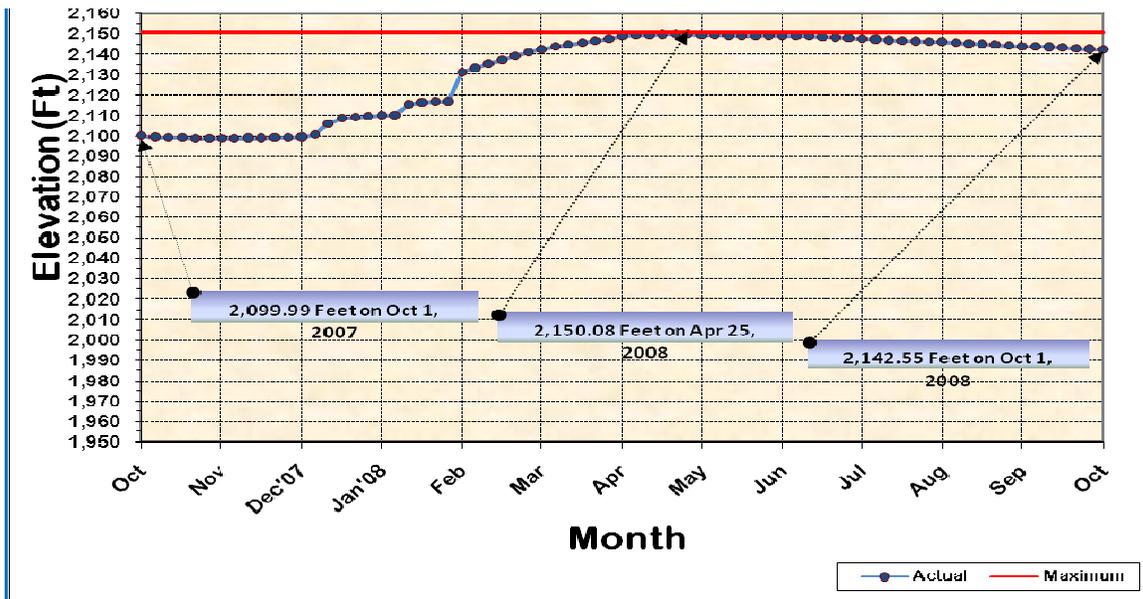
Figure 2. **Roosevelt Lake Elevation Water Year 2008**

In late November, total reservoir storage was 49 percent full with little prospect of improvement during a La Niña winter. After 4 major storms and several small events, runoff dramatically increased reservoir storage. From November 30, 2007 through April 15, 2008, storage increased by 1,132,517 acre feet. In water year 2007, total inflow to the reservoirs was just 211,000 acre feet. The Verde reservoirs were near capacity from February through April. Roosevelt Lake recorded the highest elevation in history this runoff season at 2150.08 feet on April 25, 2008.

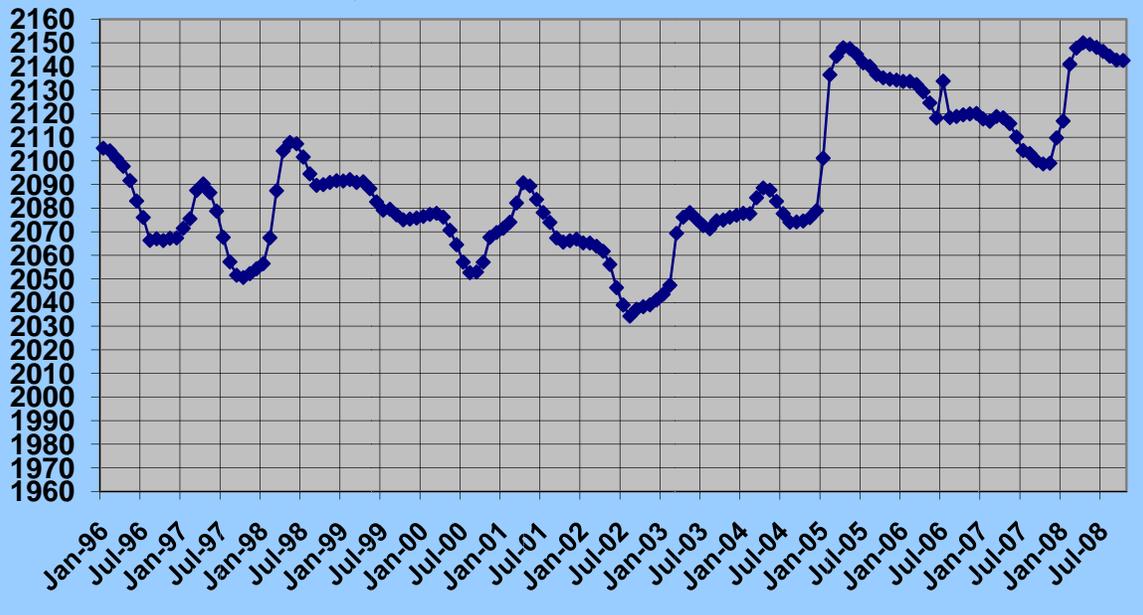
Figure 3. **Roosevelt Lake Elevations, January 1996 - October 2008 - End of month**

Roosevelt operations were influenced by a maintenance project at Mormon Flat Dam. USBR requires regular inspections and repair, if necessary. The project resulted in a 50-foot drawdown at Canyon Lake from October 2007 into January 2008. The majority of the water used to refill Canyon Lake was from local runoff from the rainfall events in January. About 30,000 acre feet

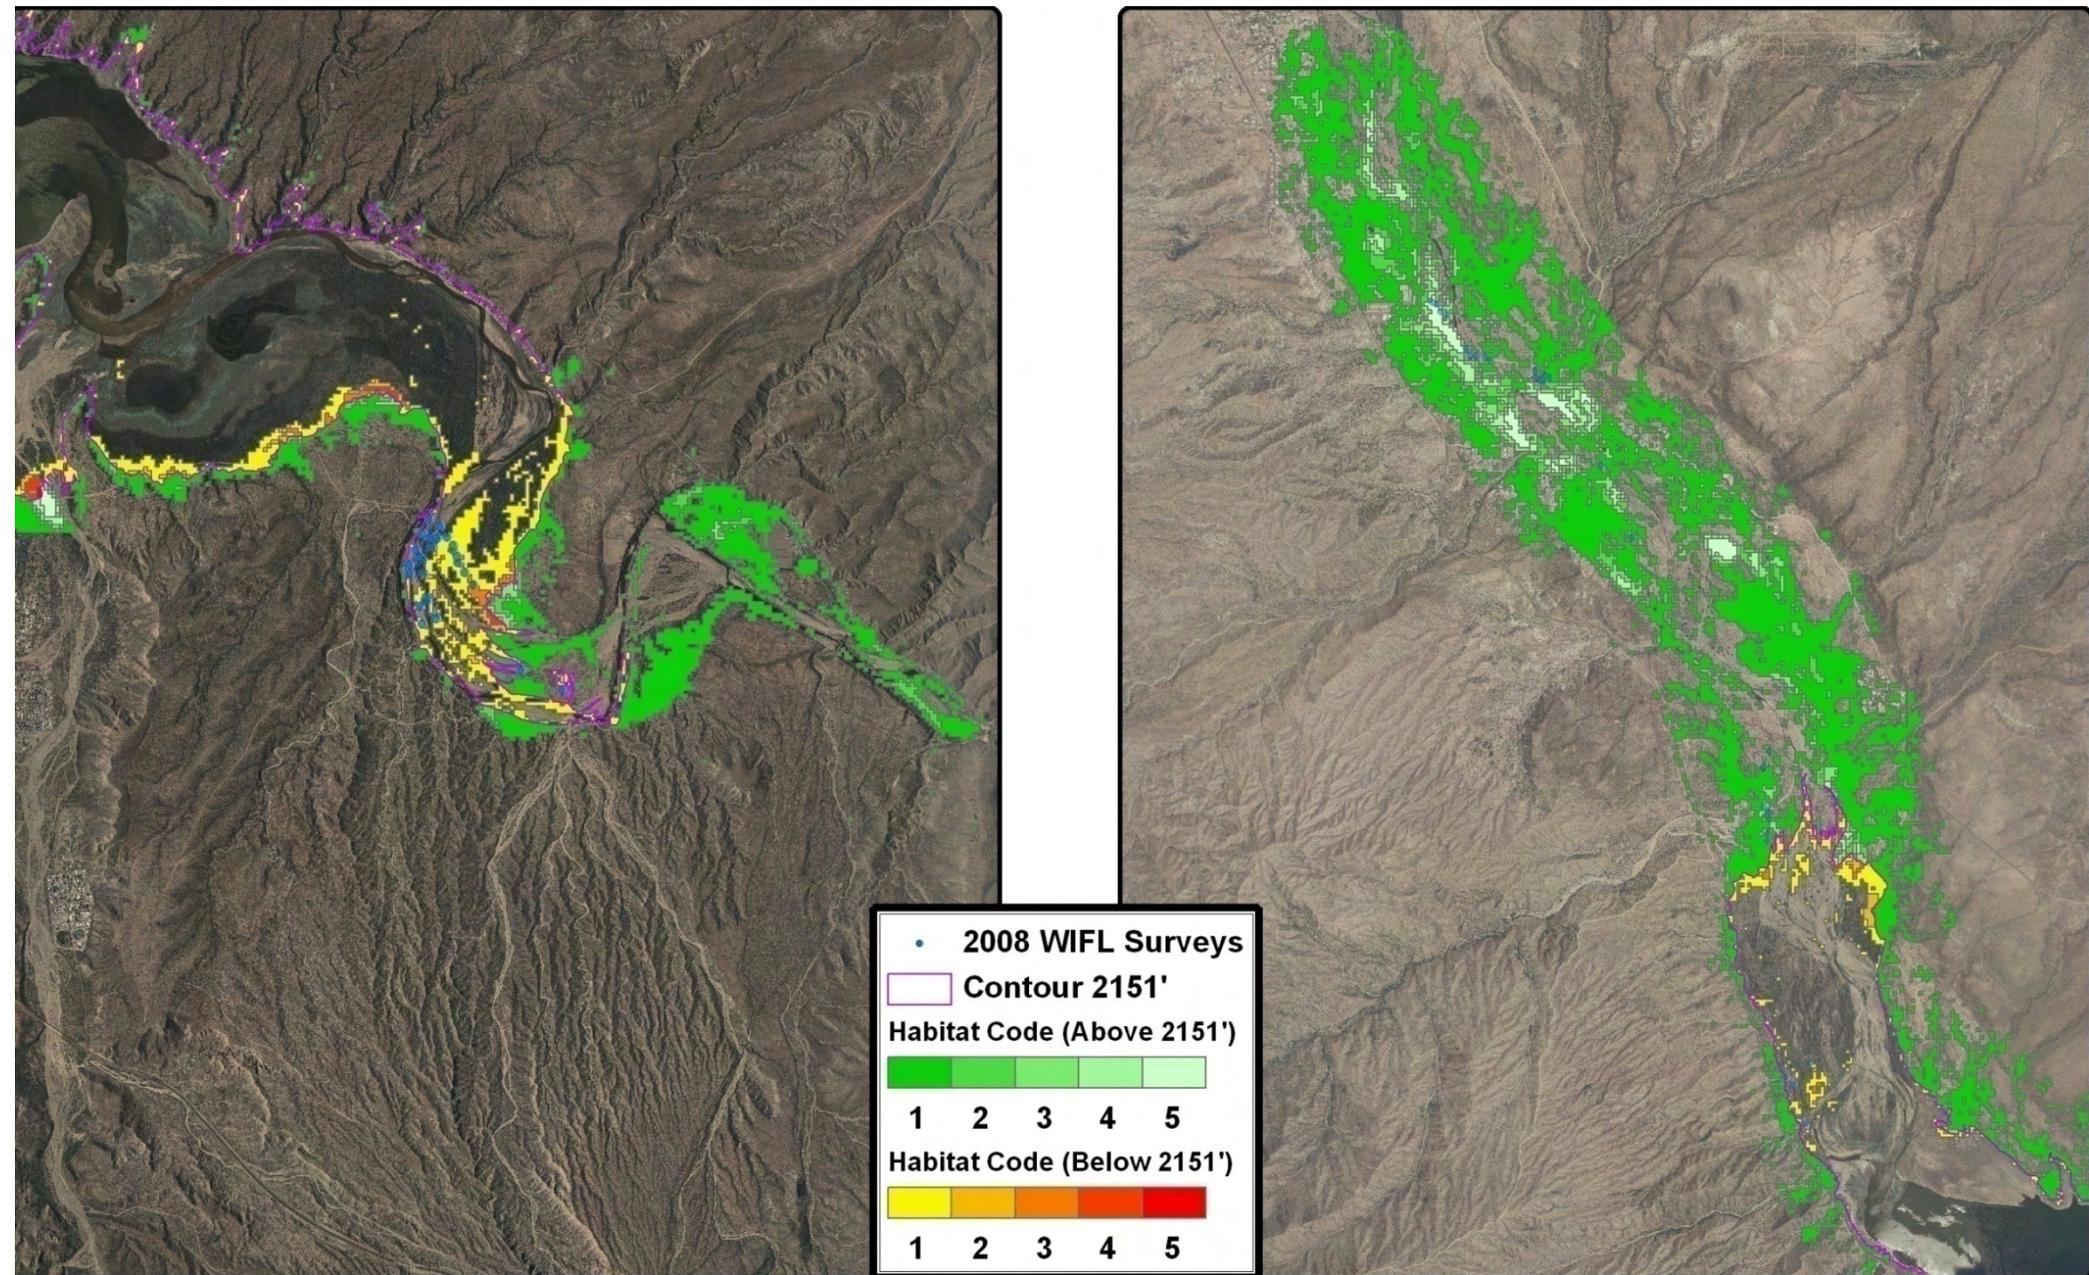
Figure 6. Salt River and Tonto Creek arms of Roosevelt Lake showing 2008 flycatcher habitat model results

In 2007, we found that much of the code 3 habitat was clustered around code 4 or 5 patches and was likely being utilized by breeding flycatchers. As a result, we included codes 3 through 5 in our estimates of potentially occupied habitat. In reviewing the 2008 results, we believe that this situation continues to be true.
