ROOSEVELT HABITAT CONSERVATION PLAN ANNUAL REPORT 2012

**Salt River Project
Environmental Management, Policy & Compliance
Biological and Cultural Resource Services
PAB 352
P.O. Box 52025
Phoenix, Arizona 85072-2025**

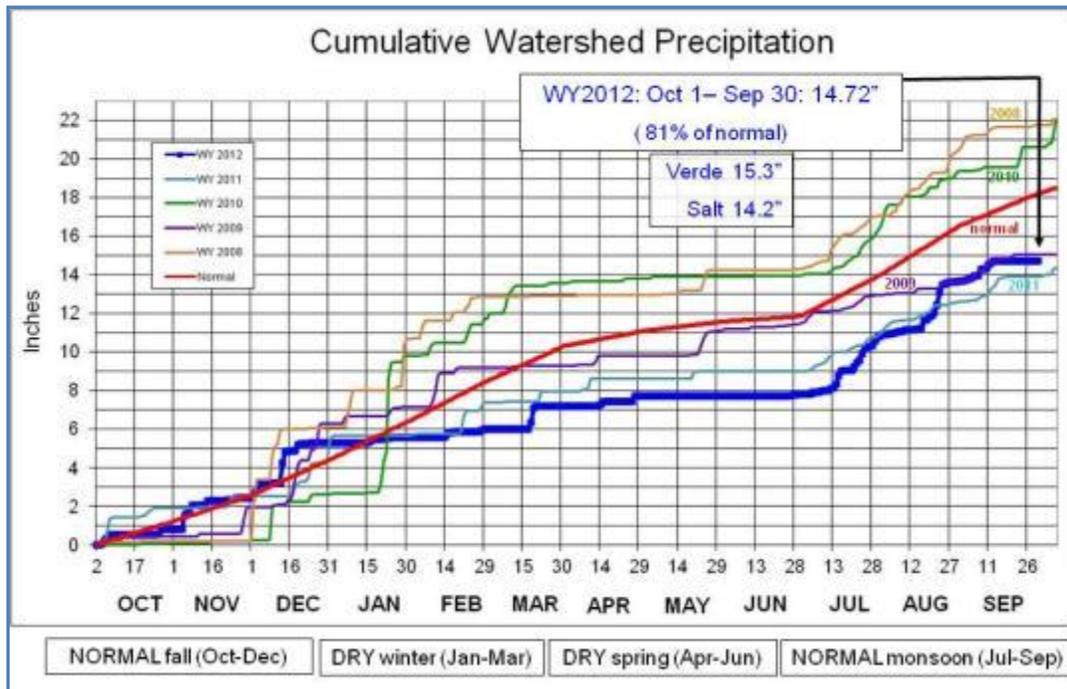
Figure 1. Water Year Precipitation for 2011-2012 for the Salt-Verde Watershed.

Water Year 2012: In spite of a wet November and December, a dry January through March kept the first half of water year 2012 dry; about 62% of normal precipitation fell. A dry spring (39% of normal precipitation) added to the water year deficit that could not be offset by the wet summer (109% of normal rainfall). In all, water year 2012 precipitation of 14.92 inches was 81% of normal. This is slightly more than the 13.91 inches that fell during water year 2011 but reflects the similarity in La Niña-influenced weather patterns during both water years (Figure 1).

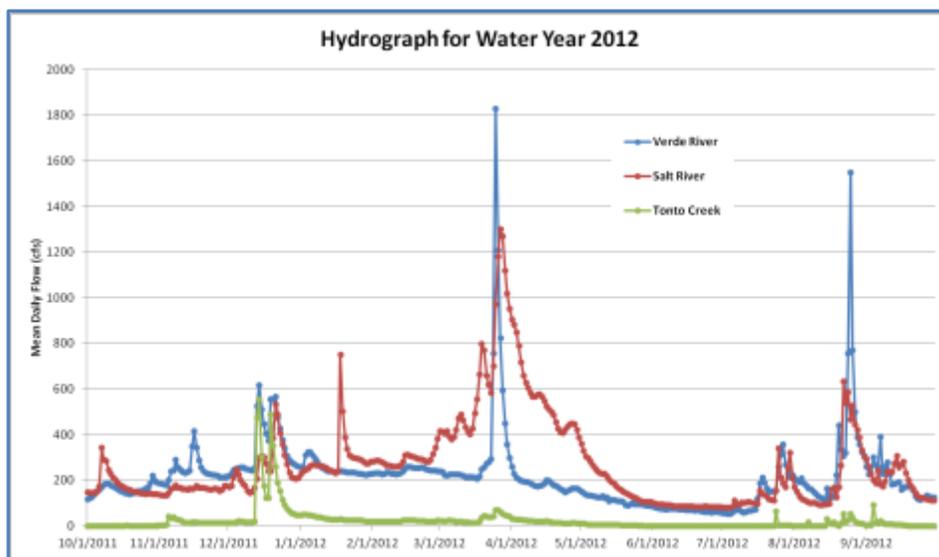
Figure 2. Water year Precipitation for 2011-2012 for the Salt-Verde Watershed

Reservoir Status: The reservoir system was 68% of capacity heading into water year 2012 due to well below median runoff from the 2011 winter season and below normal precipitation from the 2011 monsoon season. The winter season began favorably with November and December precipitation being 150% and 180% of normal respectively. However, the wet November and December were an anomaly given the moderate La Niña. Runoff this winter (January-May) was approximately 196,000 acre-feet which is 37% of median and ranked as the 16th driest winter on record. Runoff from the monsoon (July-September) produced about 70,500 acre feet. Total runoff for water year 2012 was approximately 367,000 acre-feet (Figure 2). Total storage decreased from 68% of capacity to 52% capacity during water year 2012.

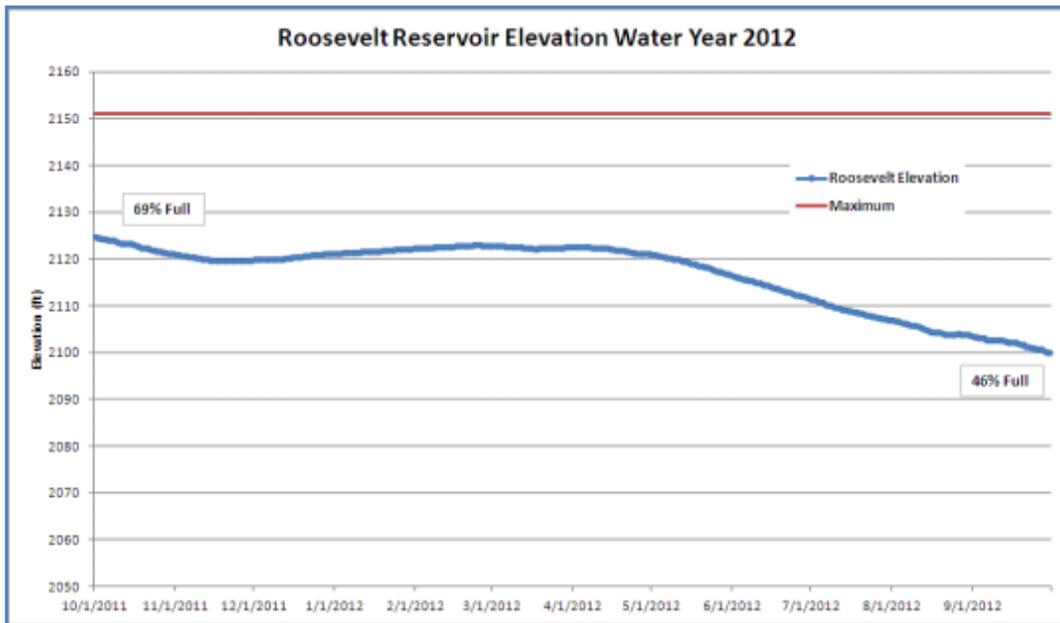
Figure 3. Roosevelt Lake Elevations, Water Year 2012

Roosevelt Operations: Roosevelt operations were most influenced by the lack of winter runoff. Roosevelt reservoir capacity entered the season with just over 500,000 acre-feet of available capacity reducing the risk of spill given La Niña conditions were in place for the second consecutive year. The winter of 2012 produced only 126,000 acre feet of runoff into Roosevelt Lake. The elevation at Roosevelt Dam varied little through the winter with well below normal inflows through the winter season. On February 20th the water order transitioned back to the Salt system. Reservoir levels began to decline as water order increased in the late spring and into the summer (Figure 3). The water order is projected to switch to the Verde system in early December, 2012. The transition is scheduled later than normal this year to position the Verde system storage at a level that will allow for better system flexibility if the 2013 winter runoff season is dry.

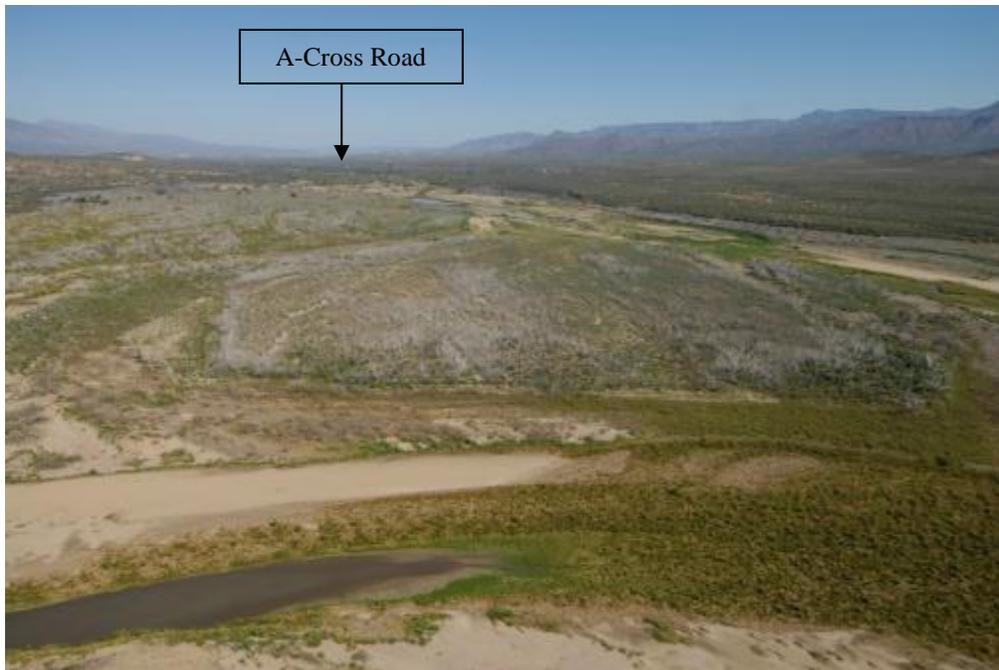
Figure 4. Vegetation at A-Cross Road, looking upstream. The 2151' elevation is adjacent to A-Cross Road on the downstream side. Photo was taken at lake elevation 2100.77' on September 26, 2012 by Michael Eller.

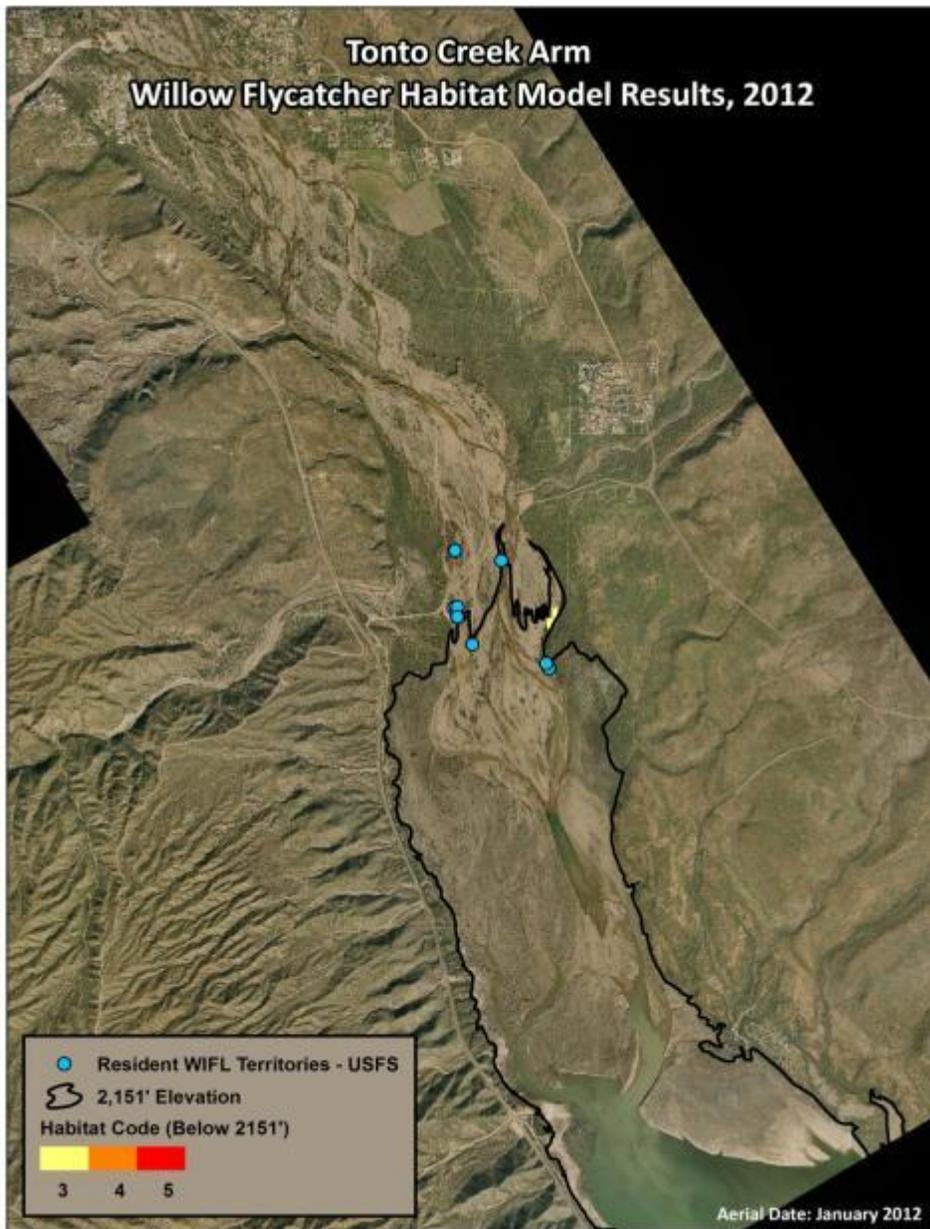
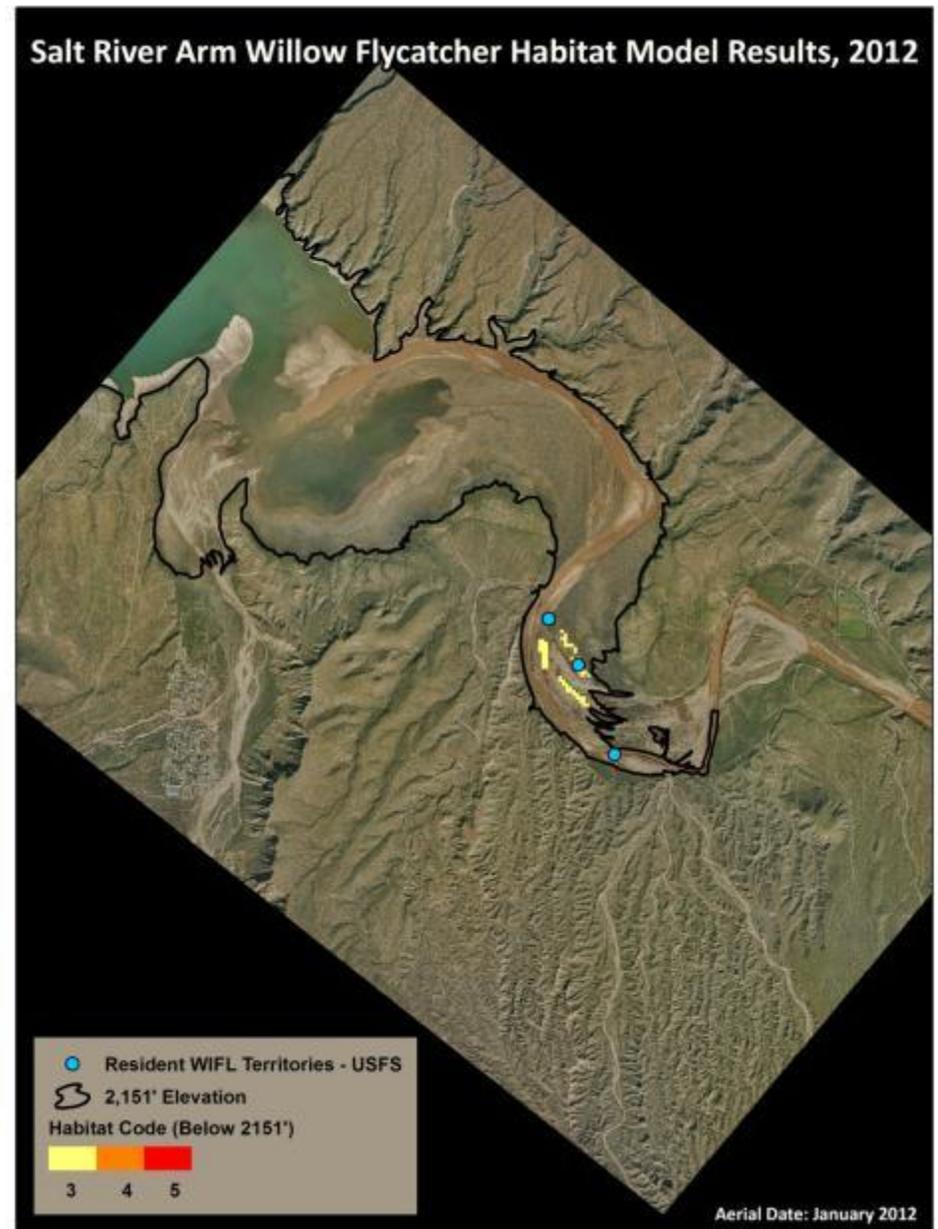
Figure 5. Salt River and Tonto Creek arms of Roosevelt Lake showing 2012 flycatcher habitat model results and flycatcher territory locations as provided by Tonto Basin Ranger District, Tonto National Forest. Satellite image was taken on July 2, 2012 at lake elevation 2111' (56% full). The aerial photo was taken in January 2012 when the lake was 66% full.

Previously, SRP ran the multi-scaled habitat model using Landsat 5 satellite images. However, Landsat 5 images are no longer available for time periods after November 2011 when the satellite experienced catastrophic failure. Because of this, SRP ran the multi-scaled habitat model in 2012 using Landsat 7 ETM satellite images. However, Landsat 7 images can contain gaps of missing information in individual scene data due to a scan line corrector malfunction in the satellite that occurred in 2003. Although the Landsat 7 data may not be optimal, SRP addressed the issue by combining two images from separate time periods during the breeding season and at similar lake elevations. The primary image, taken on July 2, 2012, adequately covered over 80% of the area. These data were supplemented with a second image taken on May 31, 2012 to cover the remaining 20%. The lake elevation at the time of the July image was 2,111.23 feet and for the May image was 2116.59 feet (Figure 5).

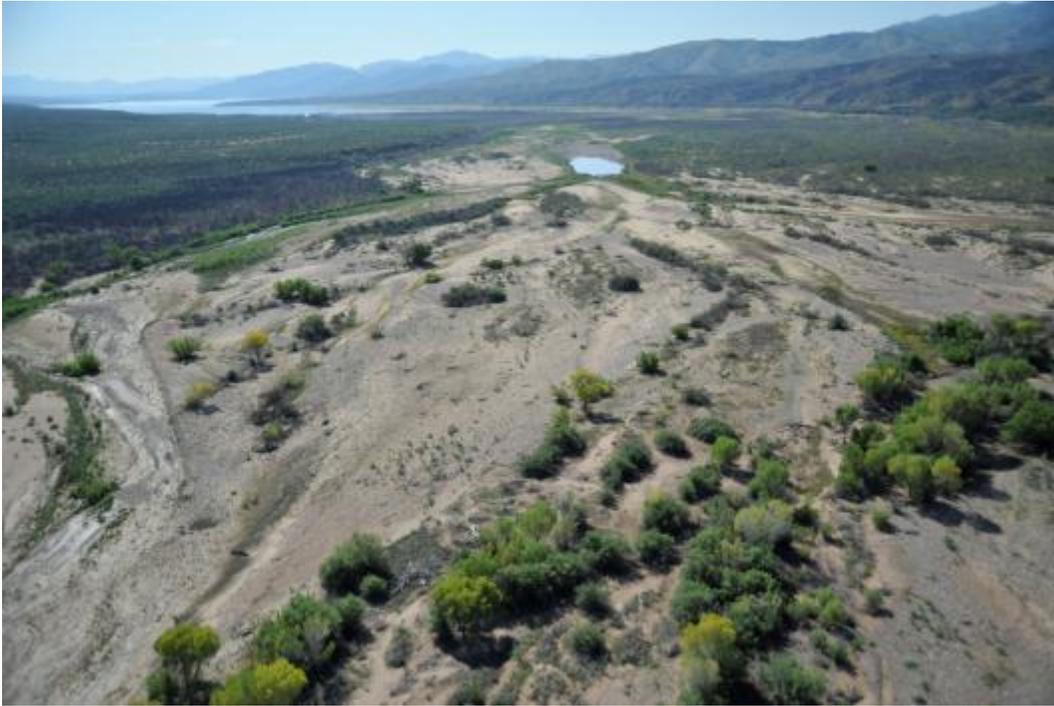
Figure 6.
Tonto Creek
arm of
Roosevelt
Lake
looking
downstream
from A-
Cross Road.
September
26, 2012.
Photo by M.
Eller.

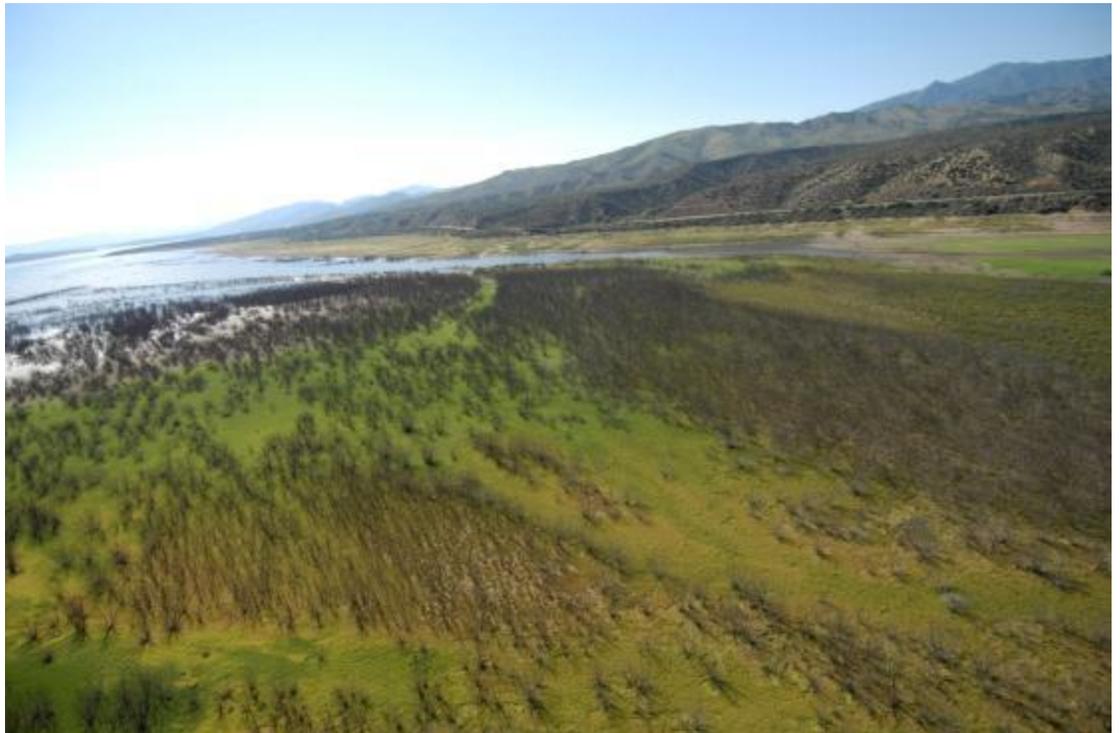
Figure 7.
Exposed Lake
Bottom at
Tonto Creek
inlet to
Roosevelt
Lake
September
26, 2012.
Photo by M.
Eller.

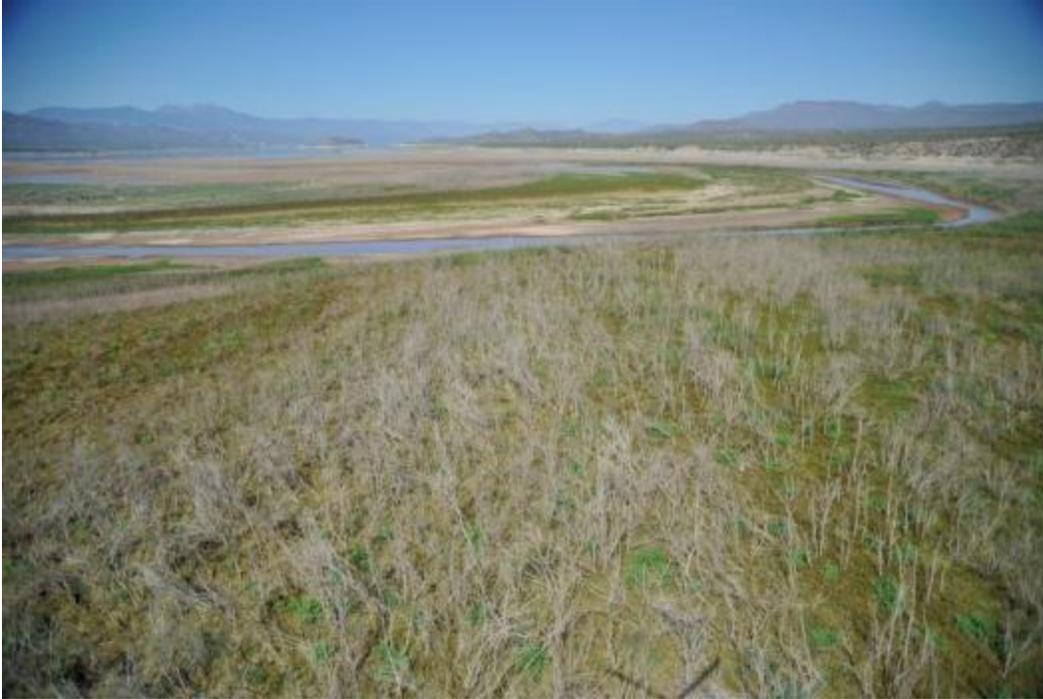
Figure 8. Exposed lake bottom upstream from the confluence of Pinto Creek. September 26, 2012. Photo by M. Eller.

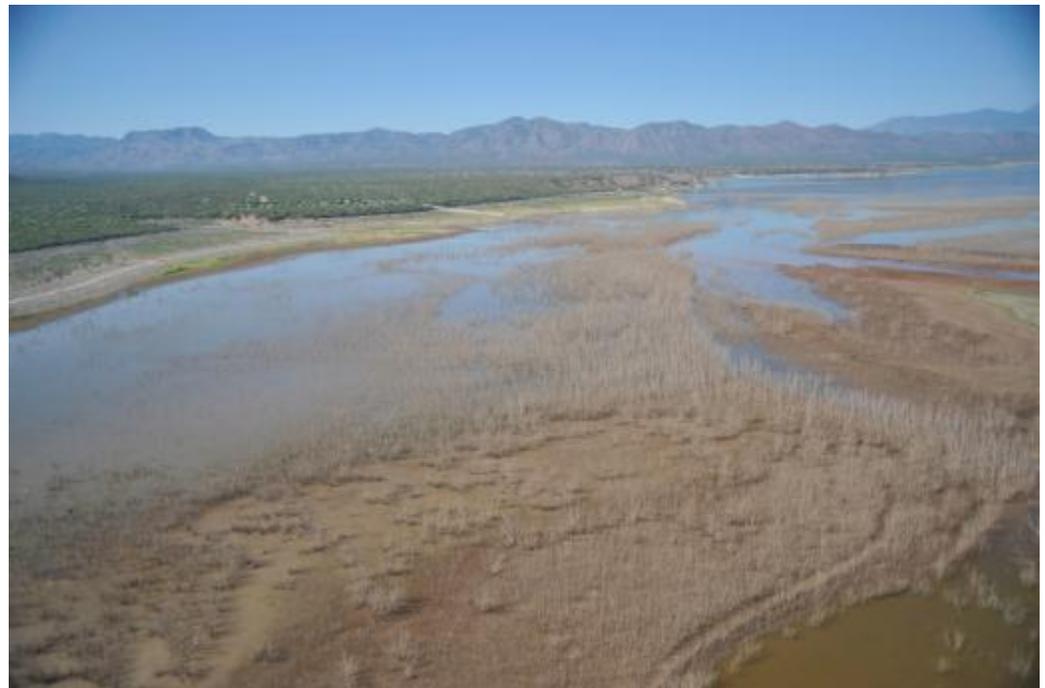
Figure 9. Exposed lake bottom downstream from the confluence of Pinto Creek. September 26, 2012 Photo by M. Eller.

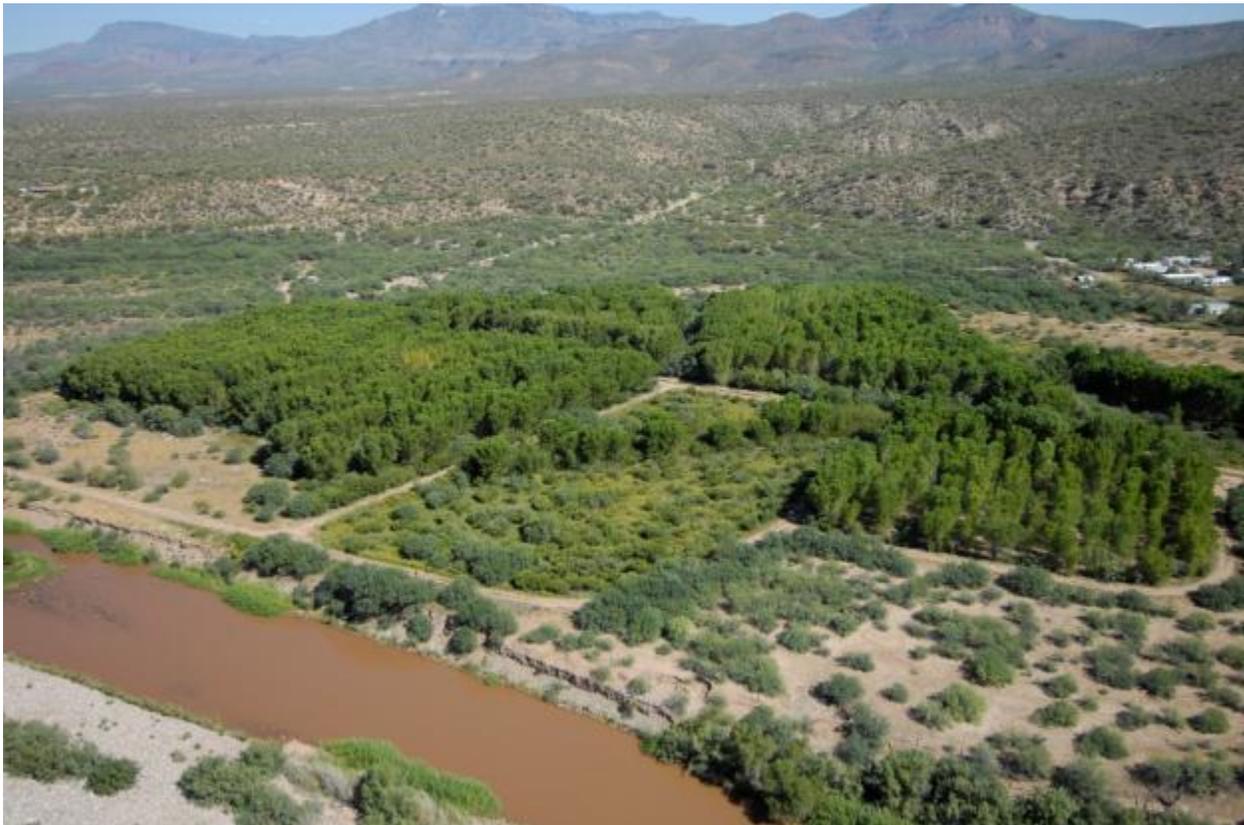
Figure 10. Rockhouse Project, looking northeast (downstream). September 26, 2012. Photo by M. Eller.

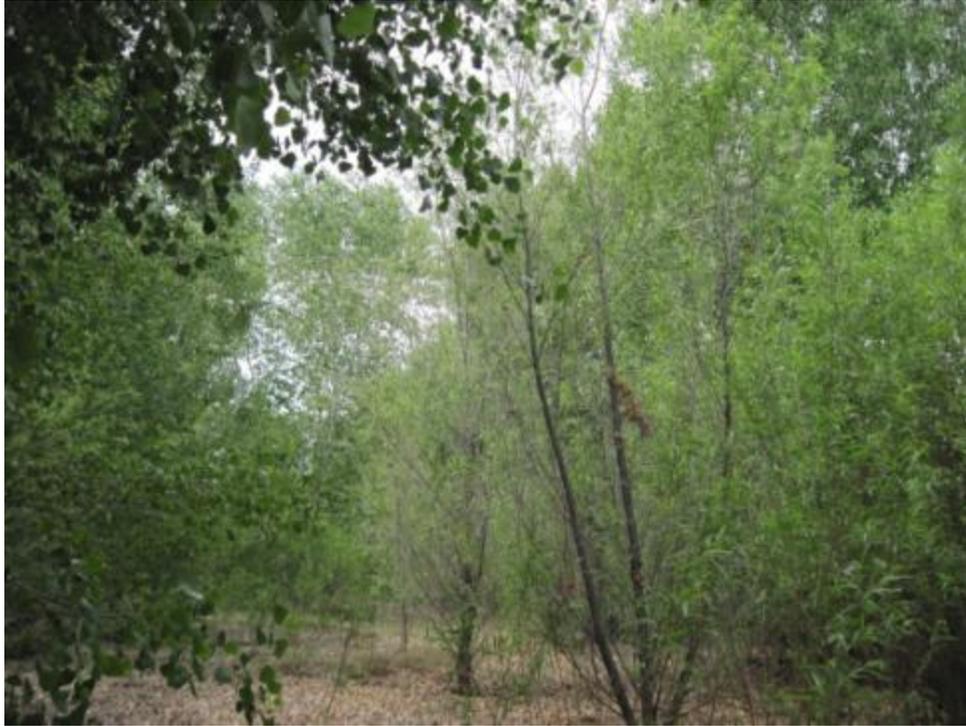
Figure 11. Interior of planting at the Rockhouse site. Photo by R. Valencia.

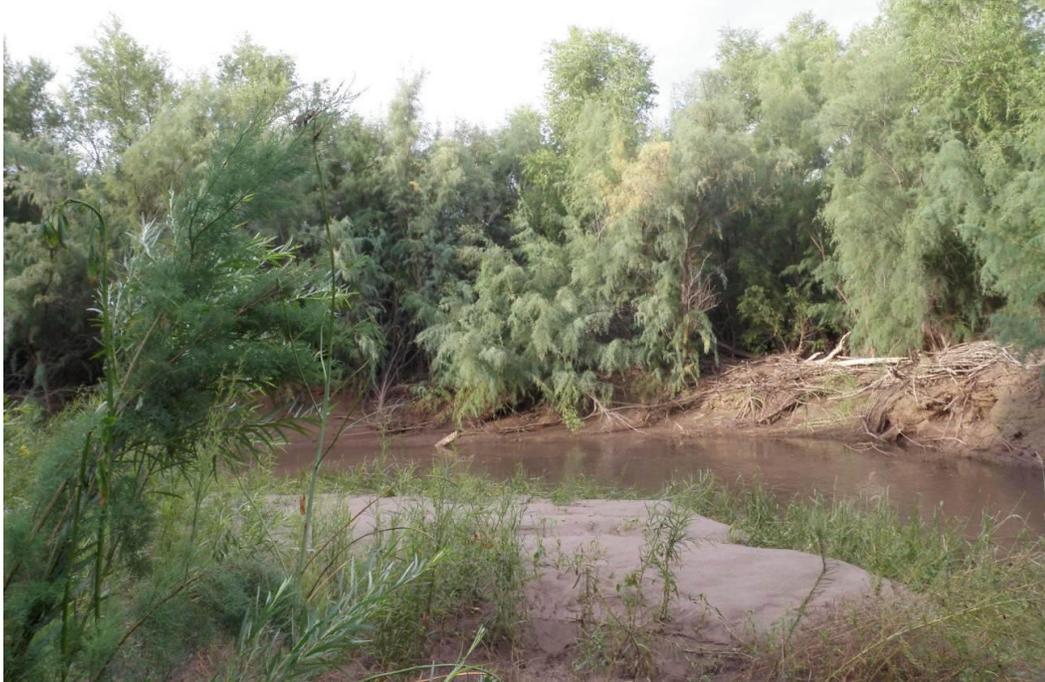
Figure 12. Interior view of suitable, occupied flycatcher exotic-dominated habitat near a territory on the Fort Thomas Preserve.

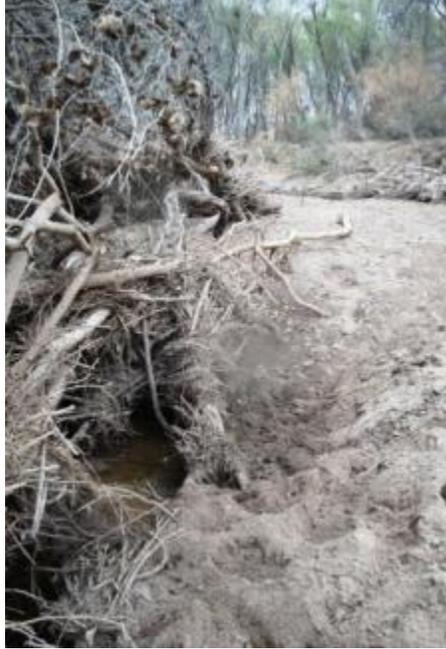
Figure 16. New pool of standing water in main channel near north river gap at Spirit Hollow (Photo taken December 12, 2011).

Habitat Conditions. The main channel remains in the middle of the river, with multiple overflow channels persisting across the floodplain. The channel bottom is covered with a dense growth of grasses, forbs and shrubs. Scouring flood flows occurred following a late summer storm and created new pools. However, the Goodding’s willows that supported many of the flycatcher territories in the past appear stressed due to lack of moisture.

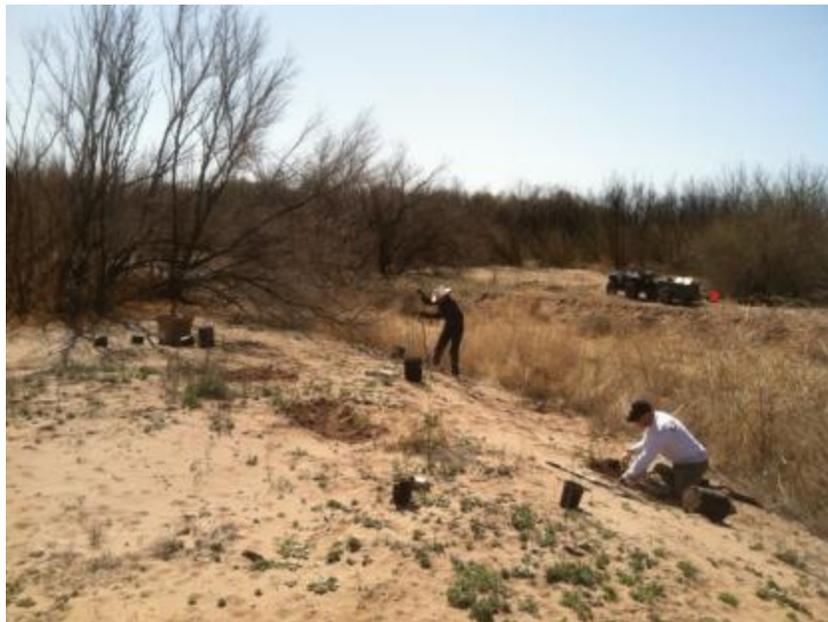
Figure 17. Photo of native planting along an irrigation return ditch at the Ft. Thomas Preserve.

In March 2012, 100 of the following grasses, shrubs and small trees were planted near a large return ditch in the middle of the burn area: *Acacia constricta* (whitethorn acacia), *Atriplex canescens* (saltbush), *Bouteloua gracilis* (blue gramma), *Chilopsis linearis* (desert willow), *Lyceum andersonii* (Wolfberry), and *Prosopis pubescens* (mesquite). DriWater (a gel based plant watering product) was utilized to provide moisture to the plants (Figures 17 and 18). Plant survival rates were assessed in August of 2012 and resulted in approximately 15% survival. Saltbush and Acacia were the predominant species that persisted. Survival was greatly influenced by sandy well-drained soils. Javelina took interest in the DriWater containers and un-earthed the majority of them.

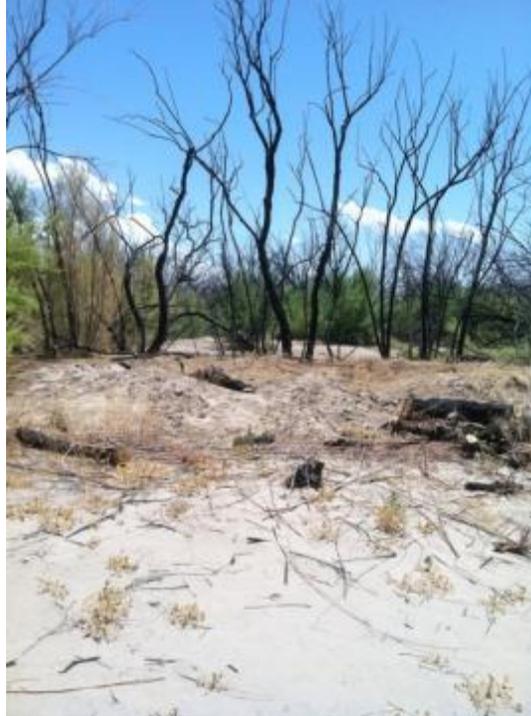
Figure 20. Same location, taken on June 28, 2012. Browned trees to the left of the frame were those receiving basal-bark treatments.

Figure 19. Test plot 3, from NW corner, taken on May 9, 2012. Trees in mid-frame were subsequently cut and the stumps sprayed with a 50-50 mixture of Garlon 3A and water. Trees to the left of the frame were subjected to basal bark treatment using the same mixture.

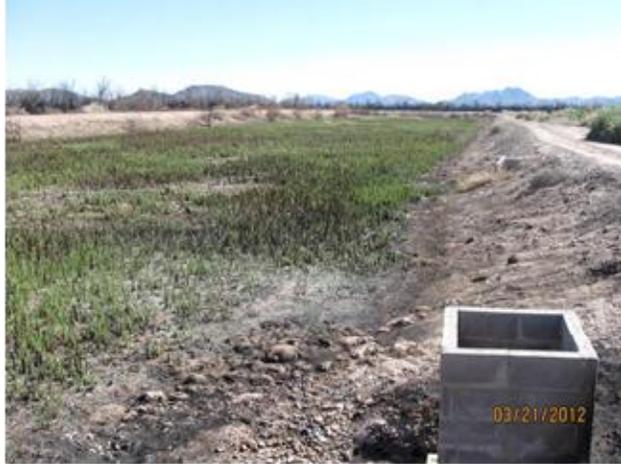
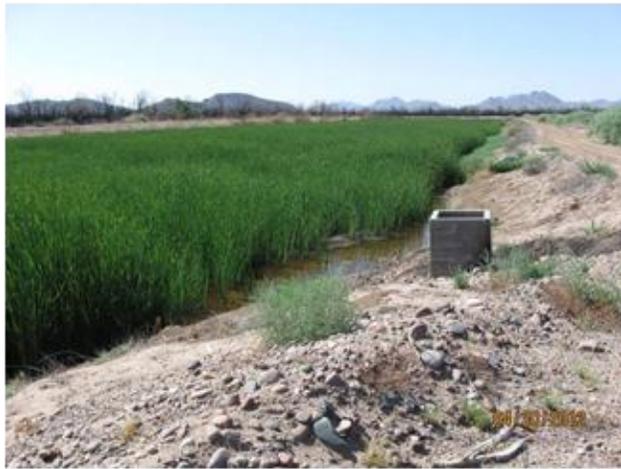
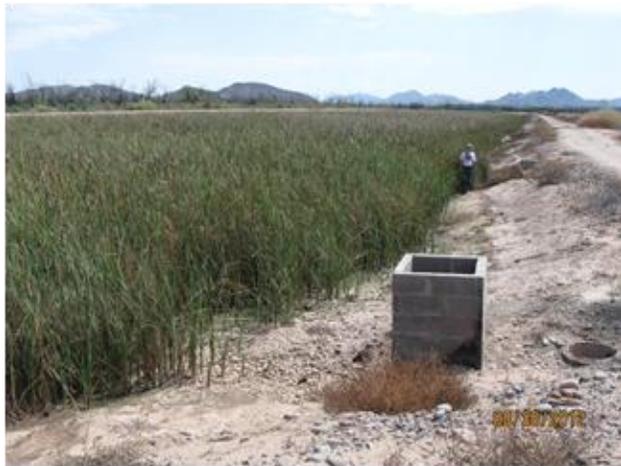
Figure 21. Photos of Arlington Wildlife Area Fire (March 7, 2012) and Aftermath (Photos taken March 21, April 30 and August 30, 2012, respectively).
