# Florida Key Deer Hurricane Irma Report

## *Salinity Measurements*

M. GRASSI, I. D. PARKER, R. R. LOPEZ, AND N. J. SILVY

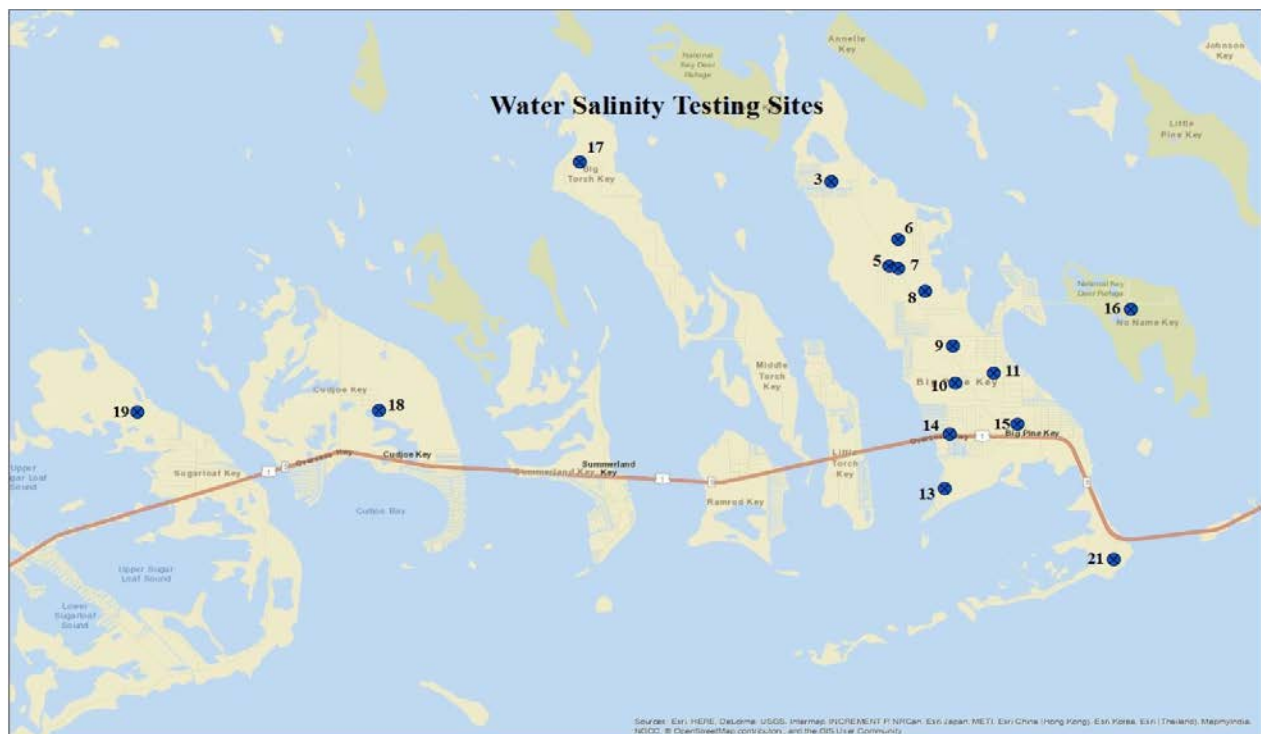
**Figure 2.** Location of freshwater holes monitored post-Hurricane Irma.

Freshwater is an important resource for Key deer. Following Hurricane Irma, salinity measurements at select waterholes were monitored to estimate recovery of freshwater solution holes (Fig. 2). The following information is a summary of those measurements.

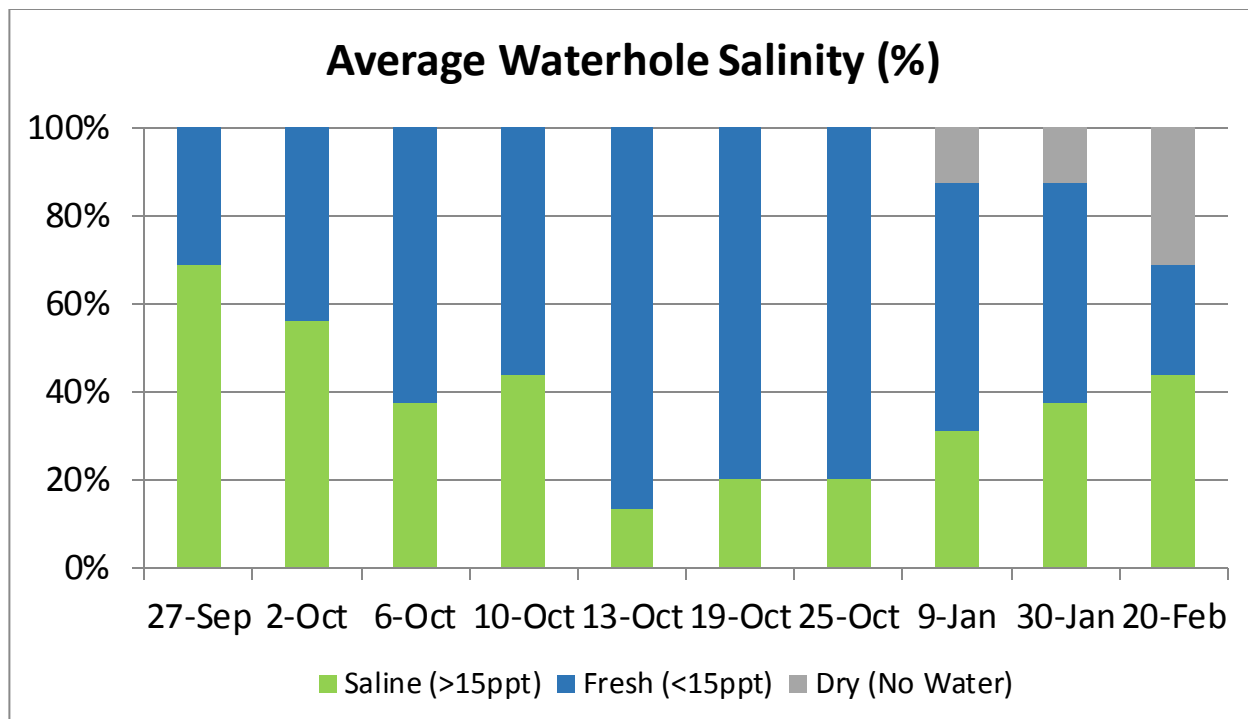
**Figure 3.** Average fresh waterhole salinity by date and status monitored post-Hurricane Irma.

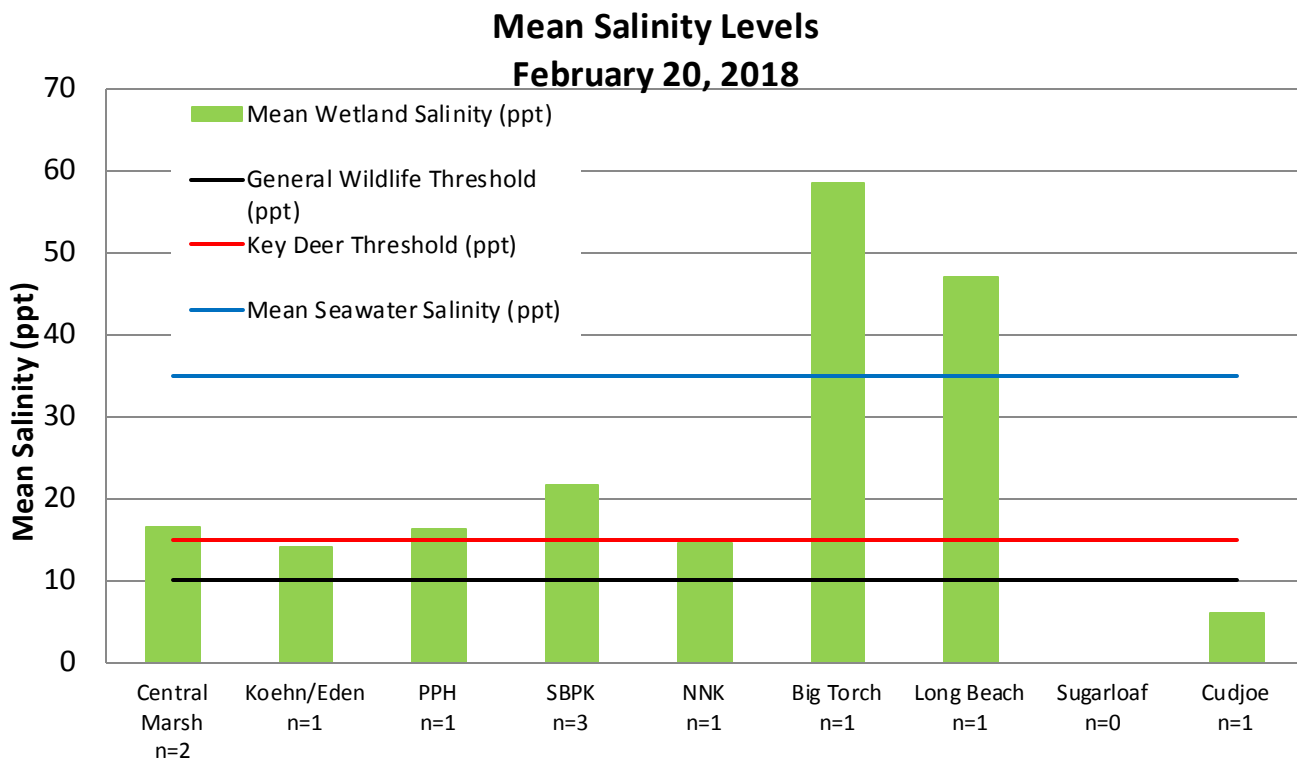
**Figure 3.** Average waterhole salinity by area monitored post-Hurricane Irma, February 20, 2018.
