EFFECTS OF LARGE WOOD AT TRINITY RIVER BANK REHABILITATION SITES

Daniel P. Menten^{*1}, Matthew Smith-Caggiano¹, Damon Goodman¹, Justin Alvarez² & Aaron Martin³

1-U.S. Fish and Wildlife Service, 1655 Heindon Rd. Arcata, CA, 95521 (707) 822-7201; 2-Hoopa Valley Tribal Fisheries Department; 3-Yurok Tribal Fisheries Program

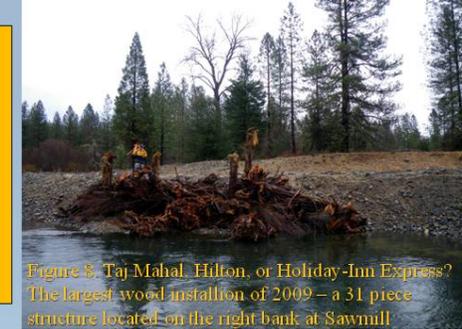
Figure 8. Taj Mahal, Hilton, or Holiday-Inn Express? The largest wood installation of 2009 – a 31 piece structure located on the right bank at Sawmill.

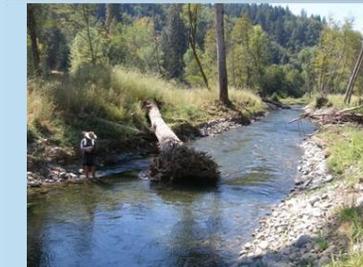
Figure 9. Large wood within the base flow threshold: available for fish use & affecting morphology. Indian Creek side channel 2008

- Of greatest significance to this study is the importance of placing installations within the active base flow channel. Pieces within the low flow channel produce immediate benefits to fish rearing at winter base flow, and initiate geomorphic effects at reduced flows (Figures 9&10)

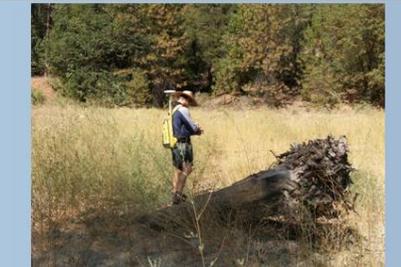
Figure 10. Large wood on the peak flow threshold where it is not producing measurable effects to channel morphology or fish habitat.

- Incorporating wood designs into site blueprints should be commonplace. Having a premeditated strategy and goals for wood installations will improve their effectiveness, reducing the incidence of ineffective or misplaced installations that provide minimal gains toward site specific objectives (Figure 10).

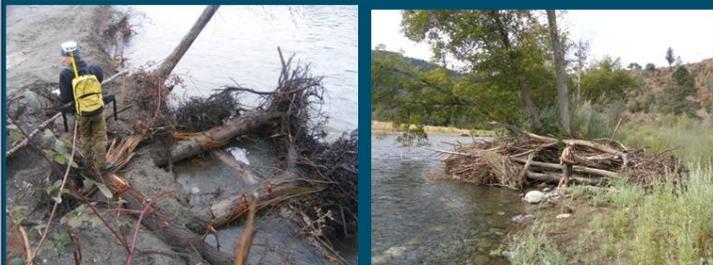
Logjams

Original Installation, Valdor 2006

Natural-Recruiting Logjam, Valdor Gulch 2008

Figure 1. The placement of this installation within proximity of the thalweg led to the natural recruitment of wood. The resulting scour and cover provides excellent rearing habitat for juvenile salmonids.

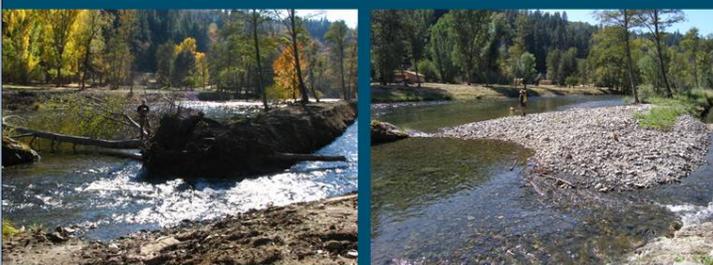
Transported Pieces-Abandoned Site

Lower Indian 2007

Lower Indian 2008

Figure 2. The transport of this wood assisted in scouring out the head of the Indian Creek side-channel and sorting of the substrate, leaving gravel and removing fine material

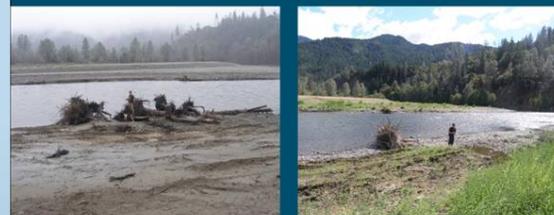
Scour: Valdor Gulch 12

Valdor Gulch 2006

Valdor 2007

Figure 4. This installation left an enormous scour pocket as high flows & vacating logs cut into the bank during Spring 2006.

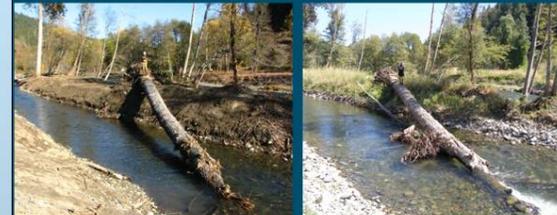
Recruited Pieces-Natural Transport:

Lower Indian 2007

Lower Indian 2008

Figure 5. Transported wood recruited onto a key piece. The resulting scour and cover provides excellent fish habitat.

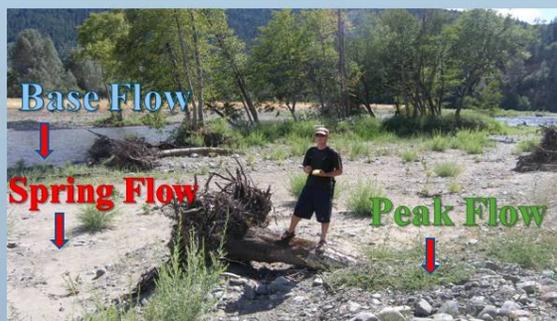
- Wood Location- All pieces of wood are assigned a channel location to which they belong, ie. bank, side-channel, etc
 - Flow-Location: Discrete classes describing where the wood is located on bank: peak-flow- wood becomes wetted at flows above 2,000 cfs. banks, spring-flow- wood is wetted between 450-2,000 cfs., and base flow- always wetted (between 300-450 cfs).

Figure 7. Picture showing flow thresholds, colors depict discrete flow thresholds from figure 6.
