Fish access to low order tributaries on the Trinity River

Abstract

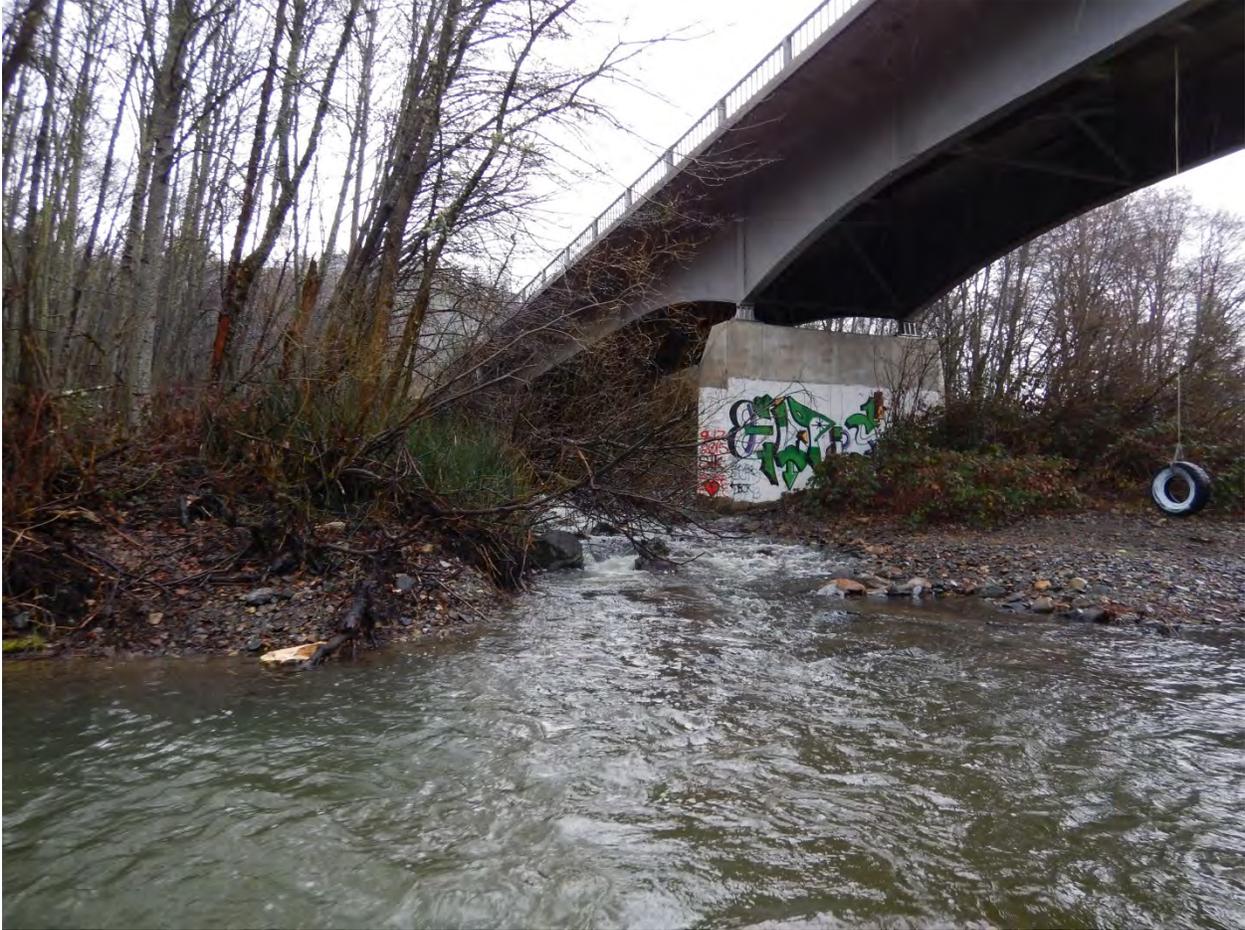
Deadwood Creek PIC102-0541-0544

Deadwood Creek is a third order tributary located at the new Lewiston Bridge in Lewiston Ca depicted in Figure 1. The long profile of Deadwood Creek is shown in Figure 2, the zero station is located at the bridge pier where tributary stages were unaffected by confluence conditions. Deadwood was easily passible by adult steelhead on the survey date. The minimum flow depth along the deepest flow path was 0.55 ft.

Figure 1. Deadwood a third order tributary located at the new Lewiston Bridge in Lewiston Ca.

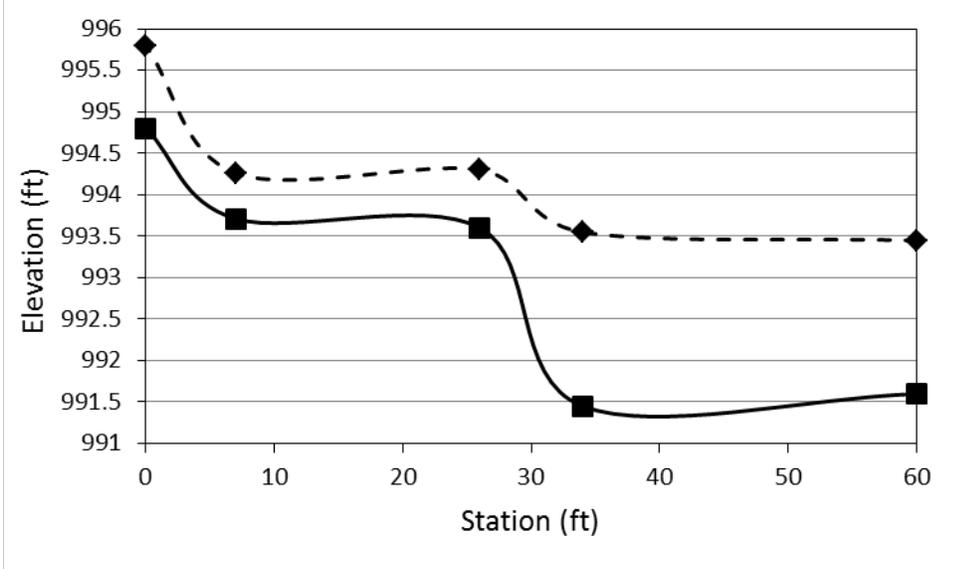
Figure 2. Profile and water surface elevation measurements of Deadwood Creek.

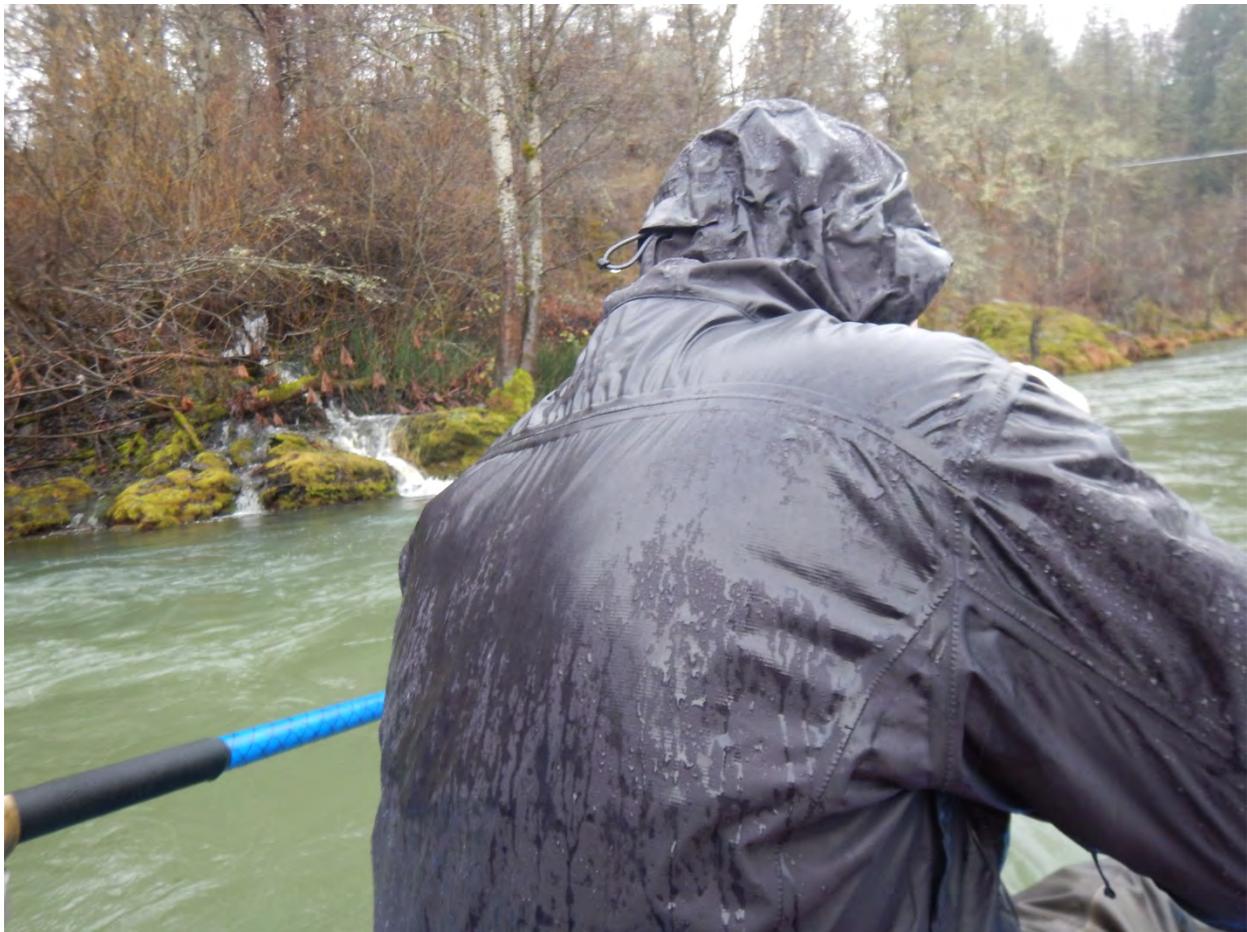
Hoadly Gulch PIC102-0572-0577

Hoadly Gulch is a 3rd order tributary that enters the Trinity from the left just downstream from the old Lewiston Bridge. The river needs to rise approximately 10' to provide access to this tributary due to a small waterfall near the confluence (Figure 3). Measurements were not obtained on this tributary because the precipitous confluence of the stream is believed to be a fish barrier at virtually all flows, and the stream gradient was deemed too steep to be surveyed safely.

Figure 3. Hoadly Gulch located downstream of the old Lewiston Bridge in Lewiston California.

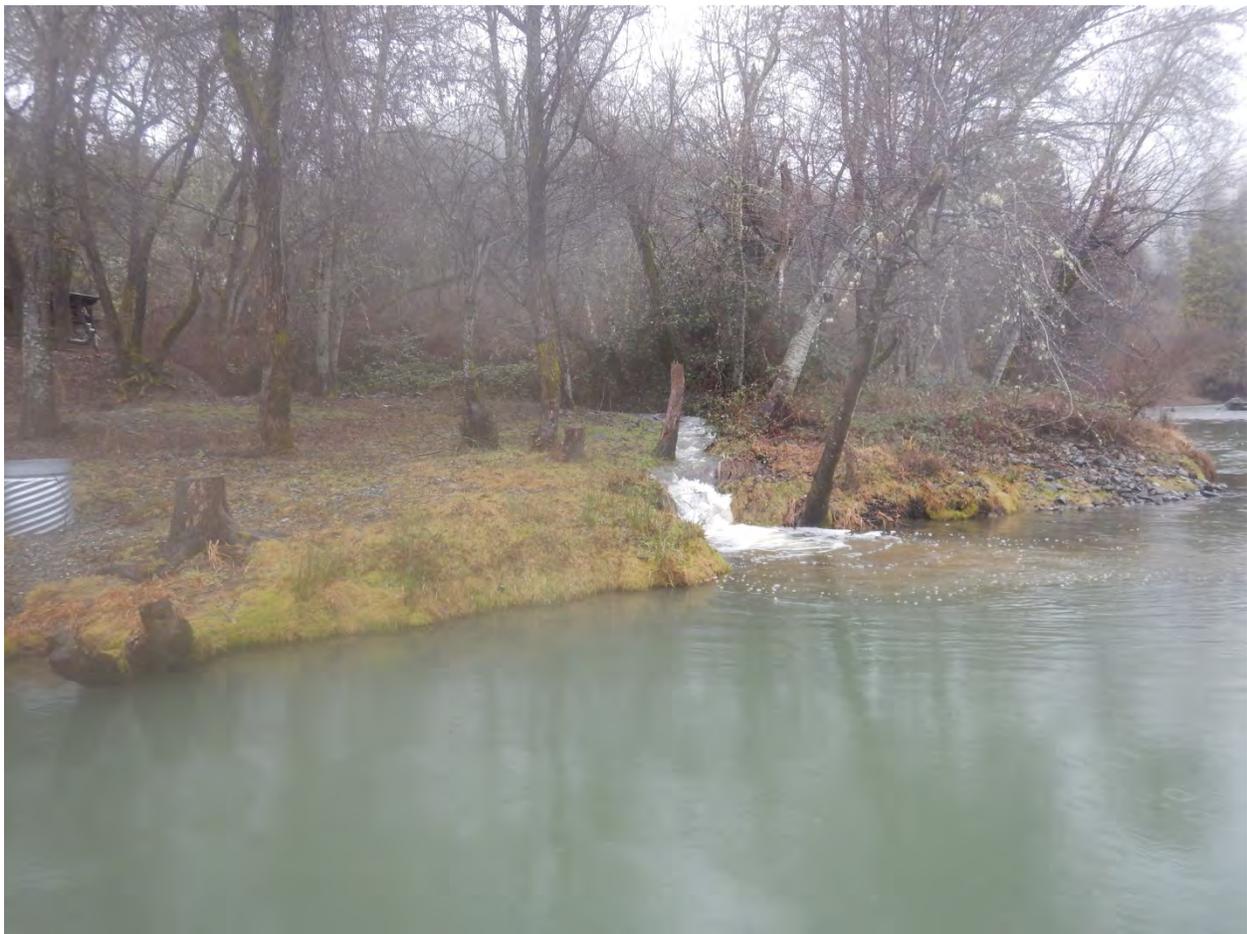
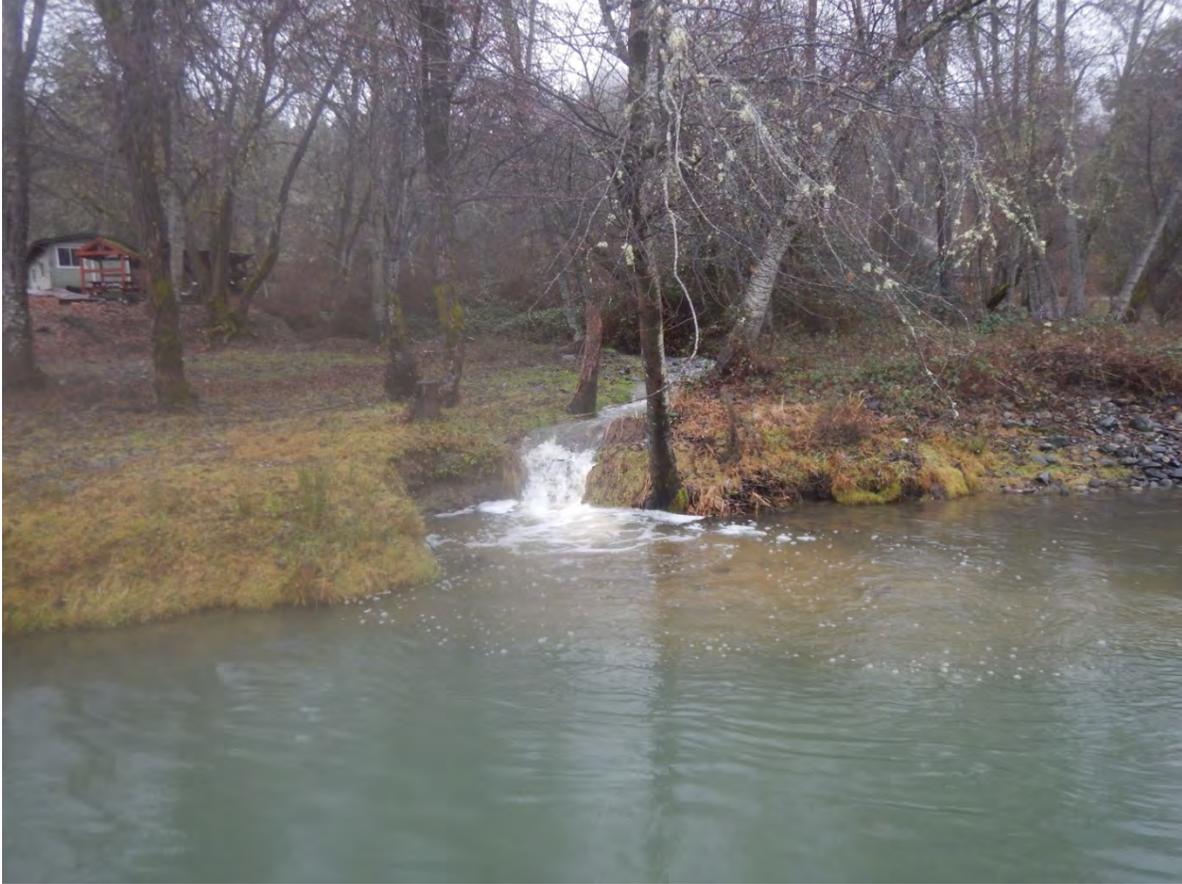
Alder Gulch PIC102-0578-0580

Alder Gulch is a 3rd order tributary that enters the mainstem on river left across from the Cemetery side channel entrance. The confluence of this tributary consists of a short plunge into the mainstem which would cause some difficulty to migrating fish (Figure 4 & 5). However this confluence is passible as a result of the pool below the plunge (Figure 6). Increasing mainstem stage by approximately 1.75 ft at the observed tributary flow conditions would ensure that this confluence presents no barrier to fish passage. This increase in depth would require a mainstem discharge of about 2000 cfs. The property owner at the confluence informed the field crew that while no adult fish have been observed in the stream, fingering size fish have been observed. The identity of the observed fingerling fish is unknown.

Figure 4. The confluence of Alder Gulch with the mainstem Trinity River.

Figure 5. The confluence of Alder Gulch with the mainstem Trinity River.

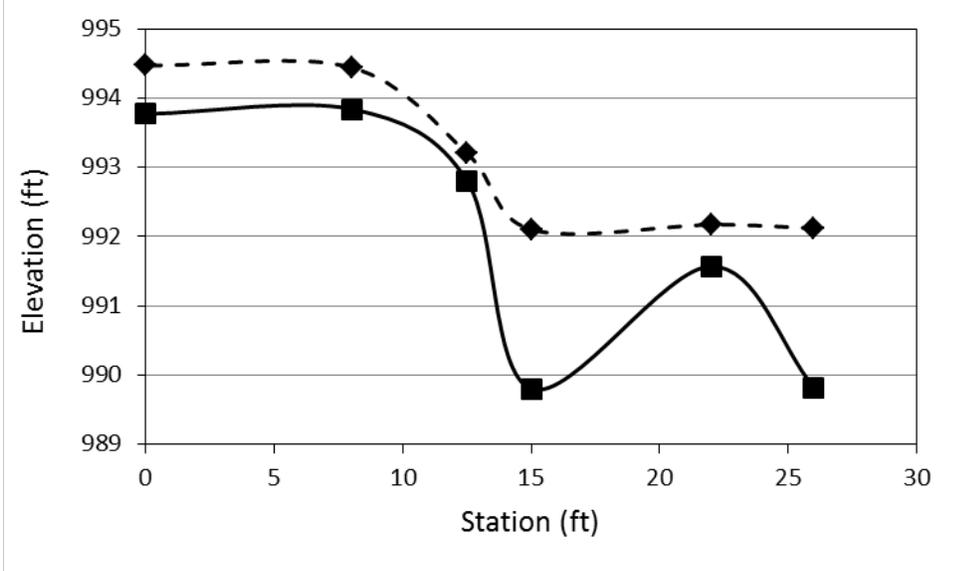
Figure 6. Profile and water surface elevation measurements of Alder Gulch.

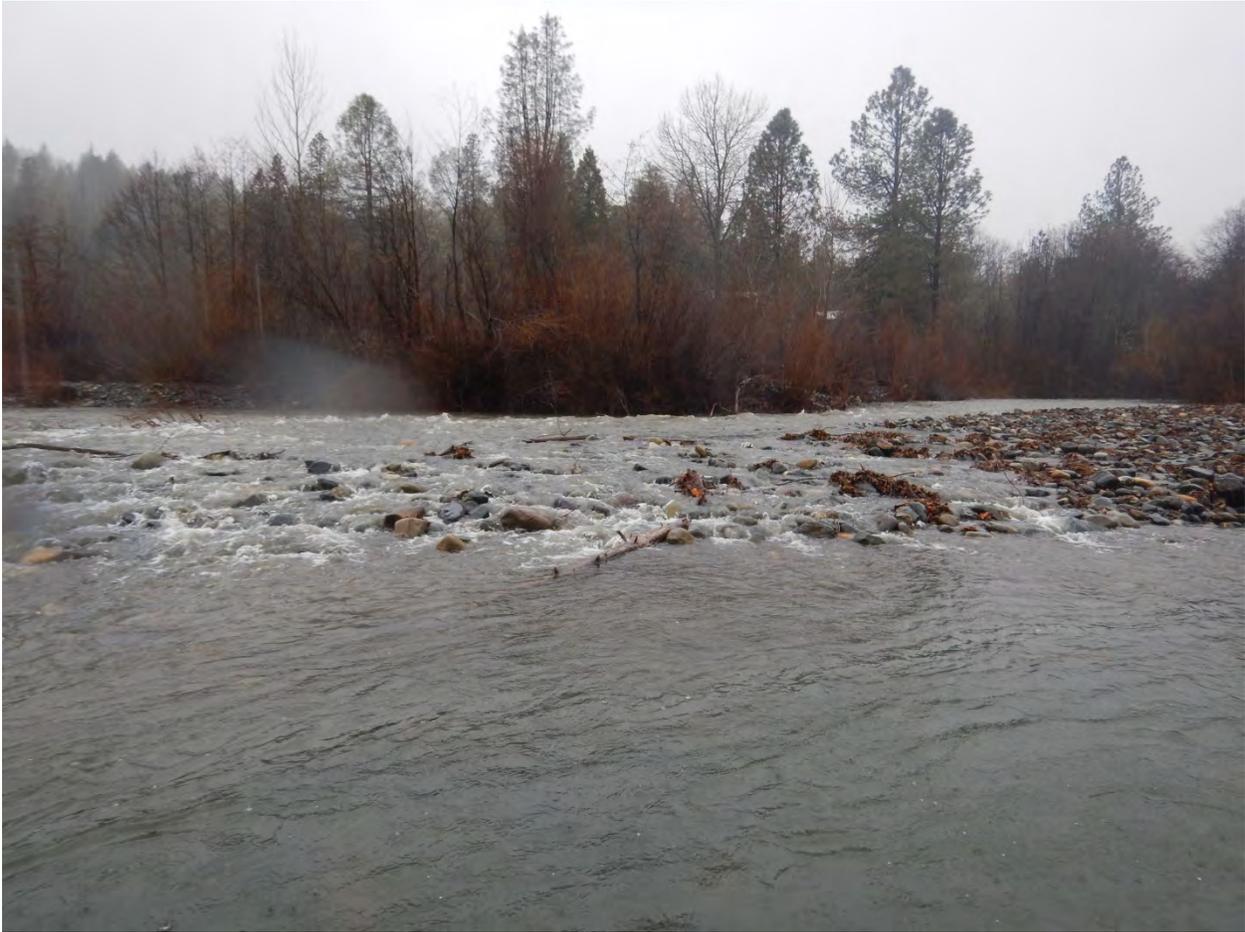
Rush Creek Pic103-0611-0617

The first major tributary below Lewiston Dam, Rush Creek enters on river right and has produced a large delta since dam closure. This delta is known to be highly dynamic and can change as a result of a single hydrologic event. Rush Creek was not surveyed during this study. Past studies have document multiple salmonid species in Rush Creek.

Figure 7. Rush Creek delta at the confluence with the mainstem Trinity River.

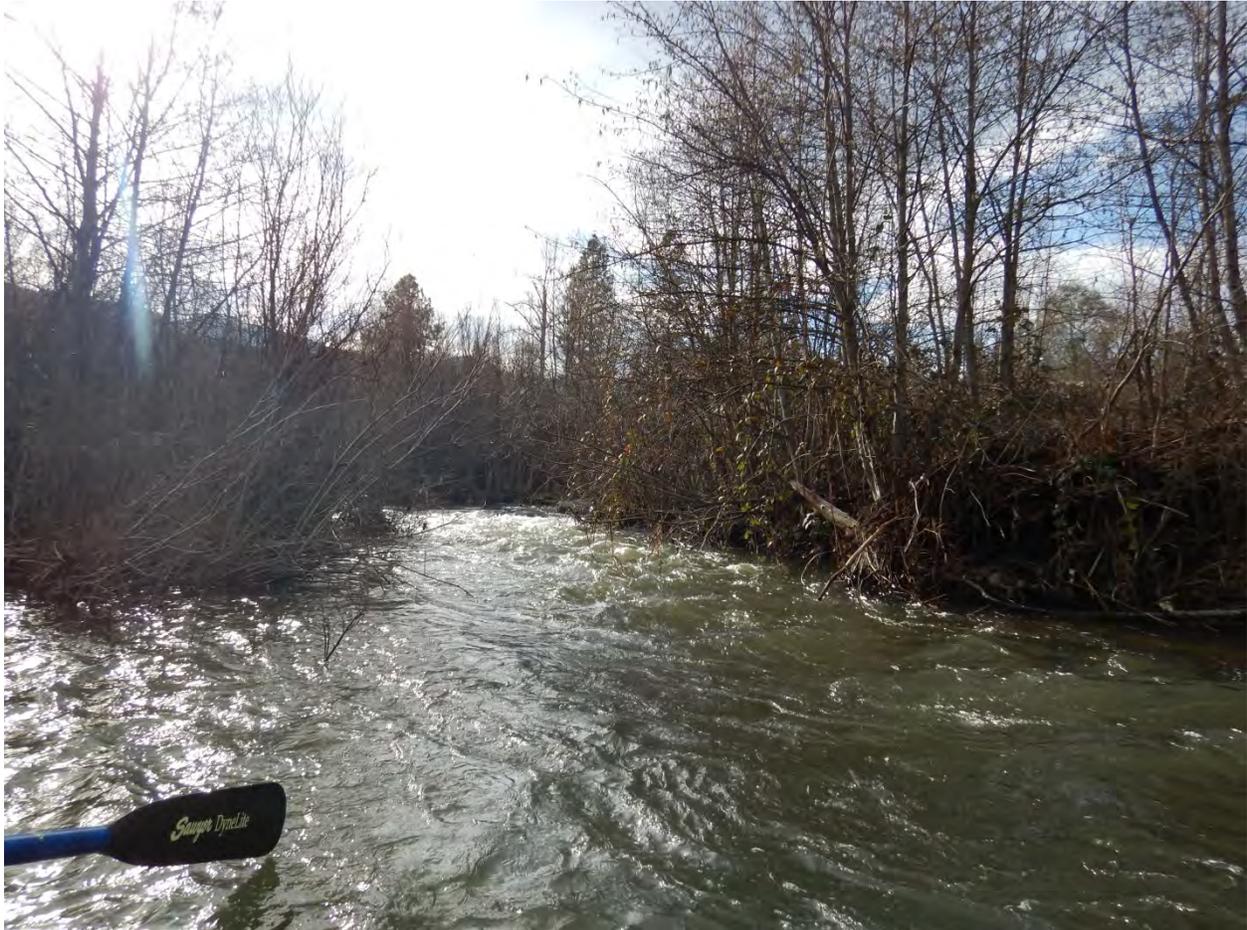
Grass Valley Creek Pic103-0734-0737

Grass valley creek is known to produce coho salmon as far upstream as the Buckhorn debris dam. Grass valley creek was not surveyed because the flow velocity and depths prevented the field crews from wading the stream. The confluence of Grass Valley is shown in Figure 8.

Figure 8. Grass Valley Creek at the confluence with the mainstem Trinity River.

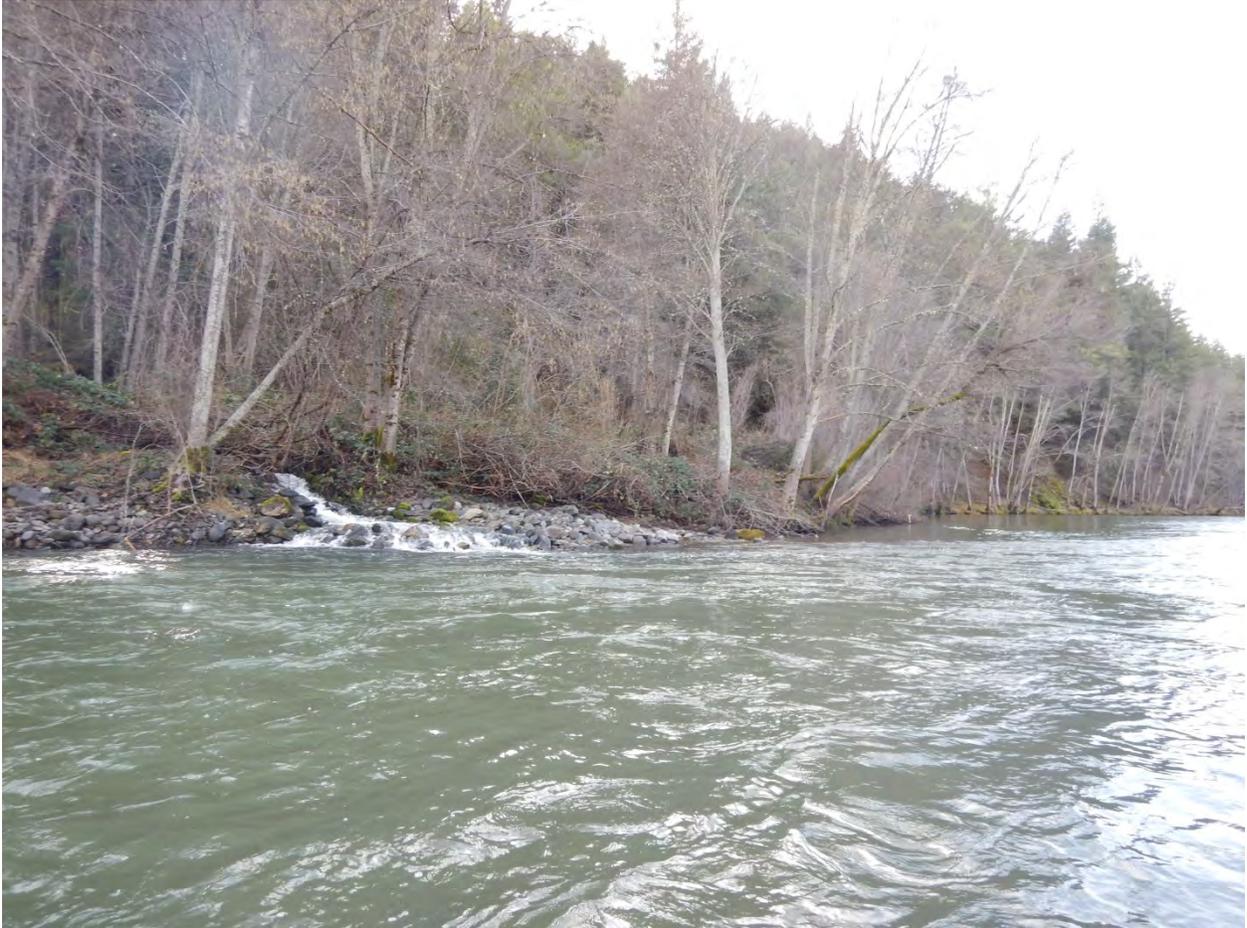
Tom Lang Gulch Pic103-0743-0749

Tom Lang Gulch is a 3rd order tributary that enters the Trinity River on the left in the Poker Bar neighborhood. The confluence of Tom Lange gulch is largely composed of cobble substrate (Figure 9). The confluence is steep (17% slope) and has multiple plunge pools, the largest of which is shown in Figure 10. All of the plunge pools observed were believed to be passible. The

Figure 9. Tom Lang Gulch at the confluence with the mainstem Trinity River.

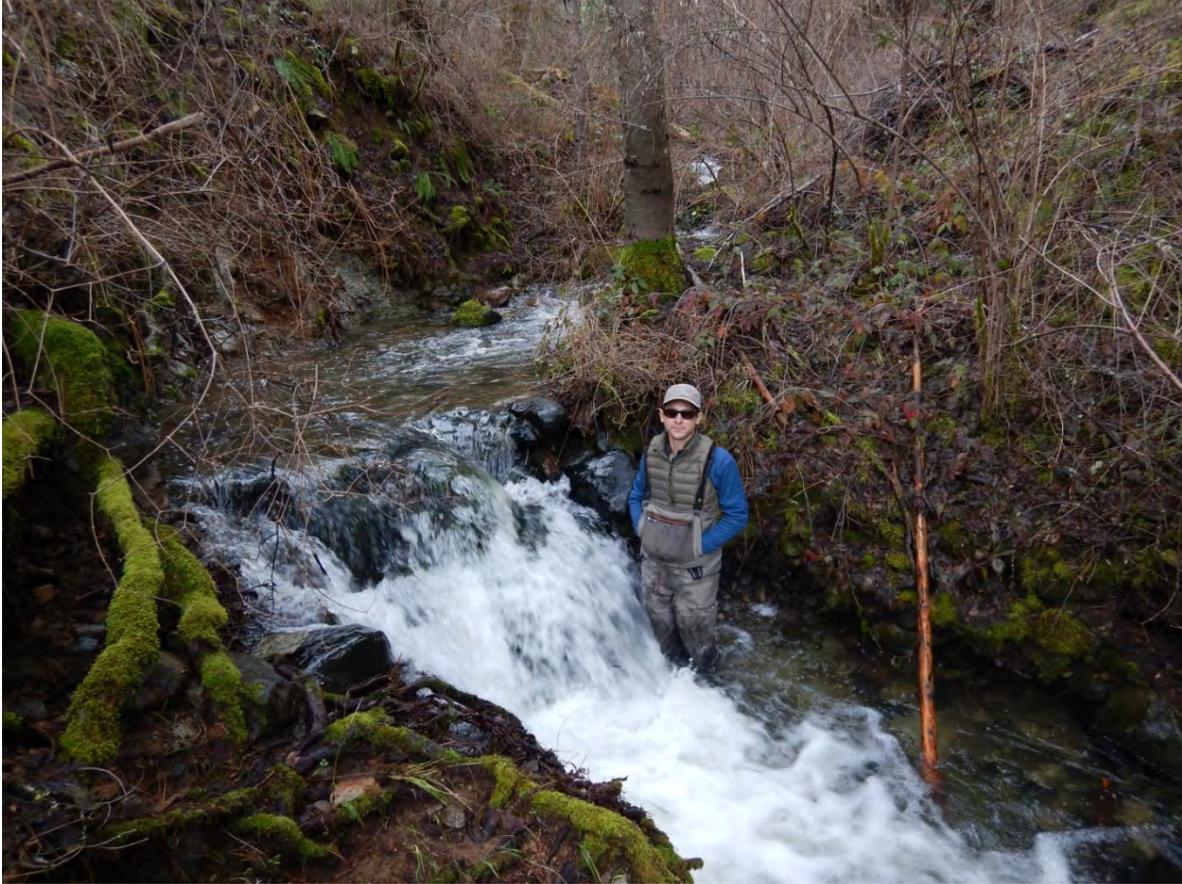
Figure 10. Plunge pool on Tom Lang Gulch with fish technician shown for scale. This plunge pool is believed to be passible by fish due to the pool at the bottom.

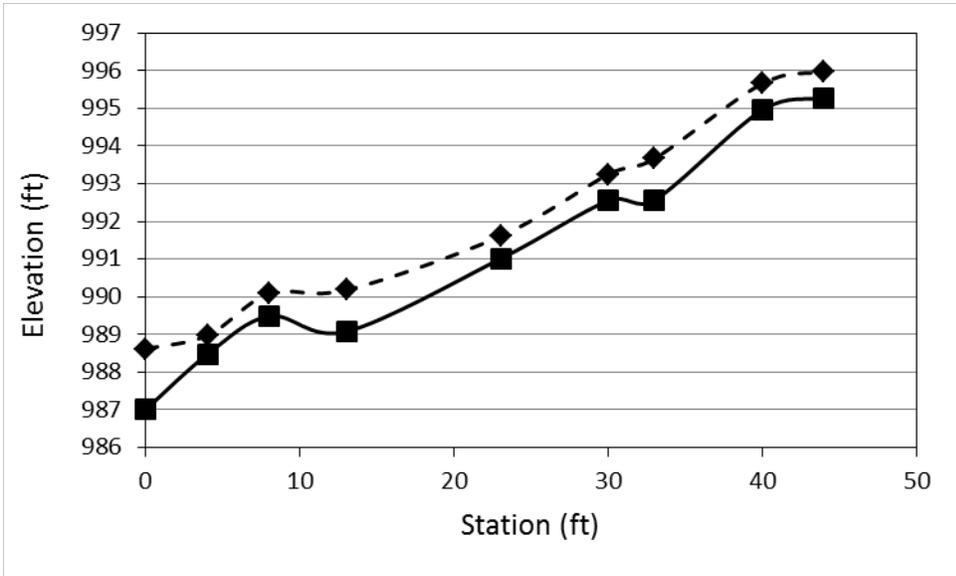
long profile and flow depth of Tom Lang confluence is shown in Figure 11. The confluence was deemed difficult for fish to pass in large part due to a debris dam near station 40 of the survey. A mainstem flow rate of about 1250 cfs is required for the confluence to pose no barrier to fish passage. That discharge produces a stage approximately 1.1 ft higher than was present on the survey date. The long term stability of the debris jam is uncertain and it may wash out during subsequent high flow events and permit fish passage up this tributary.

Figure 11. Tom Lang Gulch long profile and stream depth.

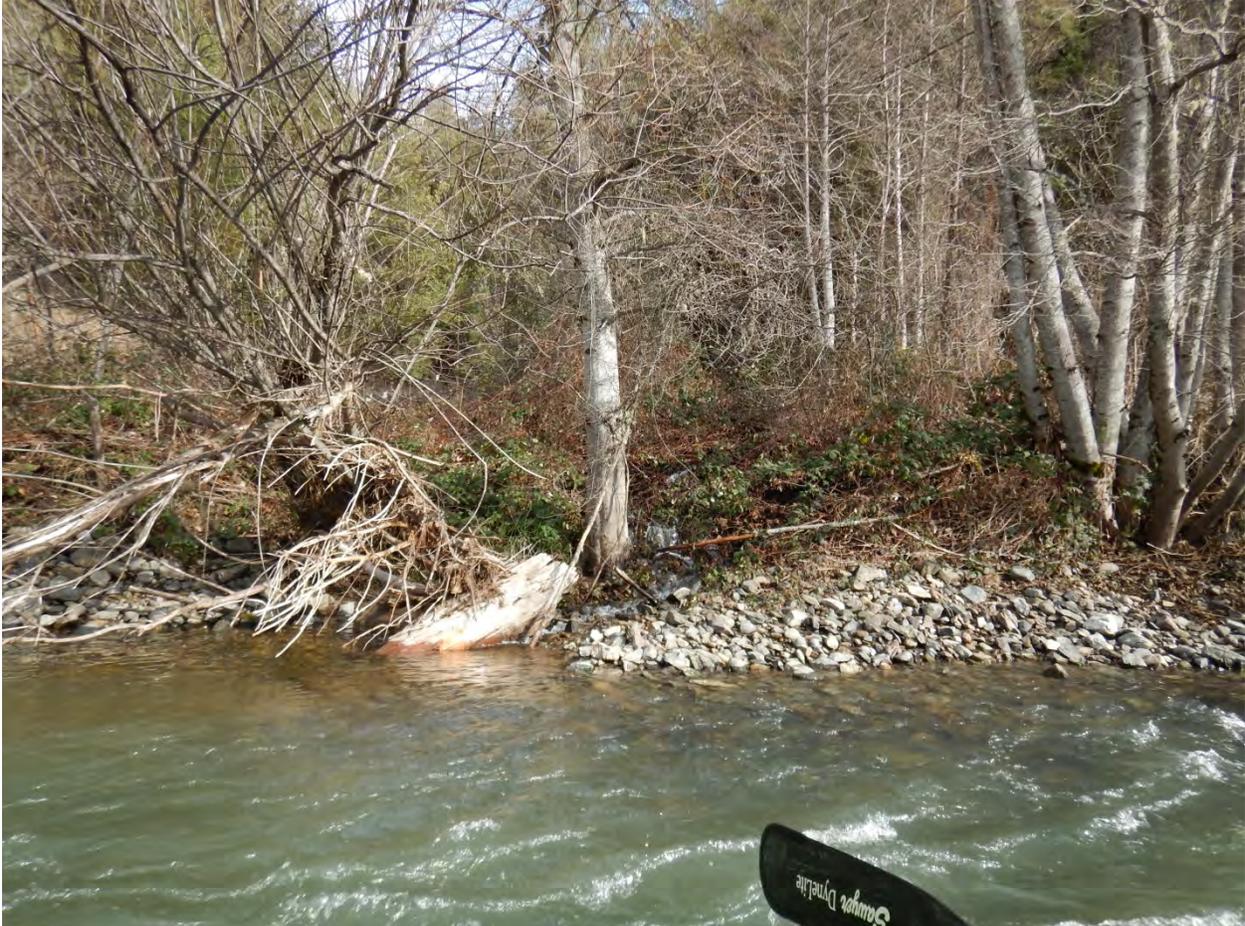
Ditch above China Gulch on the right Pic103-0762-0763

The confluence of a small (1st order) tributary located on river left upstream of China Gulch is shown in Figure 12. This tributary was impassible to fish and was not surveyed.

Figure 12. Ditch above China House Gulch at the confluence with the mainstem Trinity River.

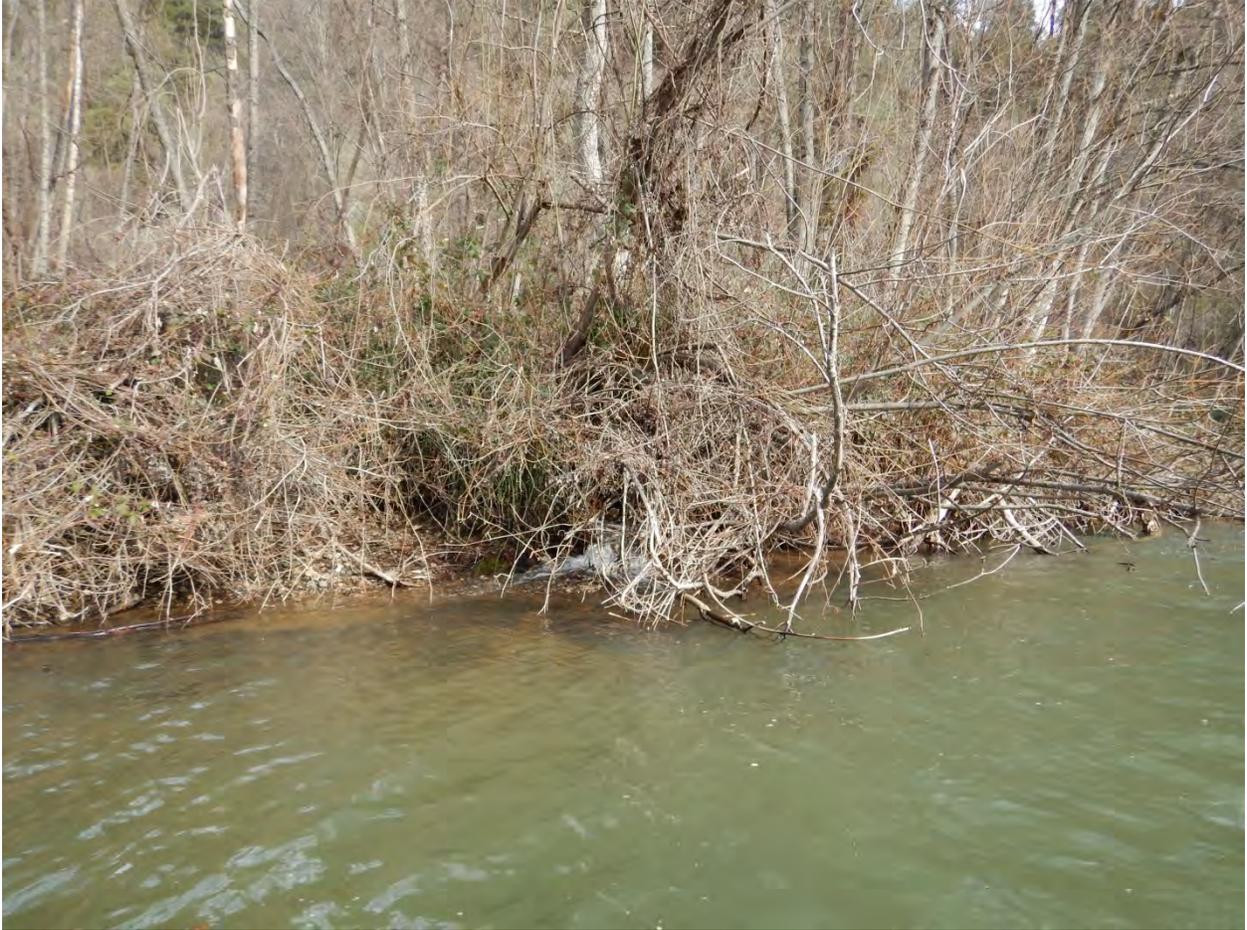
China House Gulch pic103-0764-0766 No passage

China gulch is a small second order tributary located on river right downstream of society pool. China gulch confluence is shown in Figure 13. Due to the heavy vegetation and small stream size this tributary was impassible to fish and was not surveyed.

Figure 13. China House Gulch at the confluence with the mainstem Trinity River.

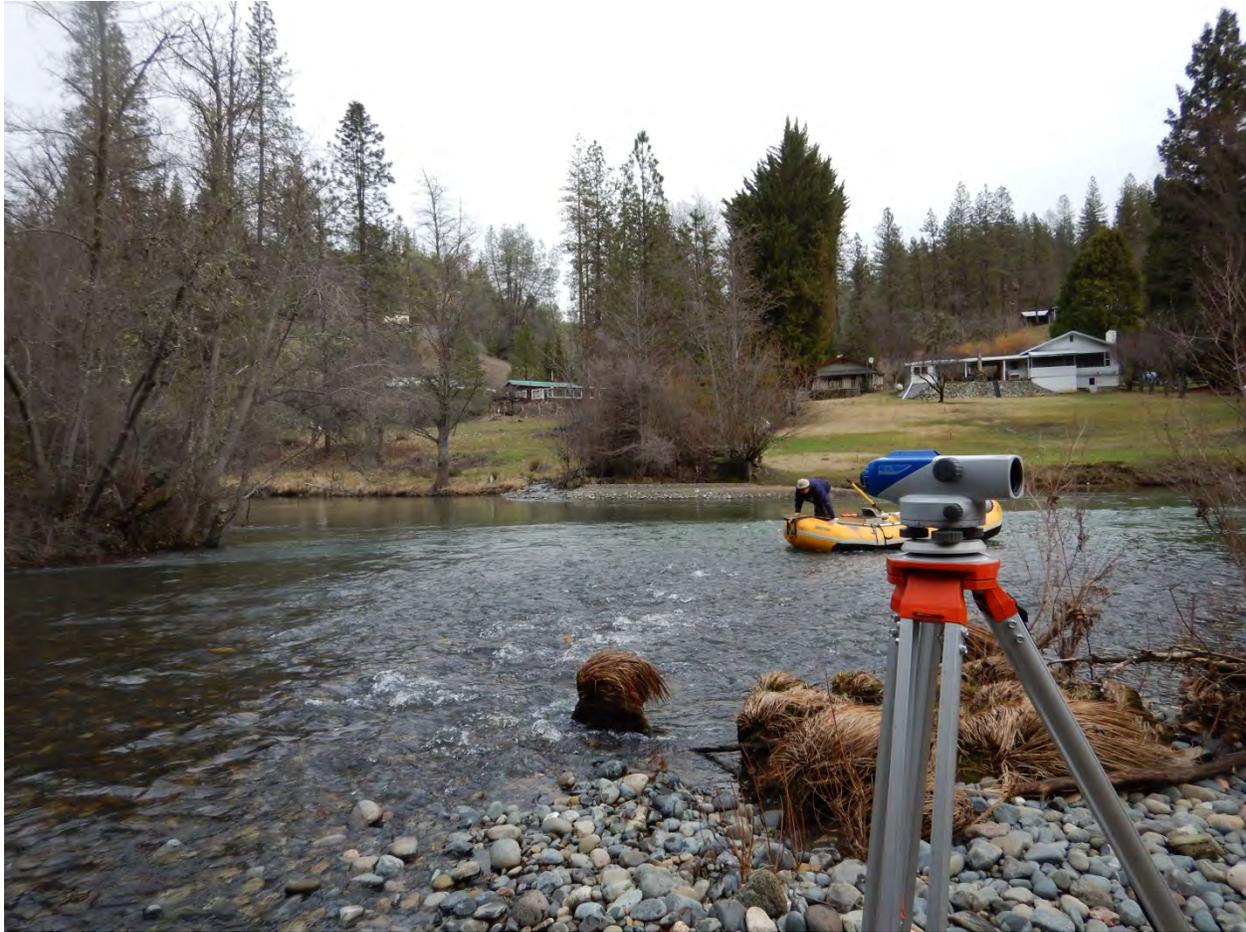
McIntyre Gulch is a second order tributary that enters the Trinity downstream of Biggers Bridge off Steel Bridge road. The confluence is located in a beautiful section of river with many flow bifurcations (Figure 14).

Figure 14. McIntyre Gulch at the confluence with the mainstem Trinity River with survey level in the foreground. The long profile and flow depth is shown in Figure 15. The shallowest portion of the deepest flow path is 0.15 ft. McIntyre Gulch is not passible to steel head due to the long shallow confluence. If the mainstem stage were to be increased by 0.5 ft McIntyre confluence would be no barrier to fish passage. Mainstem flow of 1100 cfs would increase the stage at this location about 0.5 ft and allow fish passage.

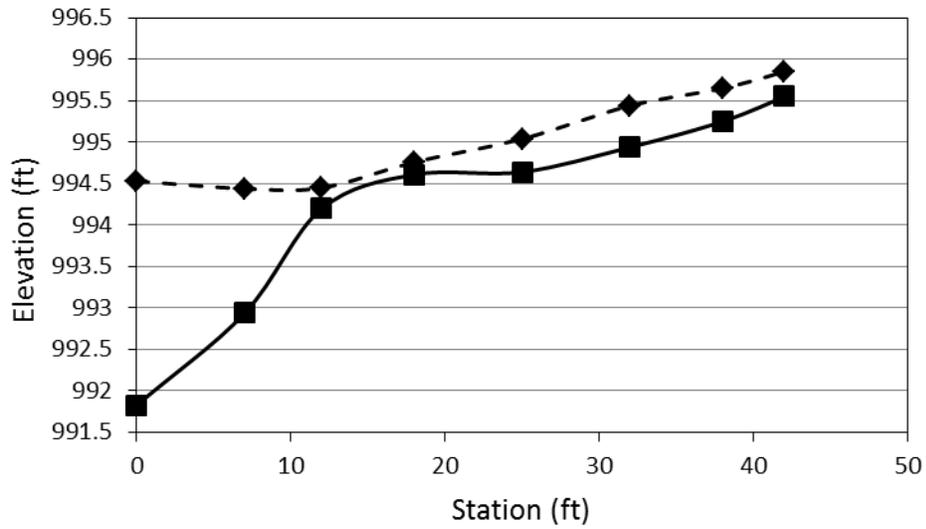
Figure 15. Long profile and depth of McIntyre Gulch.

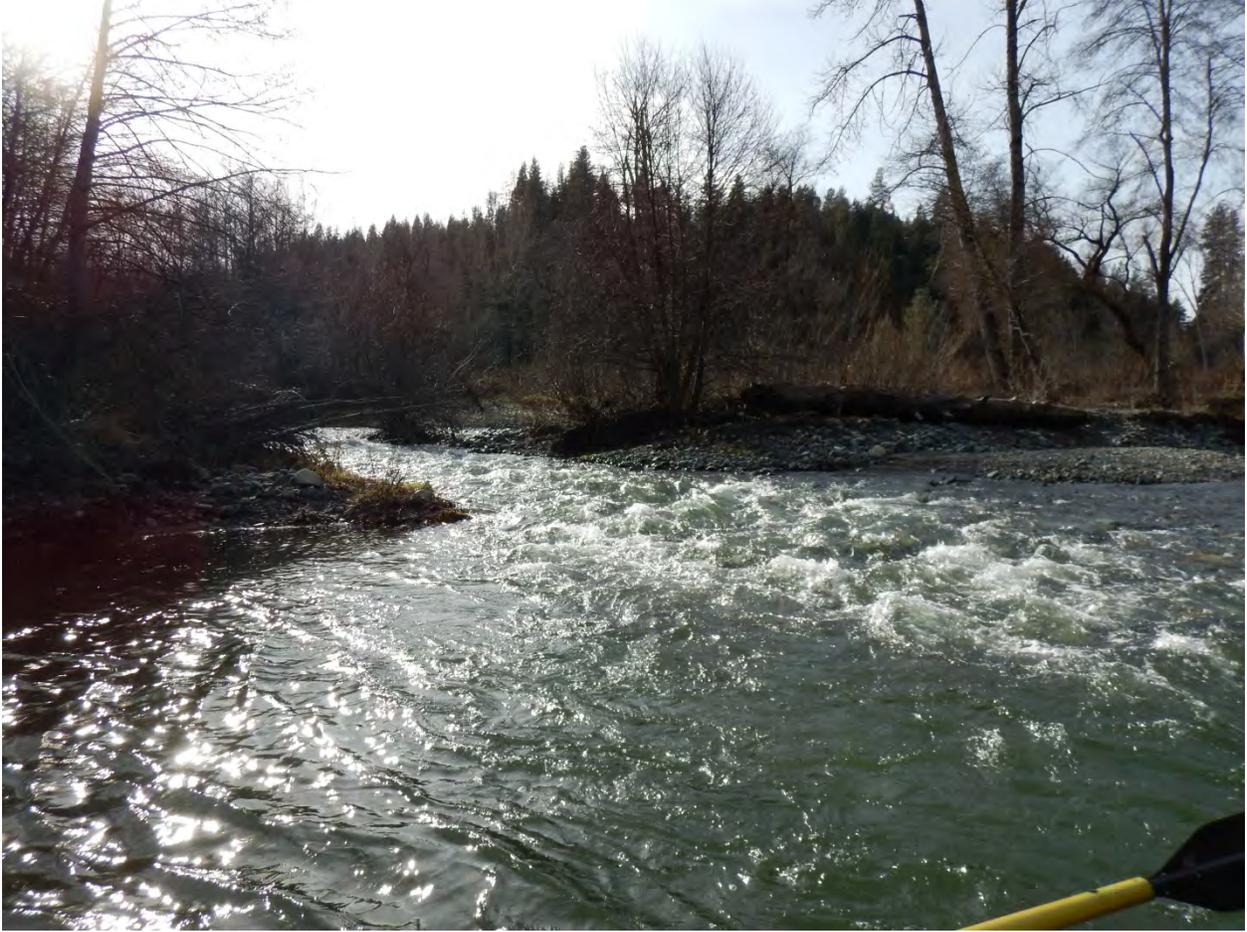
Indian Creek enters the Trinity River on the left (Figure 16). Indian Creek was not surveyed as flow rate prohibited the field crew from standing in the thalweg to obtain measurements. Indian Creek confluence provided no barrier to fish passage.

Figure 16. Indian Creek confluence with the Trinity River.

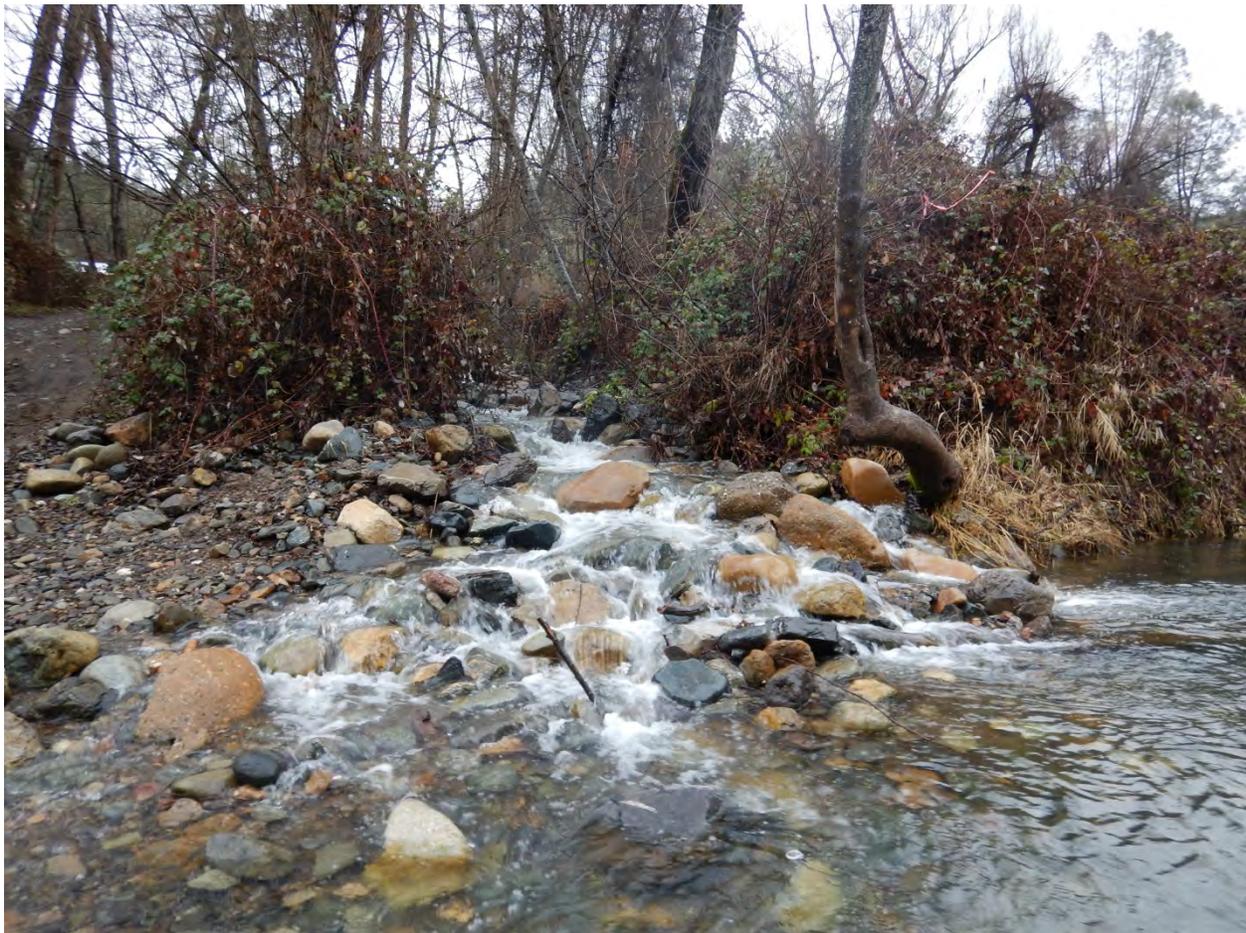
Dutton Creek Pic 0495-0501

Dutton Creek is a 3rd order stream located along Steiner Flat Rd. Dutton Creek's confluence with the Trinity River is a small delta-like feature comprised of boulder and cobble (Figure 18). The confluence was not passible on the survey date. Dutton Creek was passible upstream of the confluence to at least above Steiner Flat Road. The long profile and flow depth of the Dutton Creek confluence is shown in Figure (19). Main stem flows required to facilitate fish passage into Dutton Creek would need to raise river stage at the confluence by approximately 1.5 feet which corresponds to a flow rate of 1750 cfs.

Figure 18. Dutton Creek confluence with the Trinity River.

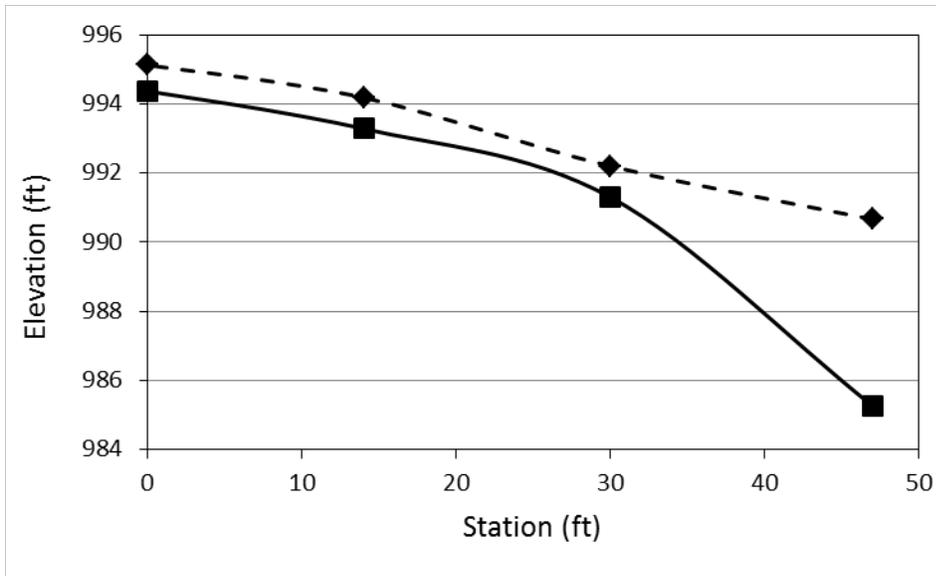
Figure 19. Dutton Creek long profile and depth.

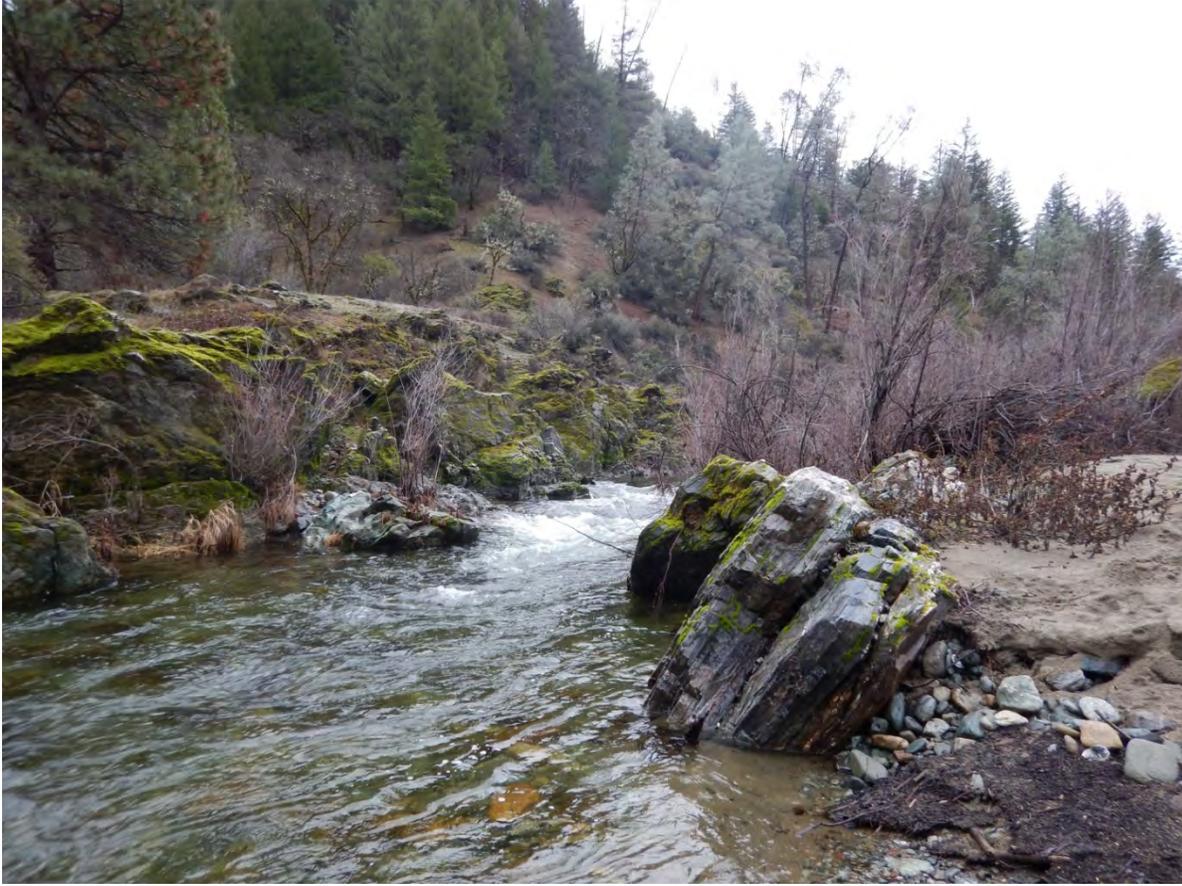
Browns Creek Pic0514-0518

Browns Creek is a fourth order tributary that enters the Trinity on river left in the canyon reach at the end of B-Bar-K road. Browns Creek confluence is shown in Figure 20. The long profile and flow depth is shown in Figure 21. The relatively deep (1.5 ft) tributary confluence provides no barrier to fish passage. Steel head spawning has been observed in Browns Creek along B-Bar-K road by program biologists.

Figure 20. Browns Creek confluence with the Trinity River.

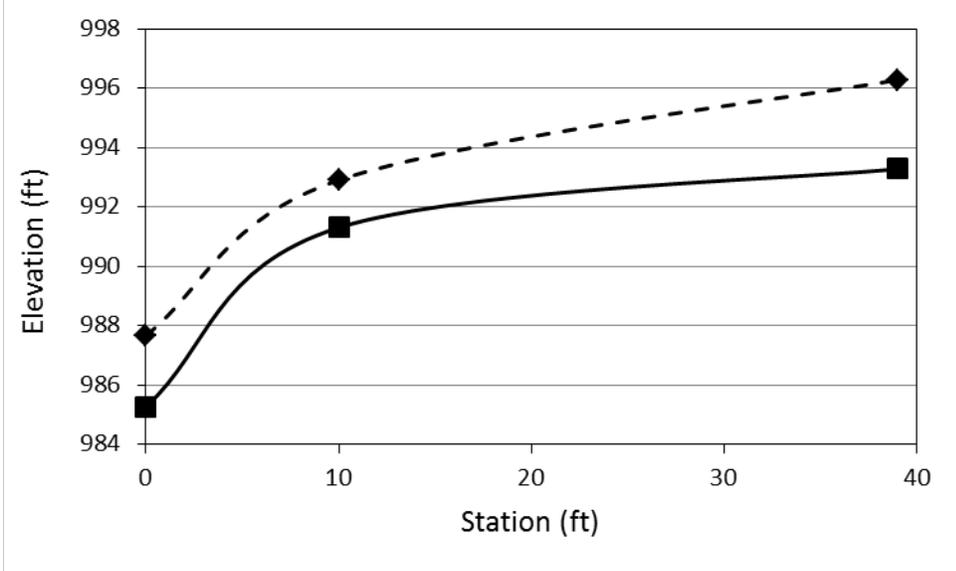
Figure 21. Browns Creek long profile and depth.

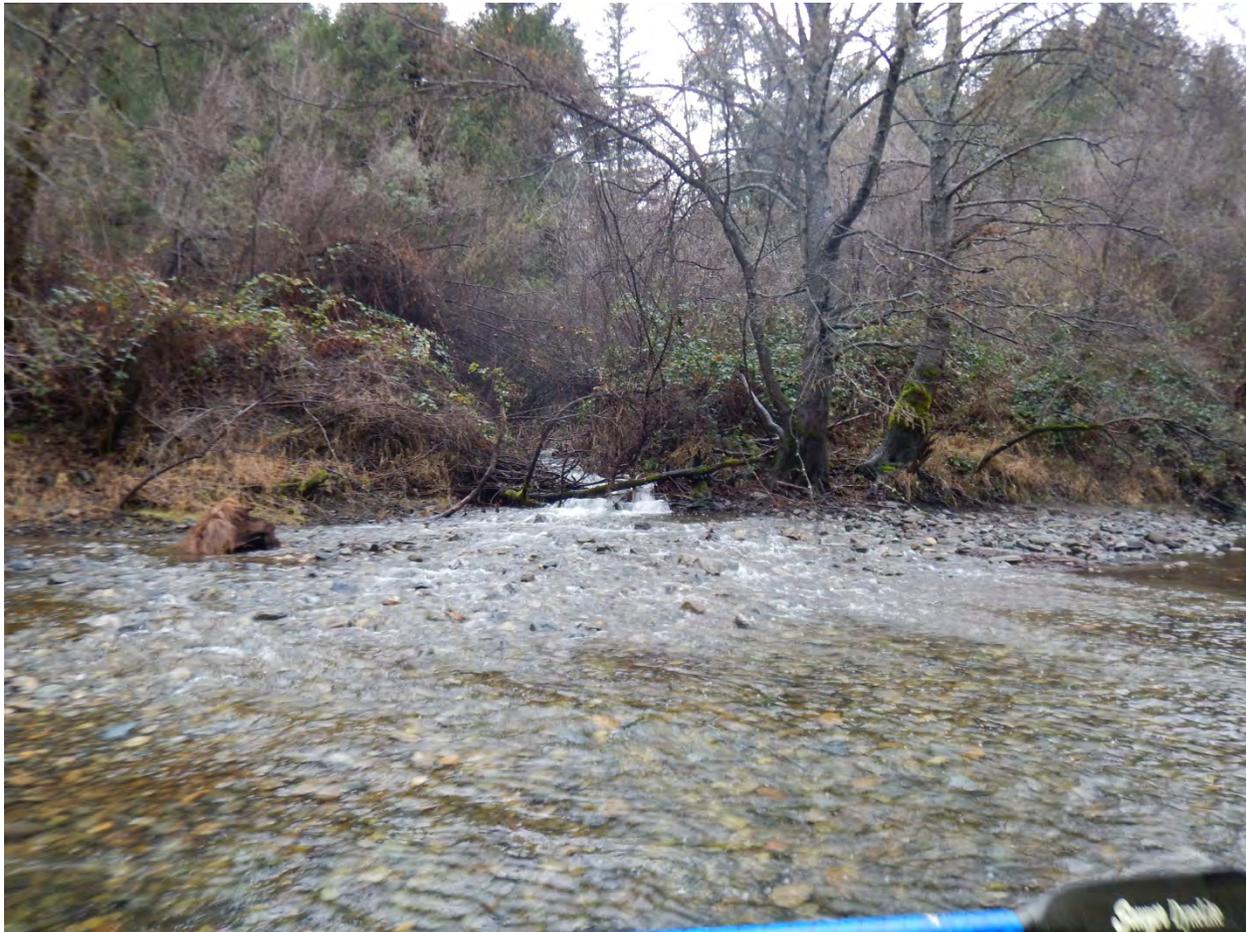
Maxwell Creek Pic0519-0529

Maxwell Creek enters the Trinity River on river left at the end of the canyon reach above Dutch Creek. This third order tributary has deposited a delta fan, which spreads tributary water over a large shallow area (Figure 22). Maxwell Creek immediately upstream of the confluence contains significant amounts of large woody debris and is relatively confined compared to the confluence (Figure 23). The long profile indicates mainstem stage would need to increase 1 ft to make the confluence easily passible to steelhead (Figure 24). The mainstem flow would need to be approximately 1250 cfs to bring the river stage up 1 ft above the stage observed on the survey date.

Figure 22. Maxwell Creek confluence with the Trinity River.
