Fish access to low order tributaries on the Trinity River

Abstract

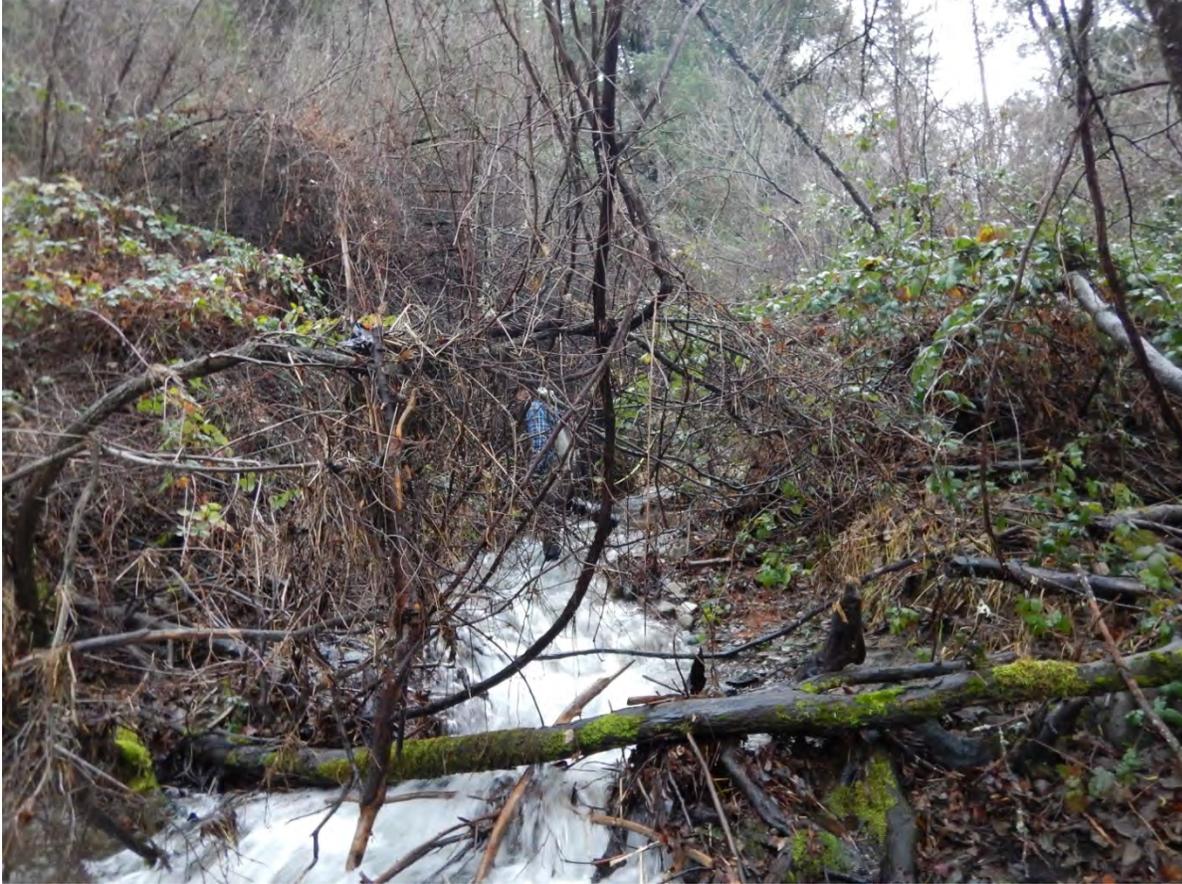
Maxwell Creek enters the Trinity River on river left at the end of the canyon reach above Dutch Creek. This third order tributary has deposited a delta fan, which spreads tributary water over a large shallow area (Figure 22). Maxwell Creek immediately upstream of the confluence contains significant amounts of large woody debris and is relatively confined compared to the confluence (Figure 23). The long profile indicates mainstem stage would need to increase 1 ft to make the confluence easily passible to steelhead (Figure 24). The mainstem flow would need to be approximately 1250 cfs to bring the river stage up 1 ft above the stage observed on the survey date.

Figure 23. Maxwell Creek just above the confluence with the Trinity River.

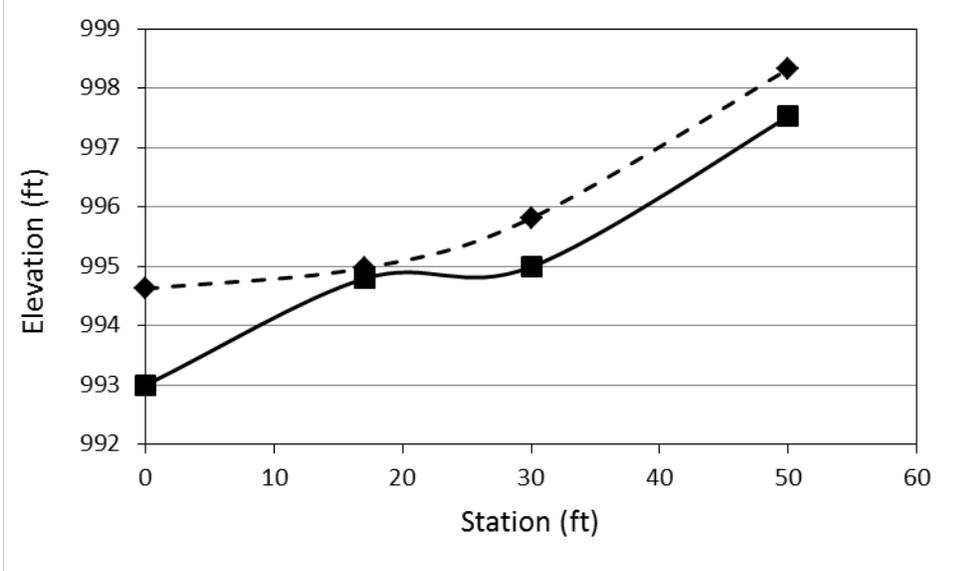
Figure 24. Maxwell Creek long profile and depth.

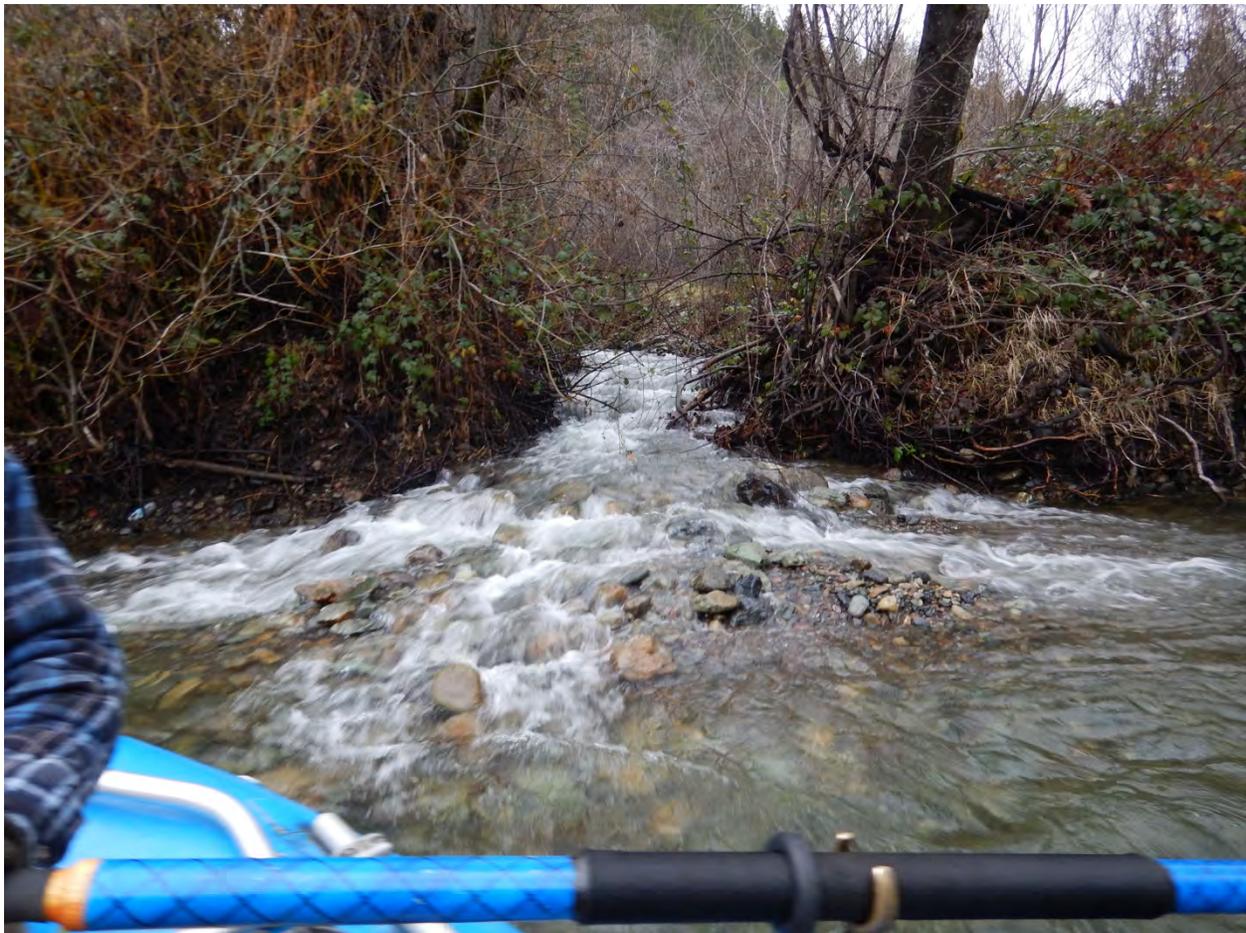
Dutch Creek Pic0530-0533

The Dutch Creek confluence with the Trinity River is on river right just upstream of Evans Bar. A small delta was present in the mainstem river on the survey date (Figure 25). The deepest flow path is in the right side of Figure 25. The shallowest spot in the deepest channel on the fan was 6”0.5 ft deep and was missed in the survey of the long profile. Dutch Creek confluence was considered difficult for fish to pass, but not impossible. The long profile indicates that mainstem stage needs to increase by approximately 1 ft to make the Dutch Creek easily accessible. Based on SRH-2D modelling, a mainstem flow rate of 1100 cfs would be sufficient to remove any barrier to fish passage.

Figure 25. Dutch Creek confluence with the Trinity River.

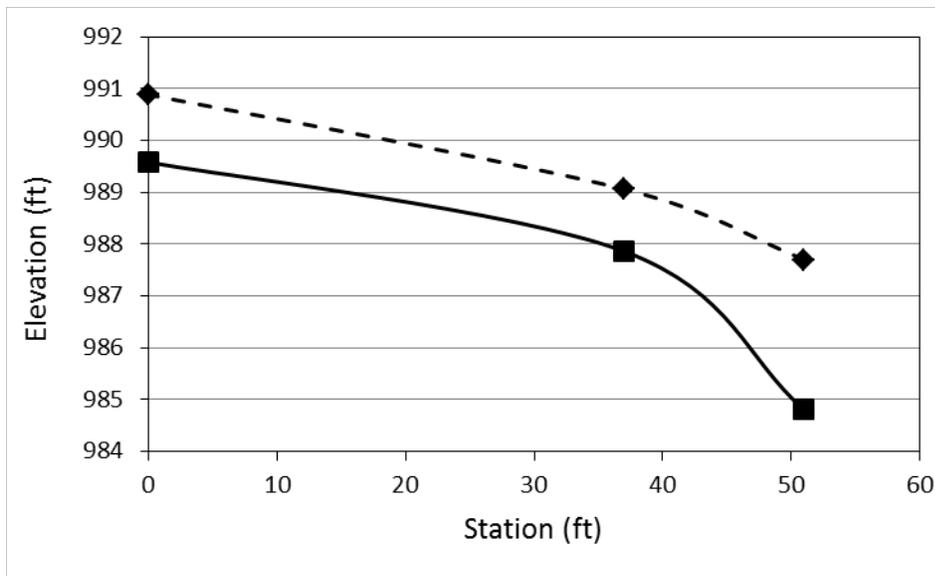
Figure 26. Dutch Creek long profile and depth.

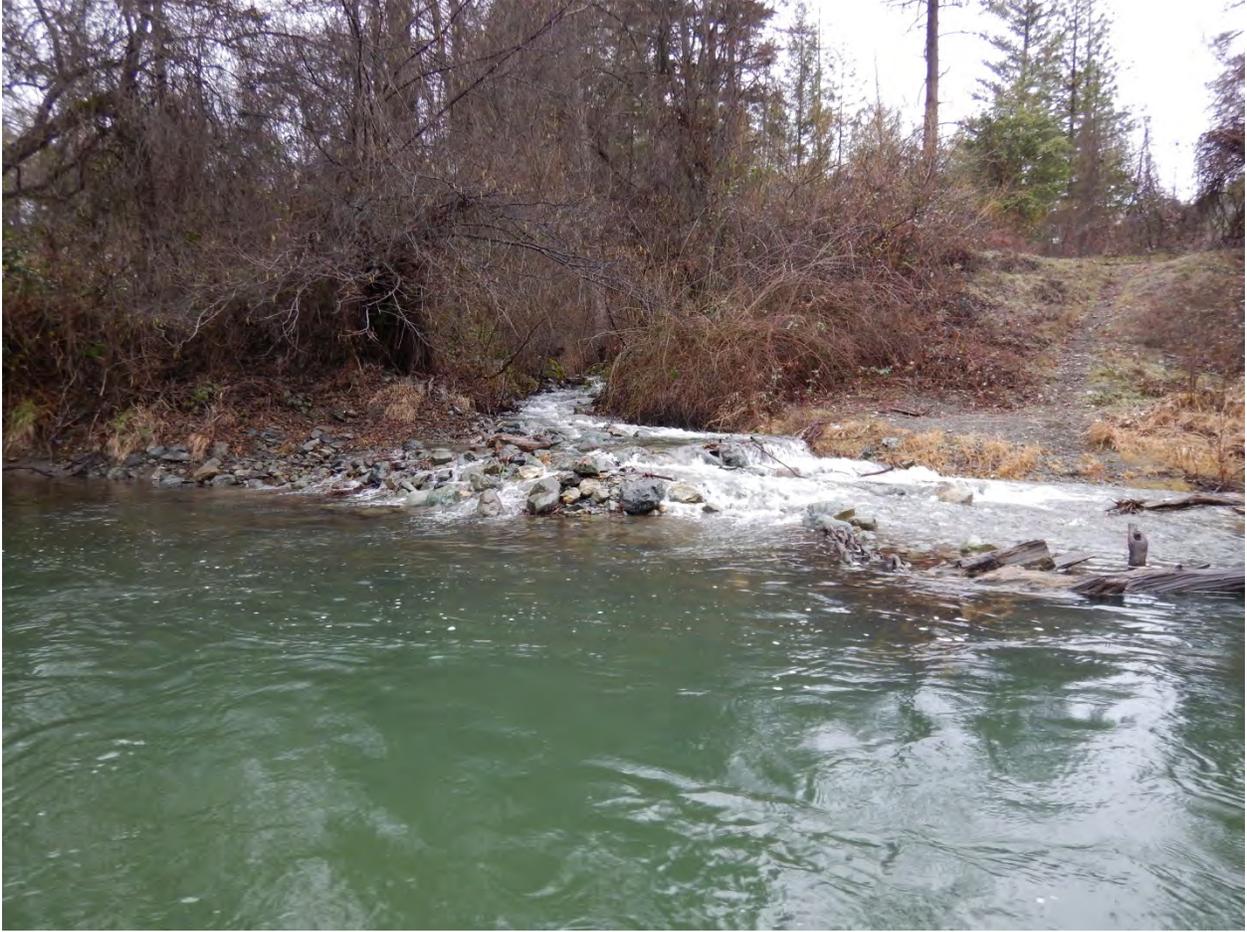
Soldier Creek Pic0371-0375

Soldier Creek is located on river left downstream of Evans Bar. When Soldier Creek is first viewed from a distance, the confluence appears difficult for fish to negotiate with white rushing waters (Figure 27). However minimum flow depth on the deepest flow path was measured at 0.75ft and determined to be easily passible for adult steelhead (Figure 28). The long profile and flow depth of Soldier Creek is shown in Figure 29.

Figure 27. Soldier Creek confluence with the Trinity River.

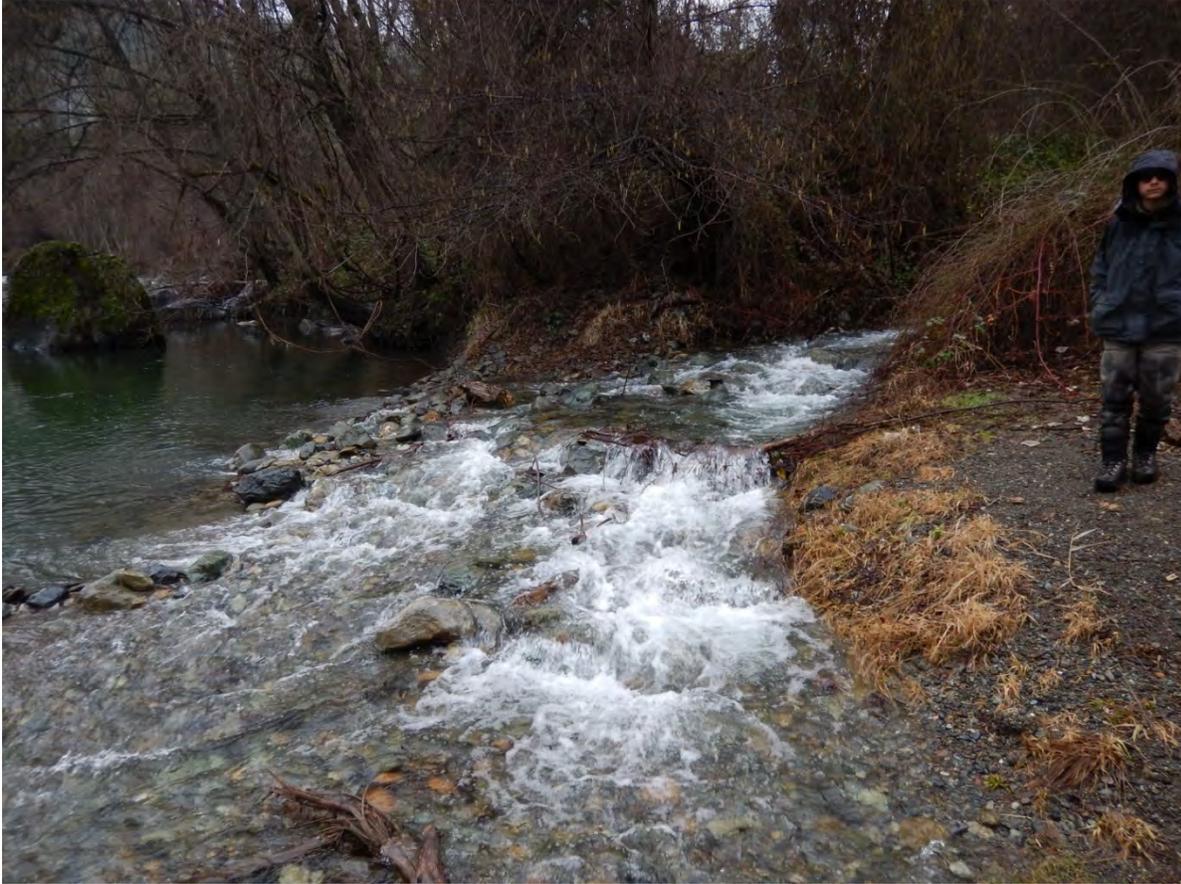
Figure 28. Soldier Creek confluence with the Trinity River. The deepest flow path is left of the wood and rock divide.

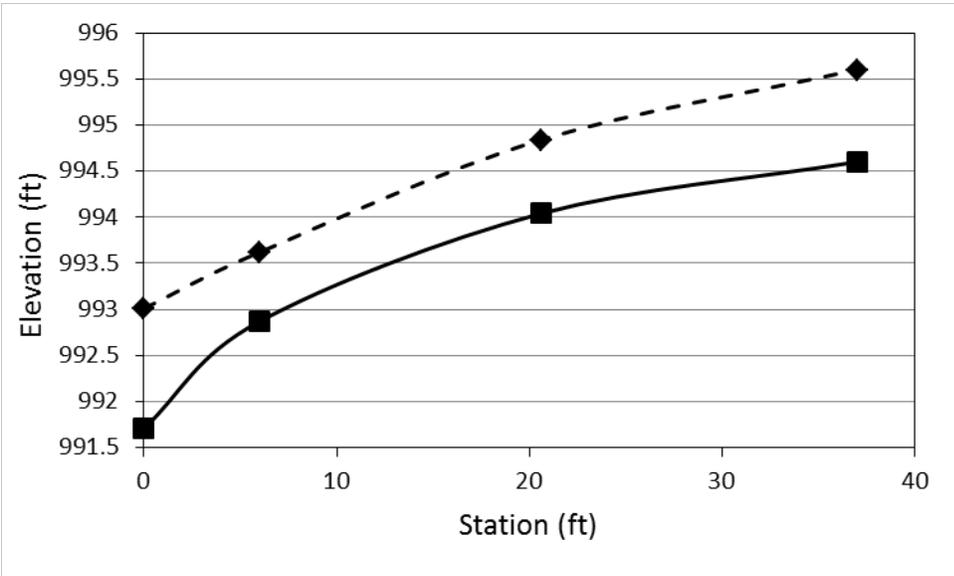
Figure 29. Soldier Creek long profile and depth.

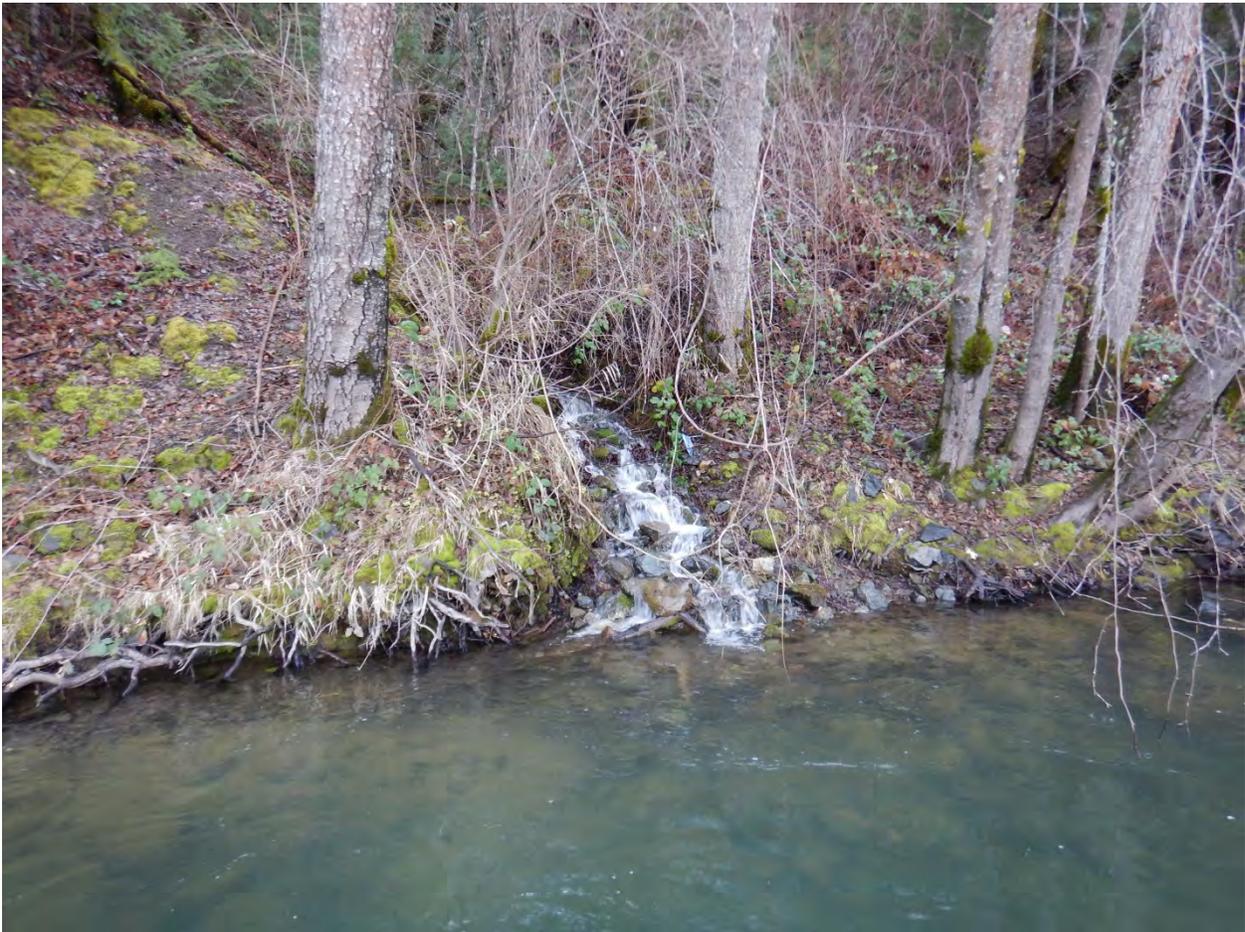
Deep Gulch Below Ed's Hole Pic0376-0381

Deep Gulch is located on river left downstream of Ed's Hole hole. When Deep Gulch is first viewed from a distance, the confluence appears impossible for fish to negotiate with white rushing waters (Figure 30). The section of stream just upstream of the confluence has a high gradient (31%) and low flow depth (0.25 ft) (Figure 31). Deep Gulch above the survey data continues as a steep stream consisting of short (1-2') water falls (Figure 32). The entrance conditions at Deep Gulch would be difficult to pass for migrating steelhead. It seemed reasonable that if fish made it beyond the confluence that natural migration barriers exist upstream which preclude this tributary from utilization by steelhead.

Figure 30. Deep Gulch confluence with the Trinity River.

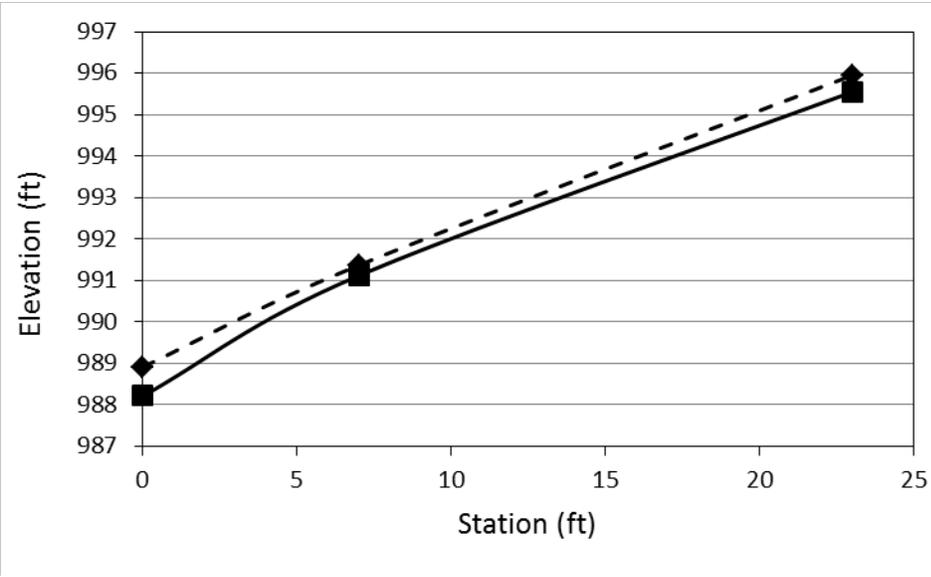
Figure 31. Deep Gulch long profile and depth.

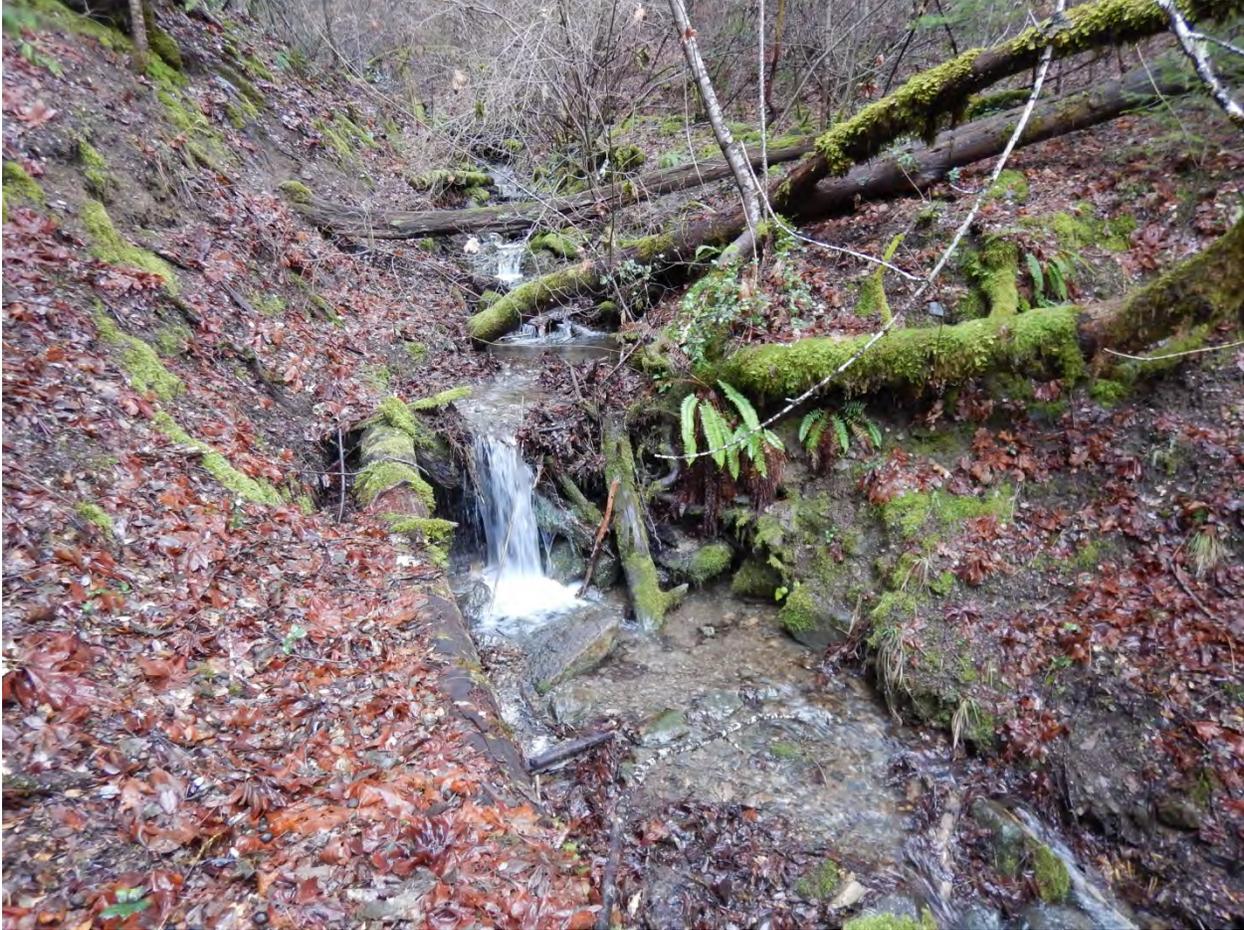
Figure 32. Deep Gulch just upstream of the confluence with the Trinity River.

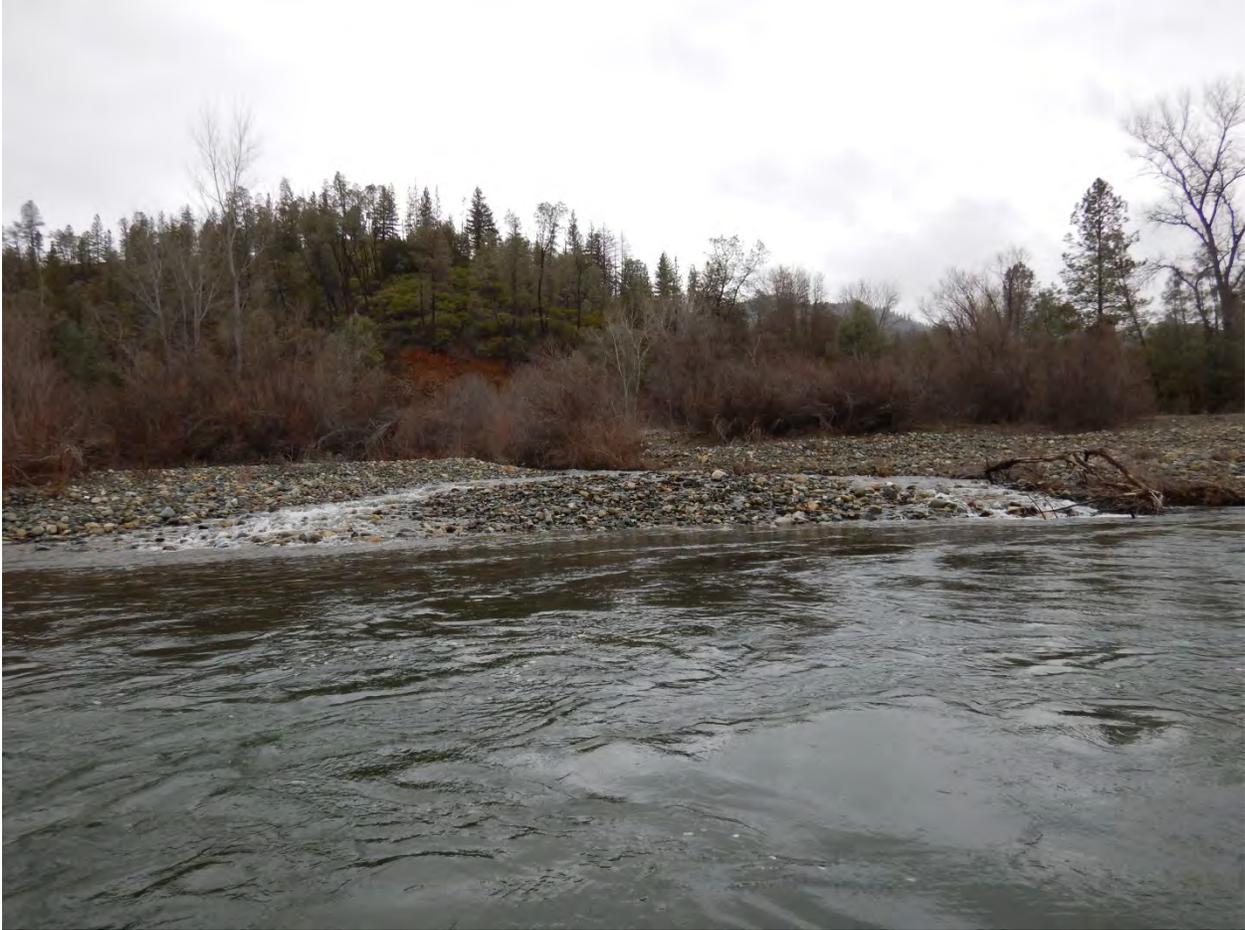
Oregon Gulch Pic0382-039

Oregon Gulch confluence with the Trinity is located upstream of Junction City near the intersection of Hwy299 and Sky Ranch Road. Oregon Gulch confluence consists of a delta-like sediment plume with two primary flow paths, the deepest of which is located on the right in Figure 33. Surveys of the long profile and flow depths shows that the shallowest location along the deepest flow path is 0.55 ft deep (Figure 34). The confluence of Oregon Gulch during the survey was easily passible to migrating adult steelhead. The culvert under Sky Ranch road located about 75' upstream of the confluence would be difficult to pass on the observation date. This culvert has been identified by the 5 counties as a fish barrier and state that adult and juvenile fish have been observed making failed leap attempts at the culvert

Figure 33. Oregon Gulch at the confluence with the Trinity River.

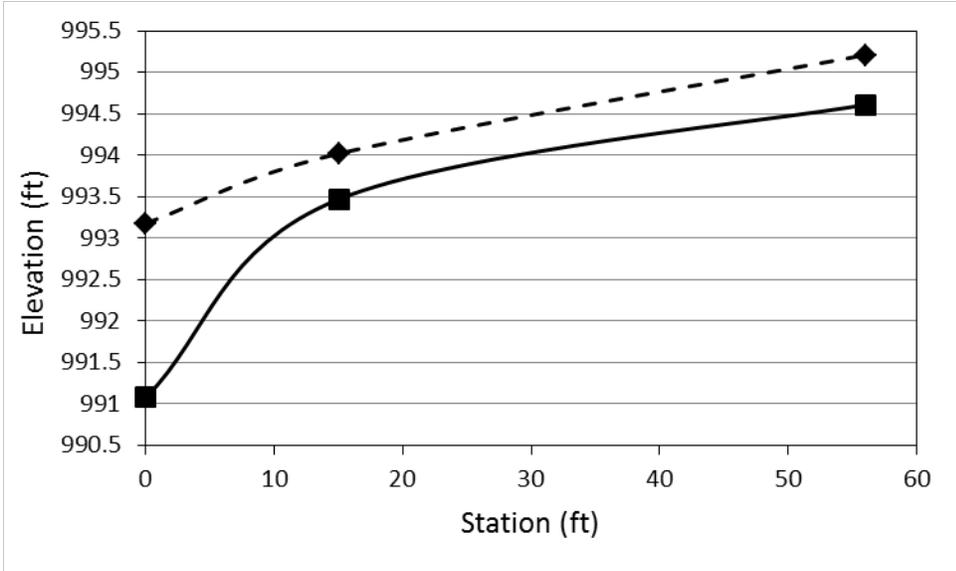
Figure 34. Oregon Gulch long profile and depth.

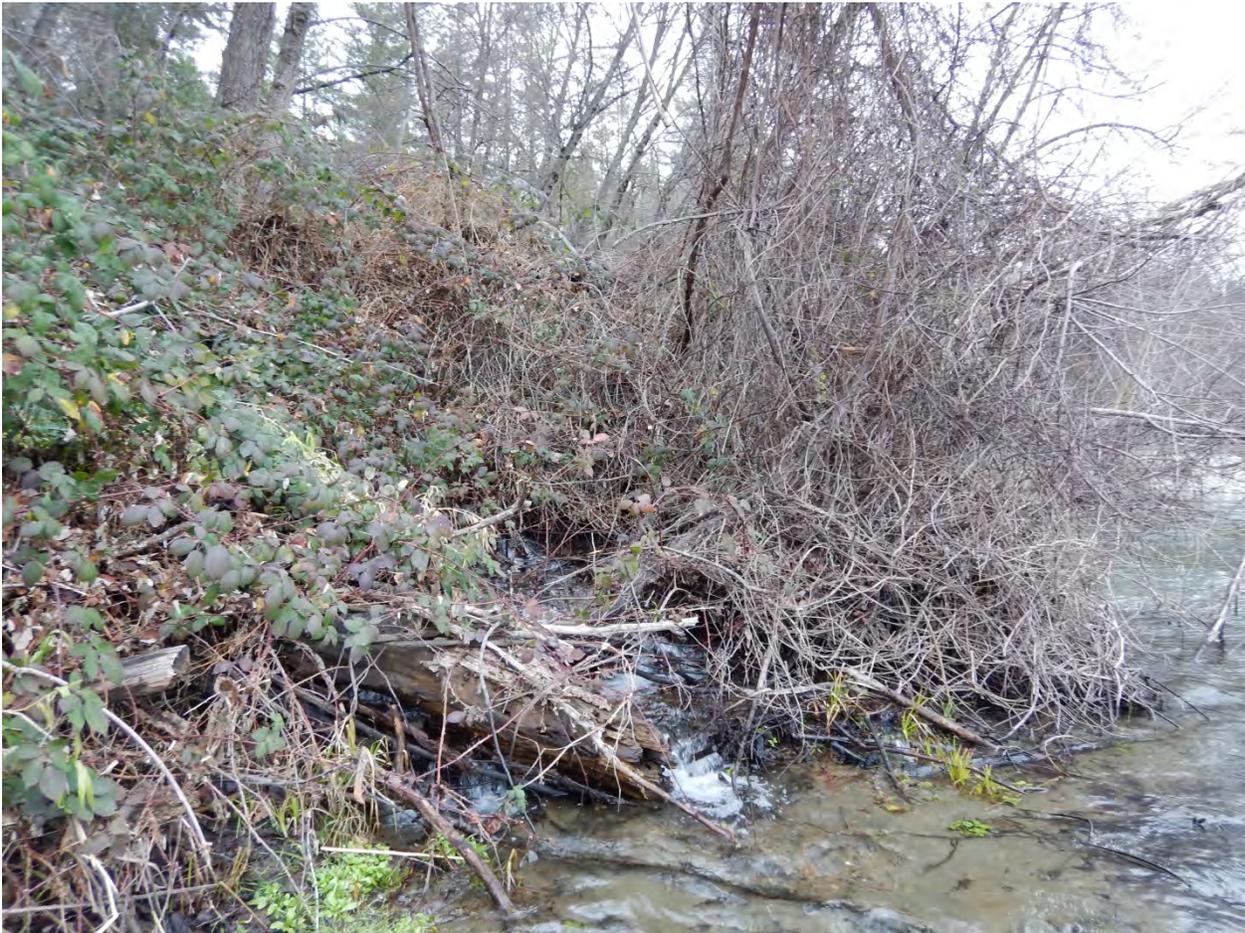
McKinney Gulch (aka Gonpa Creek) river left downstream of Dutch Creek bridge not passible Pic0398-401

McKinney Gulch, located on river left downstream of the Dutch Creek Bridge, was observed on January 1st 2016 (Figure 35). McKinney Gulch was not surveyed due to presence of thick vegetation and time constraints. The stream was determined to be impassible due to a combination of shallow flow depths, dense vegetation, and large woody debris which would inhibit migration.

Figure 35. McKinney Gulch at the confluence with the Trinity River.

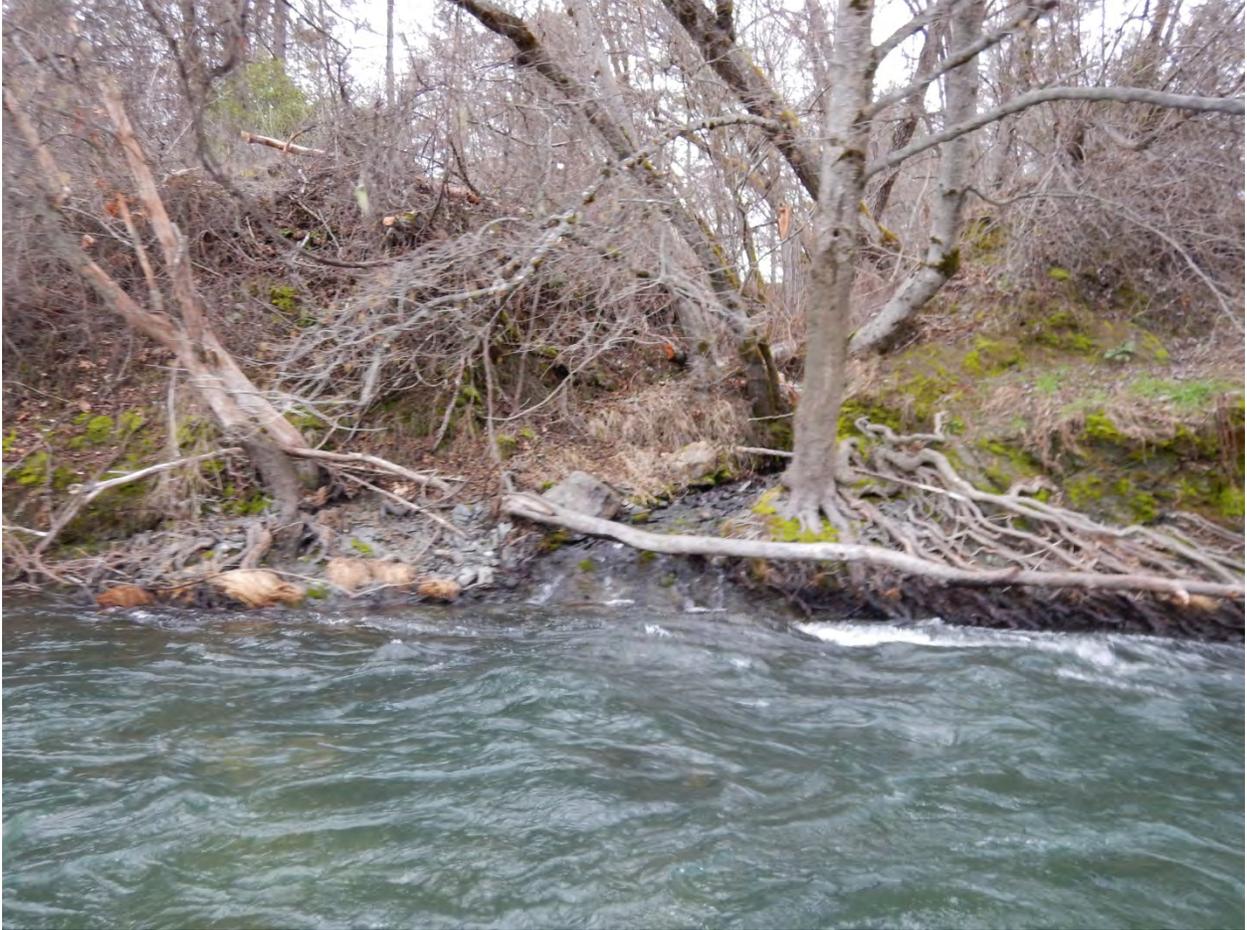
Across from Junction City Camp Pic0409

The gulch on river left across from the Junction City campground is shown in Figure 36. The stream consisted of shallow water flowing over bedrock and was determined to be impassible.

Figure 36. JC Campground Gulch at the confluence with the Trinity River.

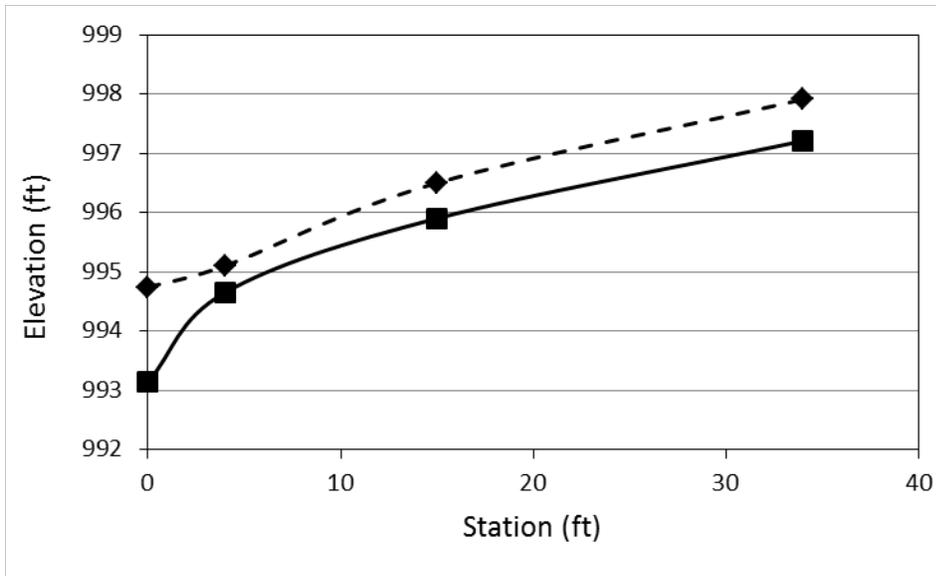
Conner Creek No Photo available

Conner Creek confluence with the Trinity River is on the left downstream of the Junction City Campground. The deepest flow path on Conner Creek reached a minimum depth of 0.45 ft (Figure 37). The flow depth of 0.45 ft would be easily passable for any steelhead attempting to traverse the confluence.

Figure 37. Conner Creek long profile and flow depth.

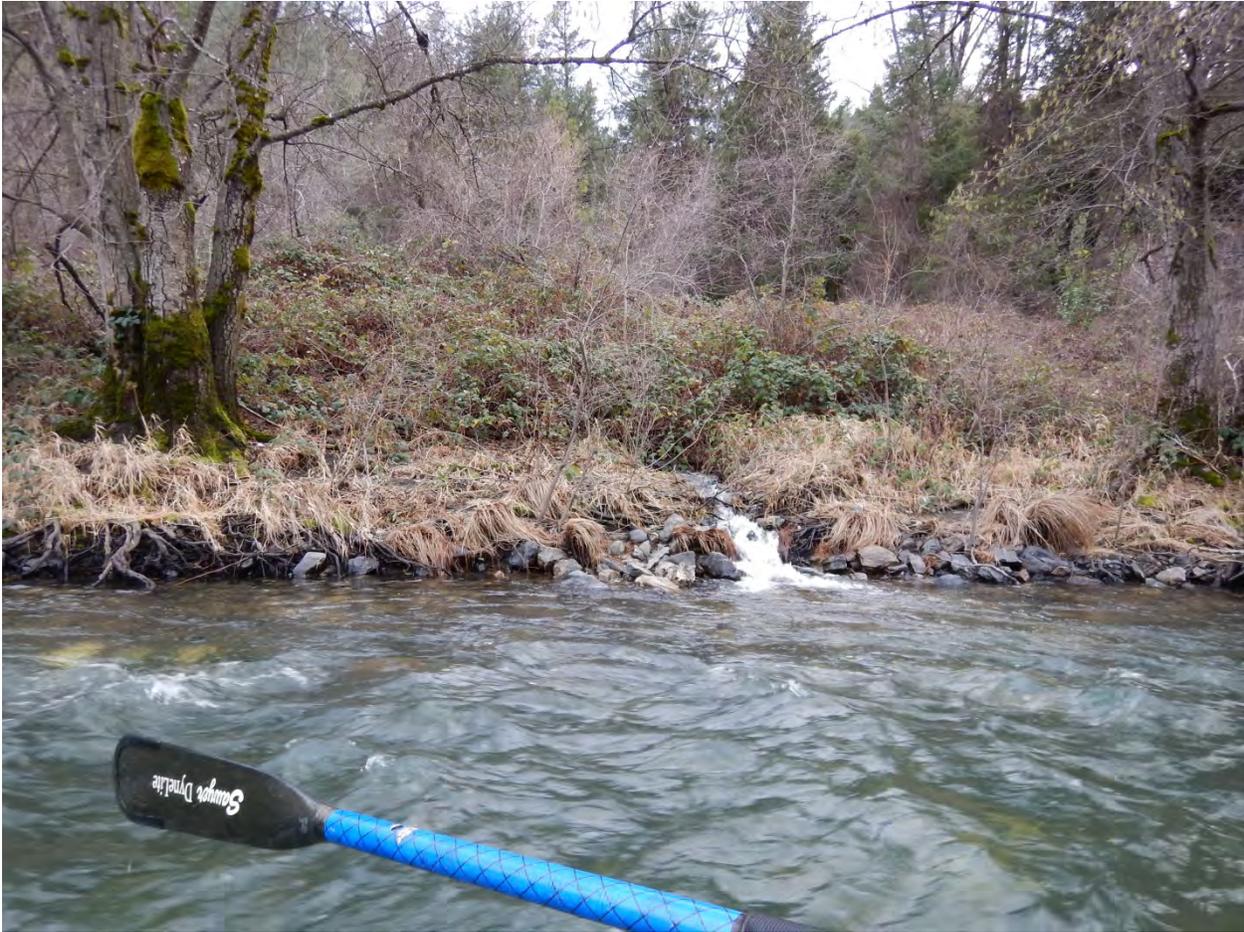
Trib on Left above Pear tree Pic0430-0431

A first order tributary located on river left above the Pear Tree screw trap was observed on January 11, 2016. This tributary was not surveyed, as the stream appeared to shallow to facilitate adult steelhead (Figure 38). The confluence of the stream was not passible on the date observed.

Figure 38. Unnamed tributary above Pear Tree on river left.

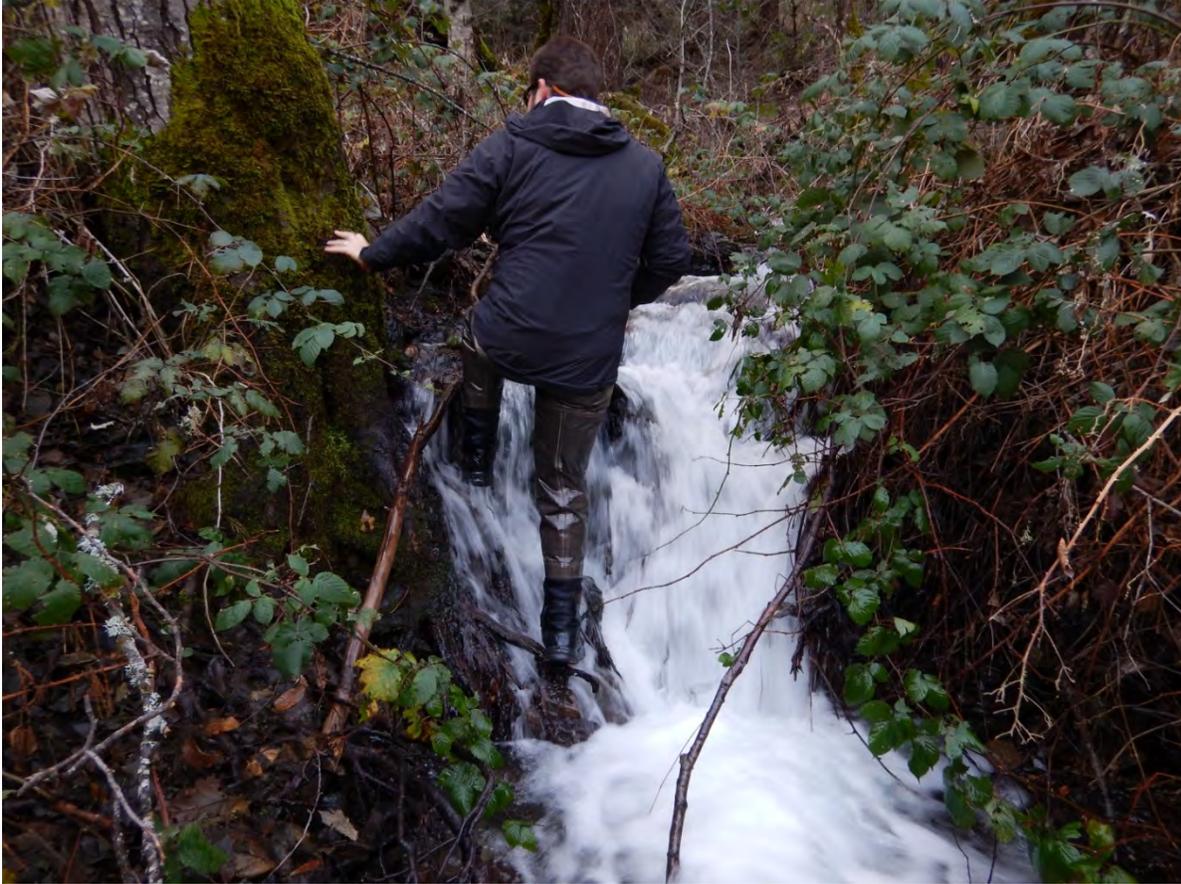
Trib on Left above Bagdad Pic0432-0435

An unnamed tributary located on river left upstream of the Bagdad boat launch was observed on January 11, 2016. The stream would have been difficult to pass for migrating steelhead on the survey date. Barriers to fish passage were observed upstream of the confluence; one is shown in Figure 34. While plunges like the one shown in Figure 39 appeared to be impassable at the flows observed the fisheries biologist were of the opinion that this barrier would be passible at higher flows. The long profile and depth is shown in Figure 40 and has a minimum flow depth of 0.5' in the deepest flow path.

Figure 39. Fish barrier just upstream of the confluence on an unnamed tributary above Bagdad boat launch.

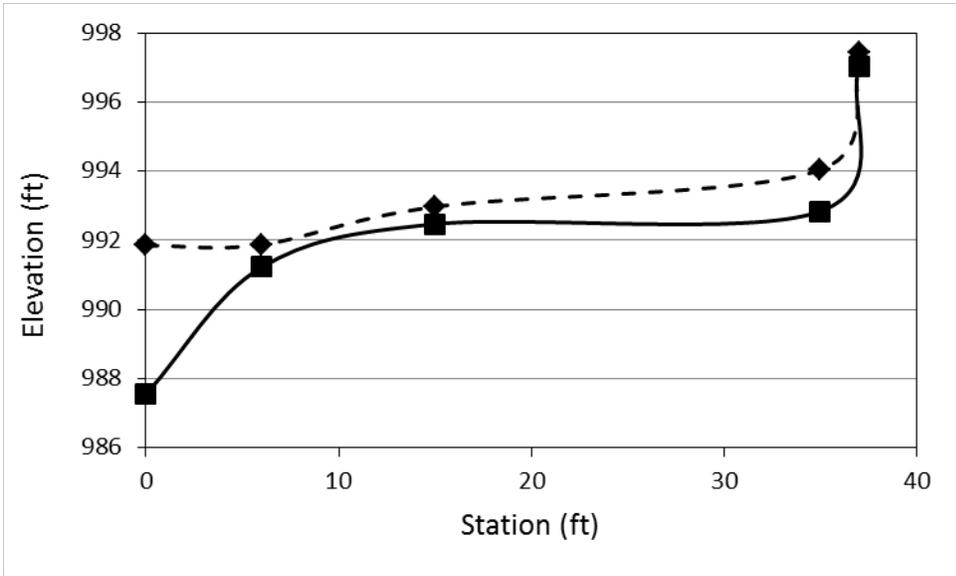
Figure 40. Long profile and flow depth of unnamed tributary on river left above Bagdad boat ramp.
