Arcata Fisheries Technical Series Report TR 2015-28

Integrated Habitat Assessment of the Upper Trinity River, 2009

Justin Alvarez, John Bair, Damon H. Goodman, Geoff Hales, Andrea Hilton, Scott McBain, Aaron Martin, and Joe Polos

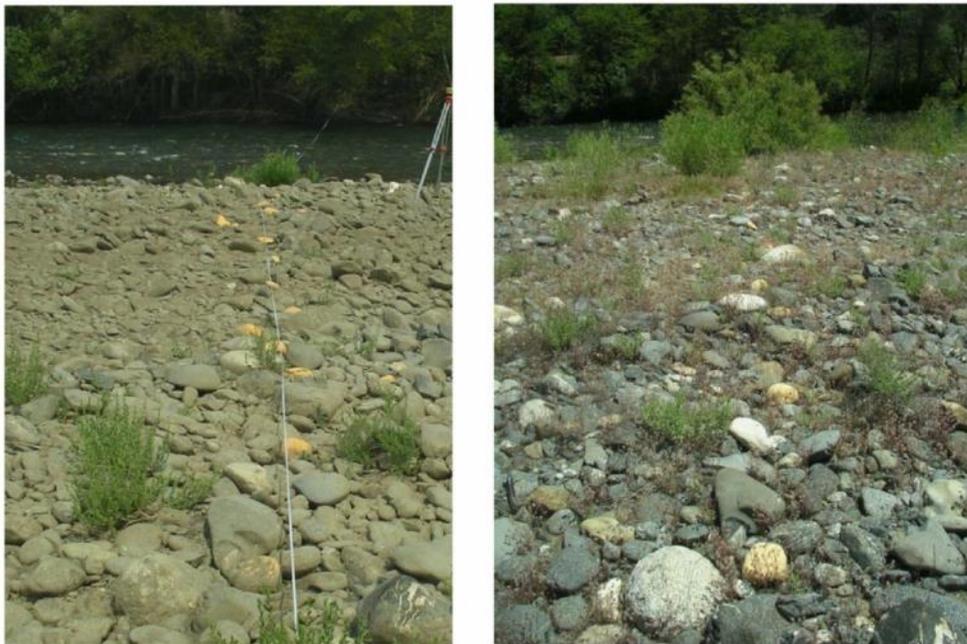
Figure 2–10. Photographs of cross section 314+15 from the left bank facing the main channel. Flow is from right to left. Left photograph shows marked rock set on constructed terrace following the spring 2006 release (309 cms [10,900 cfs] at the site). Right photograph shows the same rock set in April 2009. These rocks have not been mobilized by any flows since May 2006.

In WY 2006, marked rock placement at cross section 314+15 included the constructed low terrace and left bank point bar. The terrace rocks showed little movement in response to the WY 2006 spring release and were left in place for future monitoring. Since WY 2006 these rocks have remained in place and have not moved (Figure 2–10). Because of this, marked rocks for WY 2009 were set across the bar only; 18 D₈₄ and D₅₀ pairs were set within a single textural facies. The following bullets describe mobility measured from the winter peak flow and spring release:

- Winter peak flow (3,990 cfs): two D₈₄ and D₅₀ rocks moved on the point bar. Two adjacent D₈₄ rocks moved at station 90.2 and 91.4, but their corresponding D₅₀ rocks did not move. Both of the D₈₄ rocks moved approximately 0.6 m (2 ft) downstream, which suggests their initial placement was hydraulically unstable. They likely relocated slightly downstream to a more stable position. It is also possible that the D₅₀ rocks were shielded by larger boulders immediately upstream, preventing their movement. The D₅₀ rocks that did move were slightly landward, at stations 85.3 and 87.8.

- Spring release flow (8,230 cfs): between station 83.8 and 97.5 (the streamward-most rocks in this set), all 12 D₅₀ rocks were mobilized, and 11 of the 12 D₈₄ rocks moved (all except station 86.3).

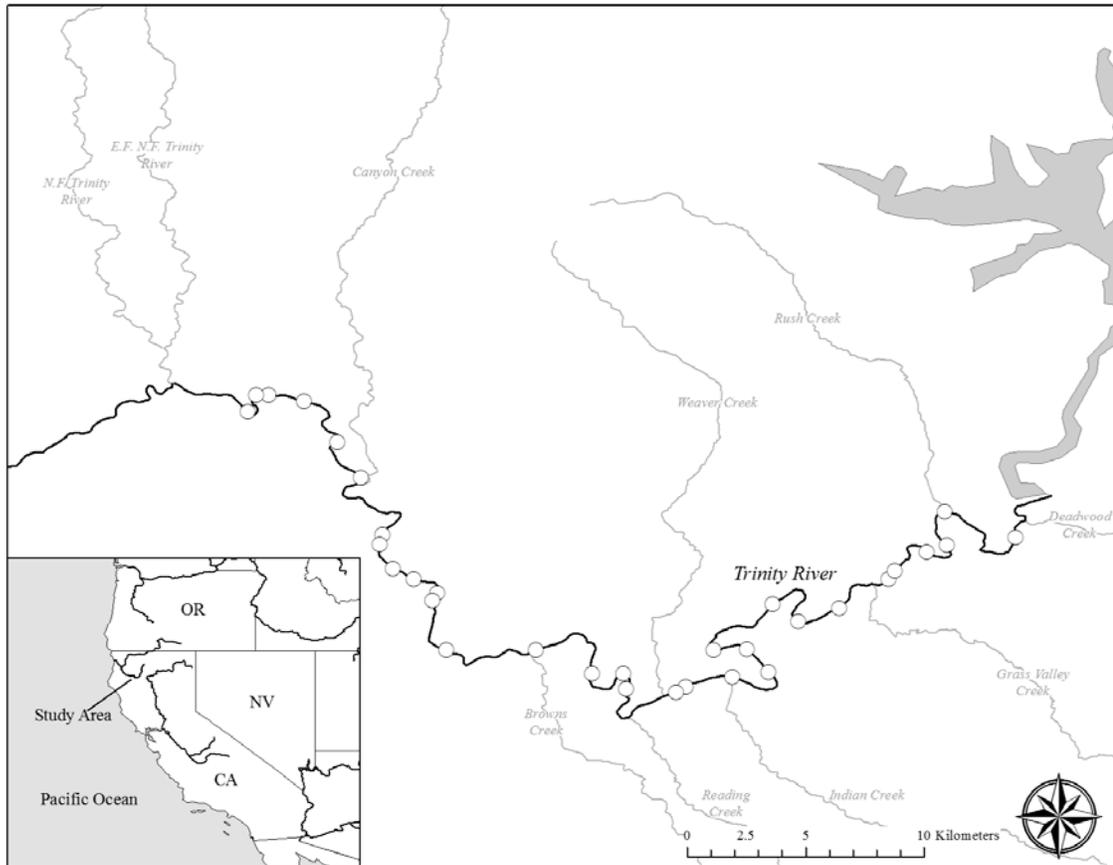
Figure 5–1. Systemic rearing-habitat assessment sample sites on the Trinity River from Lewiston Dam to the confluence with the North Fork Trinity River. Shown here are 32 400-m (1,300-ft) sample units from panels 1 and 2 of the rotating panel revisit design. Sample units were selected using the GRTS protocol.

The restoration reach rearing-habitat assessment study design includes the following components: (1) sample site definitions, (2) sample site selection protocol, and (3) revisit design. Sample sites were defined as 400-m (1,300-ft) segments of the 142-cms (5,000-cfs) centerline shapefile derived from HEC-RAS modeling (Figure 5-1; TRRP unpublished data). This sample site size was selected based on survey efficiency and recommendations from multidisciplinary planning meetings in anticipation that it will, if appropriate for specific study objectives, be adopted by other disciplines in future assessments. The sample universe was defined as the primary restoration reach. Units were selected using the generalized random

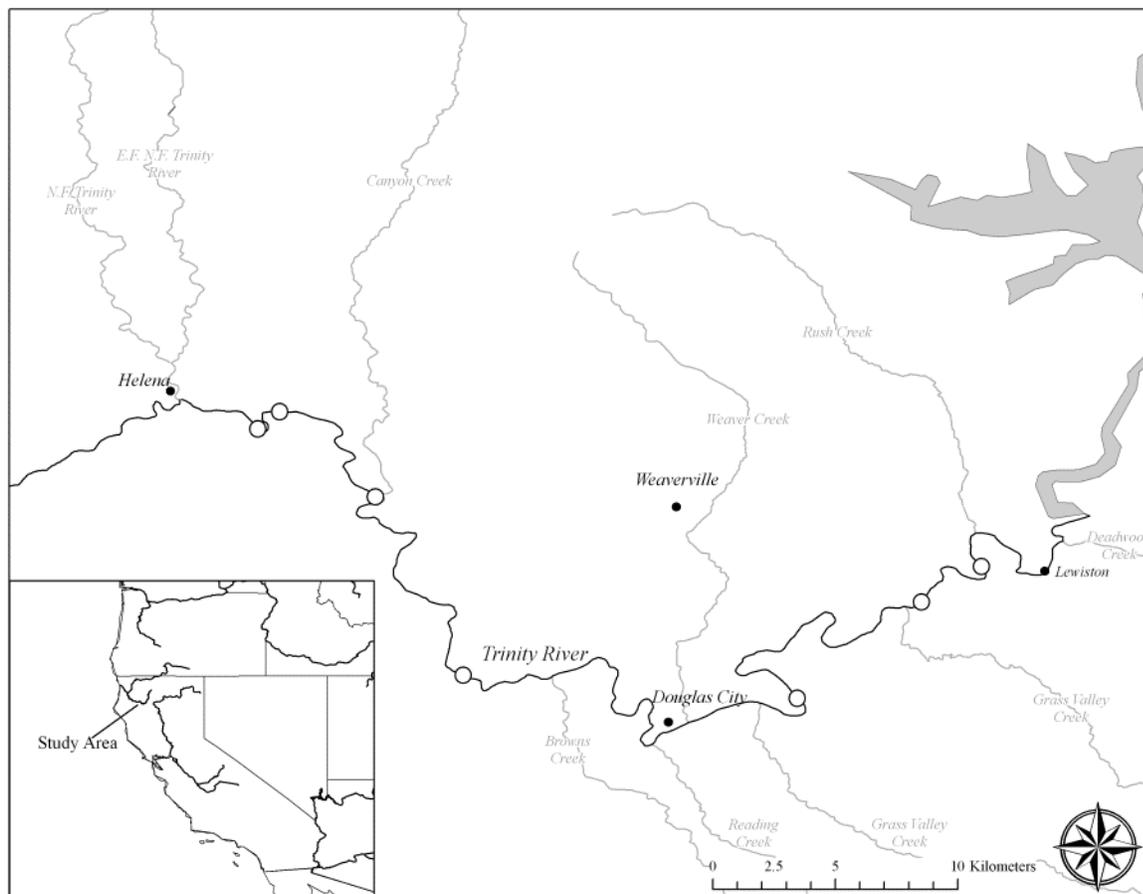
Figure 8–1. Sample sites used to evaluate precision of rearing-habitat mapping on the Trinity River. The sample includes seven 400-m (1,312-ft) sample units selected using the GRTS protocol.

The precision of the rearing-habitat mapping technique was assessed by surveying locations twice and comparing the results. Sample units were defined as 400-m (1,312-ft) stream segments of the 142-cms (5,000-cfs) centerline shapefile derived from HEC-RAS modeling (TRRP unpublished data). Using the generalized random tessellation stratified sample unit selection protocol (Stevens and Olsen 2004), units were selected between Lewiston Dam and the confluence of the North Fork Trinity River. To improve the efficiency of this survey design, initial site surveys were conducted during the systemic rearing-habitat survey (See Section 5). After the systemic habitat surveys were completed ($n = 32$ sample units), an independent team returned to resurvey until the end of the 12.7-cms (450-cfs) water release from Lewiston Dam. This resulted in repeat surveys of the first seven sample units (Figure 8–1).

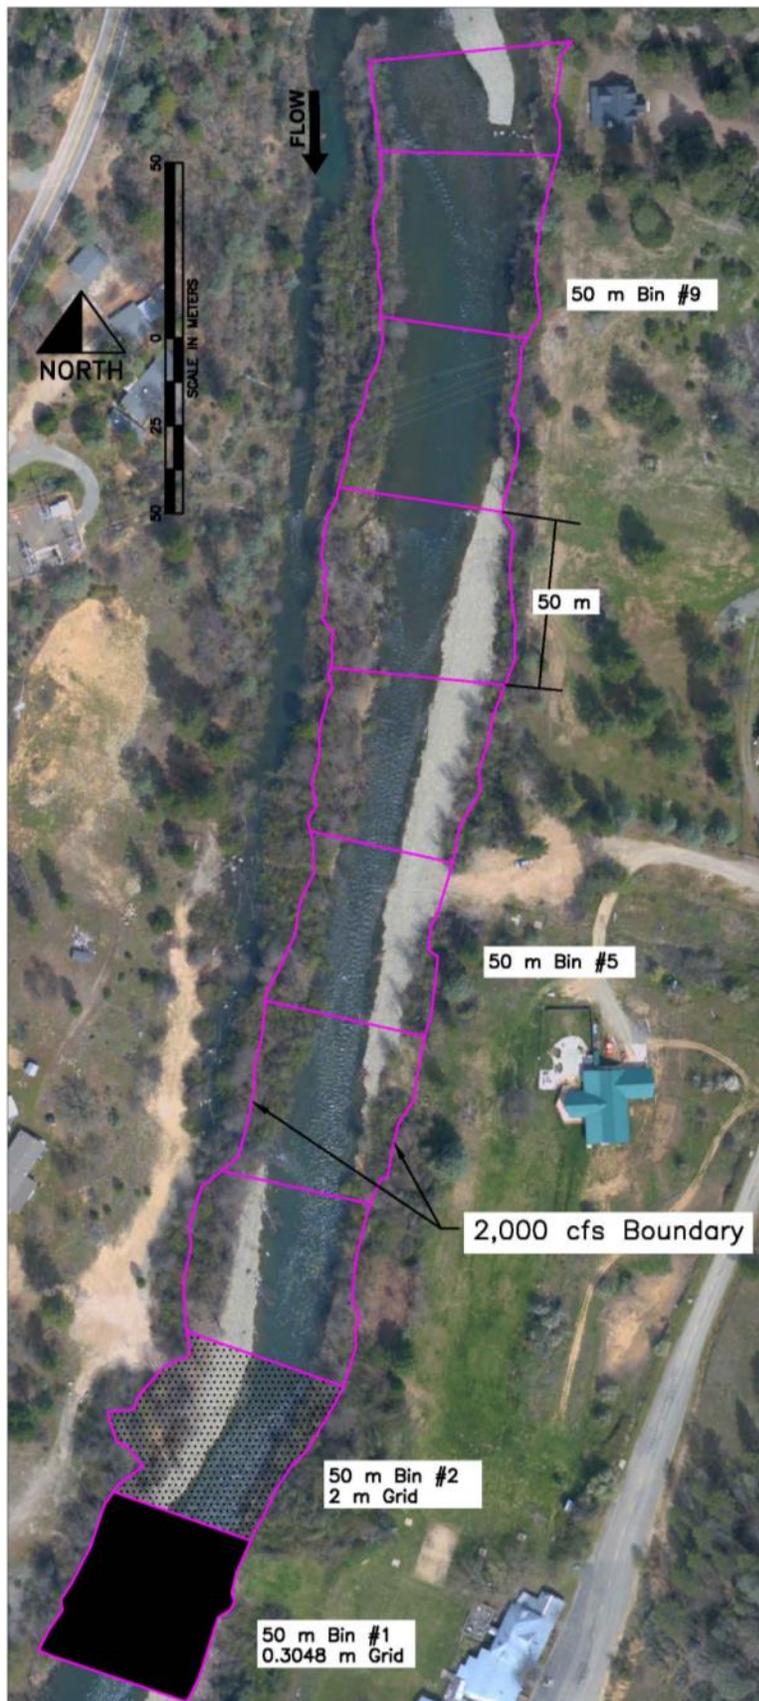
Figure 10–4. Lewiston Cableway channel rehabilitation site illustrating the measurement area (i.e., the 57-cms [2,000-cfs] lateral boundary and the 50-m [164-ft] channel lengths) and the two grid measurement systems (i.e., 0.3- and 2-m [\sim 1- and 6-ft] intervals) used to quantify topographic diversity.

The digital terrain model of channelbed topography was derived using a Total Station survey of the channel bathymetry stitched into a combination of existing photogrammetry, LiDAR, and topographic survey data (Wolpert 2009, TRRP unpublished data). A 2-m (6-ft) grid was overlaid on the digital terrain model. Higher resolution grid spacing of 0.3 m (1 ft) was evaluated; however, the spacing of points relative to the resolution of the model was too coarse to support use of a higher resolution grid. The study reach was divided into ten 50-m (164-ft) segments along the 142-cms (5,000-cfs) channel centerline (Figure 10–4). The 50-m segment lengths were deemed to be small enough to allow for a reasonable number of data points but large enough to possibly contain some topographic differences. Habitat values for pre- and post-construction conditions were calculated for a low flow (8.5 cms [300 cfs]) and for a high flow (52.7 cms [1,861 cfs] for pre-construction and 57.2 cms [2,020 cfs] for post-construction). The water surface planes for the two flow regimes were described by a HEC-RAS model. Water surface planes for the high flows were limited to approximately 56.6 cms (2,000 cfs) to avoid the topography associated with berms, and this was the maximum flow for which habitat data were available. Habitat areas at 52.7 cms (1,861 cfs) pre-construction and 57.2 cms (2,020 cfs) post-construction were assumed to be comparable for this analysis. The topographic differences within each stream segment were assessed by computing the distance between the predicted water surface elevation and the channelbed topography at the nodes of a 2-m (6-ft) grid (Figure 10–5).
