# **Taking Out the Jacks**

## **Issues of Jetty Jack Removal in Bosque and River Restoration Planning**

**By Kathy Grassel**

**Water Resources Program  
The University of New Mexico  
Albuquerque, New Mexico 87131-1217  
[www.unm.edu/~wrp/](http://www.unm.edu/~wrp/)  
Publication No. WRP-6  
July 2002**

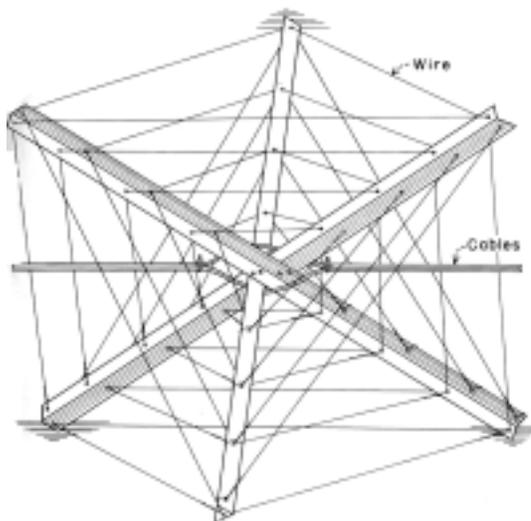
*Fig. 1: Standard jack design*

prudent to know how it goes together to effectively remove it, repair or retrofit it. The structural unit of the system is called a jack. It is a standard unit; they all look alike, no variations. It is composed of three 16-foot long 4 in. x 4 in. x ¼ in. steel angles. These three angles are bolted together at their midpoints. The angles are placed back to back with their longitudinal axes at right angles to each other. The angles are fastened into place and form three sets of intersecting planes, their common point at the center. The planes are maintained by lacing them with wire at 15-inch intervals. Then they are linked together in a line with thick cable to form a jetty.

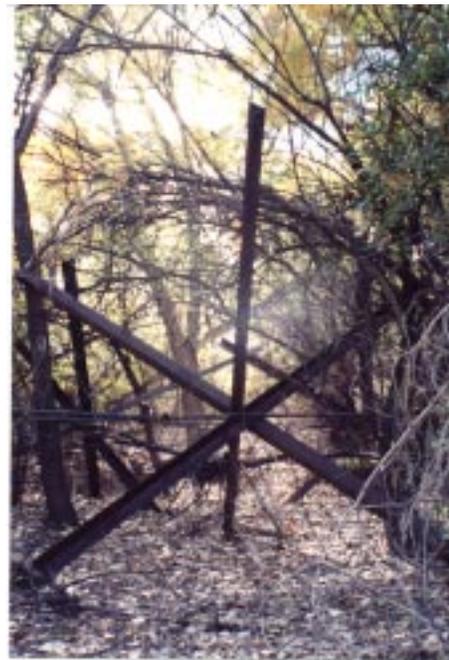
*Fig. 2: Intact jack in the bosque*

These days we observe a Kellner jetty in less than mint condition and it is most often tangled with vegetation, underwater, detached from its original line, or partly exposed. Occasionally we see a fairly intact high-and-dry jetty line as in the Fig. 2 above that gives us an idea of how it might go together. It is

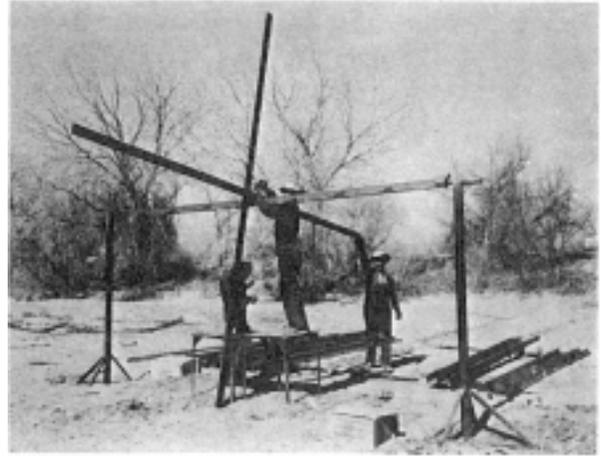
*Fig. 3: Workers assemble a jack on site. Casa Colorado area, Middle Rio Grande Project, NM. Photo:Herman E. Carter, Bureau of Reclamation (Carlson and Enger 1956).*

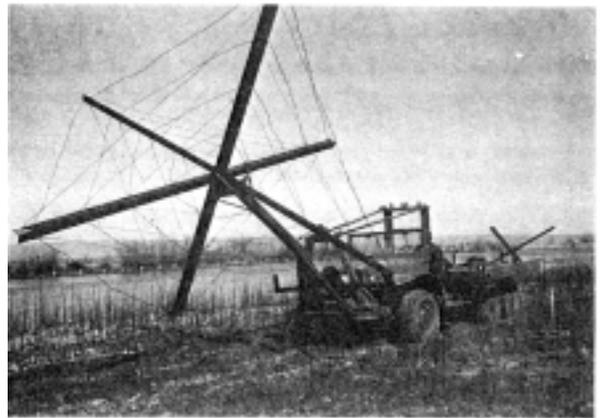
*Fig. 4: Jack unit is moved to position in jetty field by a winch controlled lift. Casa Colorado area, Middle Rio Grande Project, NM. Photo:Herman E. Carter, Bureau of Reclamation (Carlson and Enger 1956).*

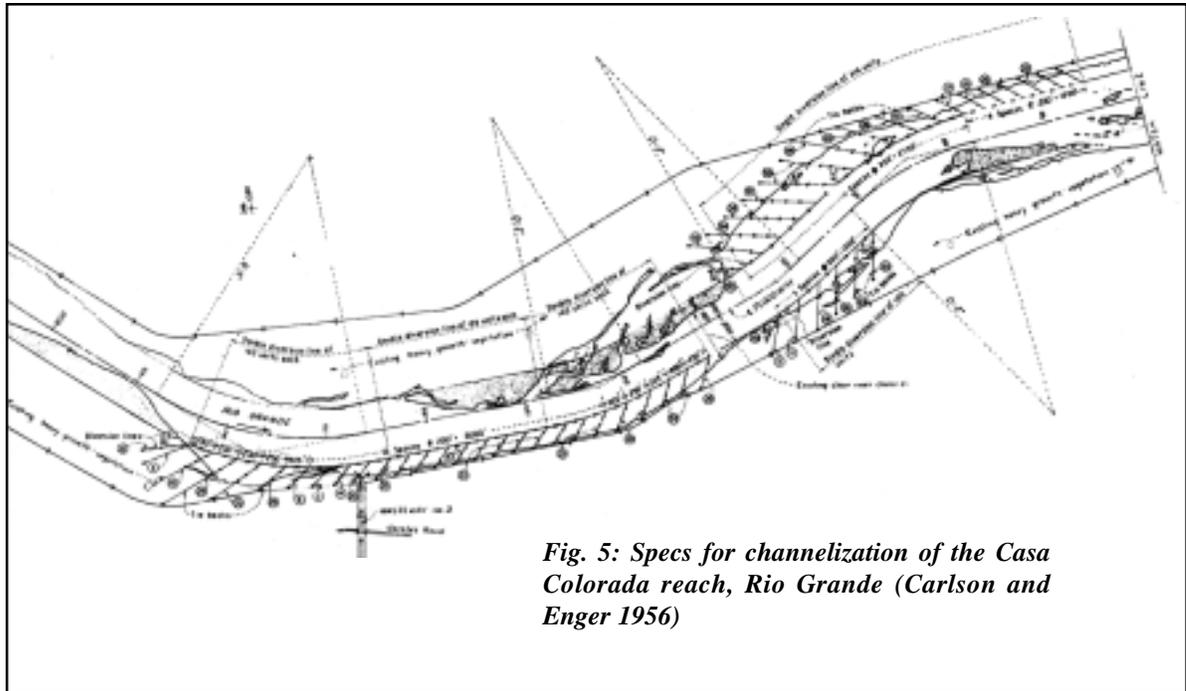
*Fig. 5: Specs for channelization of the Casa Colorada reach, Rio Grande (Carlson and Enger 1956)*

The angles were set at the factory, after which connection holes and lacing holes were punched into the angles. At this point, the parts were ready to ship to the user. From the Topeka factory, the Kellner Jetties Company would send out crates full of steel angles, lacing wire, cable, cable clamps, and railroad ties. The shipment would be hauled to the job site for assembly. The company also furnished a construction supervisor who employed a crew of 12 laborers—12 was optimum—using hand tools. The crew assembled the units (see Fig. 3), then carried, hauled (see Fig. 4), rolled, or rafted them into place, 12 ½ feet apart. They then threaded the units together with double lines of thick ¾-inch diameter cable and clamped the cables together at the unit center points. Excavation was rarely required to position the jacks (U.S. Army Corps of Engineers 1953). See a schematic of a jetty field in Fig. 5.

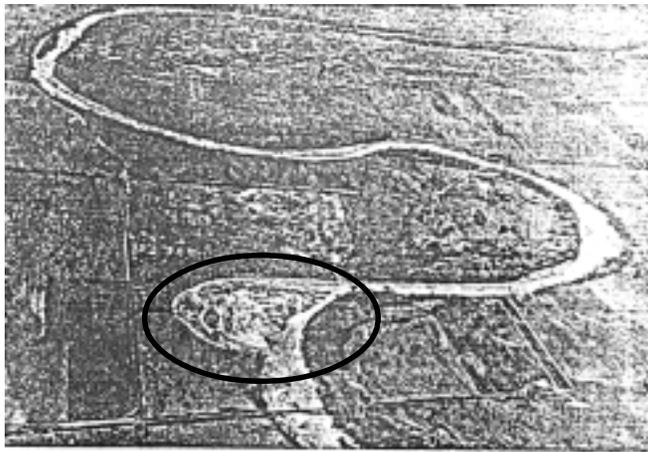
*Fig. 6: Republican River in Superior, Nebraska, prior to installation in 1946. The work was performed on the large curve above the rail track.*

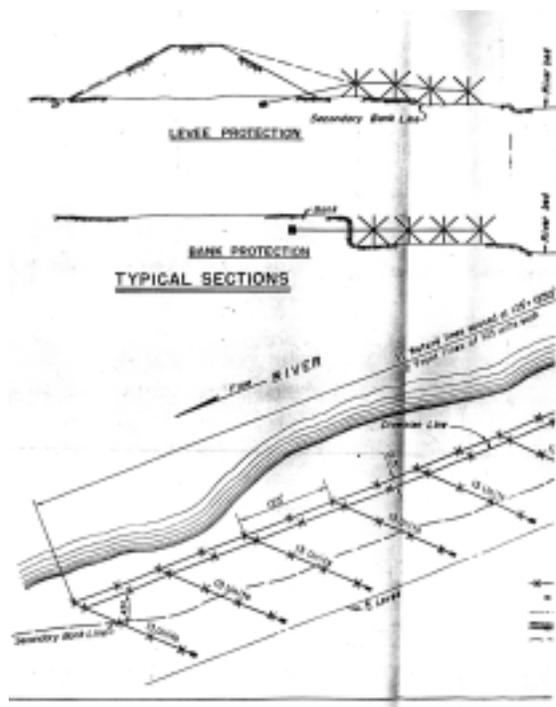
Fig. 8: How jetty jacks protect levees (top), banks (middle), and how the jetty field is configured for bank stabilization and levee protection (bottom). Source: U.S. Army Corps of Engineers 1953.

They were also used for protection of flood control structures such as levees (see Fig. 8). Levees are rarely engineered and rather consist of dirt piled up from the excavation of the riverside drains and so are vulnerable to undermining by scour (Soards, pers. com.; Grogan, pers. com.). The jetty system was also used much like riprap for bank sloping where high banks are subjected to scour by varying river stage.

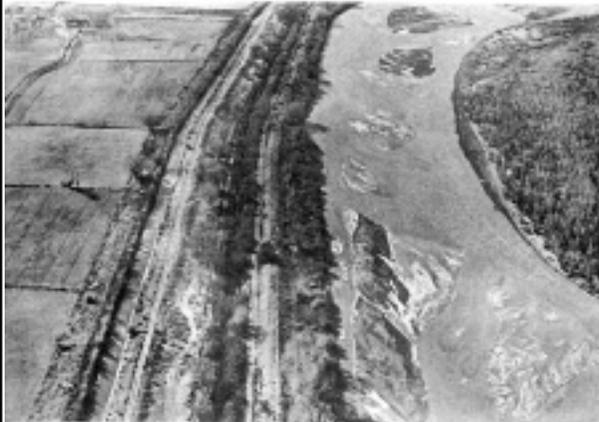
*Fig. 9(a): Location of the jetty installation. Photo: Dec. 12, 1952.*

*Fig. 9: Installation of jetty field on the Rio Grande near Bernalillo, NM. Aerial photos by the Corps of Engineers.*

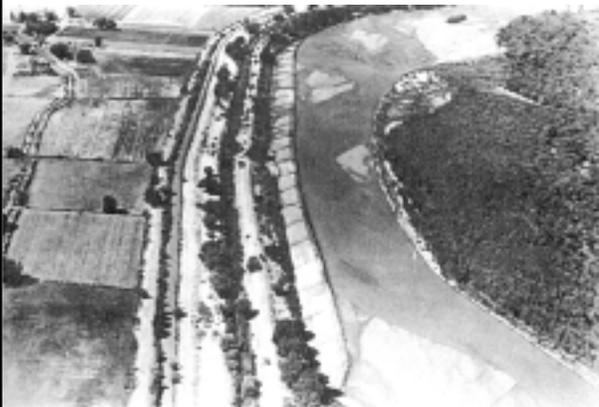
*Fig. 9(b): Jetty field installed. Photo: Aug. 12, 1953.*

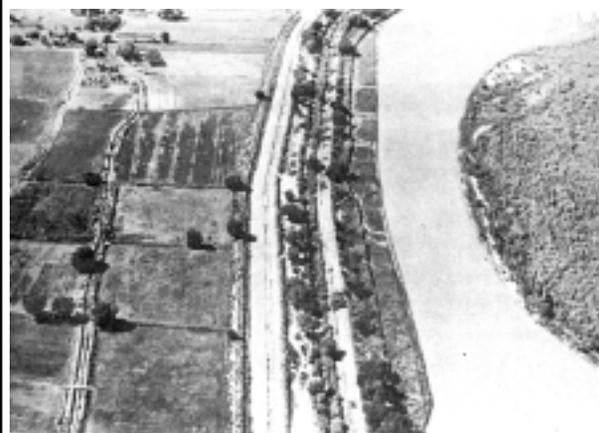
*Fig. 9(c): Vegetation dominates in the mature jetty field. Photo Sept. 2, 1955.*

tions make new ground for vegetation growth. Vegetation grows rapidly, usually within two years of installation of the jetty system. Vegetation increases the protective value of the jetty system as it greatly increases the resistance of the system to displacement during floods. Vegetation also locks in the new bank line. Fig. 9(a) illustrates the reach of the Rio Grand before jetty jack installation, in Fig. 9(b) how the field appeared in the river before vegetation, and in Fig. 9(c) how the area appeared after vegetation was established. Early reports noted growths of native vegetation such as cottonwood, willow, and grass, and also the non-native salt cedar (U.S. Army Corps of Engineers 1953).

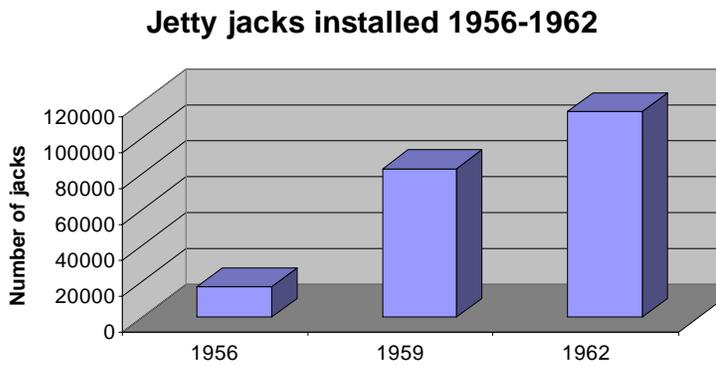
*Fig. 10: Straightening the channel with jetty jacks*

more units were installed. By 1962, a total of 115,000 jacks were in place (Lagasse 1980). Fig. 10 illustrates the rapidity of jetty jack installation between 1956 and 1962. These same years were years of low flow, so conditions were perfect both for rapid installation and subsequent

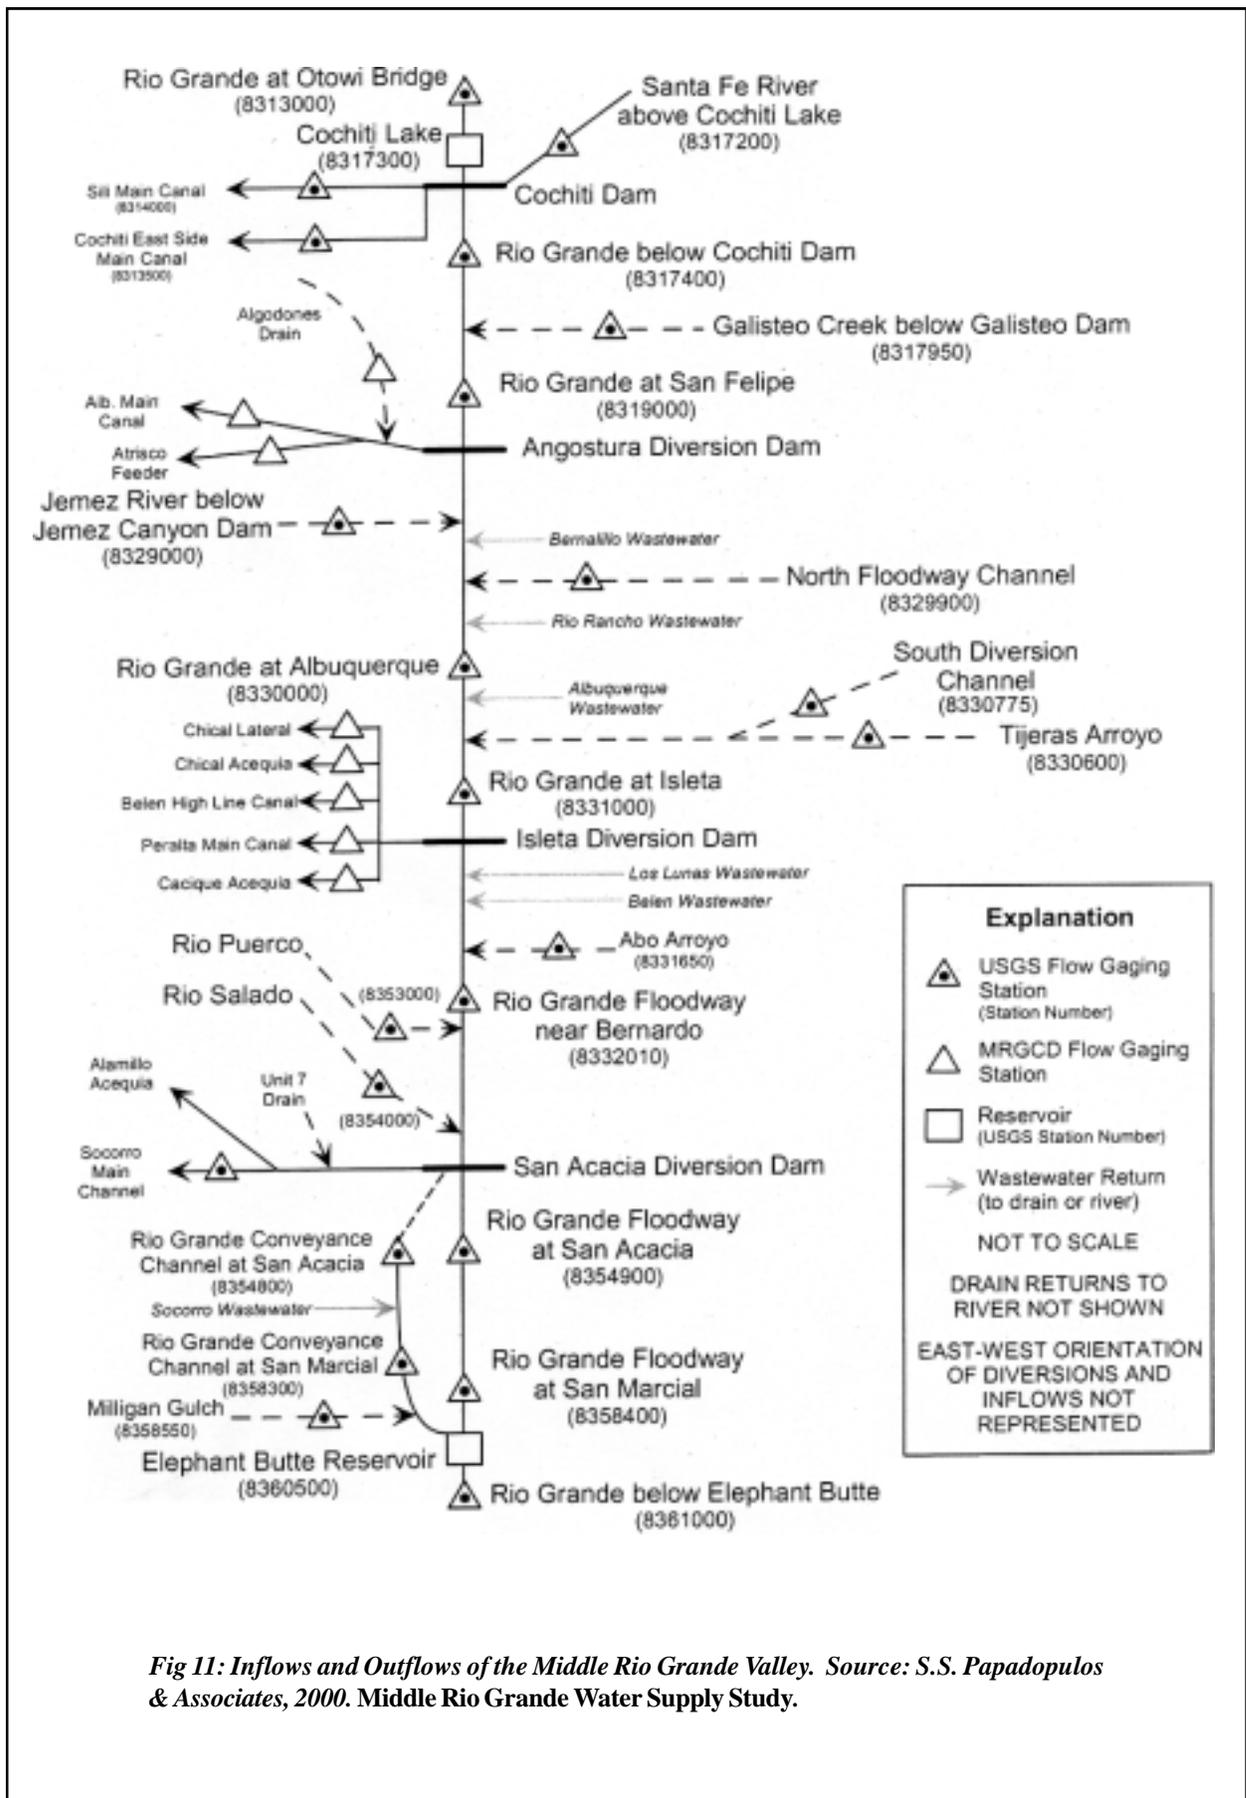
*Fig 11: Inflows and Outflows of the Middle Rio Grande Valley. Source: S.S. Papadopoulos & Associates, 2000. Middle Rio Grande Water Supply Study.*

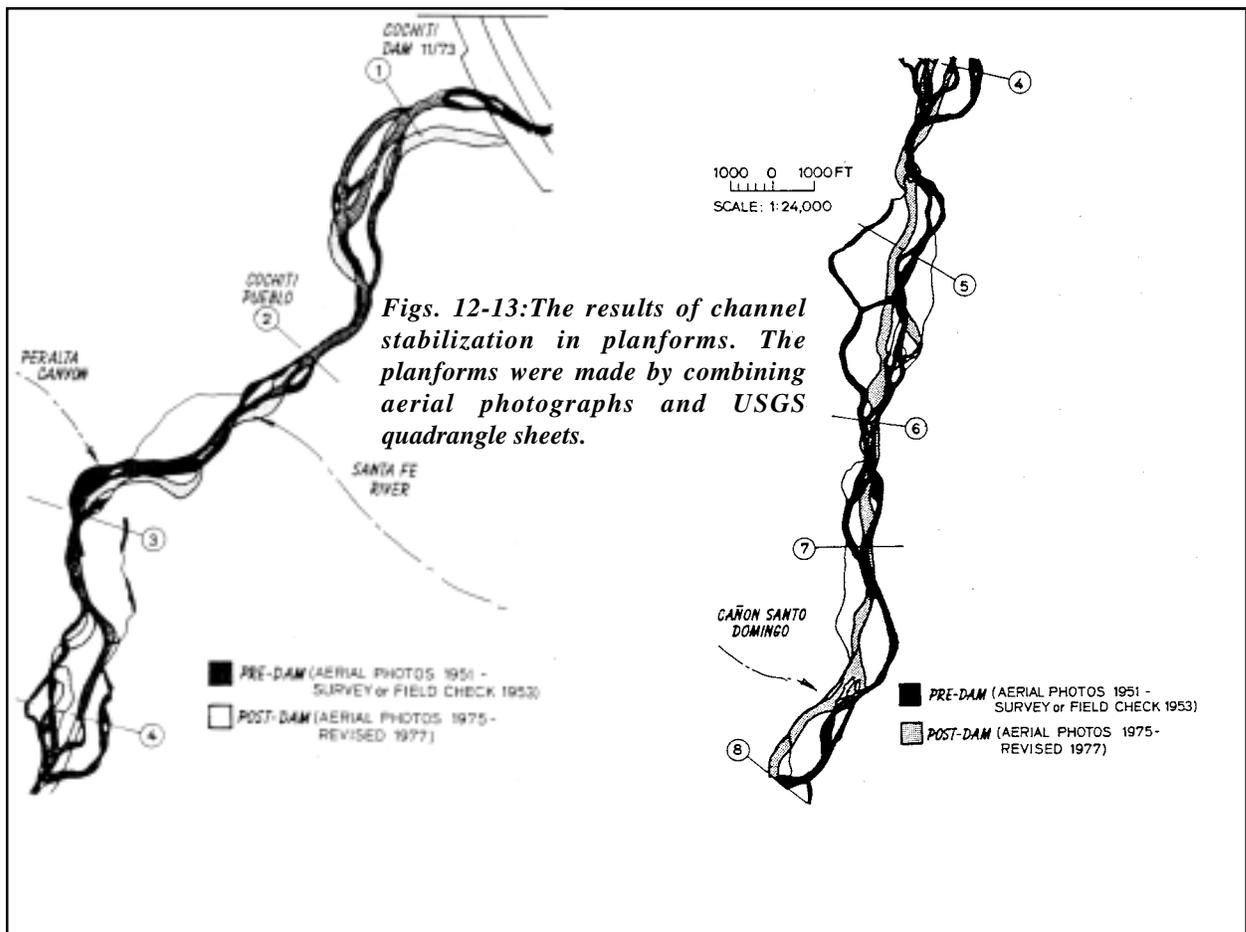
- 21.....Figs. 12-13: The results of channel stabilization in planforms. The planforms were made by combining aerial photographs and USGS quadrangle sheets.

Rather than post-dam response, the jetty fields and bosque vegetation are attributed as largely responsible for the stable channel position observed in the planforms. Interestingly, the stabilization and rectification of the floodway channel between 1954 and 1962 had, by the early 1970s, begun to accomplish the desired effect of reversing the long-term aggradational trend and lowering bed elevations. (Lagasse 1980). But that's water over the dam, as they say.

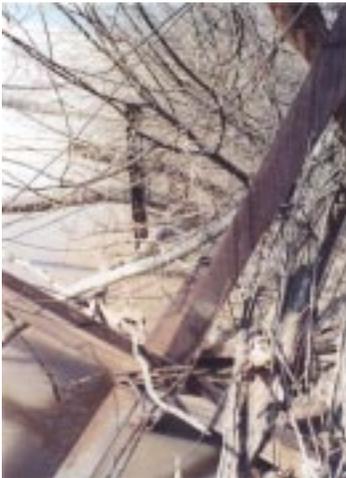
*Fig. 14: The MRGCD wants riverbank jacks to stay in place for levee protection*

Photographs below (see Figures 14, 15 and 16) of the present condition of random jacks in the Middle Valley indicate that Lagasse's calculation that then existing lines could be undercut and buried has been borne out.

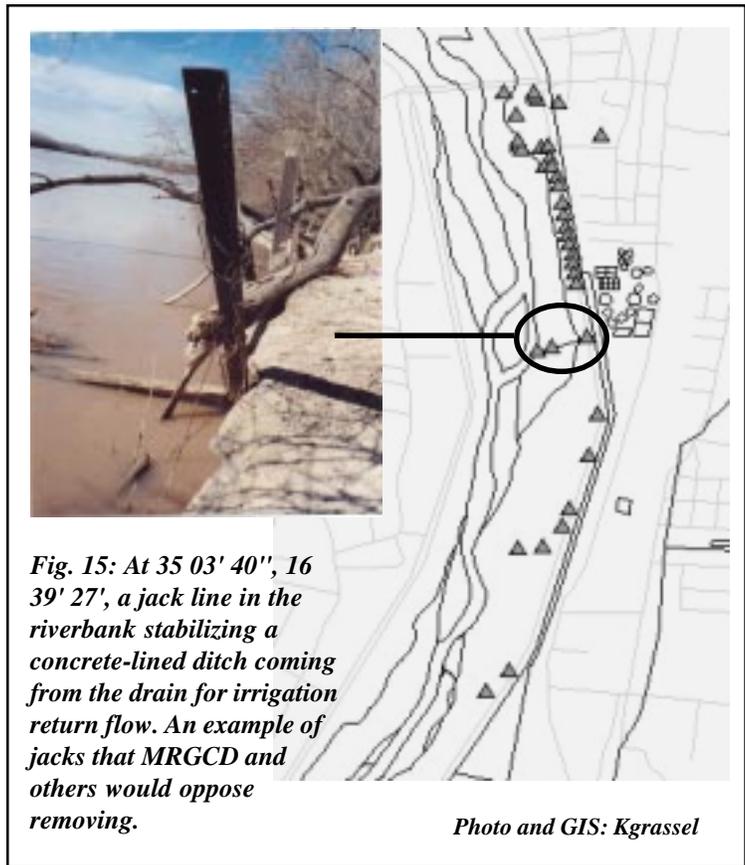
- 
- 25.....Fig. 15: At 35 03' 40", 16 39' 27', a jack line in the riverbank stabilizing a concrete-lined ditch coming from the drain for irrigation return flow. An example of jacks that MRGCD and others would oppose removing.

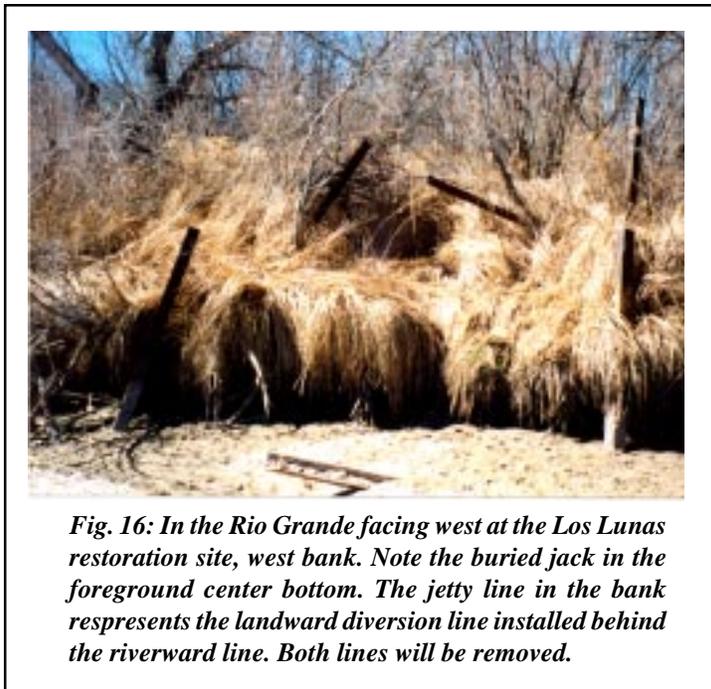
- 26.....Fig. 16: In the Rio Grande facing west at the Los Lunas restoration site, west bank. Note the buried jack in the foreground center bottom. The jetty line in the bank represents the landward diversion line installed behind the riverward line. Both lines will be removed.

As noted above, the jacks were placed to establish a bank and as a buffer to protect the levees. As lowering riverbanks and cutting channels into the area may be the only way to reconnect the river to the bosque, removal of the jacks holding those banks is the first step. Unlike in the Cochiti area below the dam where the paucity of sediment supply has caused erosion behind the jetty lines and rendered them useless, the second tier of jacks in the Los Lunas area has maintained the bank line. The vegetation built up behind the bank line provides a buffer between the river and the levee (see Fig. 16 above).

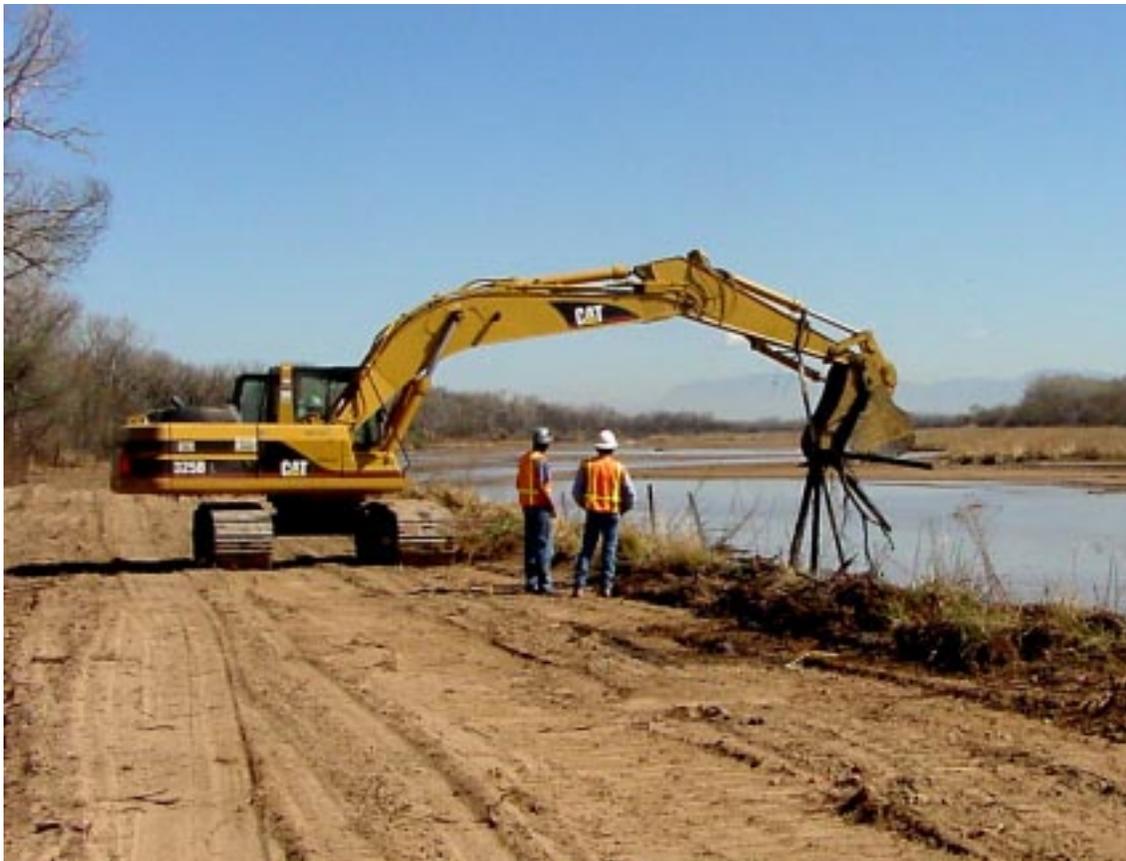
*Fig. 17: Los Lunas, west bank. The first day of jetty jack removal, Apr. 9, 2002. Bankline jacks are the first to be removed. The job of removing 1,355 jacks is expected to take one to several months. Photo by Mark Horner, U.S. Army Corps of Engineers.*

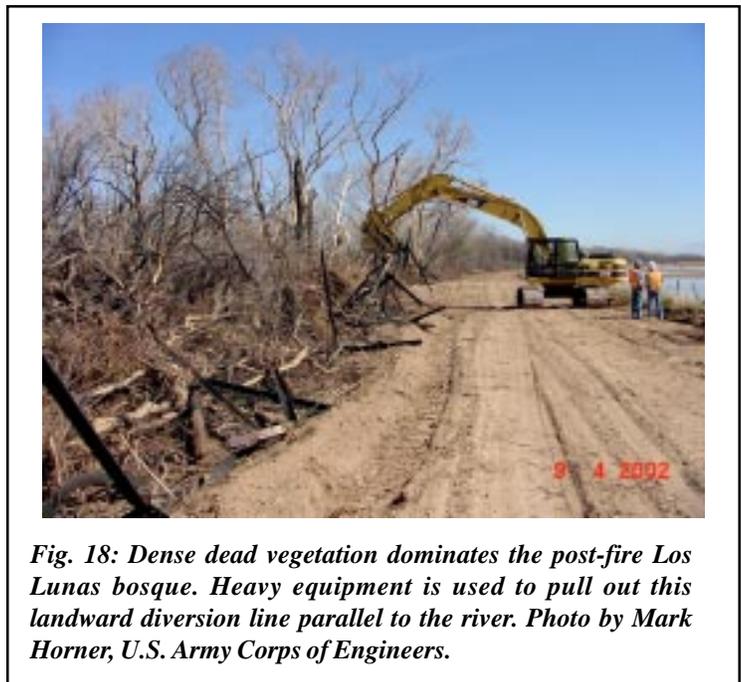
- 28.....Fig. 18: Dense dead vegetation dominates the post-fire Los Lunas bosque. Heavy equipment is used to pull out this landward diversion line parallel to the river. Photo by Mark Horner, U.S. Army Corps of Engineers.

While this much is known, no analysis was conducted to assess feasibility of removal or to predict the effects of removal of the jetties. The mostly buried river jacks were expected to crumble when pressure was applied to extract them, but the jacks came out much easier than expected (Tashjian, pers. com.). The tieback lines are expected to come out fairly easily, even though interspersed with dense vegetation.

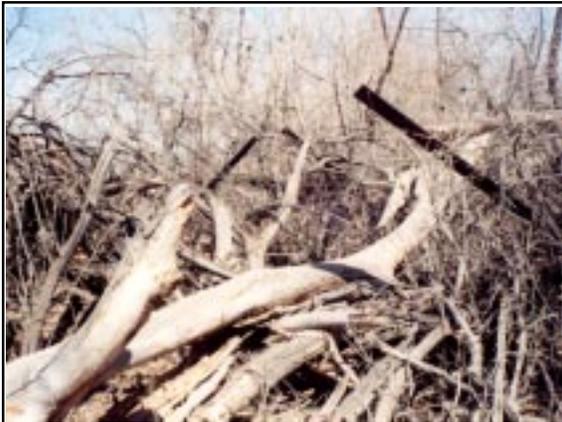
*Fig. 19: Dead and down wood tangled in jetty jacks in the bosque, slated for removal as part of the Rio Grande Valley State Park restoration project. Jetty jacks armor the river banks and prevent overbank flooding, so wood litter can't decompose, making it ready fuel for fires.*

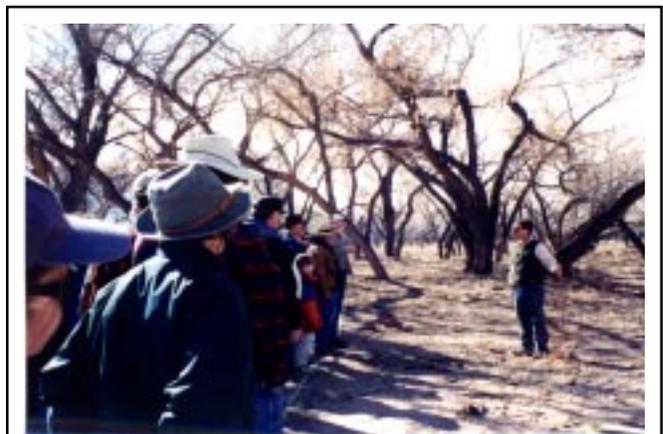
*Fig. 22: Results of jetty jack removal and exotic vegetation removal. Todd Caplan, project engineer for the Pueblo and the Bureau of Reclamation, gives a tour in the cottonwood bosque at Santa Ana restoration project area, 1999.*

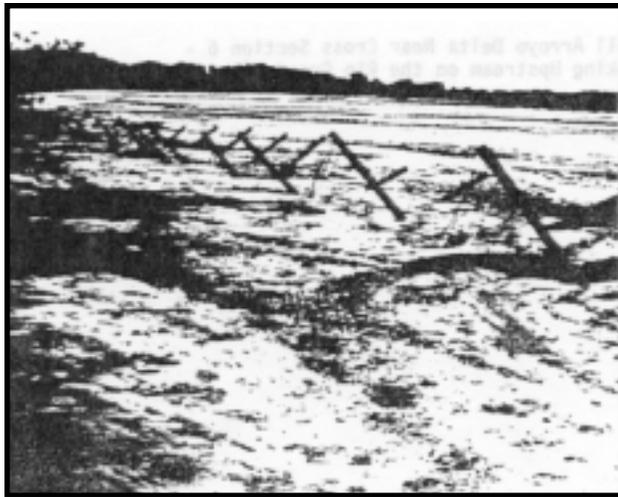
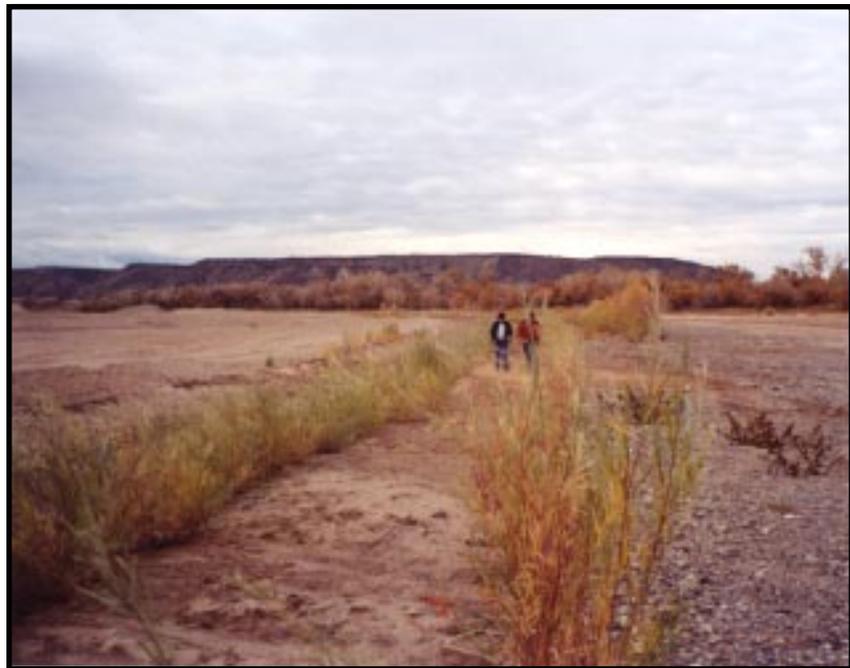
*Figures 23-24: Before and After: At left is a jetty jack installation at Santa Ana, photo 1974 (Lagasse 1980). Below is the result of bank restoration using bio-engineering methods and native willow planting.*

initiated in 1996 a restoration plan covering 1,200 acres of riparian land. The results have been impressive. The project is ongoing; so far 480 acres has been cleared of salt cedar and Russian olive (see Fig. 22 below). Revegetation with native trees and shrubs is completed on 30 acres to be expanded to additional acreage over the next several years. Soil remediation of 115 acres of saline soils had to be done before planting of native grassland. Finally, the Pueblo removed 1,600 jetty jacks from the abandoned floodplain adjacent to the river (see Fig. 23). Following clearing, part the channel was rebuilt to redirect flow away from a Bureau levee and bioengineering techniques were employed to build a new bank (see Fig. 24). The project is ongoing, well-funded, and successful.

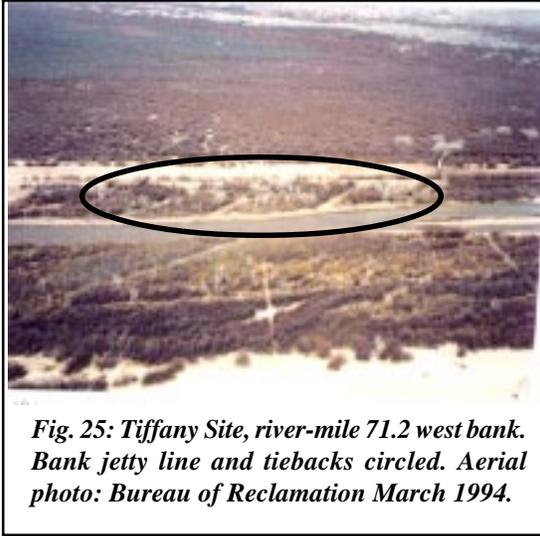
*Fig. 25: Tiffany Site, river-mile 71.2 west bank. Bank jetty line and tiebacks circled. Aerial photo: Bureau of Reclamation March 1994.*
