Watershed Assessment of River Stability and Sediment Supply Study on a Trout Stream (a Tool for Design Justification)

Mike Adams
Stantec
November 16, 2011

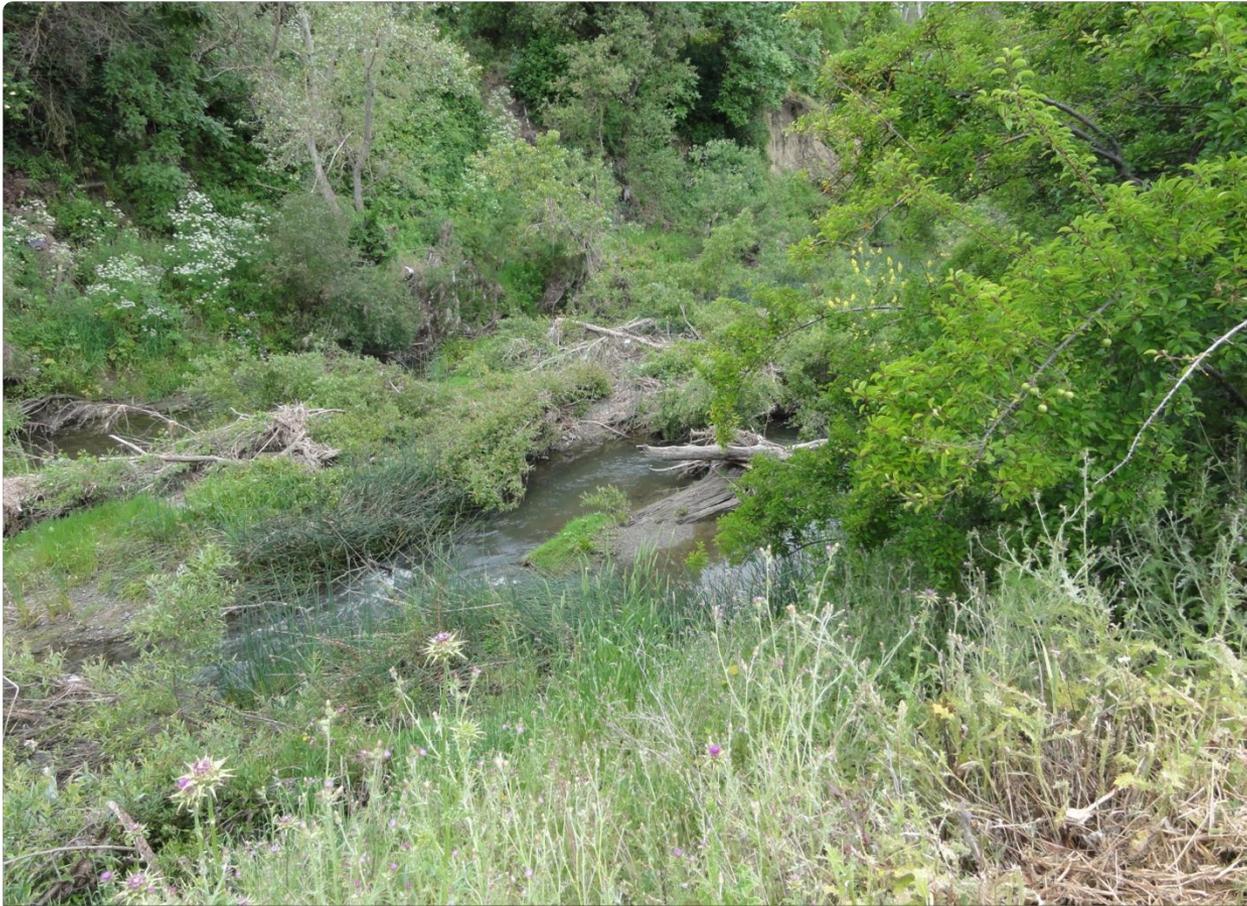
ADLL Study Reach

Mid channel bars overgrown with
vegetation

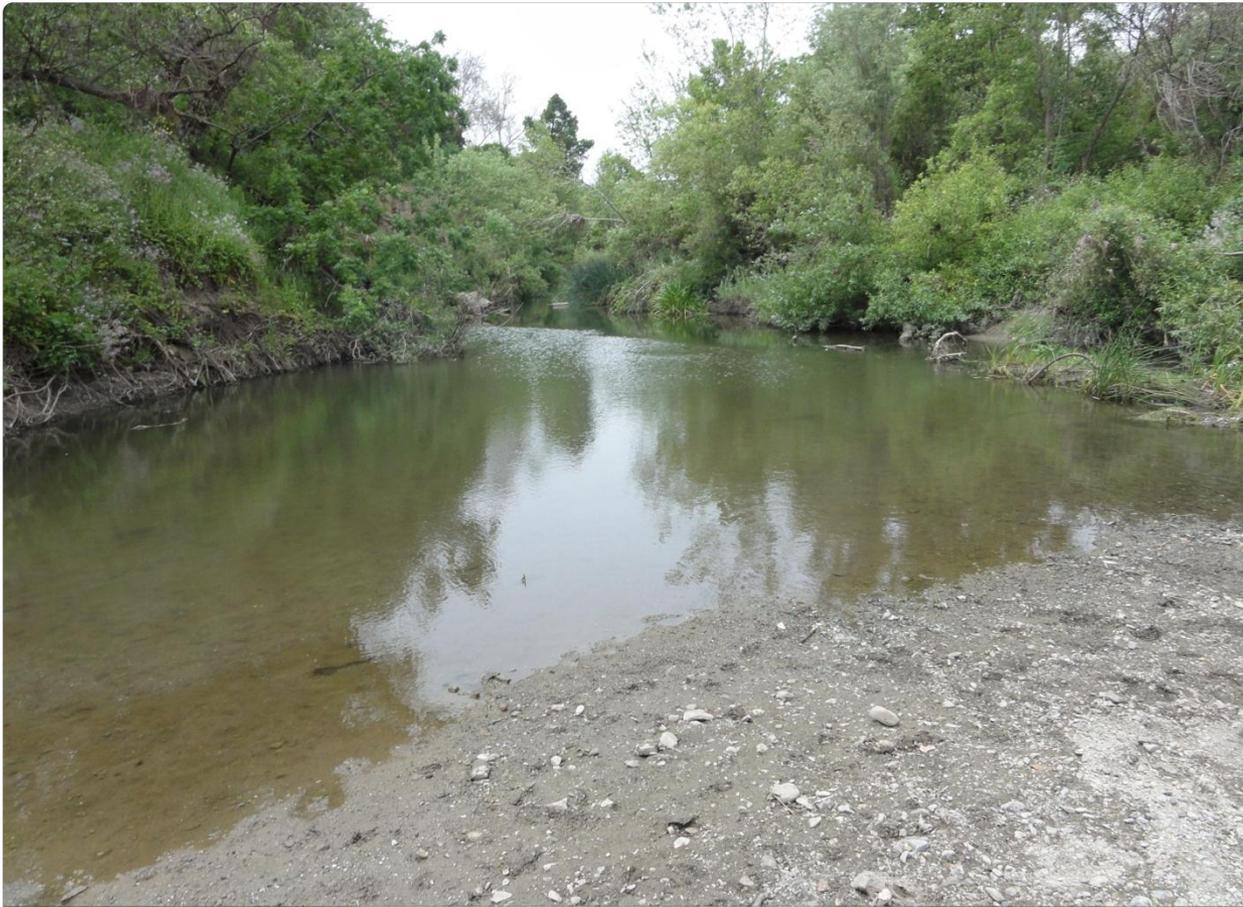
ADLL Study Reach

Long backwater pools with short riffles

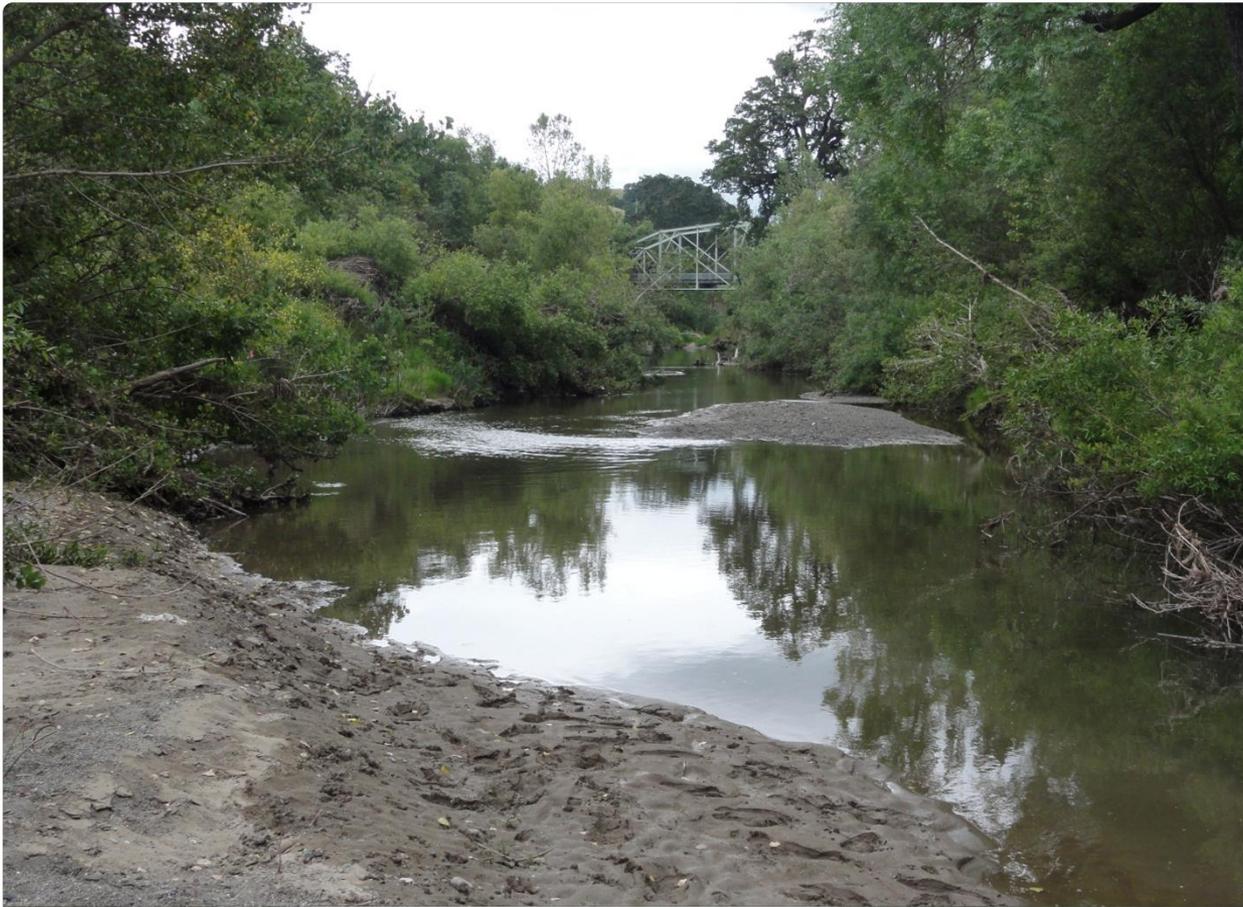
ADLL Study Reach

Alternating mid channel bars
beginning to form

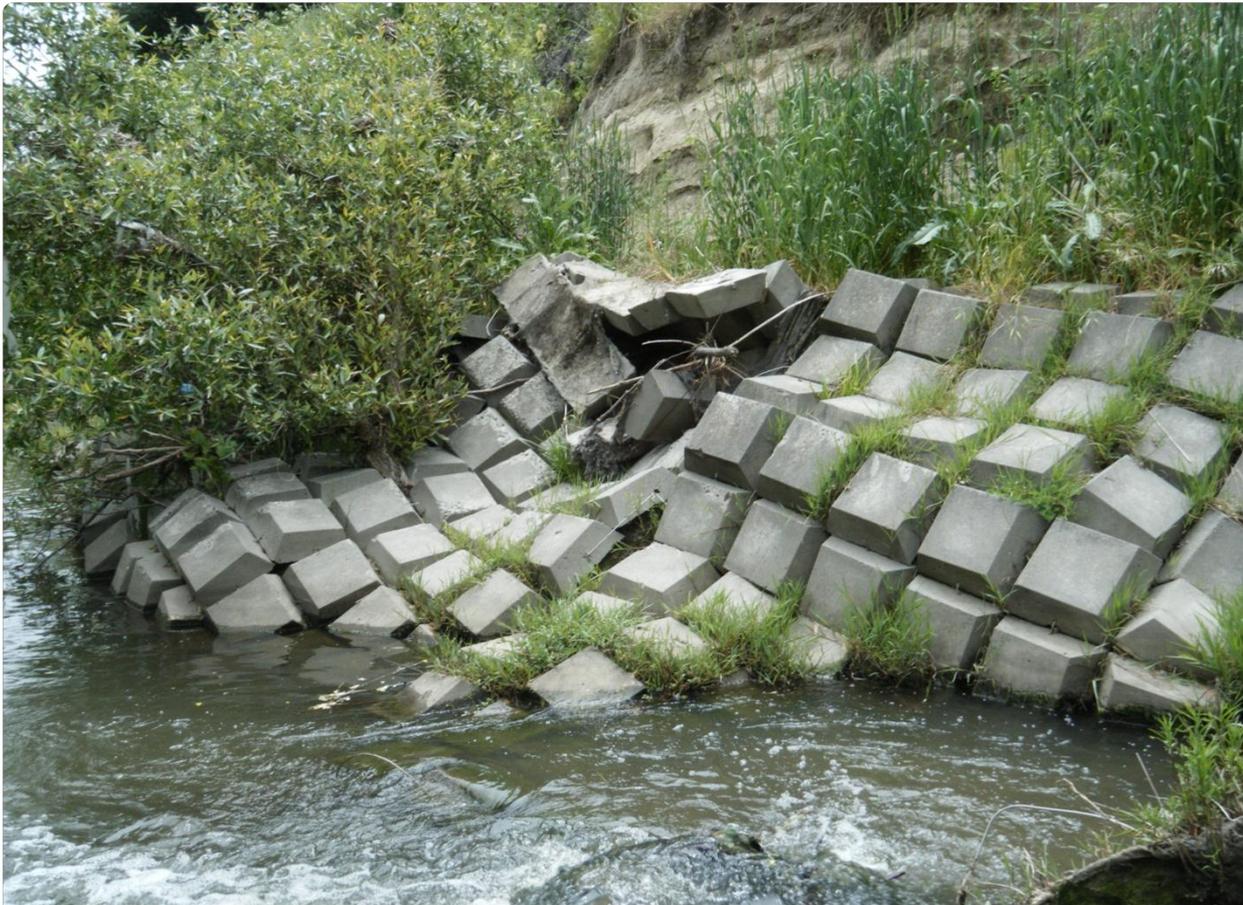
ADLL Study Reach

Failed bank stabilization measures throughout

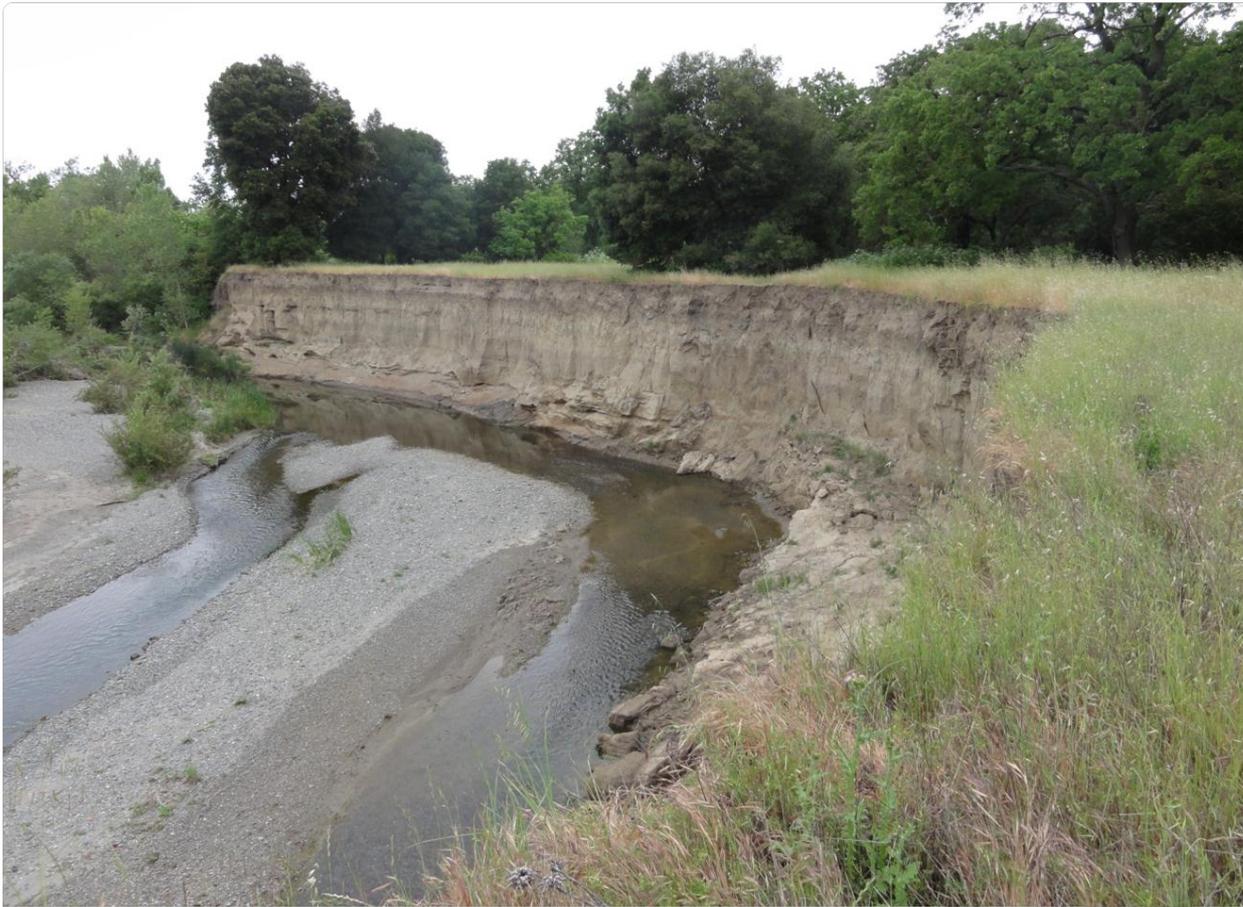
ADLL Study Reach

Looking upstream at one of two major eroding banks

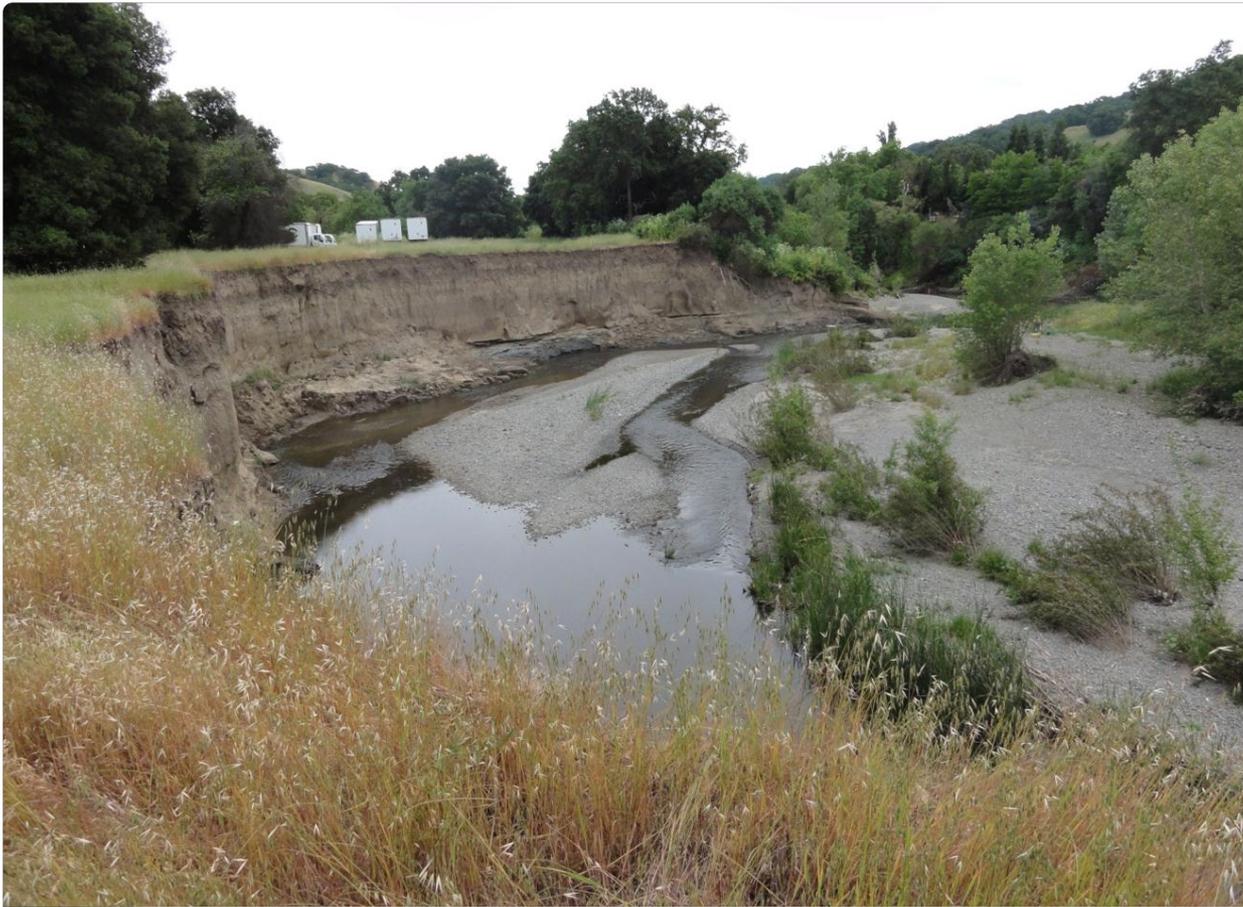
ADLL Study Reach

View looking downstream of same bank

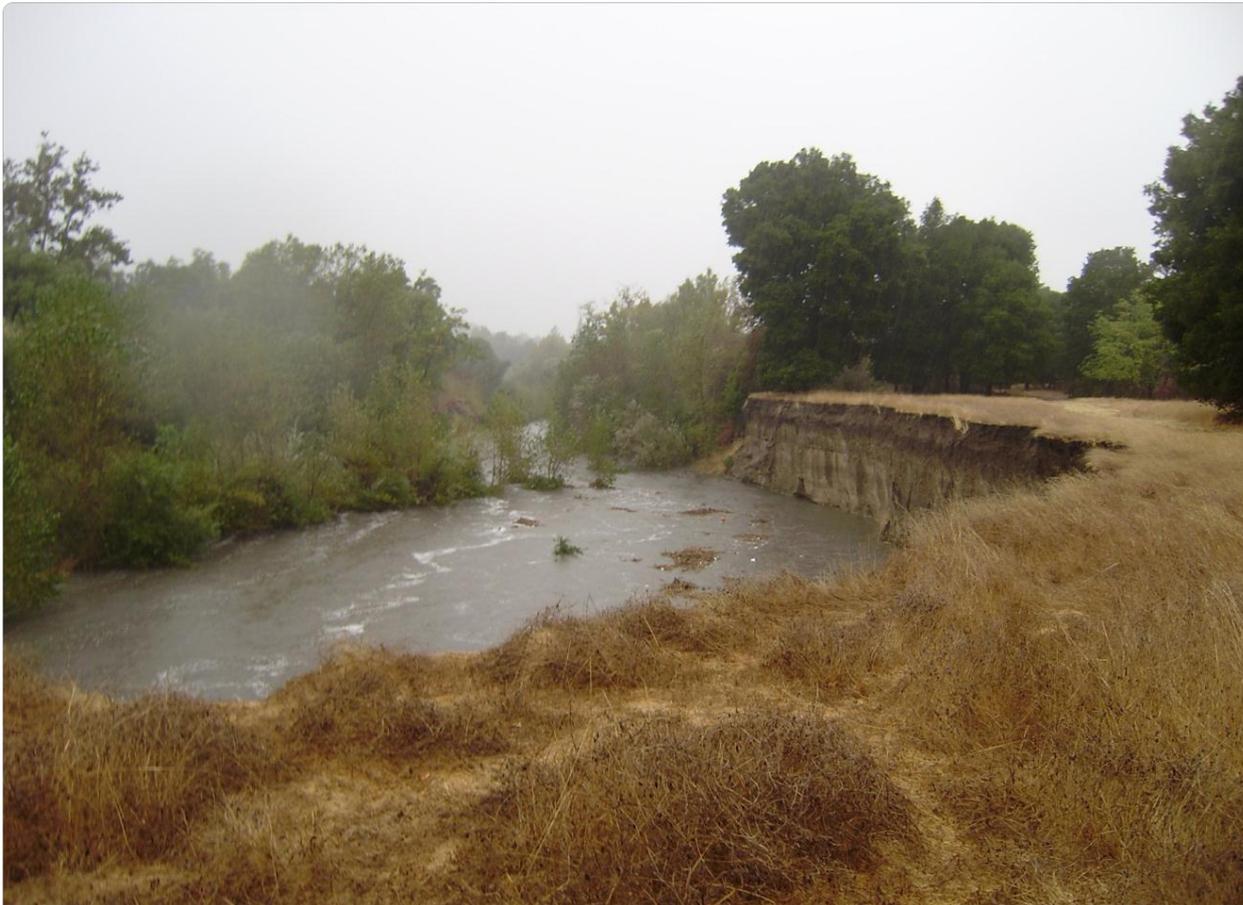
ADLL Study Reach

Flow at approximately 1,800 cfs
(bankfull discharge 1,900 cfs)

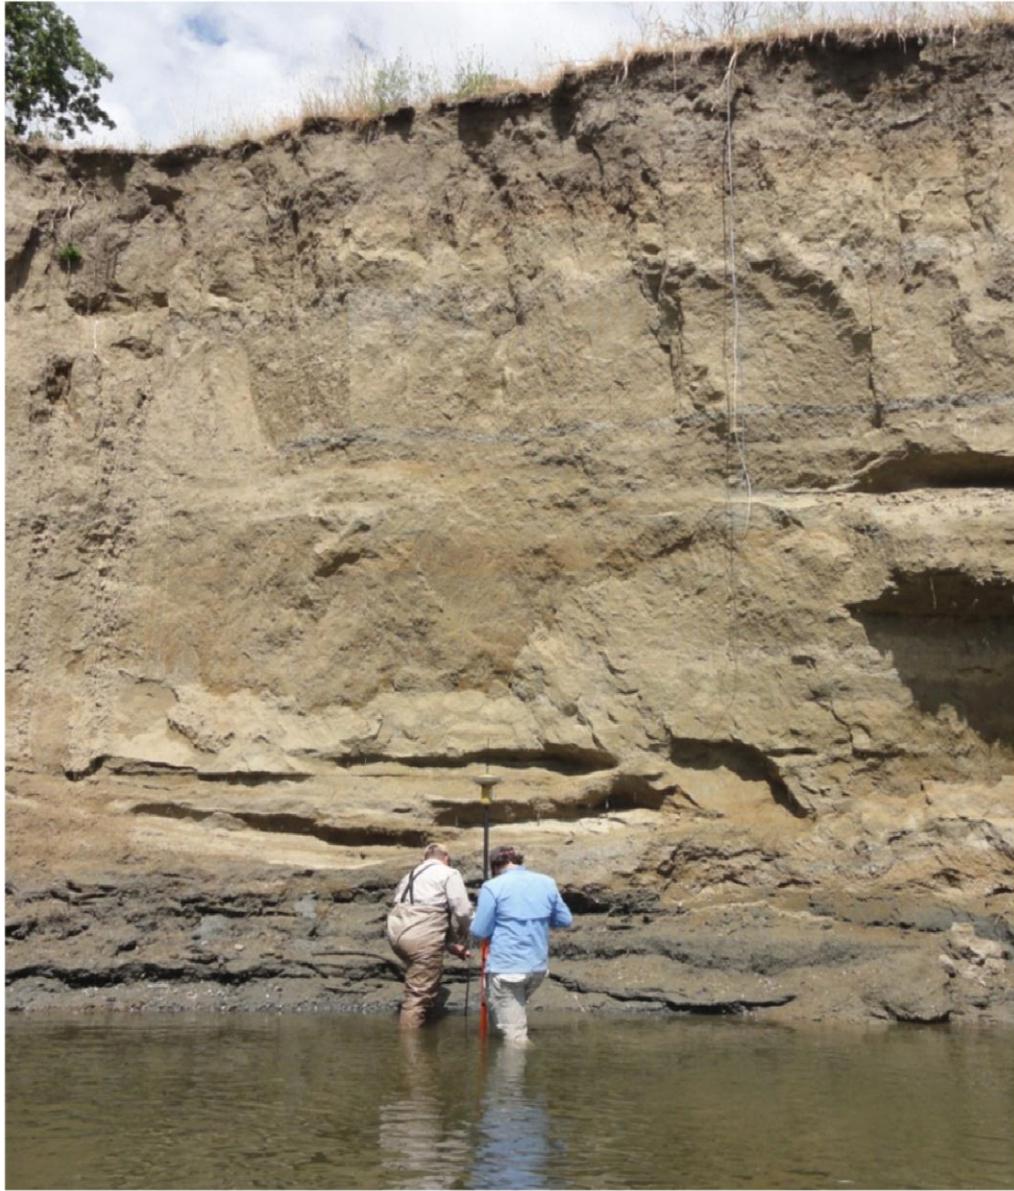
ADLL Study Reach

View of second major eroding bank

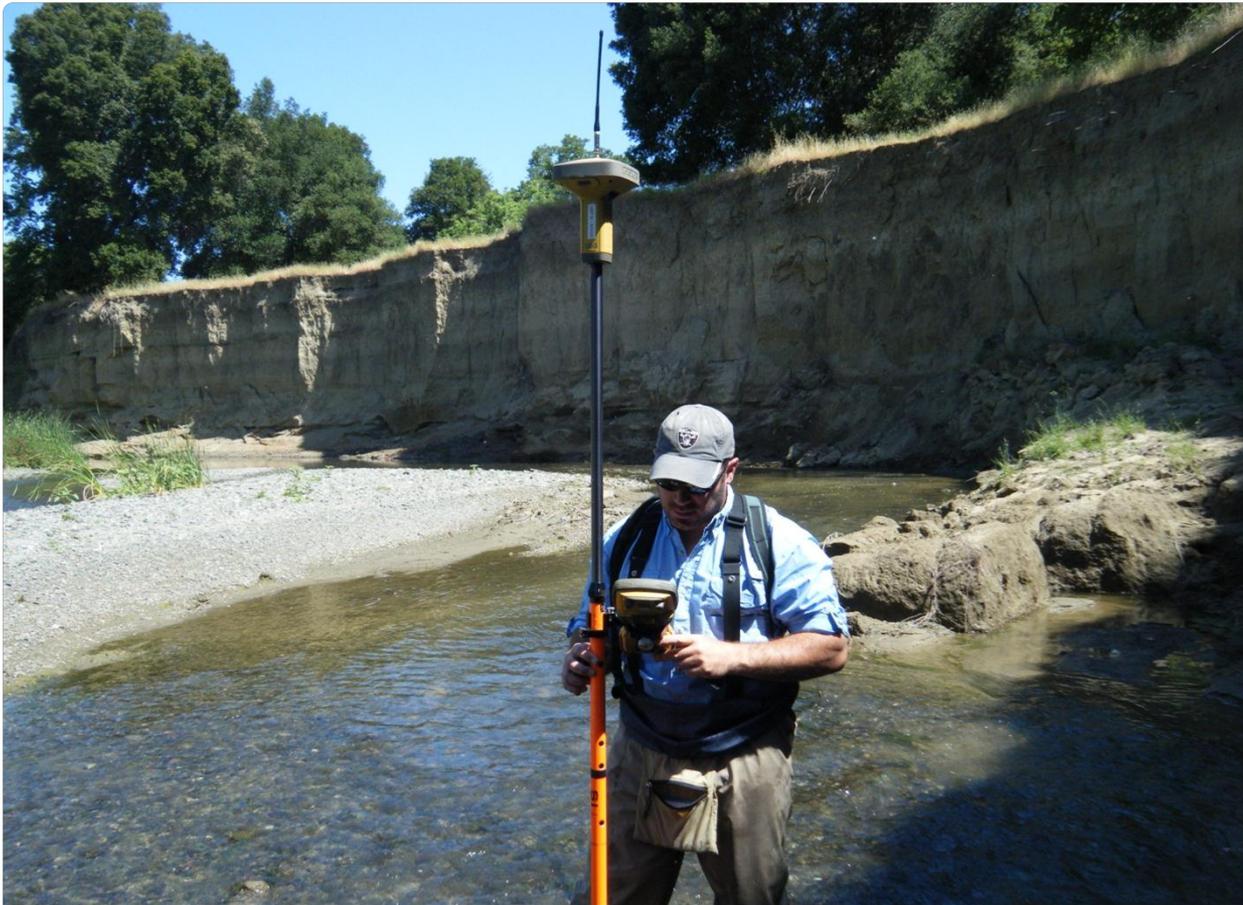
Longitudinal Profile
Cross Sections
Pebble Counts
Bar Samples
Scour Chains
Bank Profiles
BANCS

Geomorphic survey using survey grade
GPS

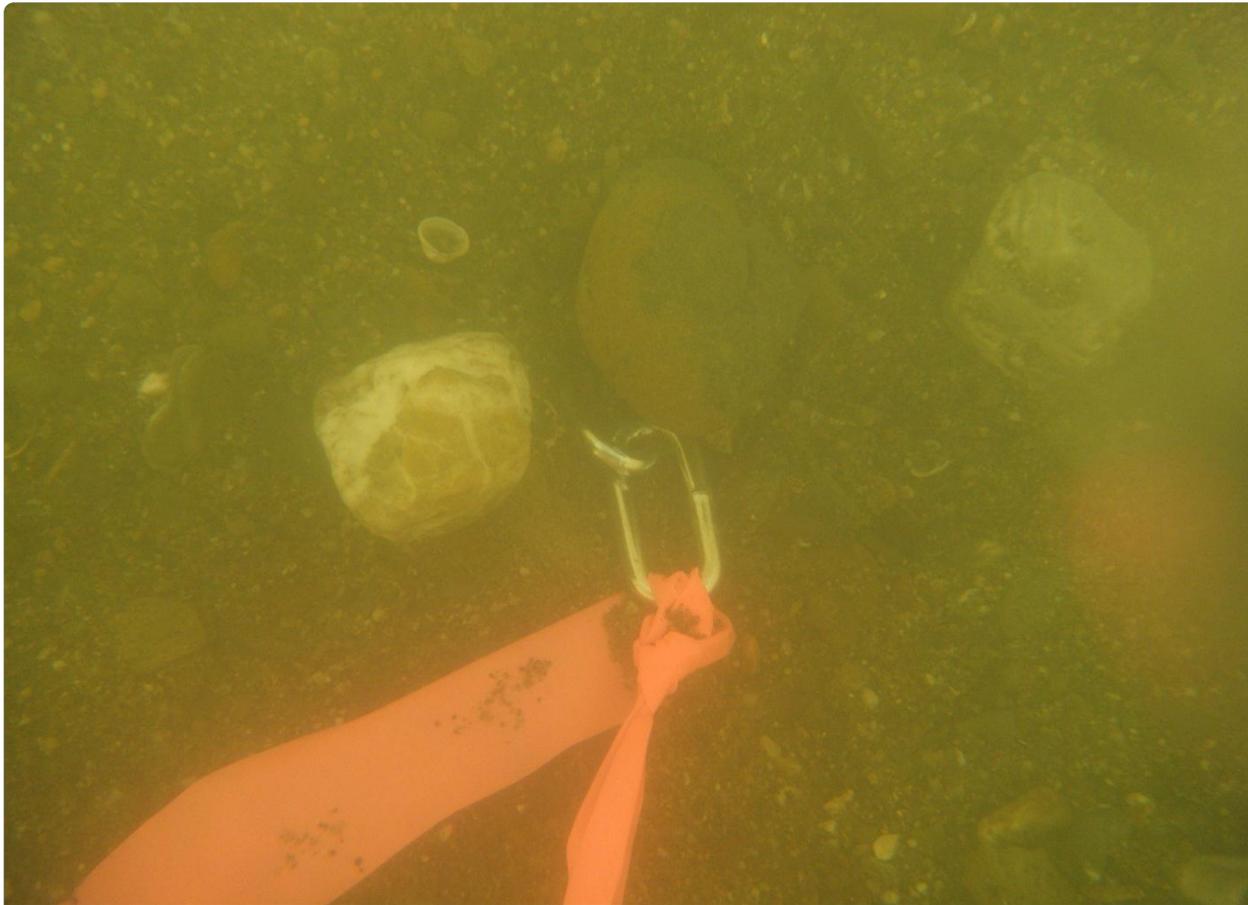
ADLL Study Reach

Scour chain

Worksheet 4-4. Field form to document scour chain results and corresponding bed-elevation changes.

Stream:		Arroyo de la Laguna				Location: Castlewood Dr to Verona Rd					
Observers:		MFA, MAV, MJG				Stream Type: F4 -> B4c			Valley Type: VIII / II		Date: 10-31-2011
		Installation Data (1st Year)				Recovery Data (2nd Year)					
		From cross-section		Particles near chain		Chain recovery			Particles near chain		
		Station (ft)	Elevation (ft)	Largest (mm)	2 nd Largest (mm)	Scenario # (1-5)	Scour depth ^a (ft)	Elevation ^b (ft)	Net change ^c (ft)	Largest (mm)	2 nd Largest (mm)
Glide Riffe	Chain #1	86.9	262.65			#4	N/A	263.28	-0.63	90 *	
	Chain #2	113.2	263.93			#4	N/A	264.61	-0.68	90 *	
Glide Riffe	Chain #3	126.6	265.43			#4	N/A	266.32	-0.89	90 *	
	Chain #4	142.4	266.06			#4	N/A	267.31	-1.25	90 *

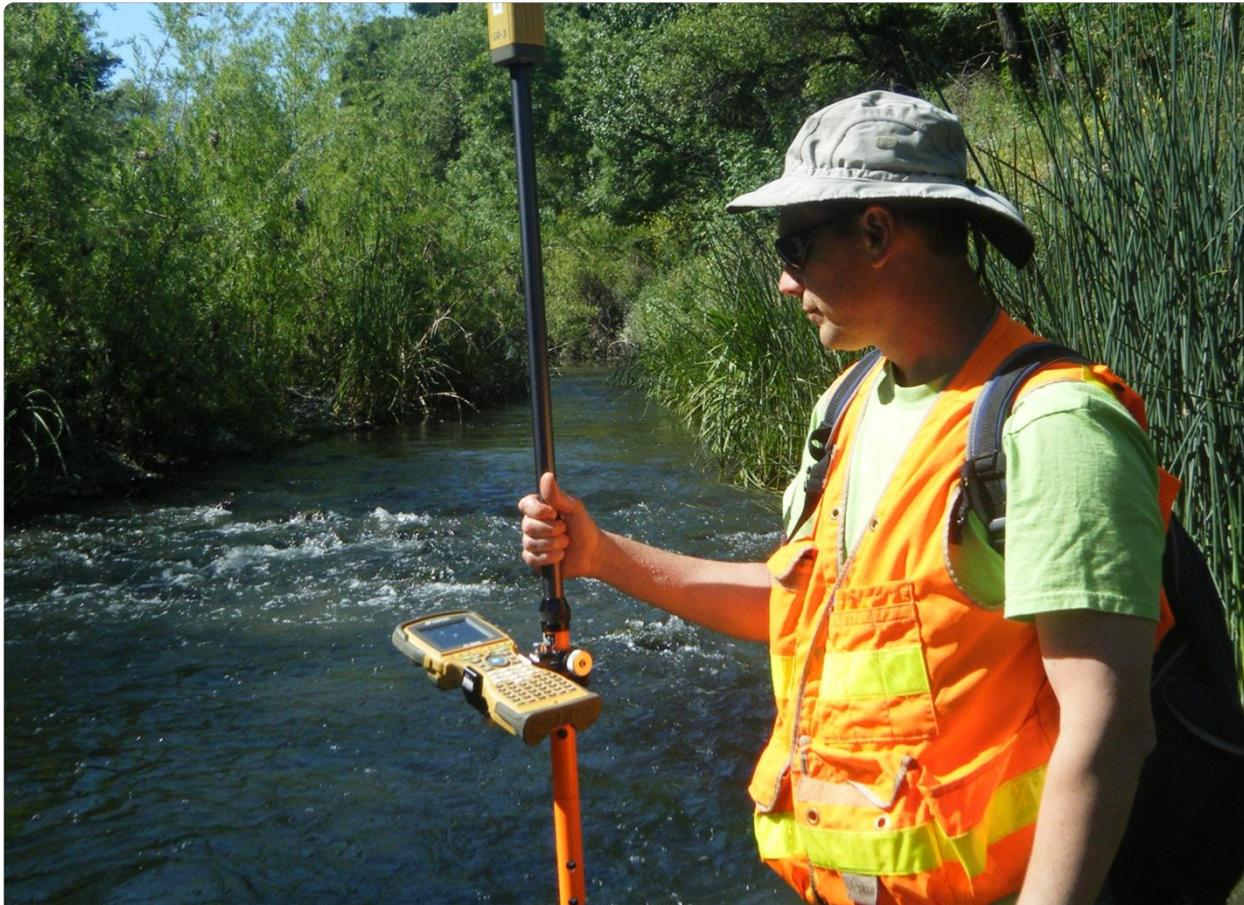
ADLL Study Site

Fisheries biologist marking and cataloging LWD habitat

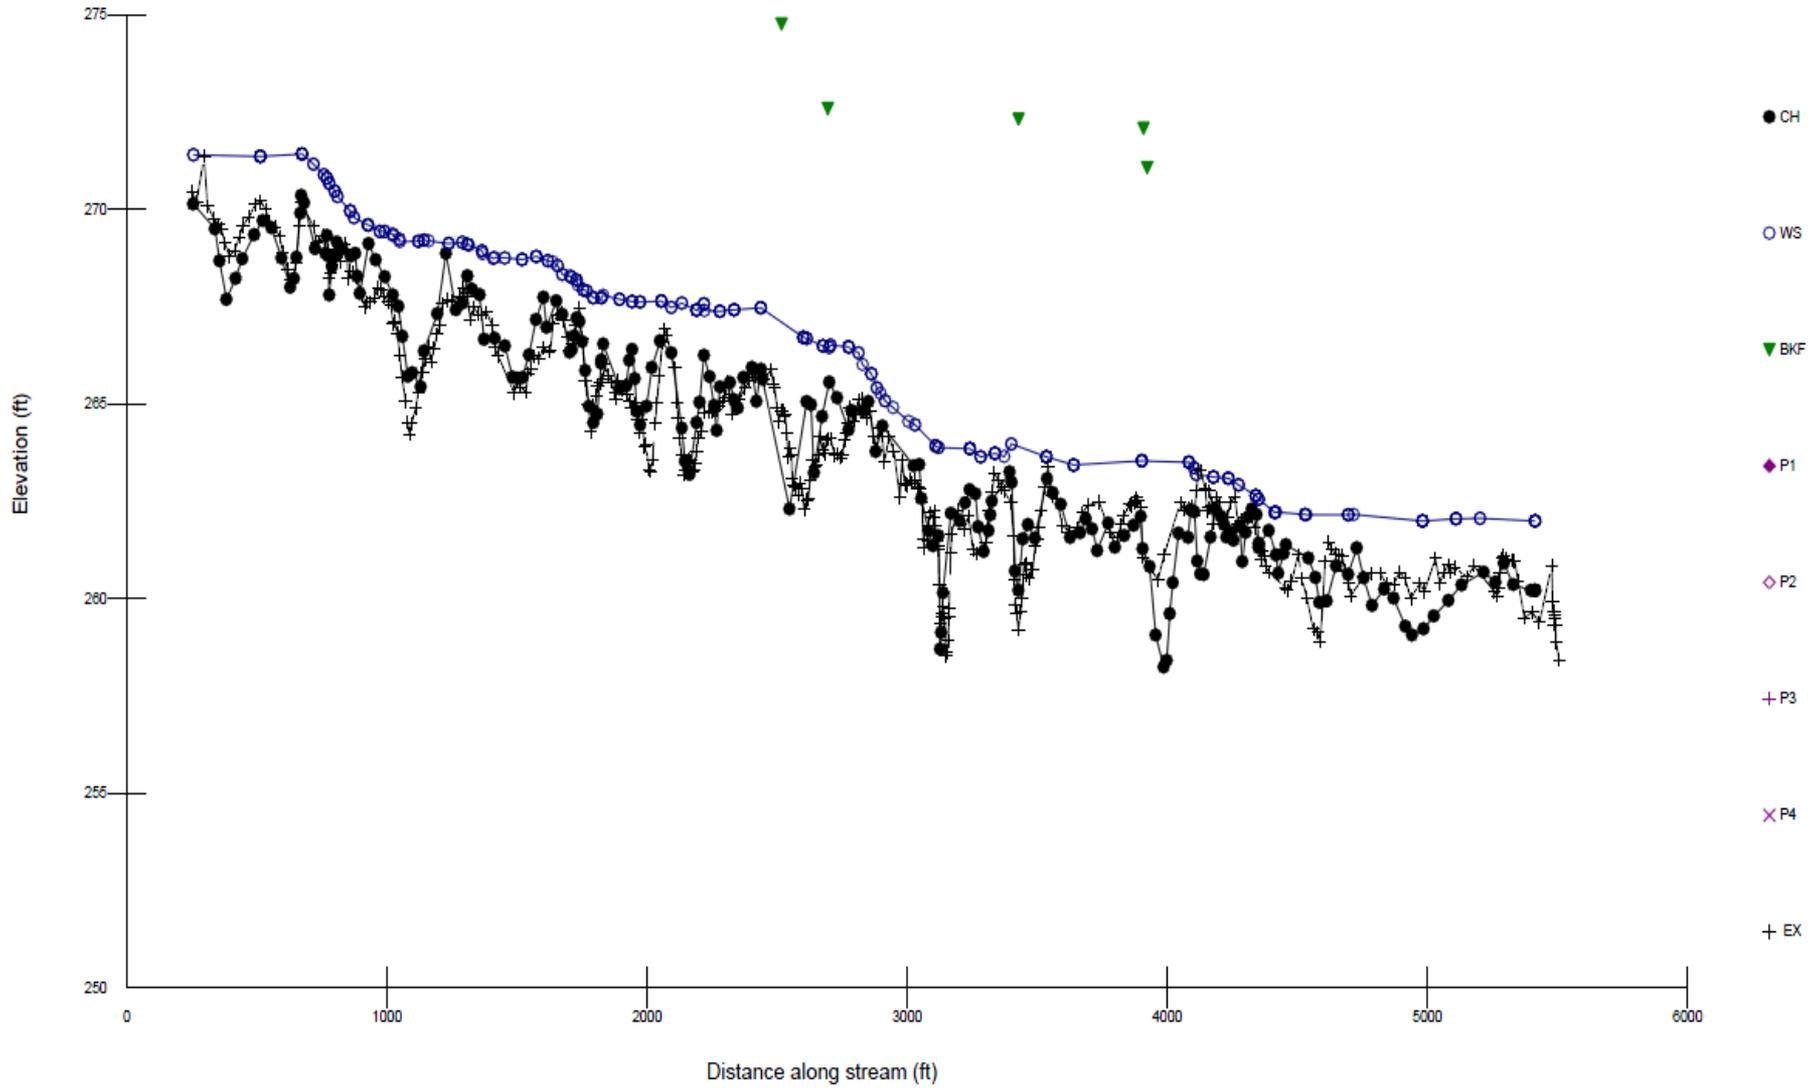
BS1-Validation

Validation Survey

Riffle XS-1:		Riffle XS-2:		Pool XS-3:	
		Station 42+69		Station 46+76		Station 22+02	
		Year 1	Year 2	Year 1	Year 2	Year 1	Year 2
Cross-section Dimensions	Width (W_{bkf})	129.9	152.4	75.8	79.4	118.7	125.2
	Mean Depth (d_{bkf})	4.54	3.6	5.75	5.72	6.5	6.63
	Width/Depth Ratio (W/d)	28.6	42.3	13.2	13.9	18.3	18.9
	Cross-Sectional Area (A_{bkf})	589.7	548.6	435.9	454.2	771.6	830.1
	Max Bankfull Depth (d_{max})	6.57	6.94	7.65	7.94	11.73	10.94

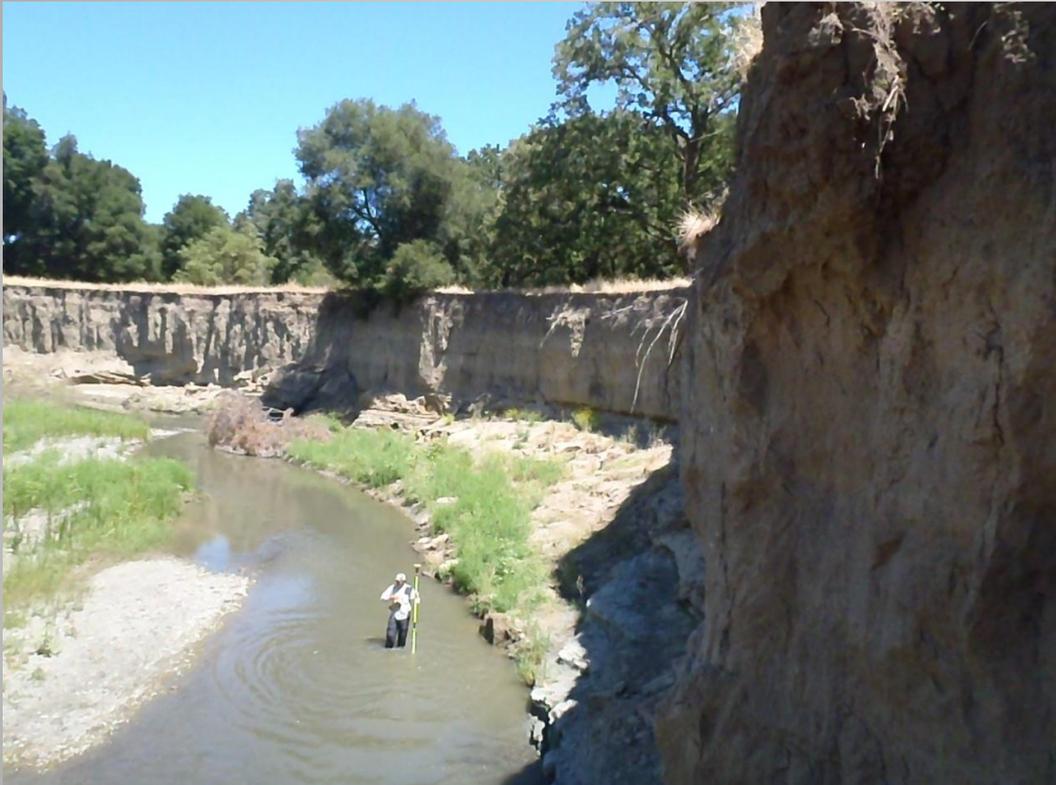
Example: Geomorphic Reach Assessment - BANCS

- 400 ft Eroding Bank Length
- How Much Sediment will Erode and When

88% of sediment inputs from bank erosion at two locations

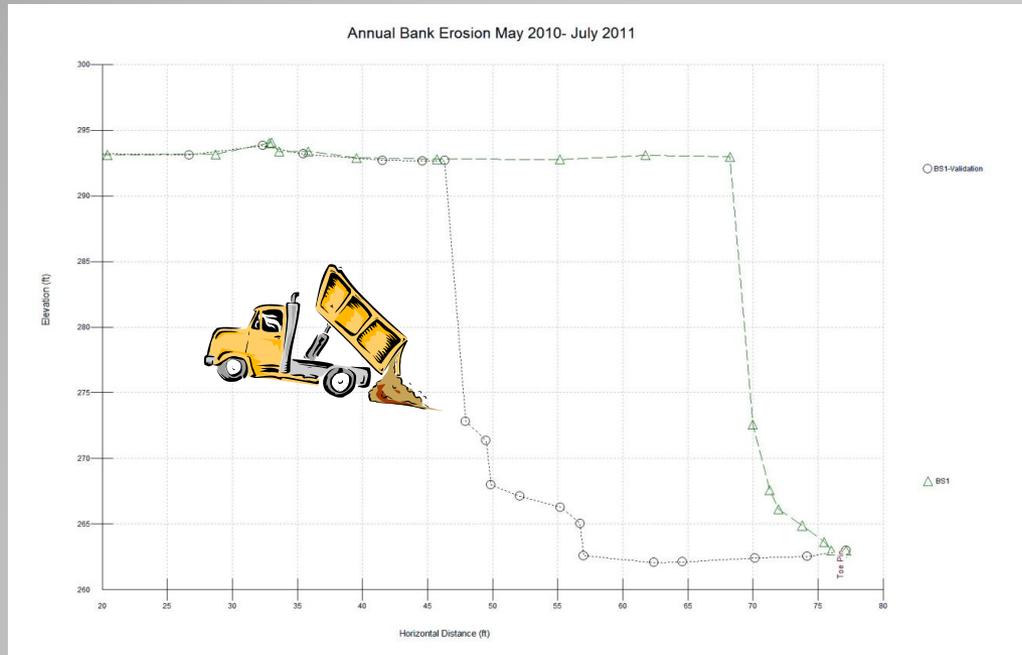
Example: Geomorphic Reach Assessment - BANCS

Prediction: 17 FT

Actual: 20.5 FT

- 20.5 Ft/yr
- 635 cubic ft/yr/ft – 2.3 Dump Trucks/yr ft
