Oxon Run, Washington, D.C. Stream Restoration Concept Development

CBFO-S04-02

April 2004

OXON RUN STREAM RESTORATION CONCEPT DEVELOPMENT

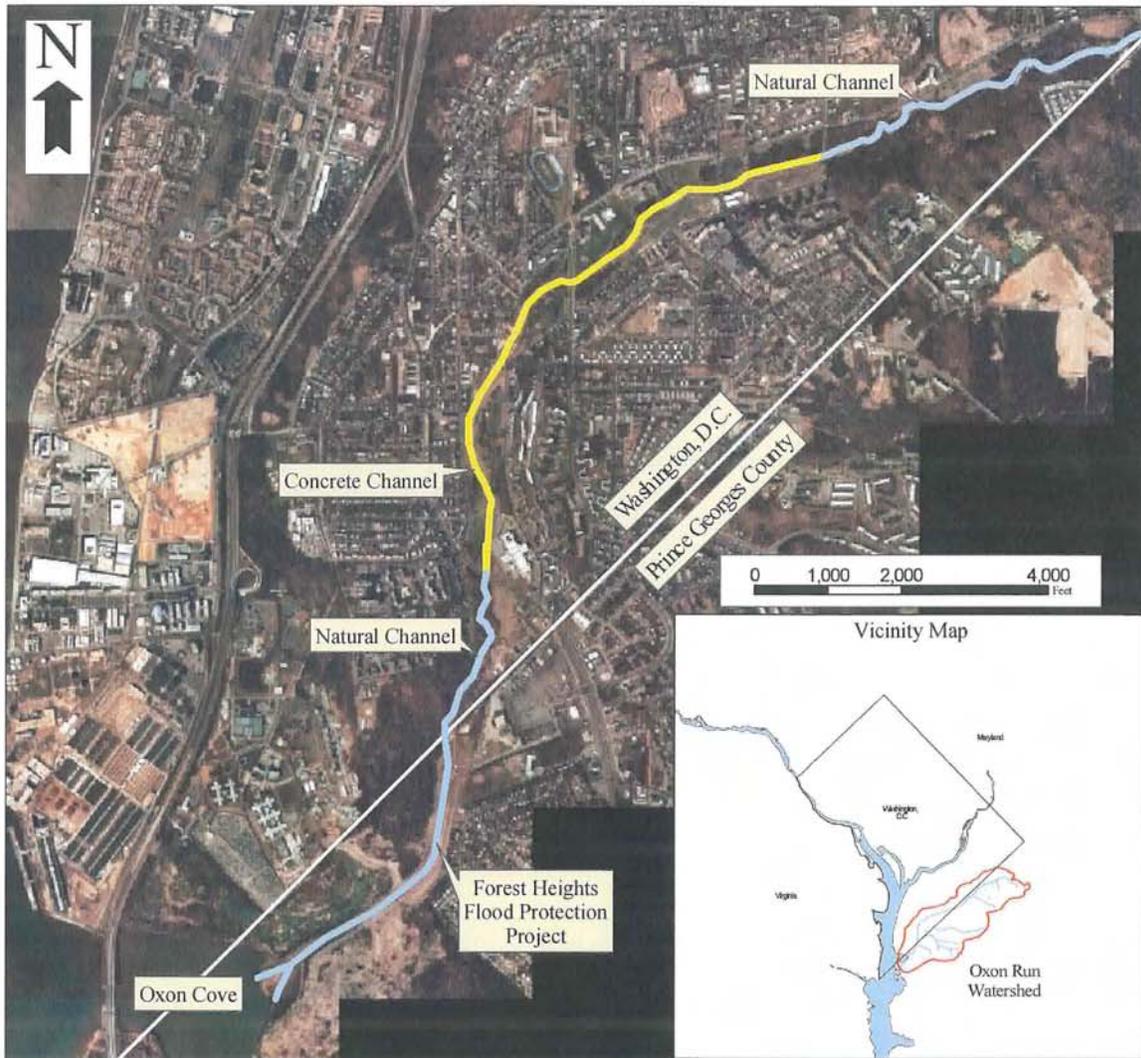
Figure 1: Oxon Run Stream Restoration - General Features

the drop structure, Oxon Run flows for approximately one mile, entering Oxon Cove and then crossing back into the District before its confluence with the Potomac River (Figure 1).

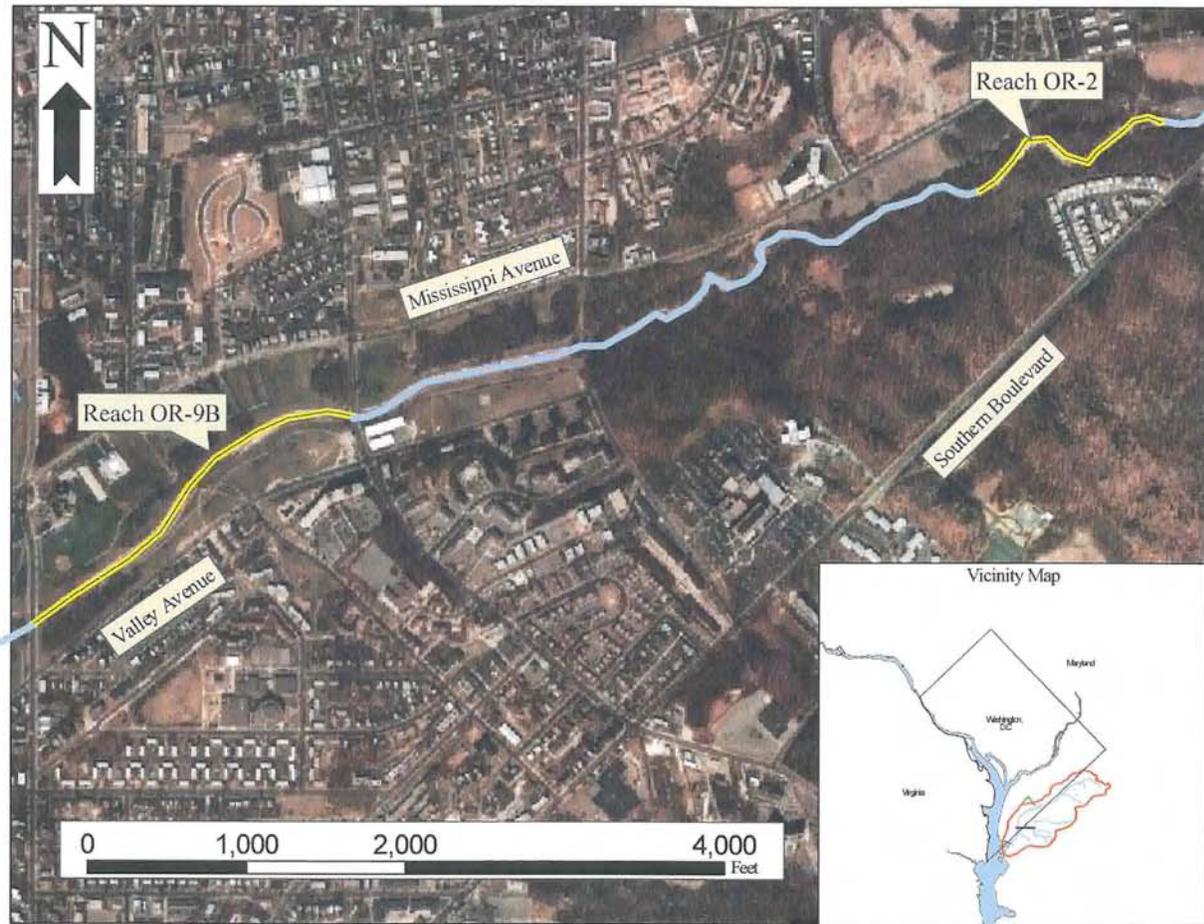
Figure 2: Oxon Run Concept Reaches

Oxon Run Reach 9 (OR-9) is the 7,920-foot long concrete channel section of Oxon Run. A portion of Oxon Run Reach 9 that extends 2,520 feet from Wheeler Road to 4th Street was selected for the concept design¹. The subsection (Reach OR-9B) is typical of the entire concrete channel reach. While the concrete channel is located in open park land, there are design issues created by the presence of sanitary sewers near the existing

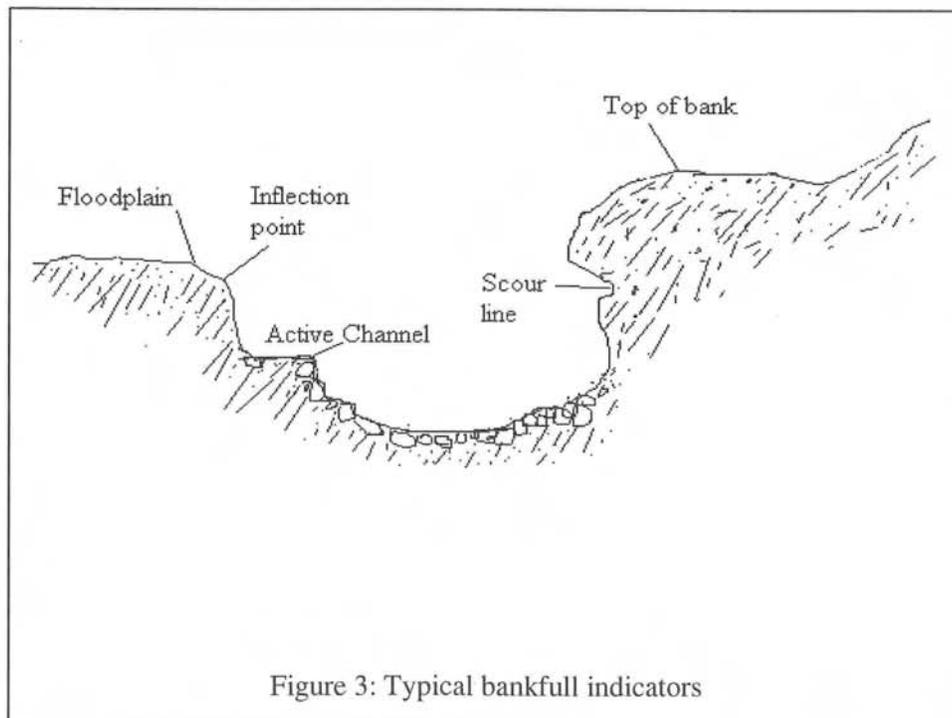
During the Oxon Run Assessment, the Service identified bankfull stages using physical indicators of bankfull stage described by McCandless and Everett (2002). Indicators found to be significant in Maryland are depicted in Figure 3 and described below:

- **Floodplain break:** a discrete transition from near vertical to near horizontal; used on straight reaches or on bends lacking point bars. In some cases, (where the stream is not entrenched or incised) the floodplain break may also be the top of bank.
- **Inflection point:** where the transition from near vertical bank to near horizontal floodplain is not relatively discrete, but instead occurs over a transitional zone often composed of one or more obtuse slope breaks over a vertical distance of several tenths of a foot, the inflection point is the lowest identifiable break in slope.
- **Scour line:** a wear mark on a vertical bank, or a discrete break in slope (acute or obtuse) of the channel bank, distinguished from an inflection point by being

further down from the top of bank.

- **Depositional bench:** the flat surface, or highest elevation, of a lateral depositional surface other than a point bar. This may also be referred to as the active channel.
- **Point bar:** the transition point from inclining point bar surface to horizontal floodplain surface.

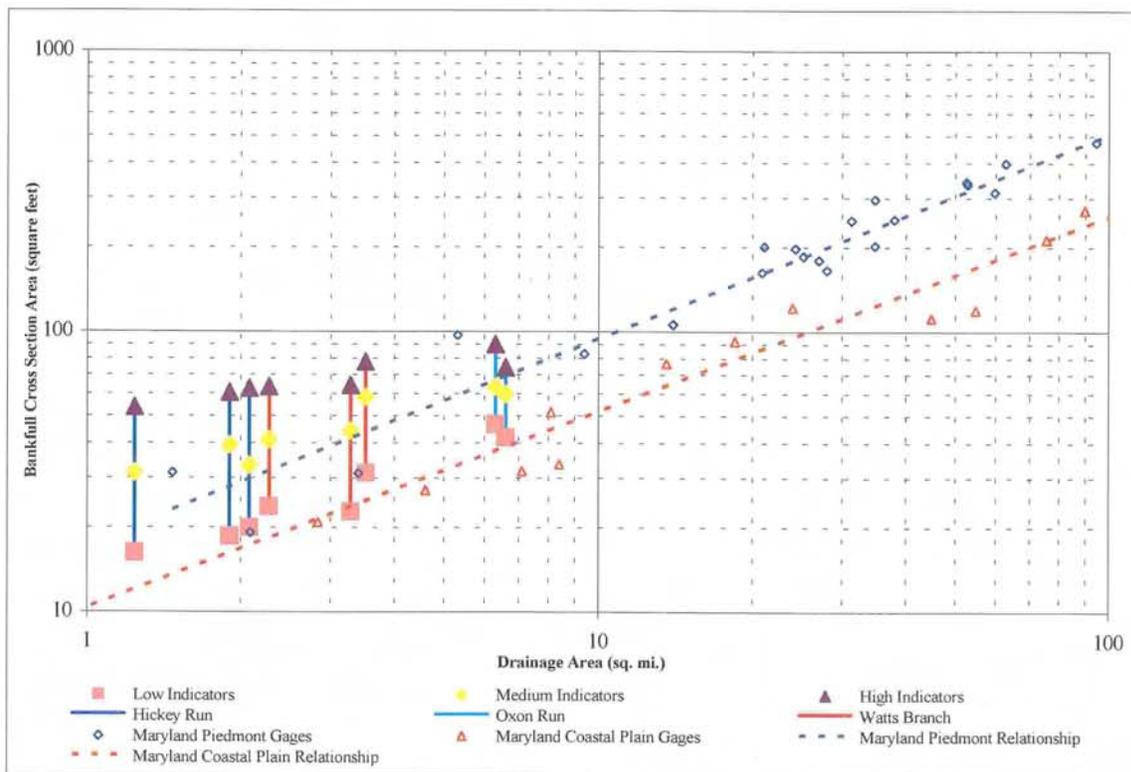
Figure 4(a): Regional Relationships for Bankfull Cross Section Area

The Maryland Piedmont hydraulic geometric relationships fall close to the District streams, but use of the Maryland Piedmont relationships for the Hickey Run, Oxon Run, and Watts Branch is inappropriate because the relationships are based on streams from a dissimilar hydro-physiographic region.

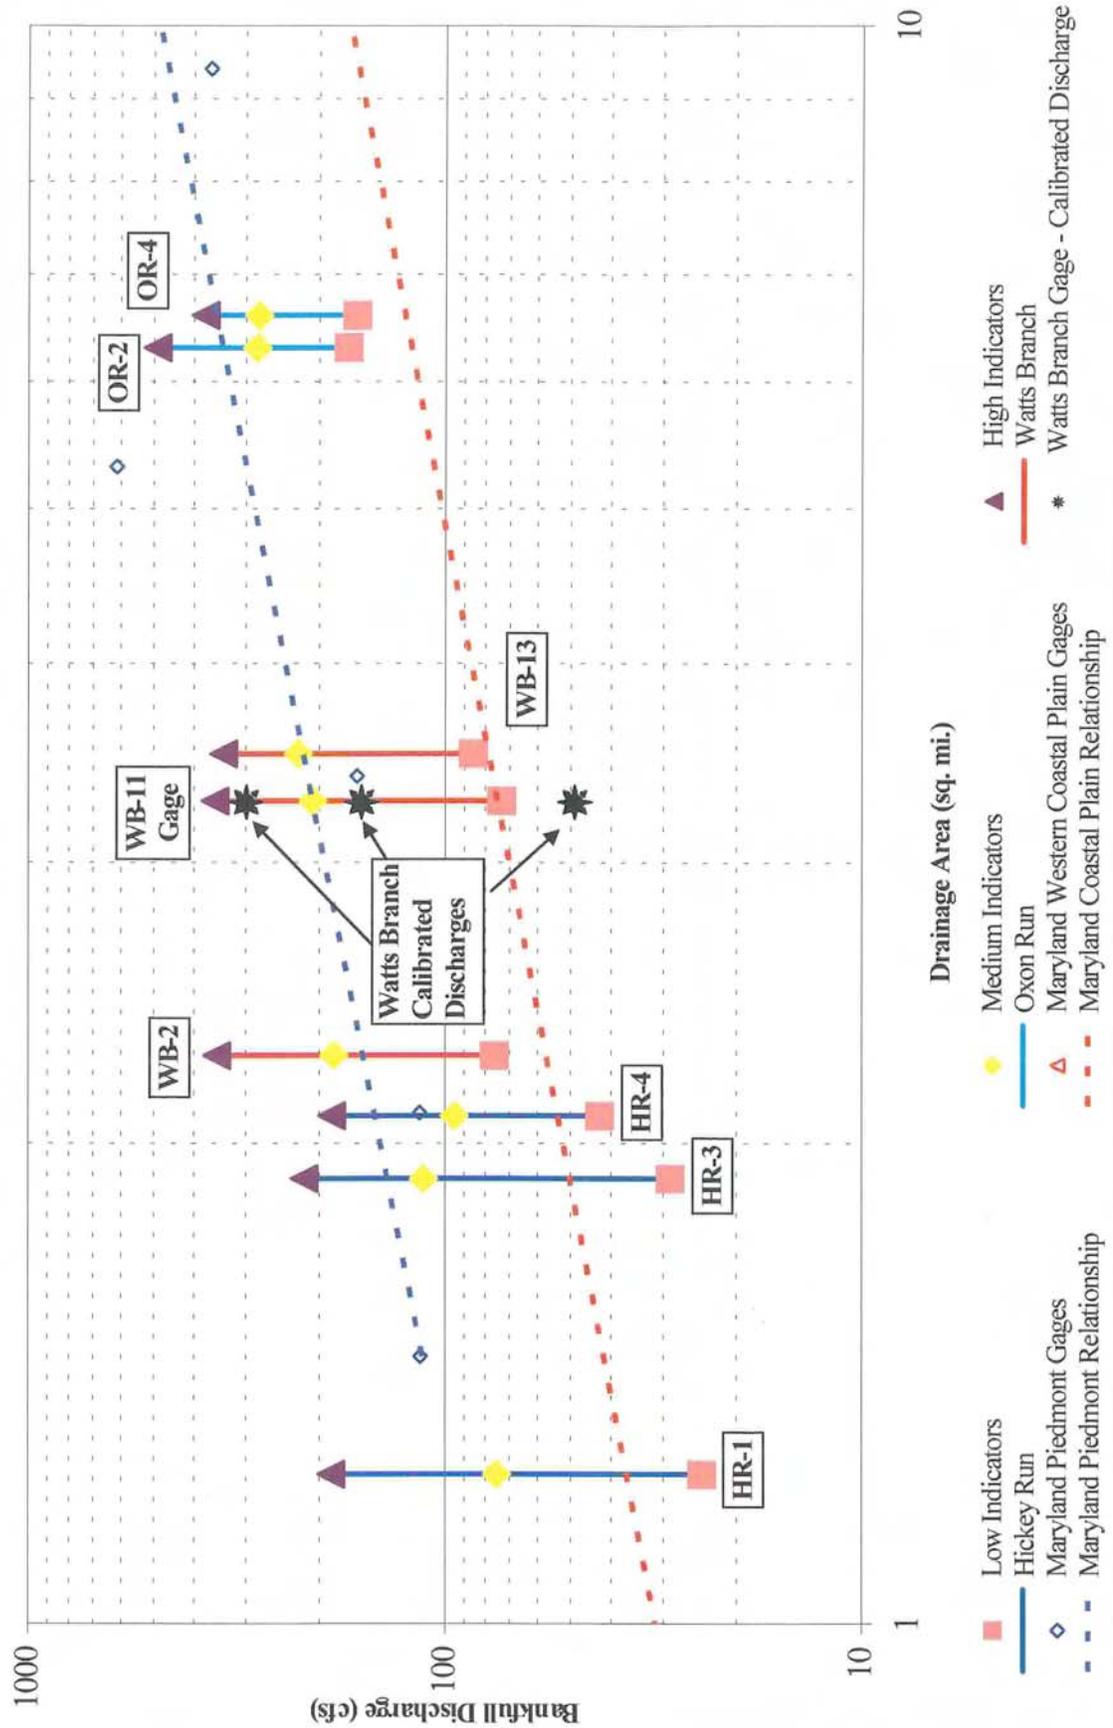
Figure 5: Bankfull Discharge Estimated using Leopold 1994

Stream	Reach	Hydraulic Radius (feet)	Bankfull Slope	D84 (mm)	Bankfull Velocity (ft/sec)	Bankfull Discharge (cfs)	Manning's "n"
Oxon Run	OR-2	2.04	0.0050	42	5.5	491	0.031
	OR-4	2.04	0.0040	36	5.1	376	0.030
Watts Branch	WB-02	2.19	0.0034	21	5.6	353	0.026
	WB-11	2.03	0.0039	23	5.5	357	0.027
	WB-13	2.11	0.0022	21	4.4	340	0.026

Comparison of the range of values of Manning’s “n” calibrated for the Watts Branch gage (0.043 – 0.032) with the values produced by Leopold’s (1994) relationship (0.028 – 0.027) indicate that at least for the Watts Branch gage that the Leopold (1994) under-predicts roughness and over-predicts discharge and velocity.

While the Watts Branch stream gage is only one data point, comparison of the predicted bankfull discharges for Oxon Run Reach OR-2 and OR-4 also suggests that the Leopold (1994) relationship may not provide accurate estimates of channel roughness for District streams. Reaches OR-2 and OR-4 are located in close proximity to each other and there are only minor inflows from storm sewer outfalls to Oxon Run between the two reaches. Bankfull discharge estimates should be similar at both cross sections, but the estimate for the high bankfull indicators in Reach OR-2 is over 100 cfs greater than for Reach OR-4 downstream. The physical characteristics of the two reaches are different (See Table 3). Reach OR-2 is wider, has a larger cross section area, and a steeper slope (0.0050 vs. 0.0040). Reach OR-2 has significant form resistance created by meanders and large amounts of vegetation within the bankfull channel. Reach OR-4 was straightened, has low form drag, and has little vegetation within the bankfull channel. The Leopold (1994) relationship fails to account for the differences in form drag created by vegetation and meanders at higher discharges.
