A Case Study of the Effectiveness of Stream Restoration in the Cacapon River, West Virginia

Jonathan Pitchford, Stephen Selego, Dr. Lance Lin, &
Dr. James T. Anderson

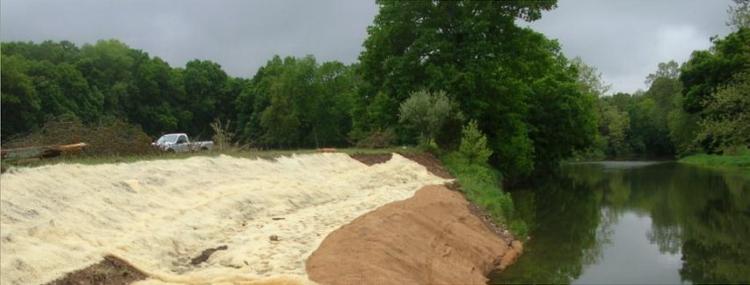
1- Morphological reconstruction of banks

- 6 streambanks sections re-contoured to include a bankfull bench
- 9 log vanes constructed
- 1500 trees and shrubs planted throughout the reach & both sides were fenced to create 50 ft buffer

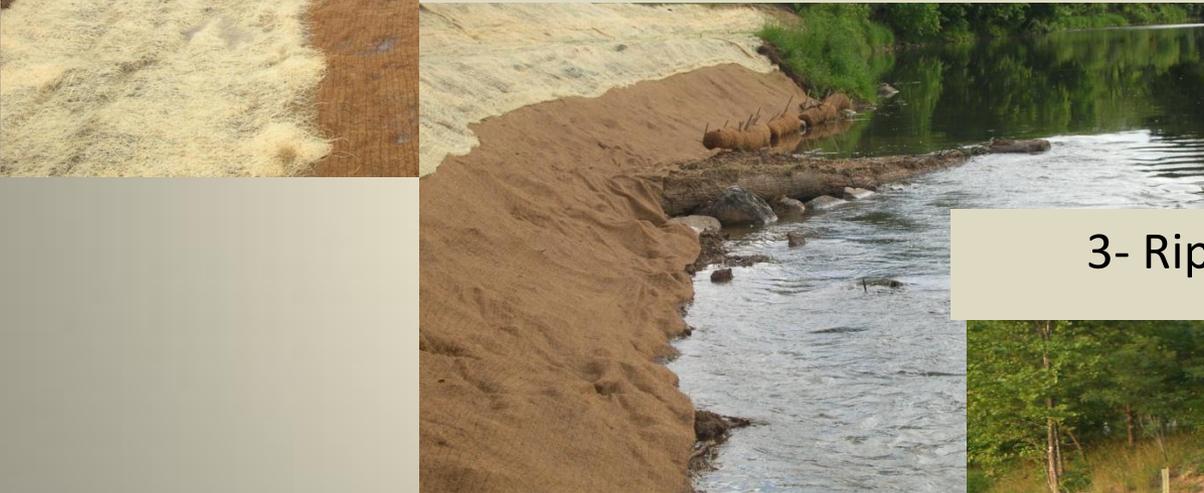
2- Construction of log vanes

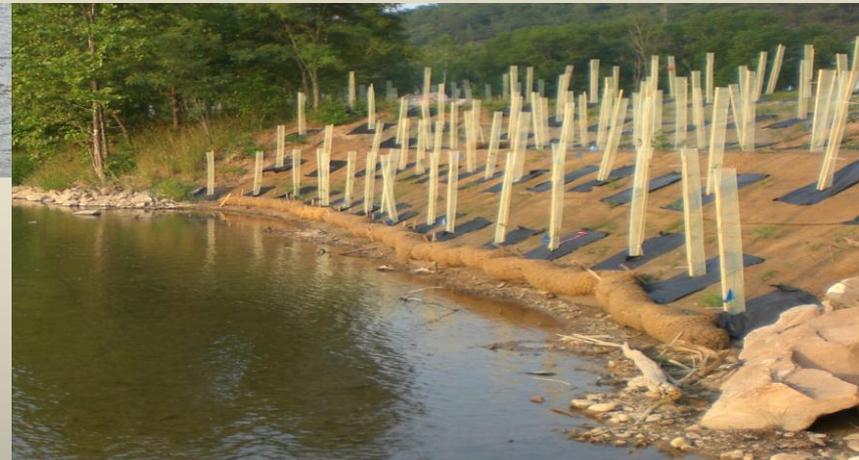
3- Riparian planting & fencing

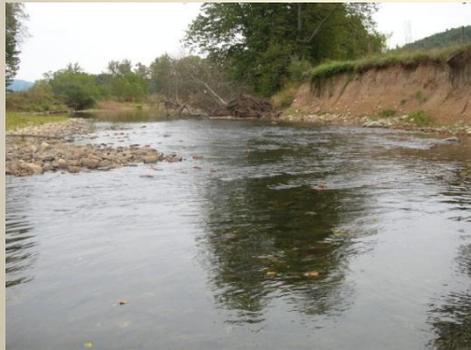
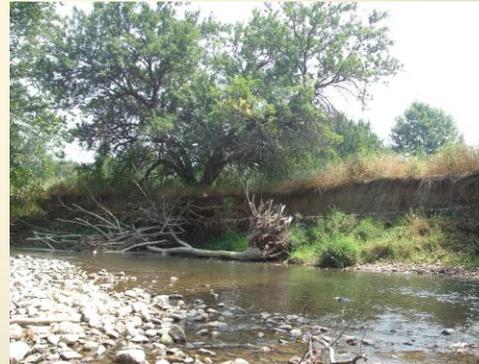
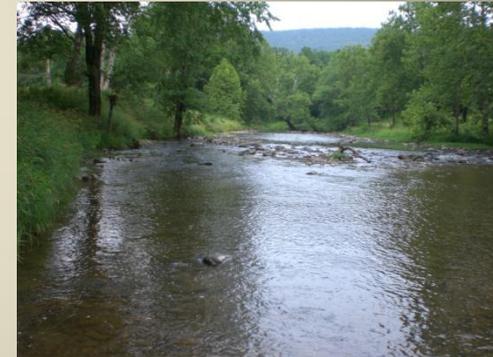
Before Restoration

Restoration

Control

Reference

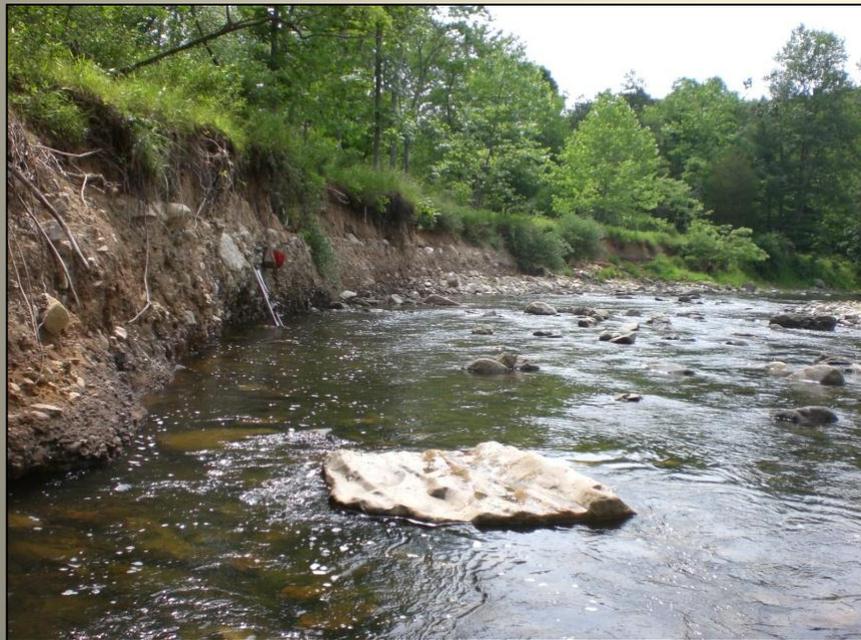
Streambank Stability

- Streambank migration rate (m/yr)
 - Pre-restoration (2009-2010)
 - Post-restoration (2010-2011)
- 3-5 survey locations within each site

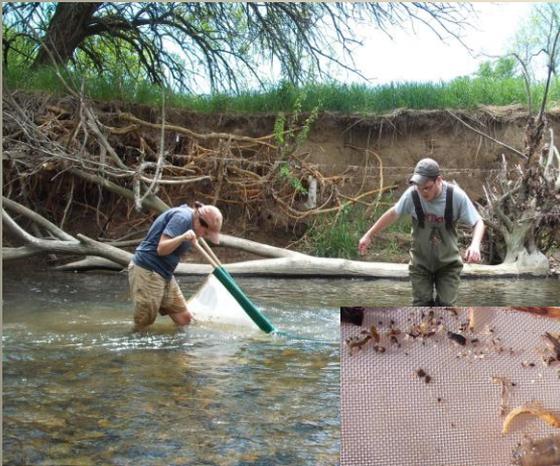
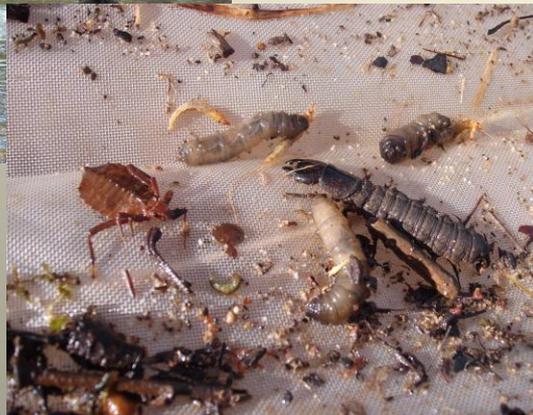
Macroinvertebrate Sampling

- 6 sampling locations within each site
- Id to genus
- 8 indices of benthic health (e.g., % EPT, HBI, etc.)
- Rank sums

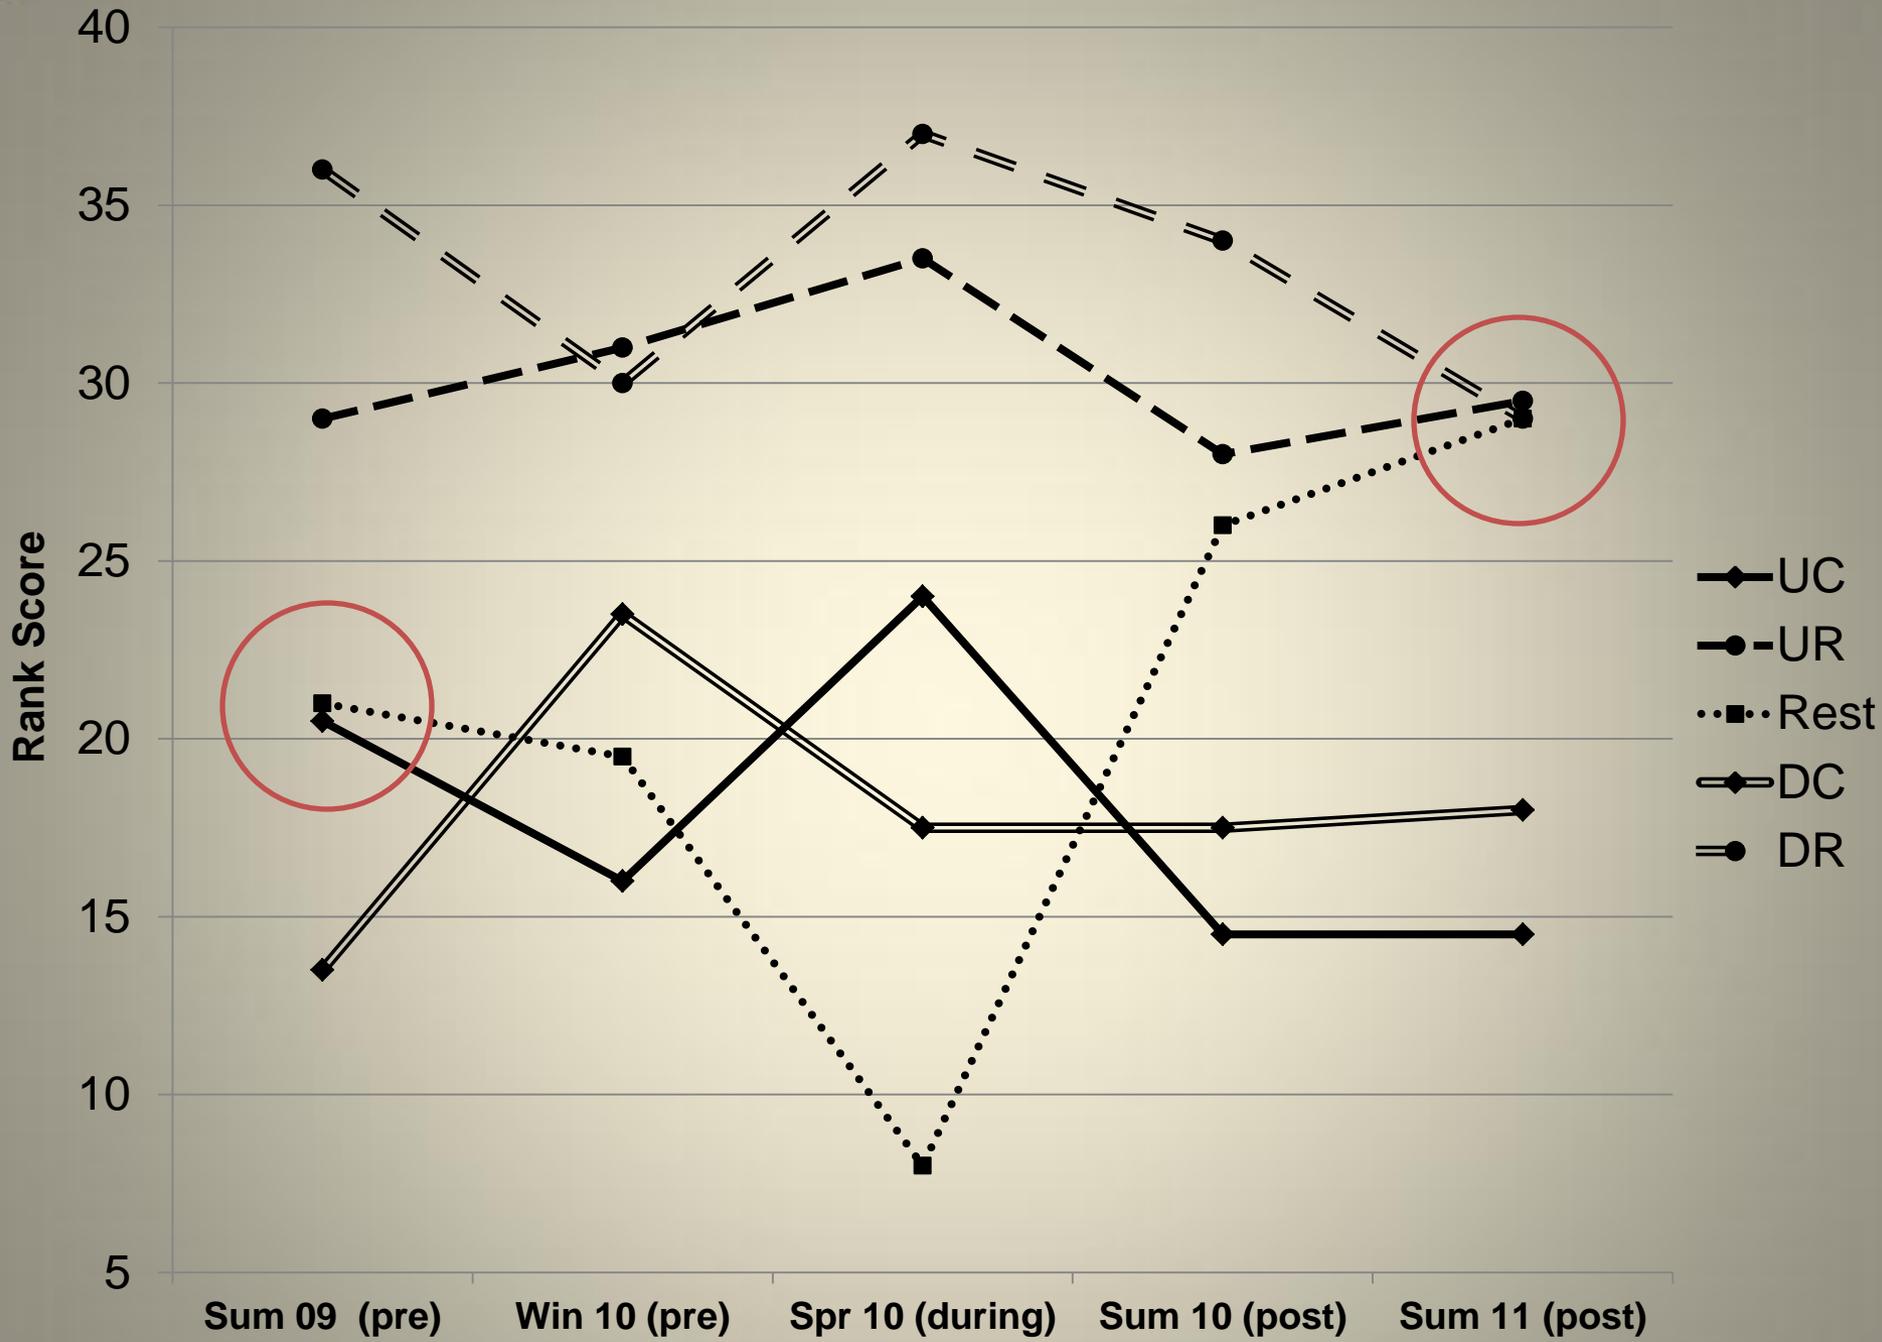
PERMANOVA Results: $F=8.2$; $P=0.001$

- Improved benthic community health
 - Increased habitat complexity
 - Decreased deposition

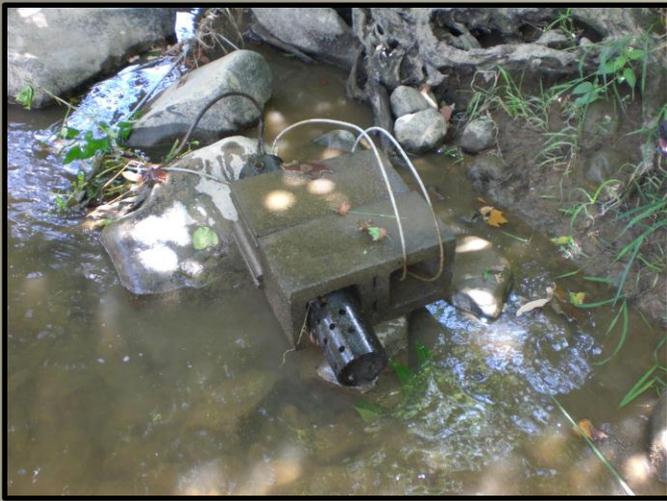
- Hourly readings:

- Temp, pH, conductivity, **turbidity**
- Calibration before each deployment
- Used to determine change in parameters associated with the restored reach

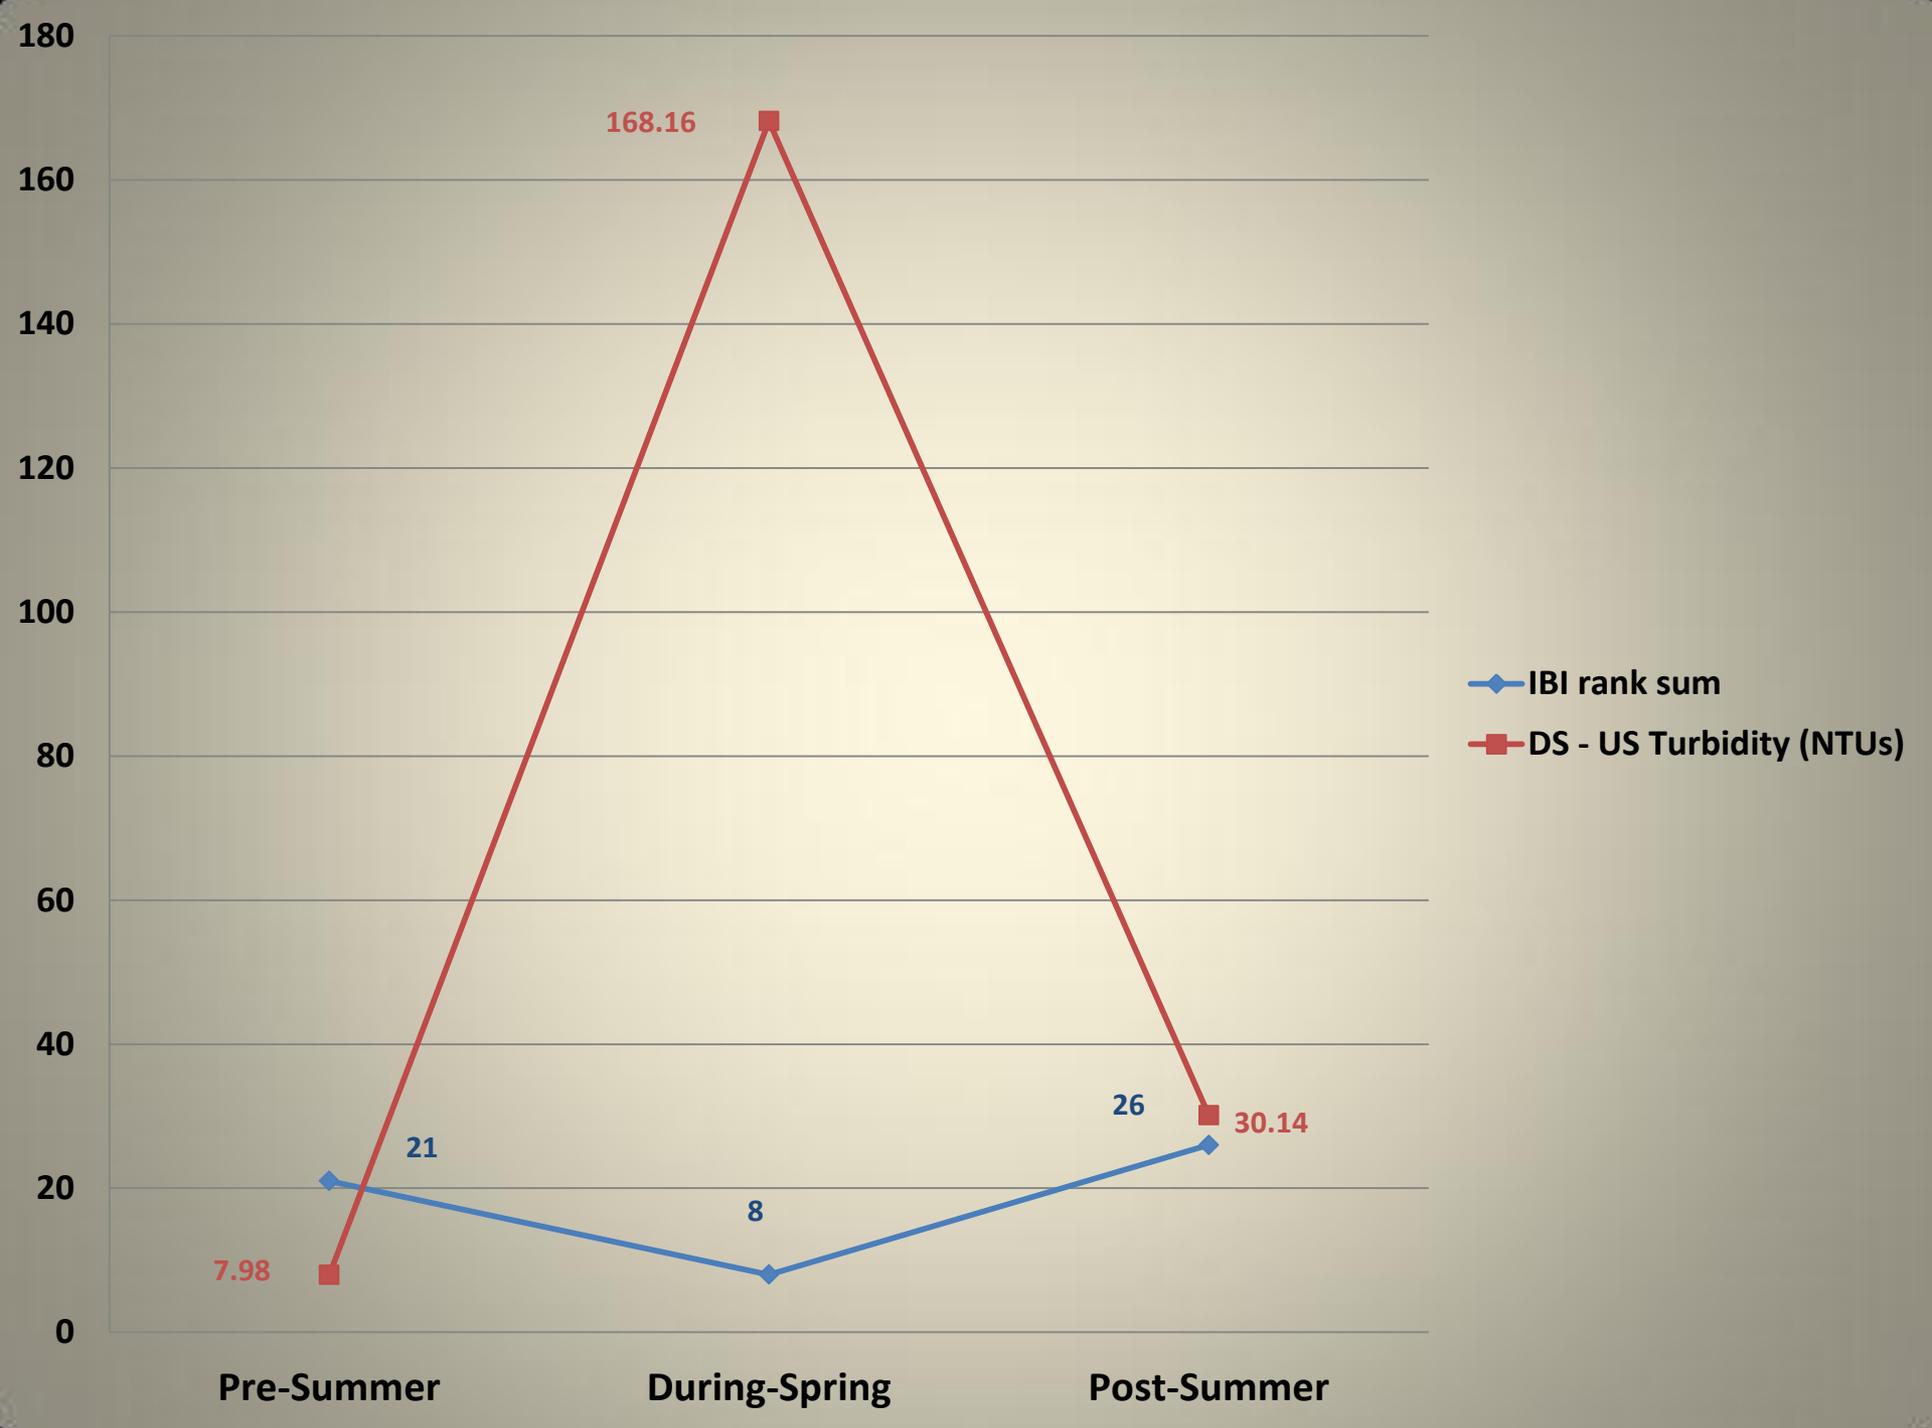
Average DS NTUs – Average US NTUs = Estimate of sediment originating in the reach
