Plum Creek Restoration Cecil County, Maryland Project Summary and Design Report Methodology

PLUM CREEK RESTORATION, CECIL COUNTY, MARYLAND: PROJECT SUMMARY AND DESIGN REPORT

CBFO – S15 - 08

Annapolis, MD
June 2015

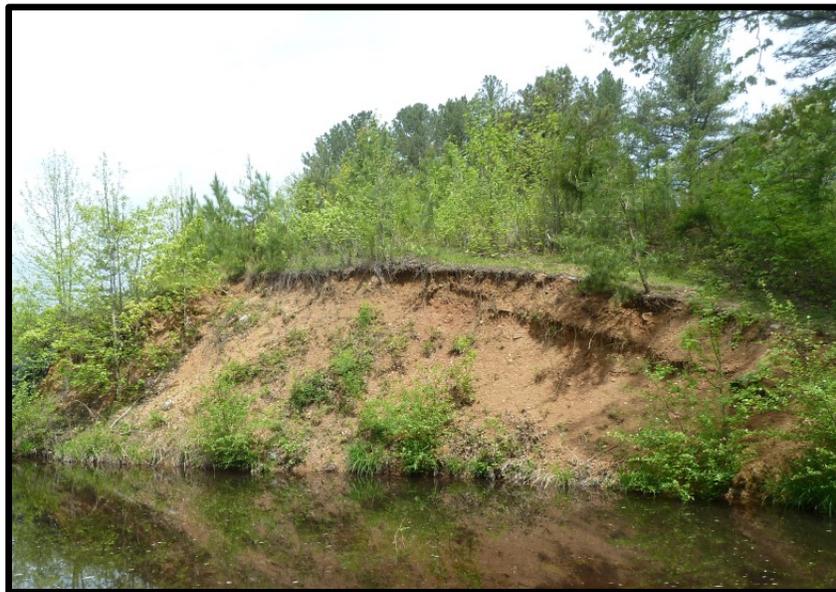
Figure 8: Eroding bank of former dam

The lateral stability of Plum Creek assessed by taking as plan form measurements to determine Meander Width Ratios (MWR) and Bank Erosion Hazard Index (BEHI) classifications of individual bank segments. A photo of typical stream bank conditions at the Plum Creek project site can be seen in Figure 8 and findings are summarized in Table 11.
