# Little Tuscarora Stream Restoration Project Frederick, MD Project Summary and Design Report

# LITTLE TUSCARORA CREEK RESTORATION, FREDERICK COUNTY, MARYLAND: FUNCTION-BASED PROJECT SUMMARY AND DESIGN REPORT

Stream Habitat Assessment and Restoration Program  
U.S. Fish and Wildlife Service  
Chesapeake Bay Field Office

CBFO – S15 - 01

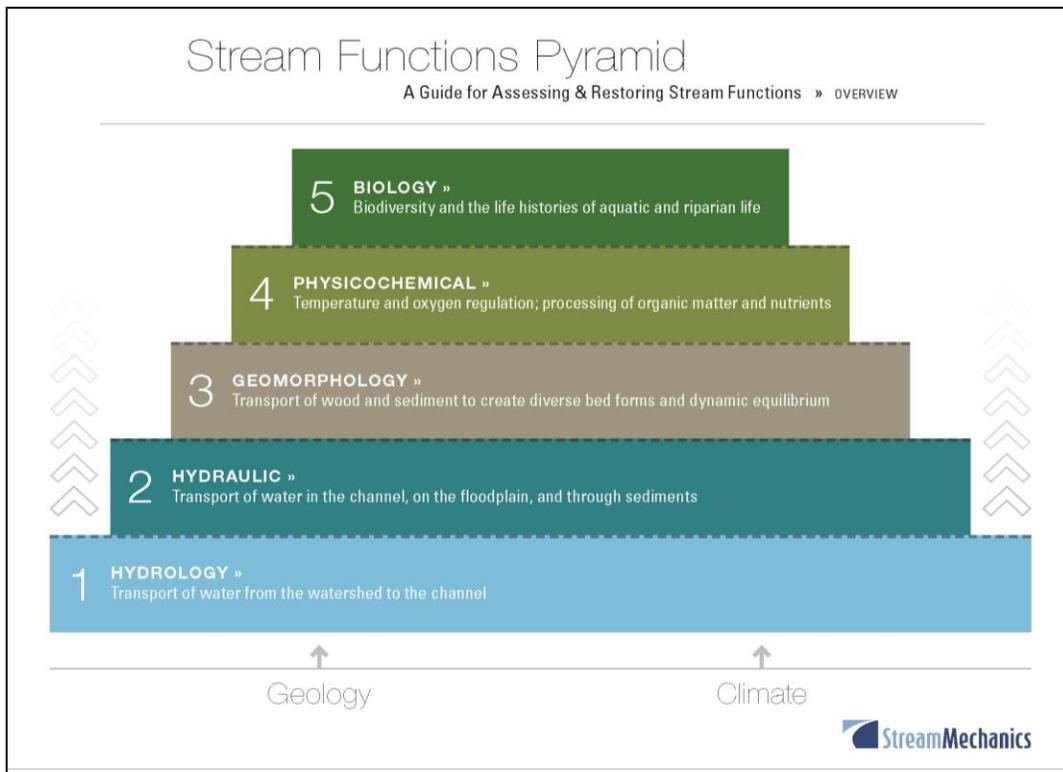
Figure 1. Stream Function Pyramid (Harman et al., 2012)

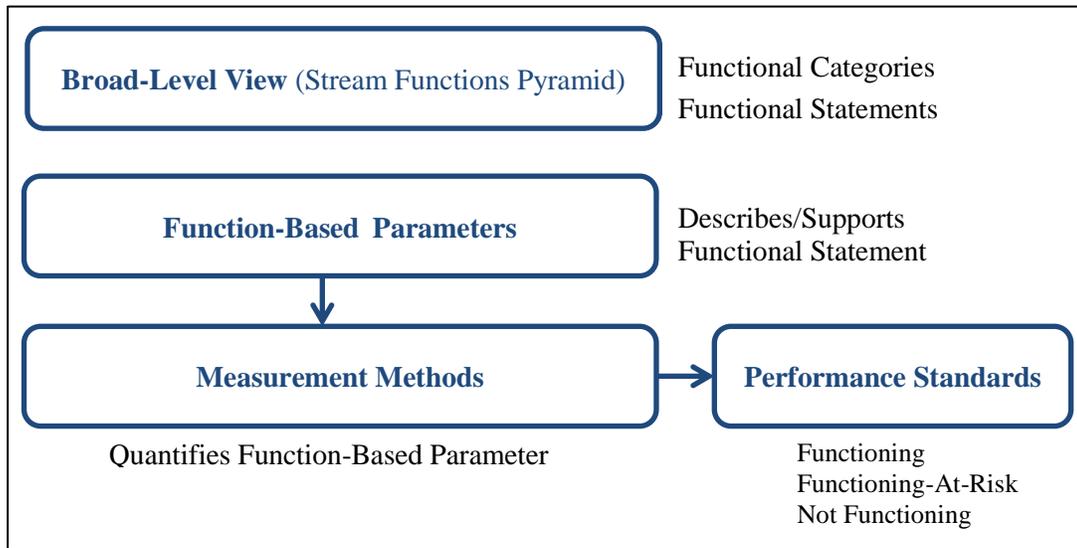
**Figure 2. Stream Functions Pyramid Framework (Harman et al., 2012)**

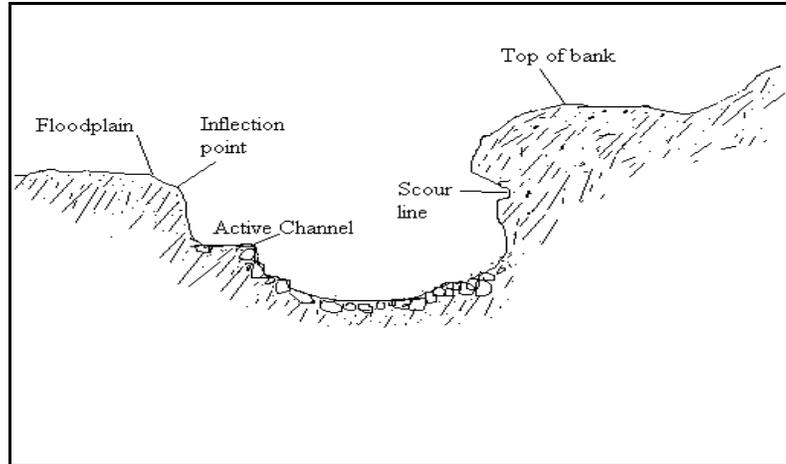
**Figure 4. Typical Bankfull Indicators (McCandless and Everett, 2002)**

During the Little Tuscarora Creek assessment, the Service identified bankfull stage using geomorphic indicators formed by the stream as described by McCandless and Everett (2002). Figure 3 depicts significant geomorphic indicators typically found in the Mid-Atlantic. Based on these indicators, the Service identified a consistent geomorphic feature at Little Tuscarora Creek. This geomorphic indicator was typically a significant slope break or back of bench found throughout the project area. These indicators were measured to determine width and depth and then compared to the “USGS Carbonate Great Valley Section of the Ridge and Valley Province” regional curve.

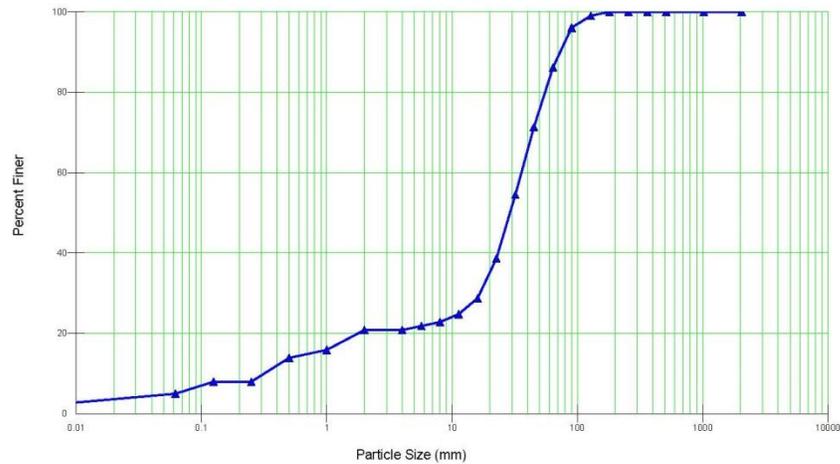
**Figure 5. Little Tuscarora Creek Reach Scale Particle Distribution**

gathered by using the Wolman (1954) pebble count procedure. Complete findings are shown in **Figure 2** below, but it was found that the d50 was equal to 29.35 mm which confirms that Little Tuscarora Creek is a gravel bed stream. While there is no performance standard associated with the Wolman (1954) pebble count procedure, the findings serve as a monitoring benchmark. Future samples can be compared to one another to see the streambed coarsen over time.

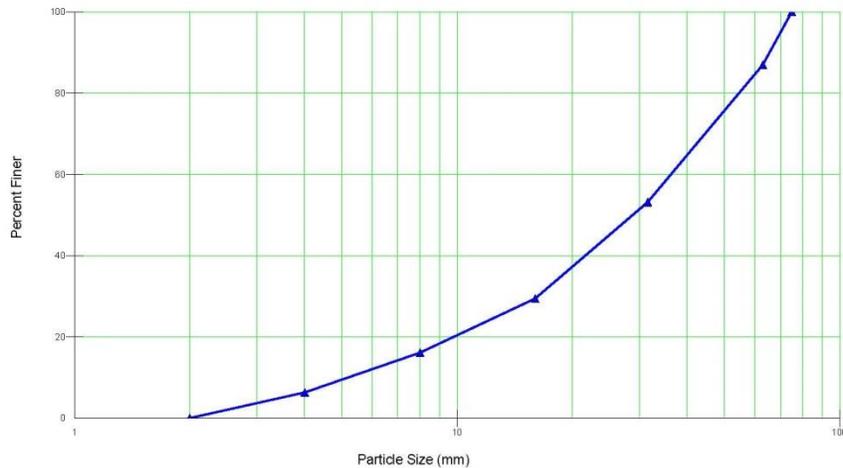
**Figure 6. Little Tuscarora Creek Bar Sample Particle Distribution**

While there is more than one method to assess sediment transport competency, the Service used a method developed by Rosgen (2006) where required depths and slopes are used to determine competency. This method involves sampling bed material from either the riffle pavement/subpavement layer or material from a point bar. The Service took a sample from a representative bar feature and sieved the sample to determine the bar’s distribution. Results can be seen below in Figure 3. The Service determined that the d100 of the bar sample was 75 mm and while the existing channel had the necessary slope to move a particle of that size, it did not have the depth necessary to move particles of that size during bankfull flows. These findings are consistent with the deposition patterns observed. A summary table of the results can be found below in Table 7 and a more detailed explanation of these findings can be seen in Appendix O.

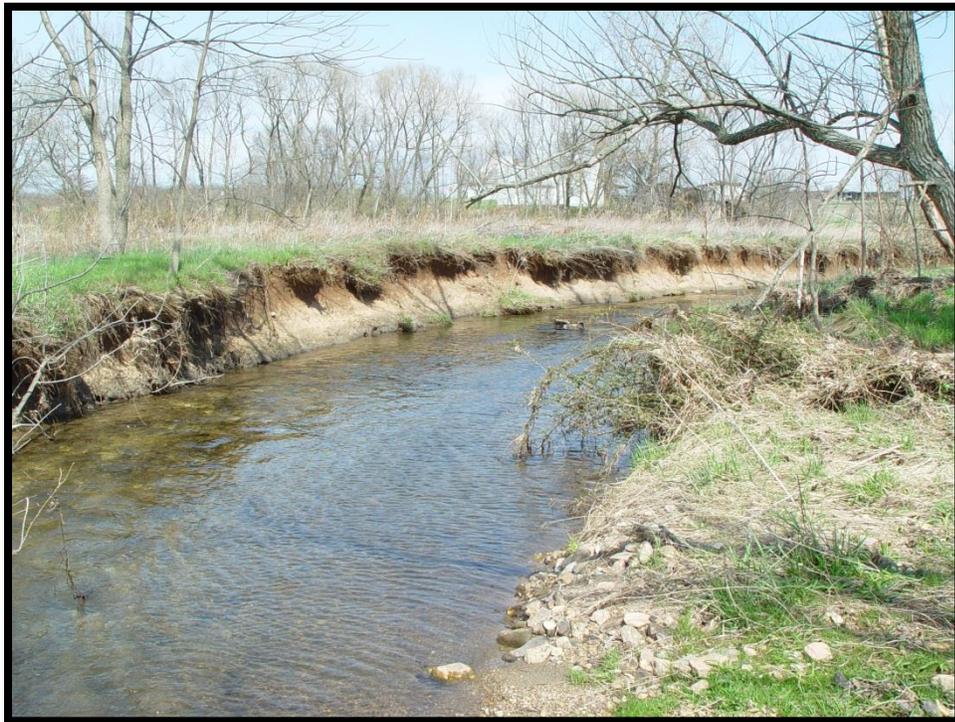
**Figure 8. Eroding outside meander**

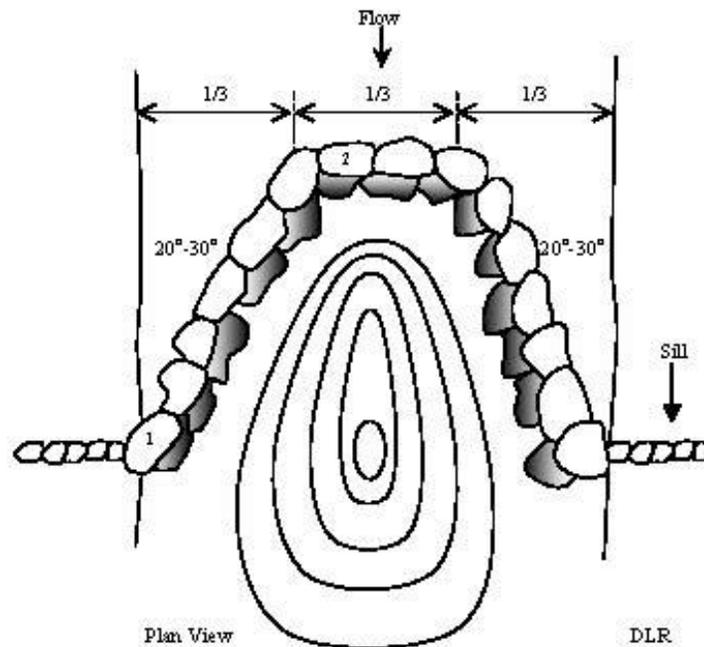
**Figure 9. Cross Vane in Plan View**

The cross-vane (Figure 8) will establish grade control, reduce bank erosion, create a stable width/depth ratio and maintain channel capacity, while maintaining sediment transport capacity, and sediment competence. The cross-vane also provides for the proper natural conditions of secondary circulation patterns commensurate with channel pattern, but with high velocity gradients and boundary stress shifted from the near-bank region. The cross-vane is also a stream habitat improvement structure due to: 1) an increase in bank cover as a result to a differential raise of the water surface in the bank region; 2) the creation of holding and refuge cover during both high and low flow periods in the deep pool; 3) the development of feeding lanes in the flow separation zones (the interface between fast and slow water) due to the strong downwelling and upwelling forces in the center of the channel; and 4) the creation of spawning habitat in the tail-out or glide portion of the pool (Rosgen, D.R., 2010). While the figure below shows a structure consisting of large boulders, the cross-vane can be constructed using other materials such as logs and rootwads.

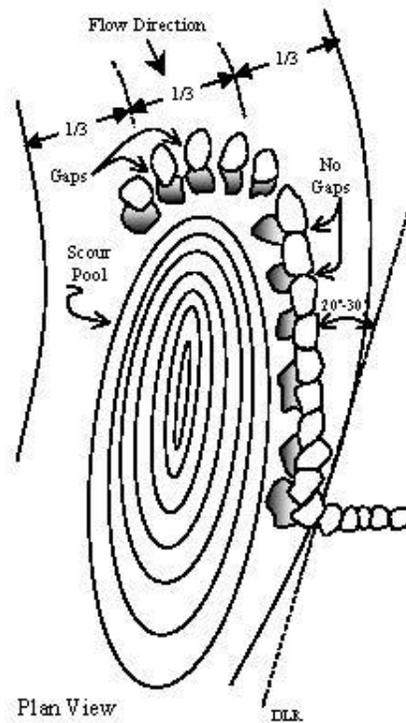
**Figure 10. J-Hook Vane in Plan View**

The j-hook vane is an upstream directed, gently sloping structure composed of natural materials. The structure can include a combination of boulders, logs and root wads (Figure 9) and is located on the outside of stream bends where strong down welling and upwelling currents, high boundary stress, and high velocity gradients generate high stress in the near-bank region. The structure is designed to reduce bank erosion by reducing near-bank slope, velocity, velocity gradient, stream power and shear stress. Redirection of the secondary cells from the near-bank region does not cause erosion due to back-eddy re-circulation. The vane portion of the structure occupies 1/3 of the bankfull width of the channel, while the hook occupies the center 1/3 as shown in Figure 9 (Rosgen D.R., 2010).

Maximum velocity, shear stress, stream power and velocity gradients are decreased in the near-bank region and instead redirected towards the center of the channel. Sediment transport competence and capacity can be maintained as a result of the increased shear stress and stream power in the center of the channel. Backwater is created only in the near-bank region, reducing active bank erosion (Rosgen D. R., 2010). While the figure below shows a structure consisting of large boulders, the j-hook vane can be constructed using other materials such as logs and root wads.

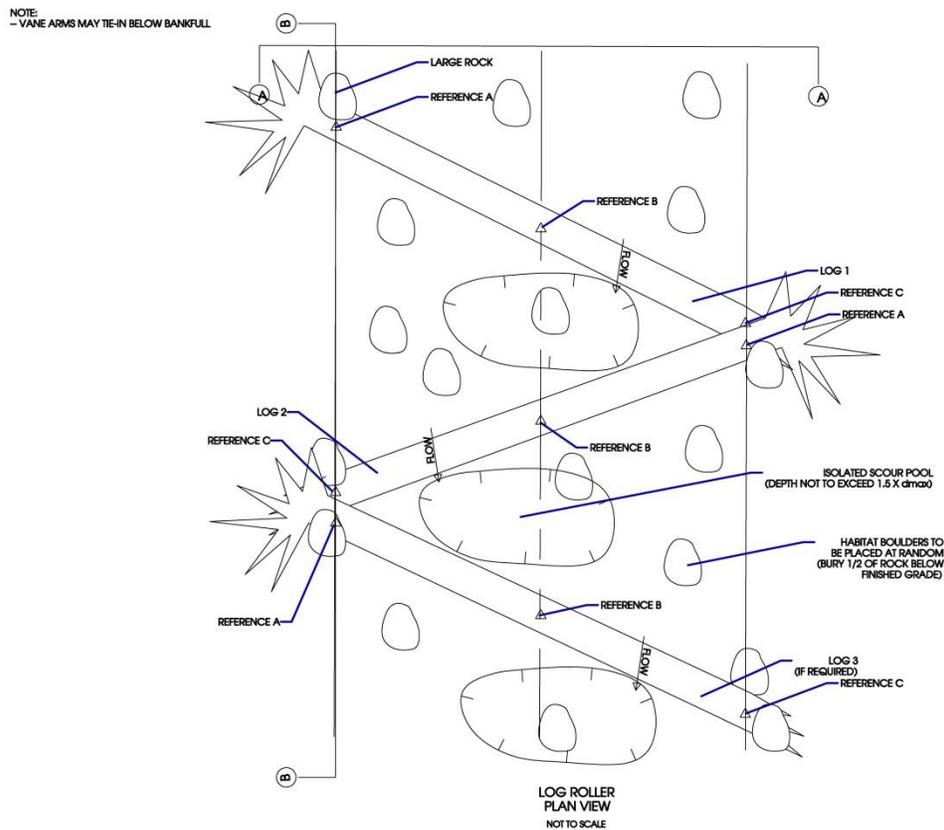
Figure 11. Log Roller Structure

The log roller structure is an alternative to hardened riffles. These structures act as a grade control, but instead of holding the grade of a glide feature, they instead hold the grade of the top of riffle feature. The log roller consists of alternatively angled and sloped logs that are placed at low grades in an effort to “roll” water back and forth while still concentrating energy towards the center of the channel. The structure is typically used in straight as they are effective in generating aeration and increased dissolved oxygen concentration by creating hydraulic rises and falls while still directing stream energy towards the center of the channel. These structures also add woody debris into the stream system promoting increased habitat for aquatic species. Figure 10 shows a typical drawing for a log roller.

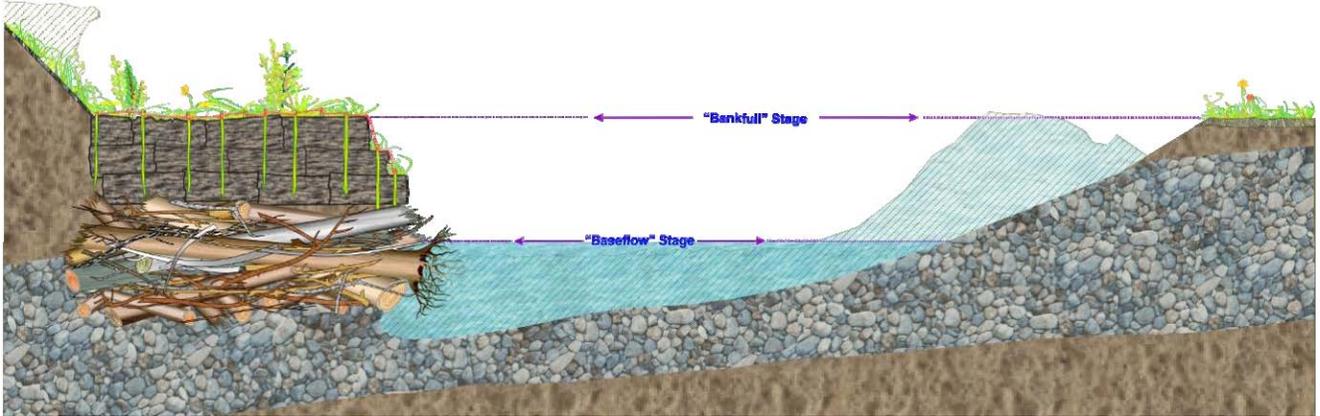
**Figure 12. Toe Wood**

The toe wood structure (Figure 11) incorporates native woody material into a submerged undercut bank to replicate natural streambanks. Toe wood is positioned on the lower 1/3 to 1/2 of bankfull height to ensure it is submerged year round to prevent wood deterioration. Cuttings with sod and live staking or woody transplants cover the toe wood and are installed up to the bankfull stage. Not only does toe wood act as an area of increased roughness which promotes reduction in shear stresses to the outside of the meander, it also serves as a haven for benthic macroinvertebrates and fish communities.

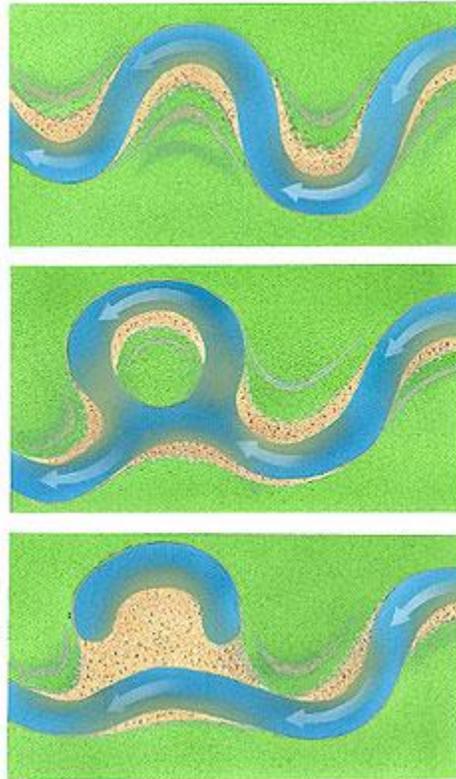
**Figure 13. Oxbow Creation**

Oxbow lakes (Figure 12) are formed when river erosion wears through the bank between two consecutive bends. Most water travels through the new channel, and the old bend is cut out, with water only passing through it very slowly. This slow speed causes sediment that is suspended in the river water to settle on the old bend's riverbed. Eventually, enough sediment settles in the old bend to close it off from the new channel and an oxbow lake is formed (DK Books, Lake Formation).

The Service utilized abandoned sections of the original stream alignment to create oxbow features in the Little Tuscarora Creek design for a variety of reasons. The introduction of these discontinuous oxbow pool features provide additional rearing habitat for fish species as well as excellent refuge for other aquatic species. Beavers are also naturally drawn to these areas and since they serve as a preferred location for dens and dams. This prevents beavers from impacting or influencing channel flow and minimizes the threat of beaver-related damming and ponding of the restored stream reach.

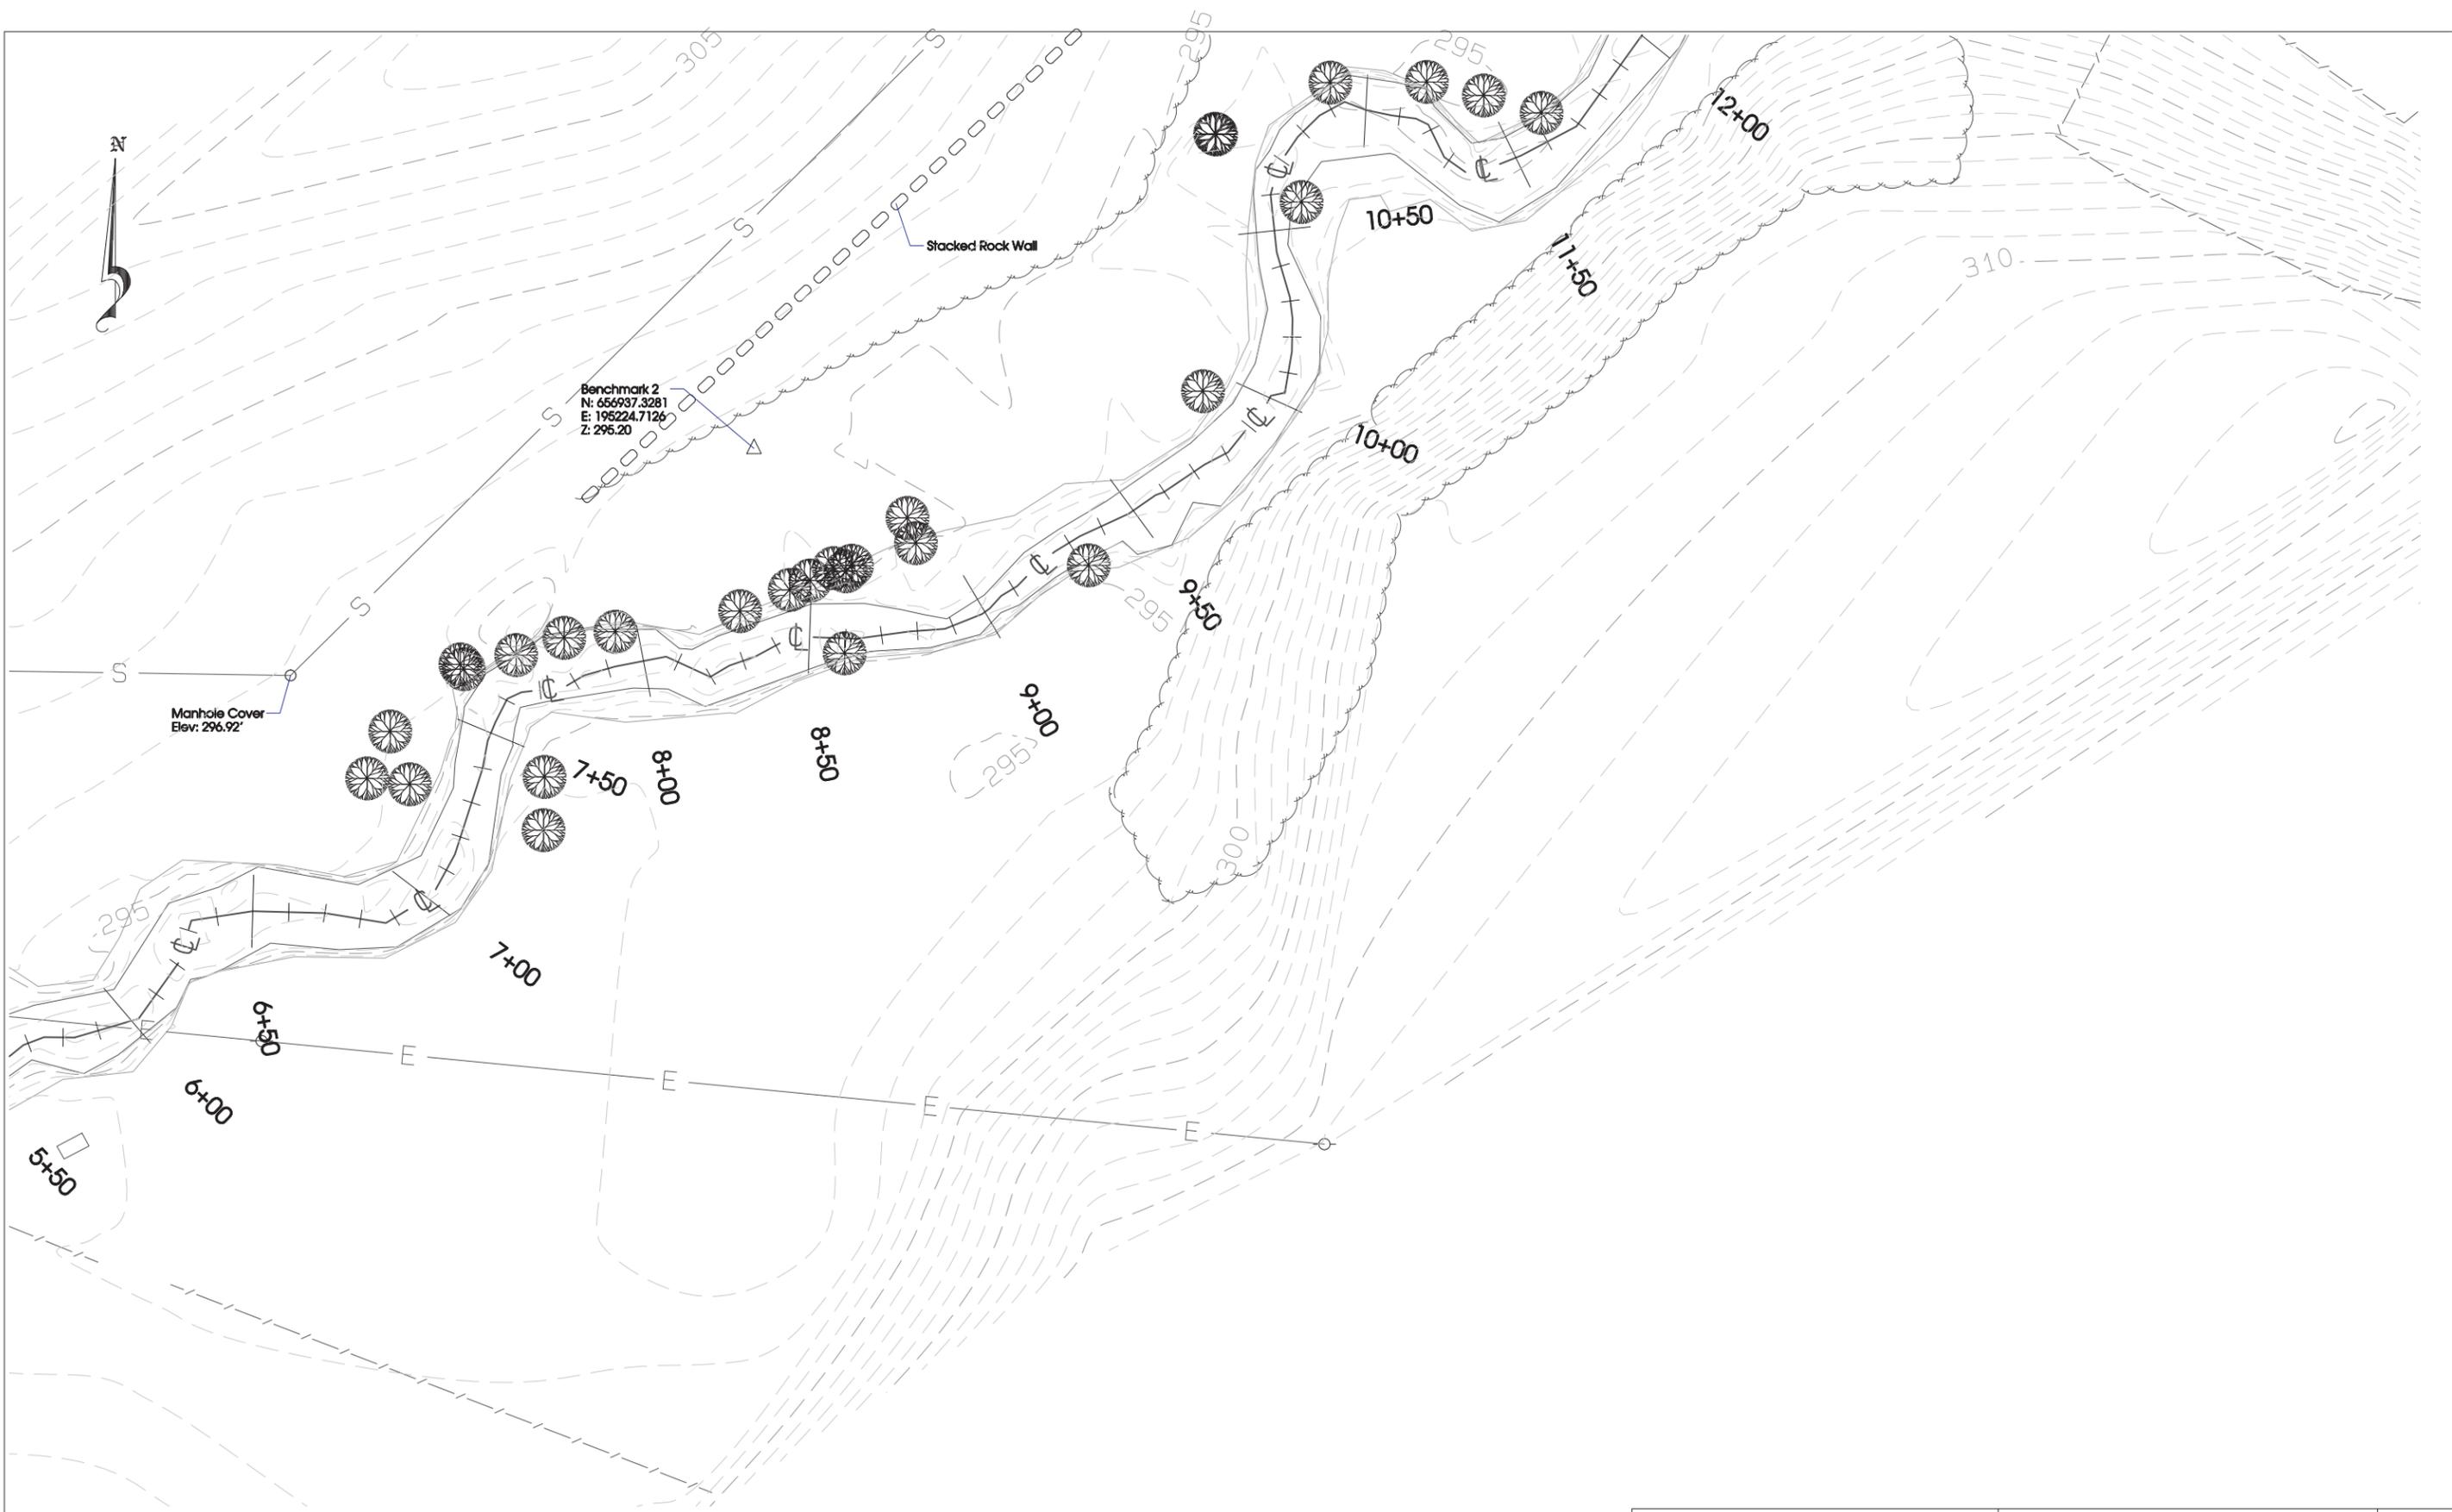
REVISIONS		LITTLE TUSCARORA CREEK Frederick County, MD		SHEET 3
DATE	BY	100% Design Existing Conditions		
		PROJECT MANAGER: BH	DRAFTING: BH	EC-1
		DESIGN: BH	CHECKED BY: RS	
		DATE: March 25, 2013	SCALE: AS SHOWN

Benchmark 2  
 N: 656937.3281  
 E: 195224.7126  
 Z: 295.20

Manhole Cover  
 Elev: 296.92'
