# CITY OF AUSTIN

## STREAM RESTORATION PROGRAM

MID-ATLANTIC STREAM RESTORATION CONFERENCE, ROCKY GAP, MD  
NOVEMBER 2011

**MORGAN BYARS, P.E.**

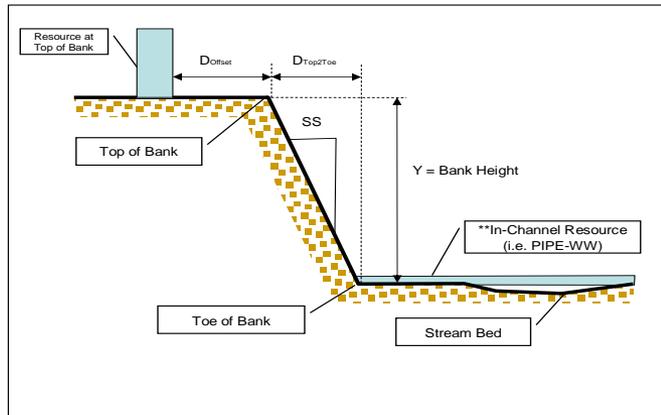
Horizontal Offset from Top of Bank to Threatened Resource (ft) \_\_\_\_\_ D<sub>offset</sub>

Bank Height (ft) \_\_\_\_\_ Y

Horizontal Distance from Top of Bank to Toe (ft) \_\_\_\_\_ D<sub>Top2Toe</sub>

Existing Bank Slope, Horizontal:Vertical \_\_\_\_\_ SS = (D<sub>Top2Toe</sub> / Y) : 1

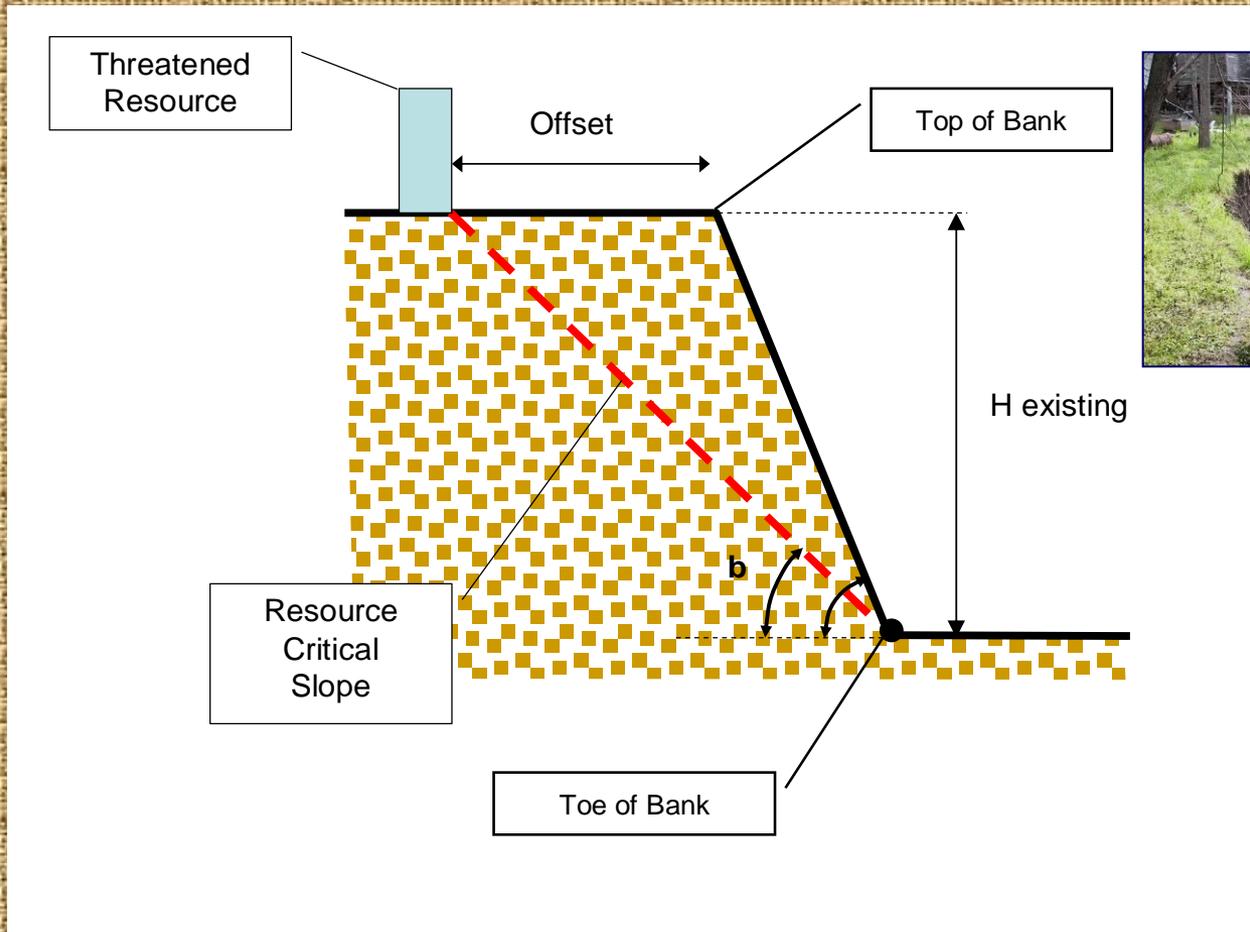
**Geotechnical Score =**  
***f(bank height, bank angle, resource distance, soils)***

***Geotechnical Score = (H/Hc) \* Normalization Factor***

$$Hc = 4 * c / \text{gamma} * [\sin(B) * \cos(\text{phi}) / (1 - \cos(B - \text{phi}))]$$

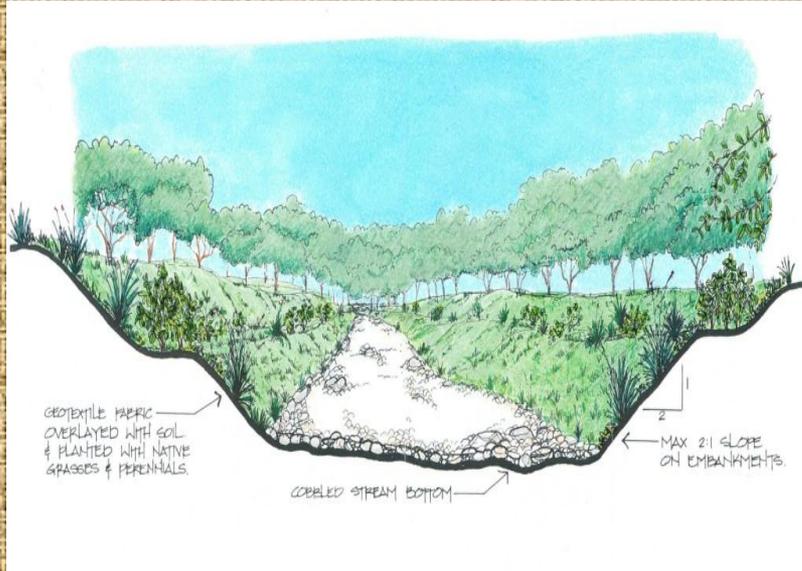
**VEGETATED GRADED SLOPES**

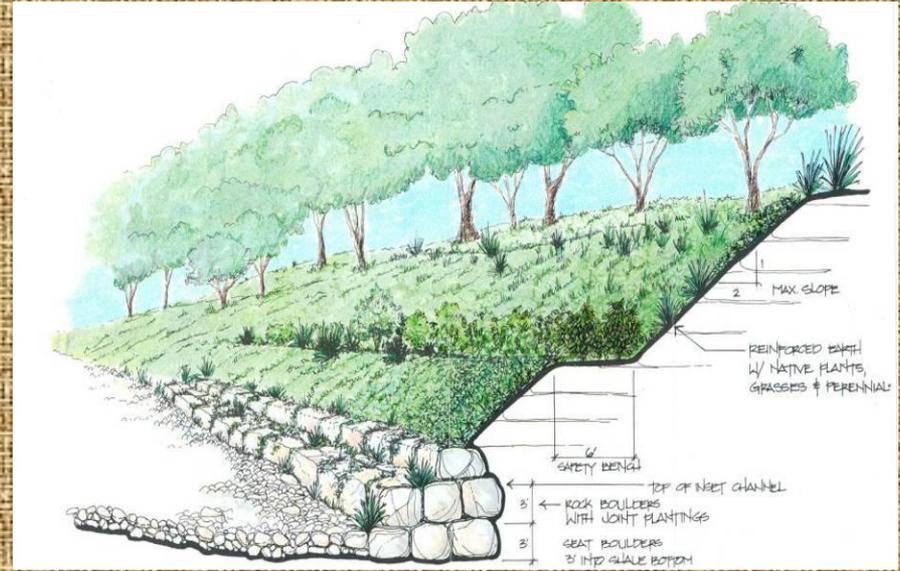
**NATURAL LIMESTONE BOULDER TOE WITH VEGETATED UPPER SLOPES**

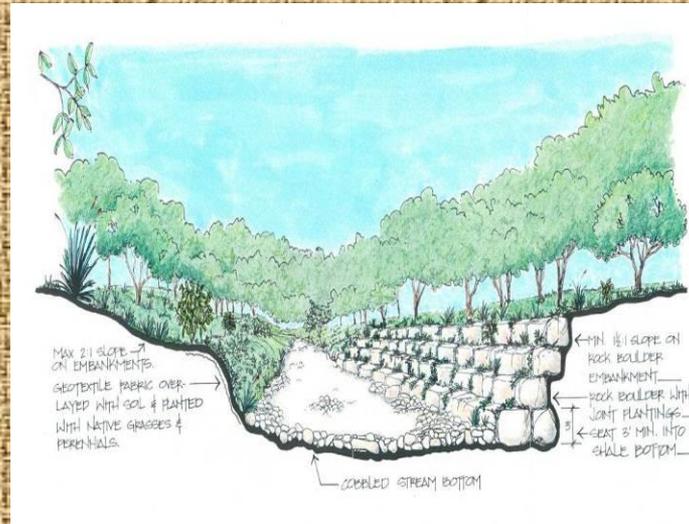
**NATURAL LIMSTONE BOULDER WALL**

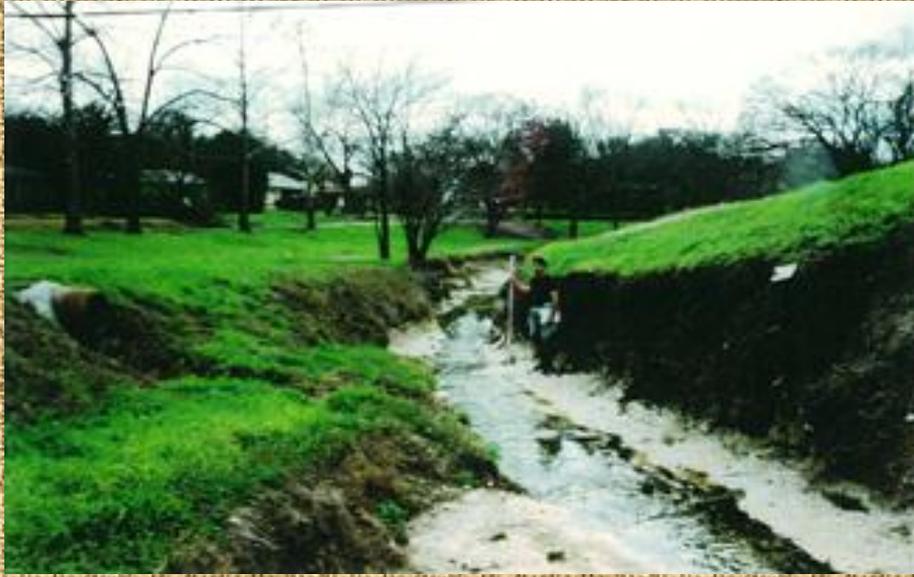
**1997**

# PASSIVE RESTORATION EXAMPLE

## WILLOW BROOK REACH (BEFORE)

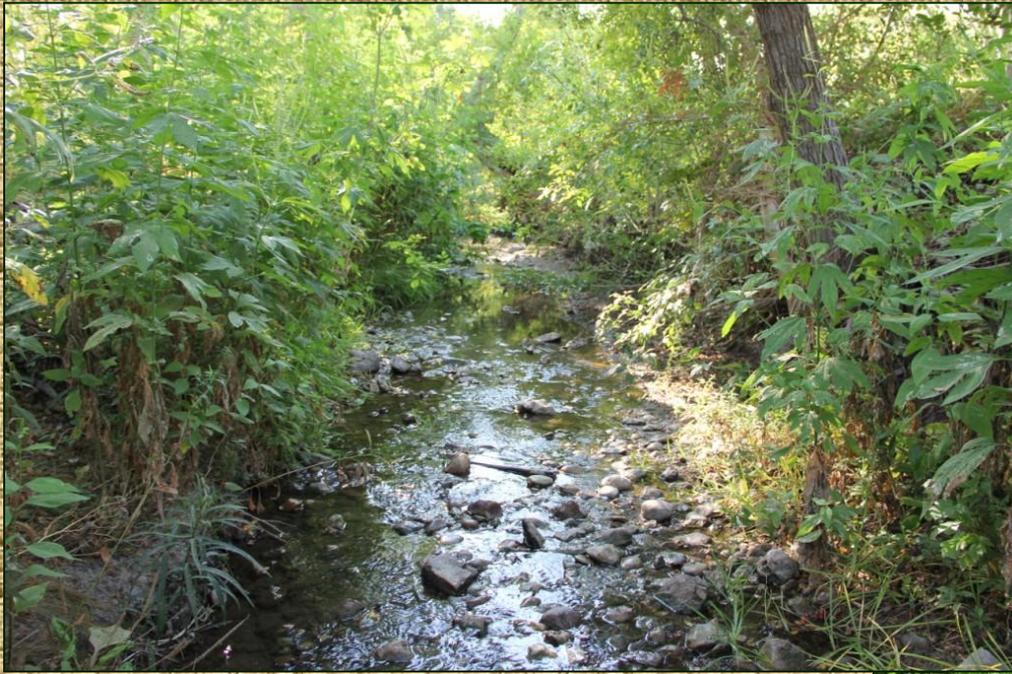
2011

# PASSIVE RESTORATION EXAMPLE

## WILLOW BROOK REACH (AFTER)

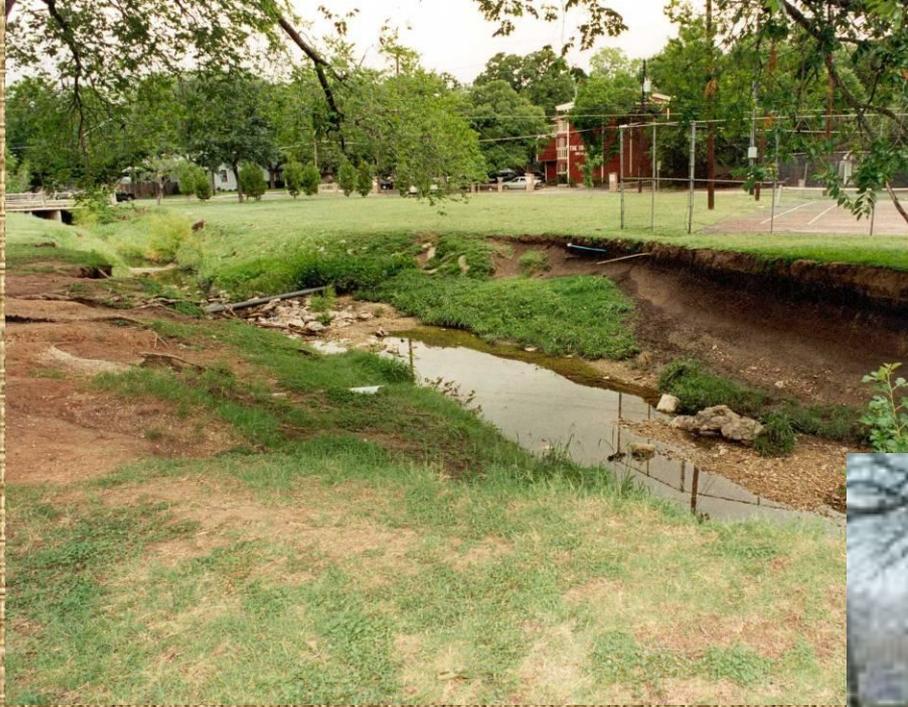
**1997**

# ACTIVE RESTORATION EXAMPLE

## SHIPE PARK (BEFORE)

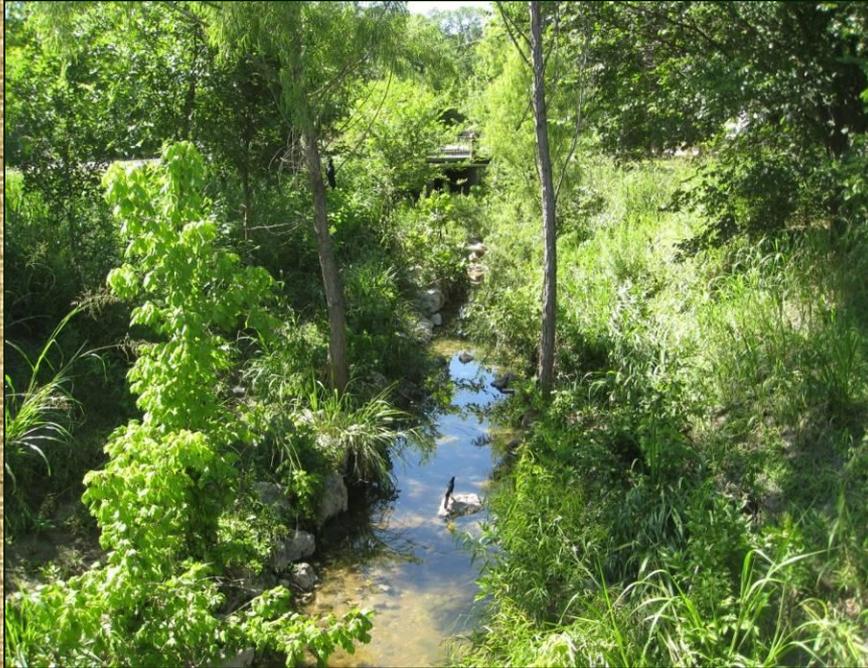
2009

# ACTIVE RESTORATION EXAMPLE

## SHIPE PARK (AFTER)

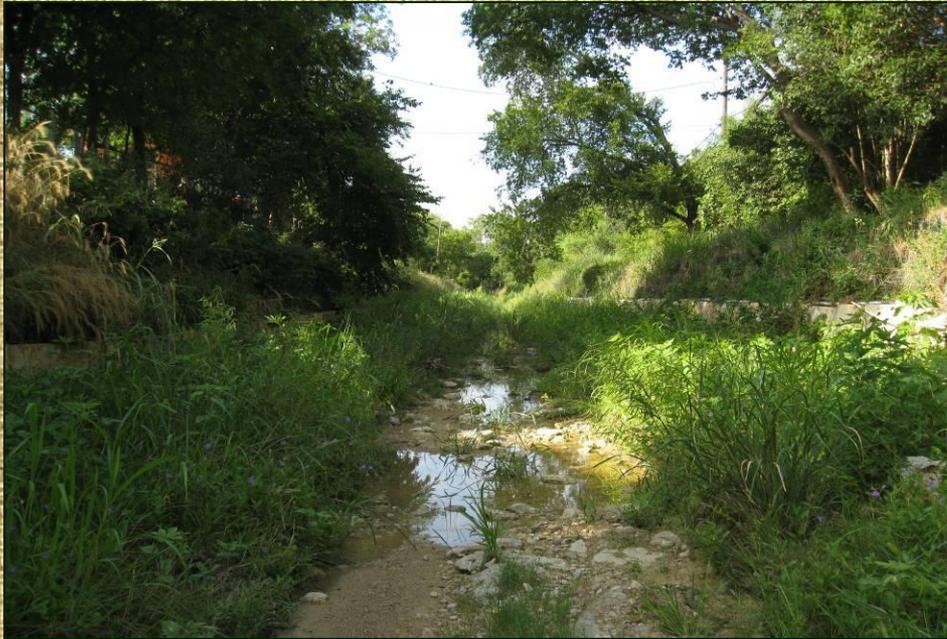
2011

# ACTIVE RESTORATION EXAMPLE

## FORT BRANCH PROJECT (AFTER)
