# Stony Run Baltimore City, Maryland

## Geomorphic Condition Survey

*CBFO-S06-03*  
*June 2007*

# STONY RUN, BALTIMORE CITY, MARYLAND GEOMORPHIC BASELINE SURVEY

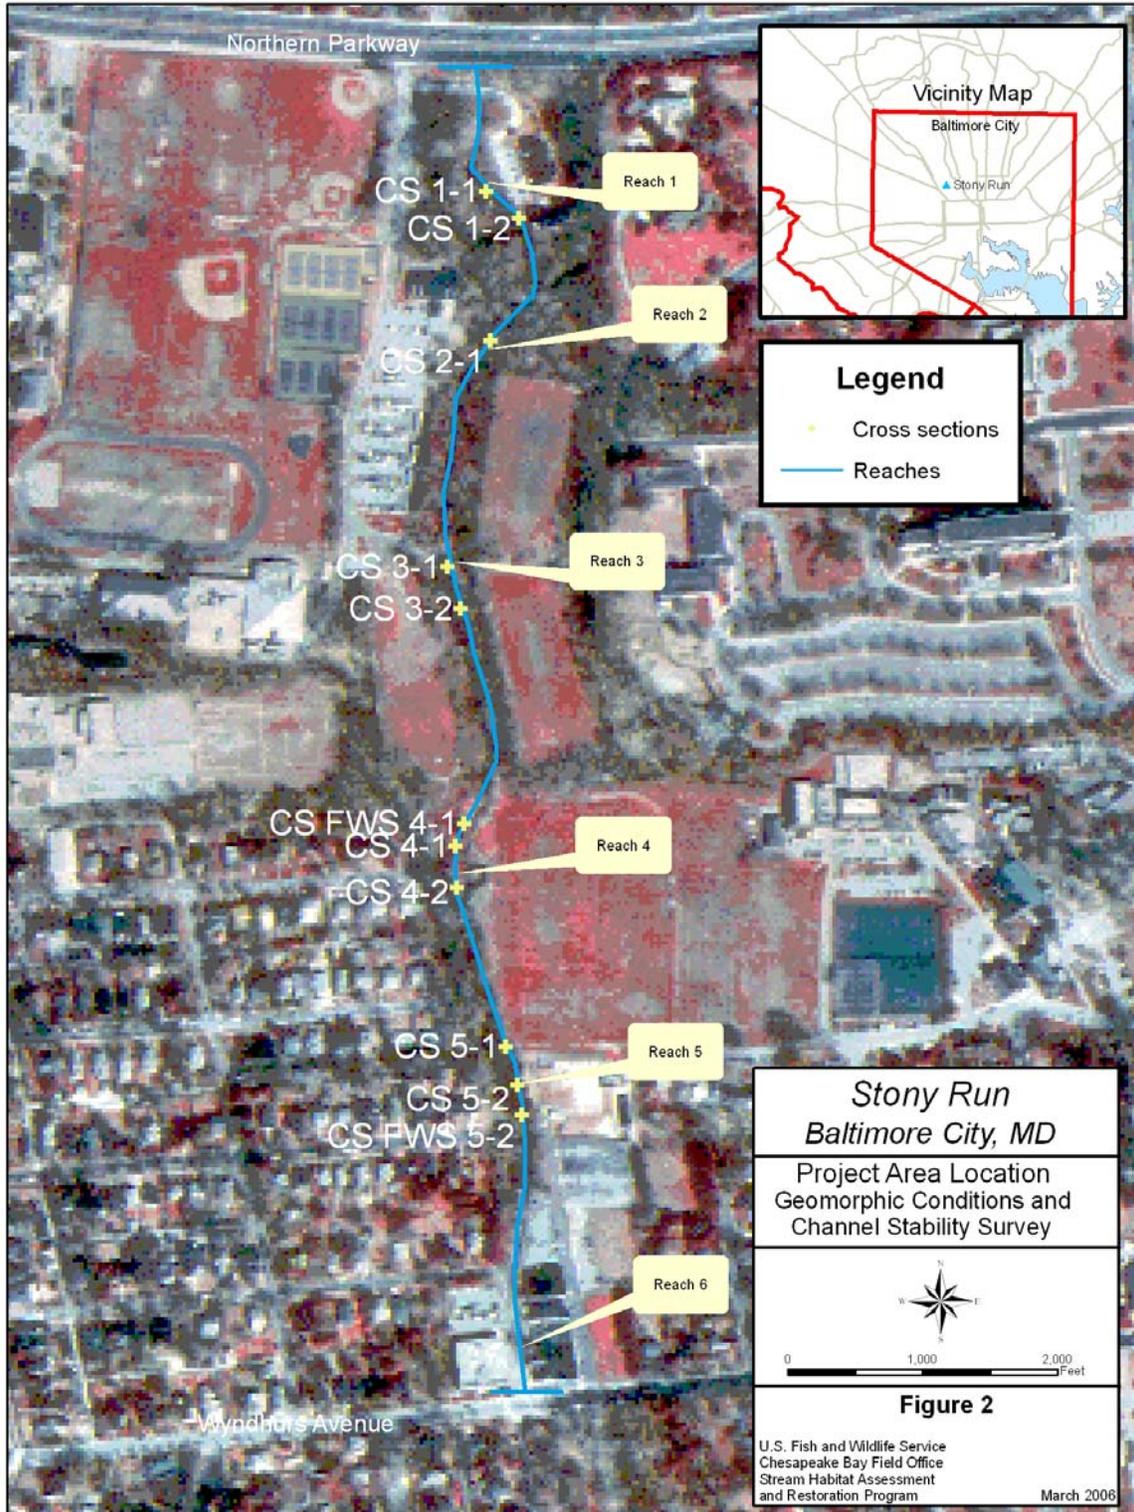
The 2001 survey established nine monumented cross sections. The Service recovered seven of the nine cross sections during the 2006 survey (Table 4). The Service surveyed two additional non-monumented cross sections to replace the un-recovered cross sections and characterize the study reaches. Figure 2 shows the approximate locations of the cross sections.

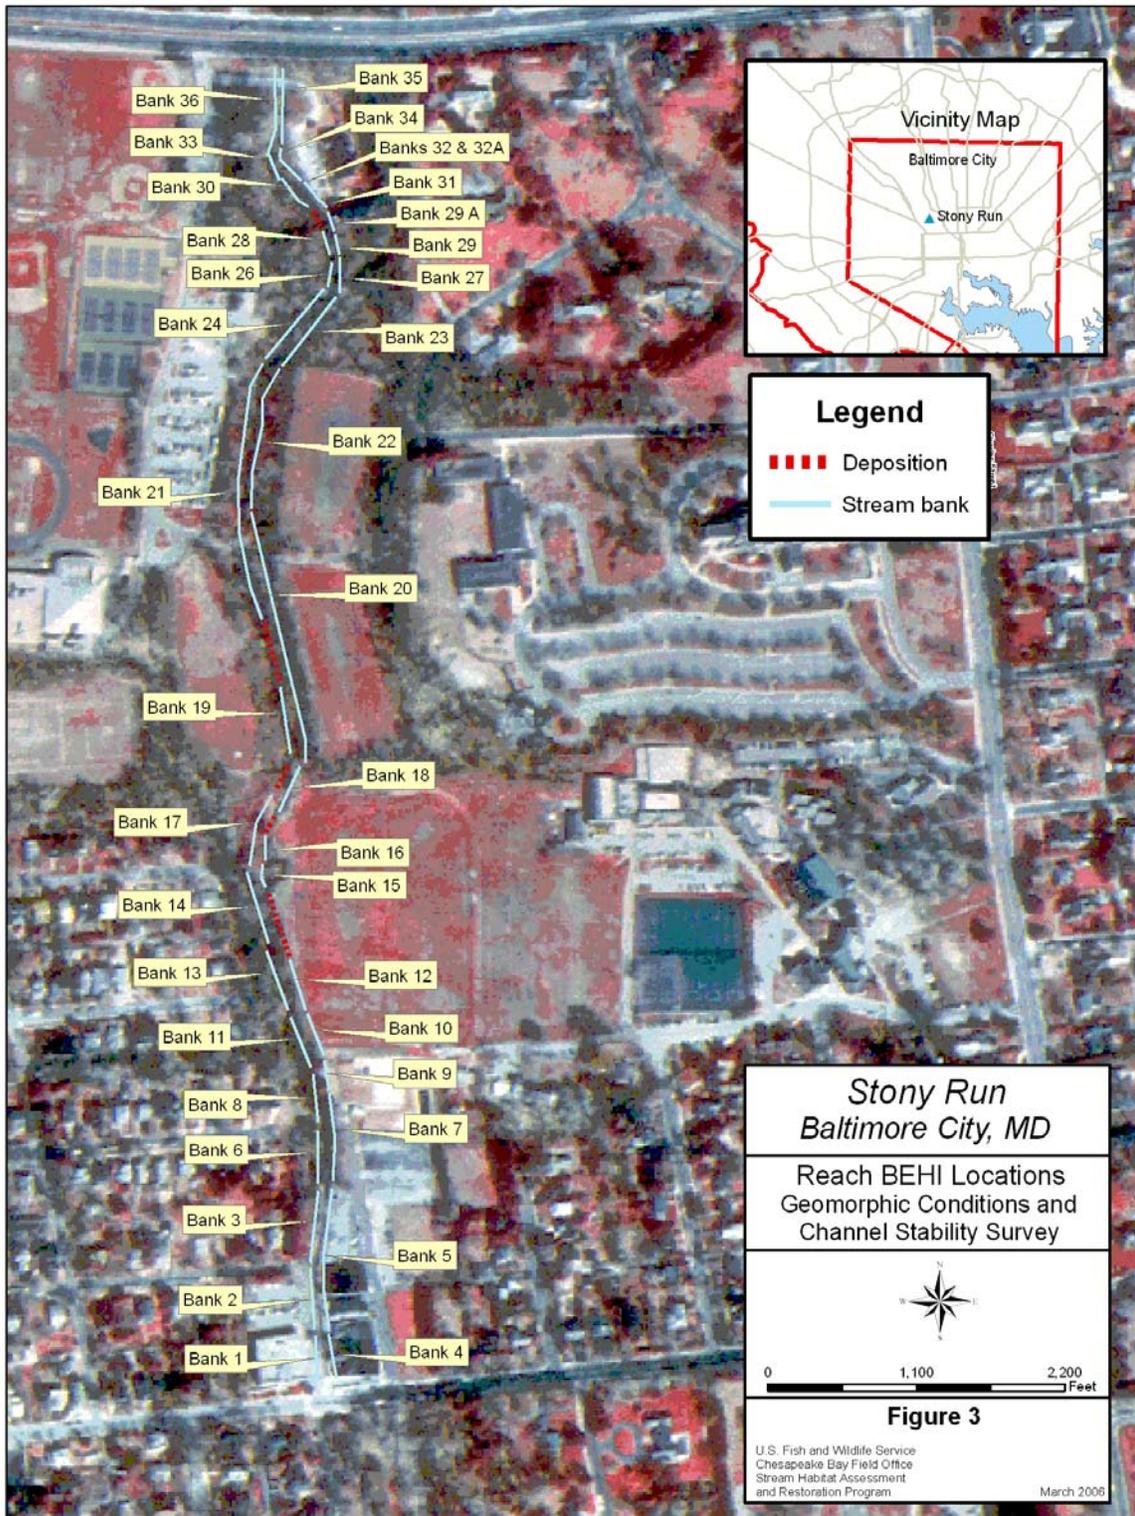
To determine the reach BEHI and NBS ratings, the Service assessed 5,900 feet of stream bank of the total 6,274 feet of bank (Figure 3). The Service did not assess banks with significant deposition. The Service has provided detailed reach BEHI criteria and scores in Appendix F. The Service summarized the reach BEHI and NBS ratings in Table 9.

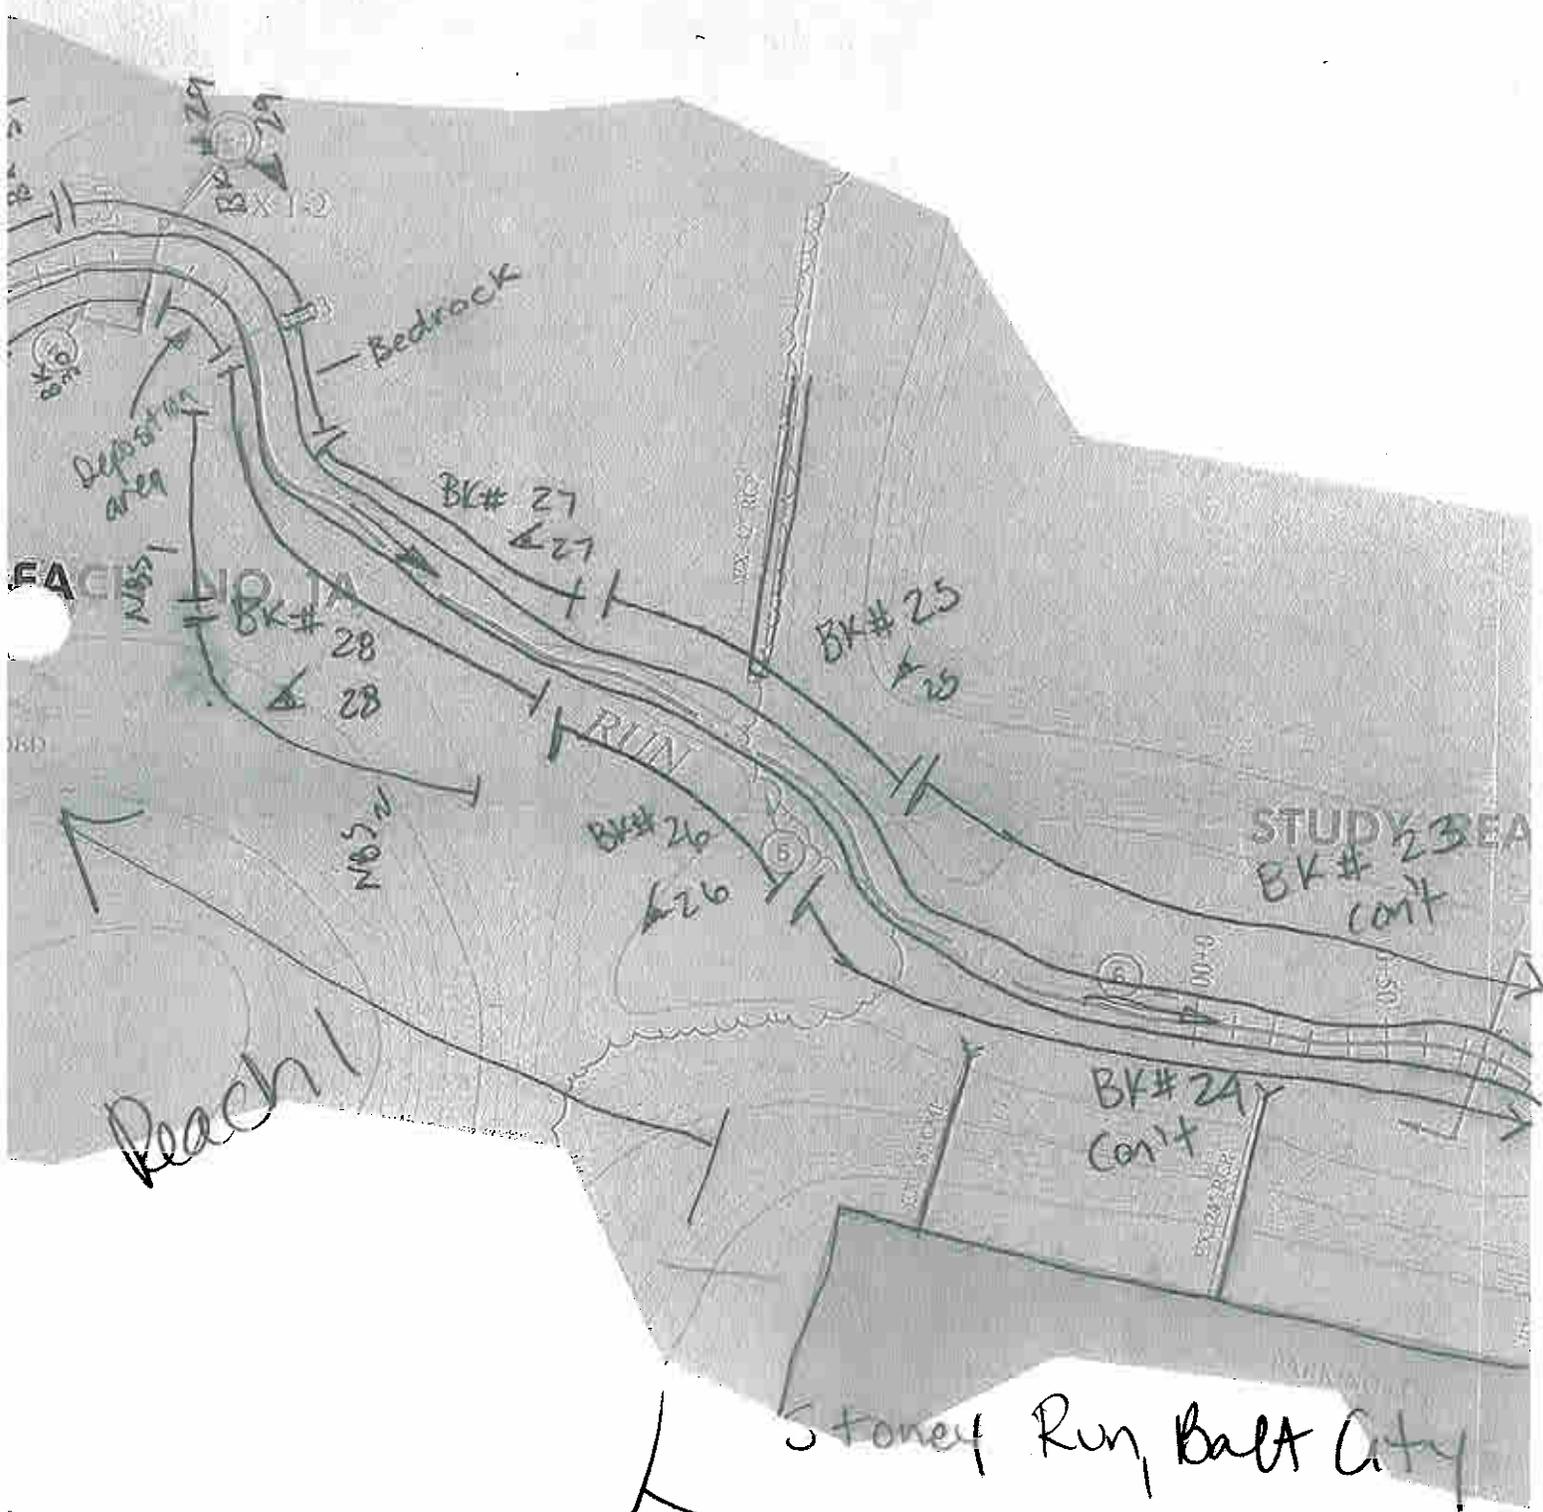
pg 6 of 9

THIS CULVERT PASSES UNDERNEATH THE PAVED AND THE EXISTING ATHLETIC FIELDS. ALSO SHOWN IS SCOUR HOLE WHICH HAS DOWNCUT APPROXIMATE

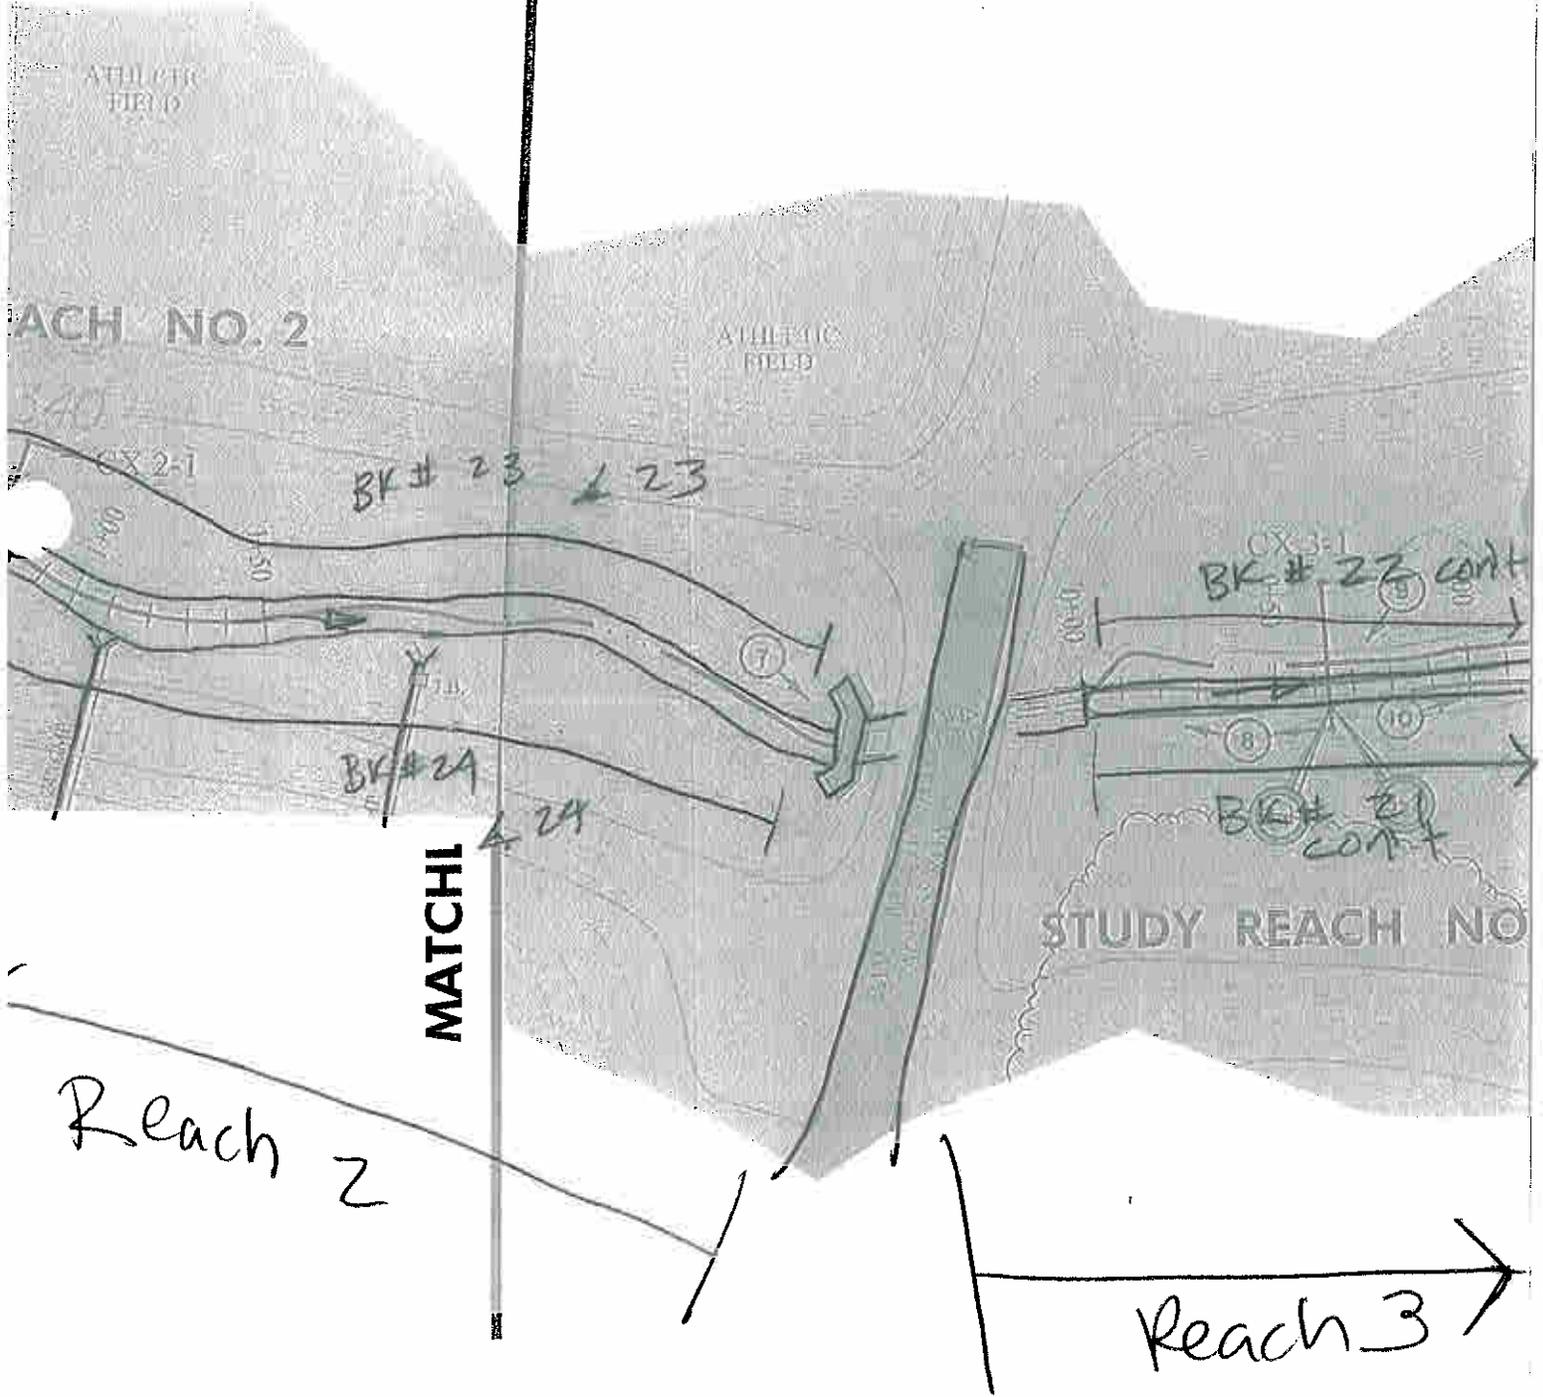
PHOTO 9: CROSS SECTION 3-1

WITH THE PAVED ACCESS ROAD TO  
ALSO SHOWN IS THE EXISTING  
CUT APPROXIMATELY 2.2 FEET.

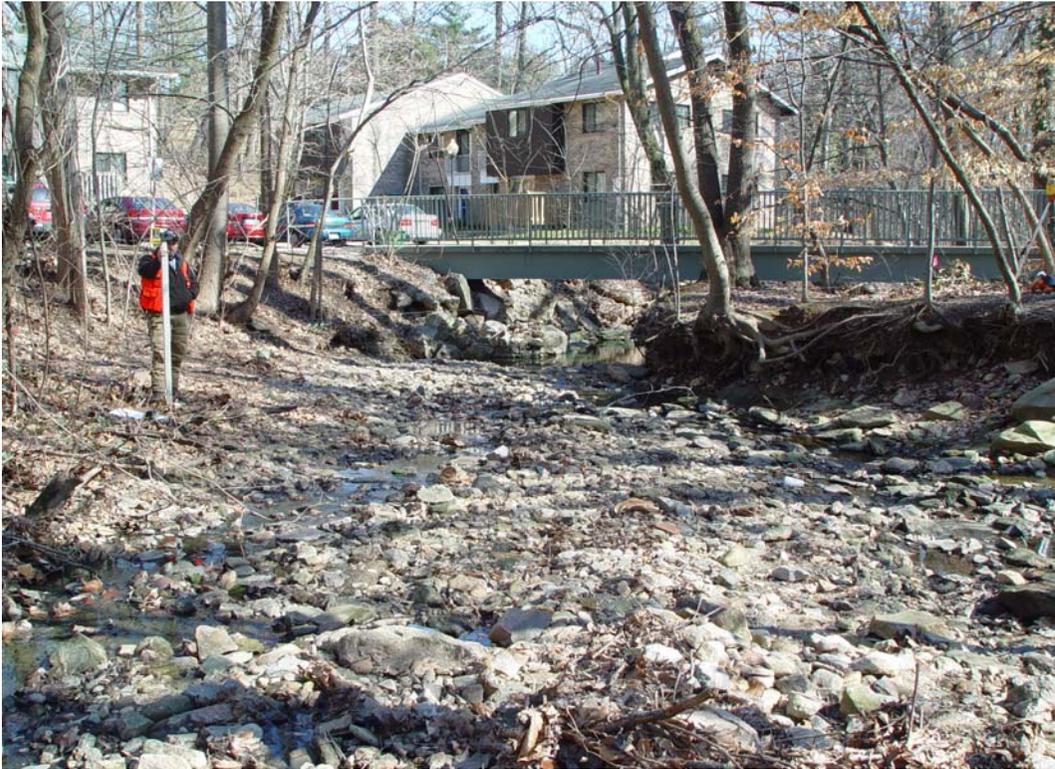
**Photo 1.** Reach 1 is a Rosgen F4 stream type with a high entrenchment ratio and width/depth ratio (looking downstream).

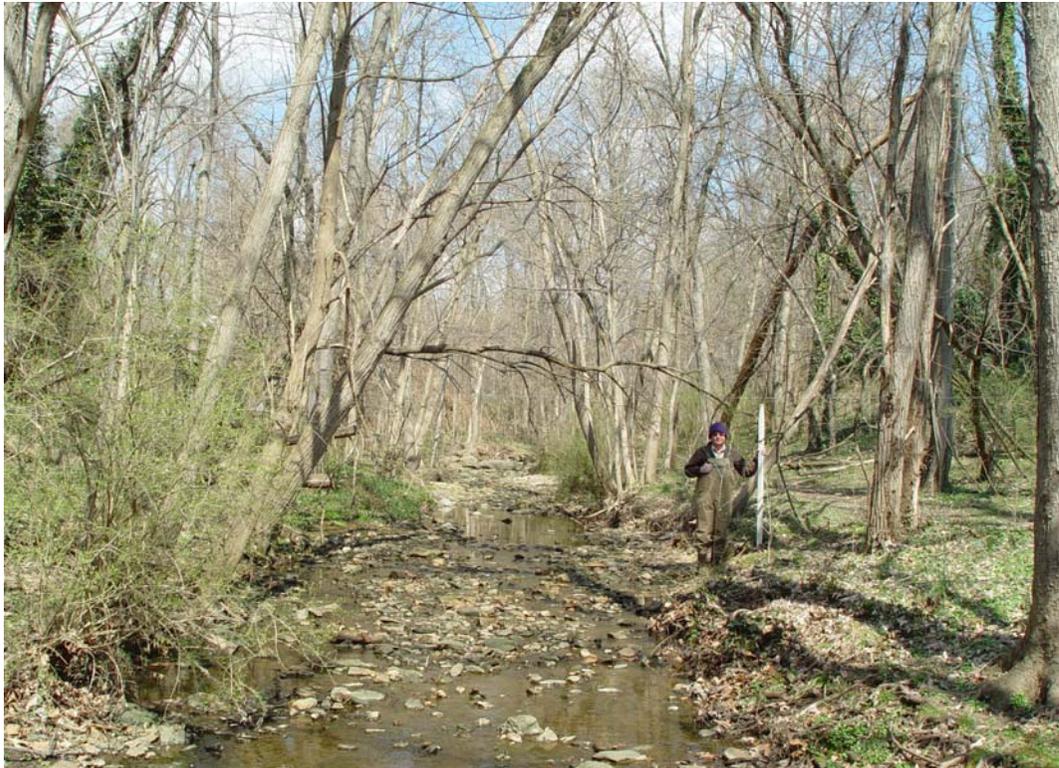
**Photo 2.** Reach 2 is a Rosgen Bc4 stream type with a moderate entrenchment ratio and width/depth ratio, and a lower than typical stream slope (looking upstream).

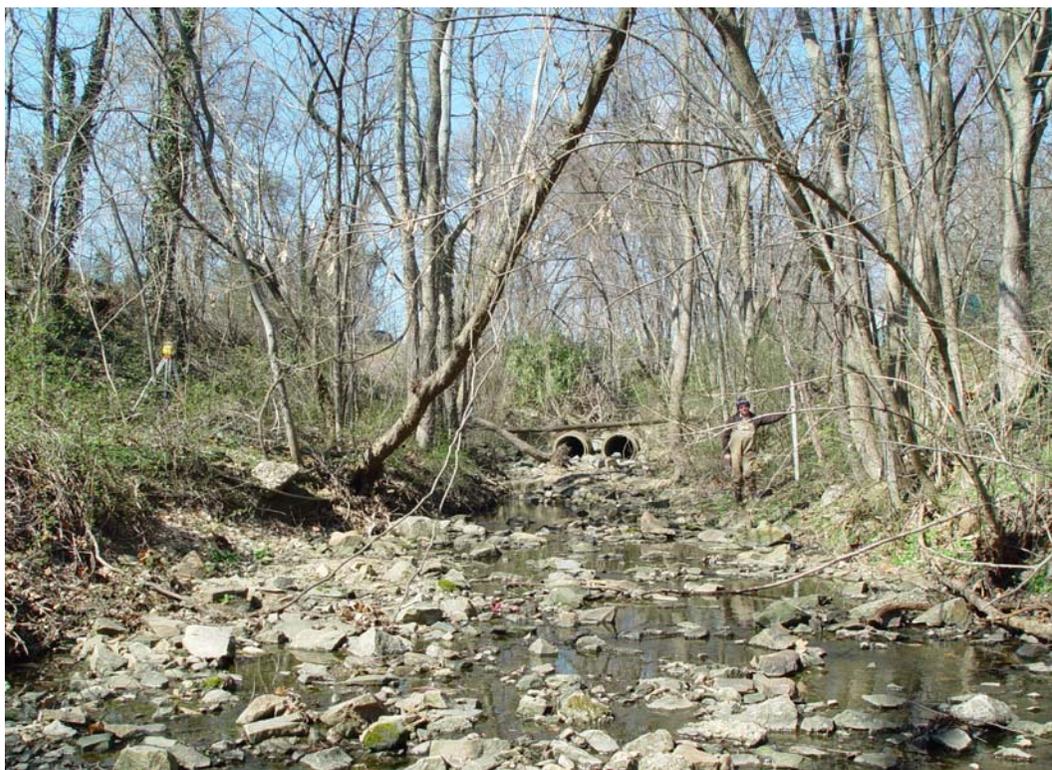
**Photo 3.** Reach 3 is a Rosgen Bc4 stream type with a moderate entrenchment ratio and width/depth ratio, and a lower than typical stream slope (looking upstream).

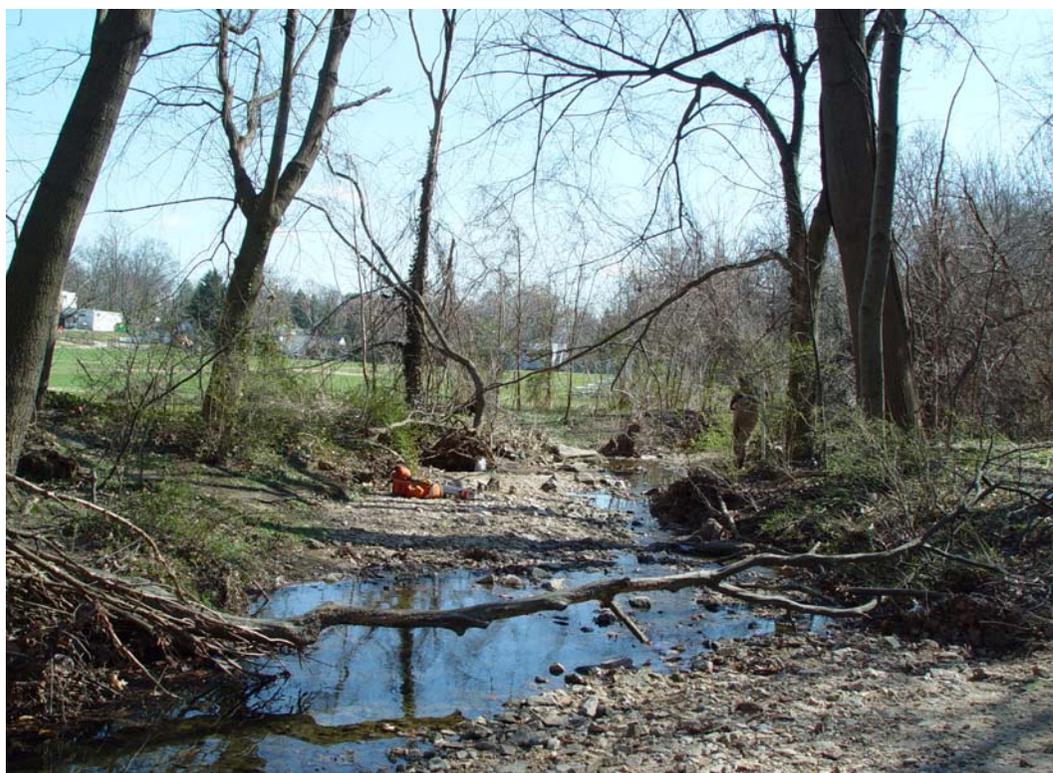
**Photo 4.** Reach 4 is a Rosgen C4 stream type with a low entrenchment ratio, and a moderate width/depth ratio (looking downstream).

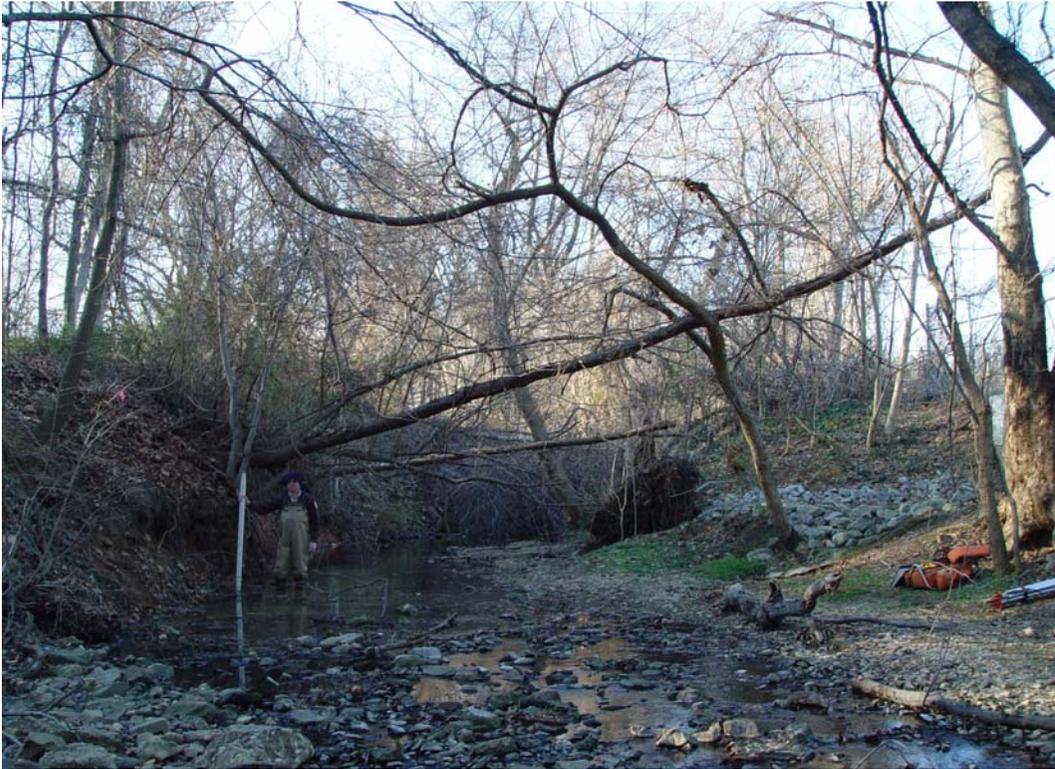
**Photo 5.** Reach 5 is a Rosgen Bc4 stream type with a moderate entrenchment ratio and width/depth ratio, and a lower than typical stream slope (looking upstream).

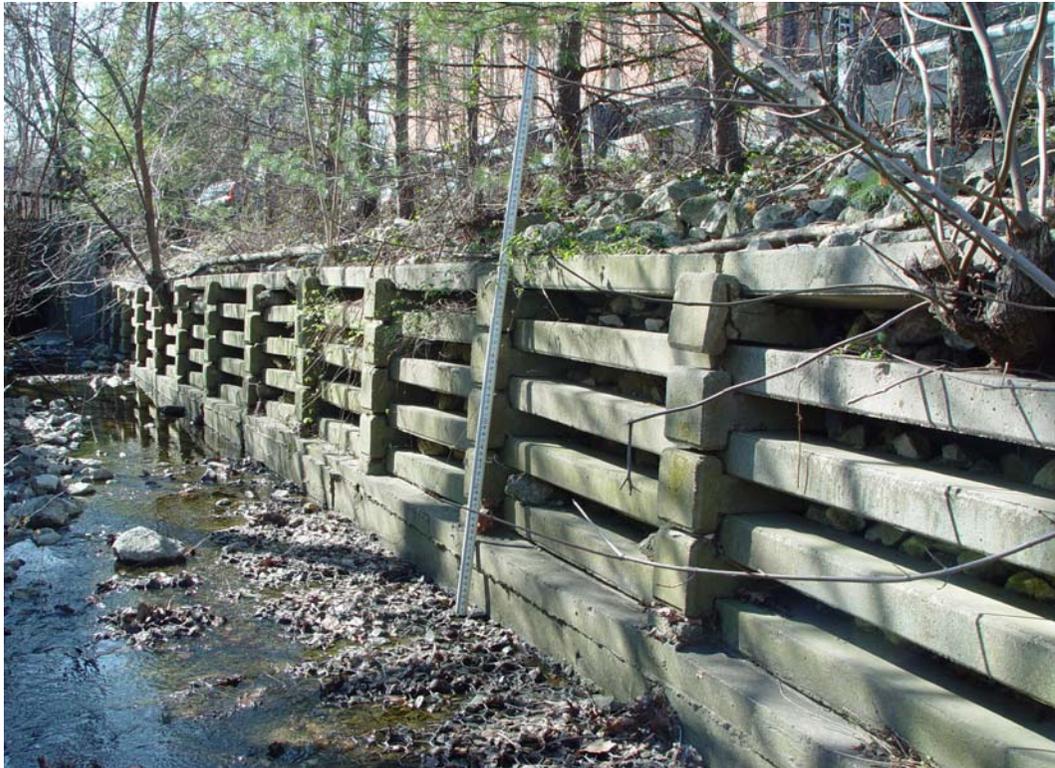
**Photo 10.** Reach 6 is a Rosgen F4 stream type with a high entrenchment ratio and width/depth ratio (looking upstream). A majority of the stream banks are concrete crib or gabion basket revetments.

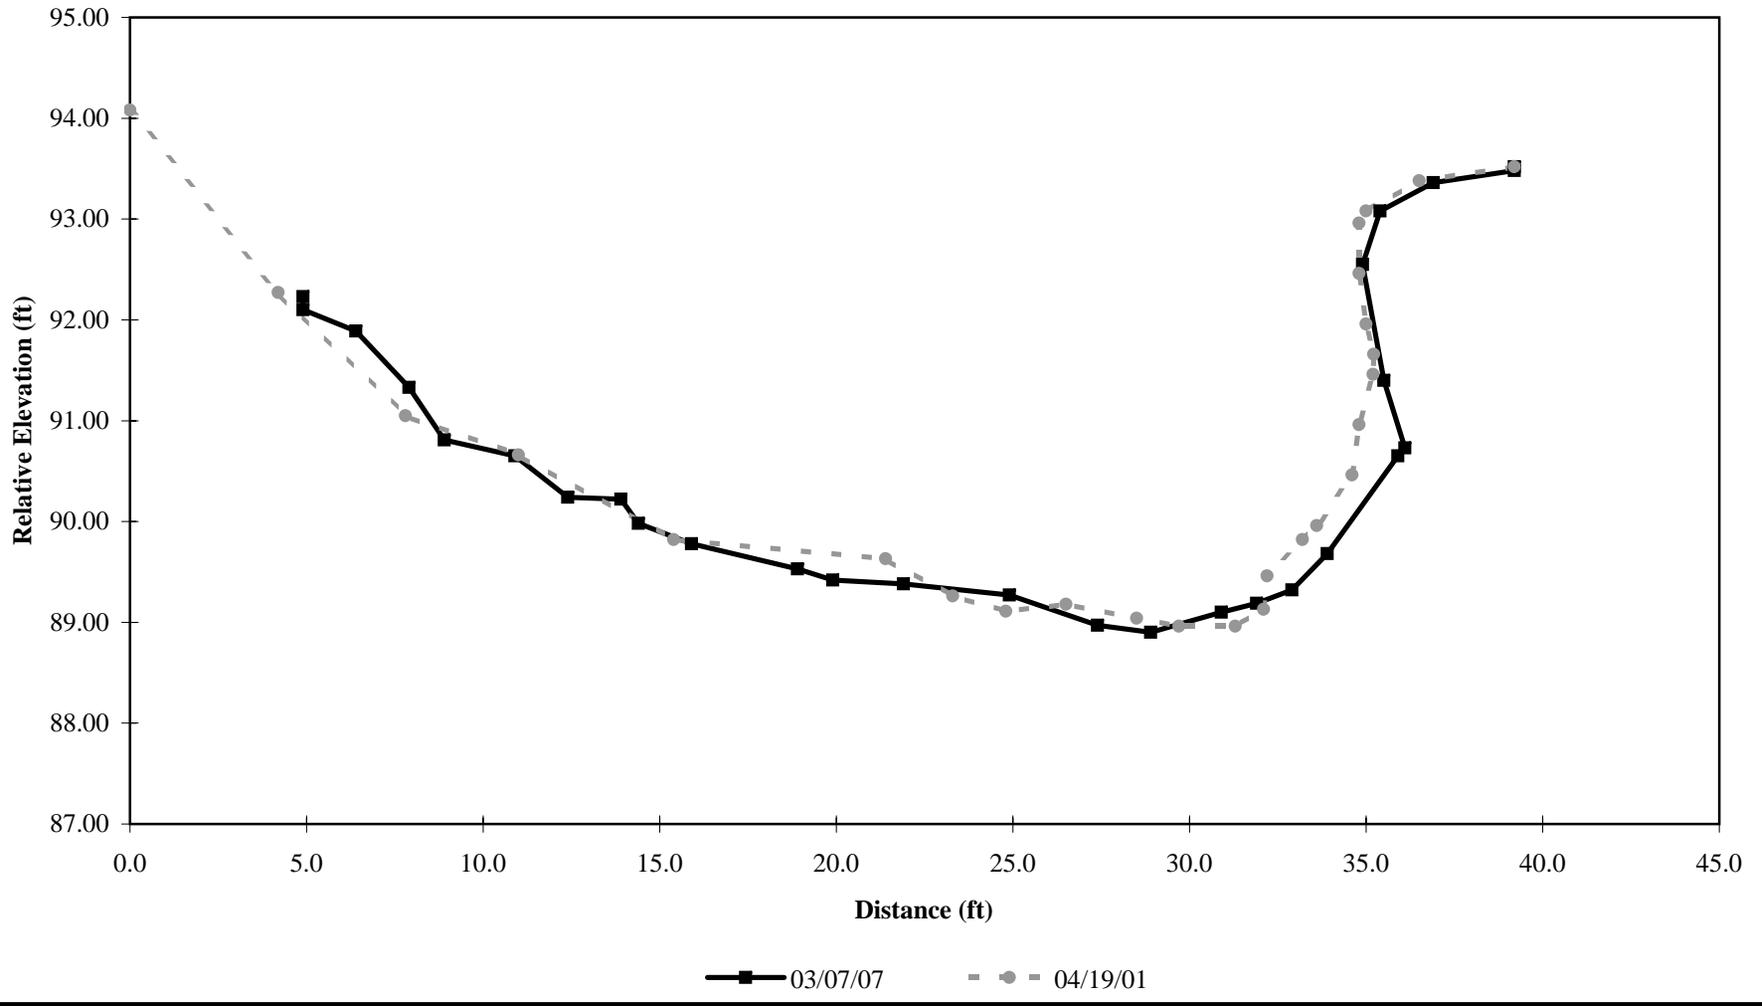
**STONY RUN - REACH 1**  
**Cross Section 1 - Overlay**  
**(Riffle)**

For the resurveyed cross sections, the Service overlaid the cross section plots from each year, by aligning both of the cross section monuments. The Service was unable to align the monuments of two cross sections: Reach 1- Cross Section 1 and Reach 4 – Cross Section 2. For those cross sections, the Service attempted to align the overlays using only the left or right monument, and evaluating the quality of the overlay. The Service found that reach 1 – cross section 1 had a reasonable overlay using the right monument, but the Service was unable to reasonably overlay Reach 4 – Cross Section 2.

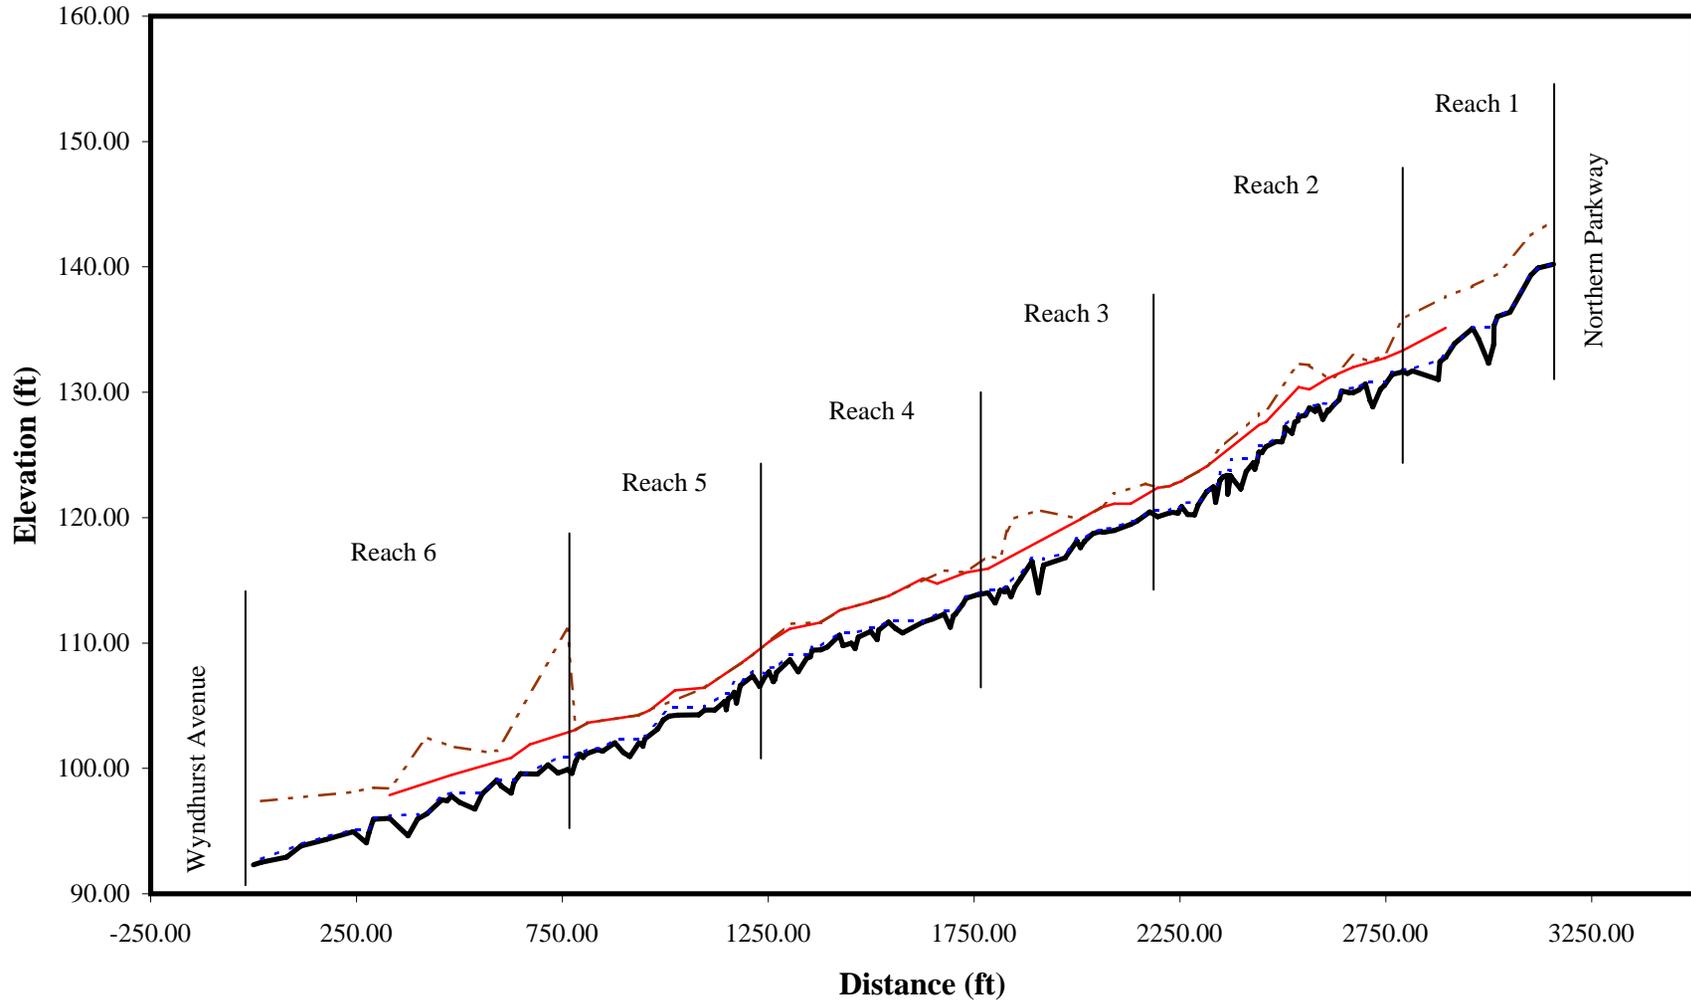
# STONY RUN, BALTIMORE CITY, MARYLAND 2006 LONGITUDINAL PROFILE

The Service entered the longitudinal profile field data into a Microsoft Excel spreadsheet and plotted the longitudinal profile. The Service delineated the study reaches and identified the road crossings on the longitudinal profile plots.

From the longitudinal profile, the Service measured study reach slopes, which range from 0.0072 to 0.0191 ft/ft (Table 6). The lowest gradient is at the downstream limit of the assessment area, in Reach 6, and the steepest gradient is at the upstream limit of the assessment area, in Reach 1. Overall, the Stony Run assessment area has an average slope of 0.015 ft/ft.

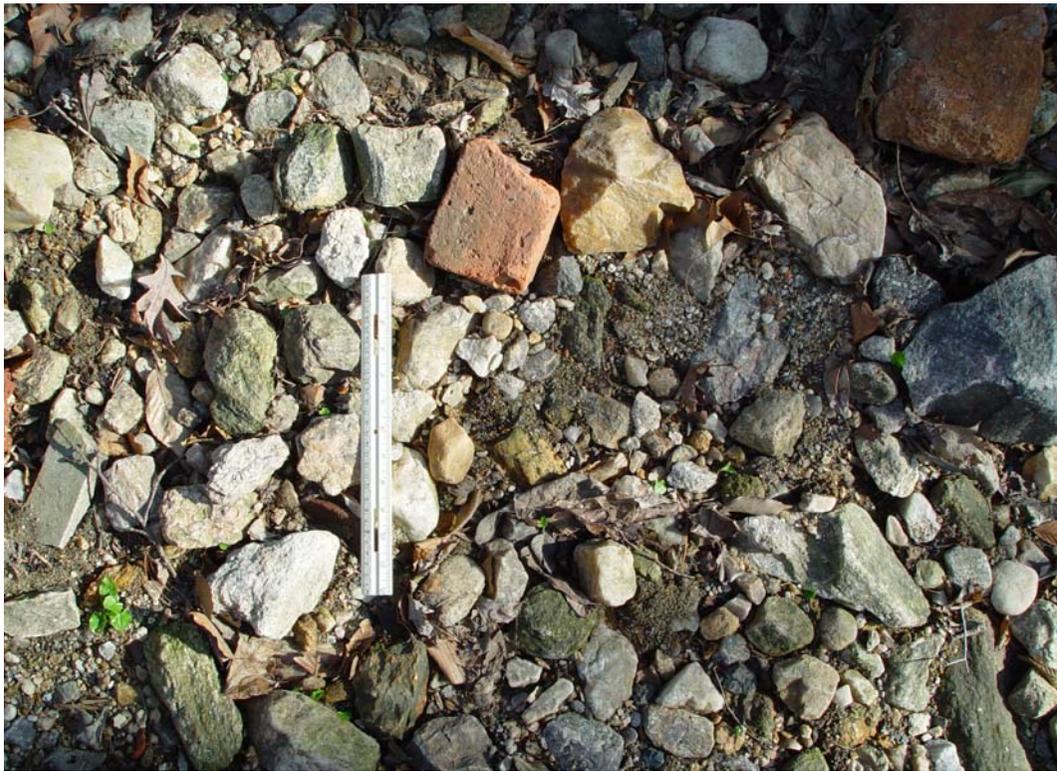
**Photo 1.** Reach 01 – Bed Substrate Characterization (with a 12-inch ruler as reference).

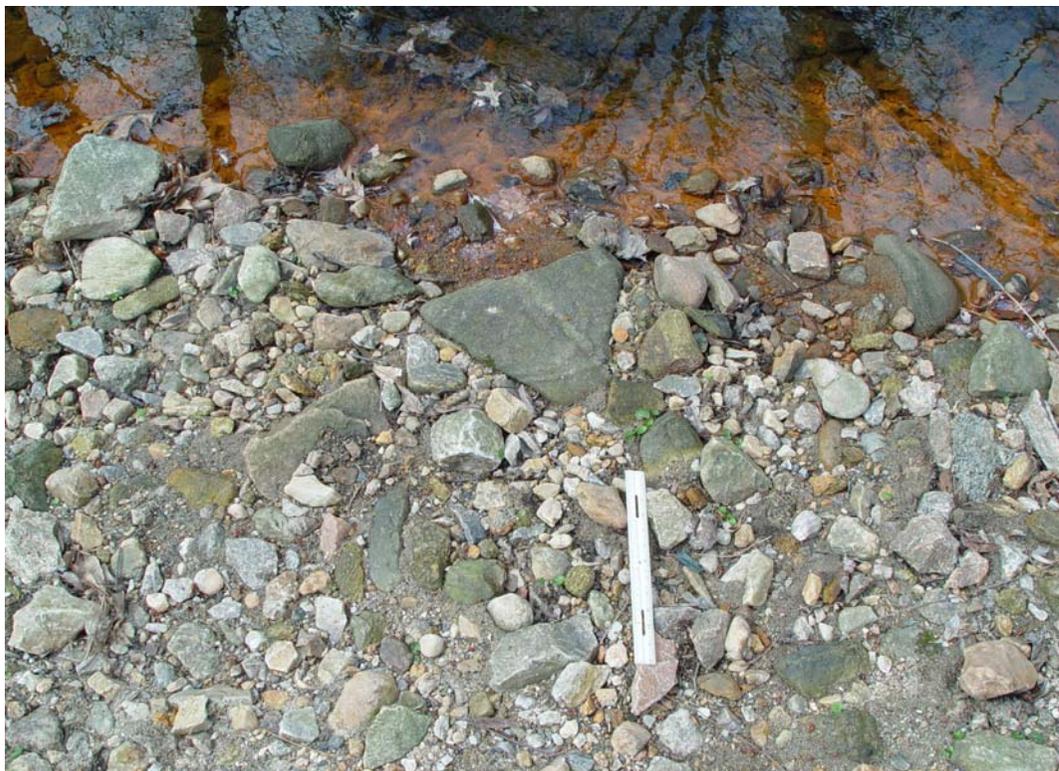
**Photo 2.** Reach 02 – Bed Substrate Characterization (with a 12-inch ruler as reference).

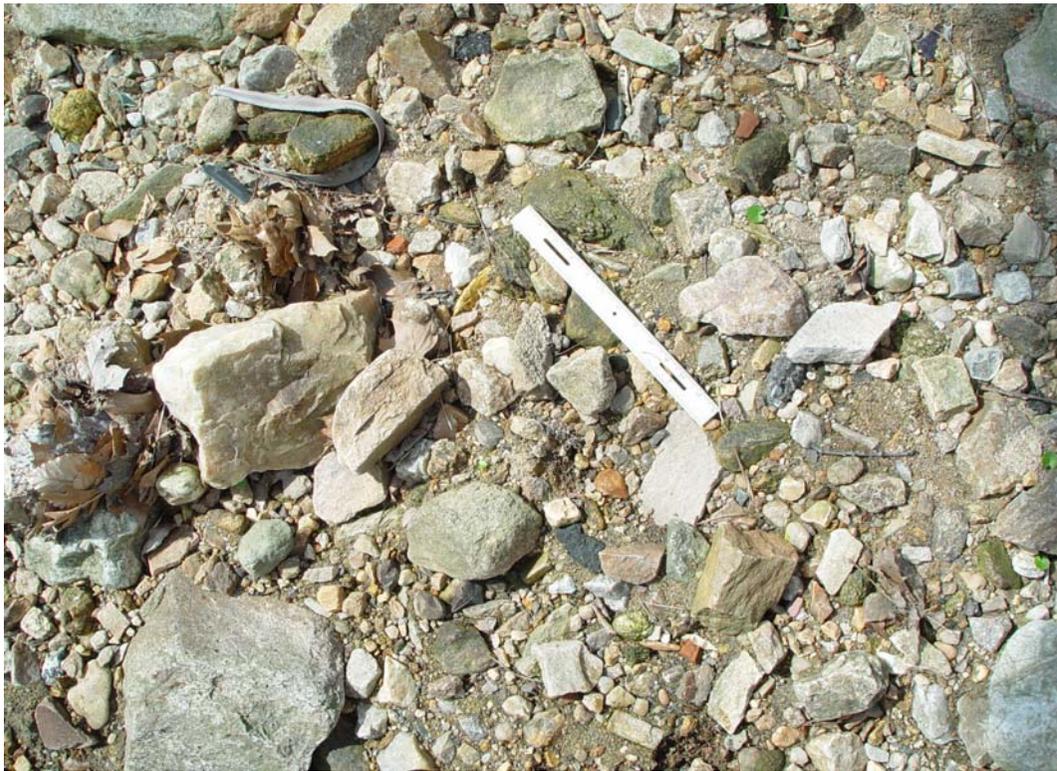
**Photo 3.** Reach 03 – Bed Substrate Characterization (with a 12-inch ruler as reference).

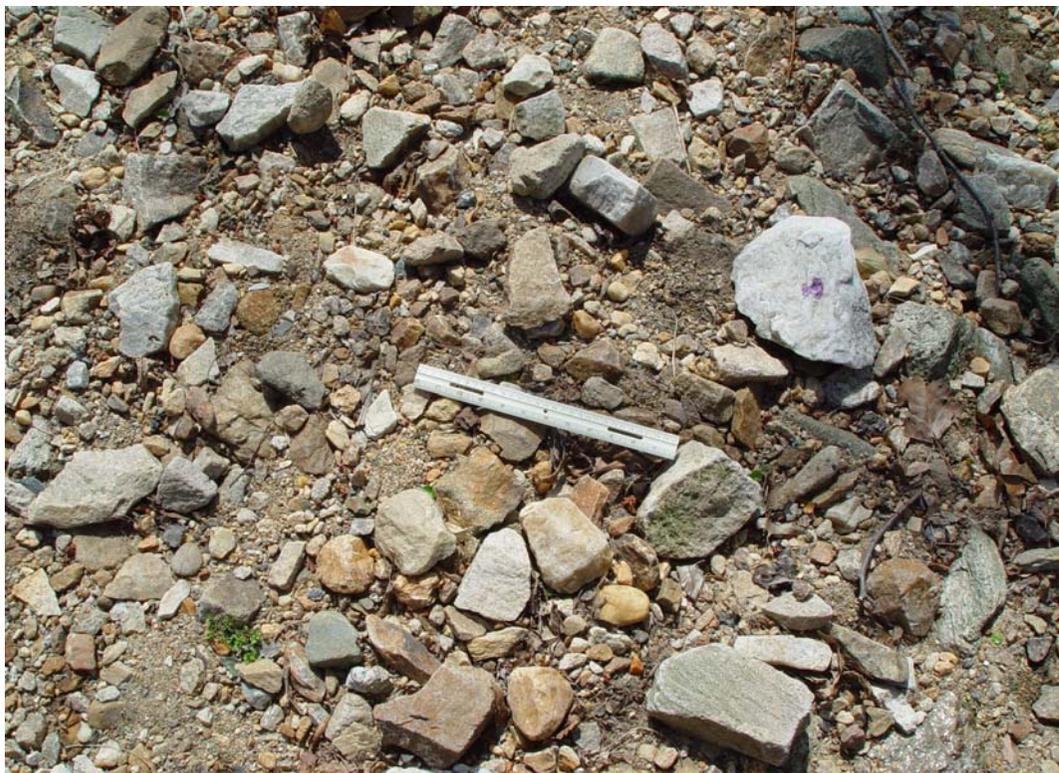
**Photo 4.** Reach 04 – Bed Substrate Characterization (with a 12-inch ruler as reference).

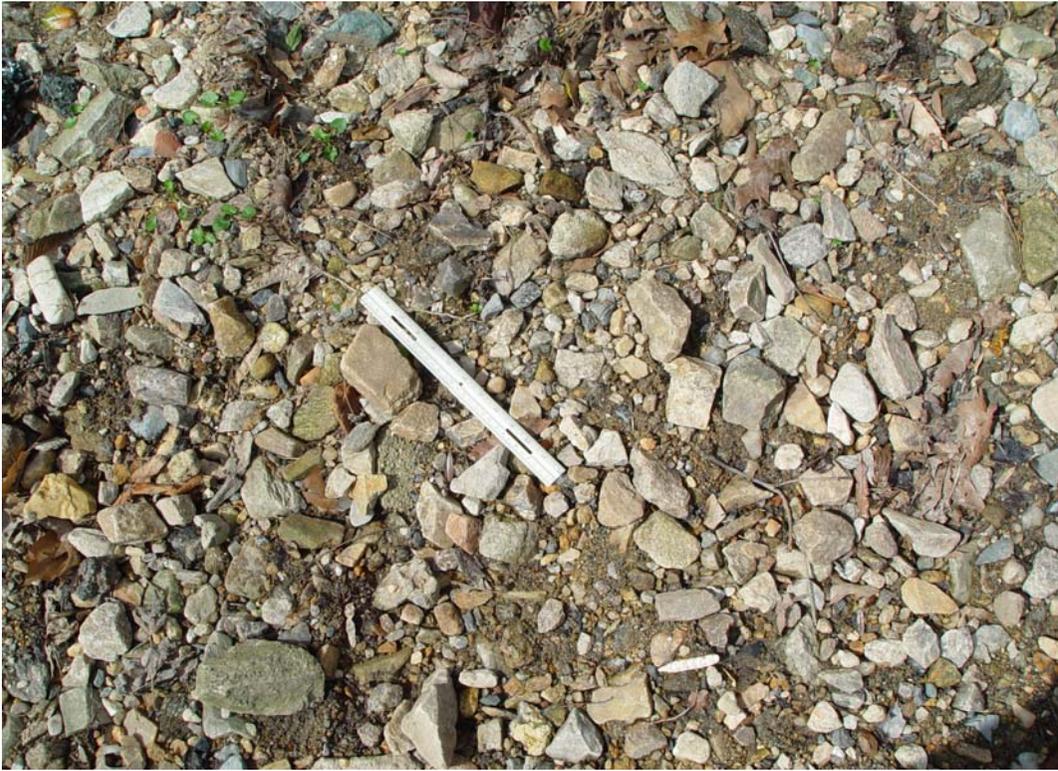
**Photo 5.** Reach 05 – Bed Substrate Characterization (with a 12-inch ruler as reference).

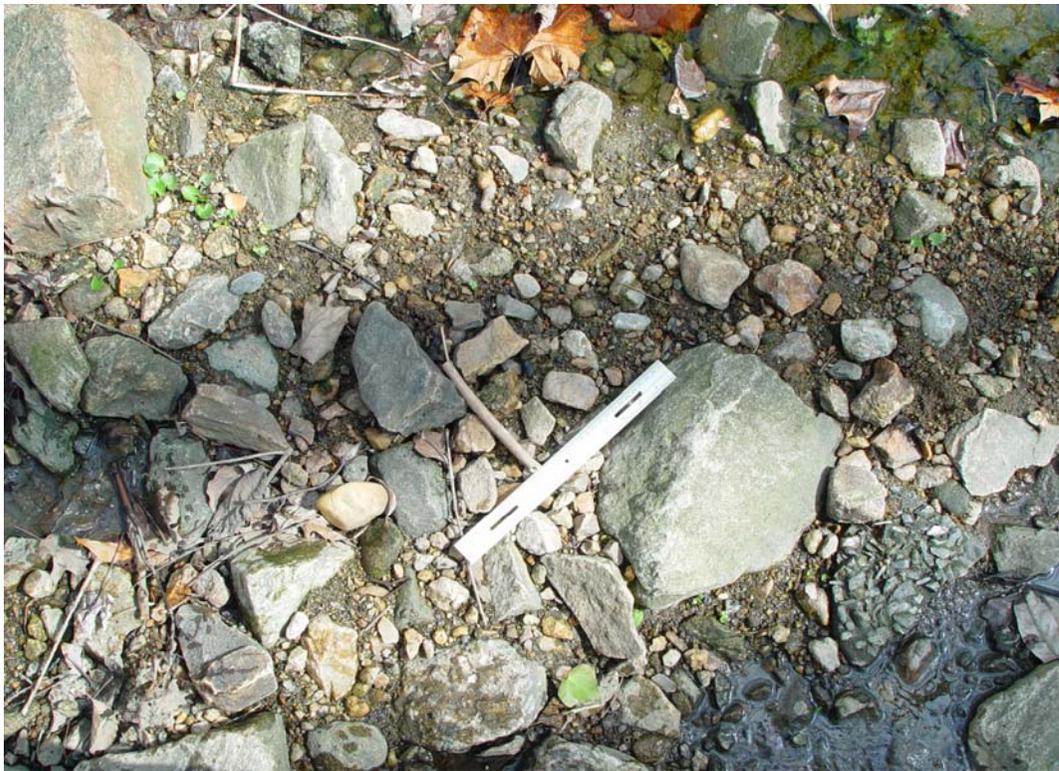
**Photo 6.** Reach 06 – Bed Substrate Characterization (with a 12-inch ruler as reference).
