Results from the Cow Creek Video Station for Years 2006-2011 for Fall-run Chinook Salmon Escapement

By
Douglas Killam
California Department of Fish and Game, Northern Region
Red Bluff Fisheries Office

RBFO Technical Report No. 02-2012

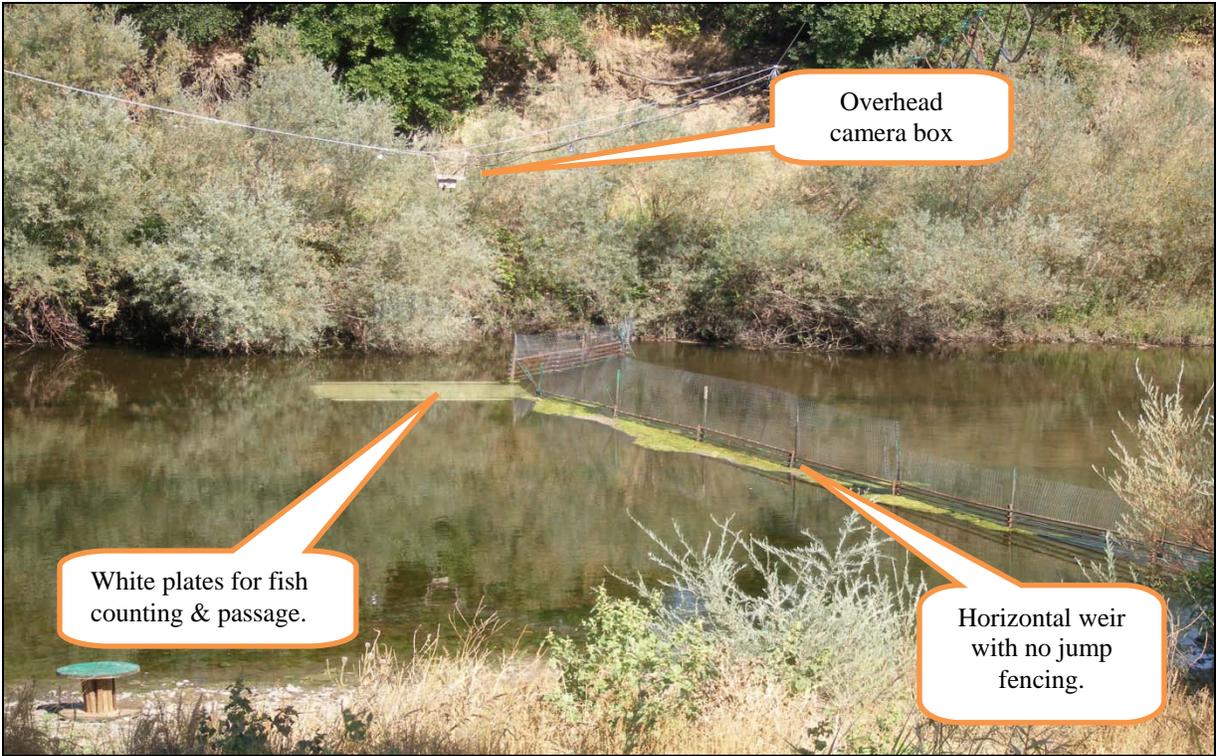
Figure 2. The 2006 Cow Creek Video station with camera box, weir, and passage opening with white plates visible.

In 2006, three overlapping 1/4" x 4 x 8-foot (6 mm x 1.2 x 2.4 m) plates were used to create an 11 x 8-foot wide (3.4 x 2.4 m) viewing area (see Figure 2 and 9). In years 2007 through 2009, two 5 x 10-foot (1.2 x 3 m) plates were used creating a 10 x 10-foot (3 x 3 m) viewing area. In 2010 three 5 x 10-foot (1.5 x 3 m) plates were used to create a 15 x 10-foot (4.6 x 3 m) viewing area. In 2011, four plates were laid end to end in a five-foot x 40-foot (1.5 x 12.2 m) design to allow higher flows to pass the video station without impacting the weir.

view of the overhead camera. The weir, as pictured in Figure 2, was designed to avoid causing upstream passage delay. The “horizontal weir” was constructed of 10-foot x 1-inch (3.0 m x 2.54 cm) steel pipes welded to uprights with 3-inch (7.6 cm) spaces between pipes. Taller panels incorporated 1-¼ -inch (3.2 cm) electrical metallic tubing (EMT) conduit on the inner cross-members to lighten the overall weight of the finished panel. These conduits were slid over 12-inch (30.5 cm) pipe “stubs” that were welded to the uprights during construction. The horizontal pipe panels are designed to fit the depth of the creek at the weir site, (e.g. panels in shallow water have only two or three cross-members while panels in deeper water have more cross-members). Figure 3 provides details of the weir components. The horizontal design and spacing between bars of the weir panels allows leaves to easily pass downstream while preventing salmon from passing the weir except at the opening. Rebar stakes were driven vertically through the two uprights on each panel and into the stream bottom to prevent the panel from sliding on the bottom. Welded fittings termed “doglegs” by the RBFO staff were bolted to the upper horizontal pipe and a “weir arm” was slid through the dog leg fitting and pounded into the stream bottom at approximately a 45-degree angle downstream.

The two cables, about 300-feet (91.4 m) each, stretched across the creek and were anchored to riparian trees on the far side of the stream as seen in Figure 2. These two trees were spaced about 100-feet (22 m) apart from each other along the edge of the creek. The two cables terminated at a single tree on the near side of the creek (Figure 2) located behind the electronic lock box in Figure 5.

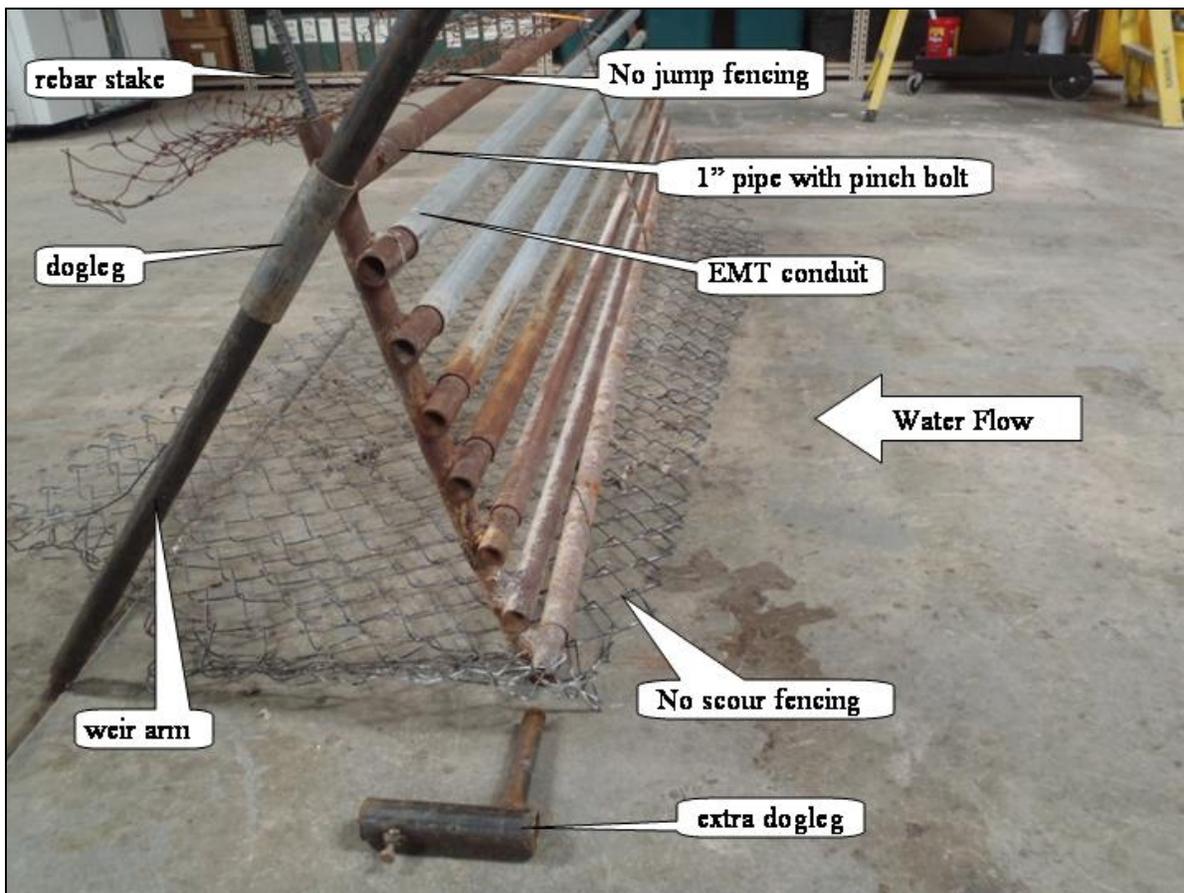
Figure 3. Image of typical RBFO video station weir panel and its components.

Dogleg fittings and other innovative designs provided the ability to position and support the weir in almost any configuration. The dogleg consisted of a one-inch (2.5 cm) solid steel round about six-inches (15.2 cm) in length welded to a 1-¼-inch (3.2 cm) pipe about six-inches (15.2 cm) in

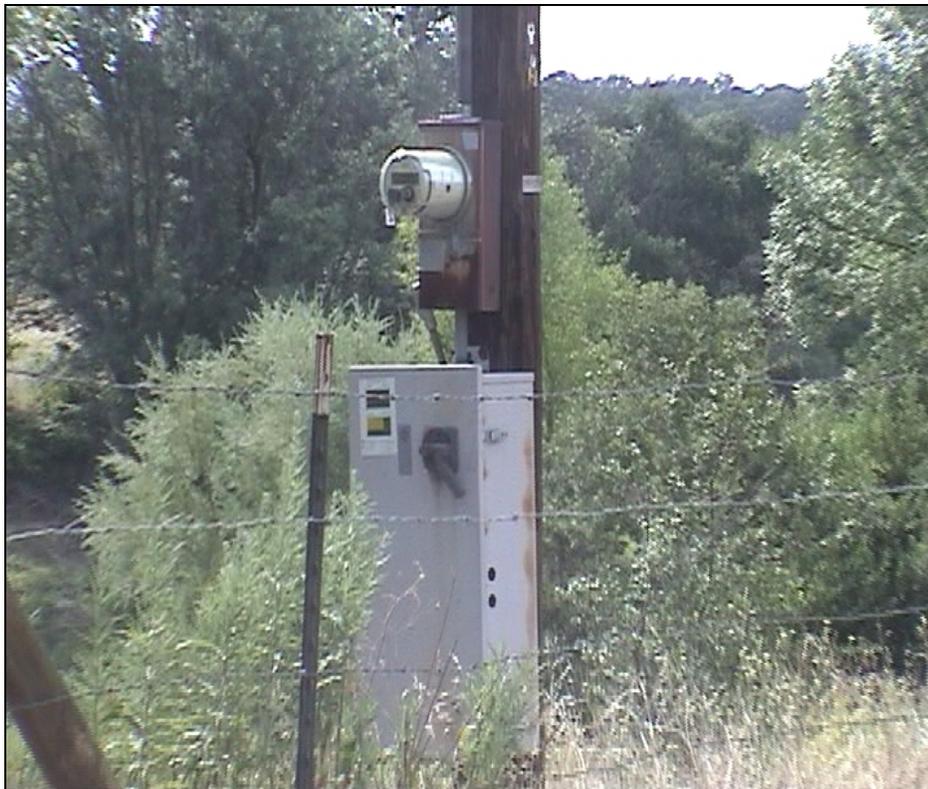
Figure 4. Cow Creek video station power supply box. Cow creek is located behind and down the hill in this photo.

One criteria of the Cow Creek video station power supply was that it be located near a conventional “on-grid” Pacific Gas and Electric Co. power supply. The Cow Creek station did not have sufficient funding to purchase solar panels and related equipment similar to the remote Battle Creek station so it was necessary to select a site with existing power. The selected site had an existing 240 volt incoming power supply. This power box shown in Figure 4 provided a close-by source of power to the station.

This box was formerly used to power an electric irrigation pump in the creek but was currently not in use. A 240 to 120 volt transformer was setup in the existing box and provided a 120 volt alternating current (AC) typical of a household power supply to run the camera lights and equipment.

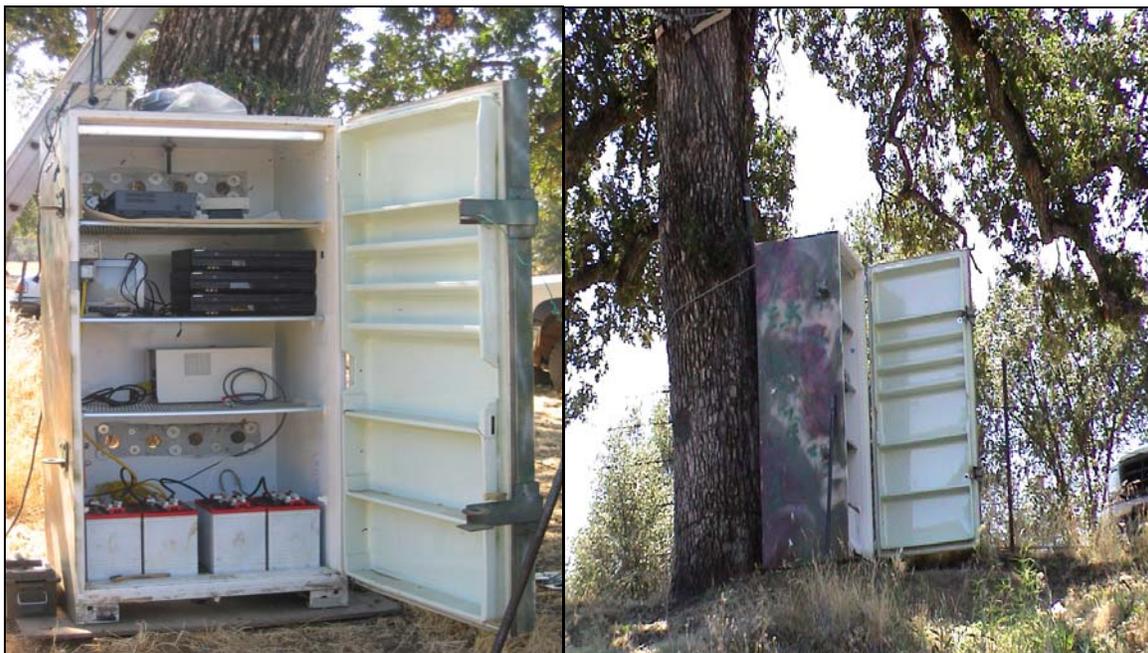
Figure 5. Images of the camouflaged electronic lock box (a modified refrigerator) in 2009 containing DVR equipment, TV monitor, power supply and battery backup for the Cow Creek video station.

The station’s electronic lock box shown in Figure 5 contained a back-up power supply used to provide power for a 1-2 day period should a power outage occur in the regular power supply.

The backup power supply consisted of four 6-volt “golf cart type” linked batteries providing a 12-volt direct current (DC) power supply to a modified 300 watt APC brand Uninterruptible Power Supply (UPS). The original batteries from the UPS were removed and the larger golf-cart batteries were connected giving a much greater power reserve if the grid power failed. All of the stations electronics were routed through the UPS to ensure continual video coverage in the event of a power failure.

From 2006 to the middle of the 2008 Cow Creek station video footage was recorded onto three video cassette recorders (VCR's). The VCR's (shown in Figure 5) were capable of recording eight hours each and were programmed to record sequentially for 24-hours.

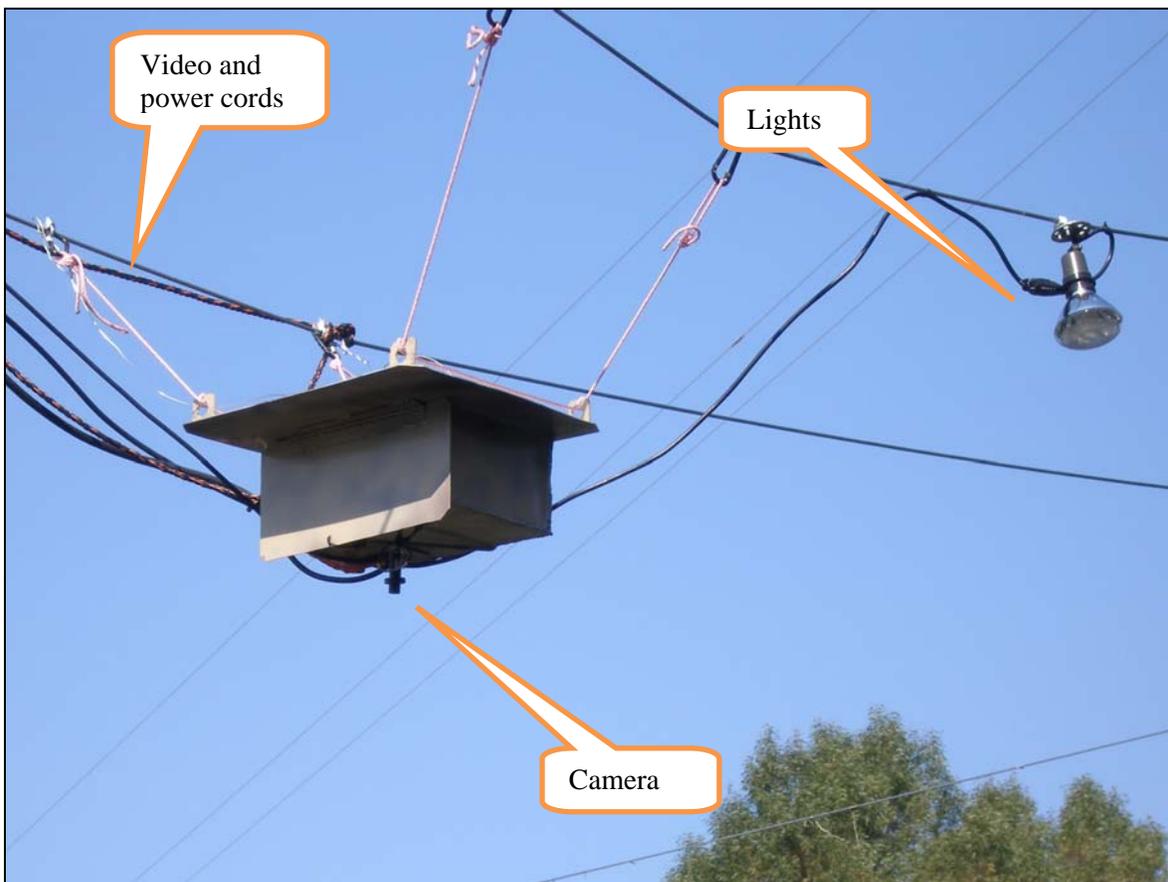
Figure 6. Image of over-head camera box with power cords, lights and camera box suspended over the Cow Creek video station.

various lighting conditions. The camera attached to the outside of a larger box containing remote lighting and other wiring hookups. The camera box and camera are shown in Figure 6. The camera box was suspended from two ¼-inch (6.3 mm) galvanized steel cables directly over the white plates where salmon passed as they migrated upstream.

This connection point in the tree was designed to allow easy movement up and down with a vehicle mounted winch so the camera could be raised or lowered to adjust for proper orientation over the white plates or when camera maintenance or cleaning was required. The camera box was attached by ropes to the cables, which reduced vibration caused by inclement weather. Power cords and camera co-axial cables were wired to the support cables with short plastic coated utility wire were run from the overhead stream camera box (see Figure 6) to the station's electronic lock box (see Figure 5). In years 2006 through 2010 a single overhead camera was

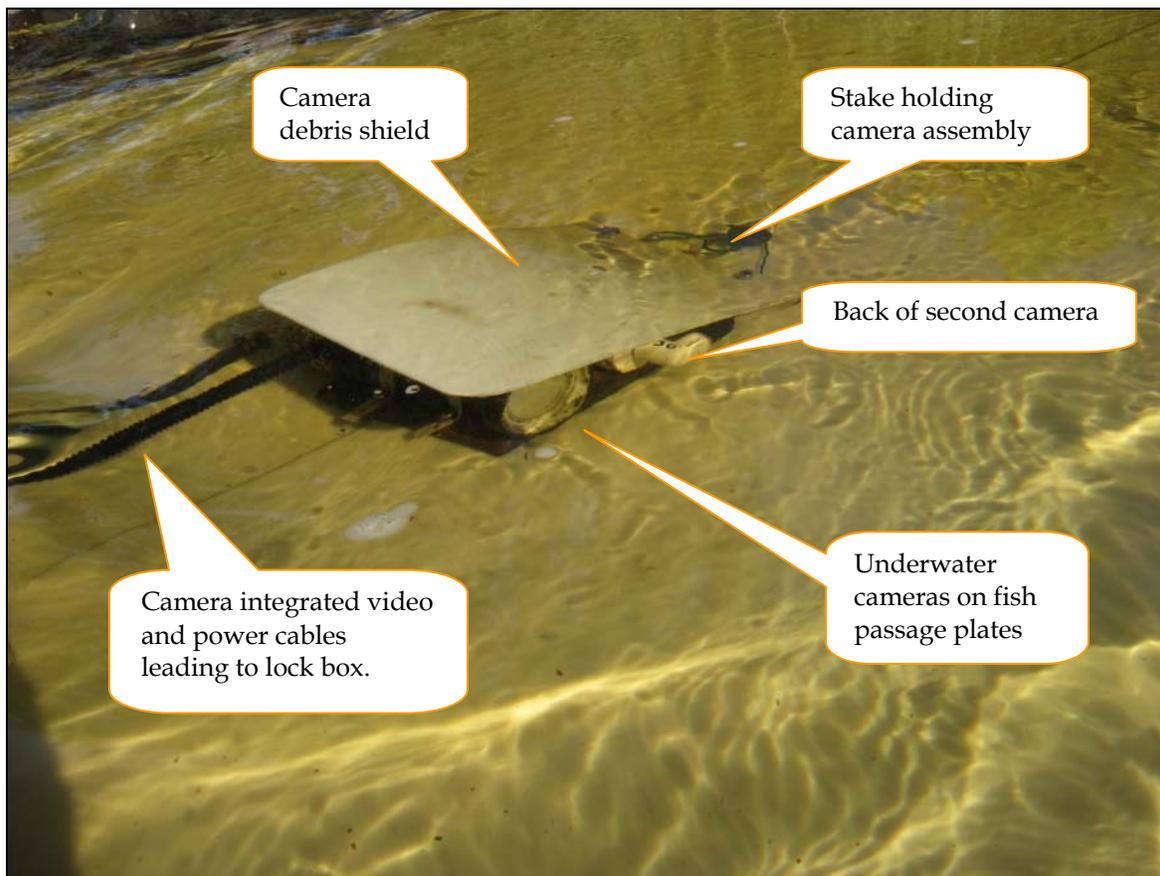
Figure 7. Image of typical underwater camera system on Cow Creek with white background plates. This is a two camera set-up with each side by side camera facing in opposite directions.

Up to three underwater cameras were typically installed in the stream to monitor salmon passage. Cameras were oriented perpendicular to the stream to record the passage of salmon as they move upstream past white plates anchored to the streambed as seen in Figure 7.

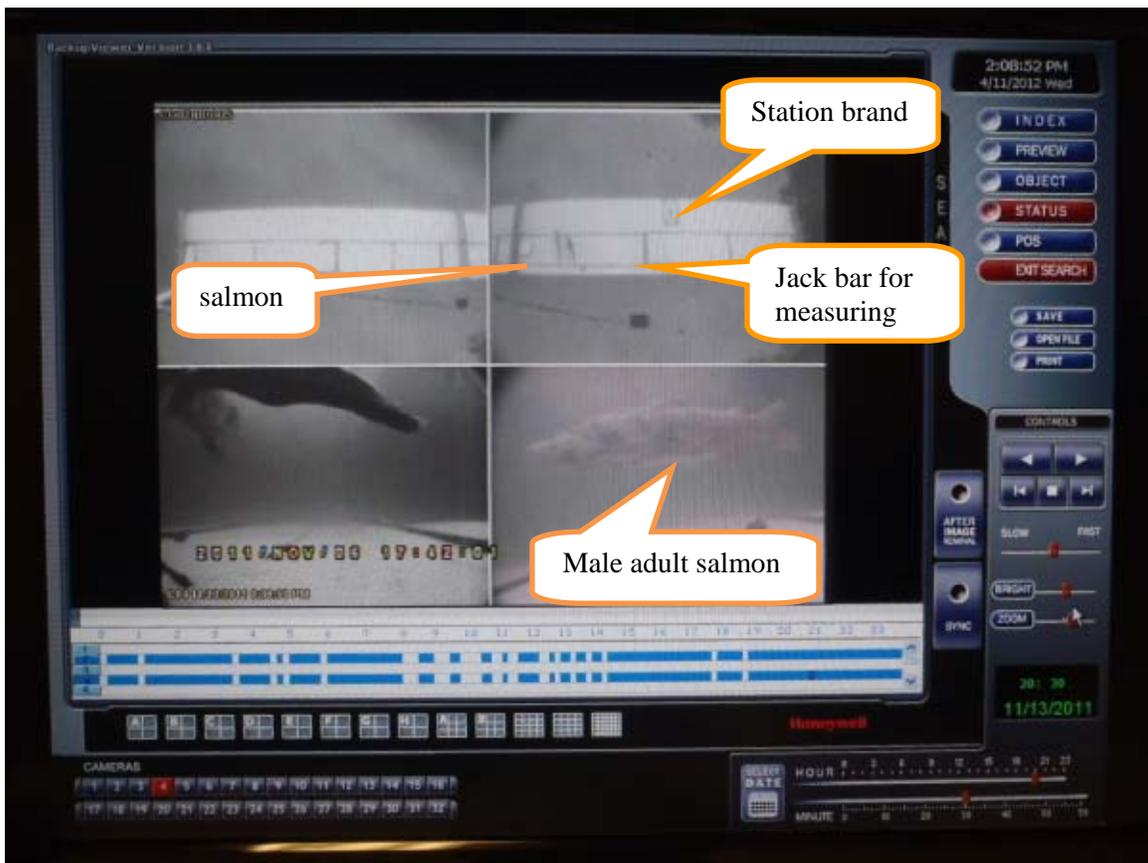
Figure 8. Image of Honeywell software with 2011 Cow Creek video station footage uploaded for fish passage reading. Top two screens are images from the overhead cameras and bottom two screens are images from the underwater cameras across the stream bed white plates.

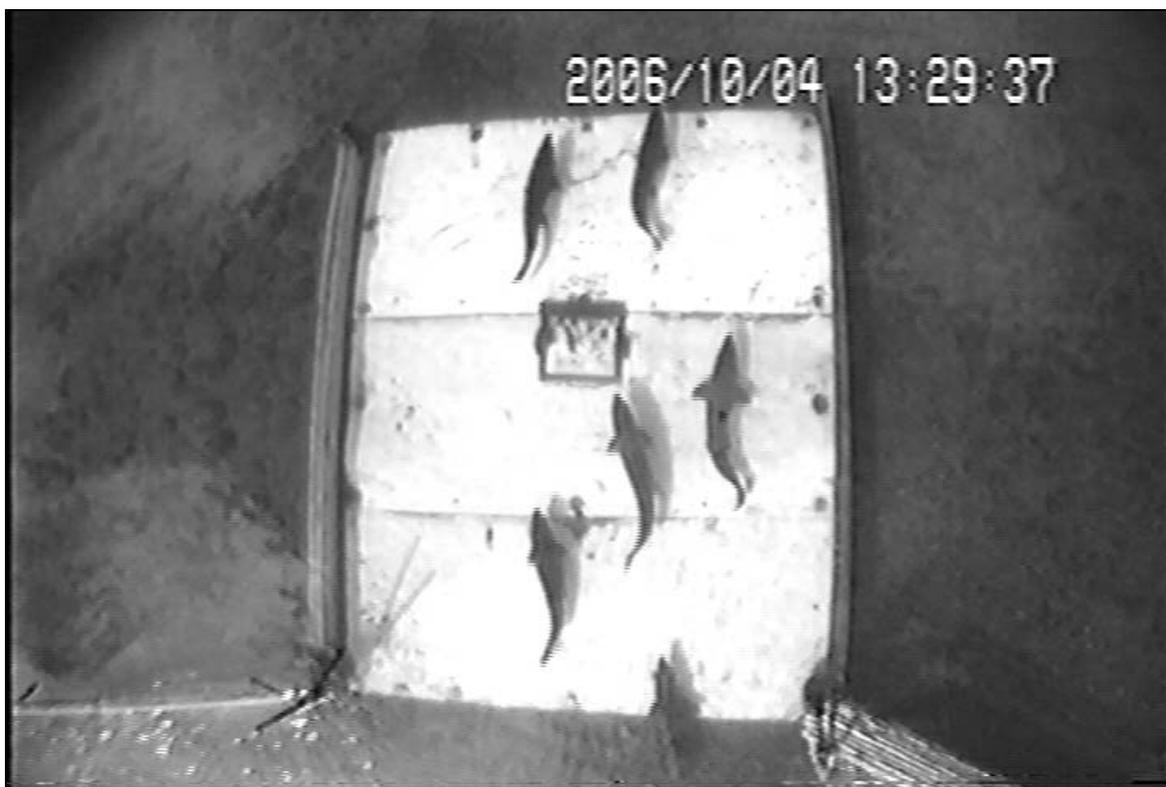
Figure 9. View from the overhead camera looking down on the fish passage opening of the 2006 Cow Creek video station.

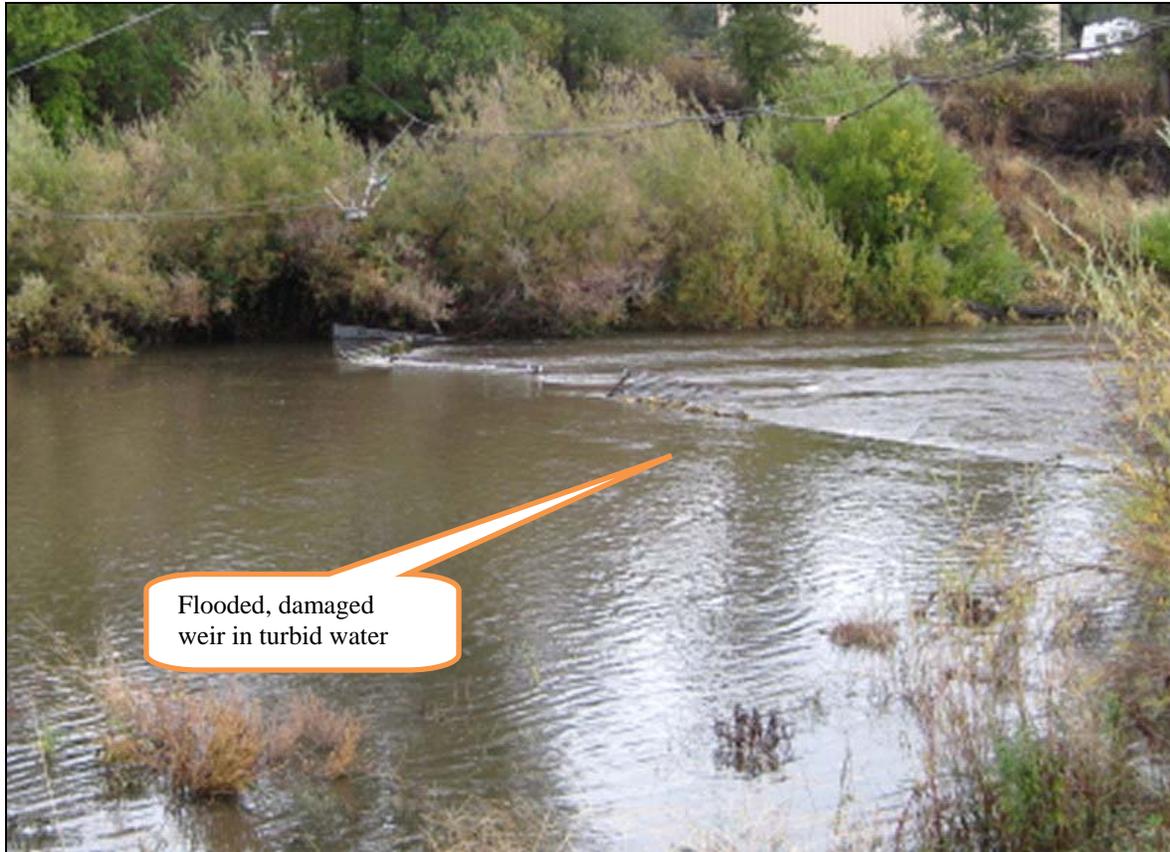
Figure 10. Image of weir during periods of turbid water and minor flooding during the 2008 season on Cow Creek. Weir is underwater and one of the panels was dislodged. Weir was rebuilt and continued operation after this flood.

At any time, when a major storm was forecast, a decision to remove the weir had to be considered. Concern for damage or loss of components of the weir (as in Figure 10) and other in-stream equipment dictated that weather forecasts were closely observed during station operation on an annual basis. The first of November was used as the unofficial annual goal to maintain station operations because experience has shown that the majority of fall-run Chinook in Battle Creek have already passed by this date (Killam 2006). For Cow Creek, earlier years, (see Table 2) indicated that the majority of the total passage had occurred by this date each year. Prior to the first of November large efforts by RBFO and WSRCDC crews were undertaken to repair flood damage and keep the station operating. After the first of November the flooding forecasts were carefully monitored and the risks of damaging or losing the equipment were weighed against the value of continued operation. If a major flood as shown in upper portion of Appendix Figure B6 was expected, the station was removed for the year.

- In 2008, flows reached 376 cfs on 3 November washing out a portion of the weir panels and fish passage could not be observed, as shown in Figure 10. The weir was repaired and counting resumed operation on 5 November.
- Appendix Figure B9 illustrates the 2008 video monitoring station on Cow Creek

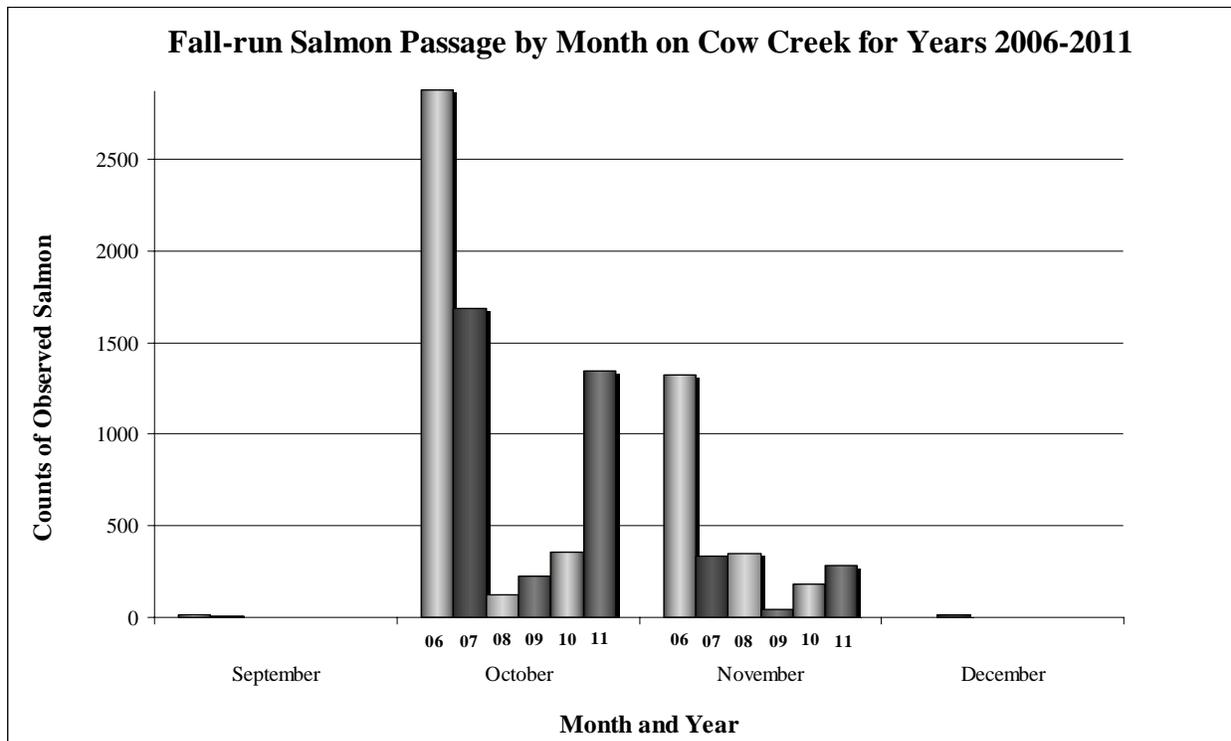
Figure 11. Fall-run Chinook salmon counts by month at the Cow Creek video station for years 2006-2011.

An illustration of the passage count by month is provided in Figure 11. Peak passage occurred in October of each year except 2008 with nearly 100% of fall-run salmon passage taking place in the months of October and November each year.

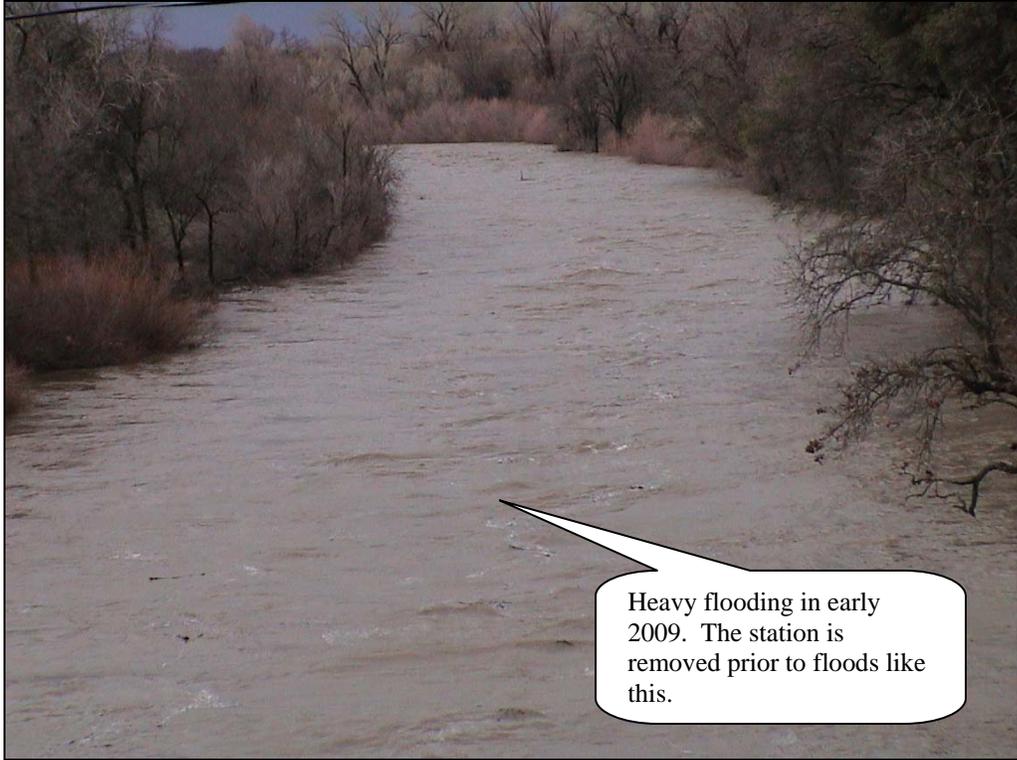
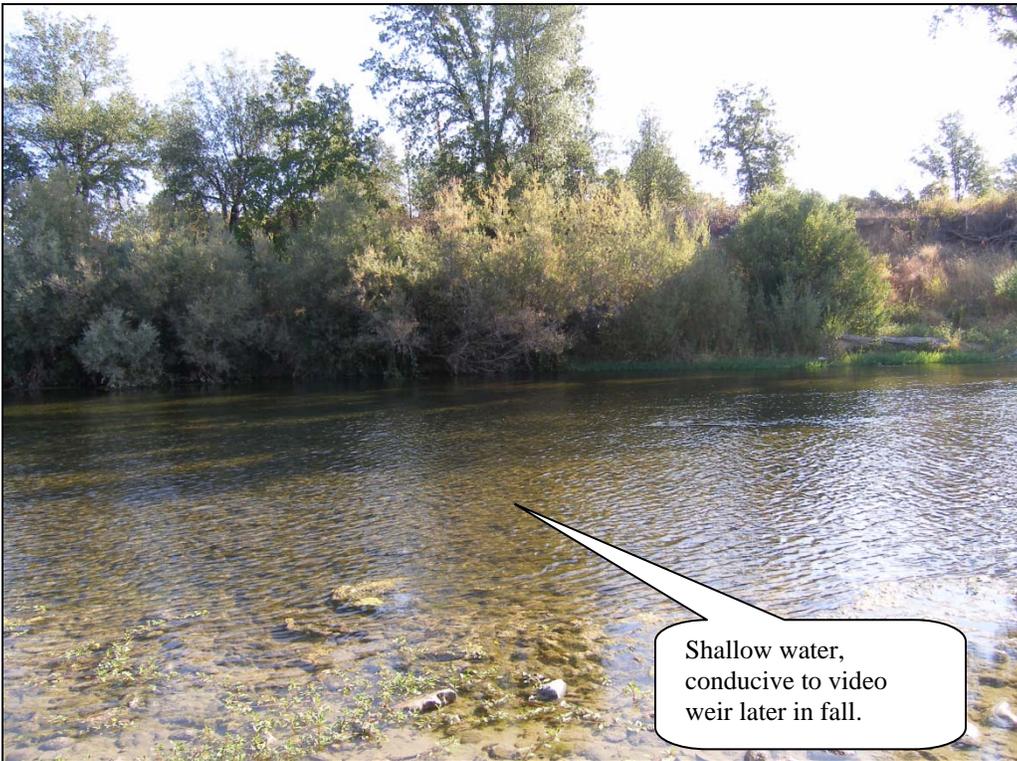
Appendix Figure B6. Upper-image of Cow Creek during major flooding. Lower-image of Cow Creek during a period conducive for construction and operation of the video weir.

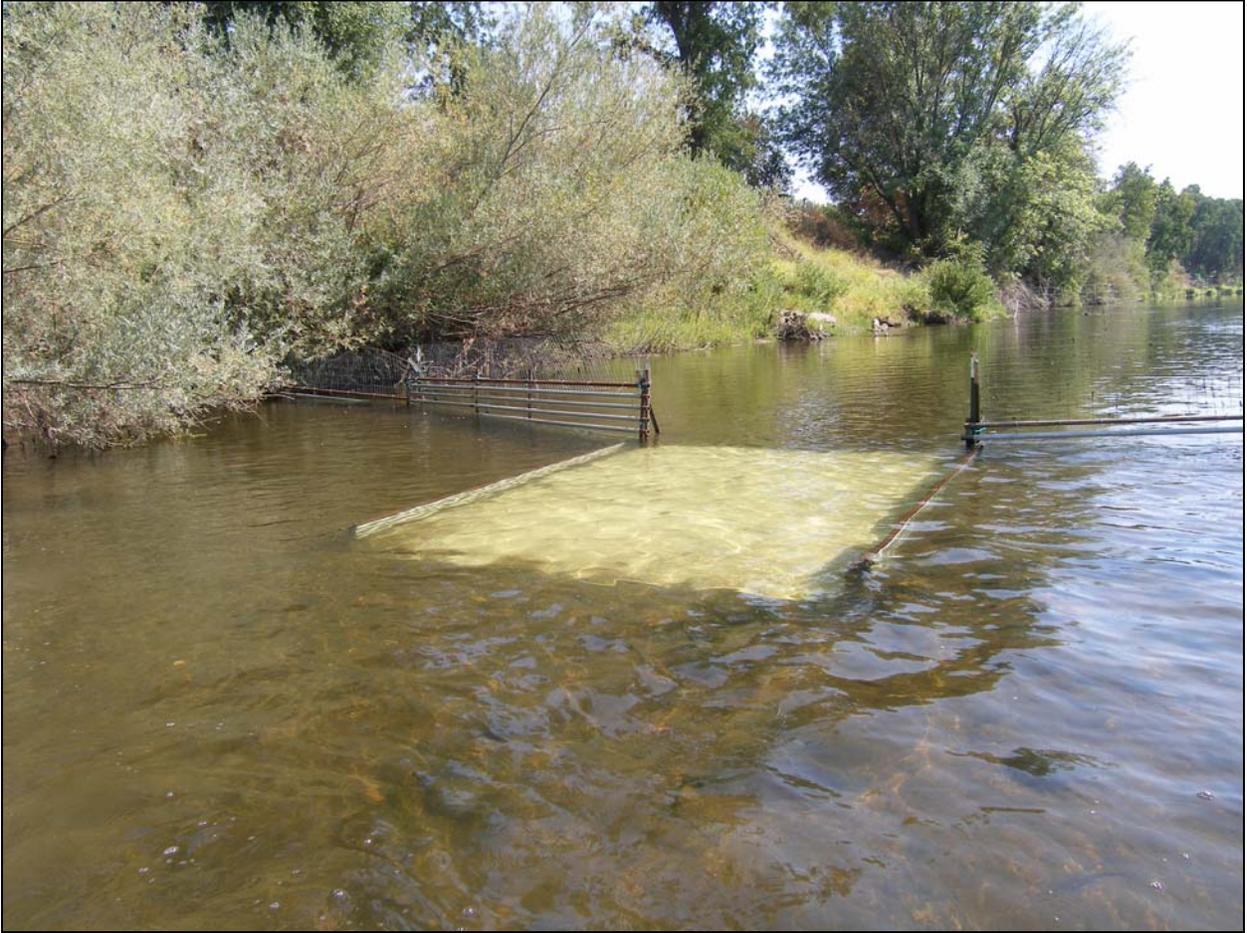
Appendix Figure B7. Photograph of 2006 Cow Creek Video Station.

- Three overlapping white plates were used resulting in an 11 x 8-foot (3.3 x 2.4 m) fish passage opening.
- 2006 was the first year a video monitoring station was constructed on Cow Creek. Design was based on the Battle Creek video station.
- The highest flow levels recorded for the season on Cow Creek were 252 cfs on 14 November.
- There were no redds observed downstream of the station.
- Appendix Figure B7 illustrates the 2006 video monitoring station on Cow Creek.

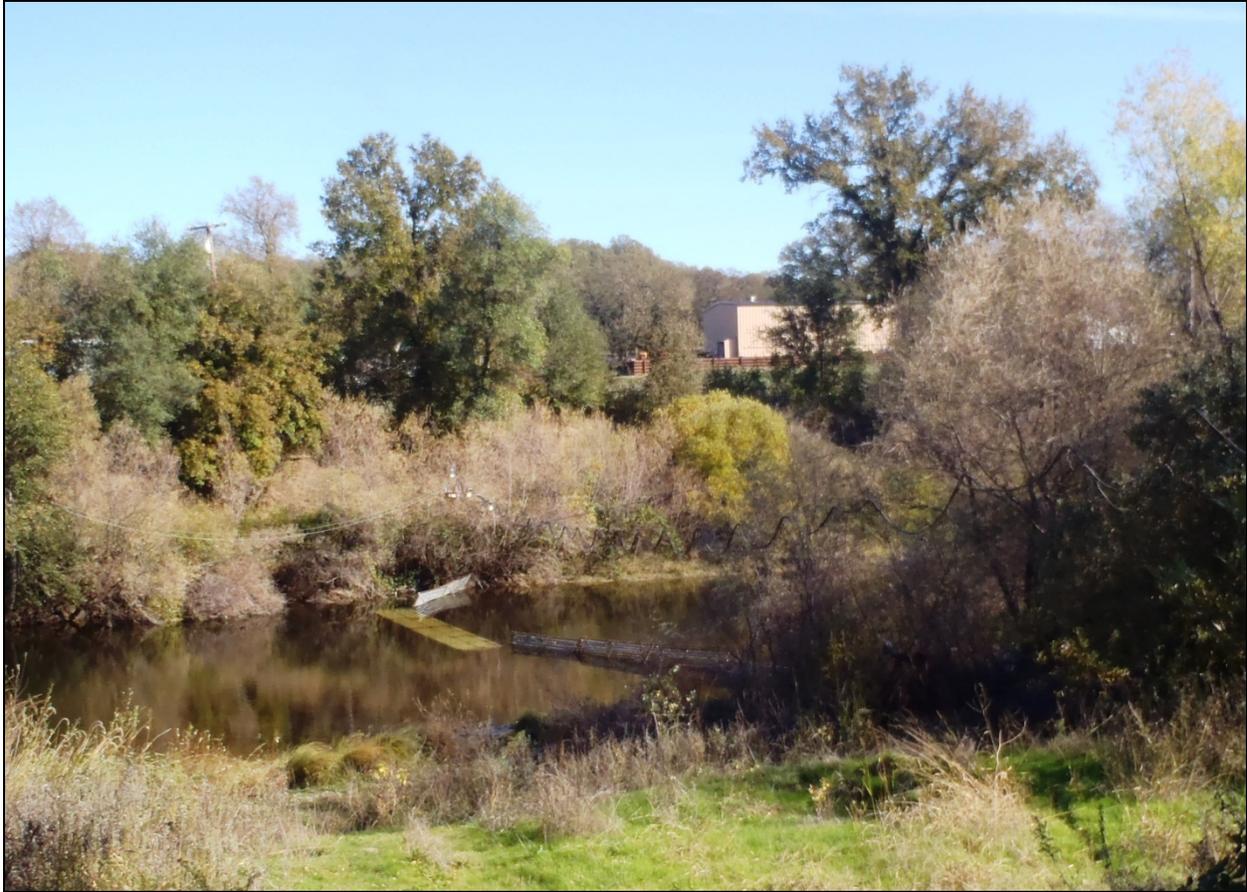
Appendix Figure B12. Photograph of the 2011 Cow Creek Video Station. Plate design proved to be less effective in tape reading than previous year designs. Greater plate length allows better visibility of fish size than a greater width, which only allows more fish to pass through at one time.
