New Zealand Mudsnaill Surveys at National Fish Hatcheries within the Lower Columbia River Basin

United States Fish and Wildlife Service, Columbia River Fisheries Program Office, 1211 SE Cardinal Court, Vancouver, Washington 98683, USA, (360) 604-2500

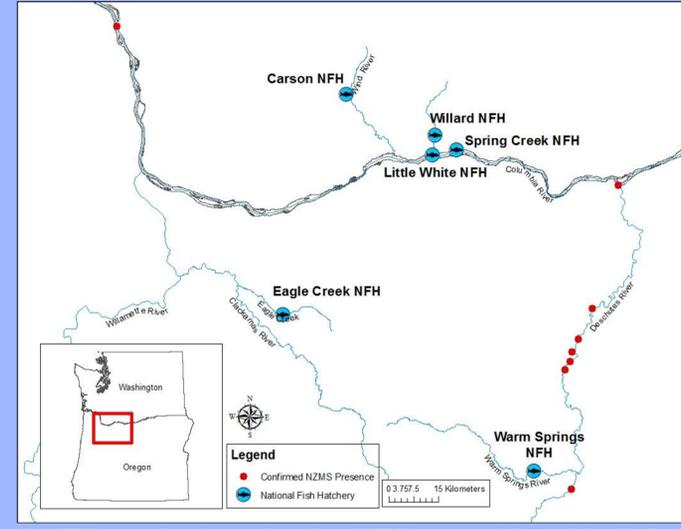
2011 NZMS survey locations and confirmed NZMS presence in lower Columbia Basin

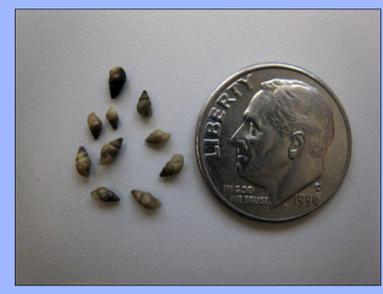
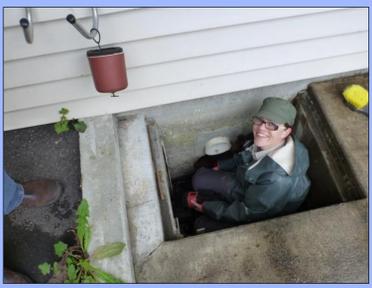
New Zealand mudsnail

- 3-6 mm total length
- Conical shell with right-hand coil and 5-7 deeply grooved whorls
- Shell dark grey/brown to light brown
- Rigid operculum covers the opening of shell
- Self-cloning, Parthenogenetic reproduction
- Broad environmental tolerances
- Resistant to desiccation and digestion
