New Zealand Mudsnail Surveys at National Fish Hatcheries within the Lower Columbia River Basin 2011

Columbia River Fisheries Program Office

United States Fish and Wildlife Service

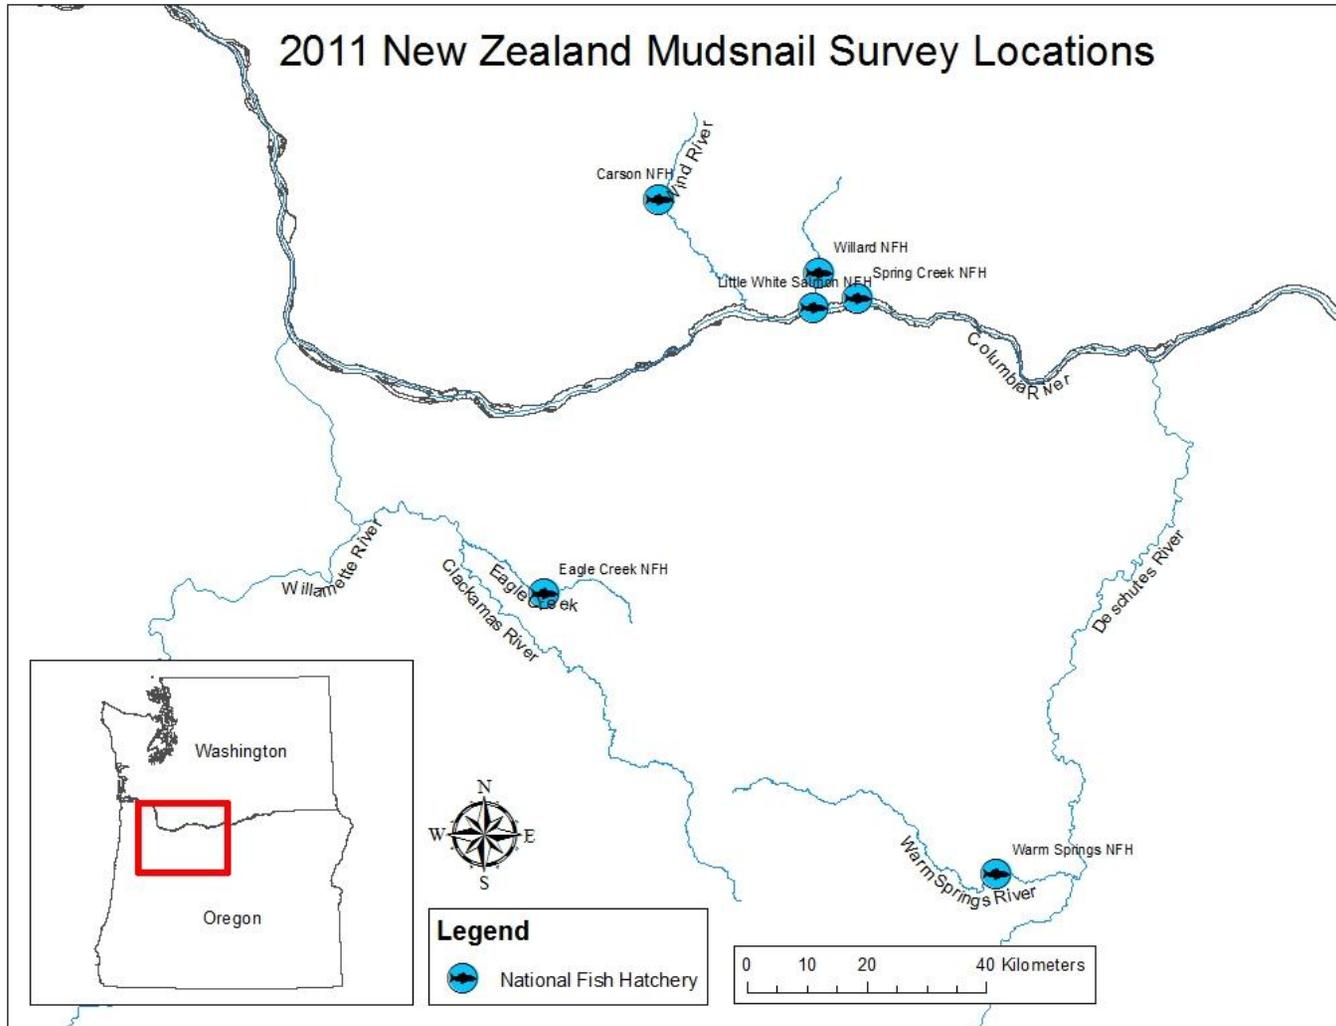
Figure 2. Map of USFWS Lower Columbia River basin National Fish Hatcheries surveyed for New Zealand mudsnail during 2011.

Six lower Columbia River Basin National Fish Hatcheries were surveyed for New Zealand mudsnail including: Carson, Eagle Creek, Little White Salmon, Spring Creek, Warm Springs and Willard National Fish Hatcheries (Figure 2). Surveys were conducted over a two week period from 6 October to 17 October, 2011. Prior to conducting the survey, hatchery managers and personnel were interviewed to identify areas where snails may access the facility as well as to determine if hatchery personnel had observed suspicious snails in head boxes or raceways. Sample sites identified during 2008 NZMS surveys were sampled again in 2011, as well as any new locations identified by hatchery personnel. All sample locations were georeferenced using a Trimble handheld global positioning system (GPS), and a photograph was taken to document current physical habitat conditions. One to two field personnel visually inspected up to a 50 meter portion of stream upstream and downstream of each survey location for approximately 15 minutes. Surface substrate was manually flipped over at random intervals, aquatic vegetation was sifted through by hand and surfaces of hatchery structures (i.e., pipes, intake/outflow grates, concrete walls, dam boards and log booms) were closely examined (visually and by hand) for the presence/absence of NZMS. In water depths greater than 0.6 m, substrate, aquatic vegetation and hatchery structures were visually inspected using an underwater viewing scope. If field personnel observed an aquatic snail closely resembling NZMS, the date and location of the snail was recorded and a specimen was collected and placed in an individual vial with 70% ethanol for preservation. Snail specimens were individually photographed and carefully examined under a dissecting microscope to determine if they were New Zealand mudsnail. Magnified photographs of specimens whose identification could not be positively determined were sent to Robyn Draheim with the Center for Lakes and Reservoirs for further examination.

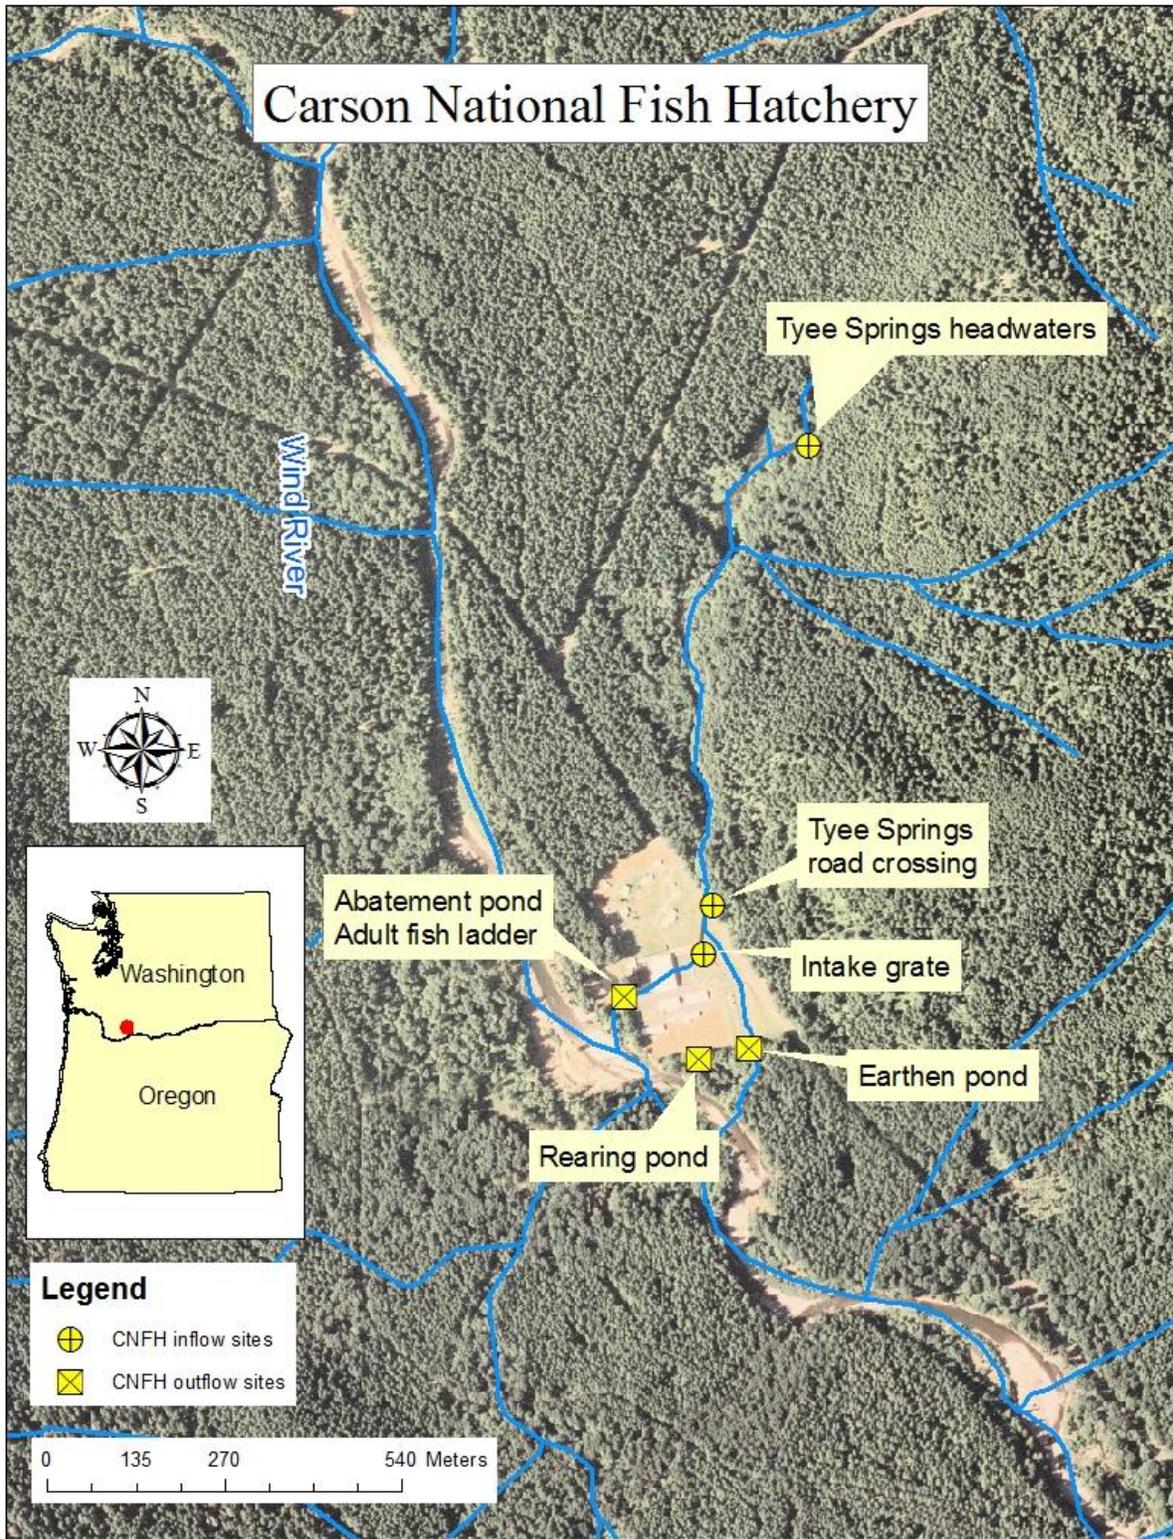
Figure 3. Carson NFH 2011 New Zealand mudsnail survey sample sites.

There were six sites surveyed for NZMS at Carson NFH in 2011 (Figure 3). Water inflow sites included the headwaters of Tyee Springs (hatchery source water), Tyee Springs road crossing culvert and primary hatchery inflow grate. Outflow sample sites included earthen pond, rearing pond and hatchery discharge water channels (i.e., raceway and adult fish ladder entrance). Two snail specimens were collected at the headwater of Tyee Springs for examination.

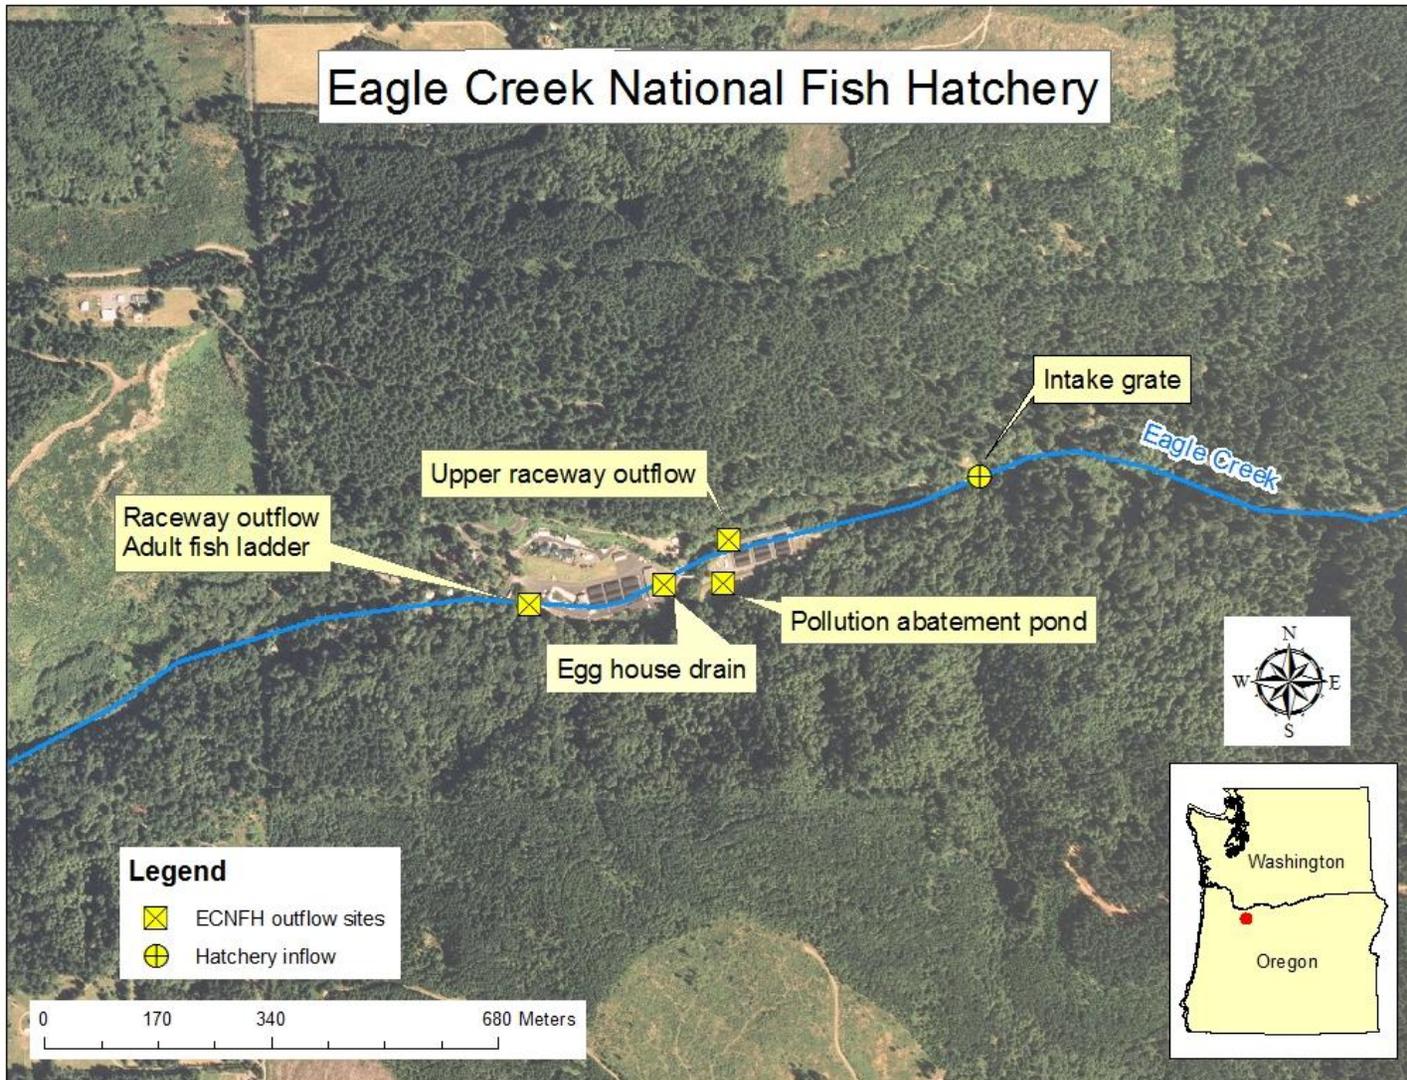
Figure 4. Eagle Creek NFH 2011 New Zealand mudsnail survey sample sites.

There were five sites surveyed for NZMS at Eagle Creek NFH in 2011 (Figure 4). A single hatchery water intake grate and four outflow sites were inspected including the egg house drain, adult fish ladder, pollution abatement pond and upper raceway outflow. No snail samples were collected at Eagle Creek NFH.

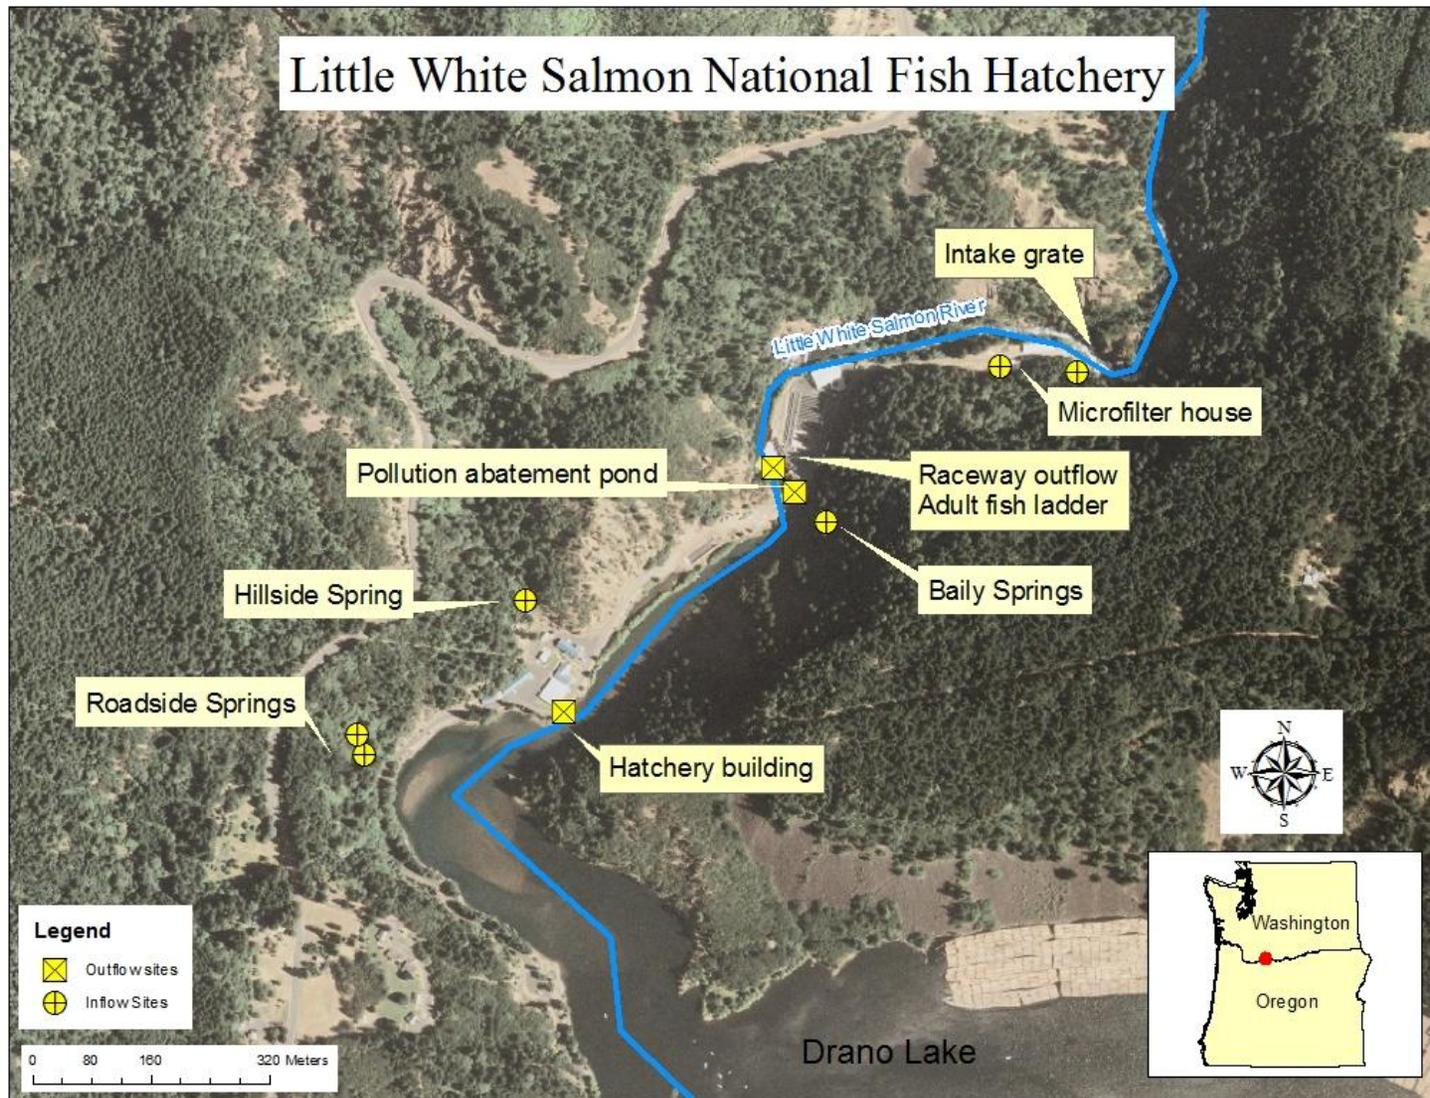
Figure 5. Little White Salmon NFH 2011 New Zealand mudsnail survey sample sites.

There were eight sites surveyed for NZMS at Little White Salmon NFH in 2011 (Figure 5). Water inflow sites included hillside, roadside and Baily springs as well as the primary hatchery inflow grate and microfilter house. Outflow sites included the pollution abatement pond, hatchery building and raceway outflow/fish ladder entrance. Two snail specimens were collected from hillside and roadside springs.

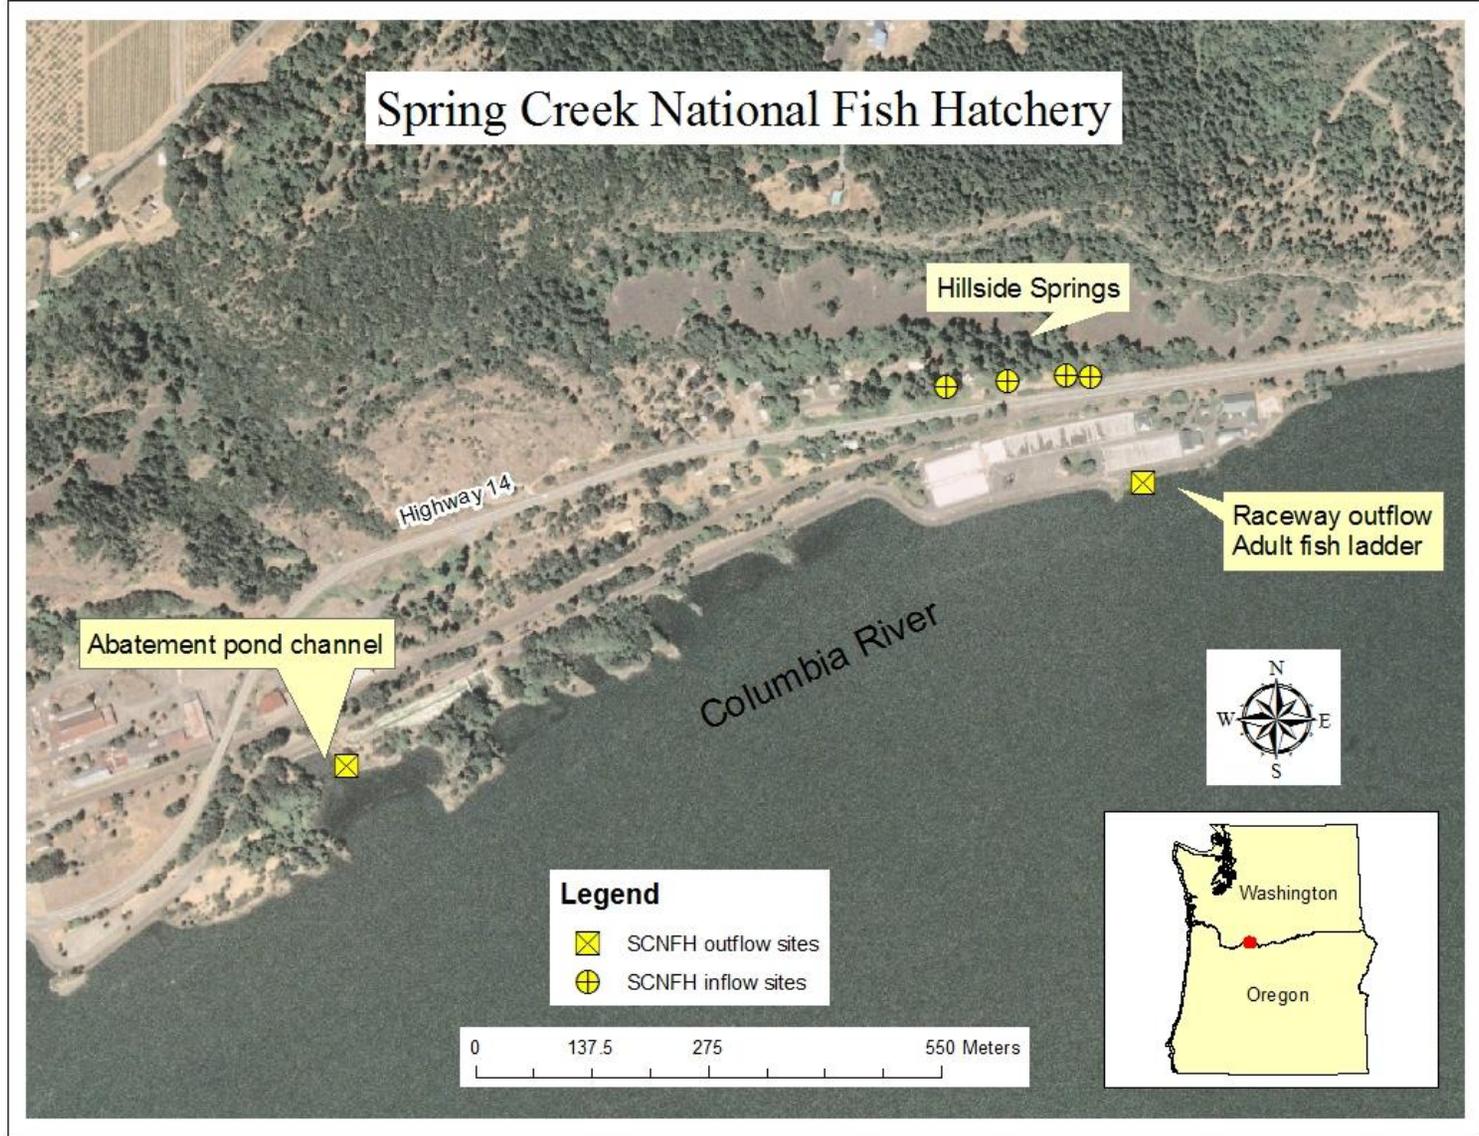
Figure 6. Spring Creek NFH 2011 New Zealand mudsnail survey sample sites.

There were six sites surveyed for NZMS at Spring Creek NFH in 2011 (Figure 6). Water inflow sites included four hillside springs located on the north side of Washington State Highway 14. Outflow sites included the adult fish ladder entrance/raceway outflow on the Columbia River and pollution abatement pond channel. A single snail specimen was collected from hillside spring #1 (Figure 6).

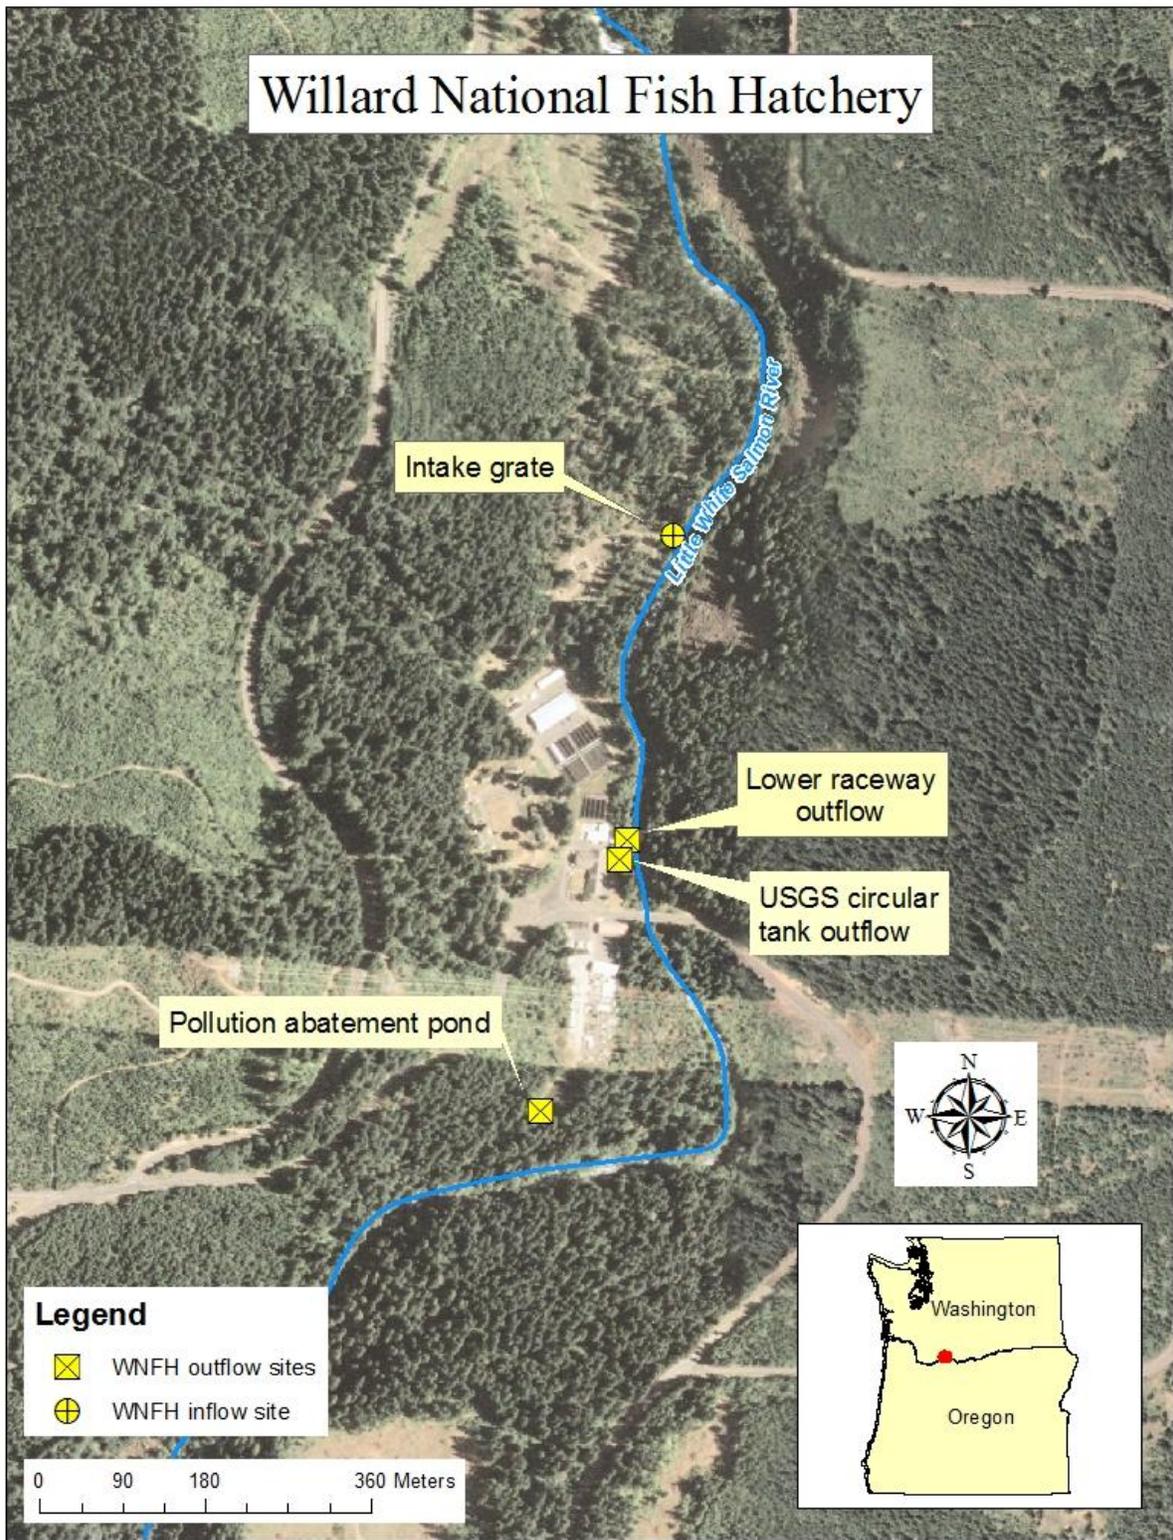
Figure 7. Willard NFH 2011 New Zealand mudsnail survey sample sites.

There were four sites surveyed for NZMS at Willard NFH in 2011 (Figure 7). A single hatchery water intake grate and three outflow sites were inspected including the pollution abatement pond, lower raceway outflow and the U.S. Geological Survey, Columbia River Research Laboratory circular tank outflow. No snail samples were collected at Willard NFH.

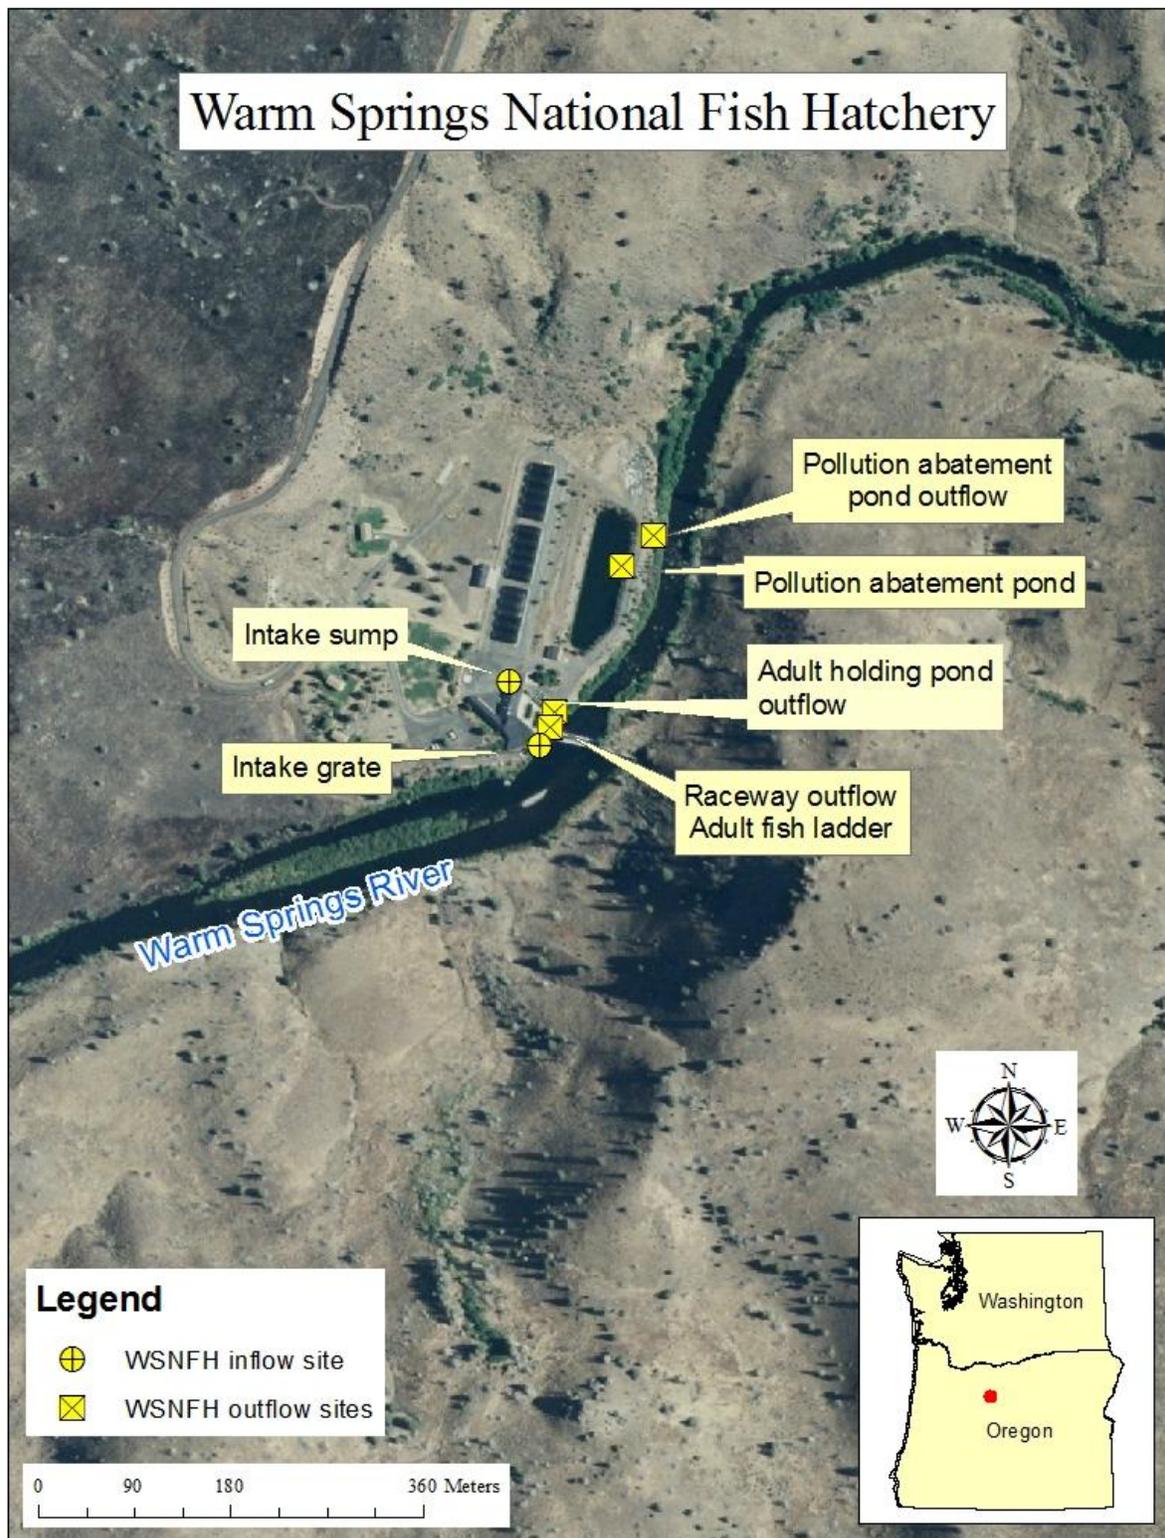
Figure 8. Warm Springs NFH 2011 New Zealand mudsnail survey sample sites.

There were six sites surveyed for NZMS at Warm Springs NFH in 2011 (Figure 8). Inflow sites included the primary hatchery water intake grate and hatchery intake sump. Outflow sites included the adult holding pond outflow, hatchery raceway/fish ladder entrance, abatement pond discharge pipe and eastern perimeter of the pollution abatement pond. A total of eight snail specimens were collected from intake and outflow sites (Table 1).
