Glenrock I, Glenrock III, and Rolling Hills Wind Energy Facilities
Eagle Conservation Plan
PacifiCorp

June 2020

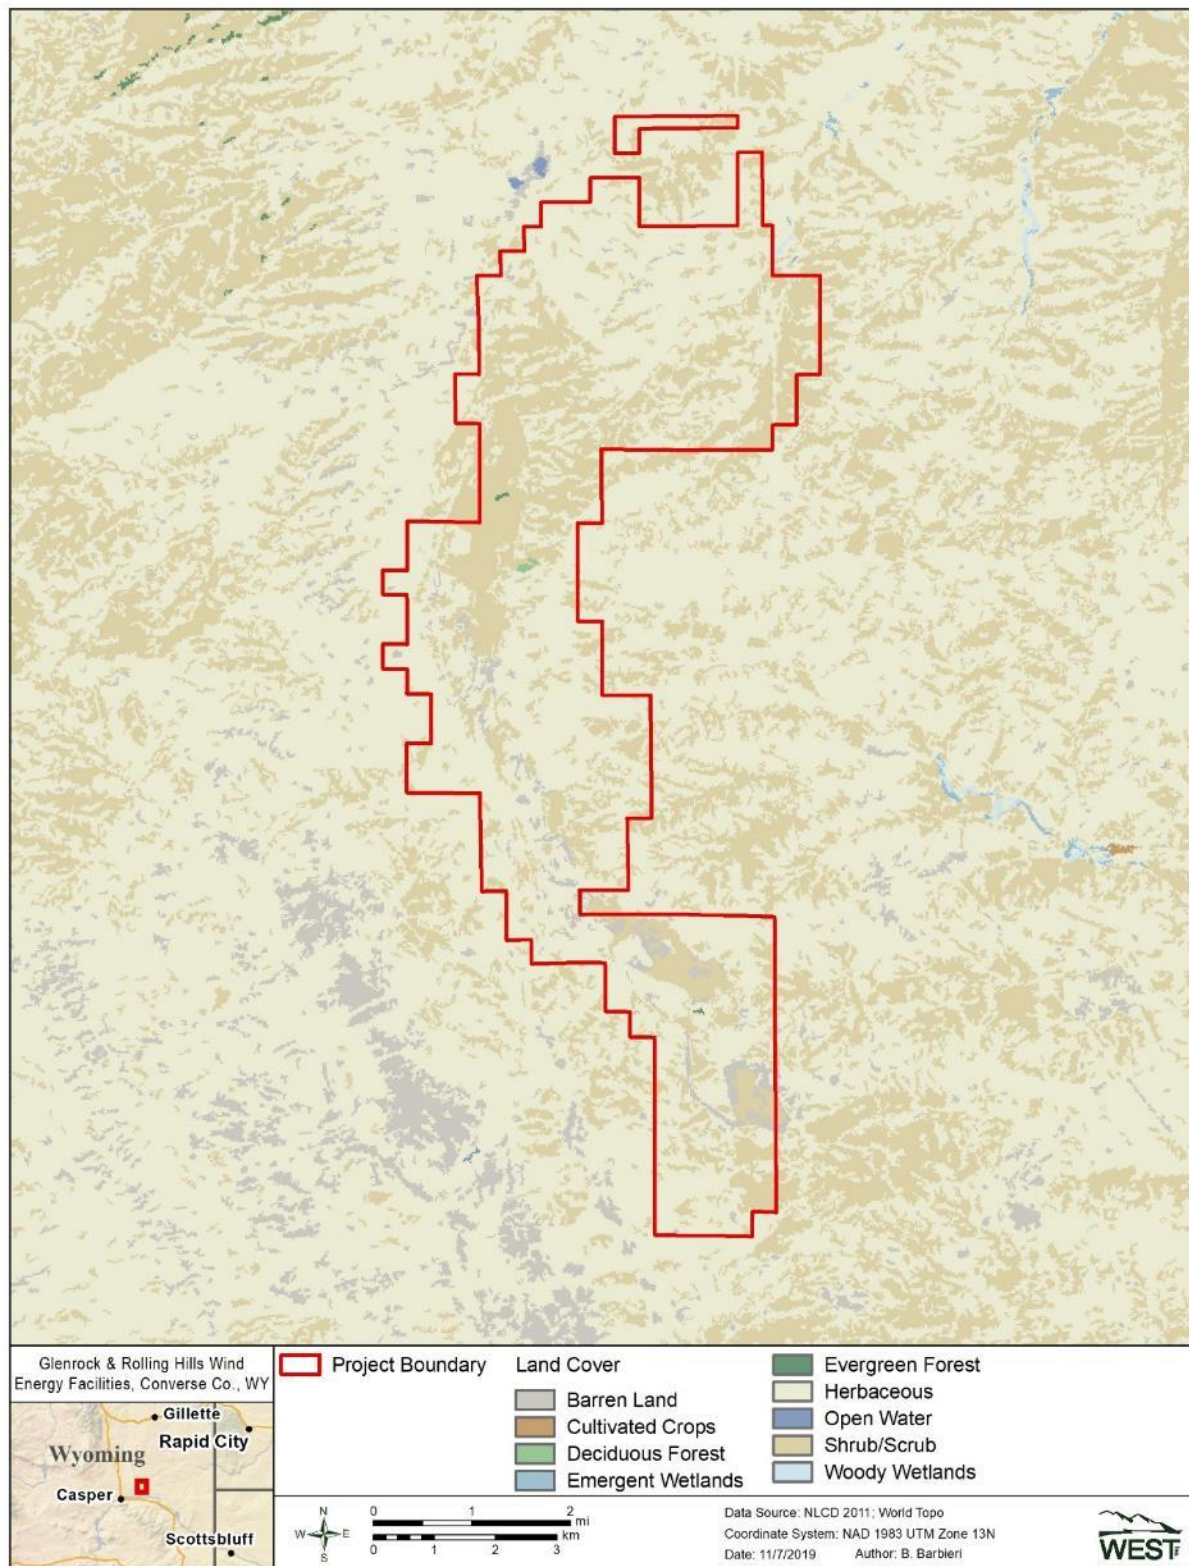
Figure 5. GRH Wind Energy Facility, Converse County, Wyoming – Land Cover for the constructed Project boundary.

Habitat at the Project is dominated by native sagebrush steppe and large areas of grassland where the coal mine has been reclaimed. According to the US Geological Survey National Land Cover Dataset (USGS NLCD 2011), the Project is dominated by two main habitat types herbaceous (grassland) and shrub/scrub (8,892 ac [64.22%]; and 4,485 ac [32.39%]; respectively; Table 2, Figure 5). In addition to these main cover types, the NLCD identifies approximately 3.27% of the landcover at the Project as barren land, while all other cover types each compose less than 1% (Table 2, Figure 5). Although the NLCD identifies small areas of deciduous forest, evergreen forest, and woody wetlands in the Project area, none of these cover types have been documented during field surveys. Based on the USGS NLCD 2011, there is no developed land with the Project area. There are three permanent stock ponds in the west-central portion of the Project area and multiple ephemeral depressions. Rock outcrops occur in the extreme southern- and northern end of the Project area.

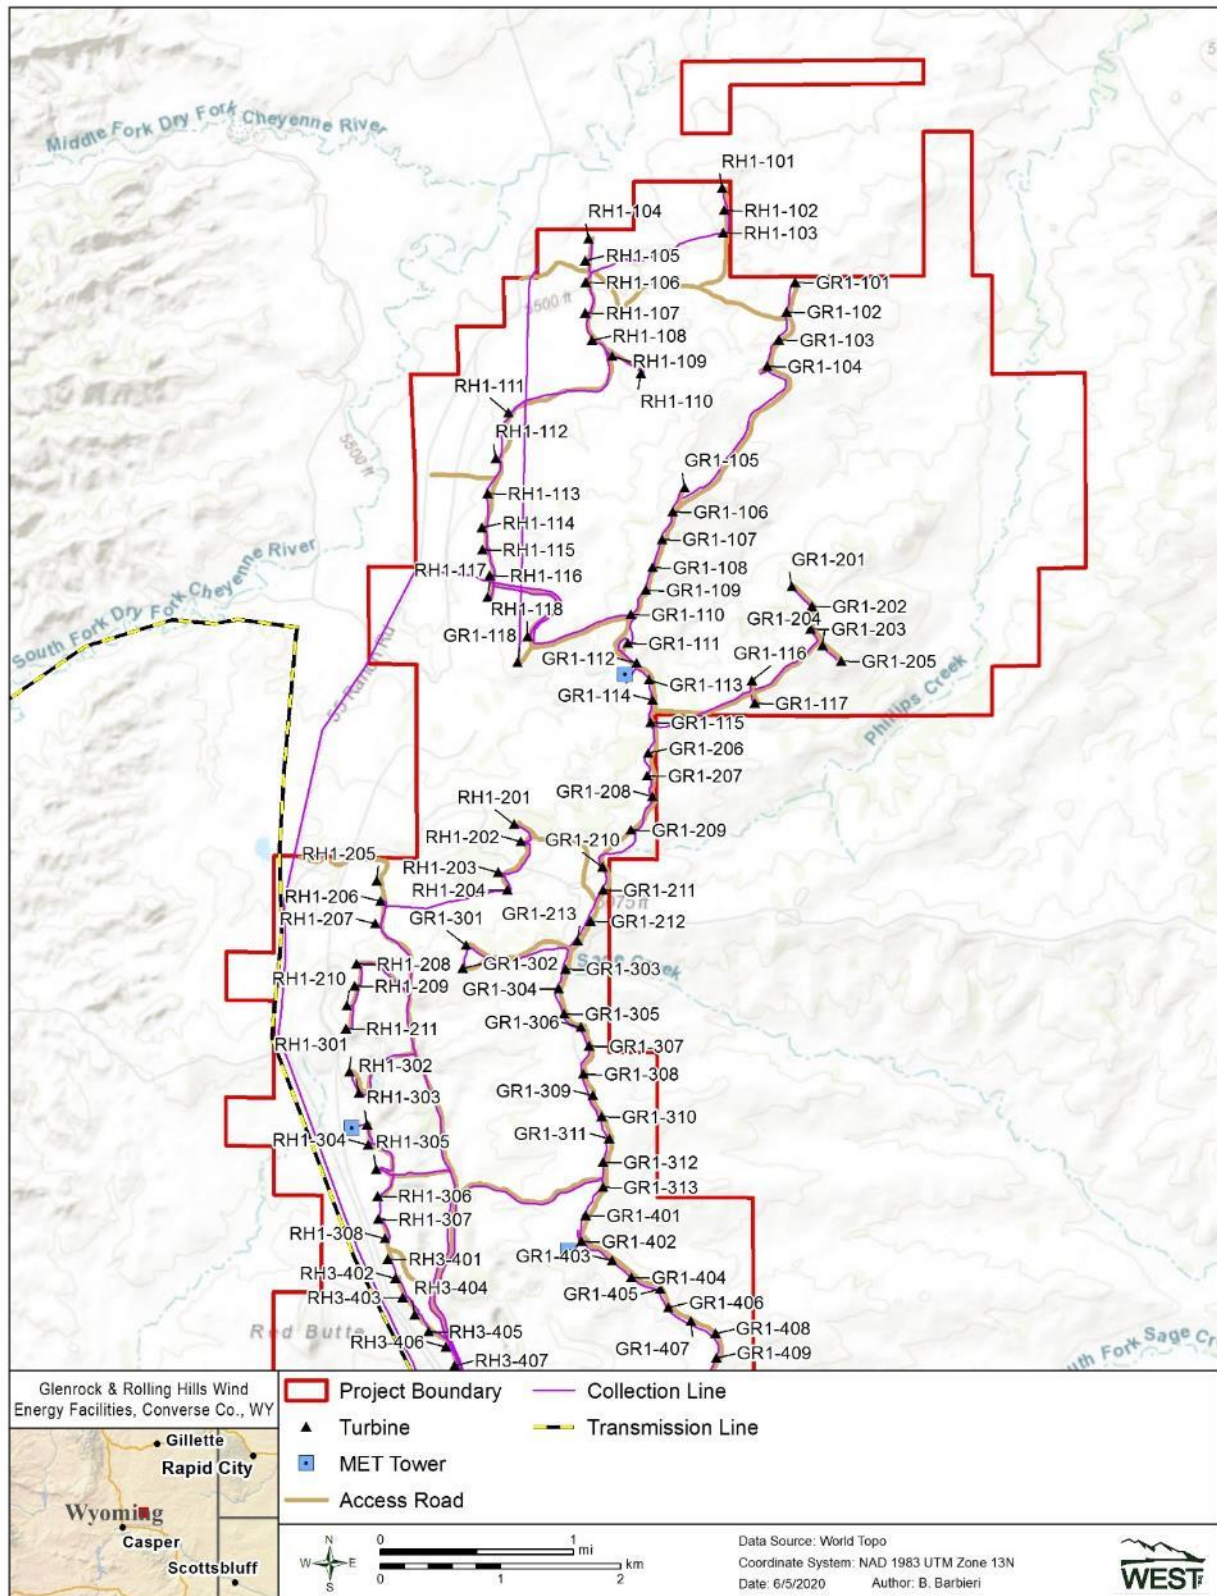
Figure 6a. GRH Wind Energy Facility, Converse County, Wyoming – Infrastructure layout.

Figure 6b. GRH Wind Energy Facility, Converse County, Wyoming – Infrastructure layout.

The Project was originally constructed as 158 turbines with a nameplate capacity of 237 MW (Figure 6a and b). The GE 1.5-MW turbines have a rotor diameter of 252 ft (77 m) and the wind turbines are situated on 262-ft tall (79 m) steel tubular towers secured to concrete foundations. In 2019, 126 turbines were repowered to 1.85-MW turbines for an updated 281.1-MW Project capacity. A 13-mile (21-km) 230 kilovolt (kV) transmission line (Figure 5) to deliver Project output to the Windstar switching substation was built along PacifiCorp-owned property that was once occupied by a railroad line that extended approximately 15 miles (24 km) from the Project to the Dave Johnston thermal energy generation facility. In addition to the turbines and interconnection line, the Project includes a variety of access roads, crane pads, a laydown area, batch plant, communication/collection systems, one substation, operation and maintenance building, transmission lines, and metrological towers. Full descriptions of Project infrastructure are provided below and temporary and permanent impacts are quantified in Table 3. Not all of the temporary and permanent impacts were quantified when they occurred; therefore, values provided below are based on the best available information and in some cases were calculated based on measurements made using aerial photographs. If the impact could not be reasonably quantified, no value was assigned and this was noted.

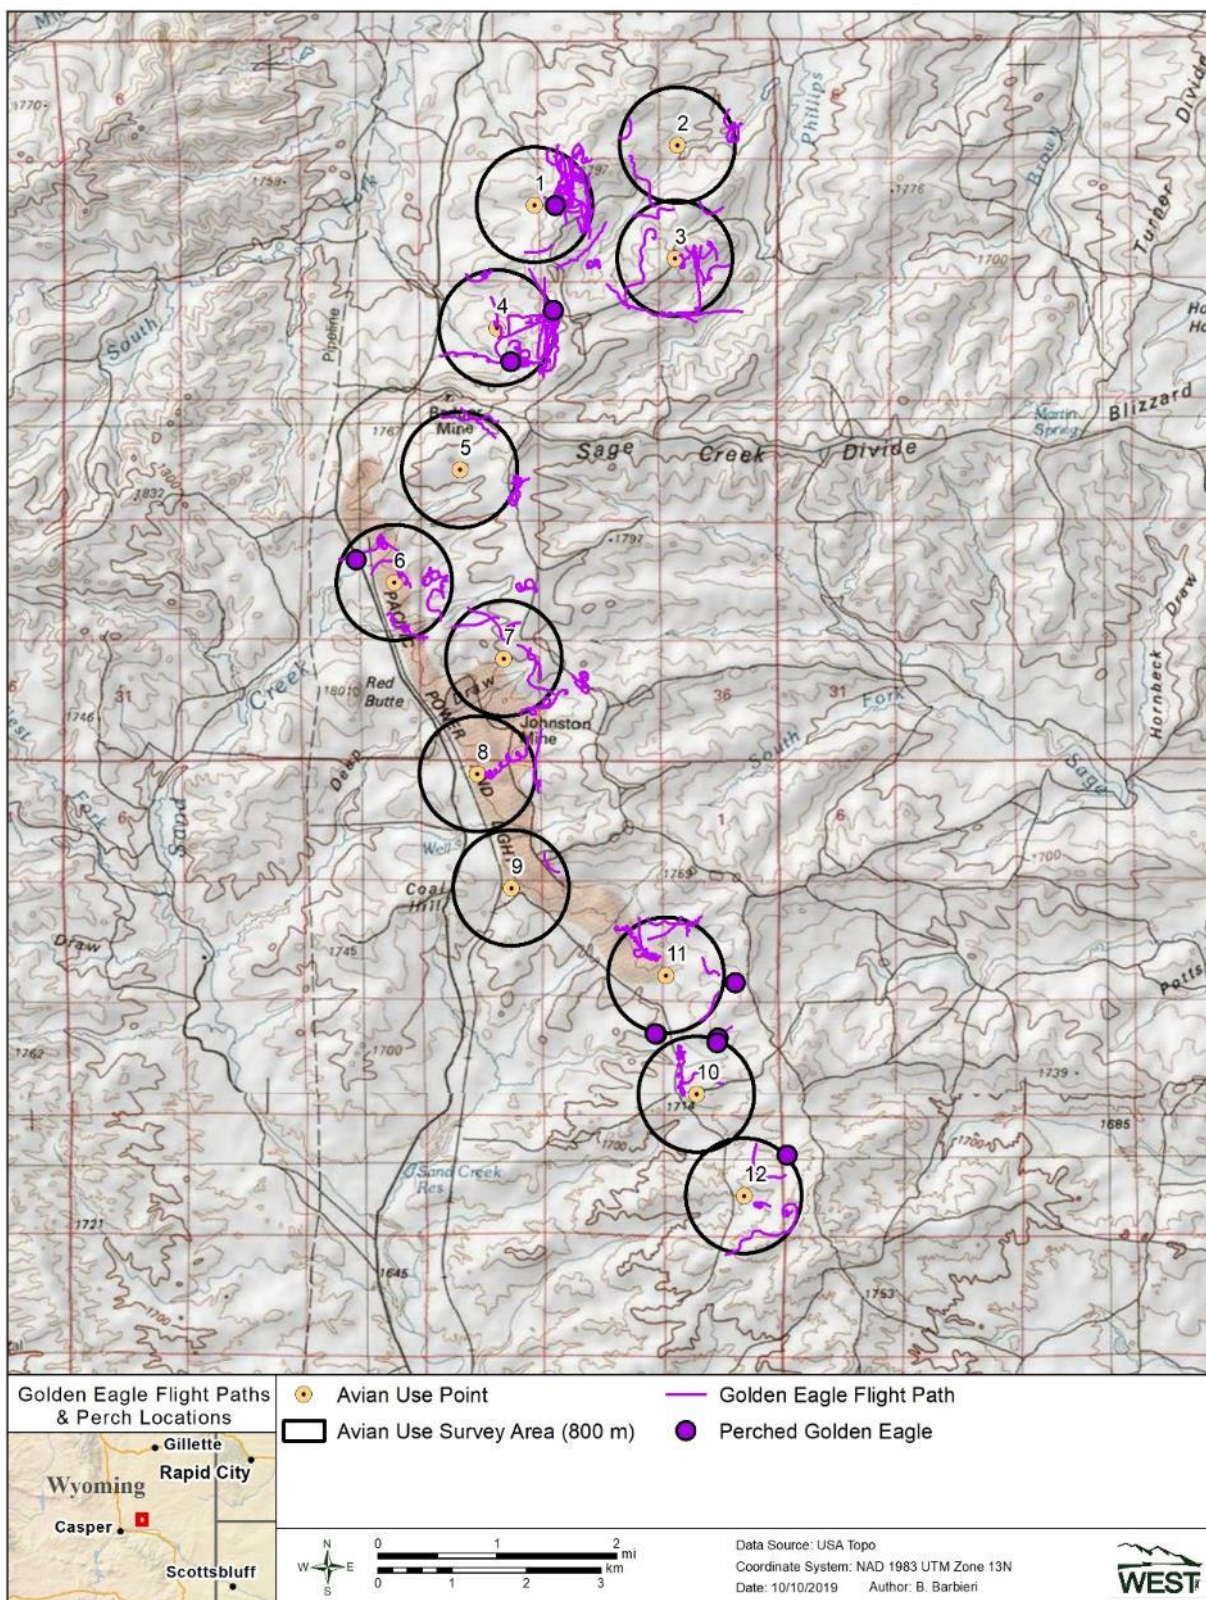
Figure 10. Golden eagle flight paths recorded at the GRH facility during the 2007 preconstruction baseline study.

not included in the original study report but are included in this ECP (Figure 10). Flight paths were mapped across all survey points, with points 1 and 4 having the most mapped observations..

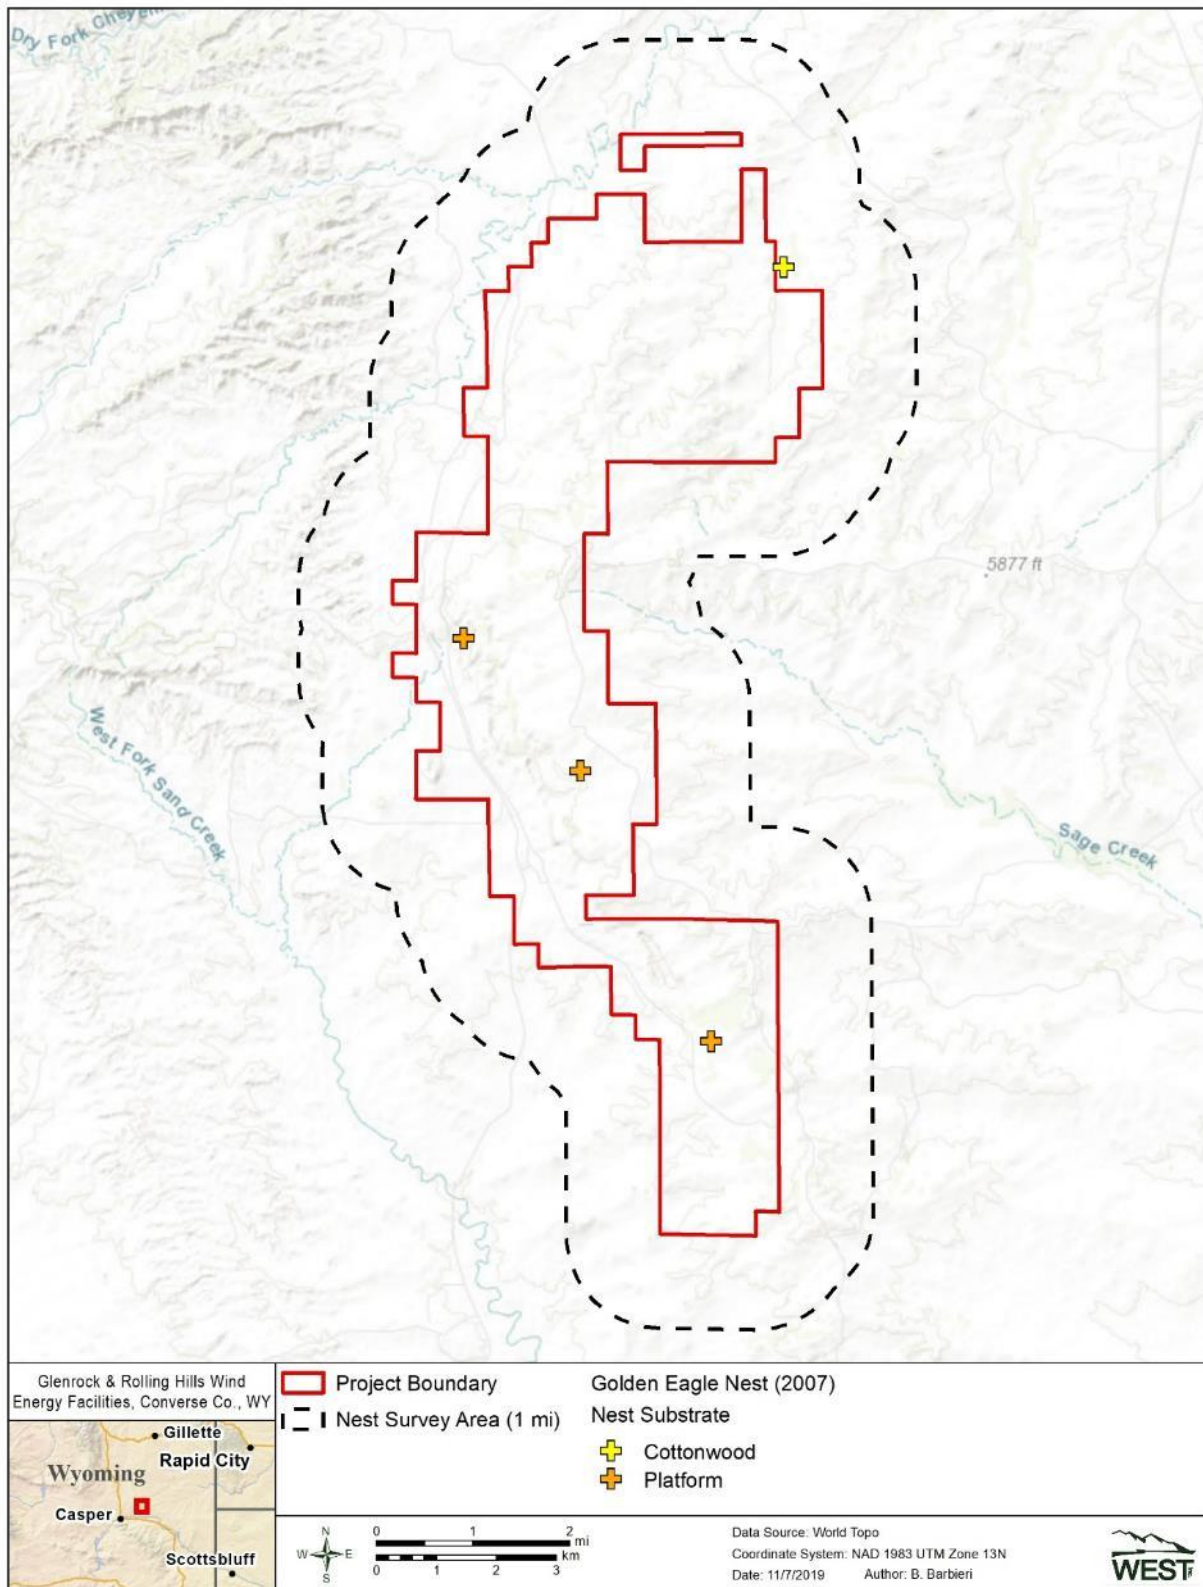
Figure 11. Location of golden eagle nests found in 2007 during nest surveys at the GRH Wind Energy Project and 1-mile buffer from the Project, Converse County, Wyoming.

Four active (incubating adult) golden eagle nests were found during the 2007 raptor nest surveys (Figure 11). Three of the nests were on artificial eagle nest platforms within the Project boundaries and the fourth active golden eagle nest was located in a cottonwood tree just northeast of the Project area (Figure 11). Fledge success was not documented during the 2007 survey. All golden eagle nests found during the survey were active, with no inactive nests documented.

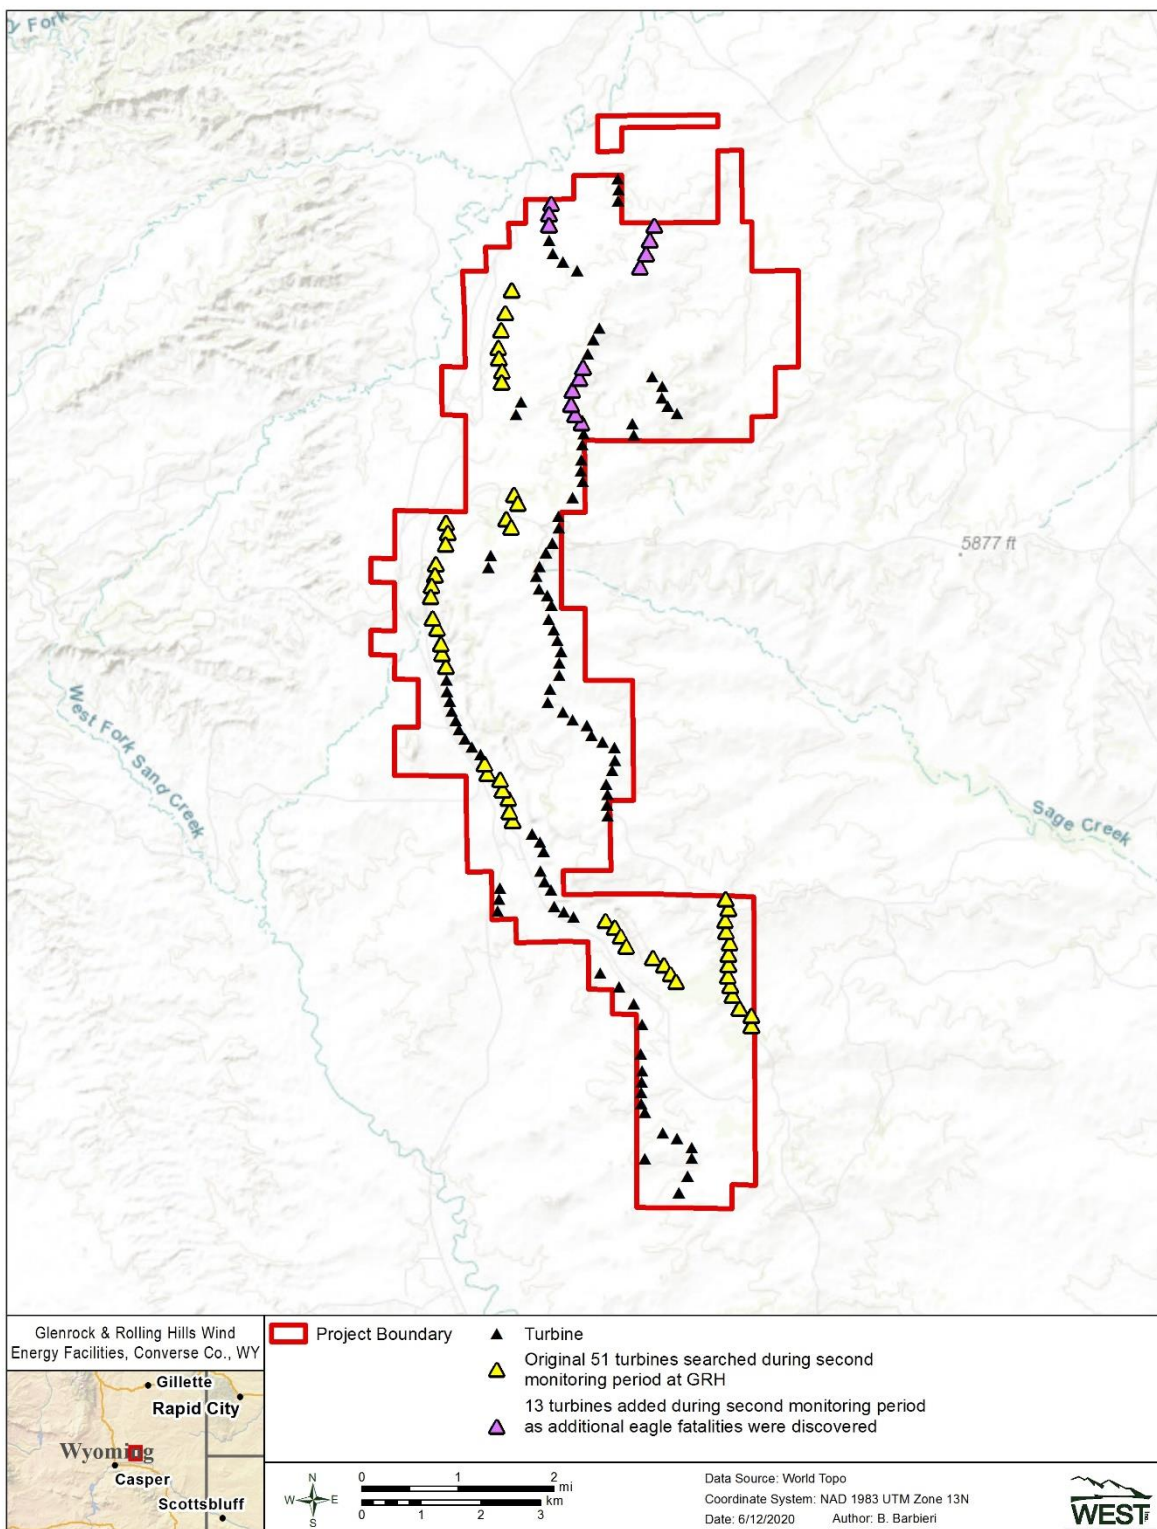
Figure 17. Turbines searched during the second monitoring period from June 26, 2012 – May 30, 2013 at the GRH Wind Energy Facility, Converse County, Wyoming.

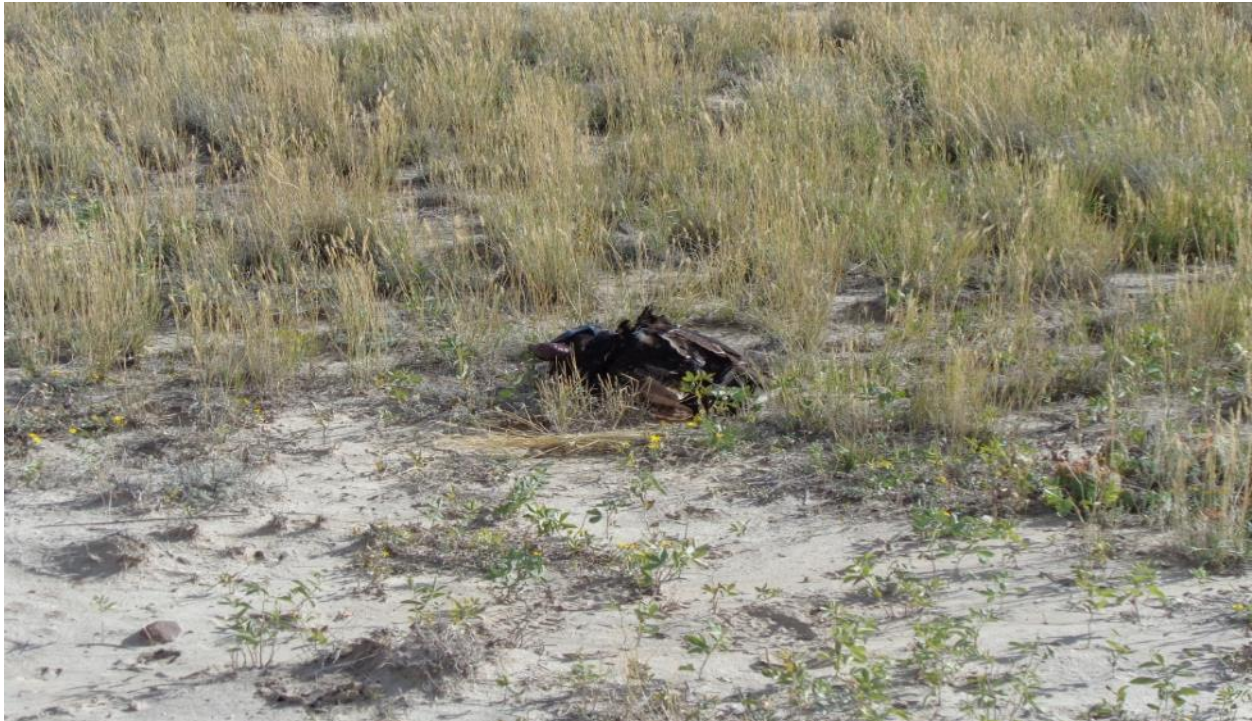
Figure 18. Photo of a representative Turkey Skinz decoy used for searcher efficiency trials at GRH Wind Energy Facility starting March 2014.

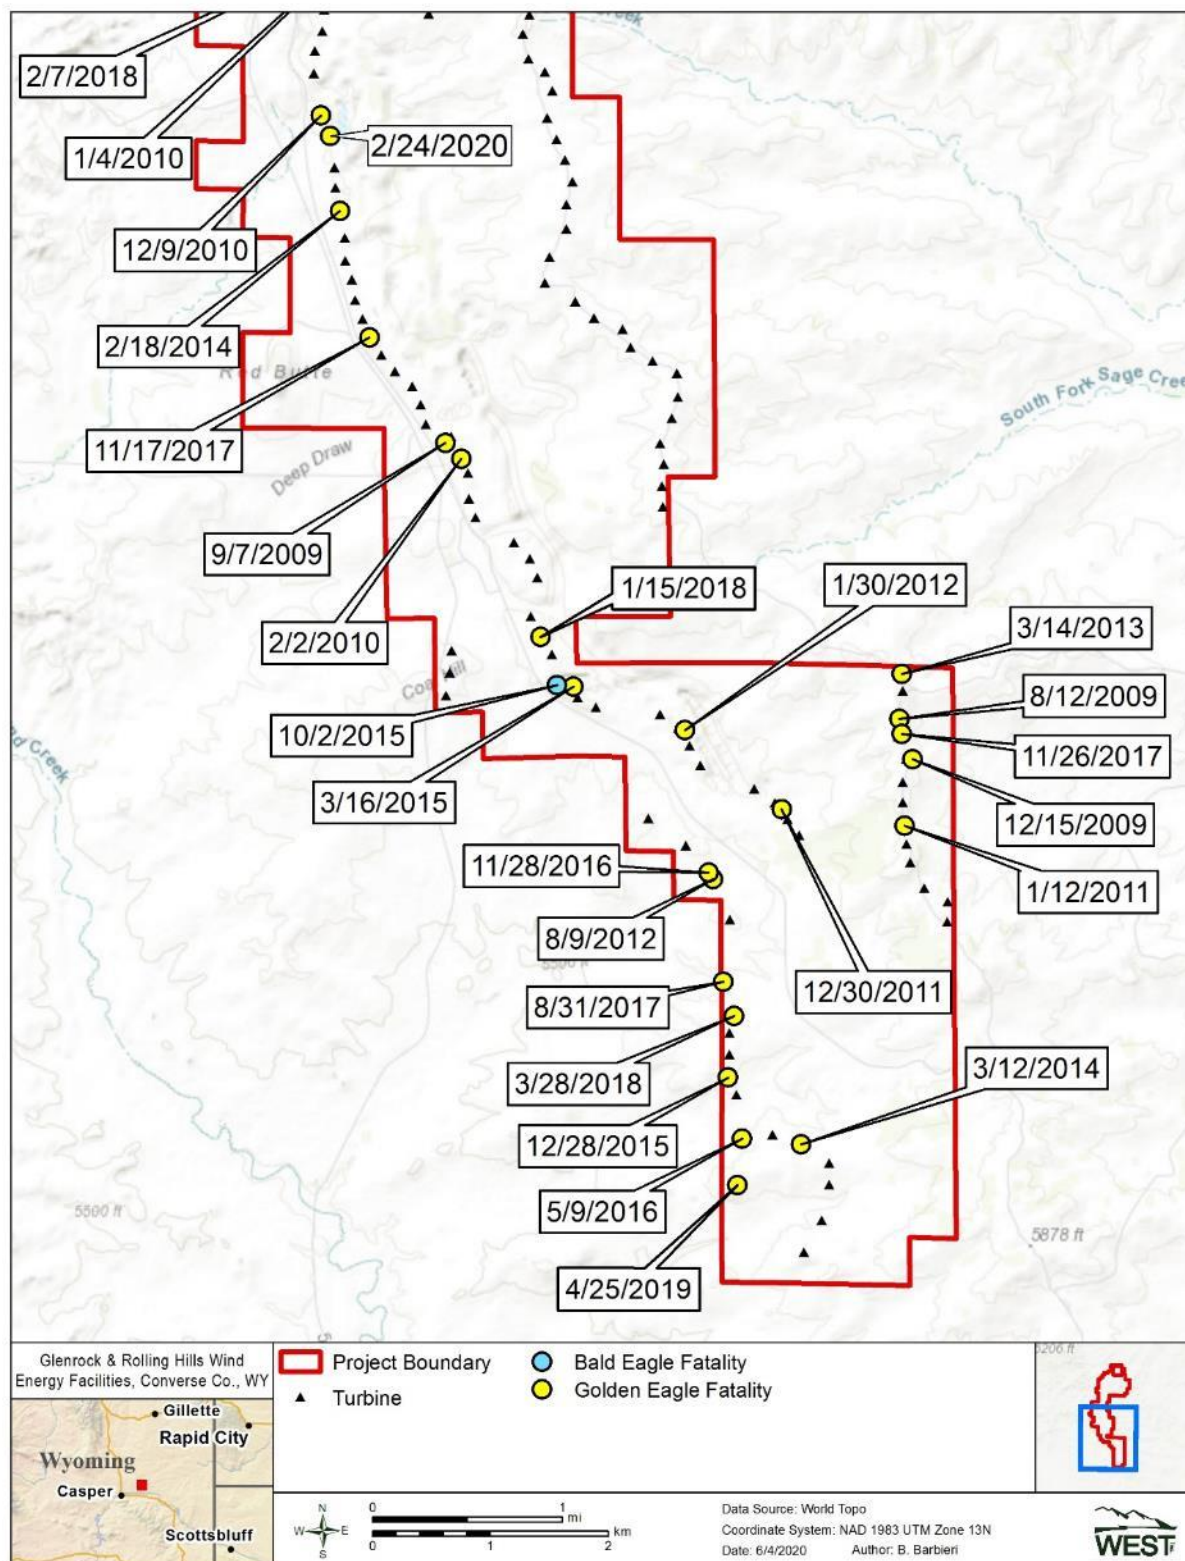
Figure 21a. Location of eagle carcasses found to date at the GRH Wind Energy Facility, Converse County, Wyoming (May 2009 through April 2020). The golden eagle found on August 9, 2012 was alive but injured, and collected and transported by the WGFD.

Figure 21b. Location of eagle carcasses found to date at the GRH Wind Energy Facility, Converse County, Wyoming (May 2009 through April 2020). The golden eagle found on August 9, 2012 was alive but injured, and collected and transported by the WGFD.

A total of 10,088 turbine plot searches occurred during the fourth monitoring period and 13 golden eagle mortalities were discovered (see Figure 21a and 21b in Section 9.5). Ten eagle mortalities were found during scheduled turbine plot searches while five were found incidentally. Approximately 77% of the trial decoys were discovered during search efforts. Twenty-six trial decoys were determined to be unavailable.
