## **Shannon & Wilson Stiles Creek Shooting Range Wetland Delineation Report**

WETLAND DELINEATION REPORT  
**Stiles Creek Shooting Range**  
FAIRBANKS, ALASKA

**CHENA RIVER SRA: UPPER STILES CREEK  
 SHOOTING RANGE IMPROVEMENTS**  
**PROJECT No. 70011-1**

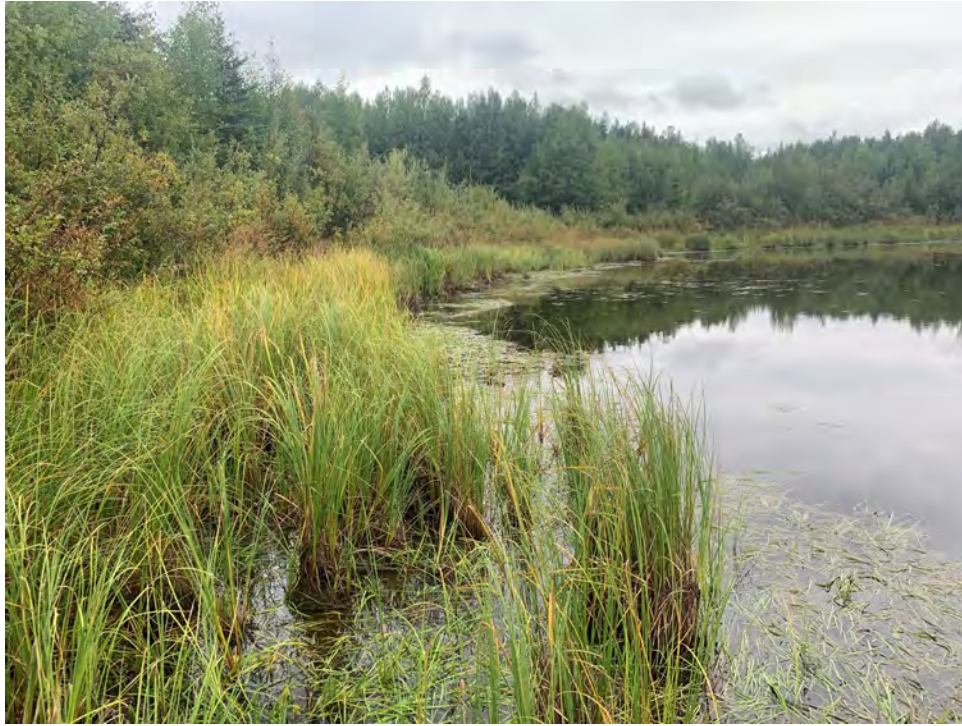
**Photo 1:** Pond near data point 1.

Plot is near surface water (pond).
