An Assessment of Museum Property at Select National Wildlife Refuges for the U.S. Fish and Wildlife Service

St. Louis District

Archaeological Curation-Needs Assessments
Technical Report No. __
2007

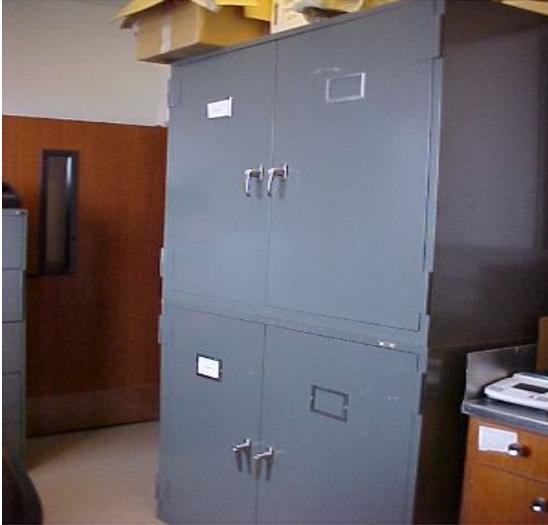
This laboratory and storage room (VC1) currently holds archaeological, botanical, and zoological materials. The room, which is approximately ninety percent full, also contains a study/work area and a sink. None of the collections are stored under pipes, and the floor load is sufficient to support the weight of the materials currently held. Collections are stored (1) in two two-door museum cabinets (Figure 4), (2) a compartmentalized herbarium cabinet, (3) a metal cabinet with drawers, and (4) loose on top of various cabinets throughout the room. Two windows are present, and they do not have shades or blinds. Some hazardous materials (e.g., peroxide, moth balls) are stored in this room; however, no ventilation system is installed. Moth balls and sticky traps have been placed in various drawers to protect zoological specimens from insects that could come in contact with the materials (Figure 5).

Figure 4. Metal cabinets are used to house archaeological and zoological specimens.

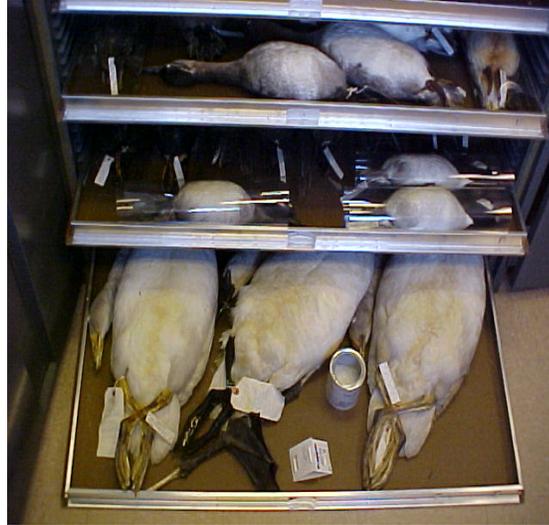
Figure 5. Close-up view of moth balls and sticky traps in drawer with zoological specimens.

Zoological—A total of 73.5 ft³ of zoological specimens are stored (1) in two two-door museum cabinets and a metal cabinet, none of which are locked or labeled, and (2) loose on various cabinets in the room. Specimens in the drawers are either wrapped in plastic or cotton batting or stored loose within the drawers, while other specimens are stored loose on mounts on top of cabinets. Specimens have been cleaned and labeled; most have a string paper tag attached listing the specimen name/type, sex, refuge, date, and collector. A general finding aid (drawer-by-drawer of contents) was created for the specimens in the drawers to help researchers.

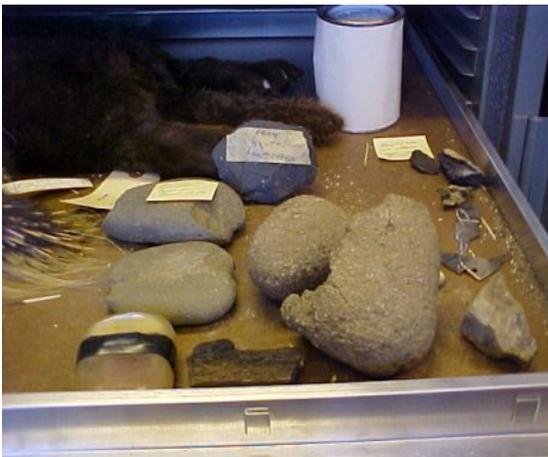
Archaeological—Only 0.22 ft³ of archaeological materials are stored at the refuge. The materials are stored in a two-door museum cabinet in one drawer, both of which are not labeled. Artifacts have been cleaned and are stored loose in the drawer (Figure 6). Some are labeled directly in marker, with masking tape, or with self-adhesive notes with the location and date only.

Figure 6. Close-up view of archaeological artifacts.

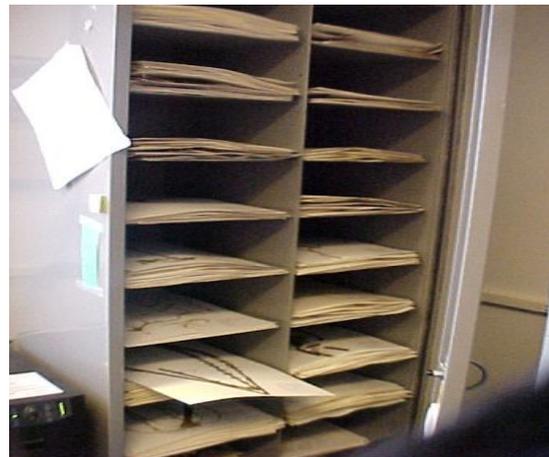
Figure 7. Metal shelf/compartments are used to house the Herbarium samples.

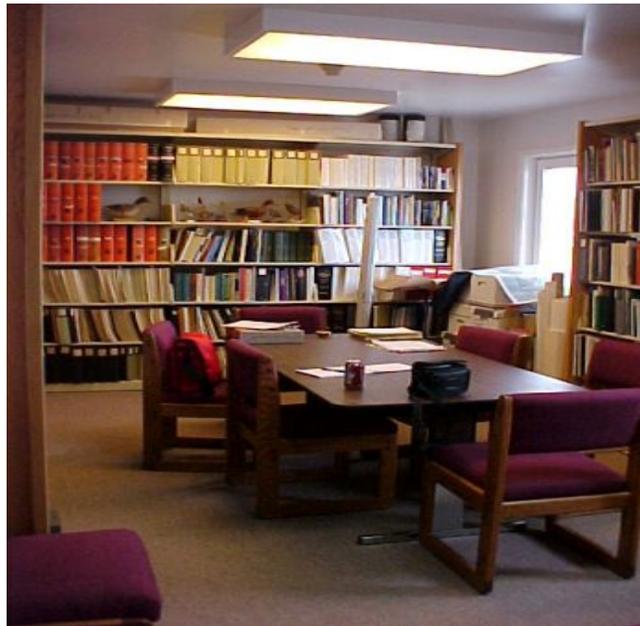
The library (VC 2) encompasses approximately two hundred square feet and currently holds zoological collections and associated records (Figure 8). The room, which is at capacity, also serves as a meeting and a break room. None of the collections are stored under pipes, and the floor load is sufficient to support the weight of the materials currently held. Zoological collections and associated records are stored on metal shelving units, while additional documentation is stored in acidic boxes stacked on the floor. Two windows are present, and they do not have shades or blinds. No hazardous materials are stored in this room.

Figure 8. A view of the Izembek NWR library.

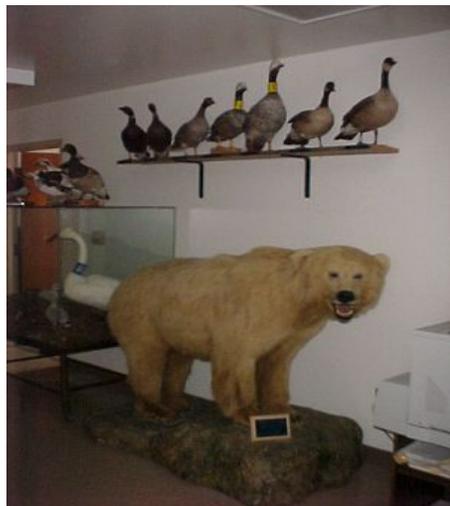
Zoological—A total of 53 zoological specimens are located in the exhibit. All of the materials have been sorted and cleaned. Specimens are mounted and labeled with the species name.

Figure 9. Zoological mounts in the exhibit hallway at Izembek NWR.

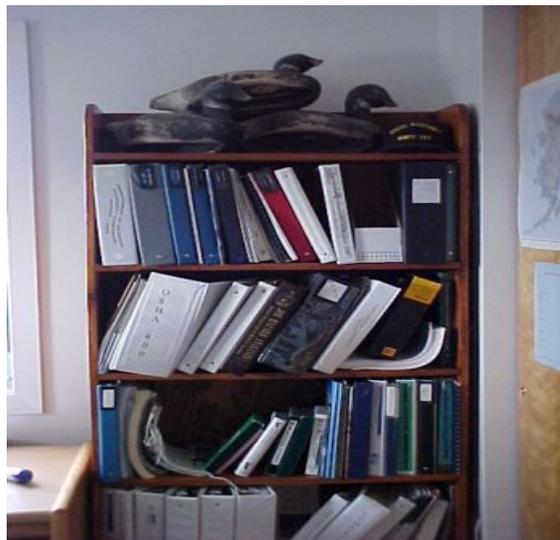
Historical Objects—Three wooden waterfowl decoys (2.35 ft³) from the 1960s are present in the assistant refuge manager's office (Figure 10). The decoys are stored loose on a wooden shelving unit. All three decoys have been incised with "N.W.R. IZM-04."

Figure 10. Waterfowl duck decoys stored on a wooden shelf at Izembek NWR.

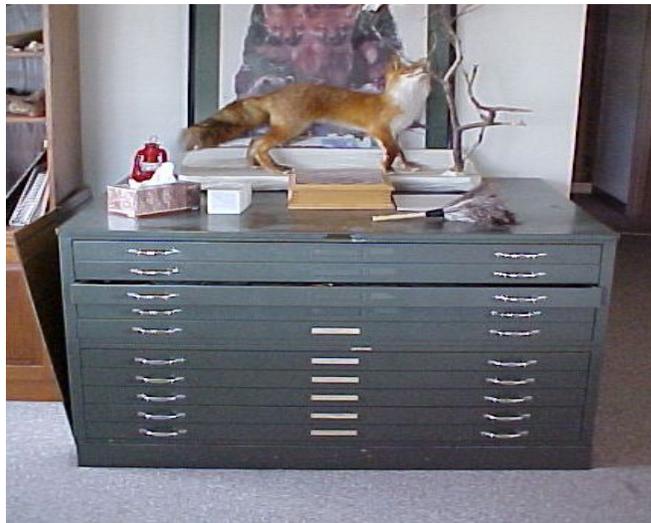
Figure 11. Map file cabinet in the bunkhouse at Izembek NWR.

Associated Records—1.71 linear feet of maps, blueprints, and reports are stored in the map file cabinet loose within the drawers. Maps and blueprints are flattened within the drawers but are not properly preserved. All records have been sorted and cleaned, but only 40–50% are labeled.

Zoological—Three zoological specimens (a fox, a bird, and a duck) are stored loose on top of a metal map file cabinet. None of the specimens have been labeled.

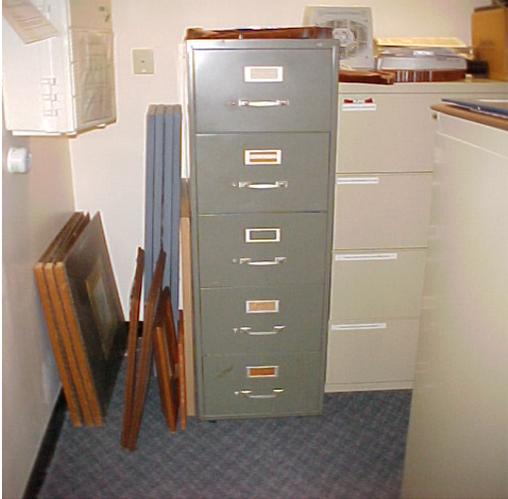
The resource room is a combination storage/meeting room that currently holds archaeological materials, associated records, and art. The room is approximately eighty-to-ninety percent full. None of the collections are stored under pipes, and the floor load is sufficient to support the weight of the materials currently held. Collections are stored in a variety of map and metal file (regular and fire-proof) cabinets, or on the floor (Figures 14 and 15). No windows are present in the room, and no hazardous materials are stored there. A first aid-station is, however, located in the entrance to the room.

Figure 14. Metal cabinets are used to house archaeological artifacts and associated records at Crab Orchard NWR. Art pieces are stored on the floor next to the cabinet.

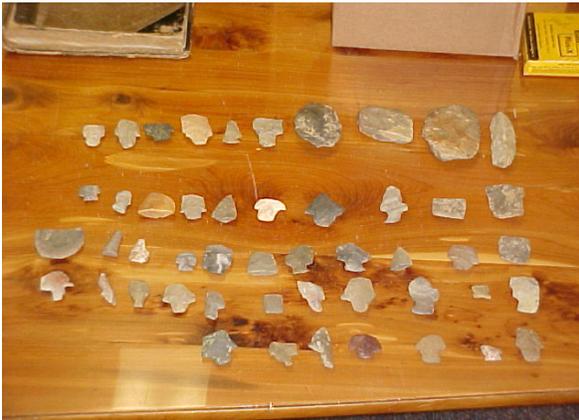
Archaeological—Less than one-half cubic foot (0.08 ft³) of archaeological materials are located in the resource room. The prehistoric artifacts are surface finds that have been located on the refuge throughout the years. The materials are stored in a metal file cabinet drawer in a small acidic box, both of which are not labeled. Artifacts have been cleaned and are stored loose in the box (Figure 16). None of the artifacts are labeled.

Figure 16. Close-up view of archaeological artifacts at Crab Orchard NWR.

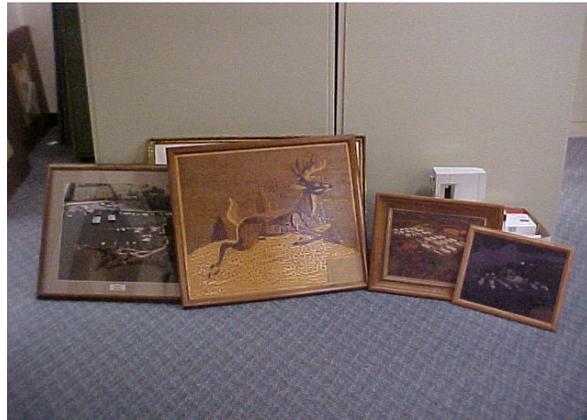
Figure 17. Close-up view of art pieces at Crab Orchard NWR.

Art—Five pieces totaling approximately 1.16 linear feet are stored on the floor (Figure 17). Four of the pieces are aerial photographs/prints of various places around the refuge. The fifth piece is an image of a whitetail deer made out of 13 different tree barks by a former refuge employee. The piece is labeled with the artist, materials used, and date.

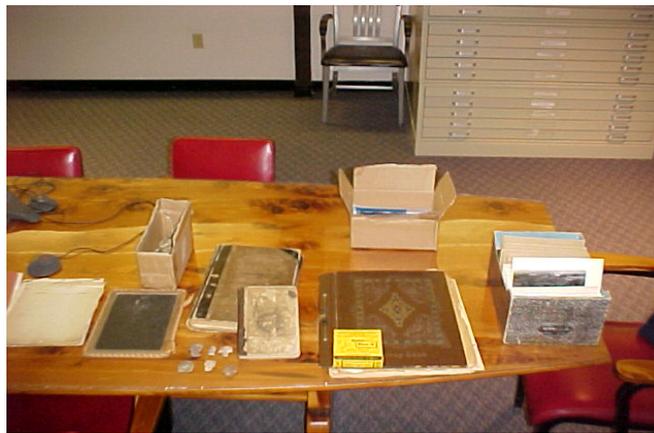
Associated Records—6.26 linear feet of records are stored in one metal file cabinet, one map file cabinet, and three Fire King® fireproof file cabinets. The records include archaeological reports, narratives, maps, blueprints, aerial photographs, a scrapbook, land abstracts/acquisitions information, color and black-and-white photographs, a 16-mm film reel, a ledger dated 1862/1863 containing old letters and abstracts of the area, one arithmetic book from 1877, and one monthly examination report dated 1887 (Figure 18). It is unknown how the refuge acquired the latter three items from the 1800s as they were found in a drawer at the refuge. Records are stored in a variety of secondary containers—acidic, expandable, and hanging folders, binders, envelopes, boxes, plastic sleeves, and loose within the drawers. All of the records have been sorted and cleaned, and approximately seventy five percent are labeled. A simple finding-aid (subject-by-subject format) has also been created. A large quantity of staples, rubber bands, binders, and paper clips were noted.

Figure 18. View of associated records in the administrative building at Crab Orchard NWR.

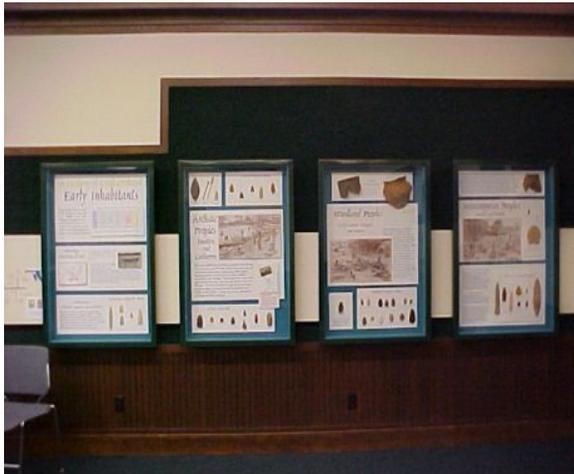
Archaeological—2.65 ft³ of archaeological collections are stored in this room. Fifty-two prehistoric artifacts are stored in four enclosed plastic exhibit cases of the same size (Figure 19); however, 14 of the artifacts are reproductions. Four historic artifacts are stored in three enclosed plastic exhibit cases of various sizes. These artifacts are part of the refuge's larger Maxwell collection, which currently are housed at Southern Illinois University in Carbondale (SIUC). According to standard museum practice, SIUC maintains long-term loan documentation for these artifacts. The artifacts have been mounted to wallboard with plastic string in the exhibit cases; however, it could not be determined if these materials are archival quality. According to the artifact inventory provided by Crab Orchard personnel, artifacts have been assigned accession numbers, but it is unknown if any of them have been directly labeled with either an accession or a catalog number.

Figure 19. Archaeological display in the Crab Orchard NWR visitor's center.

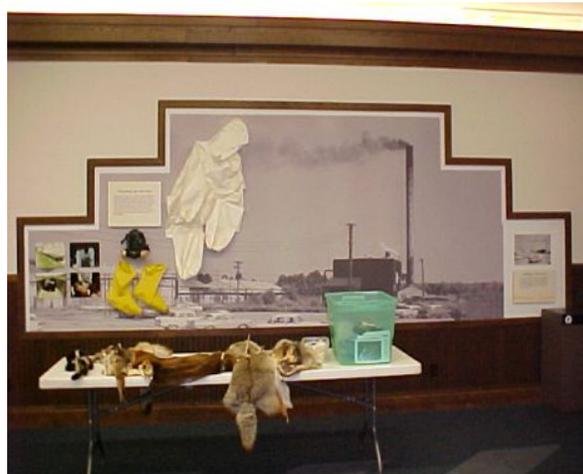
Figure 20. Hands-on display in the Crab Orchard NWR visitor's center.

Zoological—A total of seven zoological specimens are located in the exhibit hallway and are displayed in a variety of ways—on table tops for hands-on exhibits (Figure 20), loose on ceiling rafters, or in one enclosed plastic exhibit case.

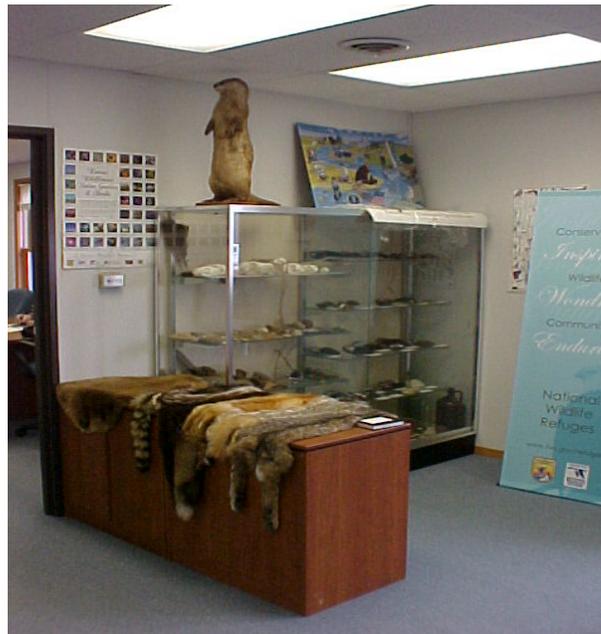
Figure 22. View of the display case and hands-on exhibit at Marais des Cygnes NWR.

Located inside the building entrance, the lobby/office (HQ 1) currently holds archaeological materials, associated records, and geological and zoological specimens. The room is fifty-to-sixty percent full. None of the collections are stored under pipes, and the floor load is sufficient to support the weight of the materials currently held. Materials are stored in lateral file cabinets, in a glass exhibit case, or loose on desk-tops (Figure 22). Two entrance doors and three windows are present. Windows are protected with blinds; however, the doors are not. No hazardous materials are stored in the room. All of the materials have been cleaned, mounted, and approximately fifty percent have been labeled.

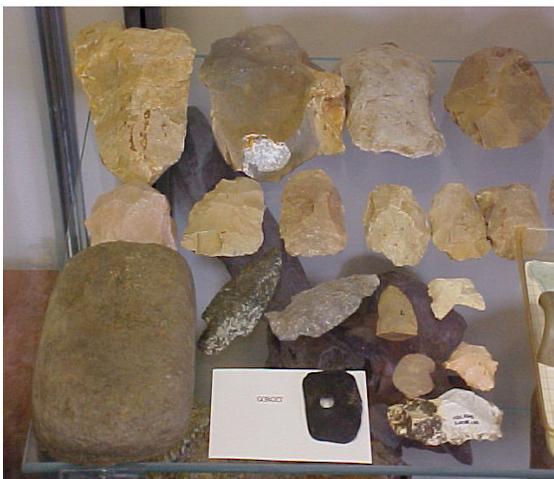
Figure 23. Prehistoric artifacts from Marais des Cygnes NWR.

Archaeological—Six cubic feet of archaeological materials are stored in the office/lobby. The prehistoric and historic artifacts are surface finds that have been recovered from the refuge throughout the years. Artifacts have been cleaned and are stored loose on shelves in a glass exhibit case (Figure 23). Some artifacts are labeled directly in marker or with index cards with the location or an artifact description.

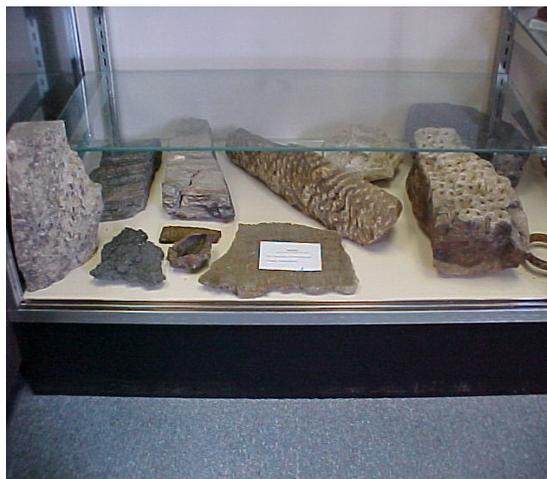
Geological—A small number (1.83 ft³) of geological materials are present at Marais des Cygnes. Materials are stored loose on a shelf in the glass exhibit case (Figure 24). All of the materials have been sorted and cleaned; however, only one item has been labeled.

Figure 24. Geological specimens from Marais des Cygnes NWR.

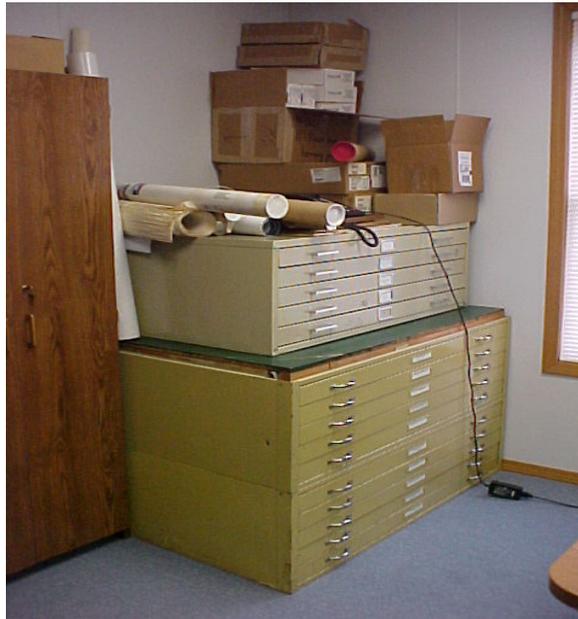
Figure 25. Map file cabinets in the meeting room at Marais des Cygnes NWR.

The meeting room (HQ 2) currently houses archaeological materials and associated records. The room is approximately seventy-five percent full. None of the collections are stored under pipes, and the floor load is sufficient to support the weight of the materials currently held. Materials are stored on top of or in map file cabinets (Figure 25). One window is present in the room and is protected with miniblinds. No hazardous materials are stored in the room; however, a kitchen area adjacent to the room does house basic cleaning supplies/agents. All of the materials have

been sorted and cleaned. None of the archaeological materials have been labeled, and approximately half of the records have been labeled.

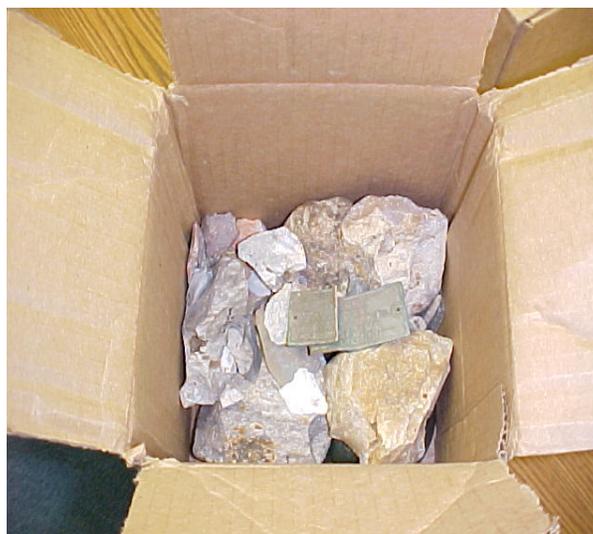
Archaeological—Less than one-half cubic foot (0.46 ft³) of archaeological materials is located in the meeting room. The prehistoric artifacts are surface finds that have been recovered from the refuge throughout the years. Artifacts are stored in two small acidic boxes, both of which are not labeled. Artifacts have been cleaned and are stored loose in the box (Figure 26). None of the artifacts are labeled.

Figure 26. Box of archaeological artifacts at Marais des Cygnes NWR.

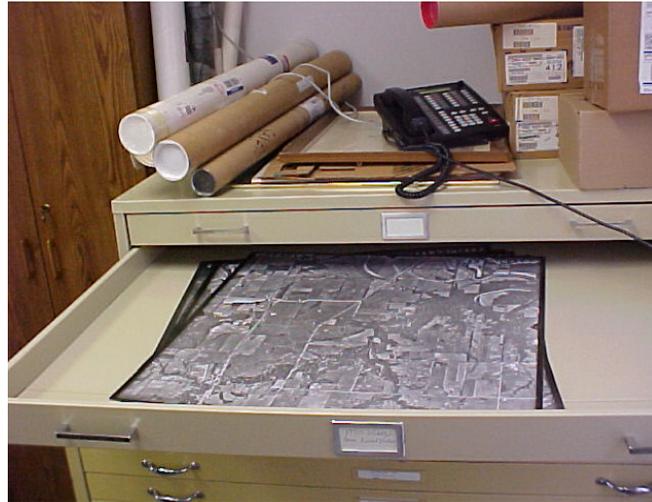
Associated Records—Oversized maps and photographs totaling 0.43 linear feet are stored in this room. Maps are stored loose within the drawers or in acidic map tubes on top of the file cabinets. Aerial and black and white photographs are stored (1) loose within the drawers (Figure 27), (2) glued to cardboard pieces, or (3) in acidic cardboard containers. Maps in the file drawers are sorted by year. None of the maps are labeled; approximately twenty-five percent of the photographs are either labeled in ink or pencil with the date, event, or location.

Figure 27. View of aerial photographs in the map file drawer at Marais des Cygnes NWR.

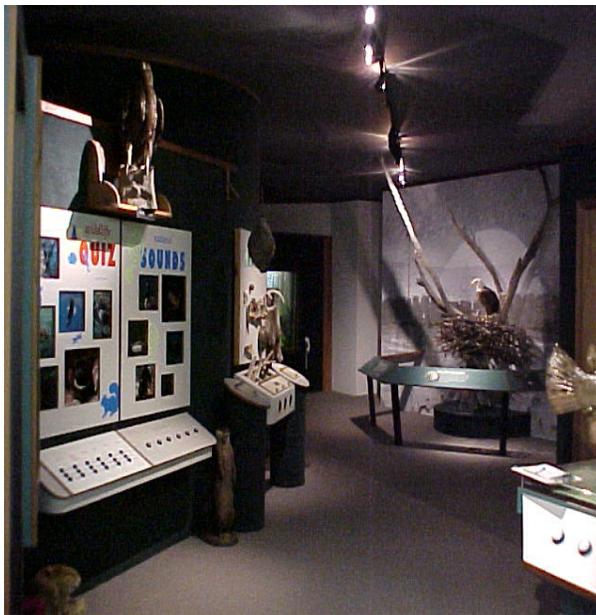
Figure 29. Zoological specimens in the exhibit gallery.

The gallery (VC1), which is located at the entrance to the visitor's center, exhibits archaeological materials and zoological specimens (mounts, skulls, furs, an aquarium, and one live biological specimen). A small gift shop, office area, and two audiovisual viewing rooms also are located in this area. The room is ninety percent full. None of the collections are stored under pipes, and the floor load is sufficient to support the weight of the materials currently held. Materials are displayed loose on hands-on exhibits, in enclosed plastic exhibit cases, or freestanding on floor mounts/displays (Figure 29). Four entrance doors and 18 windows are present. Windows are protected with blinds; however, the doors are not. All of the materials have been cleaned, mounted, and labeled.

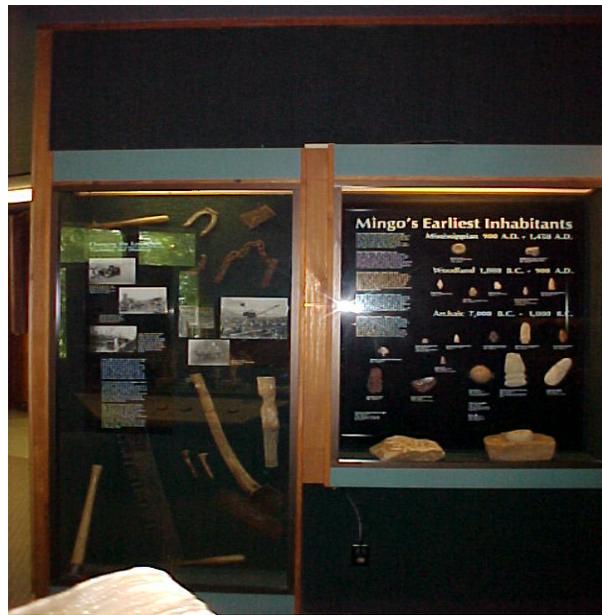
Figure 30. Archaeological artifacts in the exhibit gallery.

Archaeological—Two enclosed plastic exhibit cases (Figure 30) display historic and prehistoric artifacts (19.97 ft³). Ten historic metal and wood artifacts are displayed, while 21 lithic and one ceramic artifact are located in the prehistoric display. Prehistoric artifacts, which were collected off the refuge, are currently on long-term loan from the University of Missouri-Columbia (UMC) as they maintain the long-term documentation for these artifacts and will be returned following the conclusion of the loan. Artifacts have been mounted to wallboard in the exhibit cases with plastic string; however, it is unknown if the materials are archival. According to the artifact inventory located during the assessment, artifacts have been assigned accession numbers, but it is unknown if any of them have been directly labeled with either an accession or a catalog number.

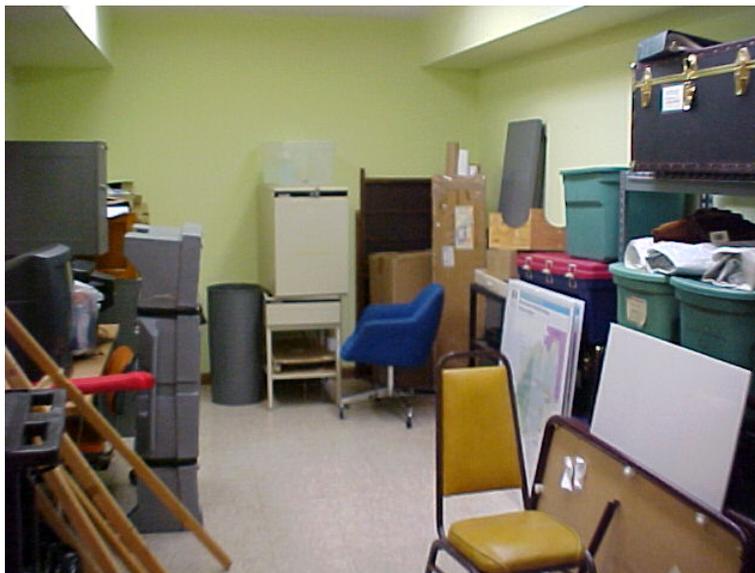
This storage room (VC 2) encompasses 150 ft² and currently holds associated records and zoological specimens (Figure 31). The room, which is at capacity, also houses excess supplies. None of the collections are stored under pipes, and the floor load is sufficient to support the weight of the materials currently held. Associated records are stored in a letter-sized file cabinet, two metal slide cabinets, and three wooden-and-metal map file cabinets, while zoological specimens are stored loose throughout the room. No windows are present in the room, and no hazardous materials are stored there. All of the materials have been sorted and cleaned and approximately half have been labeled.

Figure 31. View of map/general storage room.

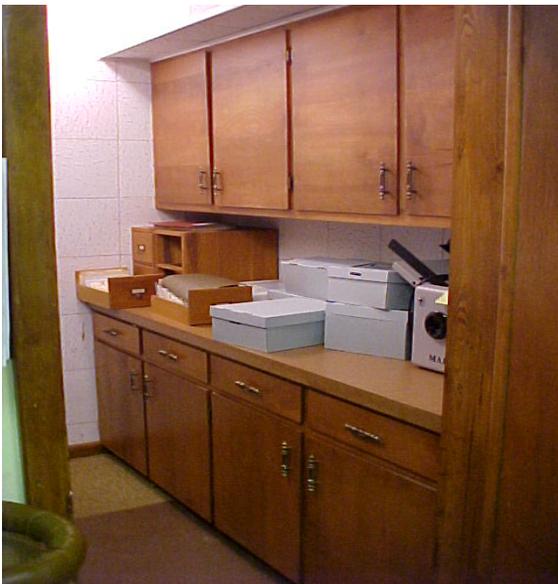
Figure 32. Wooden cabinets used to house associated records.

The photograph/audiovisual storage room (VC 3), which is located off the map/general storage room, currently houses photographic records only. The room, which is approximately ninety percent full, also houses audiovisual supplies (e.g., televisions, slide projectors). None of the collections are stored under pipes, and the floor load is sufficient to support the weight of the materials currently held. Photographs are stored on a cabinet top in wooden drawers or in archival boxes (Figures 32 and 33). No windows are present in the room, and no hazardous materials are stored there. All of the materials have been sorted and cleaned and approximately forty-to-fifty percent are labeled/identified.

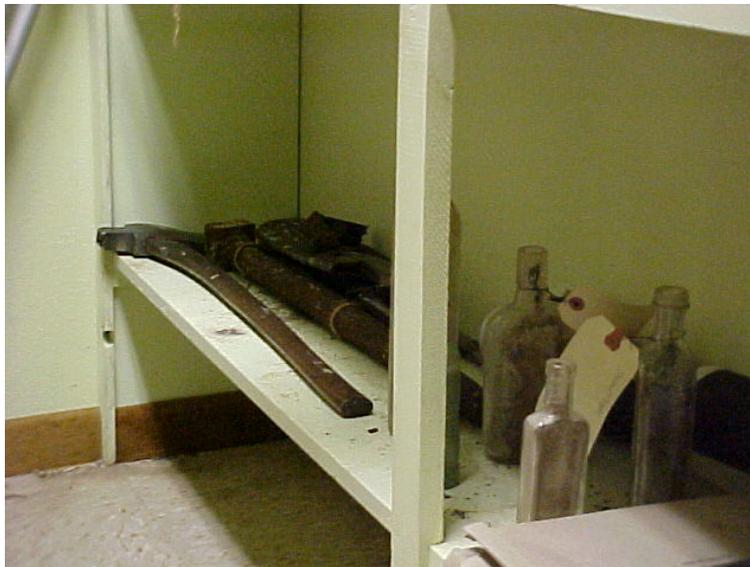
Archaeological—16.39 ft³ of historic artifacts are stored in this room. Artifacts—metal, ceramic, and glass objects (Figure 34)—are stored loose on the shelves. Fifty percent of the artifacts have been cleaned; however, only twenty-five percent have been labeled. Artifacts are labeled with acidic paper attached to wire strings listing the refuge, date, site number, place name, section, township, and range.

Figure 34. Historic artifacts in the vault room.

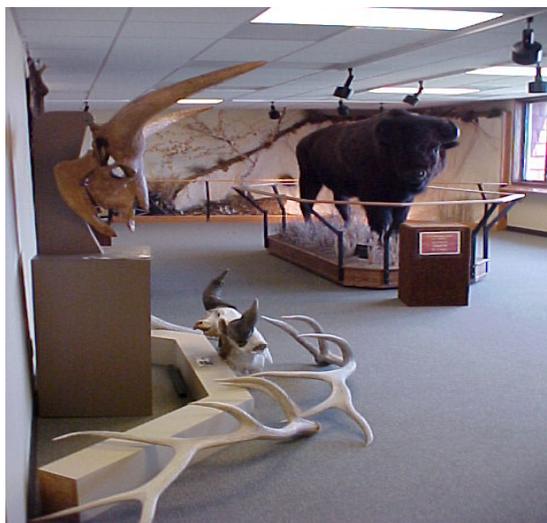
Figure 37. View of the Ft. Niobrara visitor's center exhibit galley.

The exhibit gallery (VC 1) currently holds archaeological, paleontological, and zoological materials, and is approximately fifty-to-sixty percent full (Figure 37). The room also contains an audiovisual viewing section and hands-on station. A gift shop is located adjacent to the room. None of the collections are stored under pipes, and the floor load is sufficient to support the weight of the materials currently held. Materials are stored throughout the room in a variety of ways: (1) loose on hands-on exhibits, (2) freestanding on floor mounts/displays, (3) in enclosed plastic exhibit cases, or (4) in a locked glass cabinet case. Seven windows are present in the

gallery, but they are not covered with any miniblinds or shades. No hazardous materials are stored in the room. All of the materials have been cleaned, with approximately fifty percent labeled or identified.

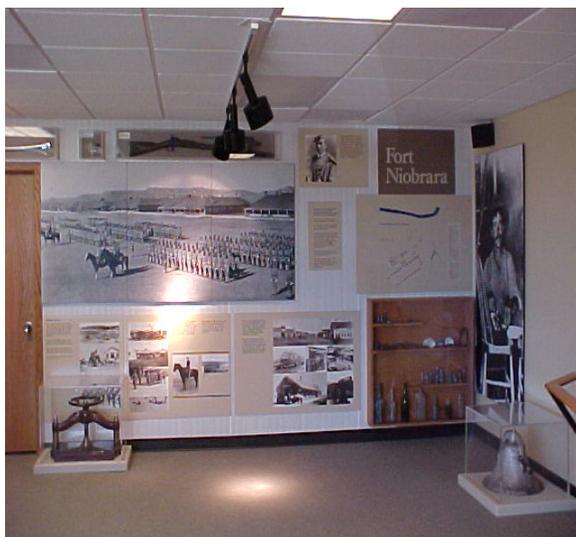
Archaeological—17.13 ft³ of historic archaeological materials, are stored in the exhibit gallery in six enclosed plastic exhibit cases of varying sizes (Figure 38). Artifacts are stored loose within the exhibit cases or have been mounted to heavy-duty wallboard with plastic string; however, it is unknown if the materials are archival. Larger items (a letter press, rifle, dinner bell, and a saber) are identified in the display case with the artifact name on a piece of paper that is located in the interior of the case. None of the materials have been directly labeled with either an accession or a catalog number.

Figure 38. Historic archaeological display in the exhibit gallery.

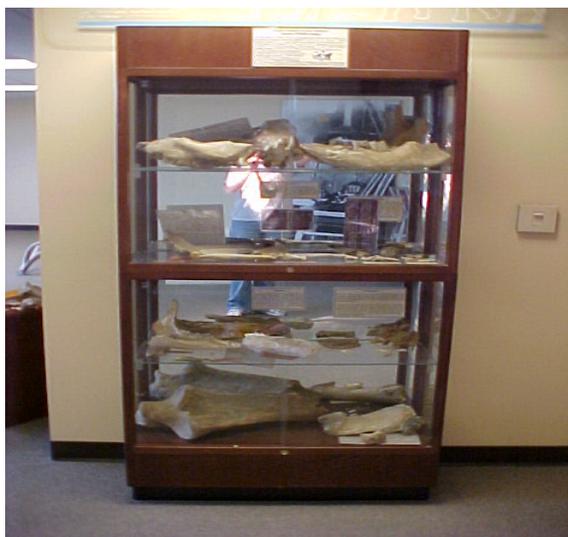
Figure 39. Paleontological display in the exhibit gallery.

Paleontological—Paleontological specimens (11.67 ft³) are stored in an enclosed glass display case, which has sliding doors that are locked at all times. Specimens are stored loose on the shelves within the case (Figure 39). None of the materials have been directly labeled; however, some of the larger specimens are identified with a piece of paper listing the species type in the display case.

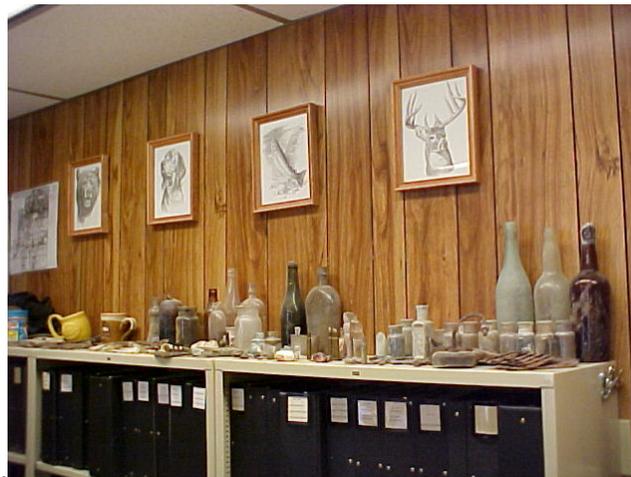
Archaeological—6.49 ft³ of historic artifacts are stored in this room. The artifacts are surface finds that have been recovered from the refuge throughout the years. Artifacts—metal, ceramic, and glass objects (Figure 40)—are stored loose on top of the shelves. None of the artifacts have been properly cleaned, inventoried, or labeled. A large portion of the metal artifacts are intact ordnance rounds, half of which have not been exploded. This is a subject that should be addressed thoroughly by FWS.

Figure 40. Archaeological materials stored on shelf tops in the refuge manager's office at the Ft. Niobrara visitor's center.

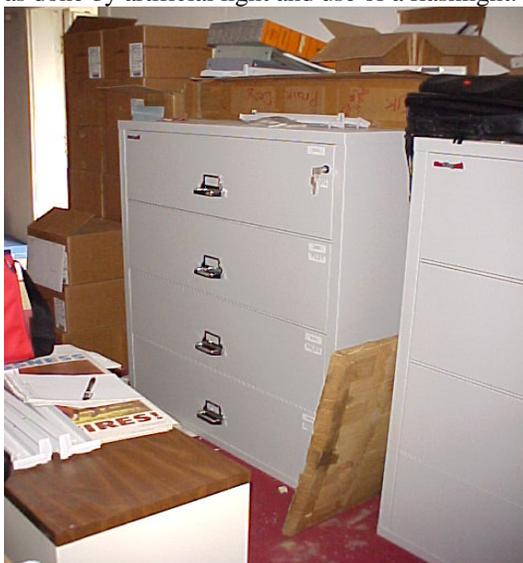
Figure 41. View of storage room and file cabinets used for records storage in the old museum building.

The general storage room (MB 1), which is located at the entrance of the building, houses archaeological materials, associated records, and zoological specimens (Figure 41). The room, which is at capacity, also houses excess materials and supplies (e.g., books, pamphlets, and computer equipment) from the visitor's center (Figure 42). A fire extinguisher is located at the rear of the room; however, an inspection date was not located. A fire hydrant is also located 30 feet from the building, as the refuge has its own fire personnel and equipment. None of the collections are stored under pipes, and the floor load is sufficient to support the weight of the materials currently held. Materials are stored (1) in seven metal fireproof file cabinets and one standard file cabinet, (2) in acidic boxes on top of the file cabinets, or (3) on the floor between the filing cabinets. Only one window is present in the room, and it is secured with a window lock. A crack was observed in the lower half of the window. It is unknown if any hazardous materials are stored in the room. All of the materials have been sorted and cleaned.

Approximately seventy-five percent of the records have been labeled, while all of the artifacts have been labeled.

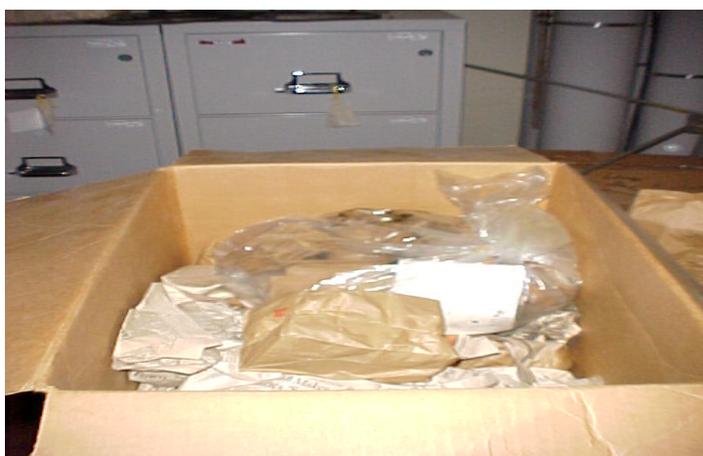
Archaeological—One-half box (1.08 ft³) of archaeological materials was located in the room during the assessment. Artifacts, both prehistoric and historic, were collected during a mid-1970s survey. The artifacts are housed in an acidic box (Figure 43) that is stored on top of a fireproof file cabinet. Secondary containers consist of acidic brown paper bags, which are directly labeled in marker with the site number, project, provenience, investigator, and date. Most of the artifacts have been cleaned and are labeled directly in ink with the site and catalog number.

Figure 43. Box of archaeological artifacts from Ft. Niobrara NWR located in the general storage room.

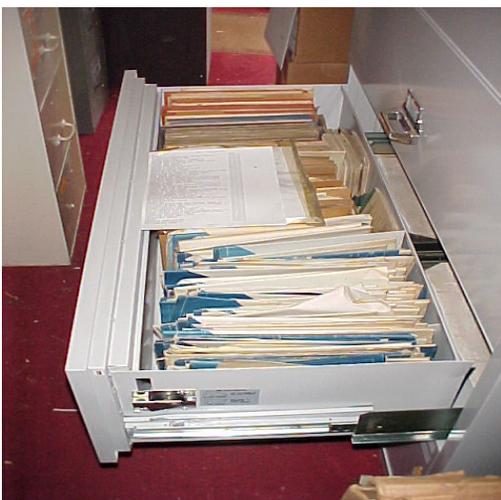
Figure 44. View of records and maps stored in fireproof file cabinets in the general storage room.

Associated Records—43.22 linear feet of records from Ft. Niobrara NWR are stored in this room. An unknown amount of records from Valentine NWR also are stored here. Record types include aerial, color, and black-and-white photographs; slides; negatives; ledgers; maps; blueprints; reports; and administrative files. Records are stored (1) in seven fireproof file cabinets and one standard file cabinet, (2) in acidic boxes stacked on the floor or on top of the file cabinets, and (3) on the floor. Secondary containers consist of acidic manila, expandable, and hanging folders, binders, envelopes, plastic slide and negative sleeves, map and smaller acidic boxes, and loose within the drawers and boxes (Figure 44). All of the records have been sorted, and approximately seventy-five percent have been labeled. A drawer-by-drawer finding-aid also has been created. One-half of the maps have been placed in map boxes (Figure 45) that are labeled with a number that corresponds to the map name on the finding aid. A large quantity of staples, tape, rubber bands, binders, and paper clips were noted.

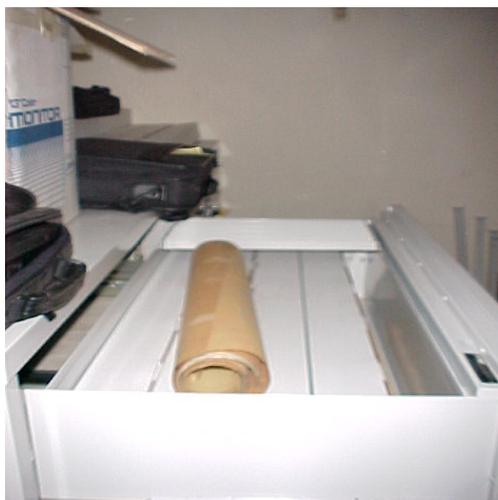
Figure 45. Maps rolled in and placed in map boxes in fireproof file cabinets in the general storage room.

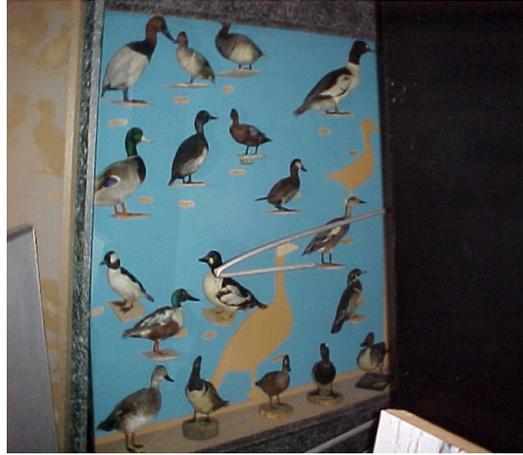
Figure 46. Old zoological display case in the old museum building.

The old zoological specimen exhibit gallery (MB 2), which is located behind the records/general storage room, currently holds zoological specimens that were once on exhibit when the building was still in use as a museum. The room, which is at capacity, also houses excess building and office materials (e.g., door frames, shelving units, etc.). None of the collections are stored under pipes, and the floor load is sufficient to support the weight of the materials currently held. Specimens are stored in old wood and glass enclosed display cases (Figure 46). No windows are present in the room. A set of stairs that lead to the basement are located along the west wall.

Zoological—One hundred twenty six (126) zoological specimens are housed loose in the cases. Some specimens are missing from the displays, and it is unknown where those materials are currently located. All specimens are mounted and identified within the cases.

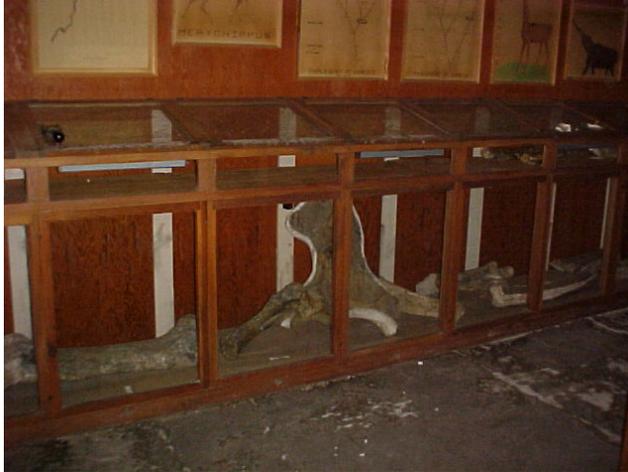
Figure 47. Old paleontological display cases in the old museum building.

Paleontological—Thirty (30) specimens totaling 48.95 ft³ are stored loose on the bottom of two exhibit cases (Figure 47). It is unknown if any of the items are directly labeled.

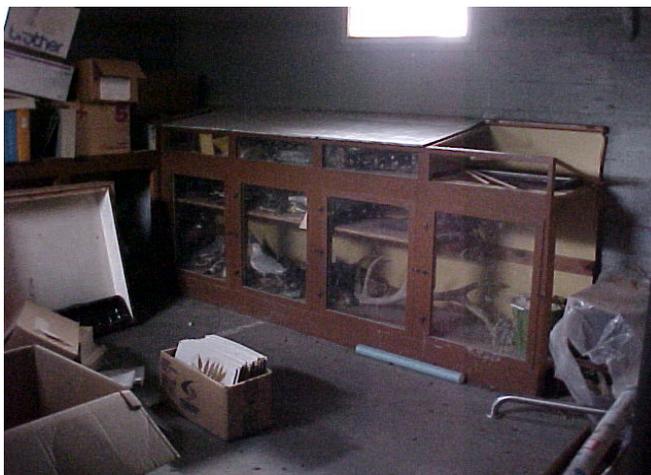
Figure 48. View of the old museum building's miscellaneous storage room.

The miscellaneous storage room (MB 4) is located in the basement and houses archaeological materials, associated records, and botanical, paleontological, and zoological specimens (Figure 48). An unknown amount of records from Valentine NWR, and potentially some archaeological materials, are also located in this room. The room, which is at capacity, also houses excess supplies (e.g., envelopes, ink cartridges, etc.). The materials are not stored under pipes, and the floor load is sufficient to support the weight of the materials currently held. Materials are stored in old wood and glass display cases and in acidic boxes on top of the exhibit cases or on the floor. Two windows are present in the room; however they are not covered with blinds or shades. Cracks were observed in the windows. Insect activity was noted in the room. Some hazardous materials (i.e., bug repellants, paint thinner) are stored on a shelf separated from museum property. An asbestos covered heating unit is also located adjacent to the room. Half of the materials have been sorted and cleaned; however, very few have been labeled.

Archaeological—5.50 ft³ of historic artifacts are stored in this room. Artifacts—metal, ceramic, and glass objects—are stored loose in the exhibit cases. Half of the artifacts have been cleaned; however, none are labeled. Objects were located next to records from Valentine NWR, so it is possible not all the objects assessed were gathered from Ft. Niobrara NWR. FWS should determine which refuge these materials are associated with in order to accurately account for their museum property holdings.

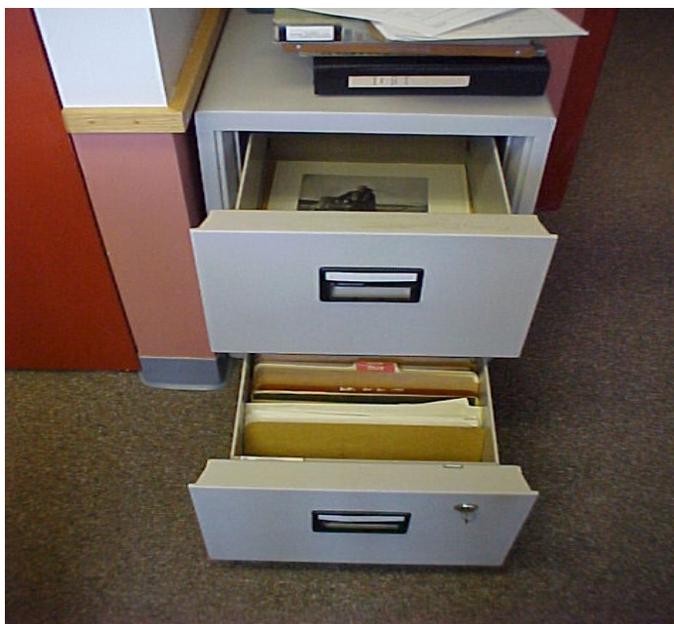
The refuge manager's office (HQ 1) currently holds associated records only and is approximately sixty percent full. None of the collections are stored under pipes, and the floor load is sufficient to support the weight of the materials currently held. Collections are stored in a Sentry[®] two-drawer fireproof file cabinet (Figure 51) and a plastic crate that is stored on the floor, both of which are not labeled. Two windows are present in the room, and they are protected with miniblinds. A fire extinguisher is located directly outside of the office. No hazardous materials are stored in the room. All of the materials have been cleaned and stored, and approximately fifty percent of the record materials have been labeled or identified.

Figure 51. A fireproof file cabinet used for associated records in the refuge manager's office at Arrowwood NWR.

Associated Records—Reports, color/black-and-white photographs, maps, blueprints, oversized aerial photographs, and administrative files totaling 2.26 linear feet are stored in this room. Secondary containers consist of acidic file and manila folders, binders, photographic frames, and photographs adhered to poster board within the drawers. Maps and aerial photographs are stored loose in the plastic crate. Paper records have been sorted by subject or year, and approximately half have been labeled. Photographs, which are sorted by year, are labeled directly with in either ink or pencil with the date, project, or event or have adhesive labels attached labeled with the same information. No finding aid has been created for any of the records. A small amount of staples, paper clips, and adhesive materials were observed on the records.

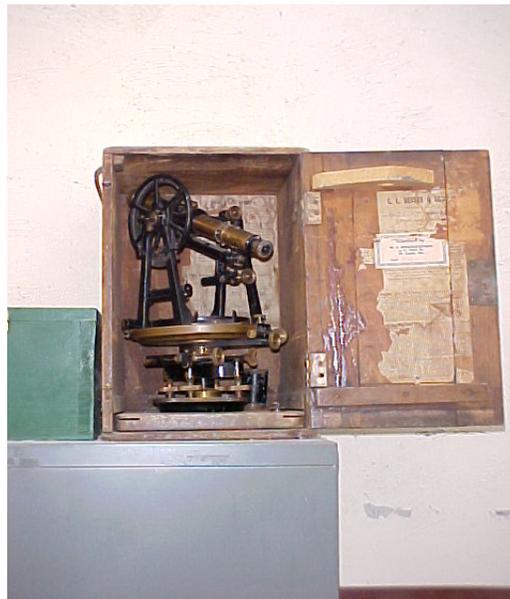
Historical Objects—One historic survey transit (1.04 ft³) from the early 1900s is located in this room. The transit, which is stored in a wooden box on top of a metal file cabinet (Figure 52), is not directly labeled; however, the box has an adhesive label that states the following: “Repaired by W.F. Sprenginether—14 N. 9th St., St. Louis, 1936 (May 12).”

Figure 52. Old survey transit stored at Arrowwood NWR.

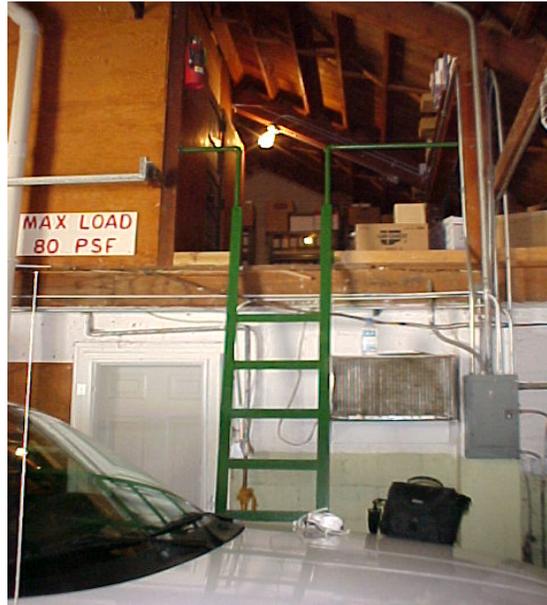
This loft/attic, which is located above the bunkhouse living quarters, currently holds associated records. The room, which is approximately ninety percent full, also houses excess materials and supplies (e.g., books, light bulbs, air filters, auto parts). Access to the room is by a ladder that is located in the garage portion of the building. A fire extinguisher is located at the entrance to the room (Figure 53). None of the collections are stored under pipes; however, the room has no ceiling—it is open to the roof and subject to external conditions should damage occur to the roof.

The floor load is sufficient to support the weight of the materials currently held. Records are stored in stackable metal shelving units with glass doors or in acidic boxes on the floor. No windows are present in the room; however, windows and garage doors are located in the space adjacent to and below the room. Windows are secured with window locks and metal bars; however, the garage doors are unlocked at all times. When garage doors are opened, birds frequently access the area.

Figure 53. Entrance to the loft/attic in the Arrowwood NWR bunkhouse.

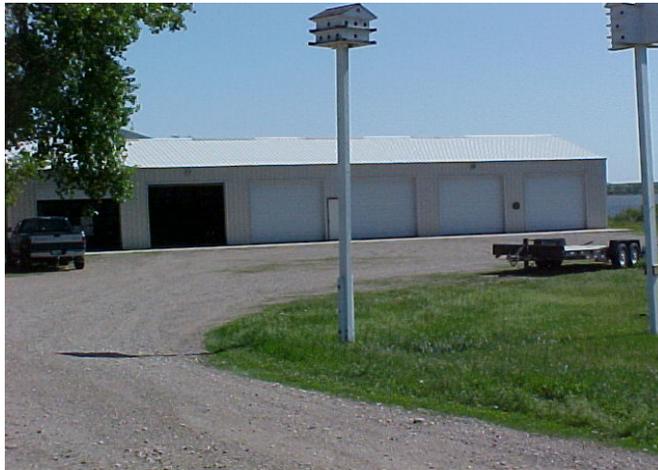
In the garage building (Figure 54), the main corridor currently holds associated records, including maps, blueprints, and aerial photographs. The room, which is approximately twenty-five percent full, also houses excess materials/supplies (e.g., lawn mowers, tires, explosives). None of the collections are stored under pipes, and the floor load is sufficient to support the weight of the materials currently held. No windows are present in the room; however, six manual garage doors are occasionally opened allowing birds, insects, and rodents access to the area. An infestation of mice in the map file cabinets was evident. One fire extinguisher is located in the garage.

Figure 54. Garage building used for housing maps at Arrowwood NWR.

No pest management practices are used in the garage. During the assessment, a mouse infestation was observed in map file cabinets. A protective mask and gloves were worn during the assessment at the request of refuge personnel.

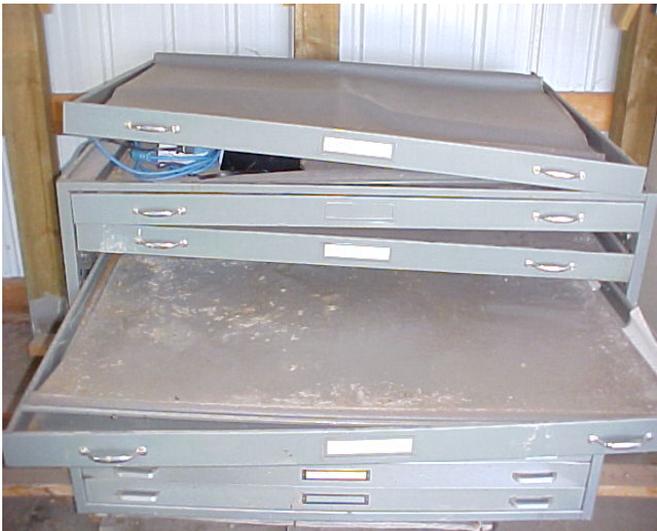
Associated Records—1.92 linear feet of oversized records—maps, aerial photographs, and blueprints, are stored in the garage. Records are stored in map file cabinets, which are severely damaged—drawers are warped and rusted and have environmental (i.e., water and mold) and pest damage (Figure 55). All records are stored loose within the drawers. Some maps and blueprints are flattened within the drawers, while others are rolled, but none are properly preserved. Approximately half of the records have been damaged by mice infestations (Figure 56). Only forty-to-fifty percent of the records have been sorted or labeled.

Figure 55. Map cabinets used to house maps in the Arrowwood NWR garage.

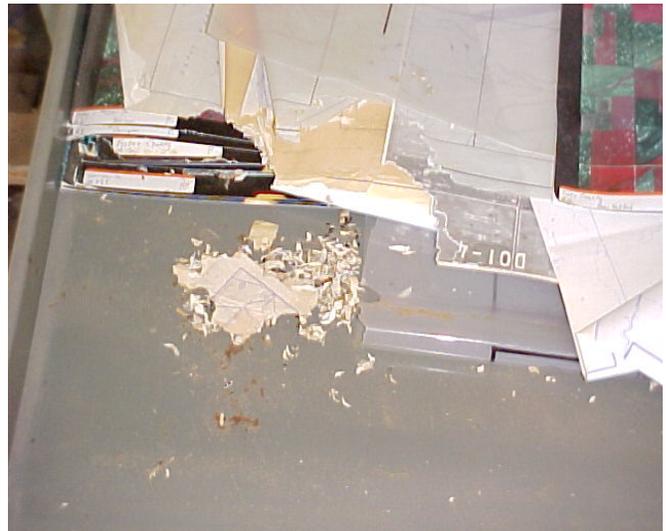
Figure 56. Close-up view of maps and aerial photographs in the Arrowwood NWR garage. Note the mice damage.

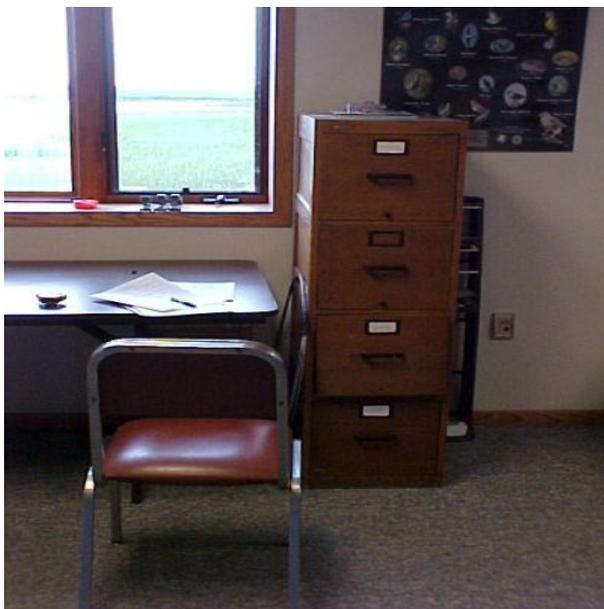
The basement (HQ 2) currently houses associated records only and is approximately seventy-five percent full. None of the collections are stored under pipes, and the floor load is sufficient to support the weight of the materials currently held. Materials are stored in a wooden file cabinet and two map file cabinets (Figures 58 and 59). Five windows are present in the room, and they are protected with miniblinds. No hazardous materials are stored in the room. All of the materials have been sorted and cleaned and approximately eight-to-ninety percent of the records have been labeled.

Figure 58. A wooden file cabinet is used for records storage at Chase Lake NWR.

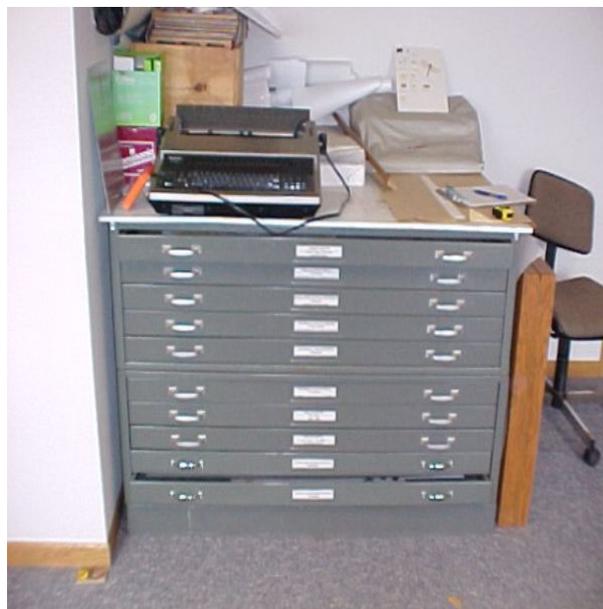
Figure 59. View of a map file cabinet in the basement at Chase Lake NWR.
