An Assessment of Museum Property at Select National Wildlife Refuges for the U.S. Fish and Wildlife Service

St. Louis District

Archaeological Curation-Needs Assessments
Technical Report No. __
2007

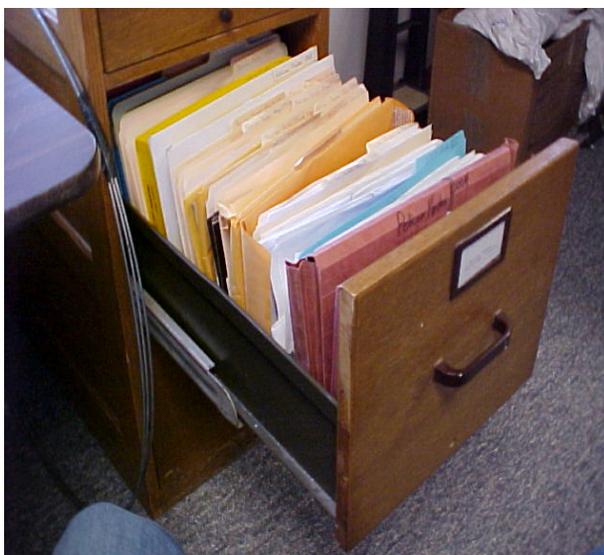
Associated Records—Oversized maps, photographs, reports, and other associated records are stored in this room. Records are stored within the drawers in a variety of secondary containers—acidic, expandable, and hanging folders, magazine file boxes, envelopes, plastic slide sleeves, and loose within the drawers (Figures 60 and 61). A large quantity of staples, rubber bands, masking tape, and binders and paper clips were noted. All of the records have been sorted and cleaned. Approximately ninety percent are labeled directly or with adhesive labels in either ink or pencil with the project, location, or year.

Figure 60. Secondary containers housing associated records at Chase Lake NWR.

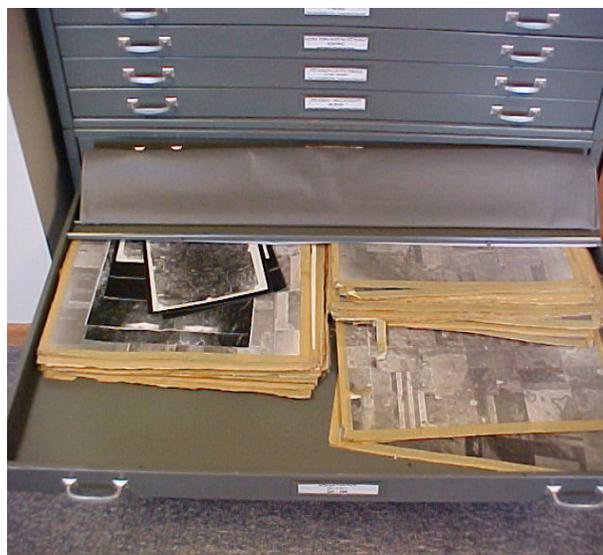
Figure 61. Drawer of aerial photographs stored at Chase Lake NWR.
