Lake Champlain Aquatic Habitat Connectivity

Fish Passage in the Winooski Watershed

Crossett Brook a tributary to the Winooski River, Duxbury, Vermont
Longitude: -72.78930 Latitude: 44.30790

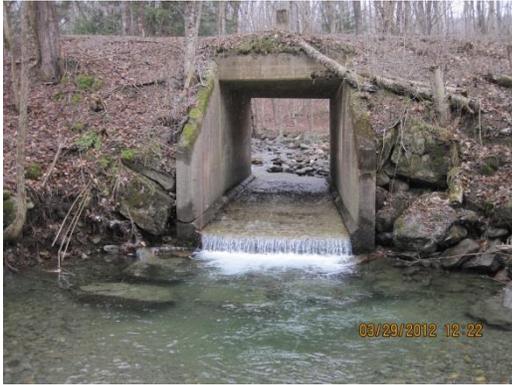
Before

Left: A view of the Crossett Brook box culvert. **Right:** After retrofit with rock weirs and baffles.

Problems / history: Brook trout habitat connectivity is disrupted by this barrier because it is undersized and perched, creating a height barrier for fish passage.
