# Connecticut River Aquatic Habitat Connectivity

## Fish Passage in the White River Watershed

Howe Brook at Oak Lodge Rd, Rochester Vermont

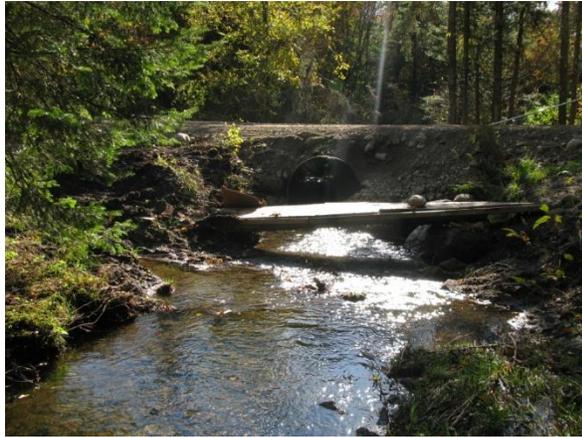
Before

**Left:** A view of the Howe Brook culvert outlet on Oak Lodge road showing the emergency replacement culvert with minimal fish or aquatic organism passage. **Right:** New Howe Brook culvert at the Oak Lodge road crossing designed for fish and aquatic organism passage as well as flood resiliency.

**Problems / history:** Multiple culverts in Rochester Vermont were in need of emergency repair following the flooding from tropical storm Irene in August of 2011. Following tropical storm Irene many of the emergency fixes were designed to quickly open roads for vehicle traffic, but not always allow for fish and aquatic organism passage. Working closely with FEMA and the town of Rochester the US Fish and Wildlife Service has provided technical assistance, engineering designs, and project over site to ensure projects allow both fish and aquatic organism passage.
