Lake Champlain Basin Aquatic Habitat Connectivity: Indian Brook Watershed

Mill Pond Dam Removal, Indian Brook, Colchester, VT

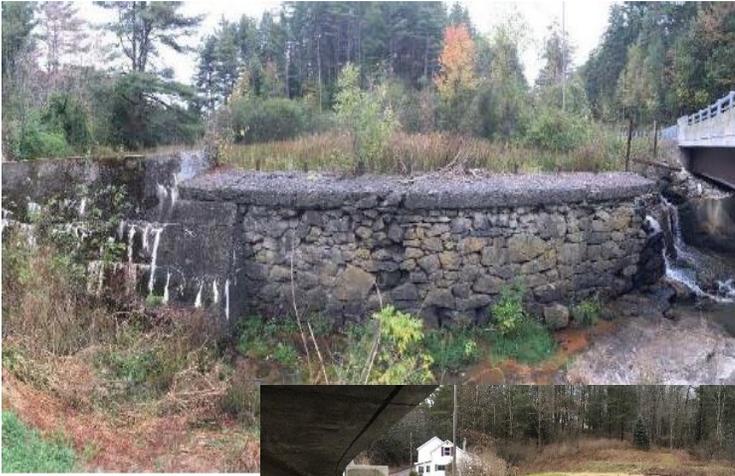
Top Left: A view of dam prior to removal (Milone and MacBroom). **Bottom Right:** Dam site post-removal (USFWS).

Site description: Mill Pond Dam, a privately owned structure, in Colchester, Vermont is located on Indian Brook. The dam has existed at this site since the early nineteenth century, but the current dam is deteriorated, partially breached at the spillway, and is listed as a significant hazard by the Vermont DEC.

Objective and Method: To restore natural stream function and AOP to ten miles of upstream habitat, the project involved removing the dam structure, excavating and removing 30,000 CY of sediment, building a new stream channel and floodplains and seeding the project area.
