Lake Champlain Aquatic Habitat Connectivity

Fish Passage in the Winooski Watershed

Crossett Brook a tributary to the Winooski River, Duxbury, Vermont
Longitude: -72.7920 Latitude: 44.3080

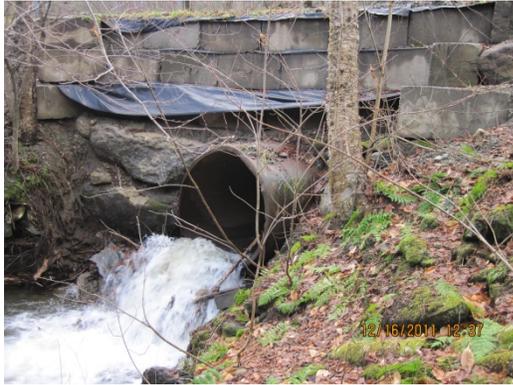
Before

Left: A view of the culvert on Hayes Rd. Right: Hayes Rd After.

Problems / history: Brook trout habitat connectivity is disrupted by an undersized and perched tank culvert creating a height barrier for all aquatic organism passage. Flooding has also been an issue with the tank culvert becoming blocked and then washing out the road.

Objective and Method: The objective is to improve habitat within Crossett Brook and its tributaries and to provide stable habitat for native brook trout. Reconnecting 3.3 miles upstream will ensure lower water temperatures needed by brook trout to thrive and promote flood resiliency within the system.
