**U.S. FISH AND WILDLIFE SERVICE  
MAINE FIELD OFFICE  
SPECIAL PROJECT REPORT: FY09-MEFO-1-EC**

**Site Assessment and Cleanup of the  
Youngs Road Small Arms Firing Range at Moosehorn NWR  
Baring, Washington County, Maine**

December 2008

**Final Report**

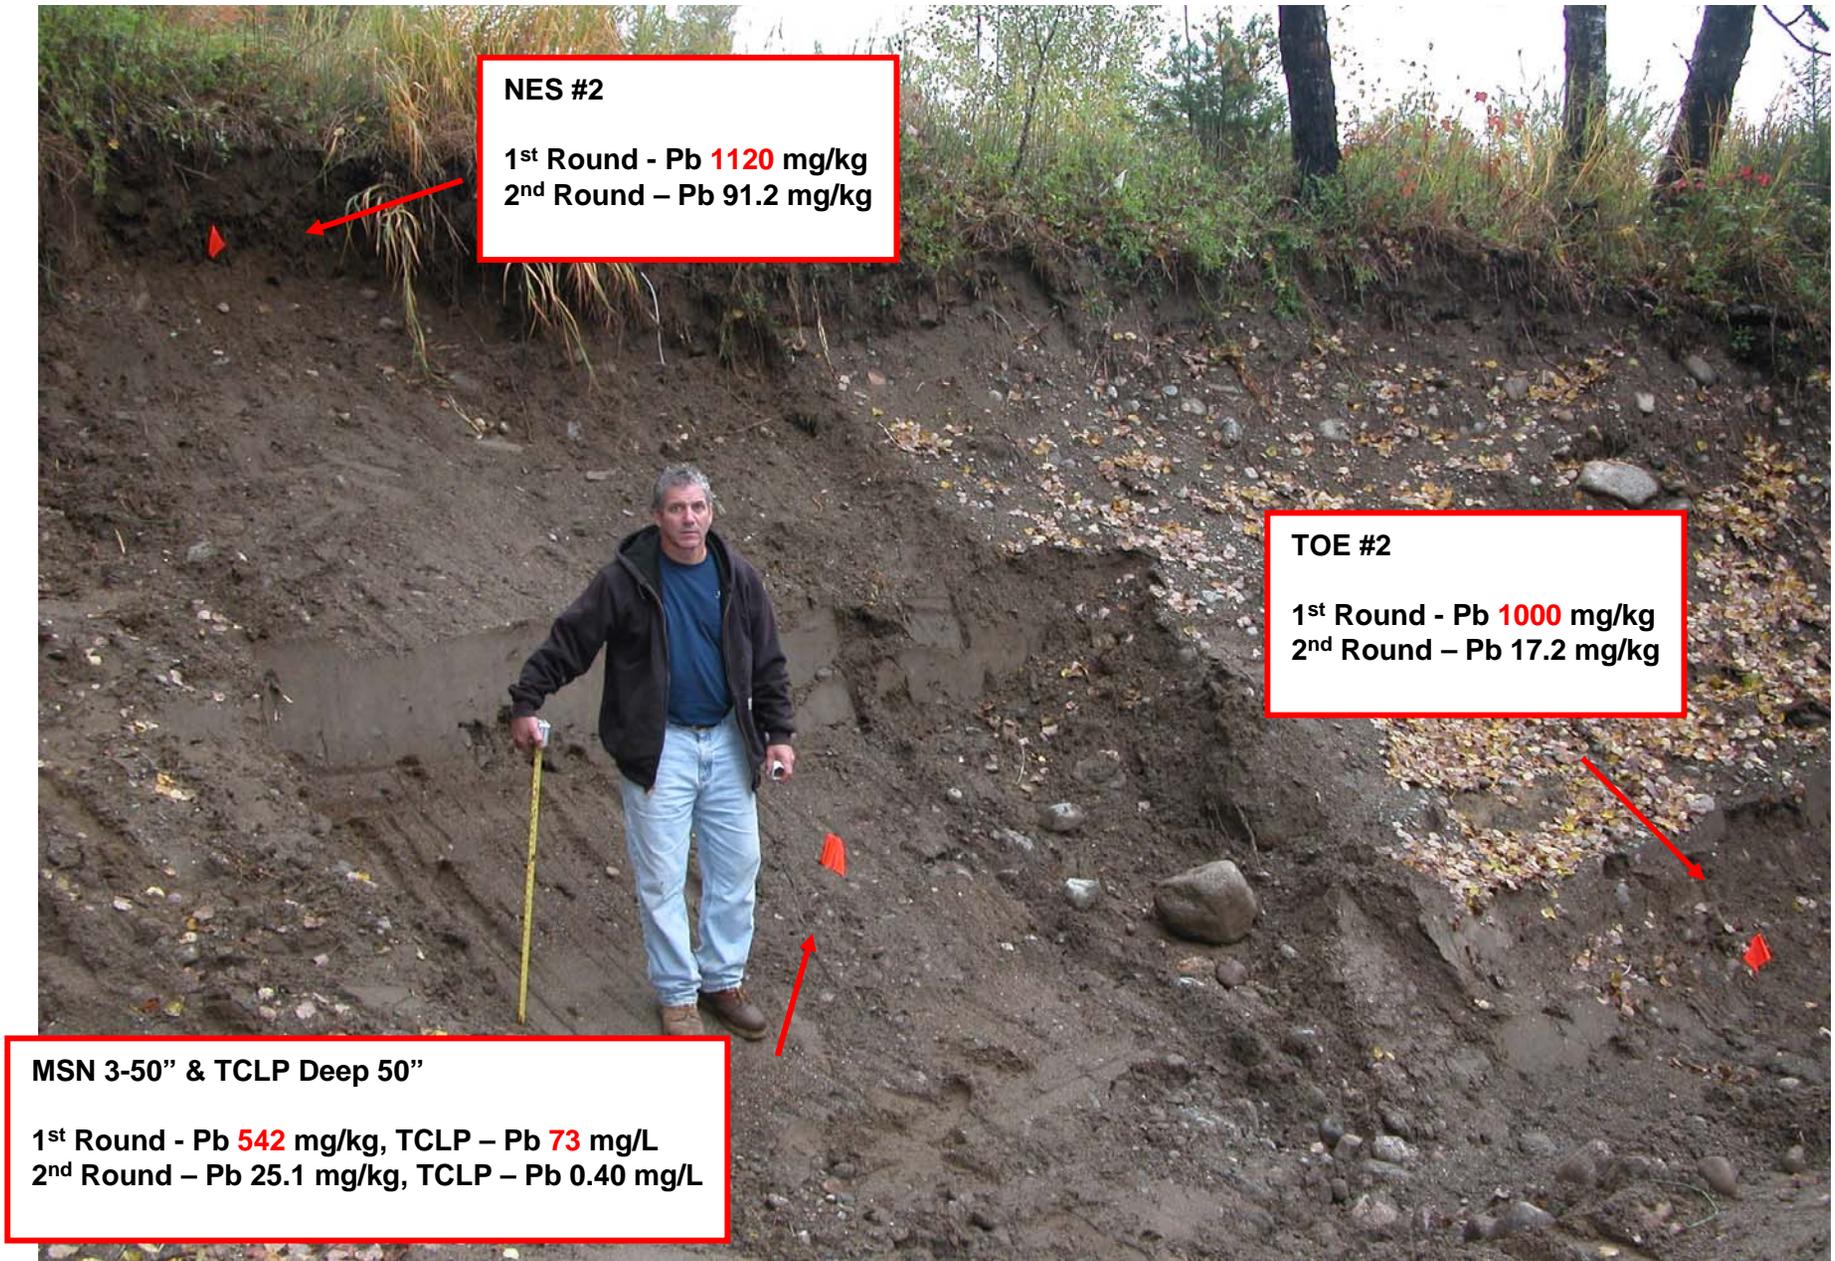
Figure 4. Sampling locations, sample codes, and laboratory analytical results (Round 2, 10/2/2008).

All post-excavation composite Pb soil and TCLP samples sieved with a #12 (1.7 mm mesh) stainless steel sieve. Soil concentrations expressed as dry weight.

sieve into a decontaminated stainless steel pail. The sieved material was thoroughly mixed before a sample was collected. For soil analyses, there were four surficial grabs per location. For TCLP analyses, there were six surficial grabs per location. All sampling equipment was decontaminated with Alconox soap, tap water, and deionized water between individual sample collections. Sieved soil and TCLP samples were placed in chemically-clean jars, and shipped overnight under chain-of-custody procedures for laboratory analysis (Figure 4). The Katahdin Analytical Services report for the second round of soil and TCLP sampling is located in Appendix C. Chain-of-custody documentation and laboratory QA/QC information are also included in Appendix C. All samples from the second round were below cleanup goals (Figure 4, Table 3).

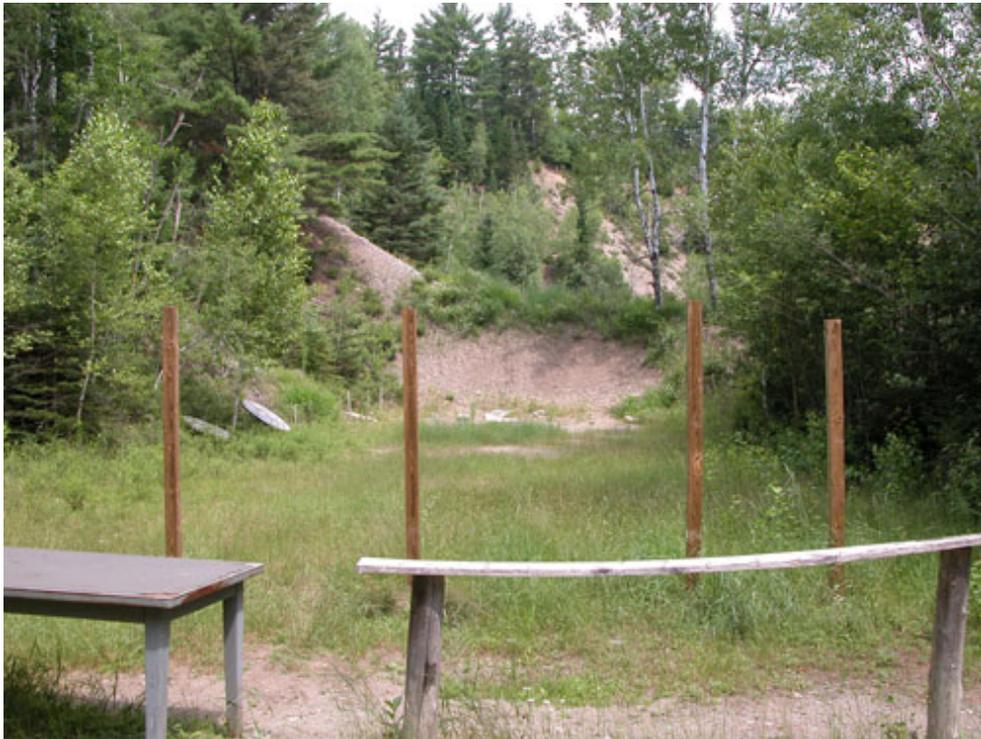
**Photo #1. Range before cleanup - 2004**

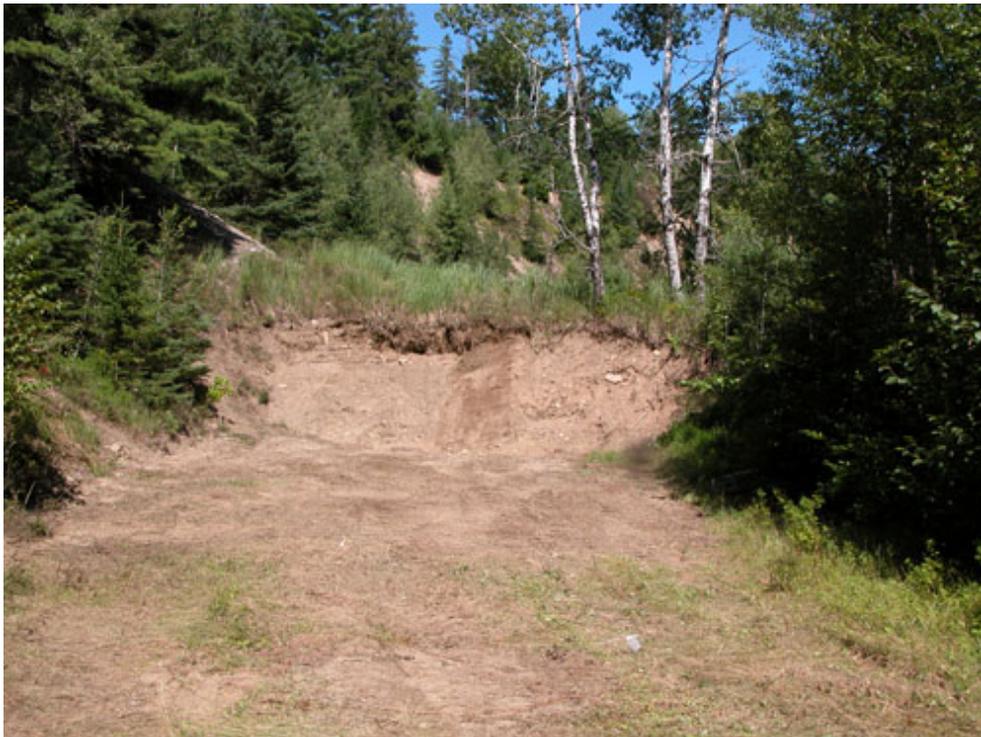
**Photo #2. Range after cleanup - 2008**

The range berm was re-graded and will be allowed to naturally revegetate (Photo #2). The project was completed in December 2008 and the final cost was approximately \$96,600.

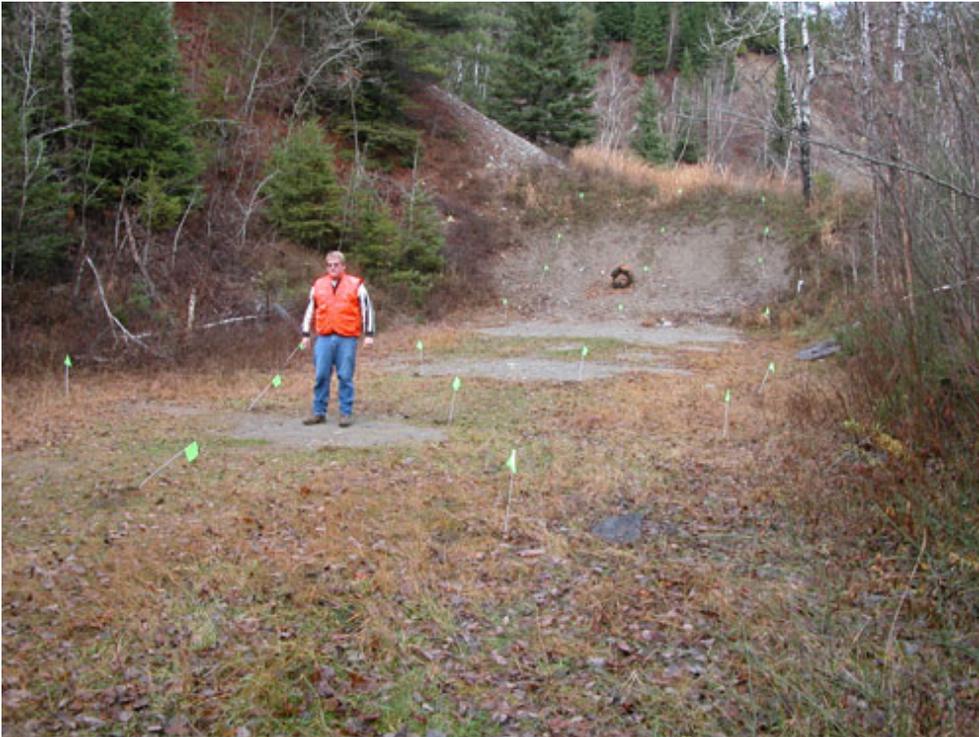
**Photo #3. Sampling locations for 2005 site assessment**

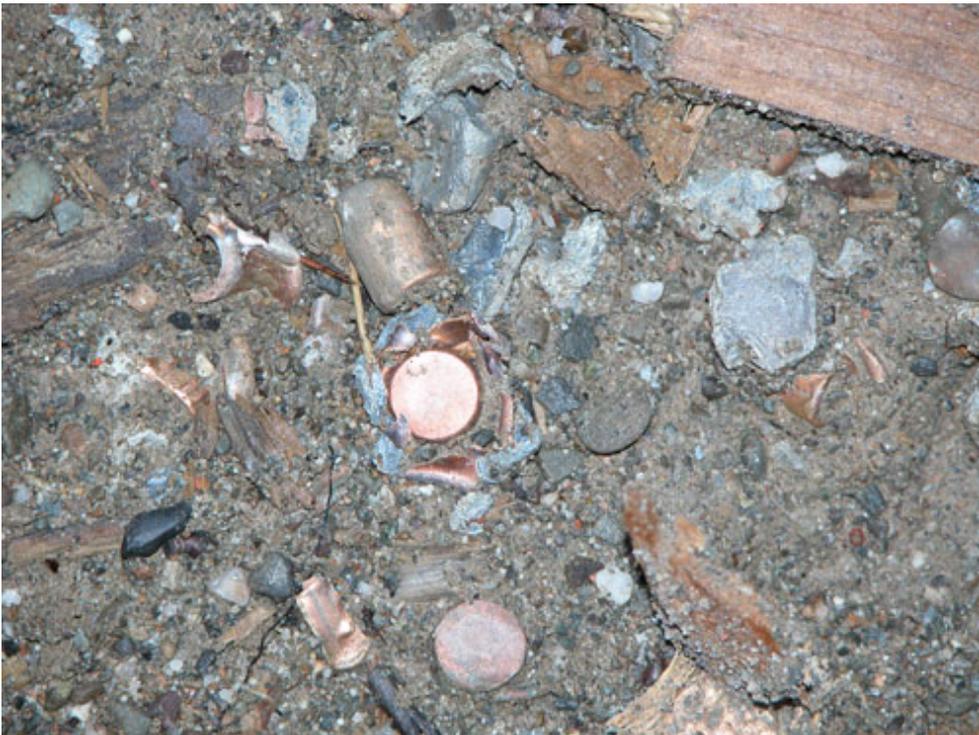
Lead and bullet fragments were not observed during visual inspections of the surface soils collected from the range floor or in surface and subsurface soils from the toe of the range berm. Bullet fragments were clearly visible in the surface samples from bore holes across the middle of the berm (Photo #4), but no fragments were found in subsurface samples. No bullet fragments were observed in the soil boring from the top of the berm.

**Photo #4. Bullets on face of berm**

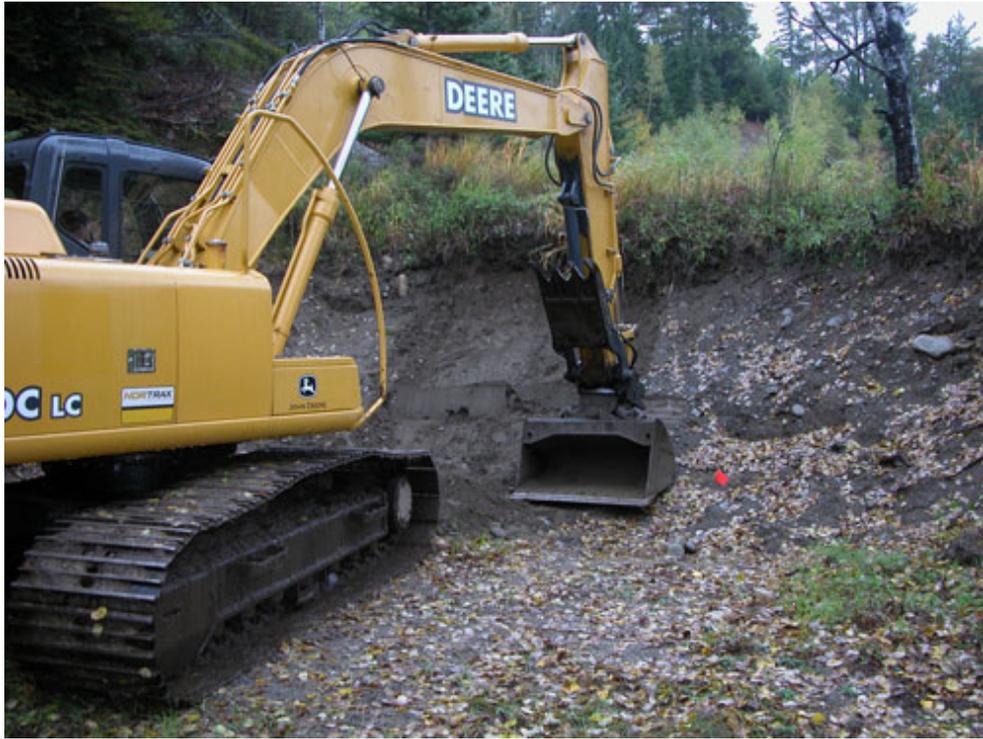
**Photo #5. Smooth-edge bucket**

An excavator with a smooth-edge ditch bucket was used to excavate the first one foot layer of the range berm (Photo #5). Material was placed into a dump truck (Photo #6), transported to the soil stockpile area, and dumped onto the geotextile fabric. Following the first soil lift, USFWS and MEDEP personnel collected eight soil samples (each approx. 500 grams) from the range berm at a depth of 0 to 6 inches for screening with a portable x-ray fluorescence spectrometer (XRF). The XRF sample locations were selected using a pre-determined grid pattern of eight 8' x 8' cells (Figure 2). XRF soil samples were placed in labeled, polyethylene bags and analyzed by MEDEP personnel for Pb. Each soil sample was screened twice with the soil bag being shaken between screenings.

6.6 Smooth-edge ditch bucket. During the development of the Scope of Services, MEDEP strongly suggested the use of a smooth-edge bucket on the excavator (Photo #5).

The rationale was that excavation of specific soil layers (e.g., 1 foot, 2 foot, etc.) could be accomplished with greater precision with a smooth-edged bucket rather than a tooth-edged bucket. In the field, the utility of the smooth-edge bucket was clearly demonstrated, particularly when under the control of an experienced heavy equipment operator. The soil lifts at one-foot intervals across the face of the berm were very precise and spillage during offloading to the dump truck and to the transport trucks was negligible.

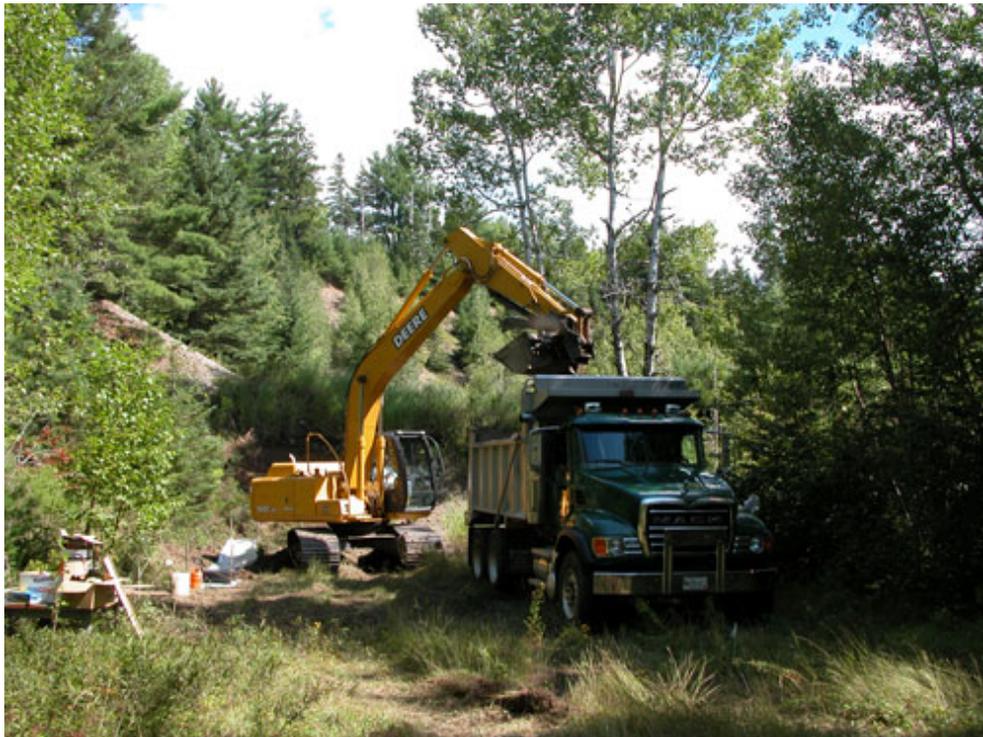
**Photo #6. Loading dump truck**

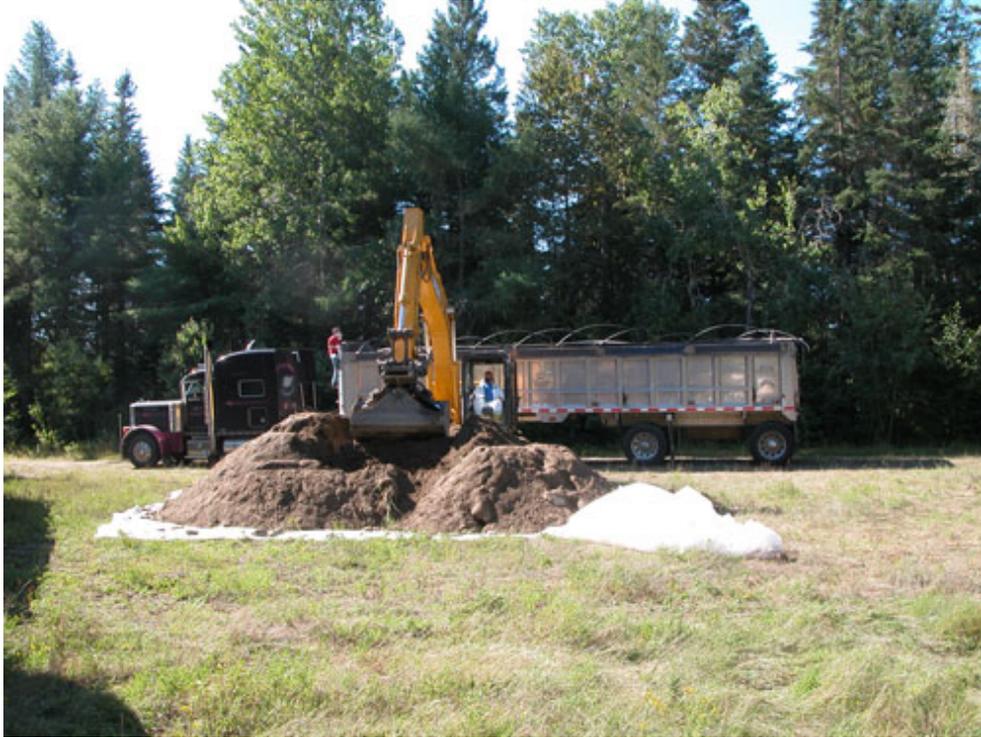
**Photo #7. Loading transport truck**

On August 21, two trucks from the waste disposal facility arrived on-site. Three trucks were expected, but due to miscommunication between the contractor and hazardous waste facility only two trucks arrived. Soil was transferred from the stockpile area into the two trucks and transported off-site (Photos #7 and #8). Traffic control was provided by Moosehorn NWR staff and R5 Refuges Law Enforcement personnel. Due to highway weight limitations, the entire soil stockpile could not be loaded onto the trucks and a portion of the pile was left at the stockpile area and covered with polyethylene sheets. Manifests and documents associated with the first round of soil transport to the hazardous waste facility are located in Appendix D.

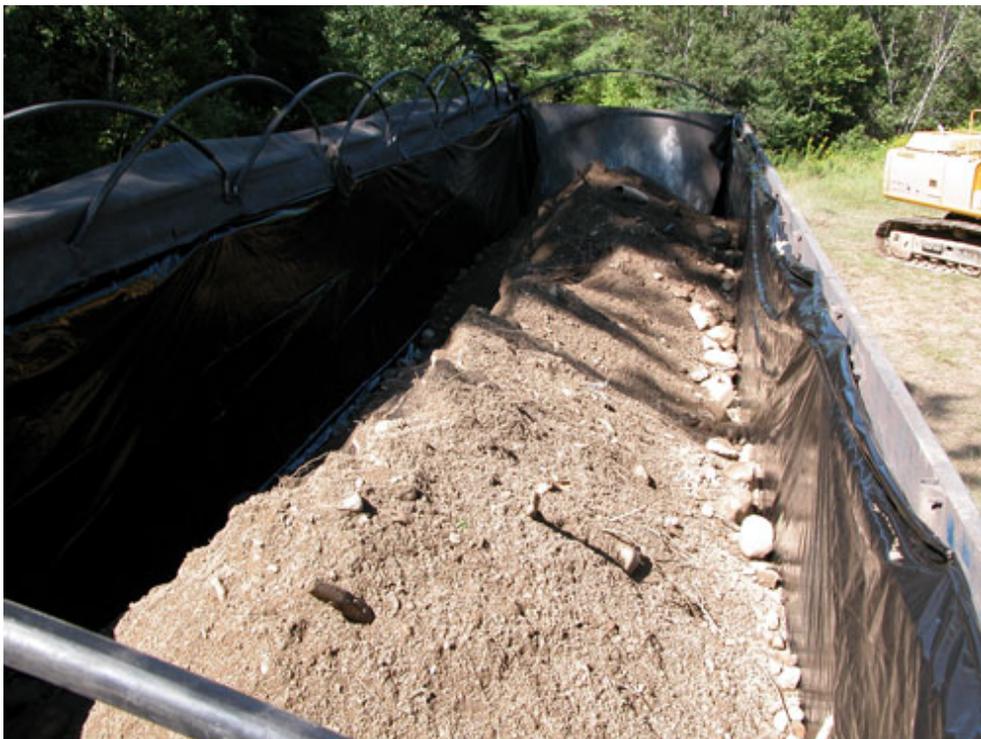
**Photo #8. Lined and loaded transport truck**
