Railroads Restoration Project Workplan

RESTORATION WORK PLAN

**Slip 5A Peninsula
Ashtabula, Ohio**

Norfolk Southern Railway Company

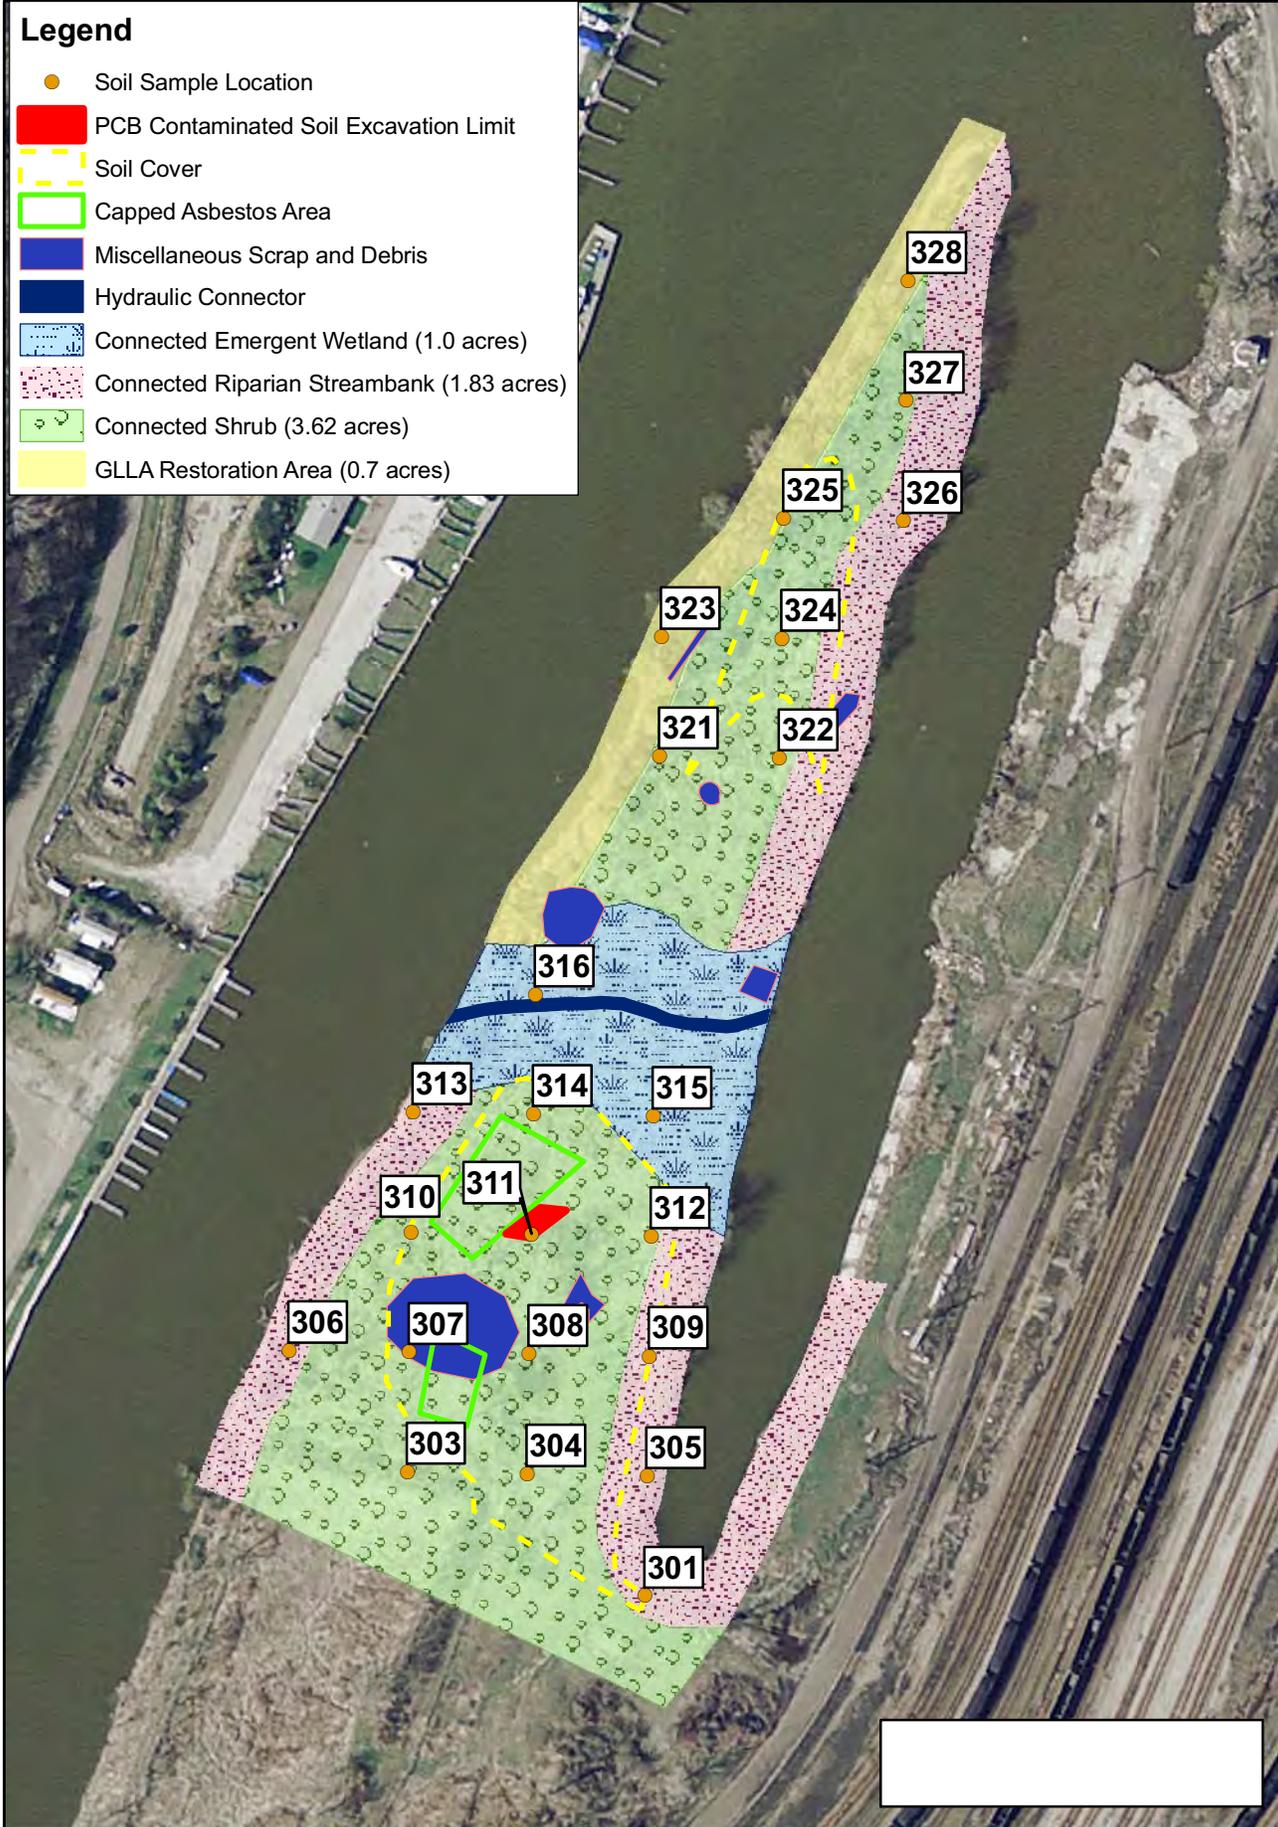
Figure
 3

- Soil Sample Location
- PCB Contaminated Soil Excavation Limit
- Soil Cover
- Capped Asbestos Area
- Miscellaneous Scrap and Debris
- Hydraulic Connector
- Connected Emergent Wetland (1.0 acres)
- Connected Riparian Streambank (1.83 acres)
- Connected Shrub (3.62 acres)
- GLLA Restoration Area (0.7 acres)

**Proposed Primary Restoration of Slip 5A Peninsula
 Ashtabula, Ohio**

Restoration projects are commonly implemented to compensate for natural resource damages. The proposed restoration projects are presented in Figures 3 and 4, respectively. Details of the conceptual restoration described in the following subsections may be refined during the final design phase.

As described in Section 1.5, additional areas in the Slip 5A peninsula (Figure 3) were selected to receive a soil cover to limit potential ecological exposure to surface soils. Soil for the cover material will be excavated from the proposed hydraulic connection and connected emergent wetland area. These soils will be placed in targeted areas and spread to at least a depth of one foot. Performance standards for the soil cover will be specified in the design documents. Following the placement of the clean soil, native vegetation will be installed as described in Section 2.6.

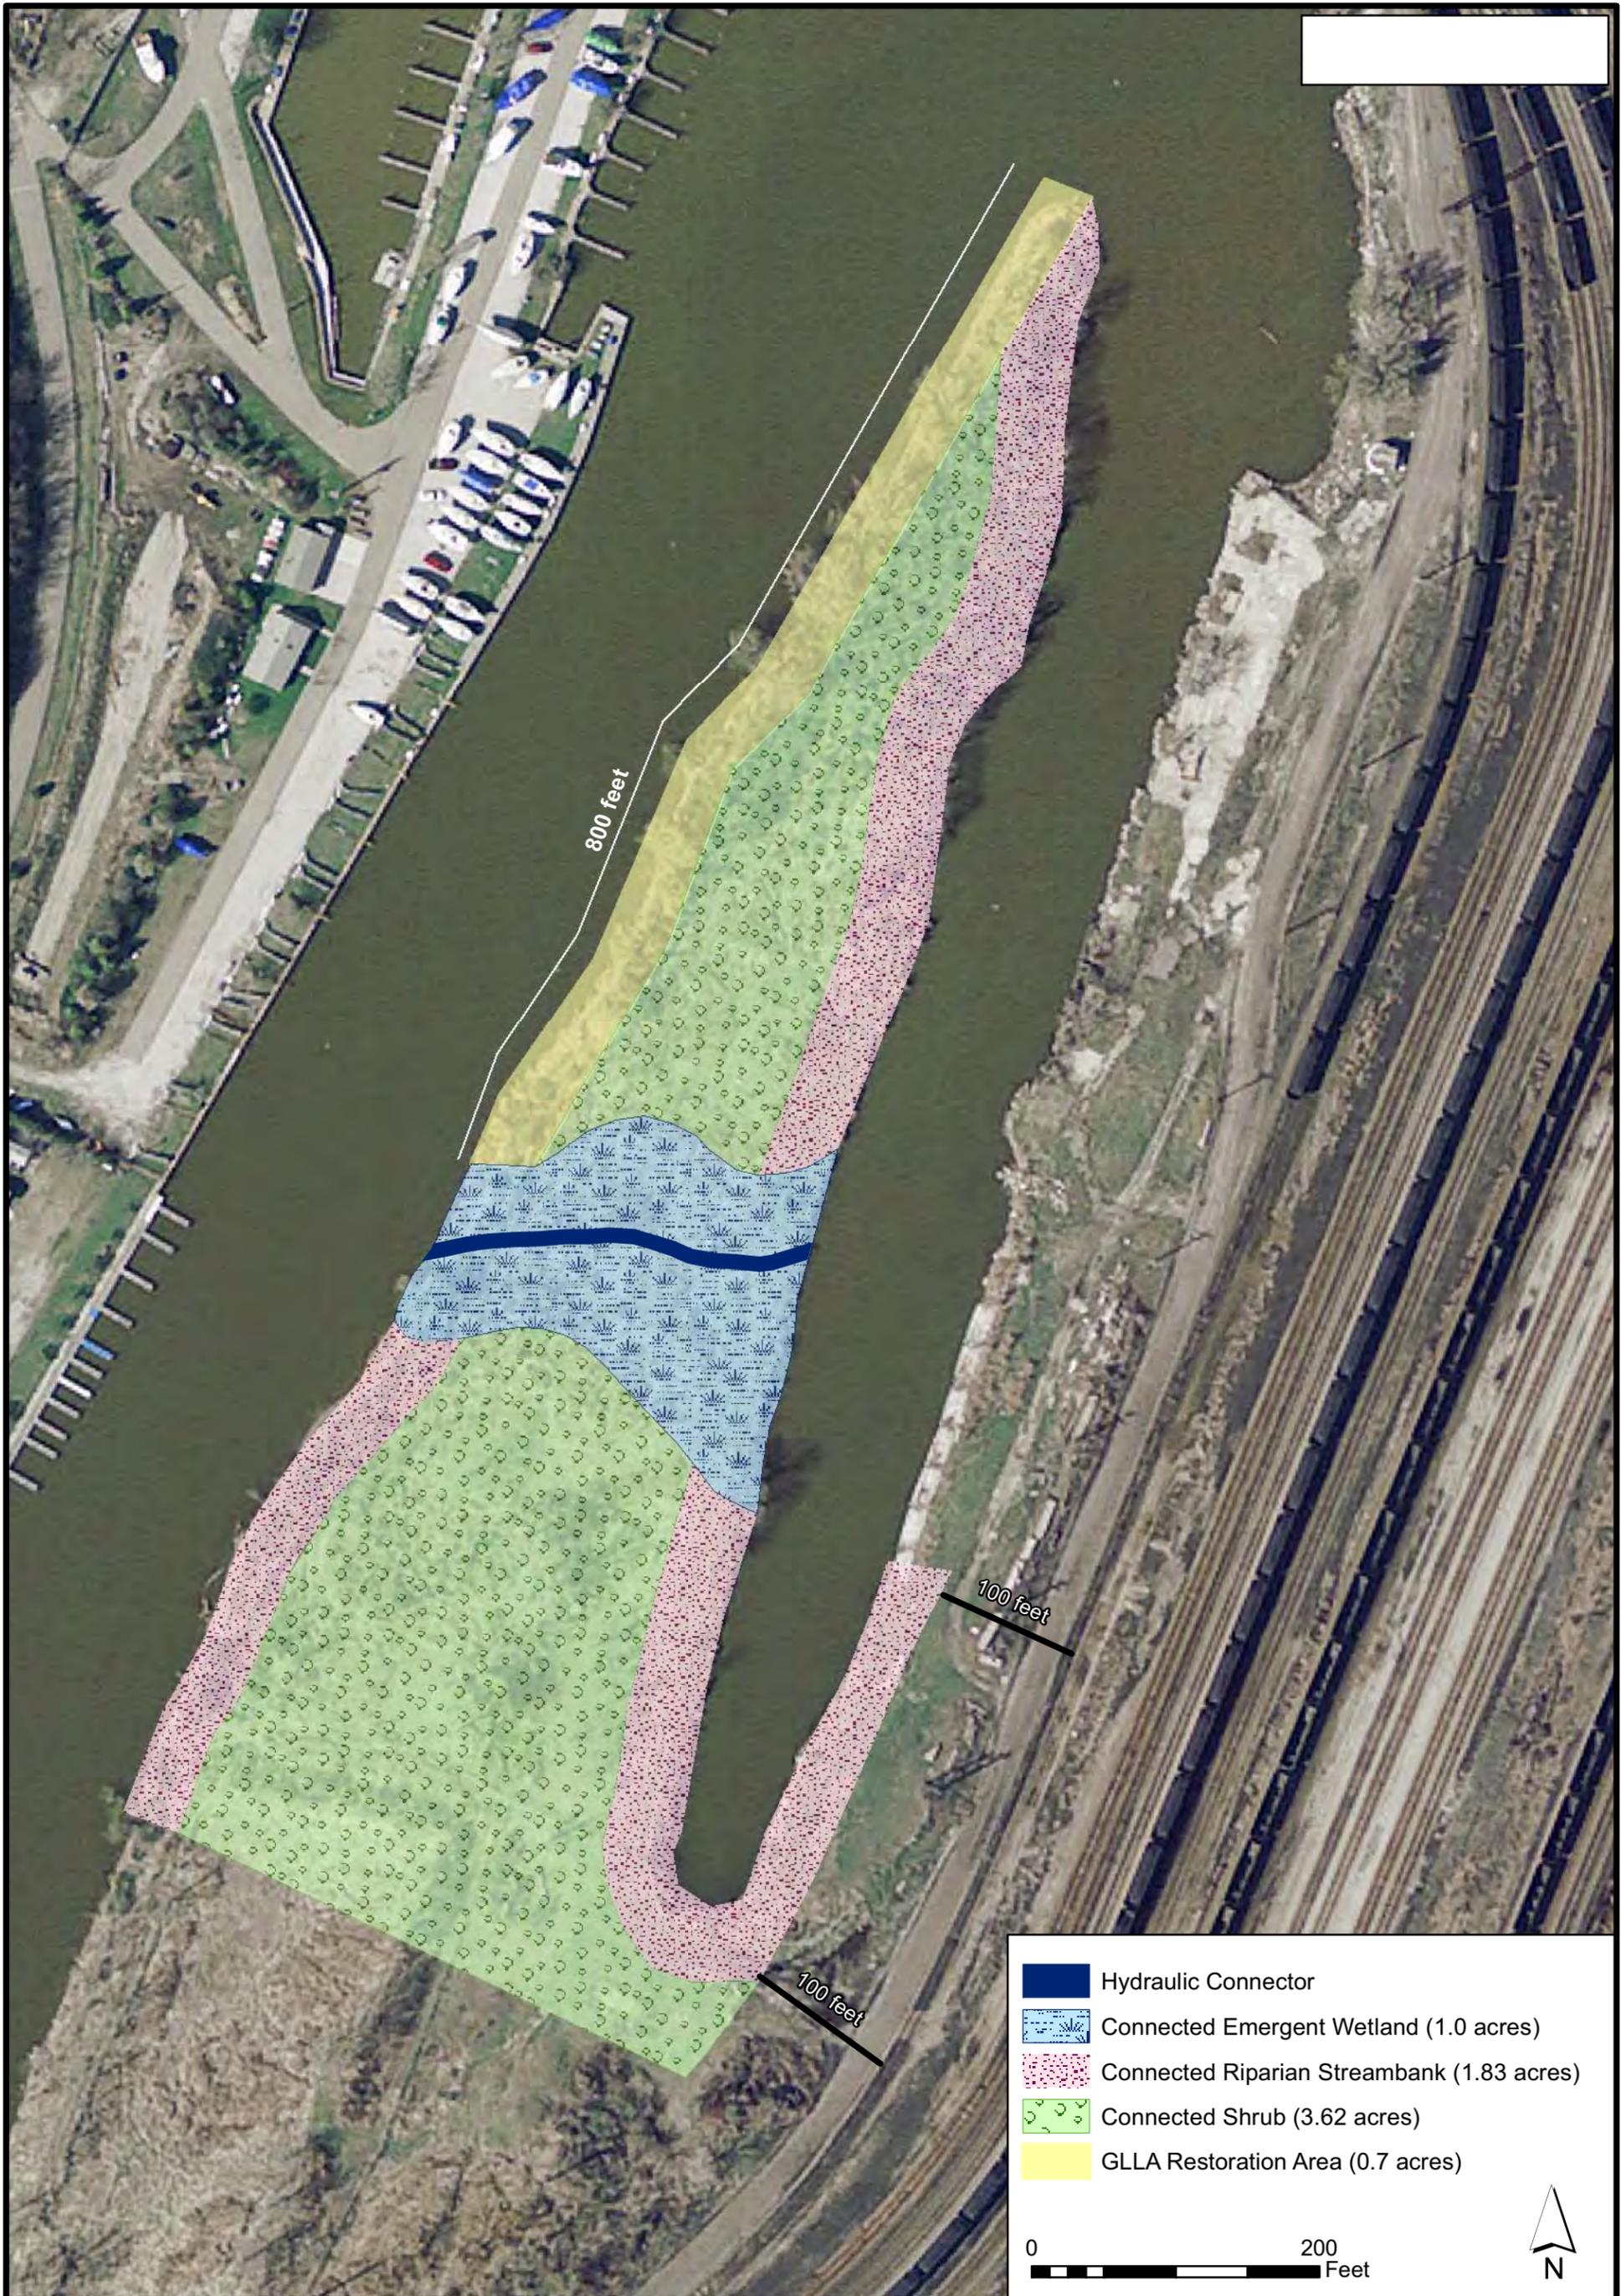
Figure
4

**Proposed Compensatory
Restoration of Slip 5A Peninsula**

A channel will be excavated to establish a new hydraulic connection between the Ashtabula River and Slip 5A (Figure 4). This component of the restoration plan will facilitate connected emergent wetland creation in the adjacent area and may increase the value of Slip 5A as a refuge for aquatic life in the heavily used Ashtabula River. The area immediately adjacent to the hydraulic connector will be excavated and graded to create a mosaic of emergent and forested wetlands. Soil excavated during the creation of the hydraulic connector and wetland areas will be placed on-site to enhance the upland connected shrub habitat.

Bank stabilization measures (Figure 5) will be implemented near the created hydraulic connection and wetland area and along the targeted connected riparian streambank (Figure 4), to reduce the possibility of erosion. The specific locations requiring bank stabilization will be identified in the design phase. Erosion issues can be addressed by regrading the banks and planting soil-stabilizing vegetation. A 3:1 slope will be considered the target where adjacent land use and conditions permit (FISWRG, 1998). Where the 3:1 target is not attainable, erosion control matting may be placed to stabilize the slope until vegetation is fully established.

Three planting zones (i.e., connected emergent wetland, connected riparian streambank, and connected shrub) will be determined based on elevation (Figure 4). Preliminary estimates indicate that the connected emergent wetland, connected riparian streambank, and connected shrub areas are approximately 1 acre, 1.83 acres, and 3.62 acres, respectively. Currently the Slip 5A peninsula is characterized by low plant diversity and high density of non-native species. Enhancing the native vegetation along the riparian corridor will increase filtration of surface water runoff; decrease erosion, contaminant, and nutrient loading; and enhance overall stream water quality. The plant community in each zone will be established using selected grasses, forbs, shrubs, and understory and overstory trees. Tables 5 and 6 provide example herbaceous seed mixes and tree/shrub species compositions for each zone. The selection of plant species will be based on the following criteria:
