COLUMBIA CONSERVATION CHRONICLE

A JOINT PUBLICATION BY
**MISSOURI ECOLOGICAL SERVICES
FIELD OFFICE
&
COLUMBIA
FISH & WILDLIFE CONSERVATION OFFICE**

DECEMBER–JANUARY 2012

2012 Year in Review: Columbia FWCO Fish Passage Projects

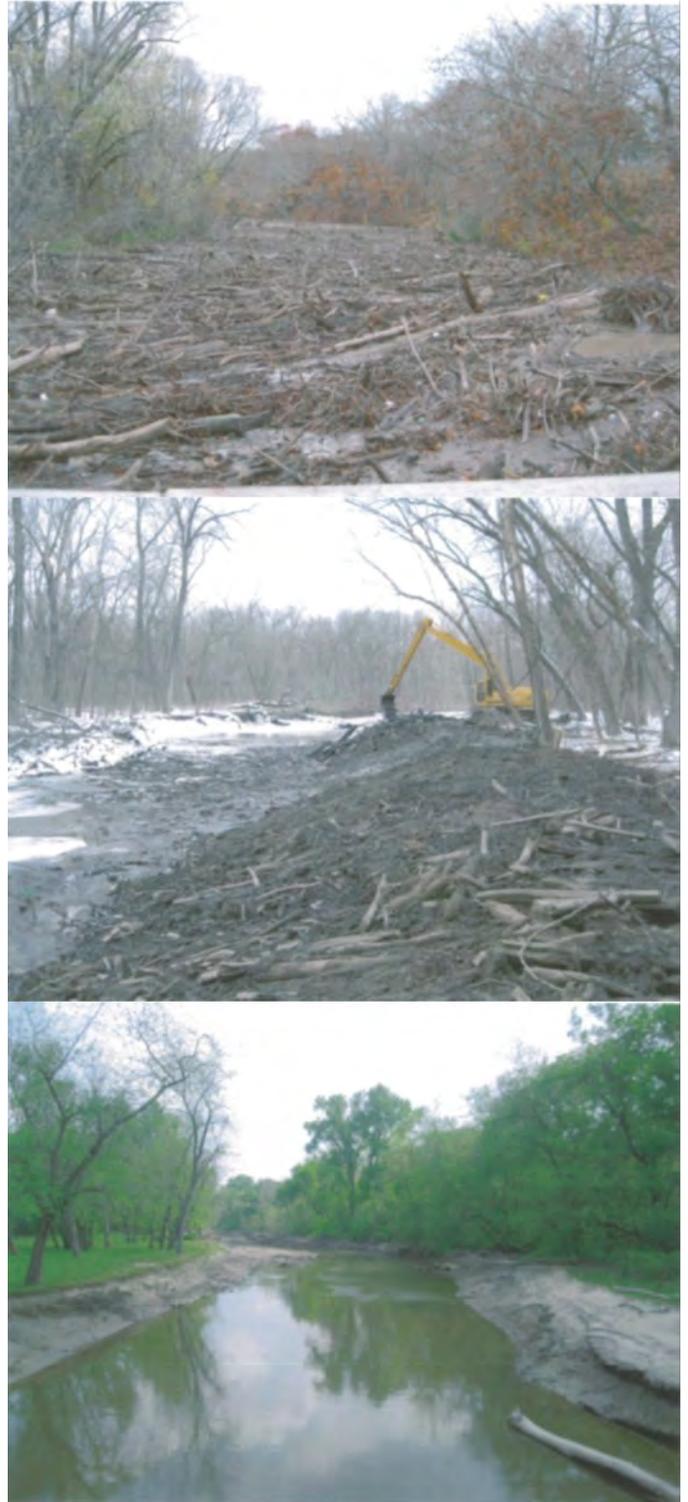
One of the logjams removed in Pershing State Park, Linn County, Missouri. Top: Pre-removal (2009). Middle: removal (2010). Bottom: open channel of Locust Creek (2011). Photos courtesy of: Missouri Department of Natural Resources.

Beginning in 2008, Missouri Department of Natural Resources (MODNR), and Missouri Department of Conservation (MDC) began working to remove five logjams in Locust Creek and Higgins Ditch on Pershing State Park in Linn County MO. This partnership was made possible because of a Fish Passage Grant through the Columbia Fish and Wildlife Conservation Office (Columbia FWCO). The purpose of the Fish Passage grant was to facilitate seasonal migration and intra-population movements of trout perch (*Percopsis omiscomaycus*), a rare species in Missouri, and restore wet prairie habitats to benefit the federally endangered Eastern massasauga rattlesnake.

Severe flooding in 2009 and 2010 thwarted efforts to remove the logjams and deposited more debris delaying completion of the project. Fortunately the mild winter and drought conditions in 2011-2012 allowed the project to be completed. In total, over 9,700 feet of logjams were removed from the two creeks and both are now free flowing. MODNR submitted their final report in 2012 and will monitor the area over the next five years.

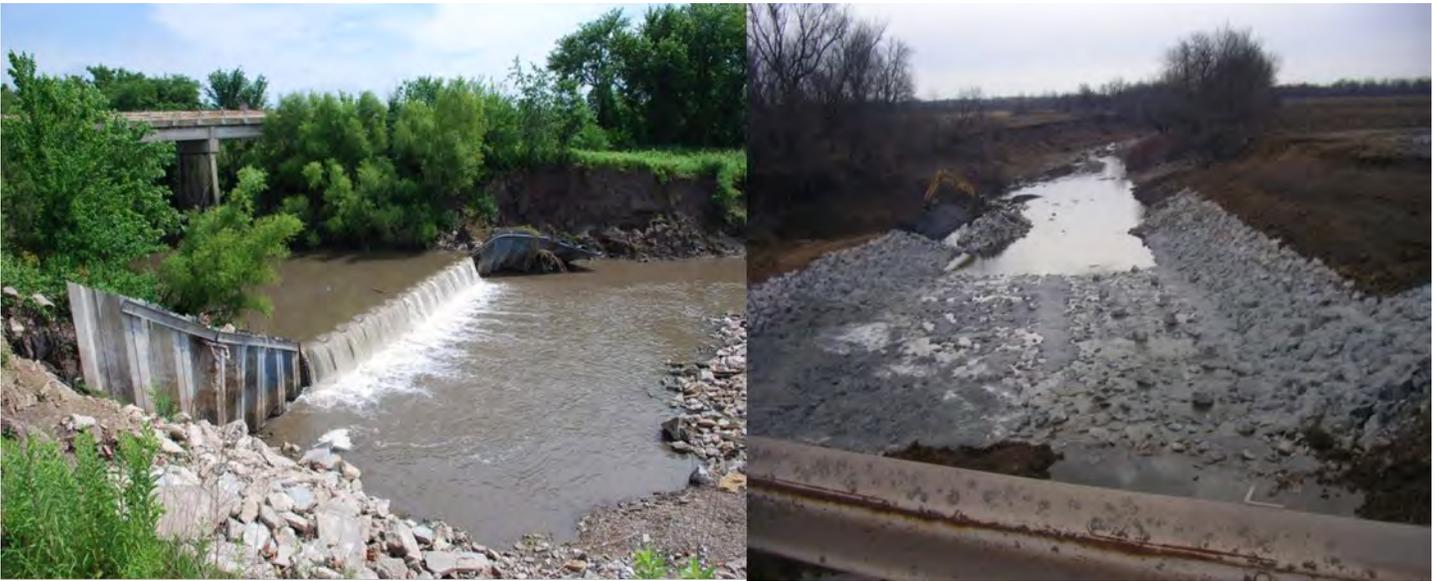
Left: Failing weir on the West fork of the 102 river in Taylor County IA in 2011. Right: After construction the 1:15 sloped grouted rip-rap fish and boat passage structure in 2012. Photos courtesy of: John Thomas, Hungry Canyons Alliance.

The steel sheet pile weir on the West Fork of the 102 River in southwest Iowa has been a barrier to fish passage for decades. The sheer vertical face of the weir made it impossible for fish and other aquatic organisms to migrate freely and was a safety hazard to paddlers. Flooding in 2010 began to wash out the weir which threatened the integrity of the upstream bridge. In 2011, the Taylor County Commission, Hungry Canyons Alliance, Iowa Department of Natural

Resources, and NRCS partnered with Columbia FWCO for a Fish Passage Grant to replace the failing weir with a fish and paddler friendly structure and to save the bridge. The flathead chub (*Platygobio gracilis*), listed as one of the species of greatest conservation need under Iowa DNR's Comprehensive Wildlife Action Plan, along with multiple other fish species, can now pass easily through the 1':15' (rise/run) grouted rip-rap slope. The structure was completed in December 2012. Iowa DNR will be conducting post-construction monitoring of fish passage at the project.

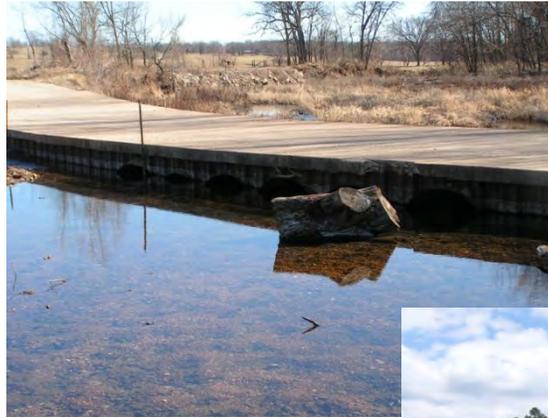
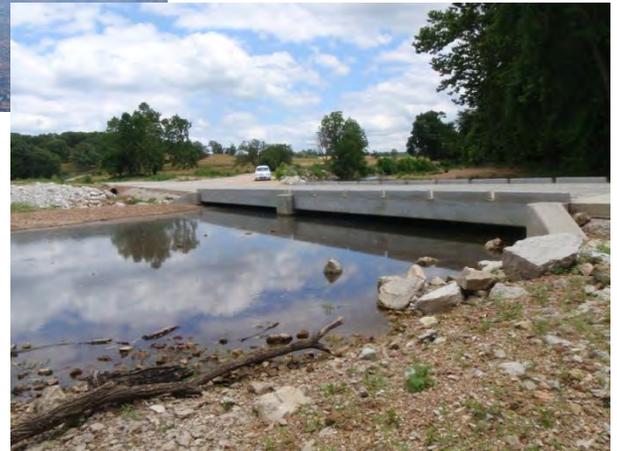
Left: Prosperity Road slab crossing on the Little Niangua River in Dallas County MO before Construction. Below: Free span bridge on Prosperity Road in 2012. Photo Credit: Columbia FWCO, USFWS.

The Missouri Department of Conservation (MDC) 2004 Niangua Darter Recovery Plan identifies slab crossings as a reason for preventing fish from migrating between reaches and a cause for the decline of the federally listed Niangua darter (*Etheostoma nianguae*) in central Missouri. The MDC conducted a crossing survey in the native range of Niangua darter and identified 32 crossings that posed a barrier to migration. Prosperity road marks the 19th crossing to be replaced with a free span

bridge in the Niangua darter range. Prosperity road is in Dallas County on the Little Niangua River and the next to last barrier on this river to be removed. Griffith road is the last slab crossing posing as a barrier on the little Niangua River and is the next upstream barrier from Prosperity Road. We hope to have Griffith road slab replaced in 2013. While MDC was the recipient of the Grant, their partnership with Dallas County Commission and Great Rivers and Associates saw the project to completion. This project began in 2011 and, despite some minor setbacks with needing heavier equipment to remove the old structure, the project was

completed with a new free span bridge in the spring of 2012. MDC conducts annual monitoring of Niangua darters throughout the range and specifically at bridge replacement projects and found them occupying the area within weeks of project completion. Only 13 more barriers are left and the entire native range of the Niangua darter will be free flowing again.

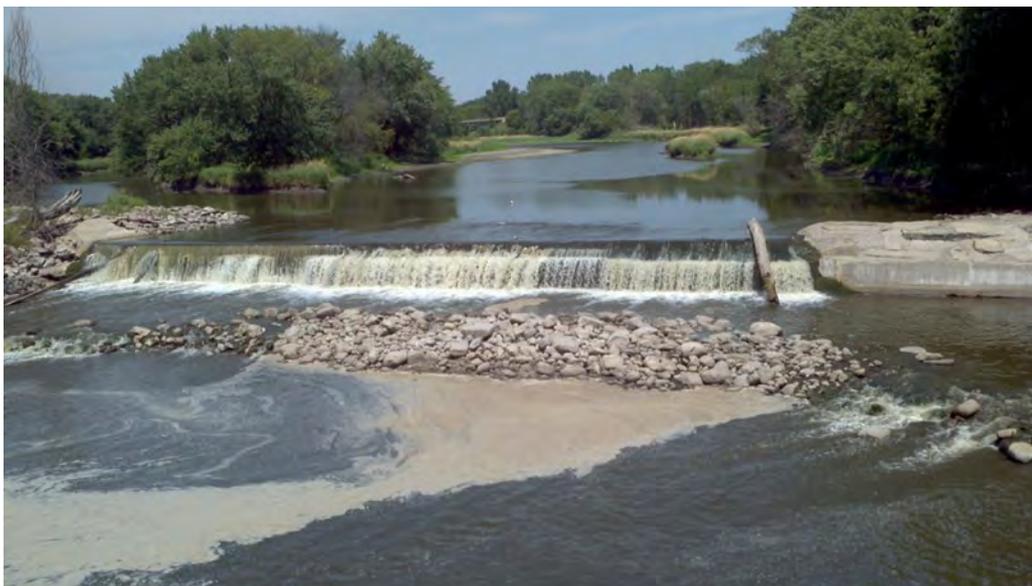
Klondike Dam on the Big Sioux River between NW Iowa and SE South Dakota. Rock Arch Rapids will be placed below the dam to allow for fish passage and paddler channels. Photo Credit: Heather Calkins, USFWS.

This project was originally funded with a Fish Passage grant in 2009. There have been several delays, primarily with determining historic significance of the dam, flooding and relocation of mussel beds in the construction footprint. Klondike Dam is a unique project to Columbia FWCO.

Game Fish and Parks in addition to local municipalities. Removal of this dam is not a feasible alternative as several alluvial wells would be affected if upstream water levels were

lowered. Instead a series of rock arch rapids will be constructed. The final reason this project is unique is that it was one of 11 river projects highlighted by Secretary of the

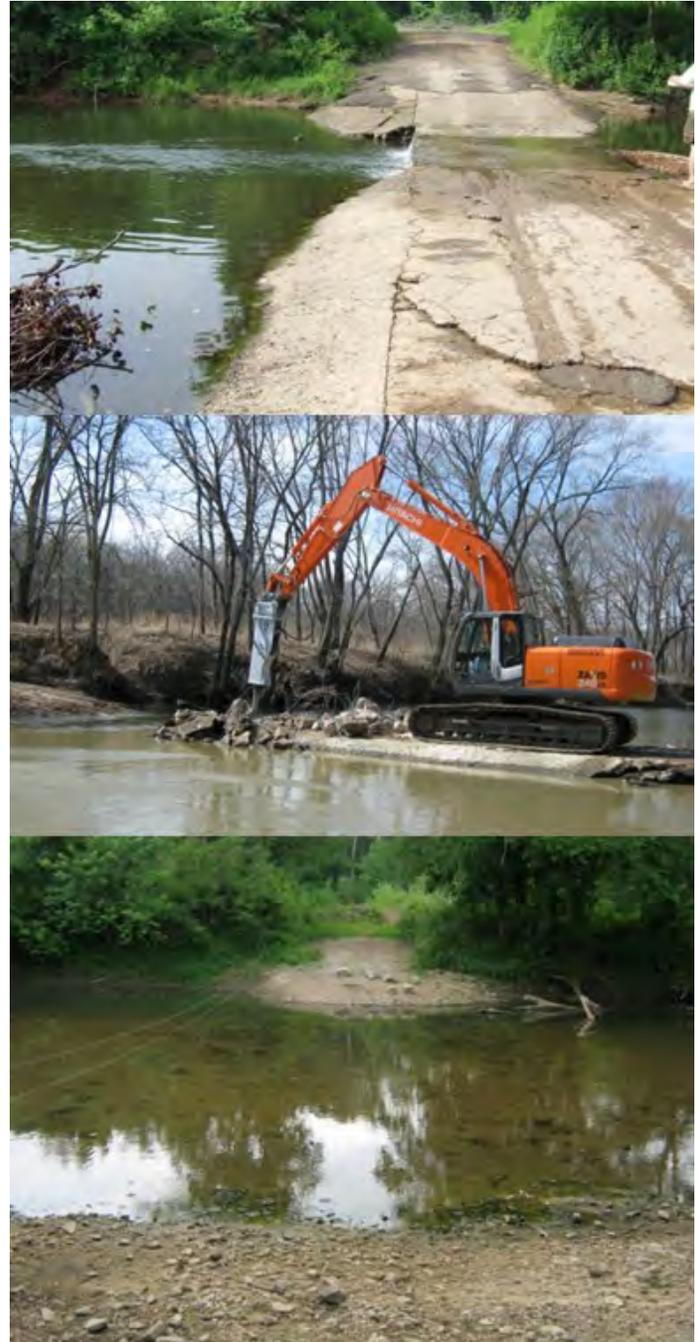
Top: Deans Ford, a slab crossing on the Dry Fork of the Meramec on County Road 3330 in Phelps County, MO before demolition. Center: Demolition of Deans Ford. Bottom: After slab removal of Deans Ford. Photos courtesy of: Missouri Department of Conservation.

Dry Fork creek, a tributary to the Meramec River, in Phelps County, Missouri, has the largest predicted and observed species diversity in the entire Meramec River basin. The slab crossing on County Road 3330, known as Deans Ford, is the only barrier on this creek. The ownership of this crossing was transferred to private ownership and is no longer maintained by Phelps County Road Commission. This was an excellent opportunity to remove this unvented slab which prevents all passage of aquatic organisms at normal stream levels. A cooperative agreement with MDC and the landowner was reached and a Fish Passage grant was provided to remove the slab crossing and replace it with a lite equipment and livestock crossing with a natural bottom. To date the slab has been removed and we are postponing installation of the material for the lite crossing until a few more high water events needed to stabilize the stream bed and transport impounded sediments. We hope to have this project completed in 2013 - if the creek will rise.

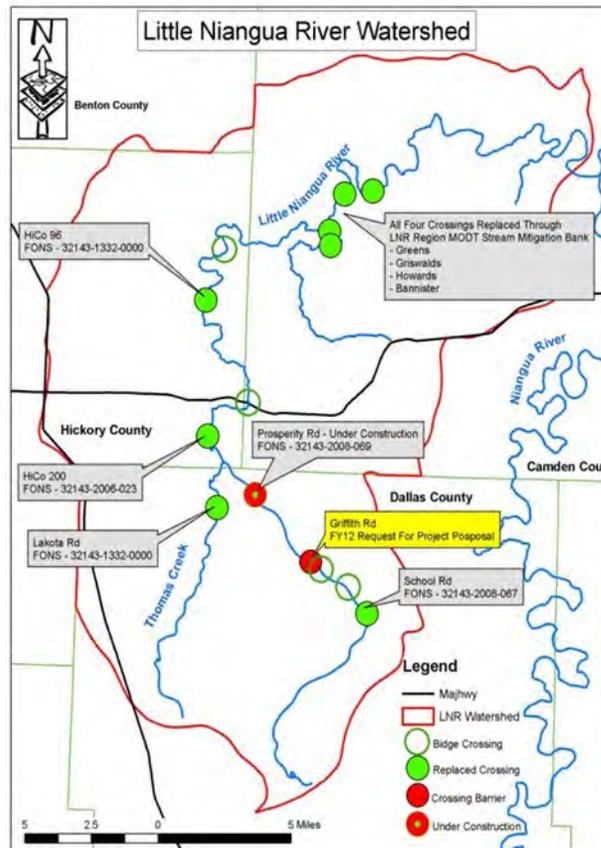
Map of barriers within the Little Niangua Watershed of Missouri 2012. Map courtesy of: Missouri Department of Conservation.

Just a few miles above the new bridge on Prosperity Road is the next barrier, Griffith Road Slab, the last fish passage barrier on the Little Niangua River. The map to the right was produced by our partner, the Missouri Department of Conservation, as part of their proposal to replace Griffith Road Slab. At the time Prosperity was under construction. What is notable is that of the ten crossings in the Little Niangua River posing as fish barriers, the Fish Passage Program only funded six; the other four were replaced by the Missouri Department of Transportation recognizing the need for fish passage. Once finished, Griffith Road Bridge will open 9.1 miles of stream habitat to the Niangua darter and the entire 55+ miles of the Little Niangua River will be barrier free. This will reduce the number of previously genetically isolated meta-populations from nine to one population, theoretically able to move and reproduce freely throughout their new range.

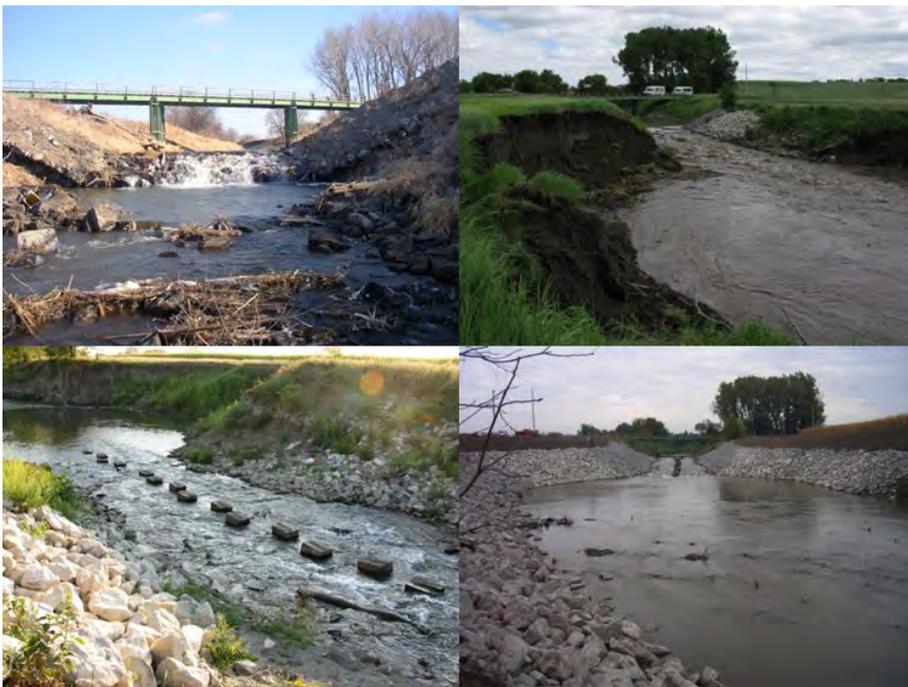
Top Left: Farm Creek Weir in Mills County Iowa before construction. Top Right: Before the project could be finished, severe flooding created a scour hole, eroding private land downstream of the modified weir. Bottom Left: 1:15 sloped modified weir at normal flow. Bottom Right: Partial completion of armoring the stilling basin to control the scour. Photos courtesy of: Hungry Canyons Alliance.

The bridge over Farm Creek in Mills County, Iowa was like many of the other 600+ bridges with steel sheet pile weirs; it prevented fish from migrating. It was selected by Hungry Canyons Alliance and Iowa DNR as the highest priority weir modification project in western Iowa. That is until a Fish Passage grant was given to fix the problem in 2007. Unfortunately before a stilling basin could be added to the outlet of the upper weir, a major flood event occurred in 2008 causing a large scour hole to form downstream of the weir. Additional funds were provided in 2011 to create a second 1:15 slope weir with a "V" notch downstream of the

stilling basin and armor the banks of the stilling basin to prevent the scour hole from expanding into private property. This project is expected to be completed in 2013.

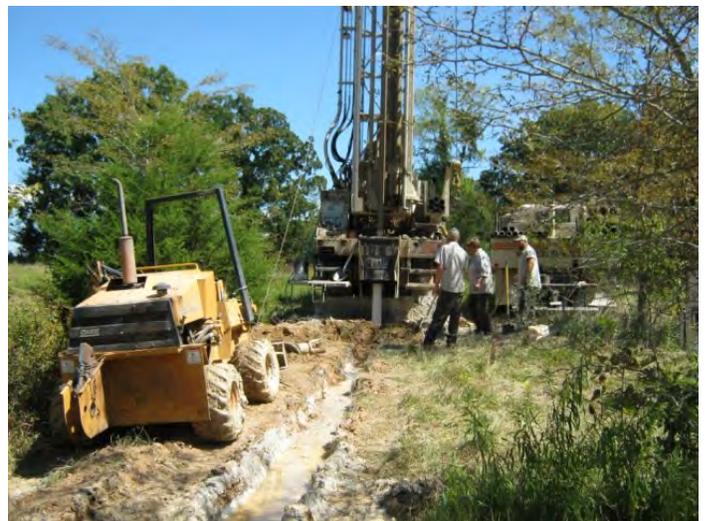
Well drilling for alternative water source for cattle. Photo courtesy of: Missouri Department of Conservation.

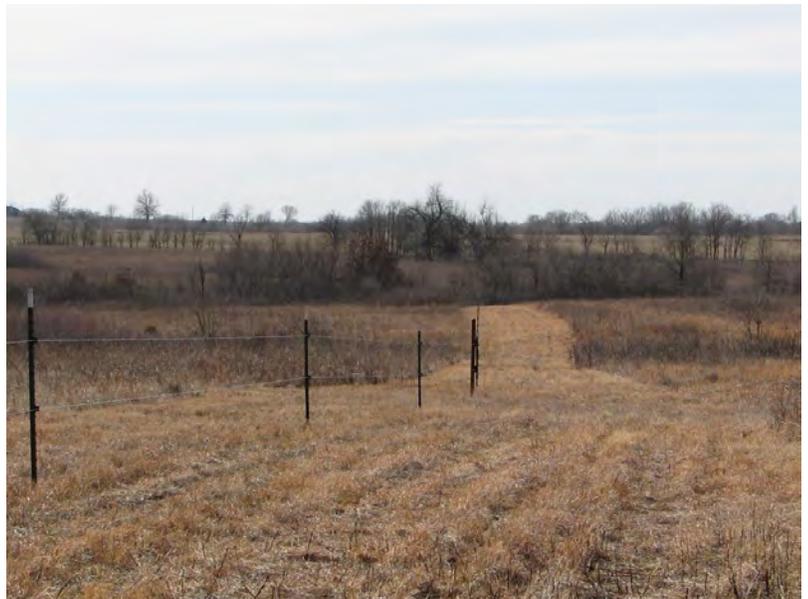
Shelton Prairie fence protecting stream from cattle. Installed using funds from the Great Plains FHP. Photo courtesy of: Missouri Department of Conservation.

This project excludes cattle access from two prairie streams located on different MDC owned prairies, Stony Point and Shelton, by constructing permanent fencing. These streams are unnamed tributaries in the Horse Creek watershed that

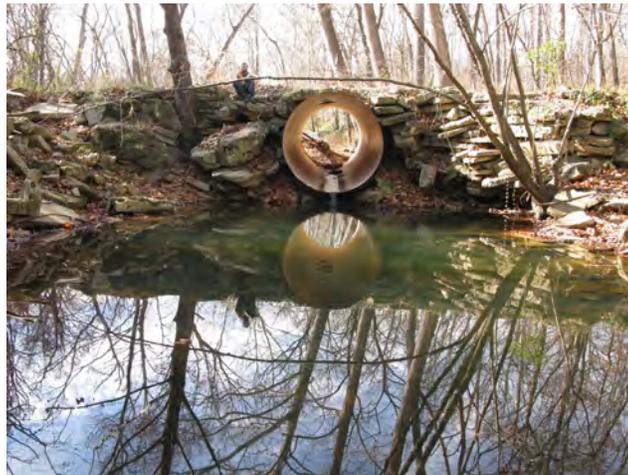
Photo of a perched culvert. Photo credit: W. Brock, USFWS.

On this particular bridge that I'm measuring, the water is pouring out of a pipe culvert and making a waterfall which pours into a deep pool below with fish swimming lazily around. This ambient environment momentarily dulled my senses to the actual problems associated with even hearing the sound of a waterfall at a bridge. The fish below know all too well what the waterfall means to them and their historic migrations. The waterfall impedes their upstream movement as it is too high for them to jump.

Originally these bridges had the bottom of their culverts well below water level. The fish were able to travel with minor difficulty upstream.

However, due to problems associated with this stream, erosion has left many bridges with a waterfall and frustrated fish downstream. This is one of the reasons crews from Columbia FWCO were measuring this and other stream crossings.

placid face, I realized how some of these waterfalls may have formed. The worn paths to-and-from their icy baths increase erosion and sediment transport. Grazing of vegetation along the streams also increases runoff and allows for the streams to become flashy during rain events. All of these factors come

together to disrupt the equilibrium of the stream resulting in perched culverts and, thus, waterfalls.
