Passages for fish

Proceeding of a workshop held at Piacenza, Italy, June 10 2006
"Fish elevators: a tool for overcoming barriers for large migratory fish"
 co-organized by Provincia di Piacenza and WSCS

World Sturgeon Conservation Society: Special Publication n°2 (2008)

LAKE STURGEON USE OF THE EUREKA DAM FISHWAY, UPPER FOX RIVER, WISCONSIN, USA

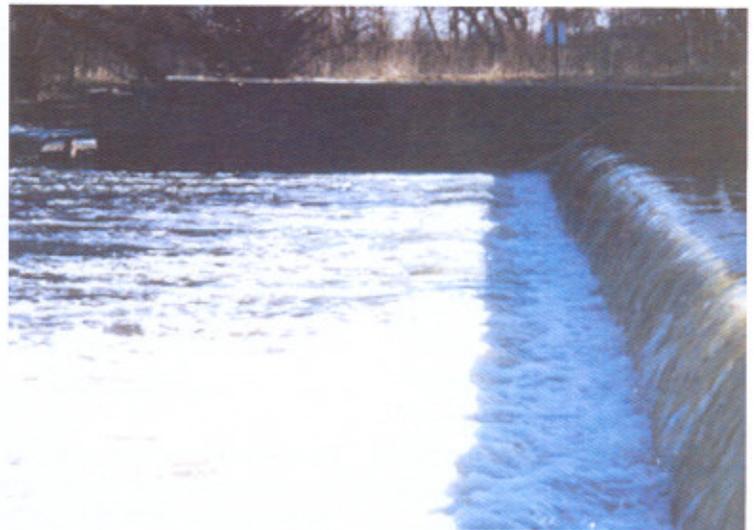
Figure 3. Eureka Dam on the Upper Fox River, Winnebago County, Wisconsin, historic photograph on the original configuration as built in 1877.

The 1 meter head Eureka dam was constructed on the upper Fox River in 1877 as part of a series of locks and dams built to facilitate commercial navigation between the Lake Michigan and Mississippi River basins (Figures 2 and 3). The construction of the dam and lock system was initiated by the Green Bay and Mississippi Canal Company, but ultimately financed and completed by the US Federal government. By the time the navigation system was completed, the railroads were well established in this area of Wisconsin, and as such, likely competed with the high maintenance Fox River waterway. Commercial traffic on the waterway ceased in 1938 and the navigation system was closed in 1951 (Wisconsin Department of Natural Resources, upper Fox Waterway files, Oshkosh). On August 1, 1962, the US Army Corps of Engineers transferred ownership and management responsibility of the 9 locks and 7 dams on the upper Fox River to the state of Wisconsin Conservation Commission. As part of the agreement for transfer of ownership, the Federal government rebuilt the Eureka dam using steel sheet piling. The Eureka locks and dam at the time were the only locks still functioning on the upper Fox River, operated since 1953 by a recreational boating club located upstream of the dam in the city of Berlin. The continued operation of the Eureka locks for recreational boat-

was solved by the installation of the plunge pool fishway, downstream migration over the dam itself was believed to still be a problem. Dyed fry drift studies completed with walleye in the 1960's indicated strongly that few larval fish were able to escape from the undertow below the spillway of the dam (Figure 3) (Priegel, G. WI Dept. of Natural Resources-retired, personal communication). Small lake sturgeon are very poor swimmers (Amaral et al. 2003), and likely would also find it very difficult to escape the undertow below the dam. To address this problem, the Wisconsin Department of Natural Resources joined with numerous sport fishing organizations including Walleyes for Tomorrow, Sturgeon for Tomorrow and Otter Street Fishing Club and a local, although world-known marine engine firm, Mercury Marine, to design and finance the construction of the Eureka Rapids.

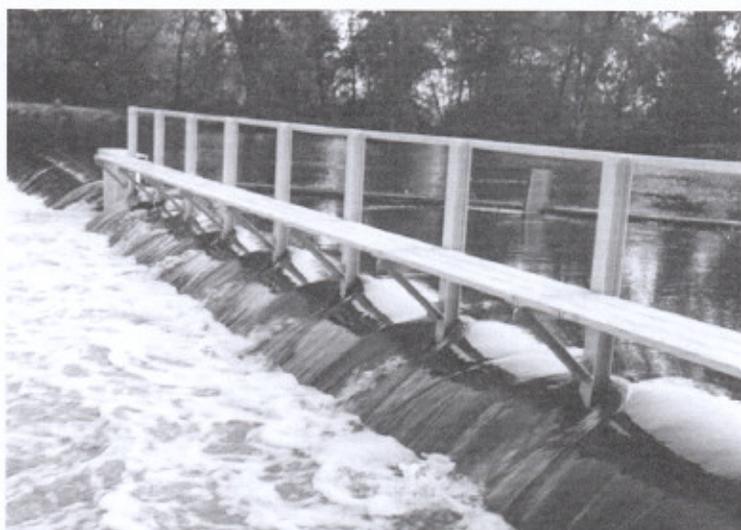
Figure 4. Original fishway at Eureka Dam after dam repairs, 1962. Fishway only operated successfully during high water events as depicted in the photo.

The first organized efforts to place an effective fishway at the Eureka dam began in May 1944. Recreational anglers upstream of the dam in the City of Berlin petitioned the Wisconsin Conservation Commission, who in turn petitioned the Federal government to install a fishway at the dam primarily to accommodate fish spring runs of walleye (*Sander vitreus*). The original dam was 60 meters long with 6 meters of hand operated sluice gates that provided an opening through which, it was thought at the time by the Federal government, fish could migrate if the sluice boards were removed. Although efforts by the recreational anglers and the state government in the 1940's and 1950's failed to secure the funding necessary to install a fishway specifically designed to pass fish past the dam, the sluice gate system was rebuilt in 1962 when the dam was rebuilt, with the hopes of improving fish migration past the dam. Fish passage occurred over Eureka dam following the re-construction of the sluice gates, but only during extreme flood events (Fig. 4).

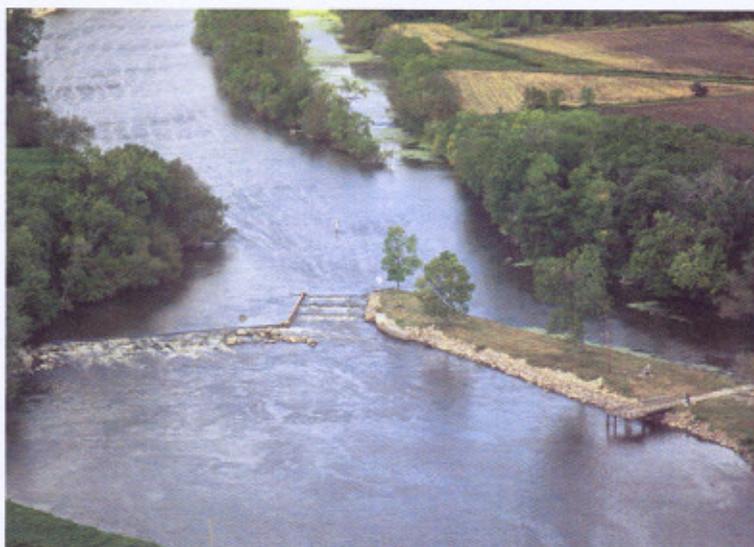
Fig. 8. Eureka "Rapids" and fishway looking upstream from below the dam, 2005.

In the winter of 1992-93, barges dumped 3250 cubic meters of quarried limestone rock, 2-100 cm in diameter, below the dam to fill in the scour hole and create a "rapids". The south edge of the rapids was formed into a wing deflector to direct flow along the shore downstream of the fishway. The enhanced flow increased the movement of fish into the fishway, and ex-

The final configuration of habitat created at the dam by construction of the rapids and the fishway resulted in creating some of the most diverse fish habitat on the upper Fox River in addition to providing unimpeded safe upstream and downstream migration past Eureka dam for a wide range of fish species including lake sturgeon (Figure 8). Long term monel tagging studies from 1954 – 2006, and recent radio and sonic telemetry studies on Winnebago System sturgeon have clearly shown unimpeded annual movement of sturgeon upstream and downstream of the Eureka Dam since the fishway was installed in 1989 and rapids were built in 1992-93 (Bruch, R.M., WI Dept. of Natural Resources, Oshkosh, unpublished data).

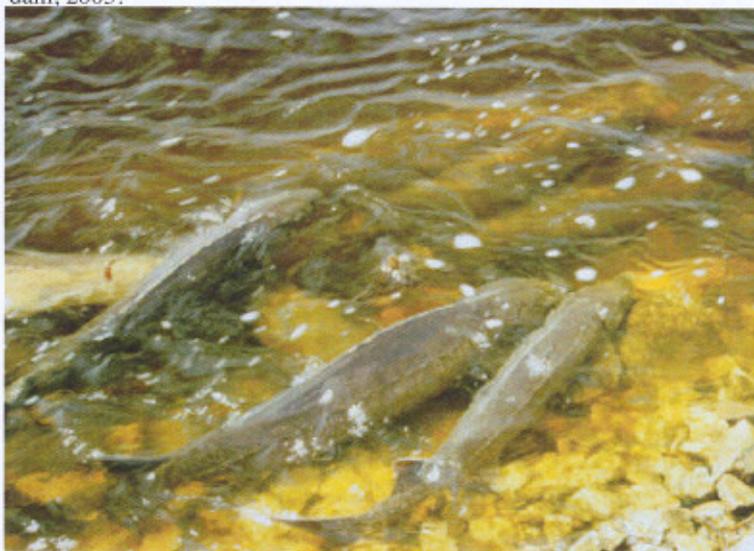
Fig. 7. Spawning lake sturgeon utilizing rip rap bank downstream of fishway following the creation of the "Eureka Rapids" and associated wing deflector.

panded the suitable spawning area for sturgeon to an additional 80 meters along the rip rapped shoreline downstream of the fishway. Figure 7 illustrates a group of lake sturgeon spawning along the riprap shoreline immediately below the fishway following construction of the rapids and wing deflector. The large quantity of rock used to create the rapids not only eliminated the undertow below the dam, it also created excellent spawning, nursery and/or food producing habitat for a variety of other fish species including walleye, small-mouth bass (*Micropterus dolomieu*) and flathead catfish (*Pylodictis olivaris*) (Bruch, R.M., WI Dept. of Natural Resources, Oshkosh, unpublished data).
