## Rice Creek Floodplain Reconnection

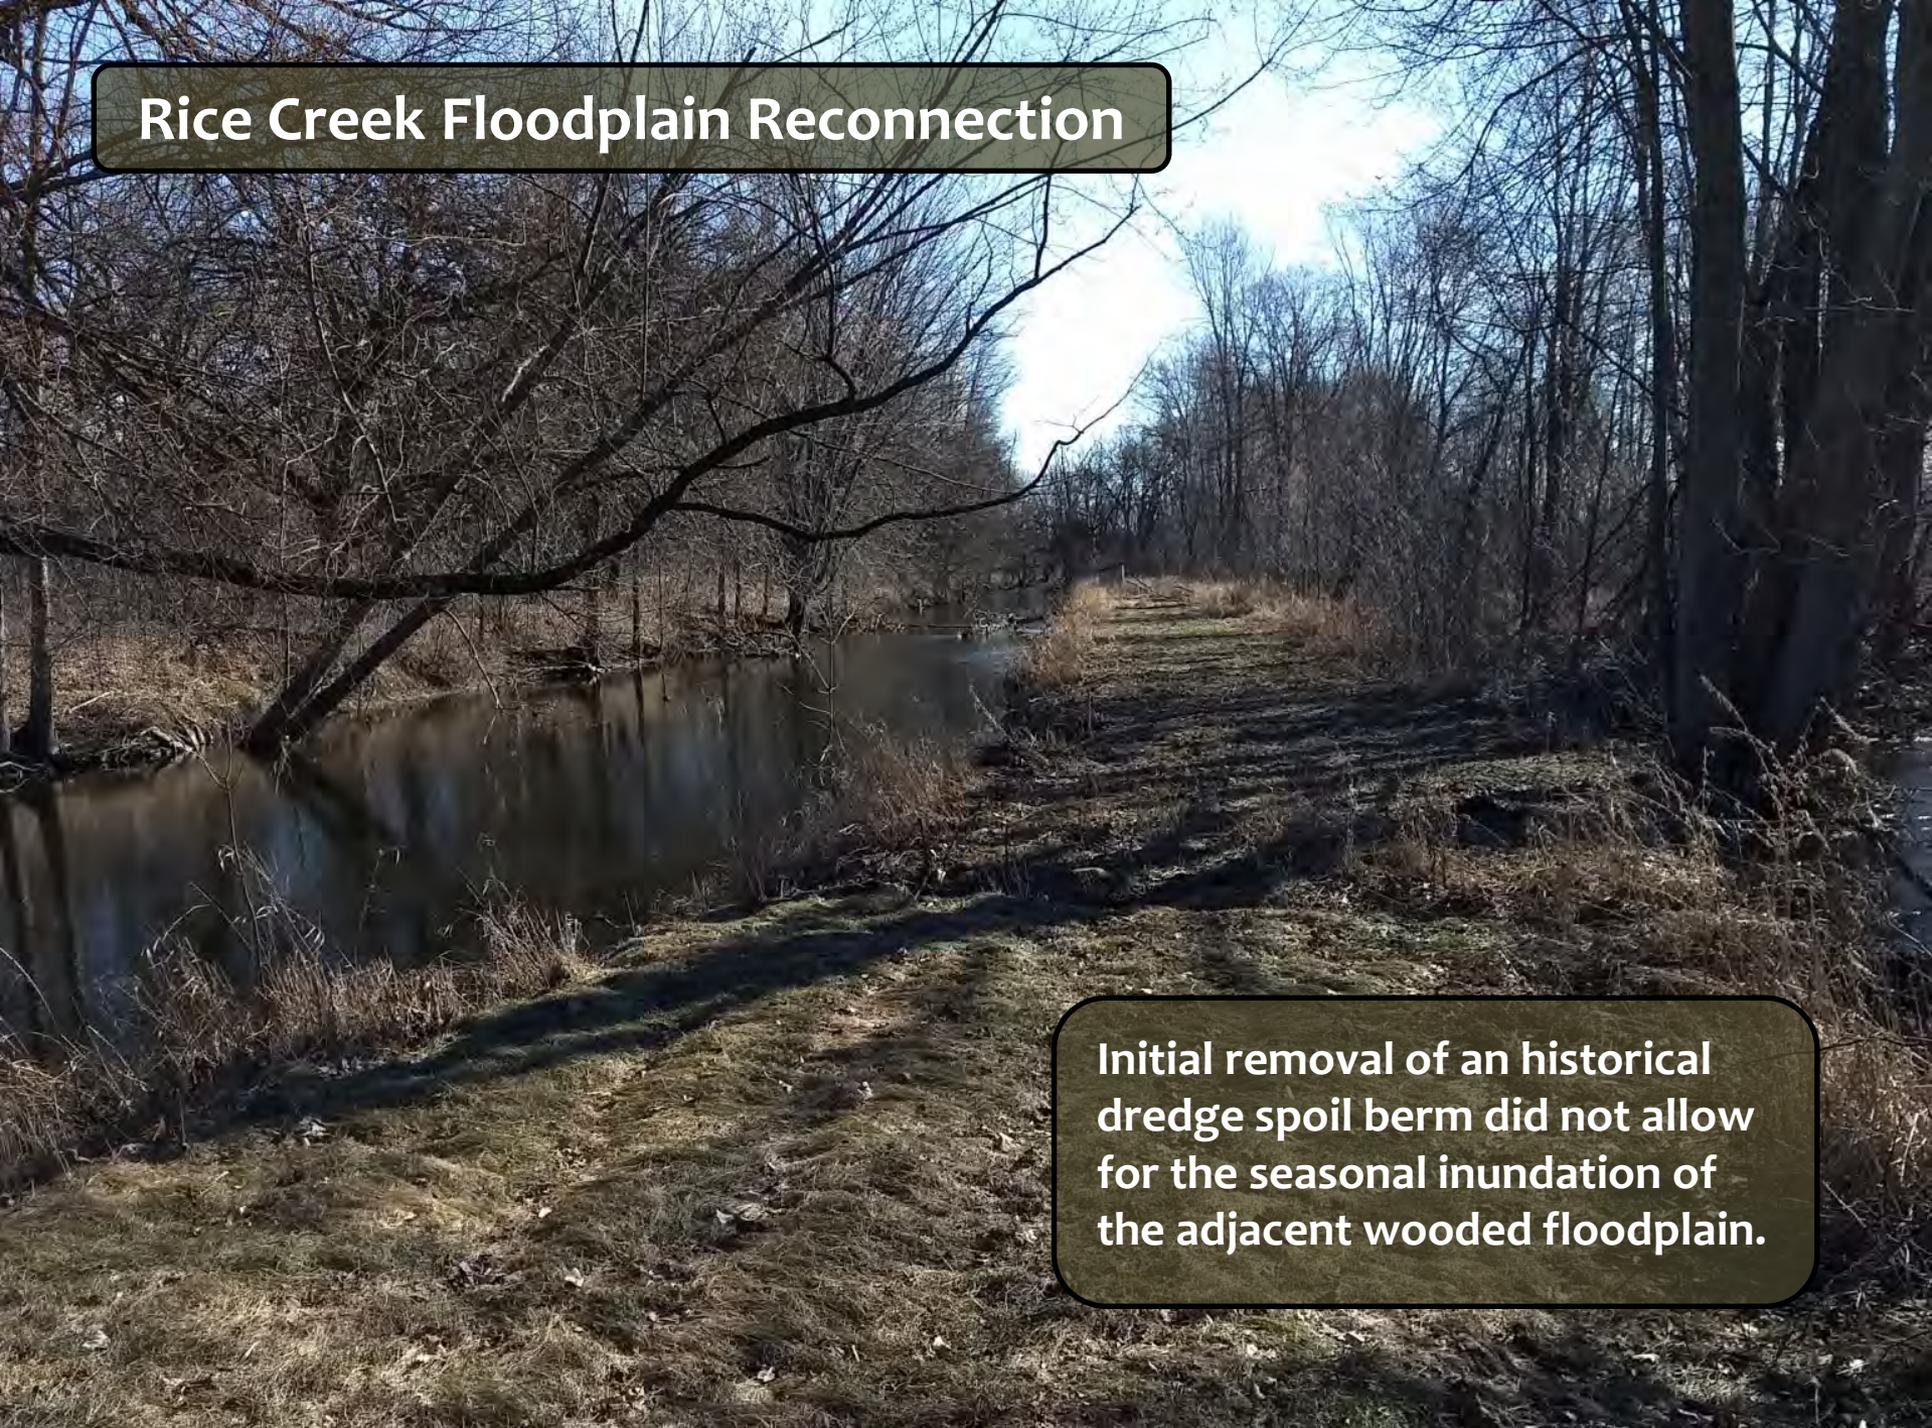
Initial removal of an historical dredge spoil berm did not allow for the seasonal inundation of the adjacent wooded floodplain.

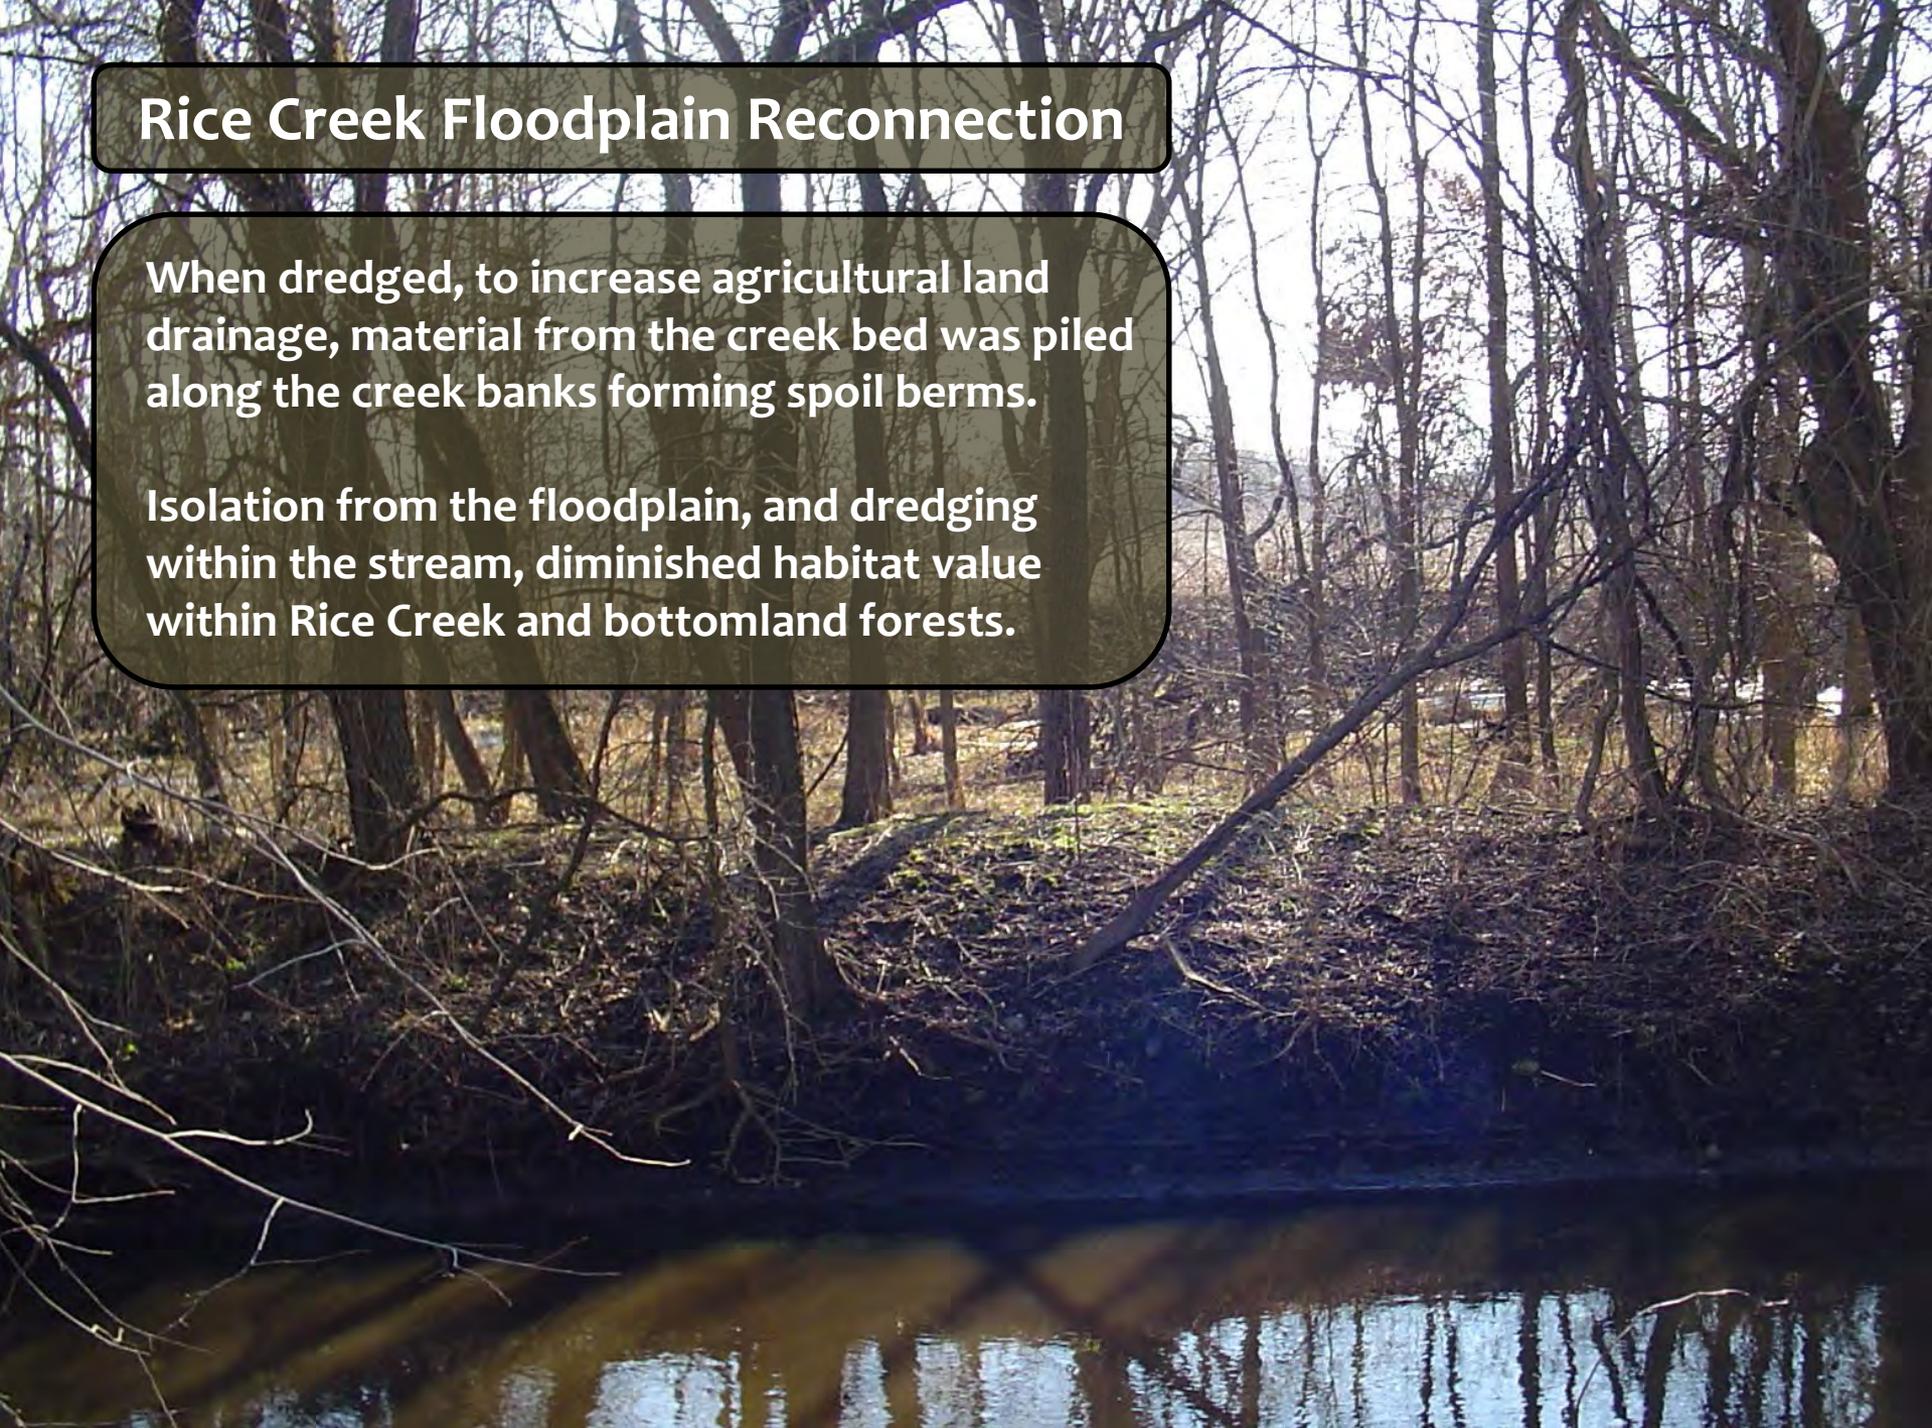
When dredged, to increase agricultural land drainage, material from the creek bed was piled along the creek banks forming spoil berms.

Isolation from the floodplain, and dredging within the stream, diminished habitat value within Rice Creek and bottomland forests.

An engineering firm was hired to survey the site. A local excavator then lowered the elevation of the existing berm to allow the creek to overflow its bank during flood events.

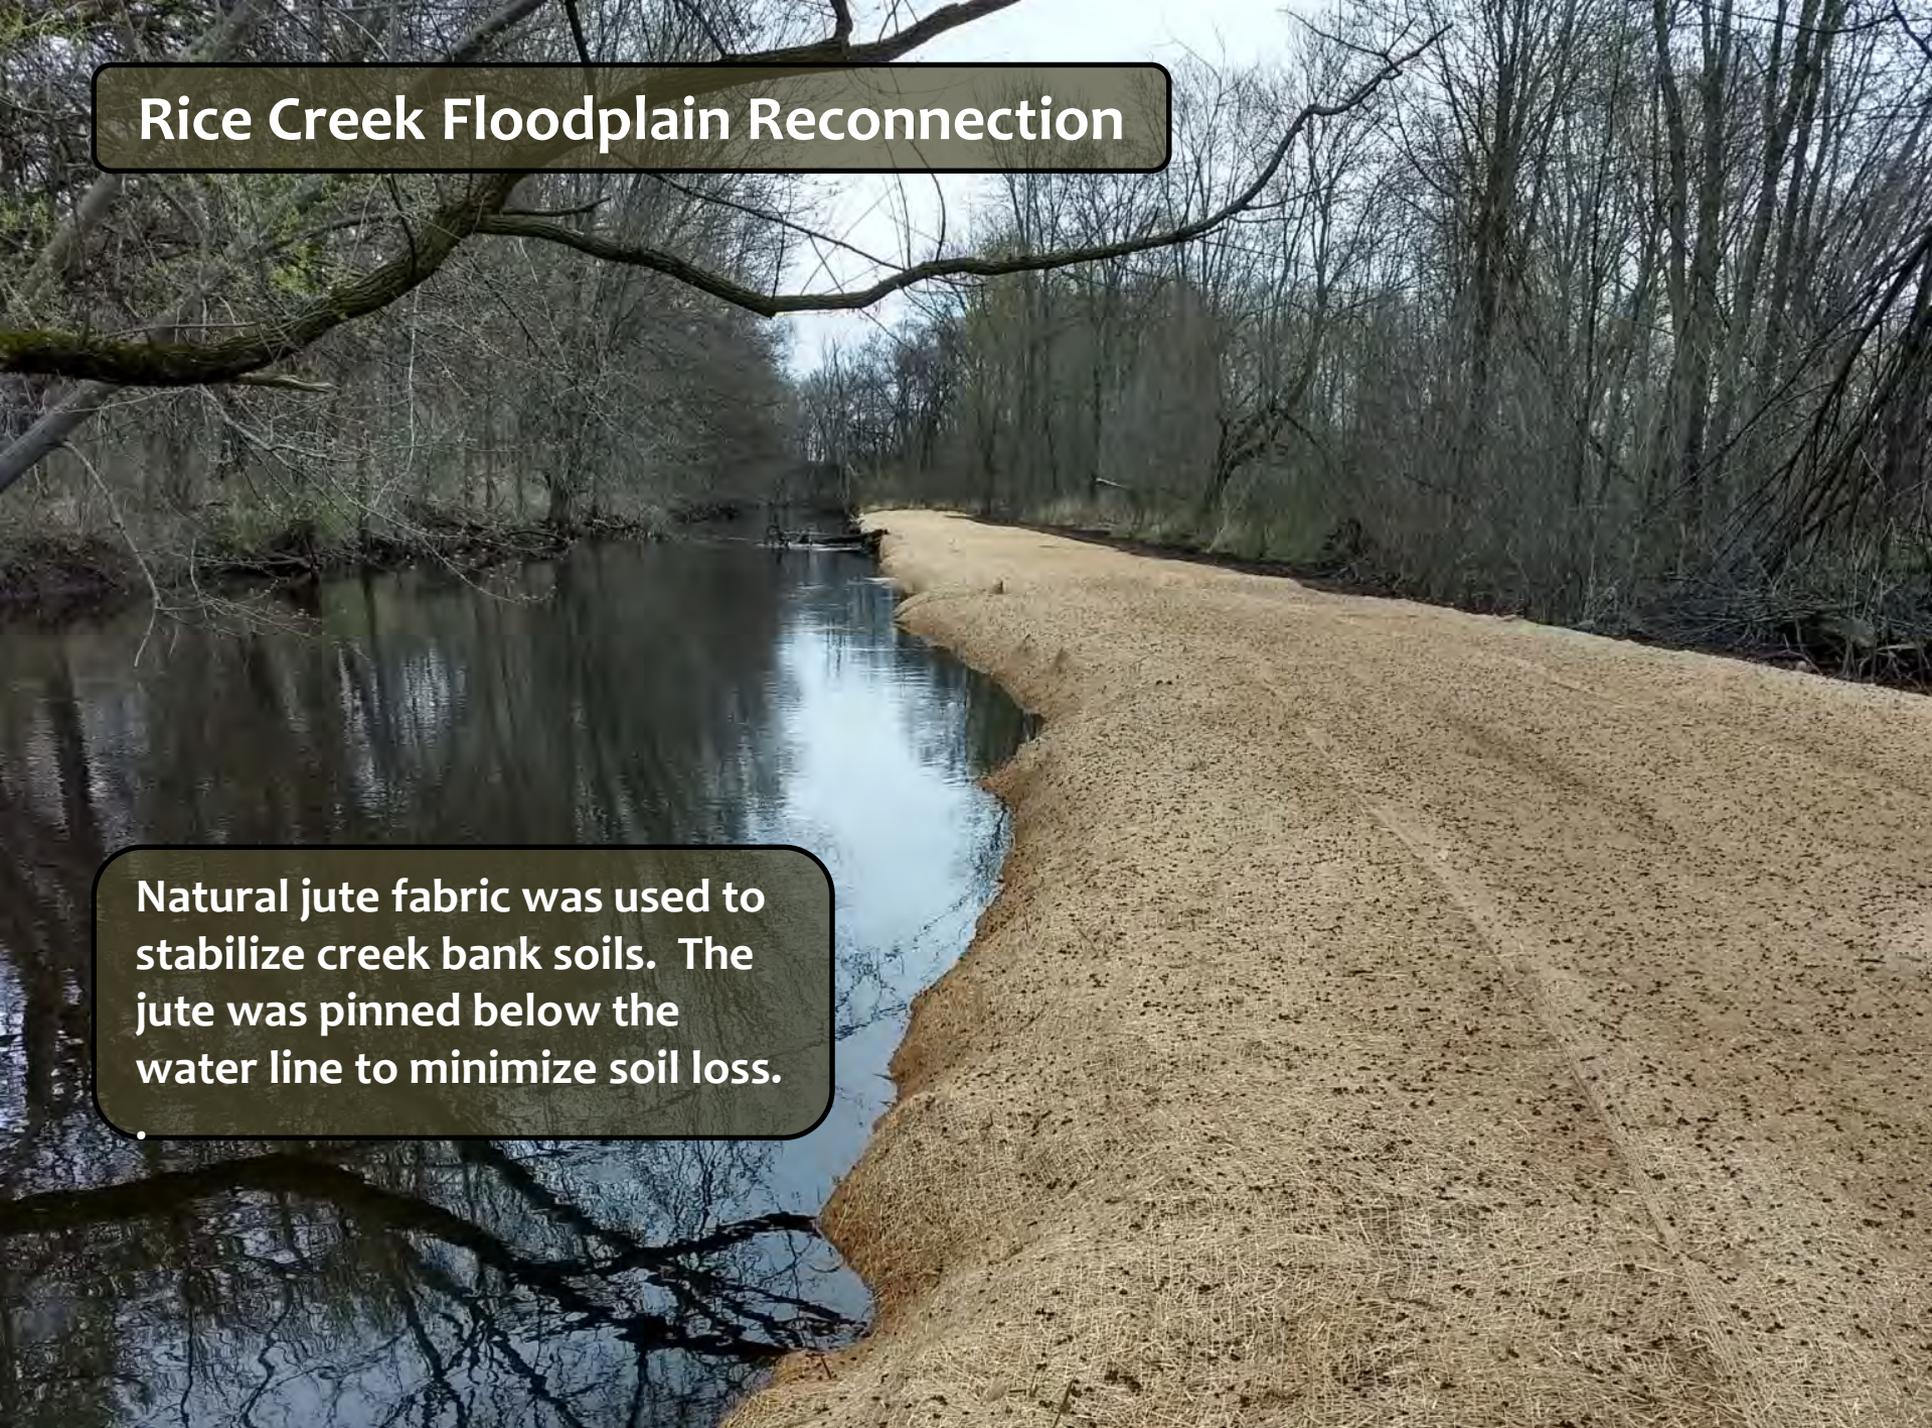
Natural jute fabric was used to stabilize creek bank soils. The jute was pinned below the water line to minimize soil loss.

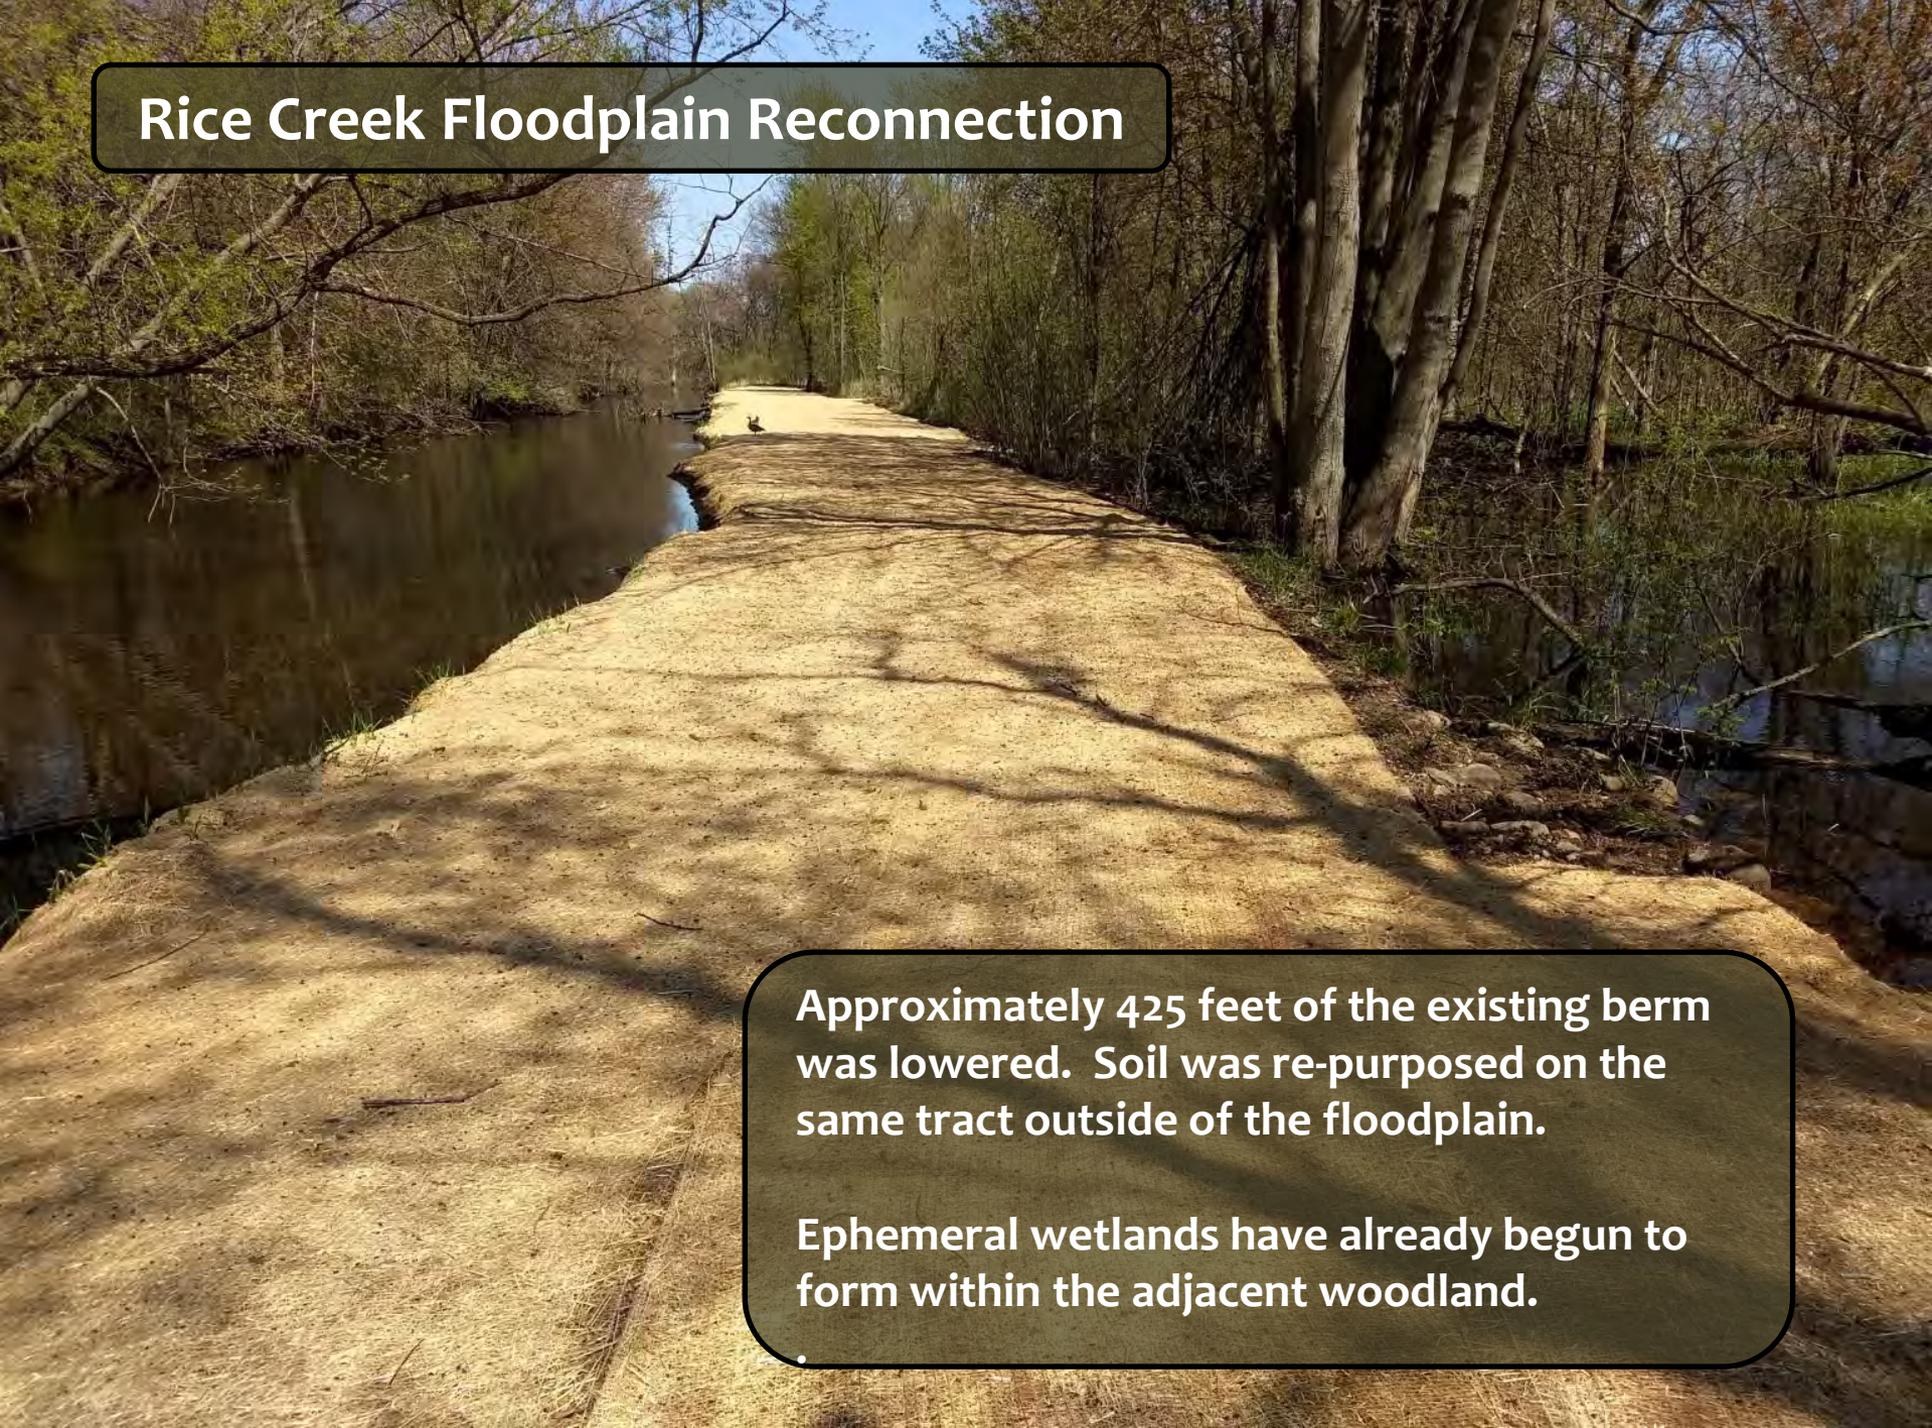
Approximately 425 feet of the existing berm was lowered. Soil was re-purposed on the same tract outside of the floodplain.

Ephemeral wetlands have already begun to form within the adjacent woodland.

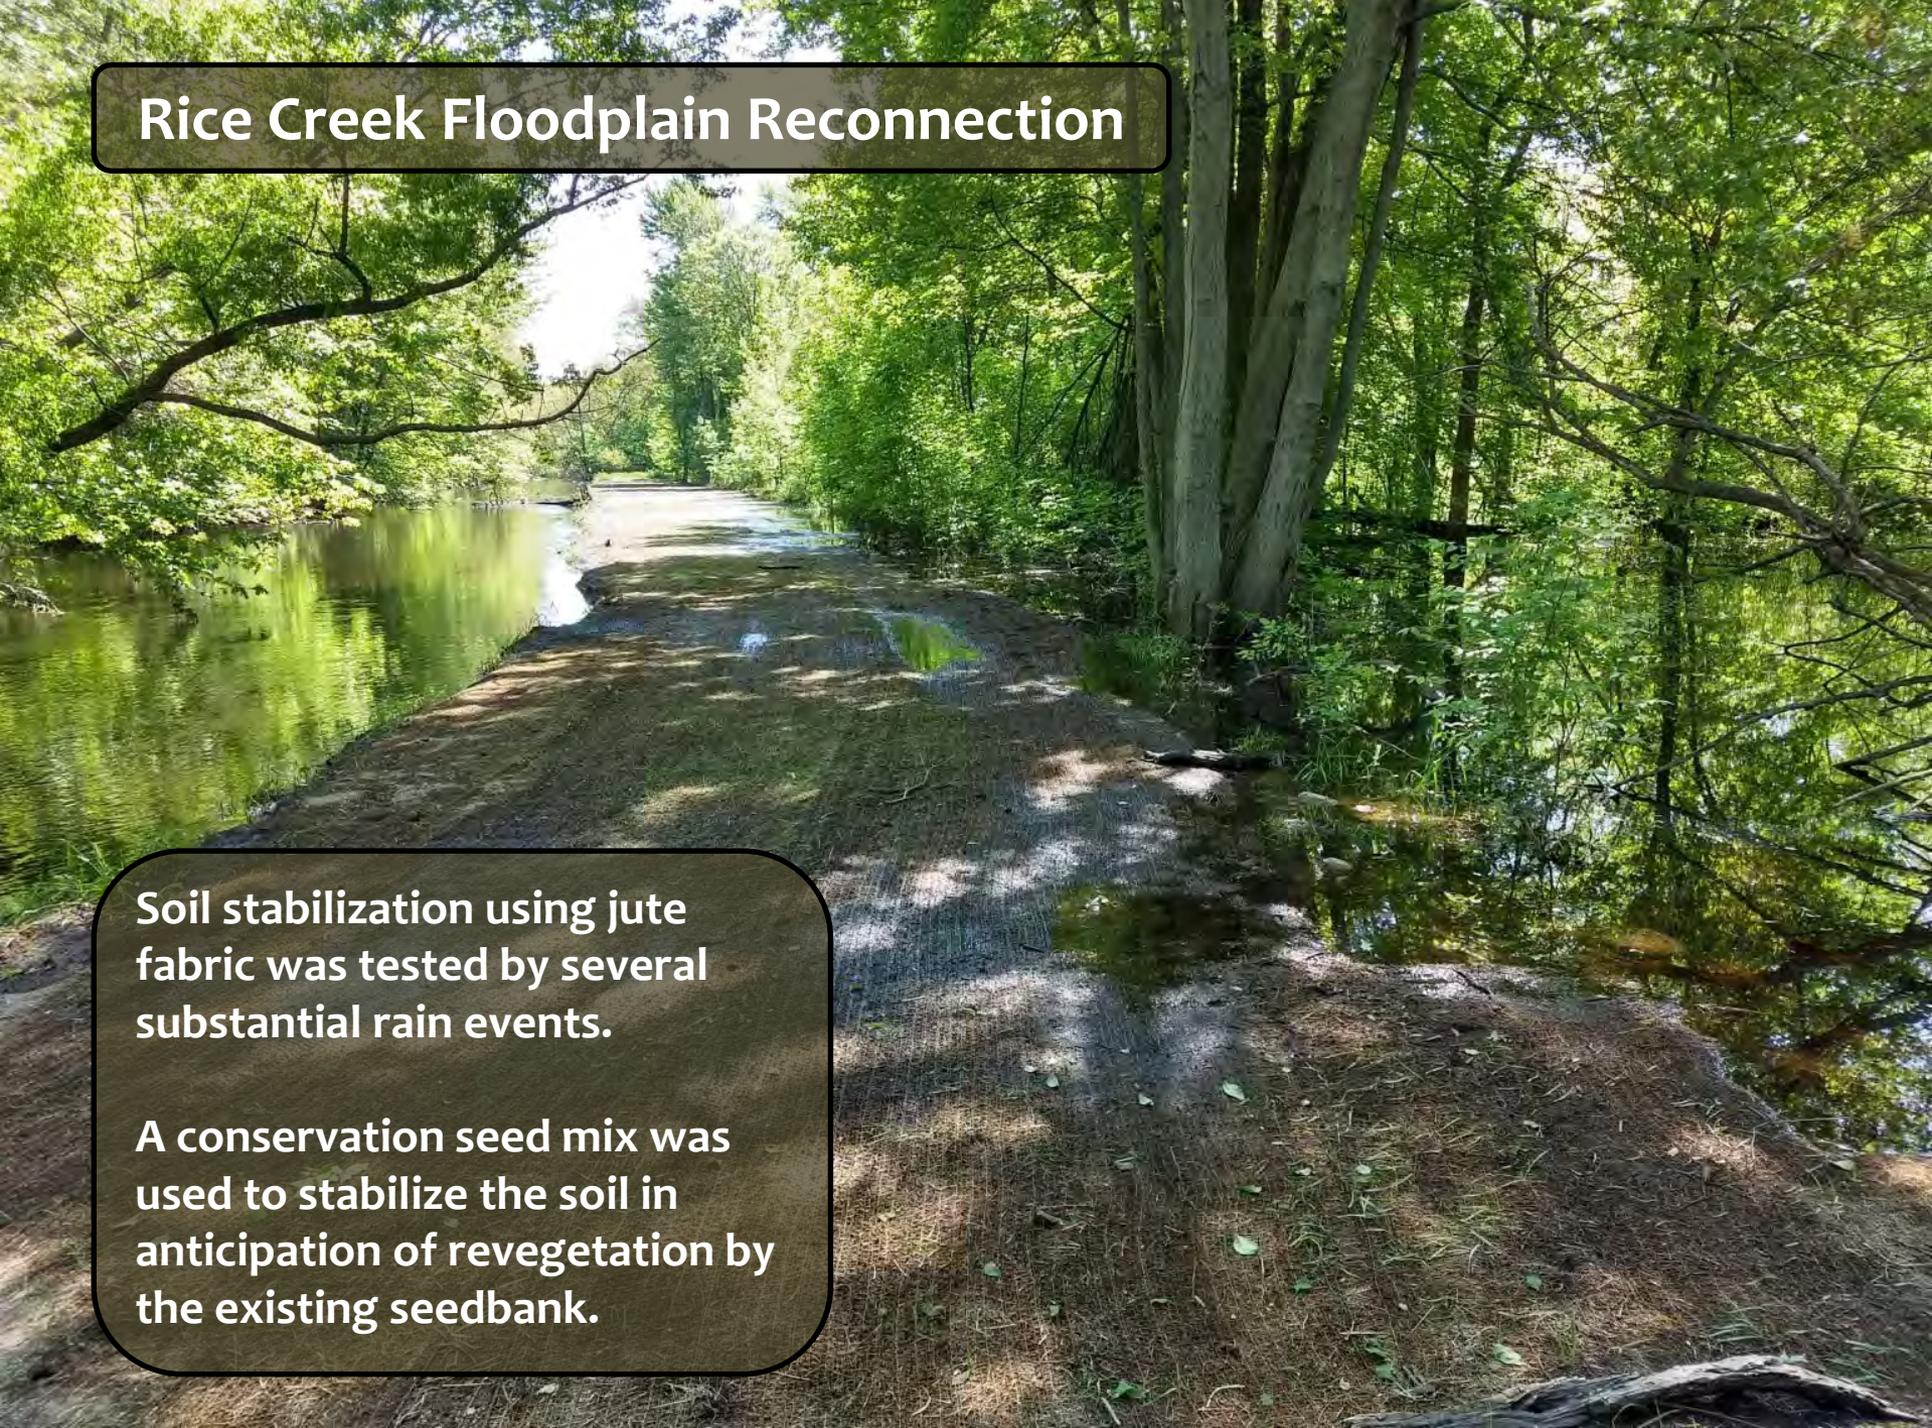
Soil stabilization using jute fabric was tested by several substantial rain events.

A conservation seed mix was used to stabilize the soil in anticipation of revegetation by the existing seedbank.

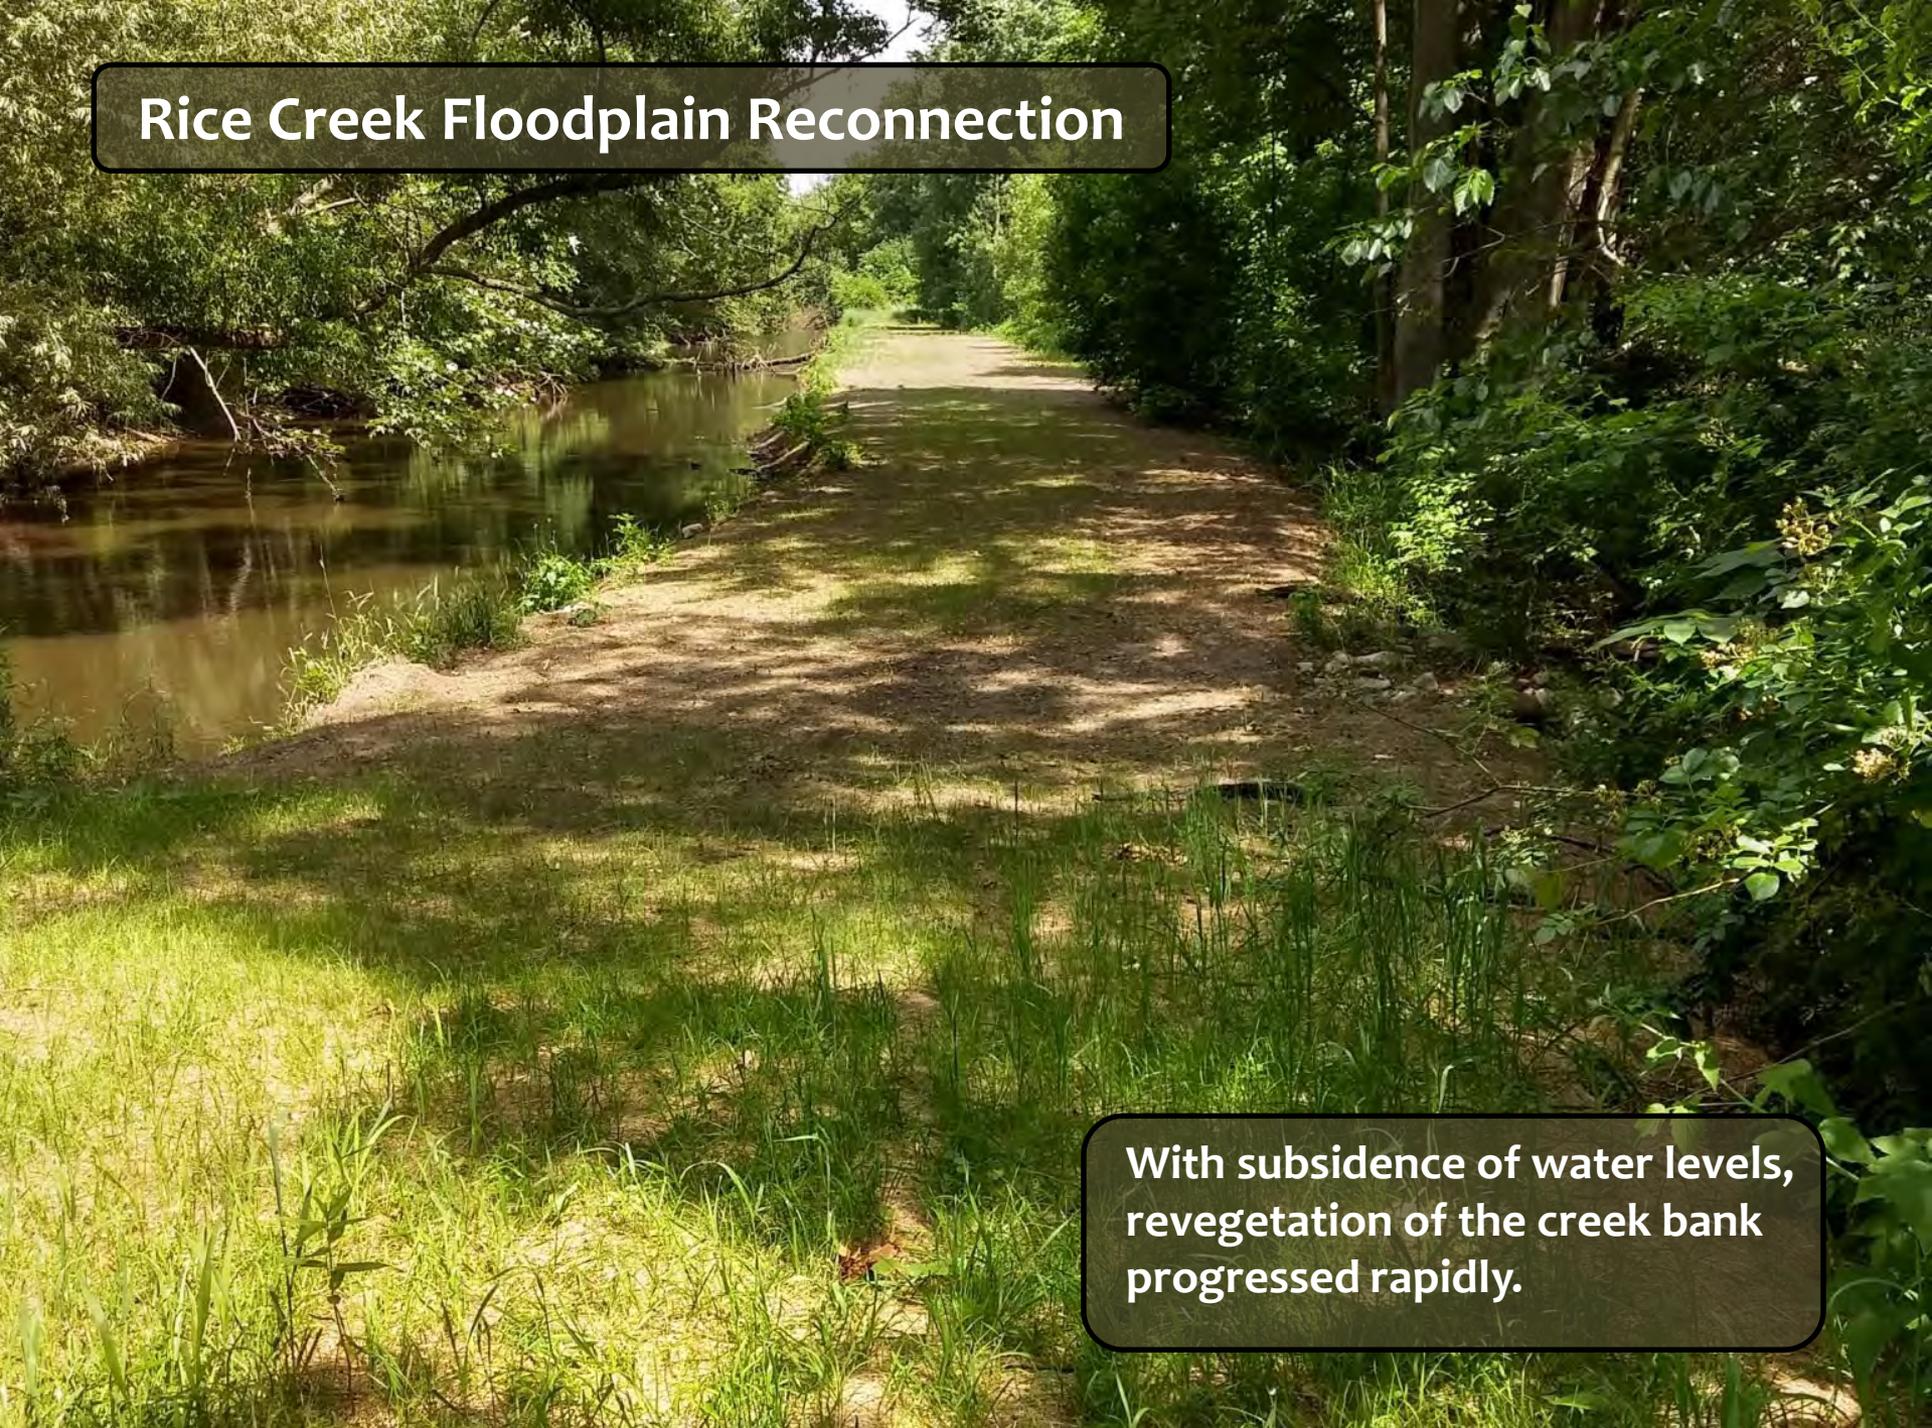
A photograph showing a dirt path leading from a grassy area towards a creek. The path is flanked by dense trees and vegetation. The creek is on the left side of the path, and the path appears to be a natural or semi-natural connection between the floodplain and the water body.

With subsidence of water levels, revegetation of the creek bank progressed rapidly.

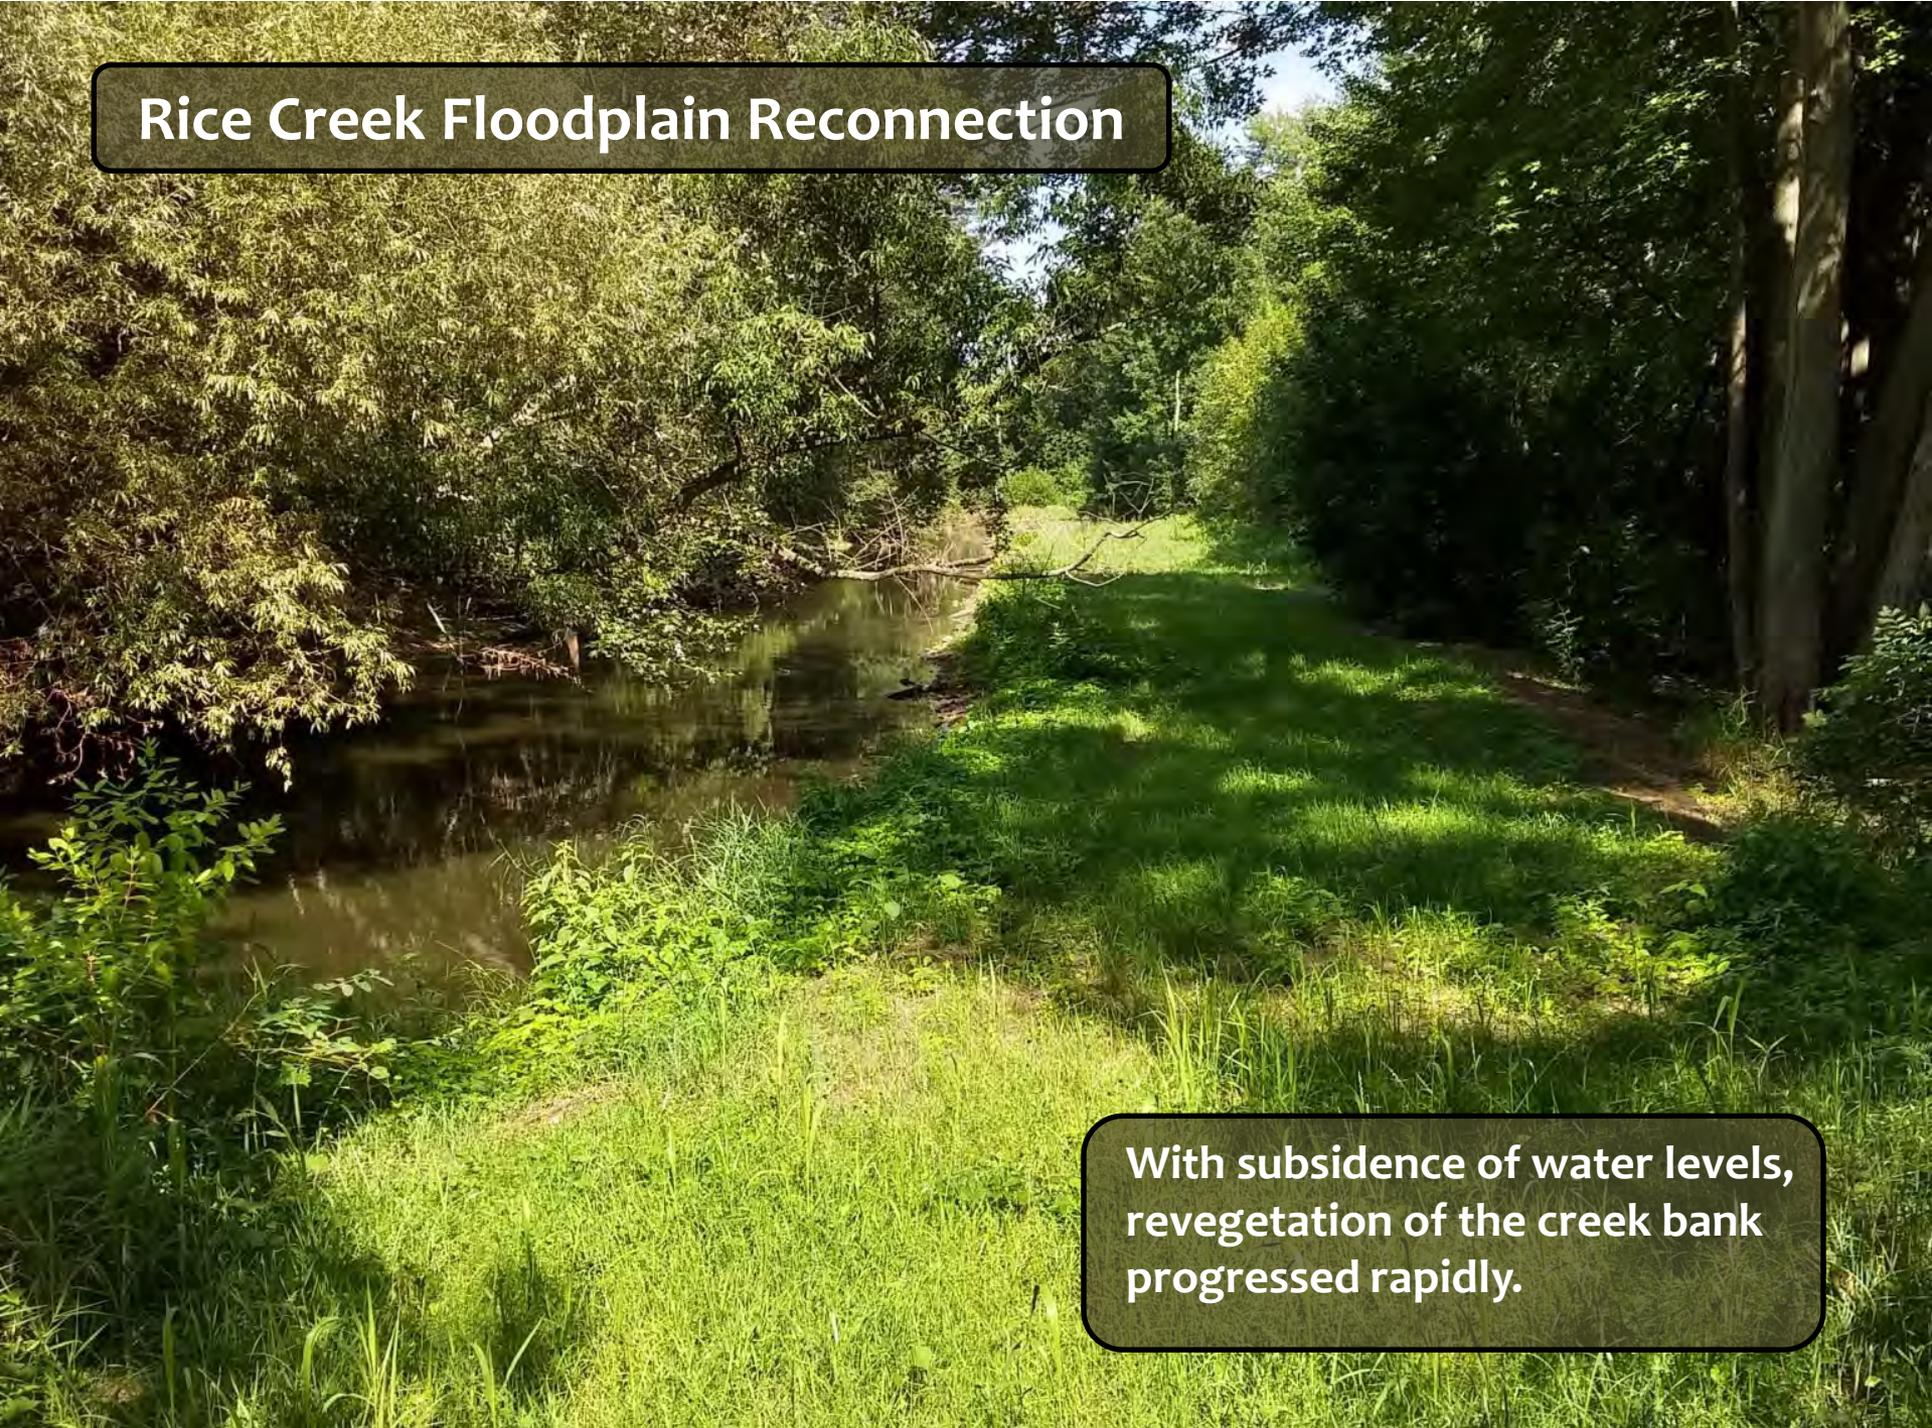
With subsidence of water levels, revegetation of the creek bank progressed rapidly.

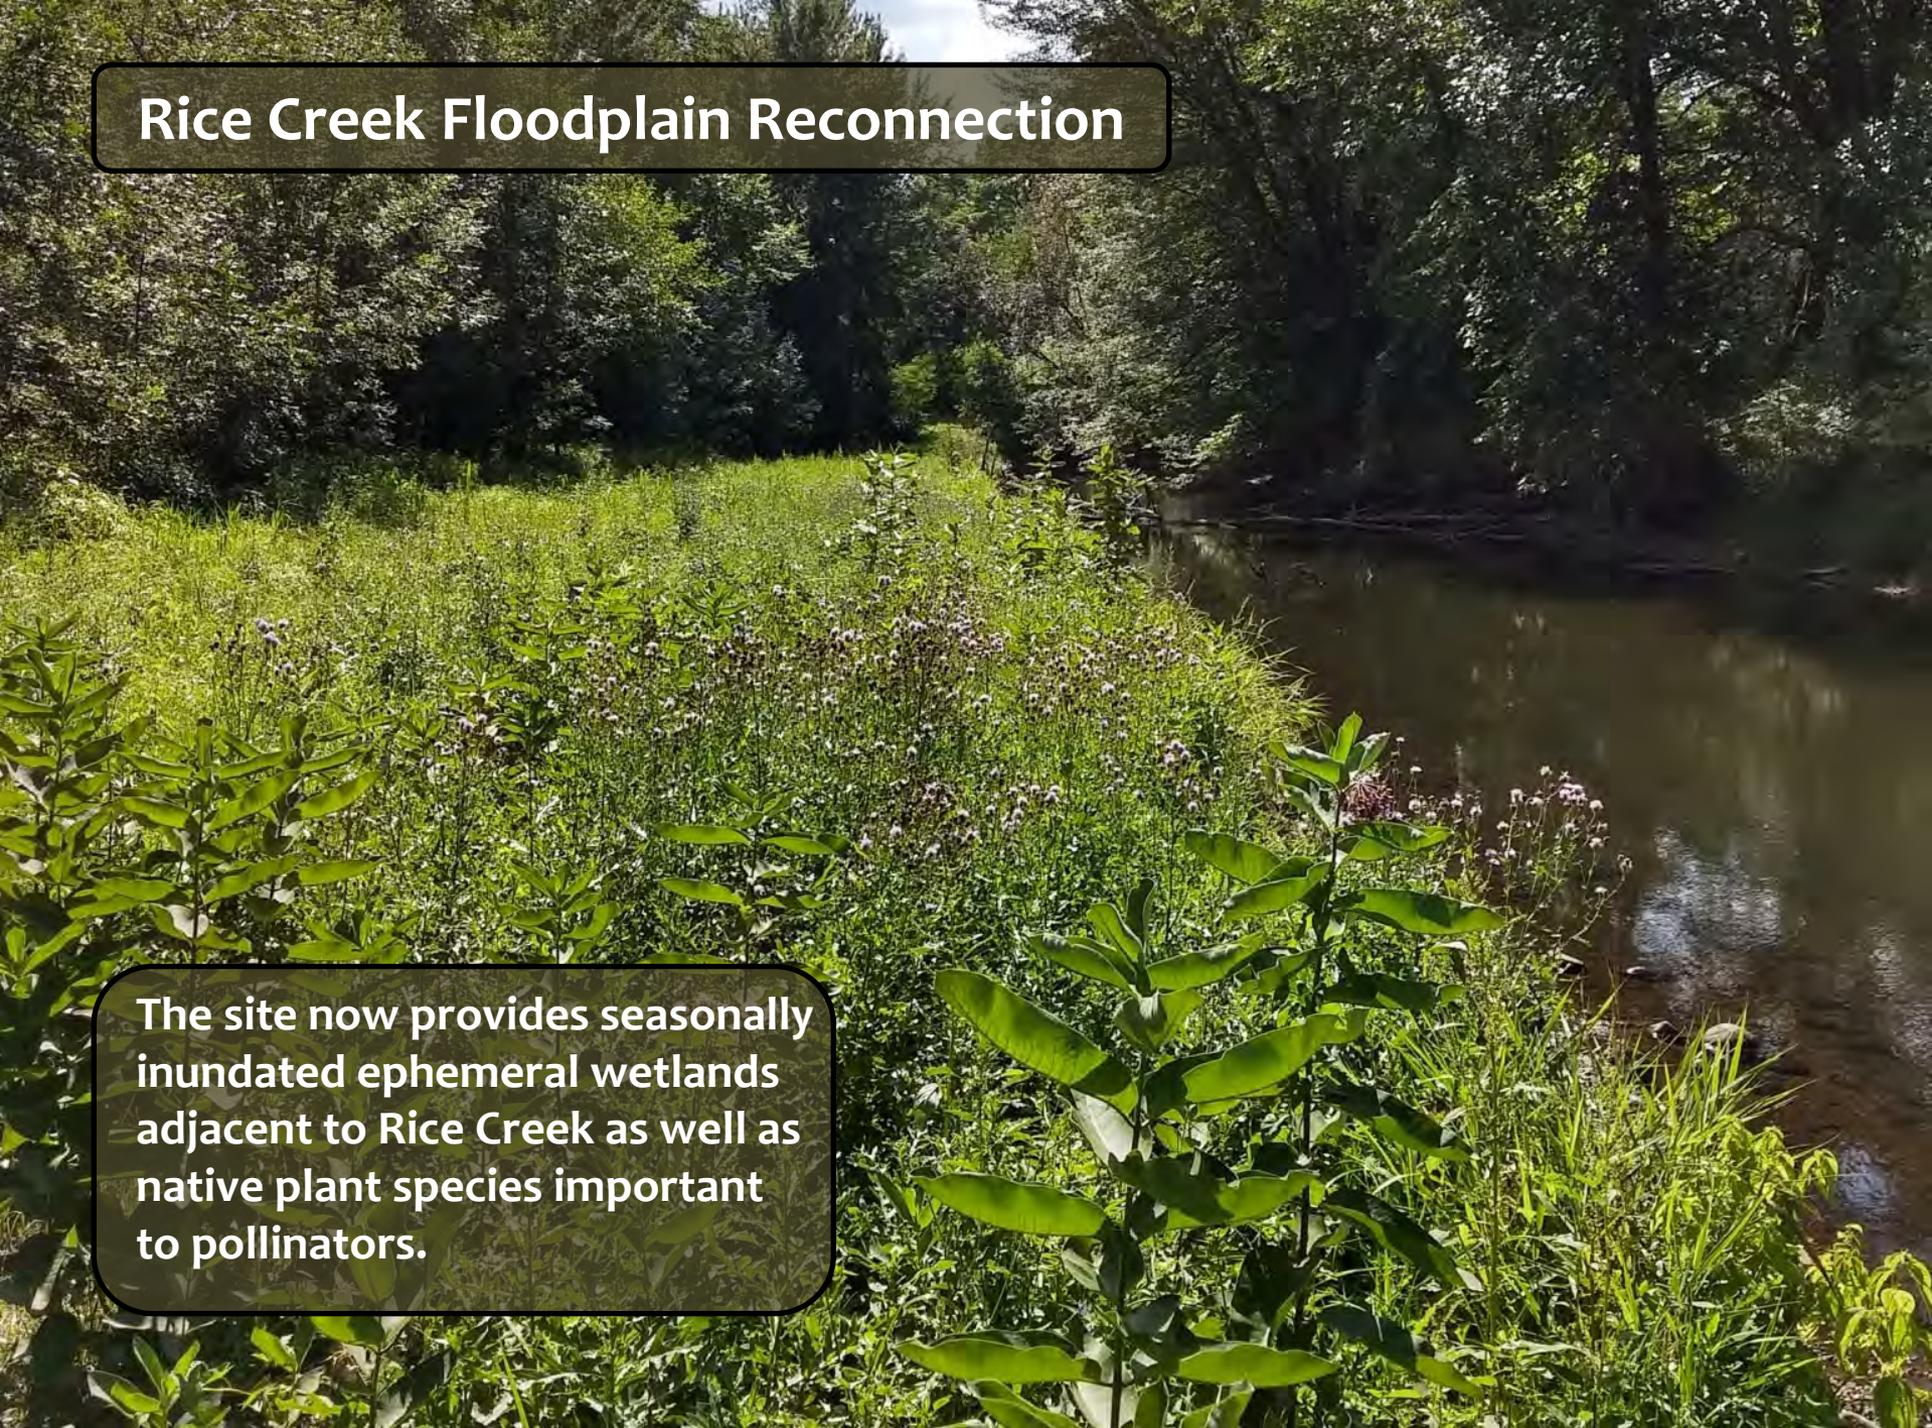
A photograph showing a lush green floodplain area adjacent to a river. The foreground is filled with dense, vibrant green vegetation, including tall grasses and various flowering plants. The river flows through the middle ground, reflecting the surrounding greenery. The background is a dense forest of tall trees, creating a shaded and natural setting.

The site now provides seasonally inundated ephemeral wetlands adjacent to Rice Creek as well as native plant species important to pollinators.
