AN EVALUATION OF ECOSYSTEM
RESTORATION AND
MANAGEMENT OPTIONS
FOR
LEE METCALF NATIONAL WILDLIFE REFUGE

U.S. FISH AND WILDLIFE SERVICE
REGION 6
DENVER, COLORADO

Greenbrier Wetland Services Report No. 10-02

May 2010

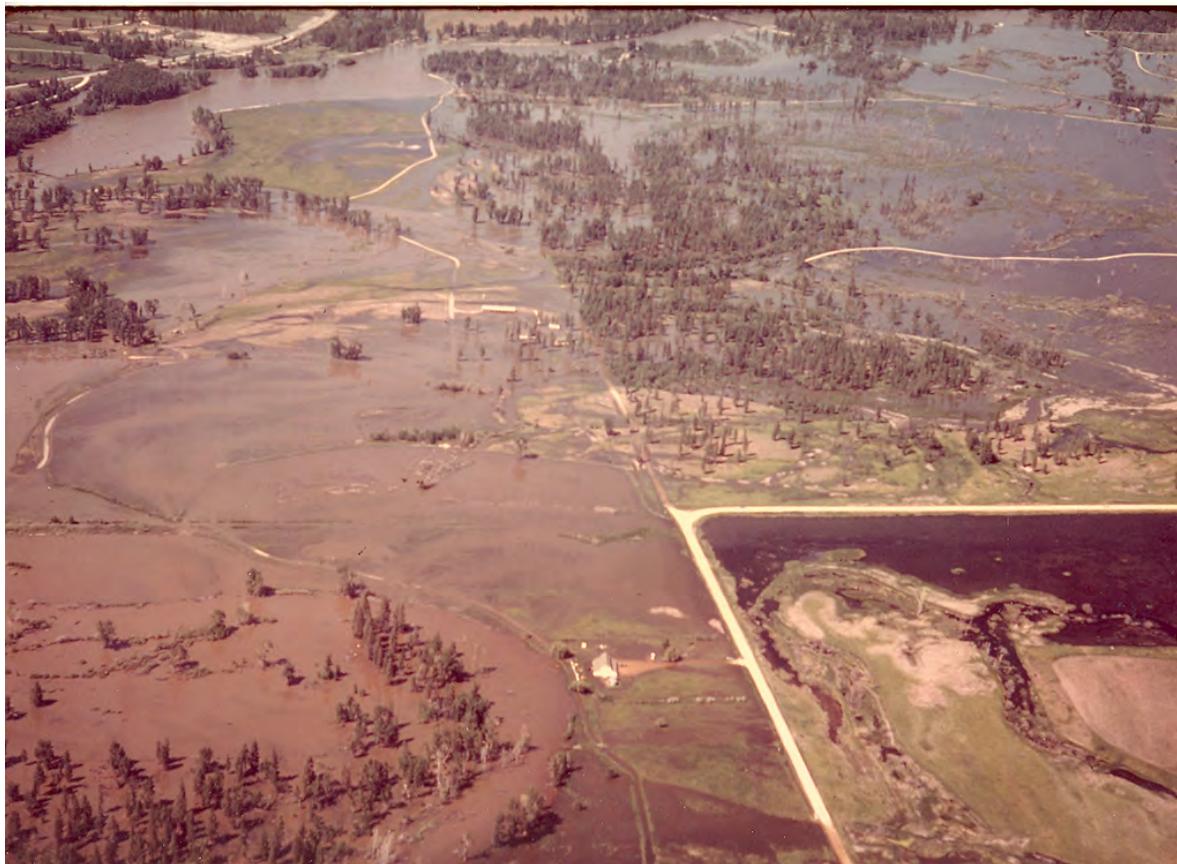
Figure 11. Aerial photograph of flooding on Lee Metcalf National Wildlife Refuge in summer 1974.

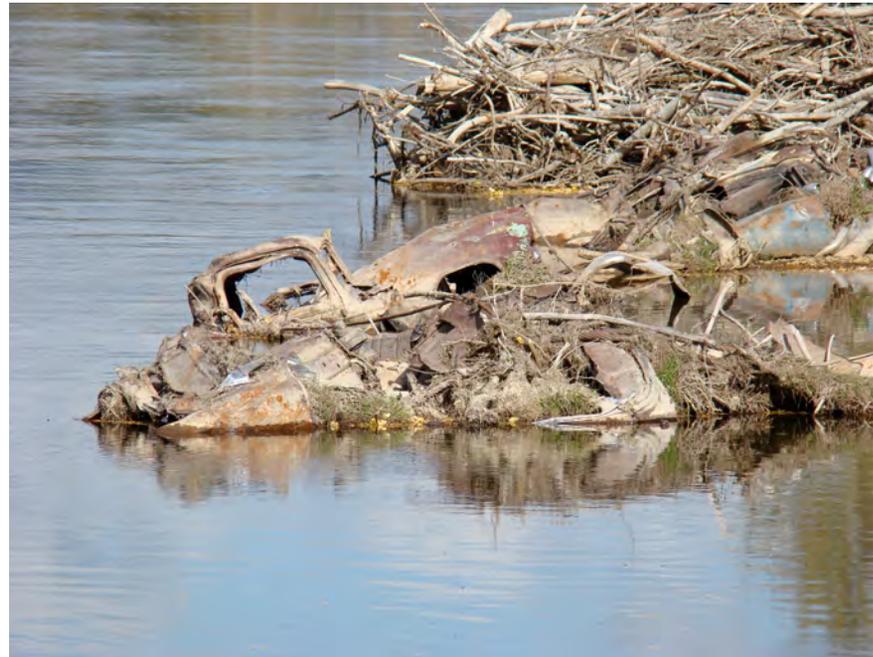
Figure 18. Photograph of car bodies, acting as rip-rap material along the Bitterroot River on the north end of Lee Metcalf National Wildlife Refuge.

(Fig. 18) along the river bank, to act as rip-rap and cut off the river, which created an oxbow that still is present. The most active area of river migration in 2009-2010 is at Point "C." Between 2004 and 2009, the river migrated about 60 m east, or about 12 m/year. If this rate of river migration continues, then

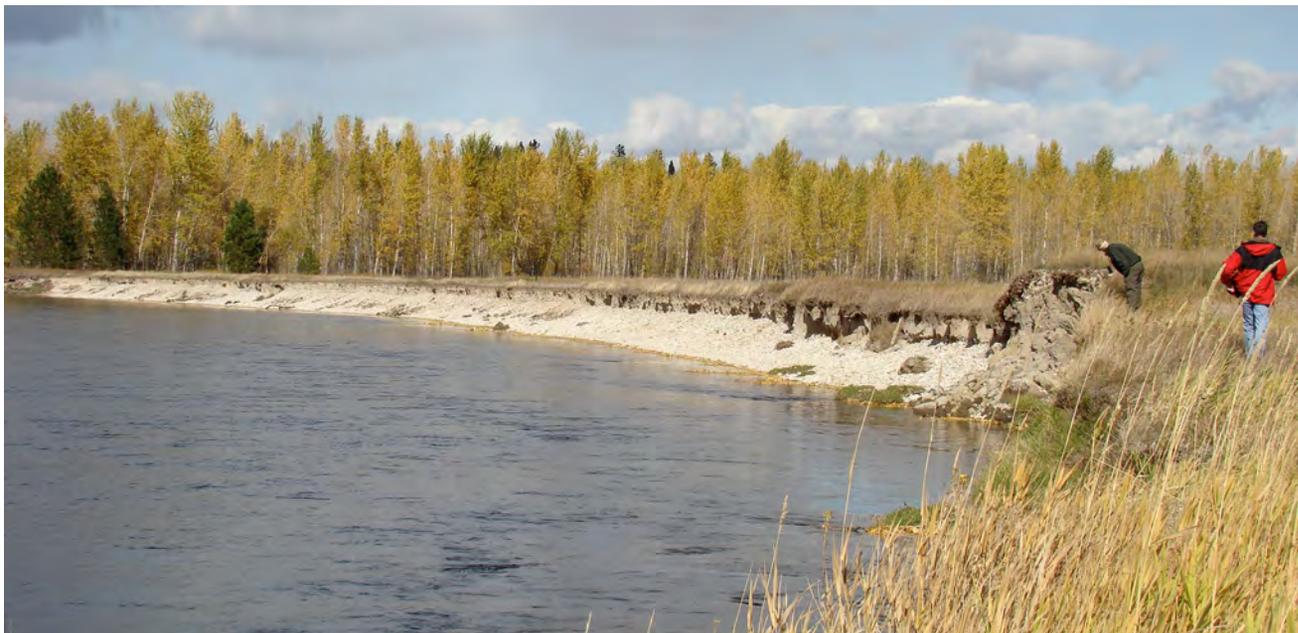
Figure 19. Photograph of bank and levee erosion along the Bitterroot River on the west side of Lee Metcalf National Wildlife Refuge.

reaches of the Bitterroot River (Gaeuman 1997). This instability has caused rapid erosion of river banks on Lee Metcalf NWR (Fig. 19) and increased physical dynamics of sediment and water flow that facilitate rapid lateral channel migration across the Lee Metcalf NWR floodplain. In contrast to the highly active river migration physics from Hamilton to Stevensville, substantial narrowing of the Bitterroot River occurred near Stevensville and Lee Metcalf NWR after 1937 in part because of artificial control structures. Part of the river has been channeled immediately upstream of rip-rap bank stabilization structures near the railroad embankment on the refuge (Fig. 18). This artificial narrowing of the Bitterroot River to control river migration and bank erosion actually has heightened river migration tendencies immediately upstream of structures and currently is threatening to carve new channels across the floodplain at Lee Metcalf NWR (Fig. 19).

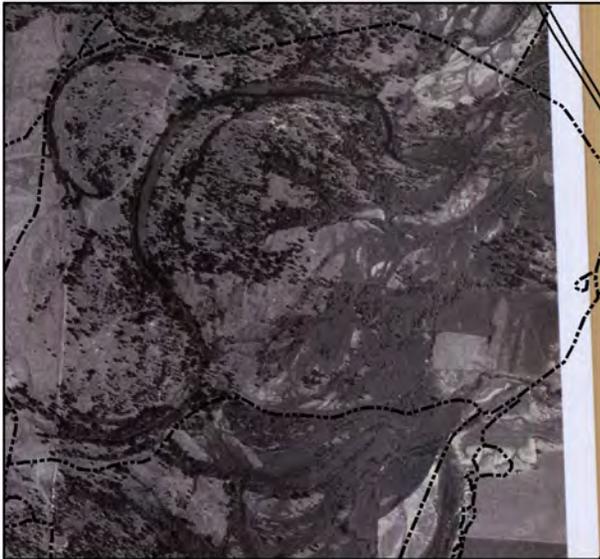
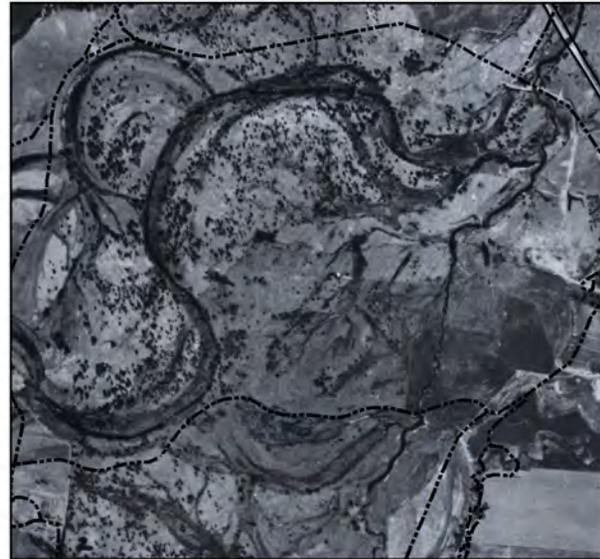
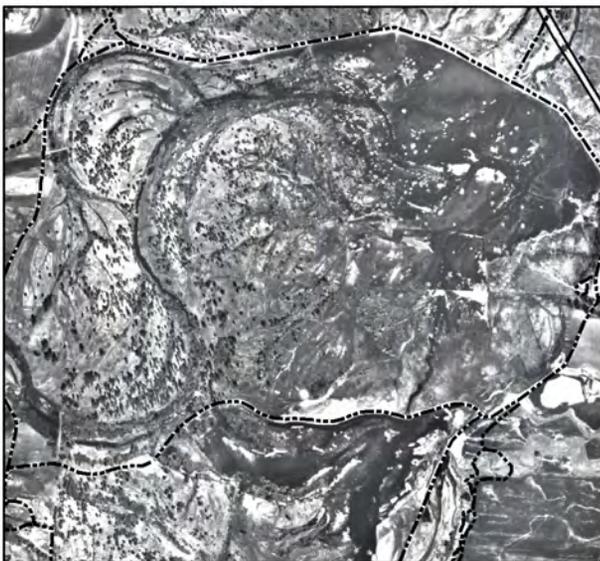
Figure 22. Aerial photographs of wetland pond and management developments on Lee Metcalf National Wildlife Refuge before (1960s and 1970s) and after (2005) construction. (cont'd on next page)

Figure 22 (cont'd). Aerial photographs of wetland pond and management developments on Lee Metcalf National Wildlife Refuge before (1960s and 1970s) and after (2005) construction.

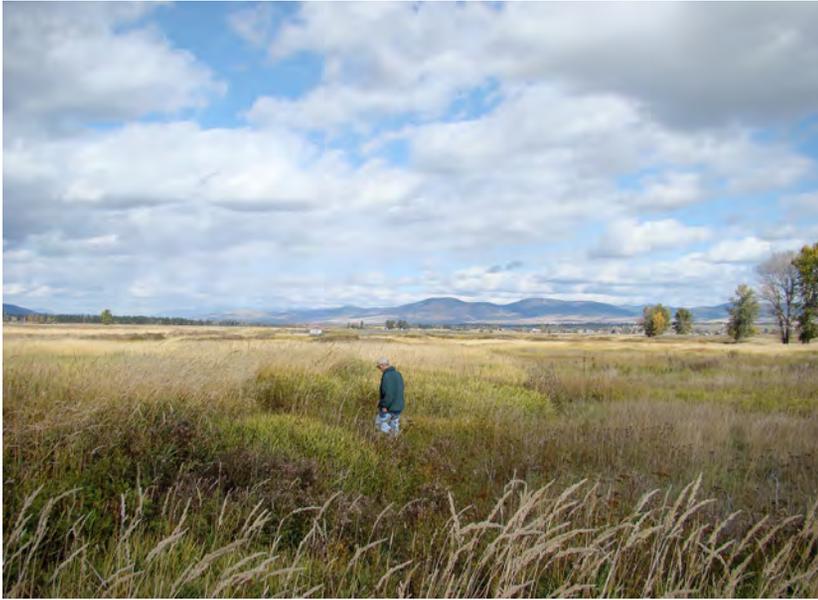
Figure 23. Photograph of a field planted as waterfowl dense nesting cover on Lee Metcalf National Wildlife Refuge.
