AN EVALUATION OF
ECOSYSTEM RESTORATION
AND MANAGEMENT OPTIONS
FOR THE
OURAY NATIONAL WILDLIFE REFUGE, UTAH

U.S. FISH AND WILDLIFE SERVICE
REGION 6
DENVER, CO

Mickey E. Heitmeyer and Leigh H. Fredrickson
Gaylord Memorial Laboratory
University of Missouri - Columbia
Puxico, MO

February 2005

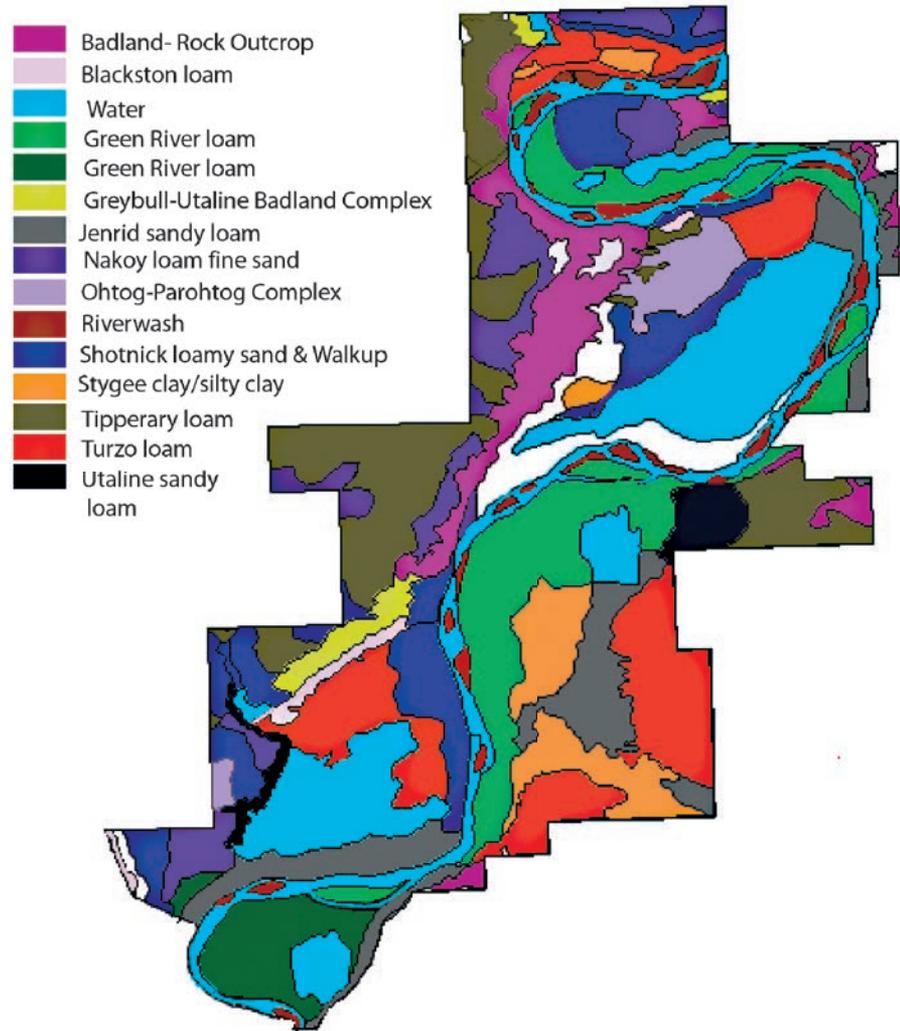
Figure 4. Soils on Ouray National Wildlife Refuge, Utah.

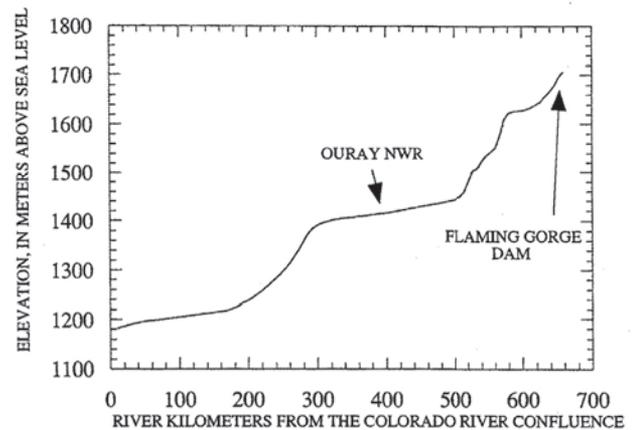
Figure 5. Longitudinal profile of the Green River between Flaming Gorge Reservoir and the confluence with the Colorado River (adapted from Schmidt 1994).

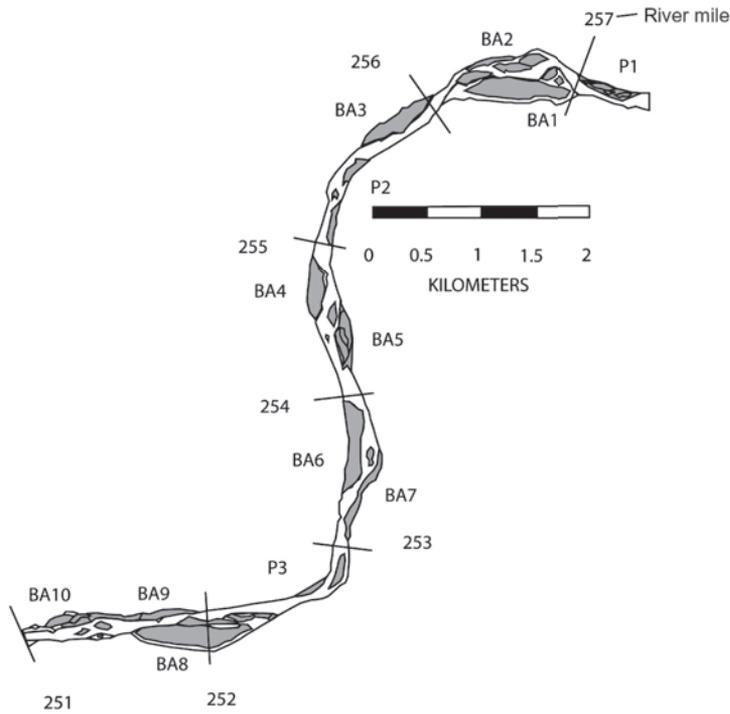
Figure 6. Map of bar locations of the the Green River next to Shepard and Wyasket Bottoms, Ouray National Wildlife Refuge, Utah.

and Nelson 1989). Alternating pool/bar configurations (Fig. 6) include both fixed bank and forced

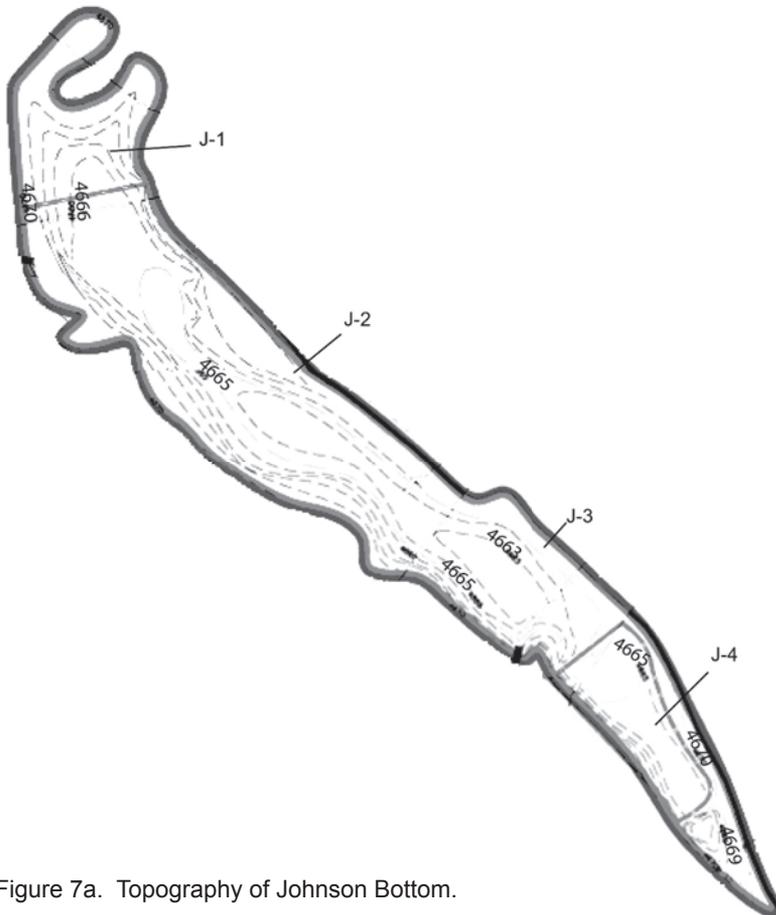
Figure 7a. Topography of Johnson Bottom.

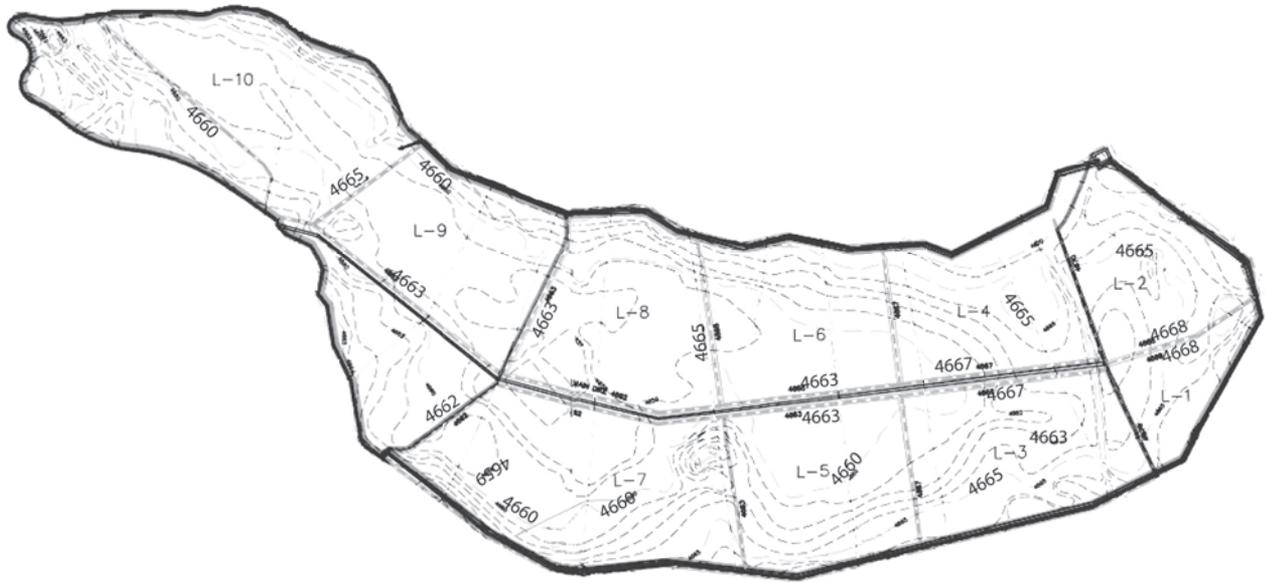
Figure 7b. topography of Leota Bottom.

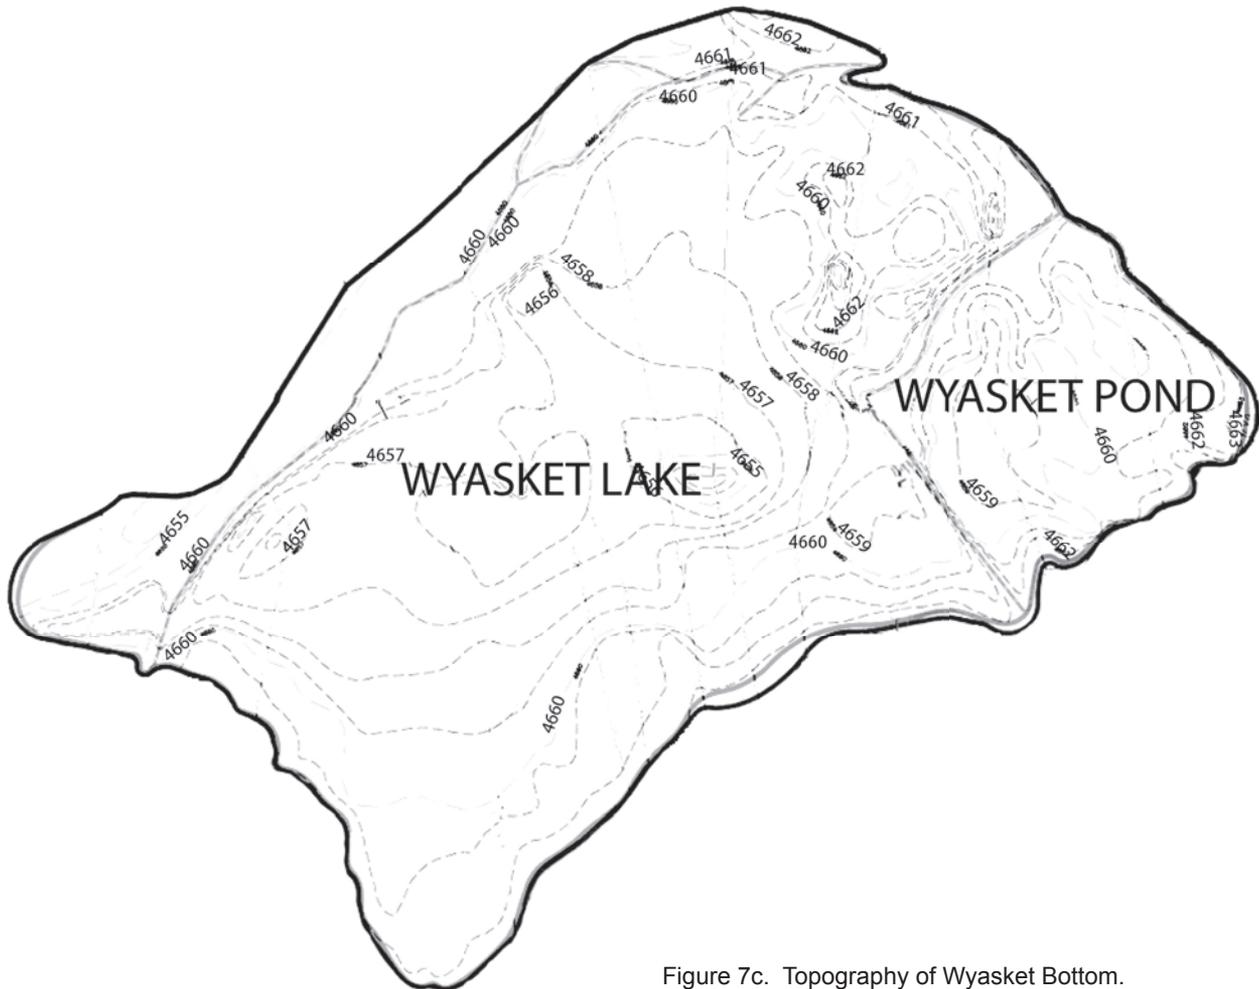
Figure 7c. Topography of Wyasket Bottom.

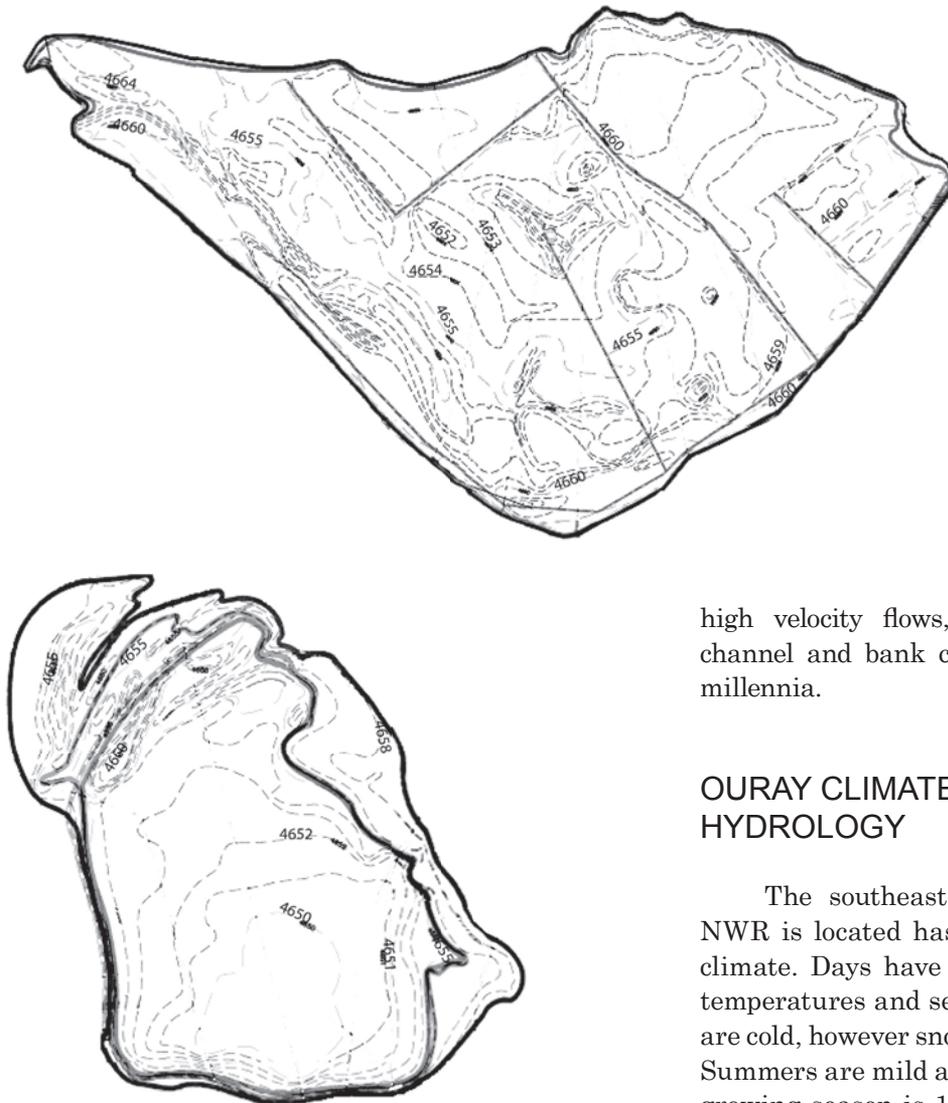
Figure 7e. Topography of Woods Bottom.

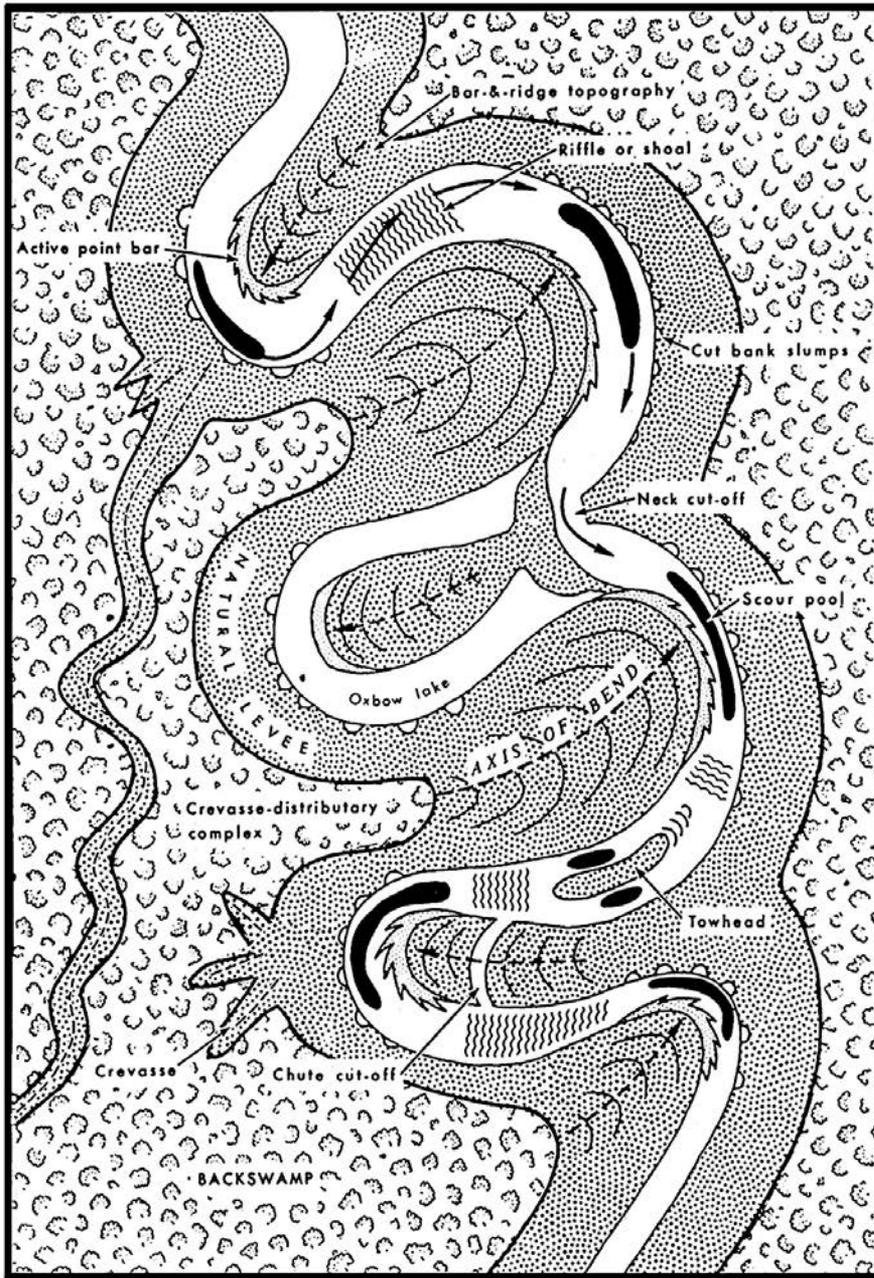
Figure 9. Topographic relationships of Holocene point-bar environments (from Saucier 1994).

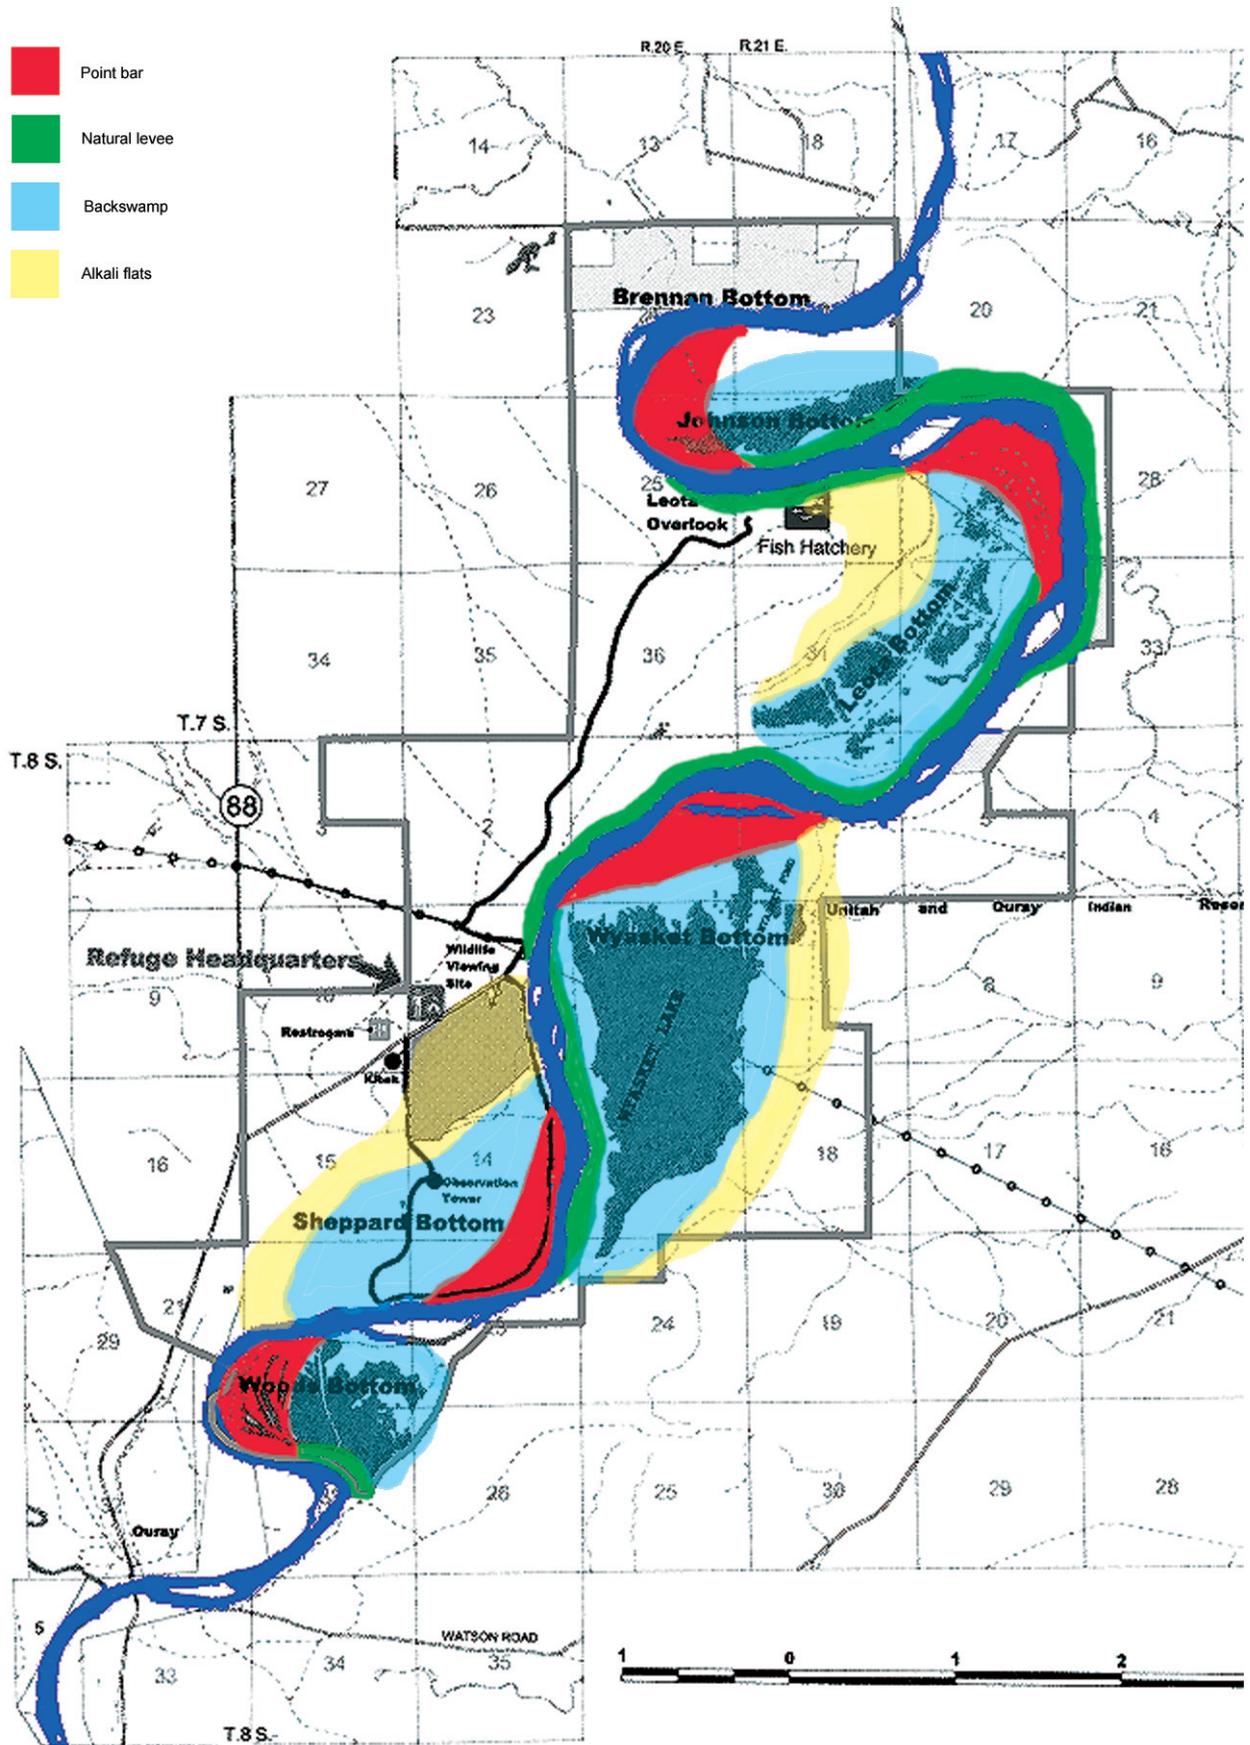
Figure 10. Geomorphic surfaces on Ouray National Wildlife Refuge, Utah.

Groundwater levels under Ouray NWR floodplains are influenced by geomorphic surfaces, soil types, and subsurface connectivity with the Green River. Where soils are relatively porous (coarse texture), groundwater moves between floodplain soils and the Green River and consequently, groundwater, and perhaps even some surface, water tables are influenced by stage of Green River flows. The degree and location of subsurface connectivity between floodplain wetlands on Ouray NWR and the Green River has not been determined, however sites that probably have the greatest connection include sites immediately behind point bars (Fig. 10)

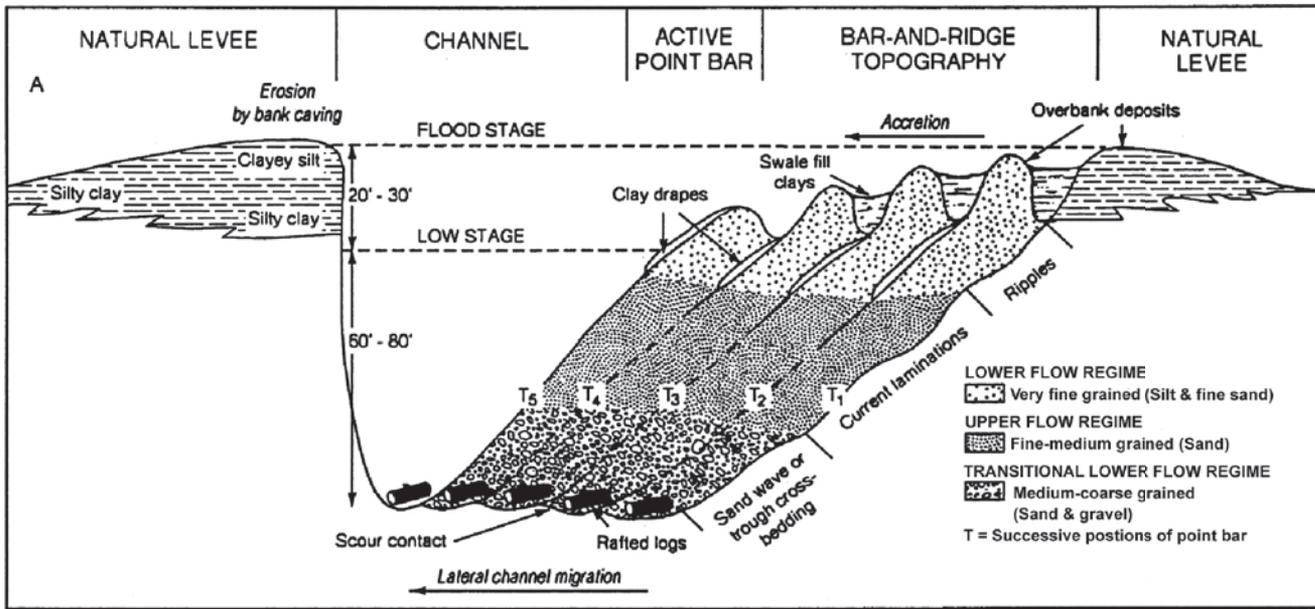
Figure 11. Topographic variation in relation to river processes that create meander belts in large sand bed rivers (from Saucier 1994).

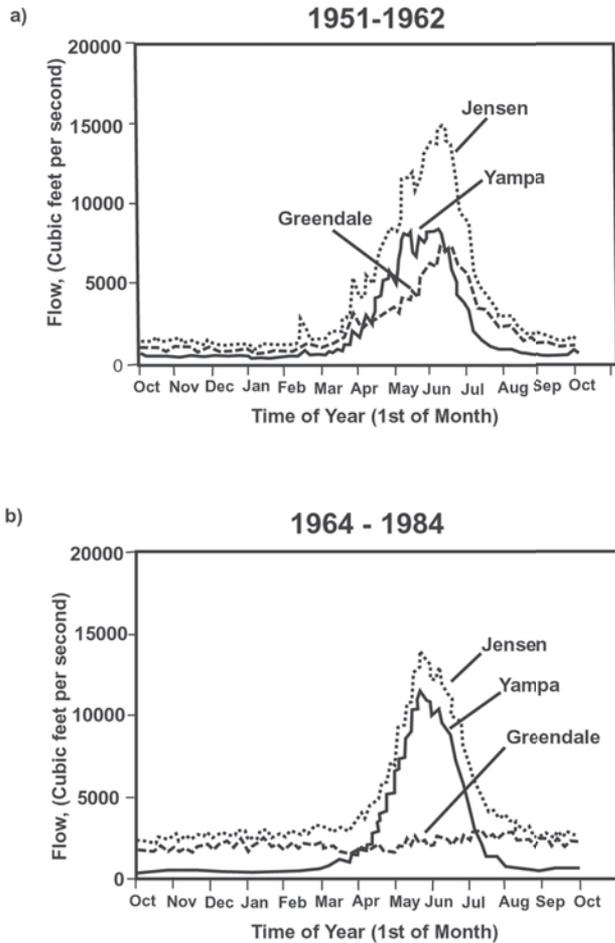
Figure 12. Green River basin flows at 3 gage stations above Ouray National Wildlife Refuge, Utah: a) prior to, and b) after closure of Flaming Gorge Dam in 1963.

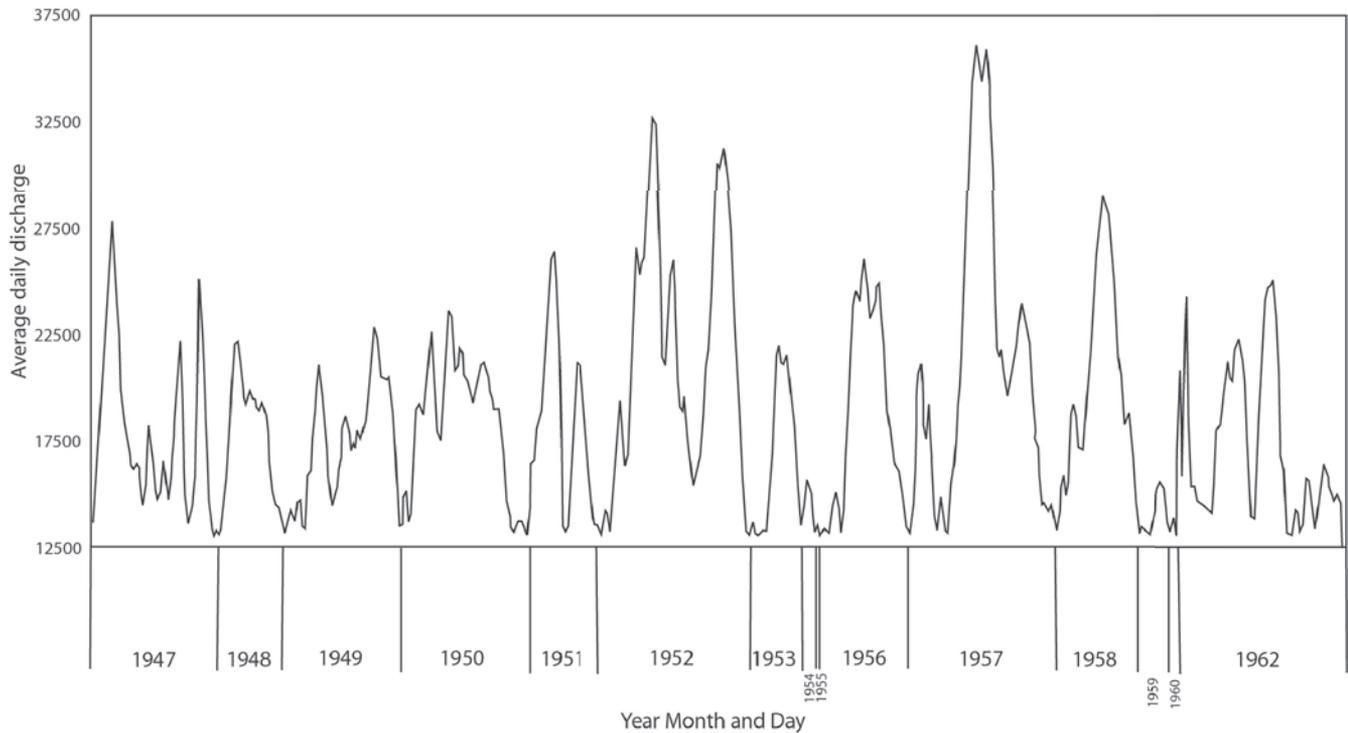
Figure 13. Green River average discharge 1947-1962 at Jensen, Utah.

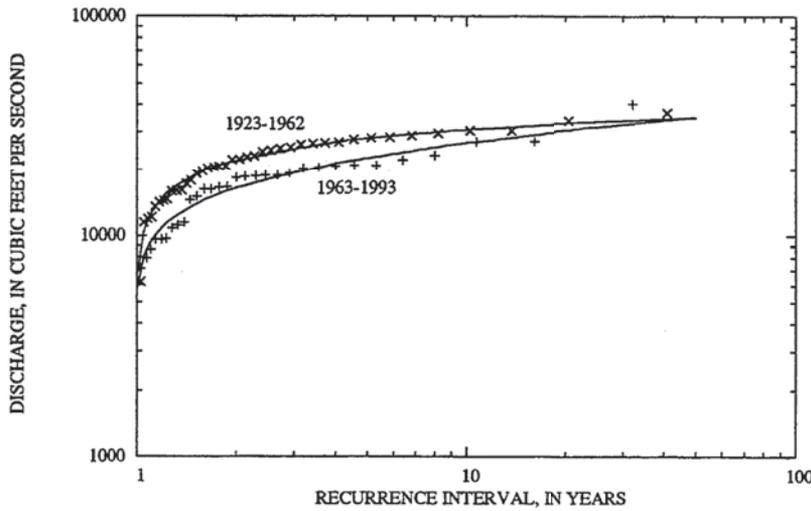
Figure 14. Recurrence interval of instantaneous peak flow for the Green River near Jensen, Utah (from Schmidt 1994).

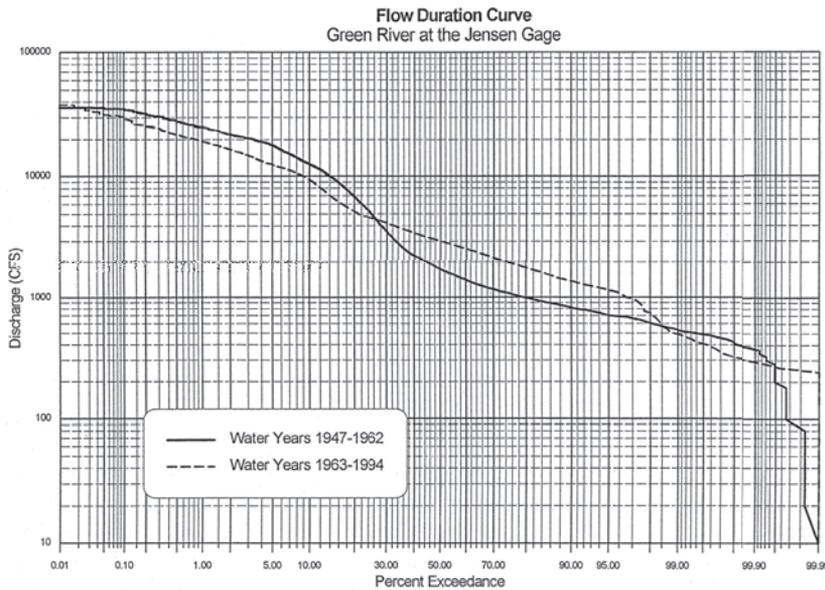
Figure 15. Pre- and Post- 1963 flow duration curves for the Jensen, Utah gage (from FLO Engineering, Inc. 1996).

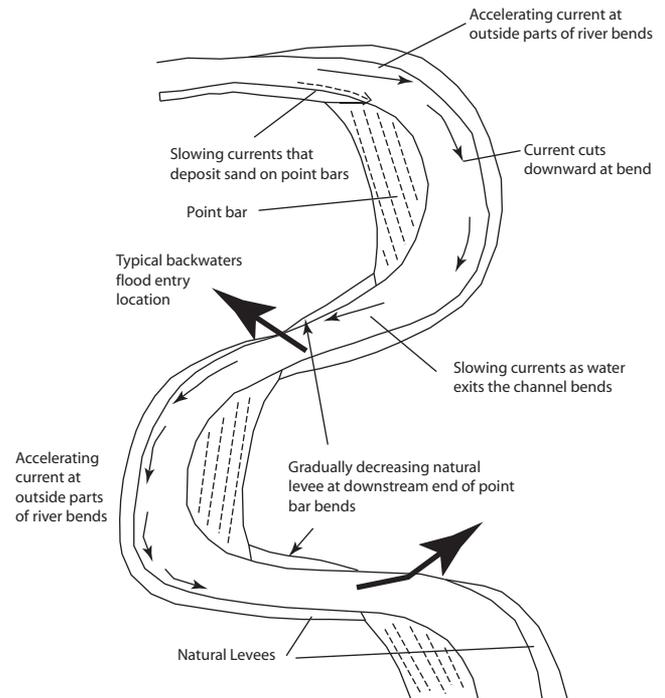
Figure 16. Schematic of typical geomorphic surfaces, river flows, and flood entry locations on sand bed rivers that have “S”-shaped channel configurations.

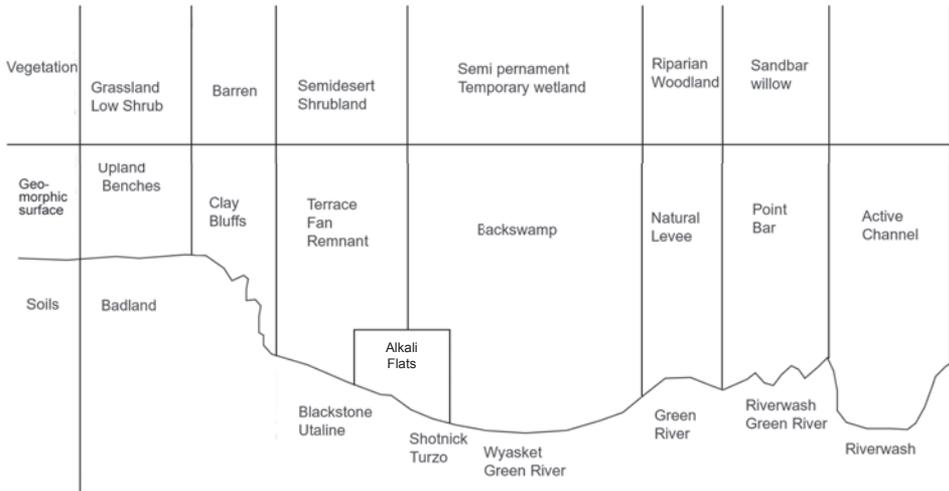
Figure 17. Cross-section of habitats on Ouray National Wildlife Refuge, Utah, indicating vegetation type, geomorphic surface, and soils.

and distribution. Historic and current surveys of animals associated with different vegetation communities provide a basis for determining species occurrence and resource use among habitat types. Other ecological information identifies the basic ecological processes, both abiotic and biotic, that control these ecosystems. Collectively, historic and contemporary information suggest a gradation of vegetation types and ecological processes from high elevation upland benches to the present river channel at Ouray NWR (Fig. 17).

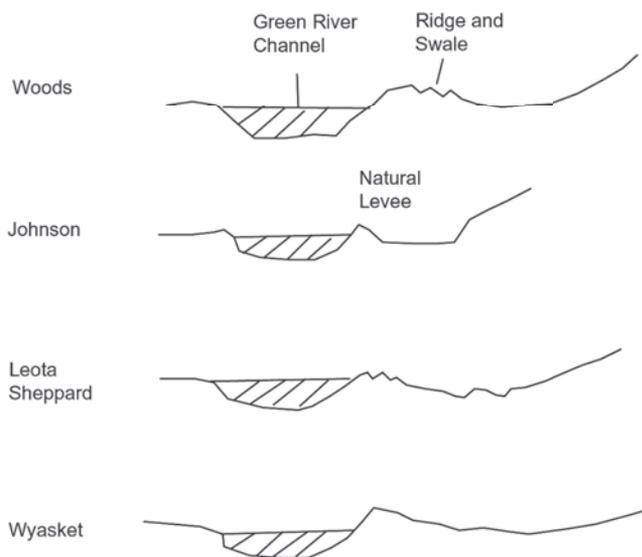
Figure 18. Cross-section of elevation and topography of floodplain “bottoms” on Ouray National Wildlife Refuge, Utah.

Most floodplain bottoms on Ouray NWR have low depressions in the middle of the bottoms that slope upward toward natural levees and point bar deposits next to the Green River. When extensive flooding occurs, water may be up to 7-9 feet deep in these locations (Table 5). Woods and Johnson bottoms each contain a single relatively deep “bowl-shaped” depression in the middle of the bottom while other bottoms have more gently sloping topography that contain large shallow flats (Wyasket), multiple shallow depressions of moderate size (Leota), or only a few small shallow depressions surrounded by wide higher elevation flats (Sheppard) (Figs. 7, 18).

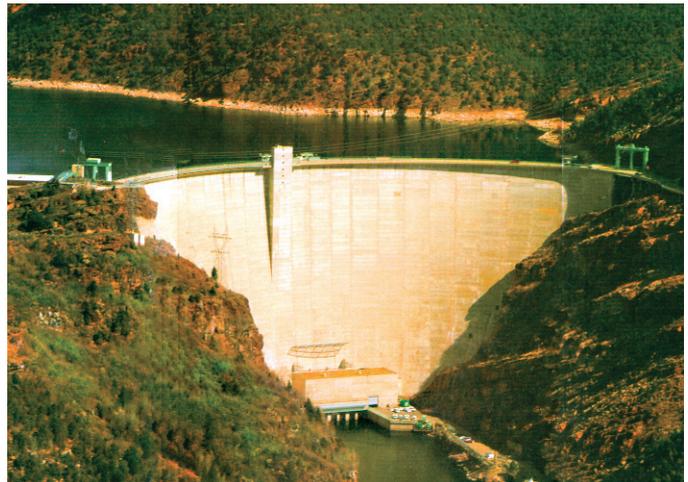
Flaming Gorge Dam on the Green River north of Ouray National Wildlife Refuge, Utah.

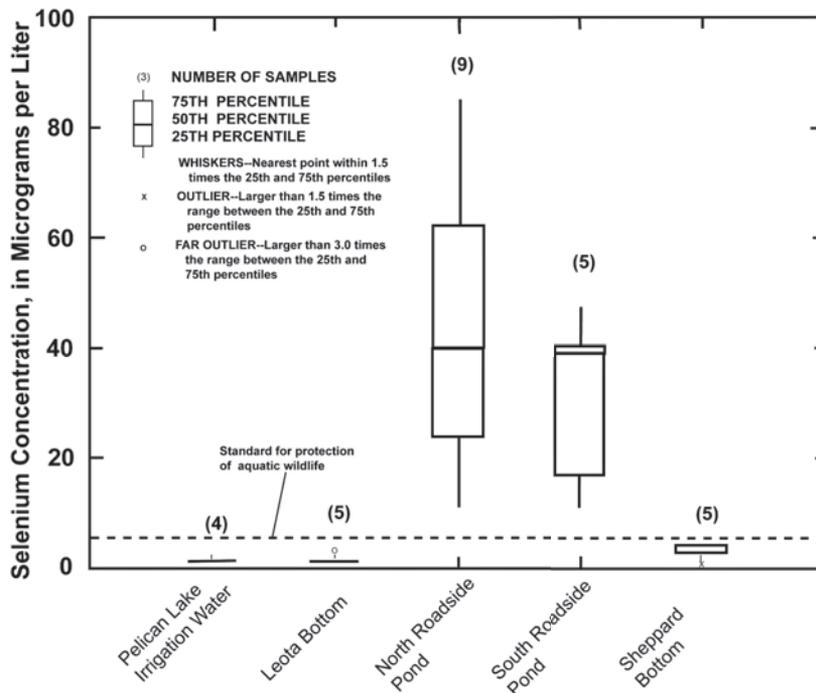
Figure 19. Selenium concentration in areas of Ouray National Wildlife Refuge, Utah, during 1988 and 1989 (from Stephens et al. 1992).

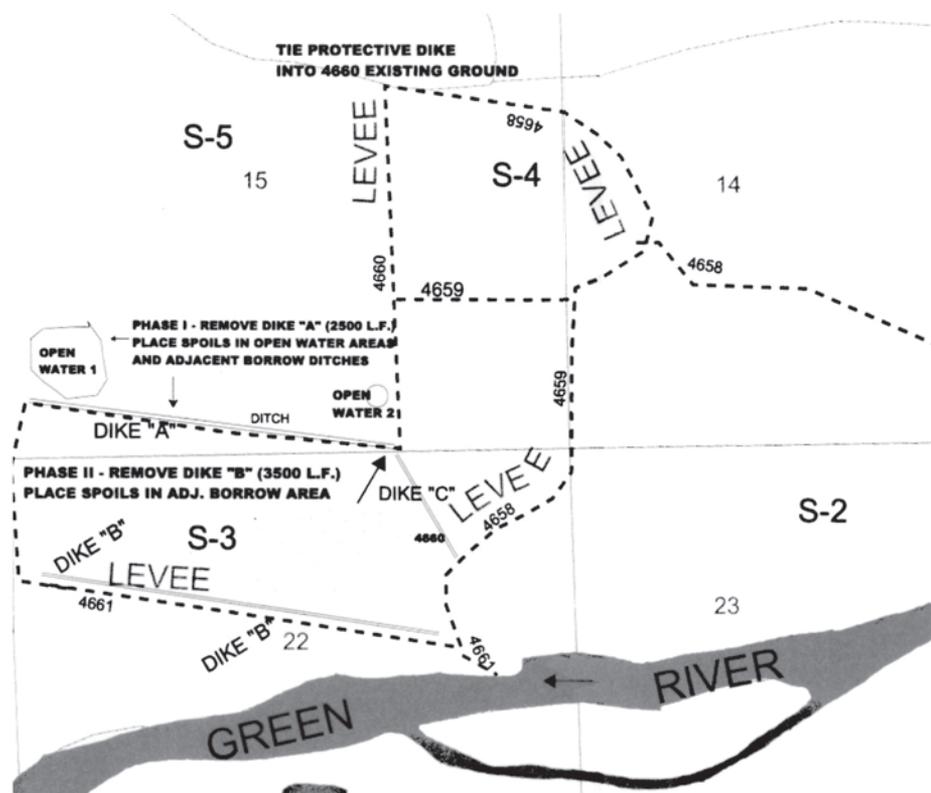
Figure 20. Structure modifications to Sheppard Bottom for dilution of selenium concentrations.

Historically, agricultural irrigation runoff and seep/spring water draining from the Roadside Draw flowed into Sheppard Bottom. Small levees were built in the Roadside Draw area to impound water for waterfowl production in the 1970s. In the 1980s, water in the Roadside Draw ponds were determined to contain high selenium concentrations that posed health risks to wildlife (Fig. 19). Consequently, the Roadside Ponds were retired from impoundment use in 1996. To offset loss of the Roadside Ponds, 5 independently controlled moist-soil impoundments were constructed in 1997 adjacent to the north part of Sheppard Bottom Unit S-4. These moist-soil

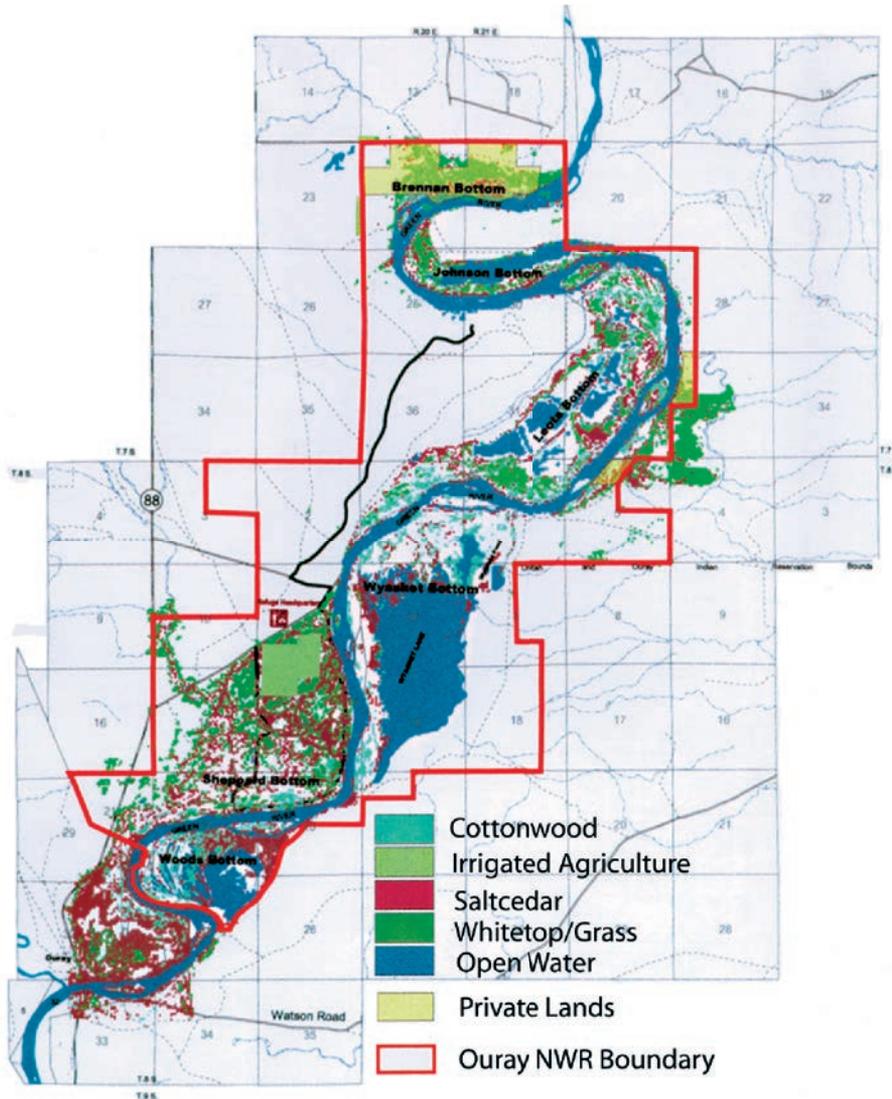
Figure 21. Distribution of saltcedar and tall whitetop on Ouray National Wildlife Refuge, Utah, during 2000.

In addition to saltcedar, other nonnative plants that have invaded large areas of Ouray NWR include tall whitetop, Russian-olive, and Russian knapweed. The exact area of coverage of these species is not entirely known and apparently is expanding (Fig. 21). Many chemical and mechanical techniques have been used to control nonnative plants including disking, burning, cutting, and application of herbicides, especially Round-up, Arsenal, and 2,4-D amine (USFWS 2000, Gardner 2002).

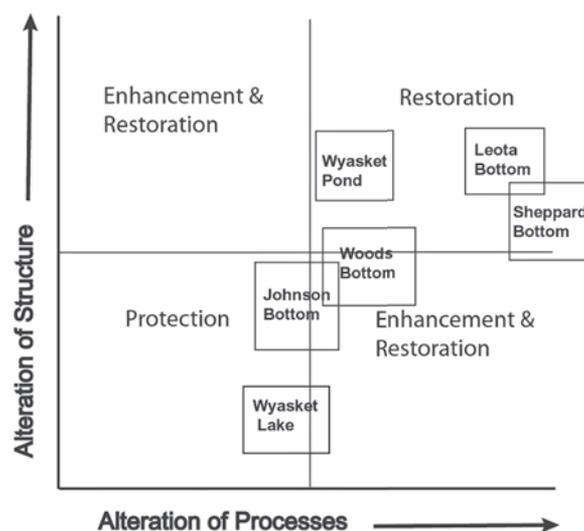
Figure 22. Model of conservation actions most appropriate for floodplain "bottoms" on Ouray National Wildlife Refuge, Utah.

The various floodplain bottoms on Ouray NWR have different degrees of alteration to process and structure (Fig. 22). Wyasket Bottom has the least amount of degradation and Leota and Sheppard Bottoms have the most altered conditions. Most of Wyasket Bottom has minor structural alteration because no levees were built in this area, except for the old Wyasket Pond levees. Although Green River flows and flooding are altered from pre-Flaming

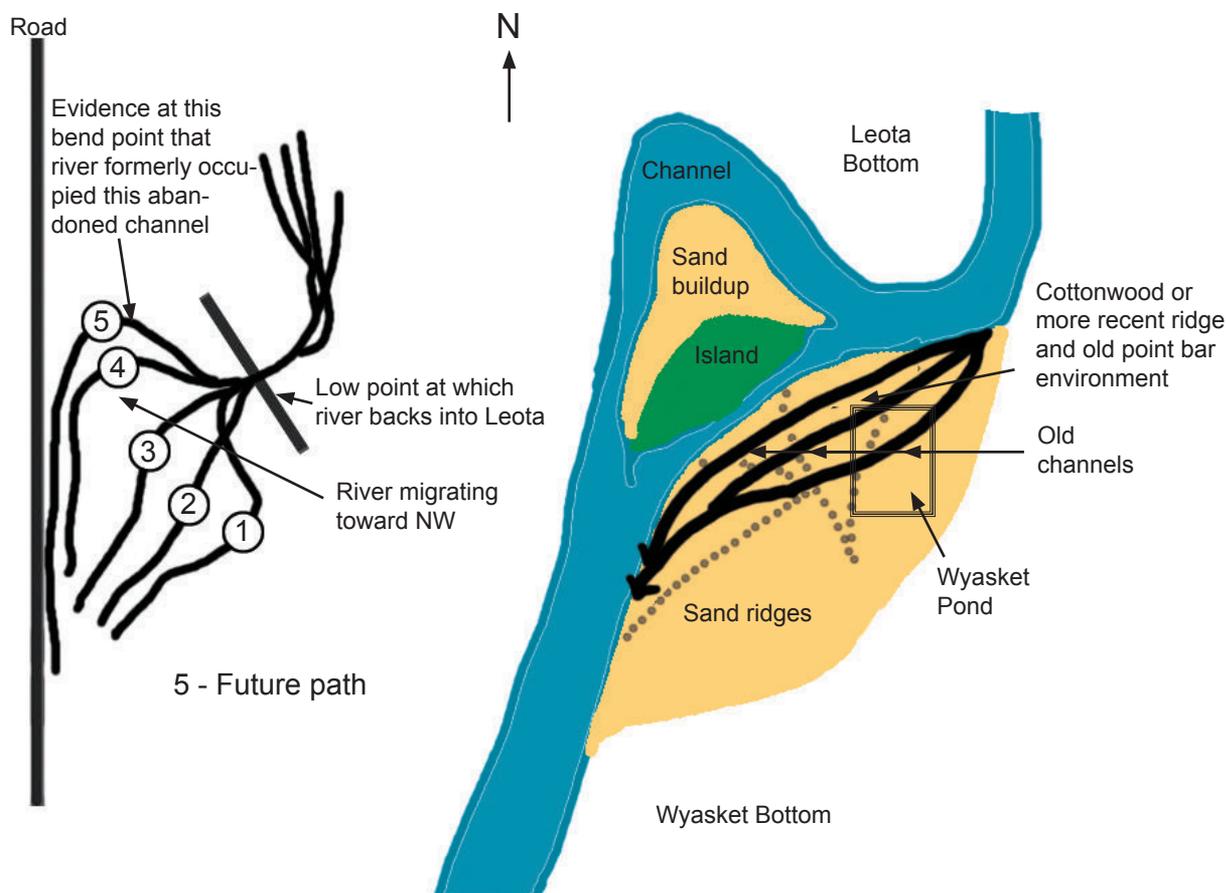
Figure 23. Green River channel migration (1= oldest, 4= current, 5 = projected future path) that formed point bar ridge and swale complex at the north end of Wyasket Bottom. Location of Wyasket Pond includes former channel paths and sand-based ridges and swales.

Wyasket Pond provides an example of using base abiotic information to make sustainable habitat restoration decisions. Wyasket Pond historically was a higher elevation point bar surface with interspersed riparian woodland habitat on ridges and herbaceous seasonal wetland in swales (Fig. 23). The point bar surface at Wyasket Pond graded into alluvial and upland terrace that contained finer alluvial sediments and upland grassland and semi-desert shrubs. These soils were conducive to crop production and in the mid-1900s a protective levee was built in this area by a private landowner to exclude flood waters from the Green River. After Ouray NWR was established, managers reversed use of the Wyasket Pond levee from an exclusion purpose to an inclusion purpose used to impound water. Clearly, this change created a different wetland condition than historically occurred on the site and management of Wyasket Pond has traditionally been difficult and intensive, because
