## CHANGES IN THE OURAY ECOSYSTEM

### HYDROLOGY AND RIVER GEOMORPHOLOGY

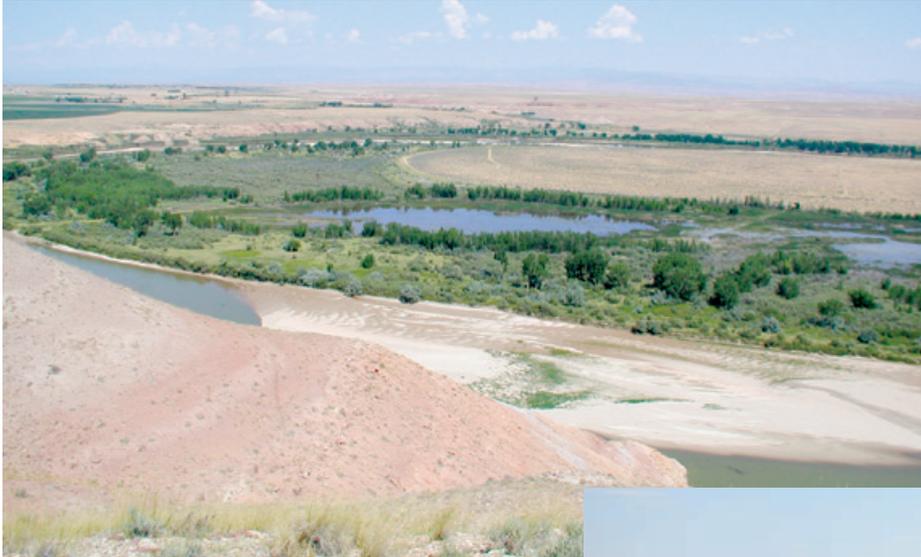
West side of Johnson Bottom, point bar surface.

Johnson Bottom river bar/channel geomorphology.

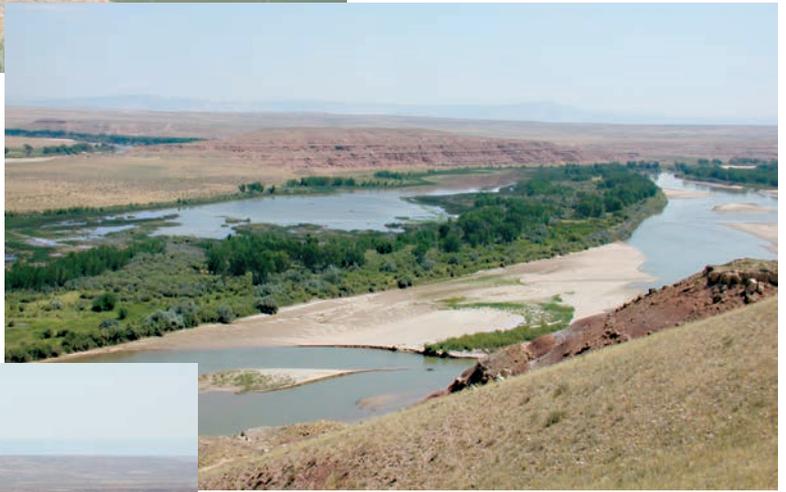
Green River channel dynamics creating ridge-and-swale surfaces.
