HYDROGEOMORPHIC EVALUATION OF
ECOSYSTEM RESTORATION
AND MANAGEMENT OPTIONS
FOR
ALAMOSA NATIONAL WILDLIFE REFUGE

May 2013

Greenbrier Wetland Services
Report No. 13-06

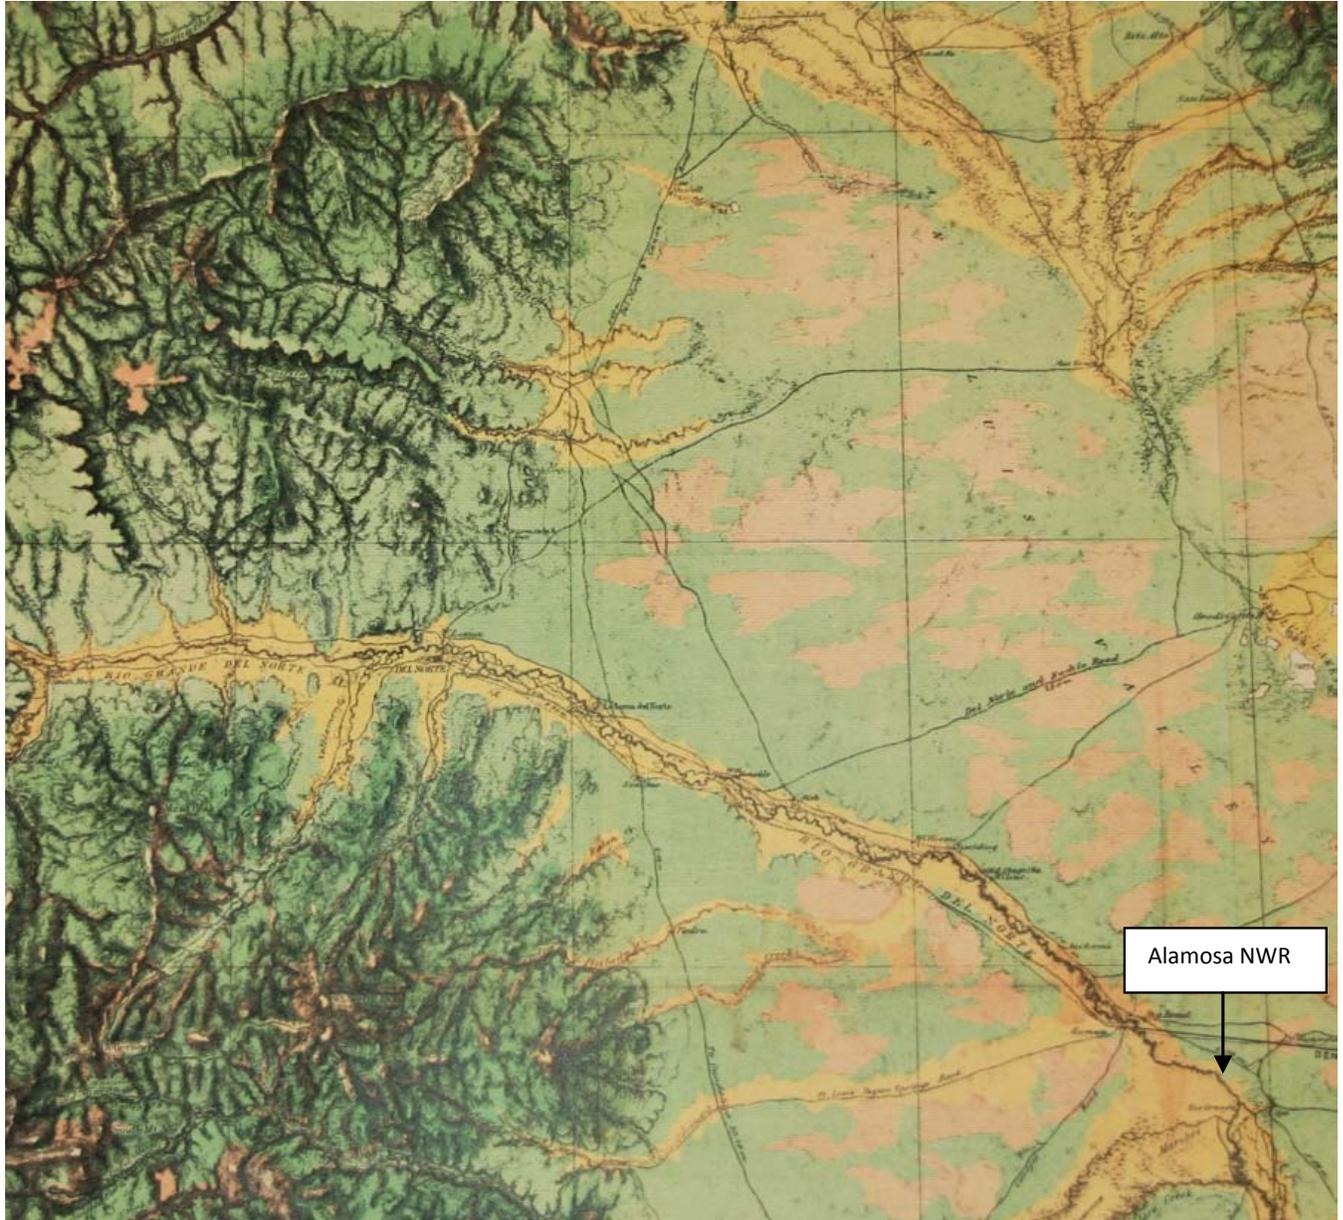
Figure 15. Wheeler Geologic Map of the San Luis Valley depicting land coverages. Yellow= Agricultural (irrigated); Pink= Arid and barren; Light green= Grazing; and Dark green= Timber. From U.S. Geological Surveys West of the 100th Meridian Land Classification Map of Southwestern Colorado: Expeditions of 1873, 74, 75, and 76. Atlas Sheet No. 61. Modified from Wheeler (1887).

Ramaley 1929), and older maps and aerial photographs (Figs. 9, 15). This information defines the locations of Hansen's Bluff, the historic Rock and La Jara Creeks, Alamosa River, and the Rio Grande along with descriptions of the location of salt desert shrub and larger wetland depressions such as abandoned river and creek channels. Aerial photographic mosaics taken during the 1940s and 1950s also identify vegetation communities present in various areas of Alamosa NWR and document relationships of vegetation to particular attributes such as the soils and topography. These major communities were overlaid on contemporary geomorphology, soil, and topography maps to determine correspondence. While older maps and accounts have limitations and may not be completely georeferenced, they do provide the opportunity to specifically define some areas, such as the historic Rock

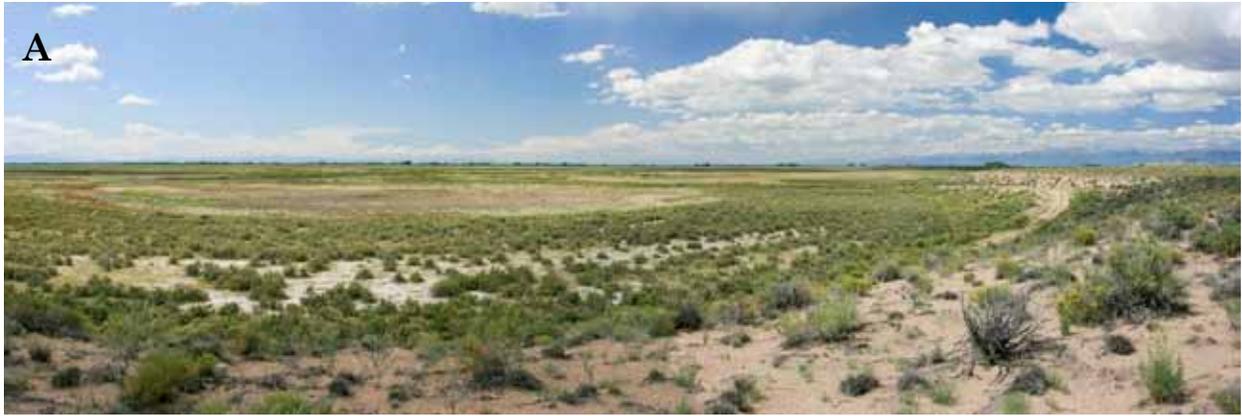
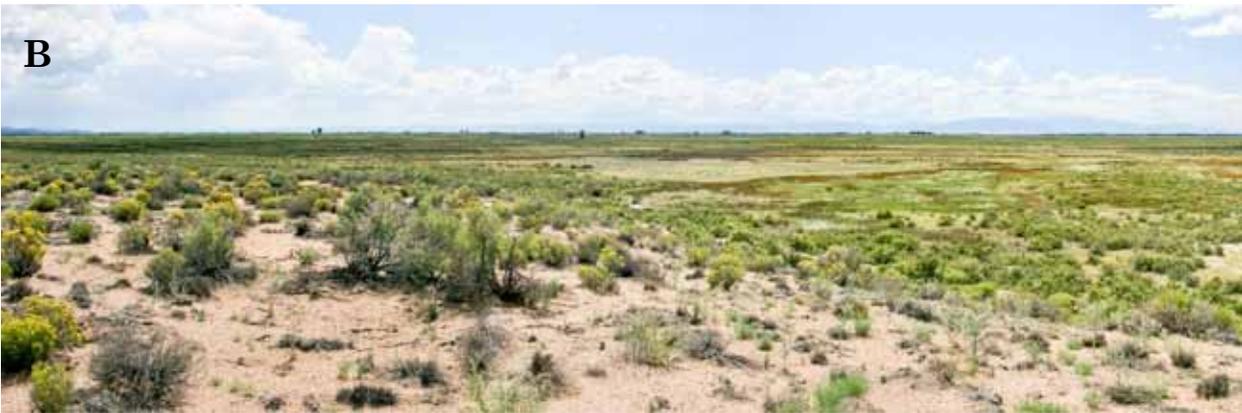
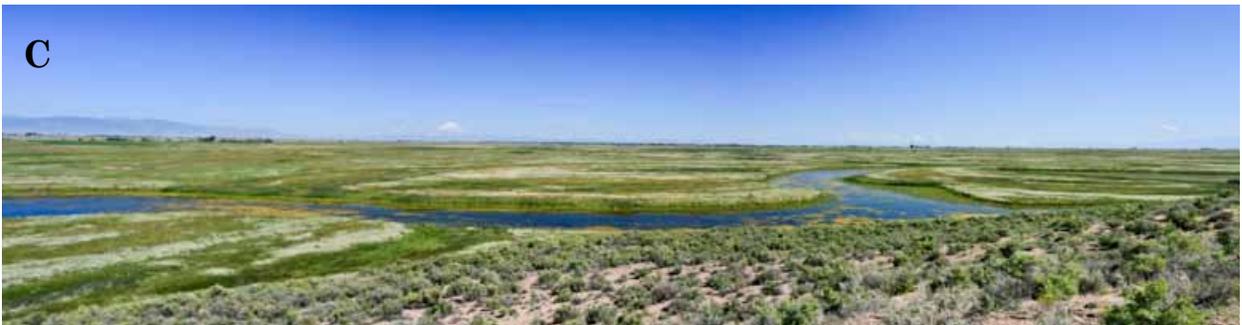
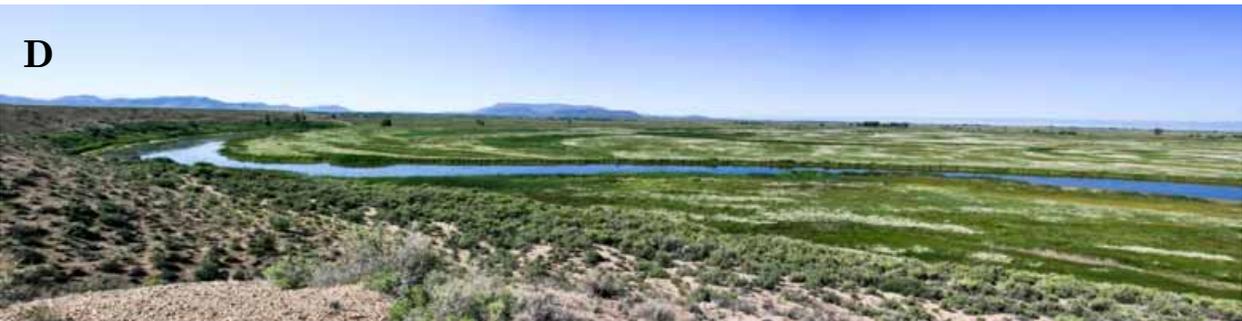
Figure 24. Panoramic photos of Alamosa National Wildlife Refuge in 2012: A) Point A on Bluff Road near units M and N1 looking north in 2012; B) Point A on Bluff Road near units M and N1 looking southwest in 2012; C) Point B on Bluff Road near overlook looking north in 2012; and D) Point B on Bluff Road near Overlook looking southwest in 2012.
