Nevada Strip Fishery Survey

Challenge Cost Share

Nevada Department of Wildlife

Prepared for the Lower Snake River District Office
Bureau of Land Management

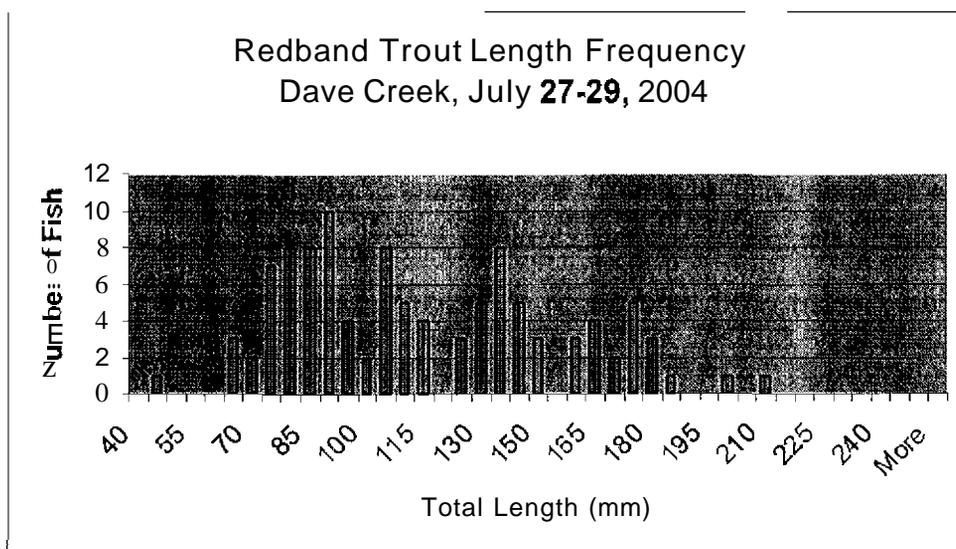
Figure 1. Dave Creek redband trout length frequency, July 27-29, 2004.

There were seven fish population sample sites completed in Dave Creek during the period of July 27-29 (Appendix II). The 6.4 mile reach of Dave Creek below the Forest Boundary had an average of 844.8 redband trout per mile. An estimated 5407 redband trout resided within the surveyed reach. Length frequency analysis of the sample of 105 redband trout revealed five age groups including a single young-of-year, a large age-I class, age-II, age-III, and two age-IV fish (Figure 1).

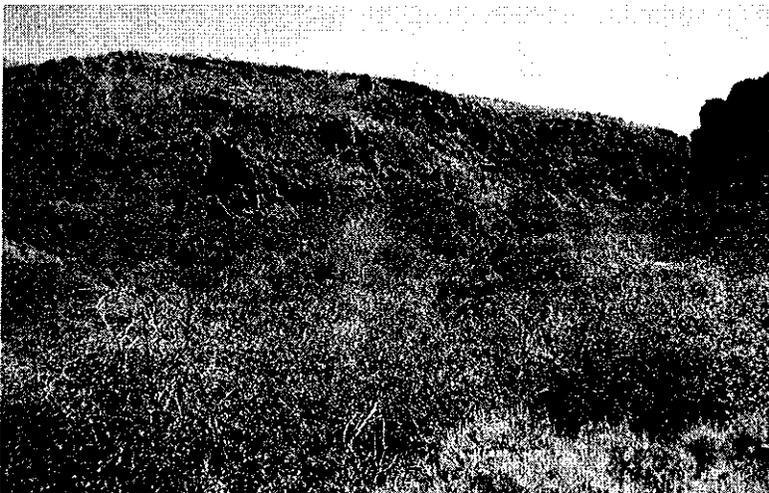
Figure 2. Cherry Creek 88-1 located near the stateline.

A total of six sample sites were slated for survey on Cherry Creek during July 7-8 (Appendix II). Only 88-1 was not surveyed due to the extreme density of riparian vegetation (Figure 2).

The water status of lower Cherry Creek should be assessed in late-August.
