## APPENDIX A

Project Area Photographs  
& Figures

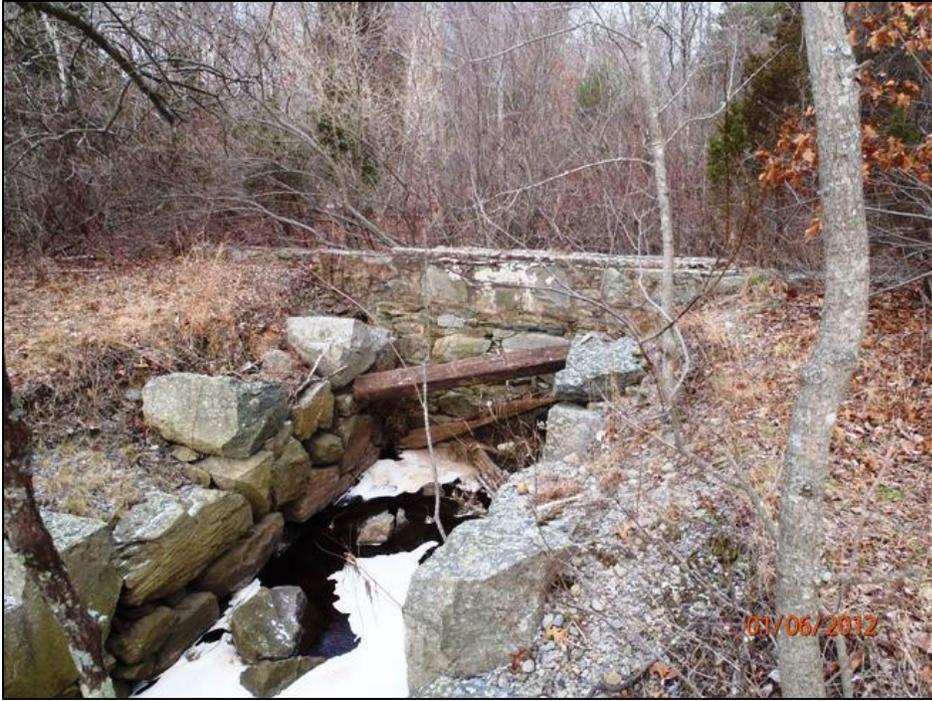
**Figure 1 Looking upstream at the western spillway of Rattlesnake Brook Dam.**

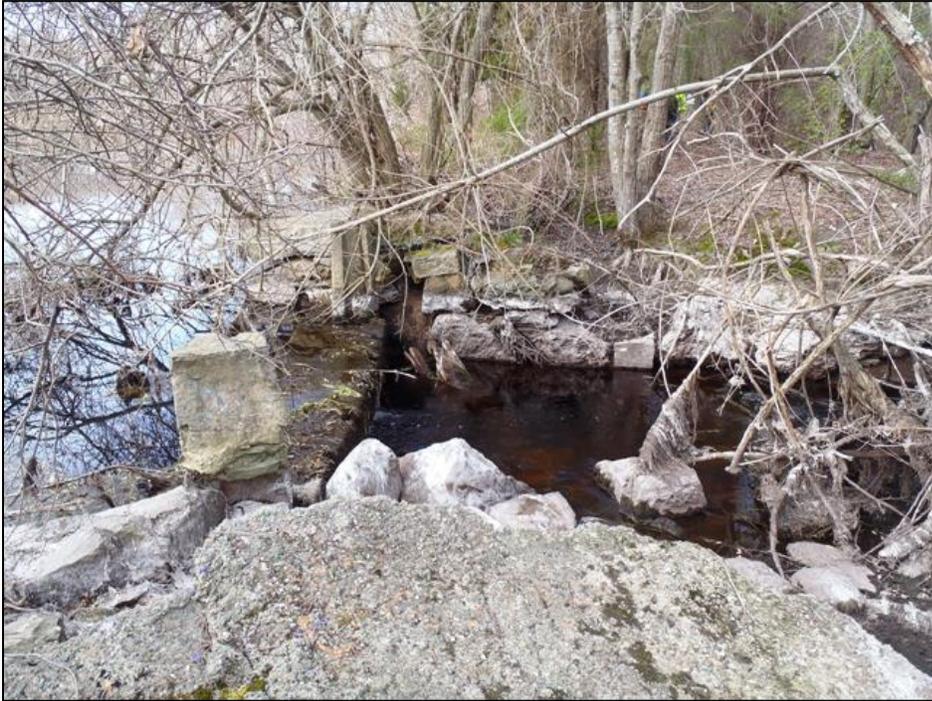
**Figure 2 Eastern spillway of Rattlesnake Brook Dam.**

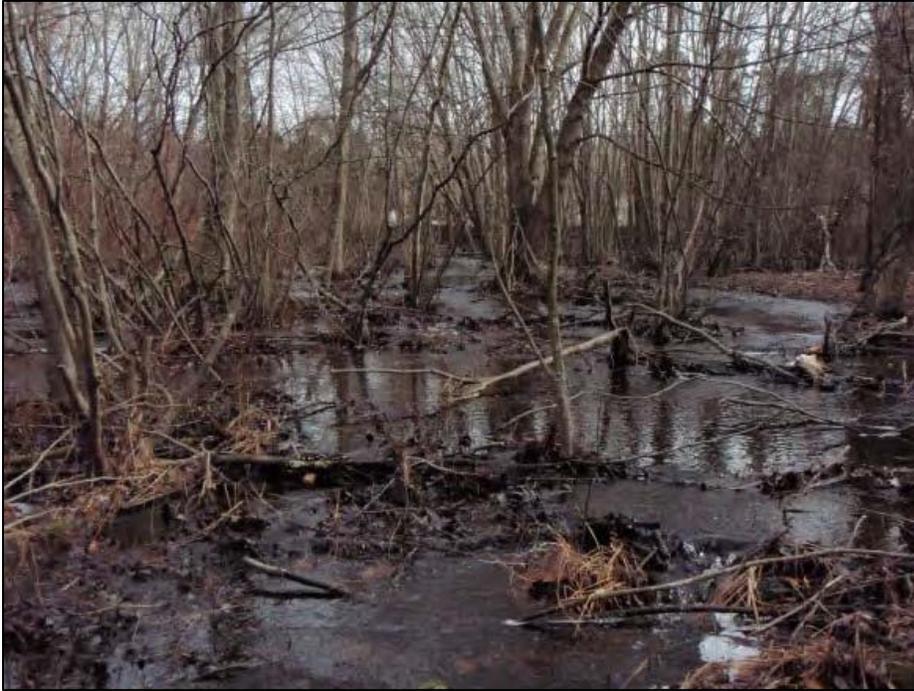
**Figure 3 Surface flow traversing floodplain from breach in eastern portion of Dam.**

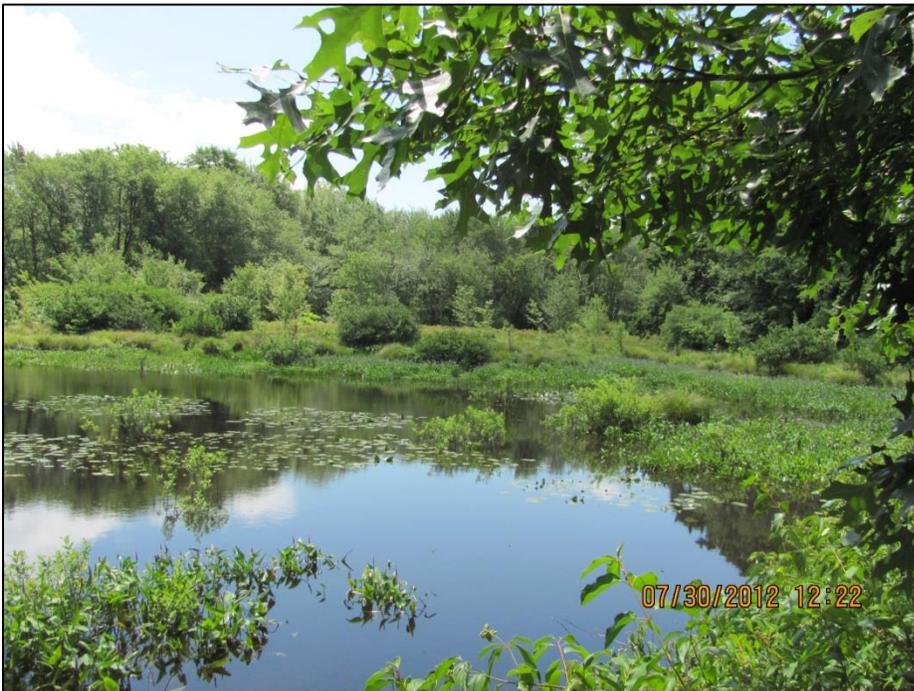
**Figure 4 Looking upstream of Rattlesnake Brook Dam at the impoundment.**

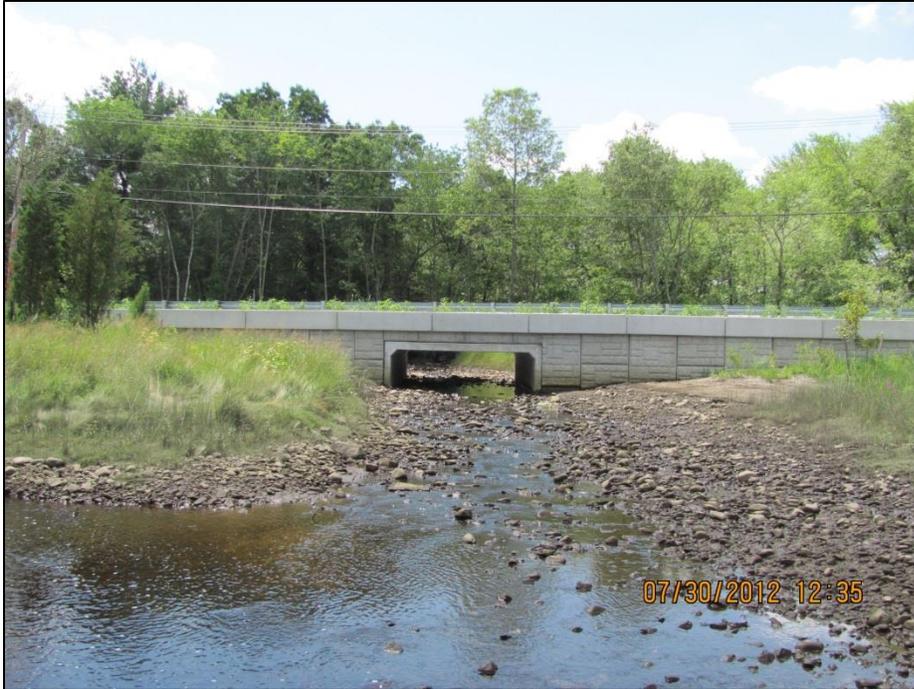
**Figure 5 Looking upstream from the estuary at the new box culvert under Narrows Road.**

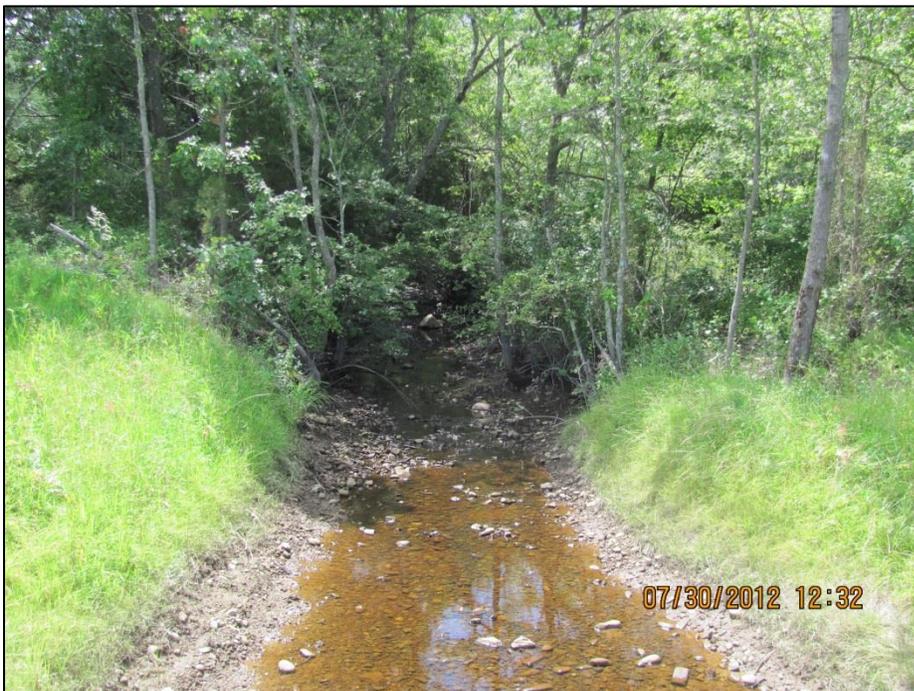
**Figure 6 Looking upstream at the western channel of Rattlesnake Brook from just upstream of Narrows Road.**

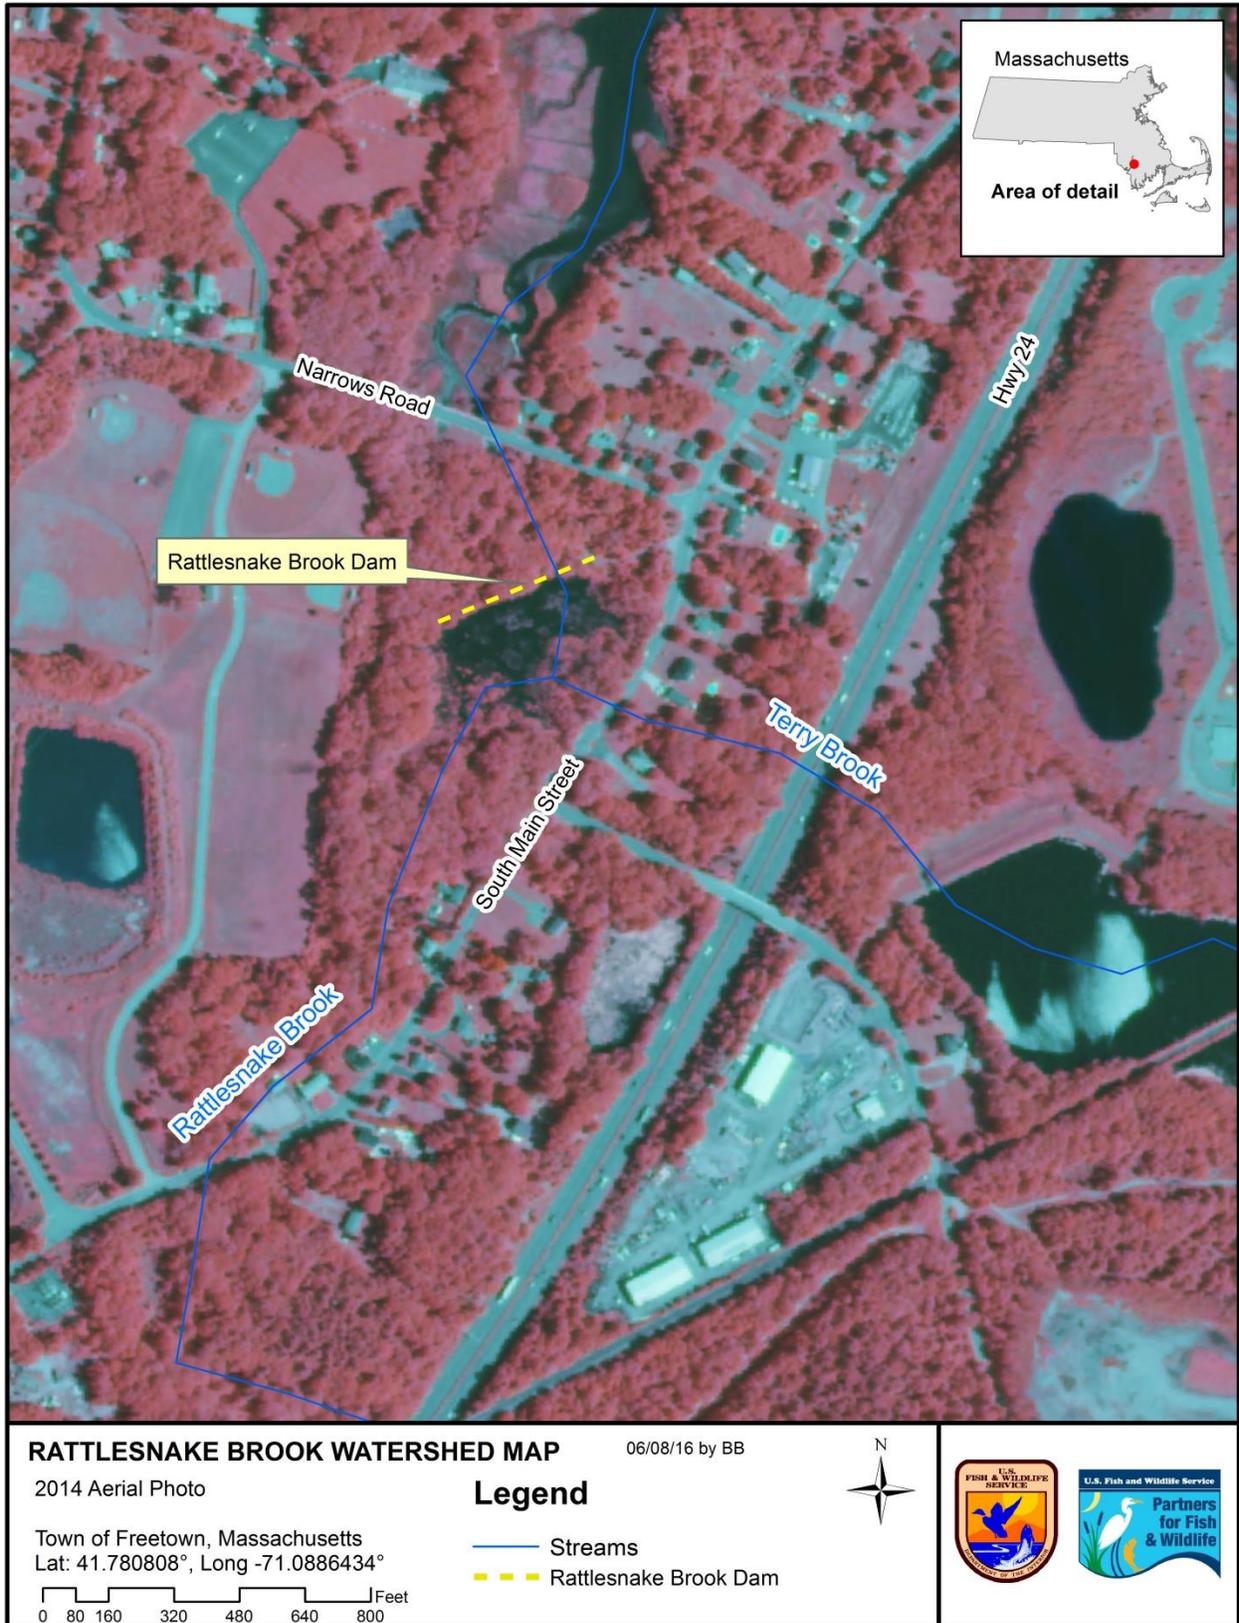
Figure 7 2014 Aerial photo of Rattlesnake Brook Restoration Project area in infrared color by USDA NAIP.

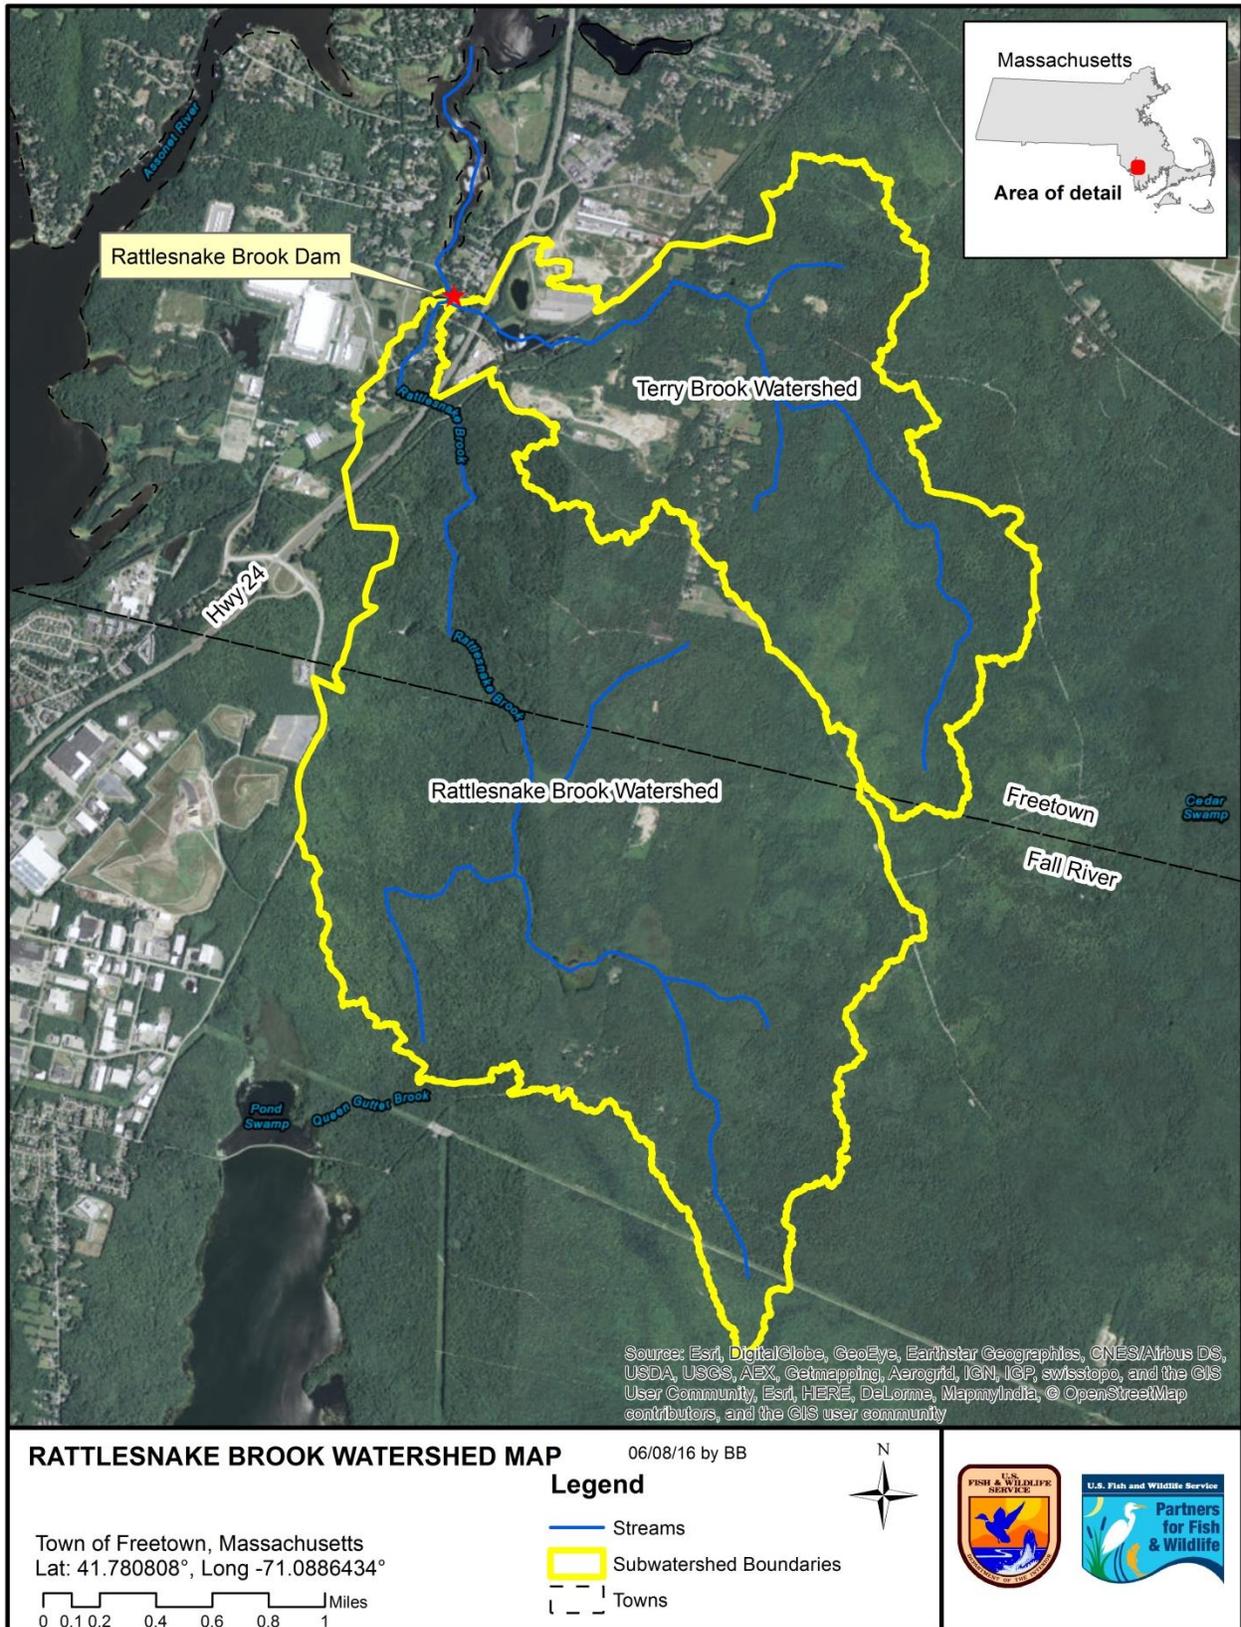
Figure 8 Contributing watersheds to the Rattlesnake Brook Dam.

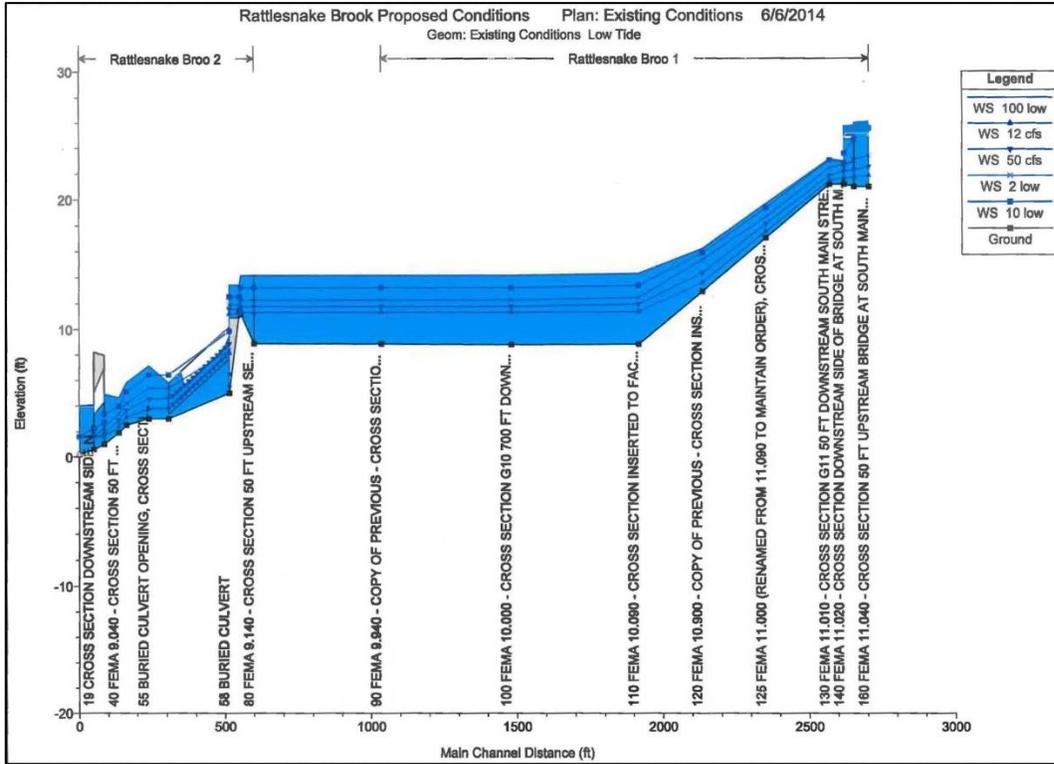
Figure 9 MMI existing water surface profile output from HEC-RAS for base flow up through the 100-yr storm event in the western channel of Rattlesnake Brook (MMI 2014).

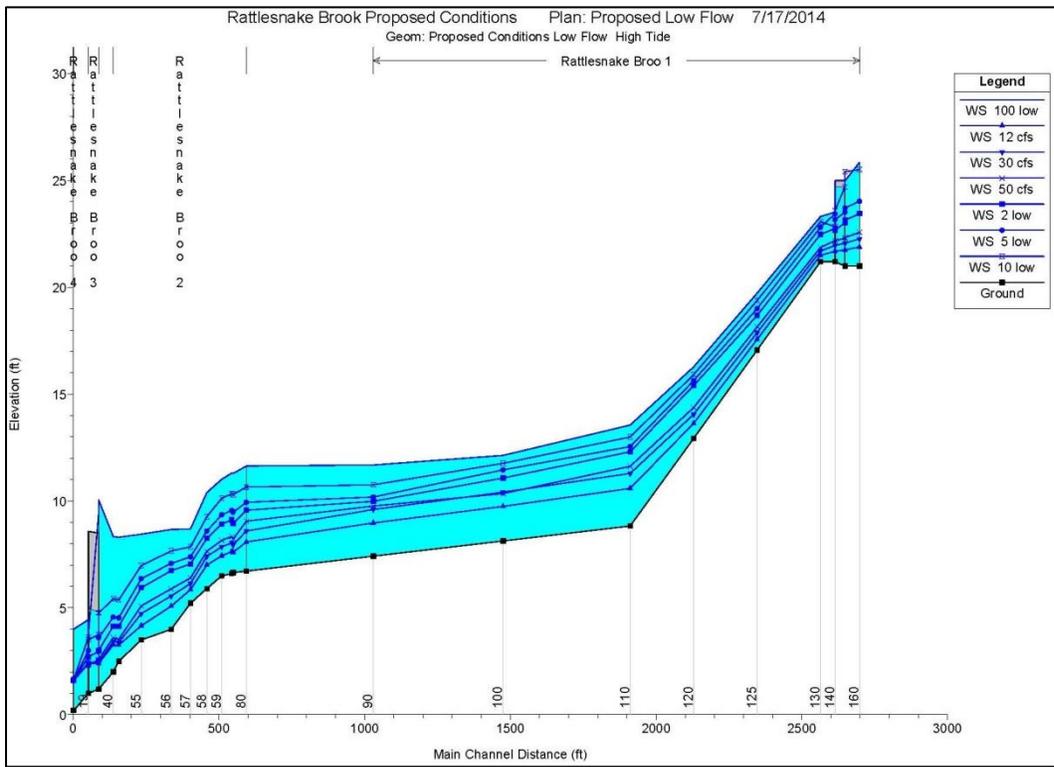
Figure 10 MMI predicted water surface profile output from HEC-RAS for base flow up through the 100-yr storm event in the western channel of Rattlesnake Brook (MMI 2014).
