# Potential Wetland Restoration Sites for Connecticut: Results of a Preliminary Survey

*May 2013*

Potential Wetland Restoration Sites for Connecticut:  
Results of a Preliminary Statewide Survey

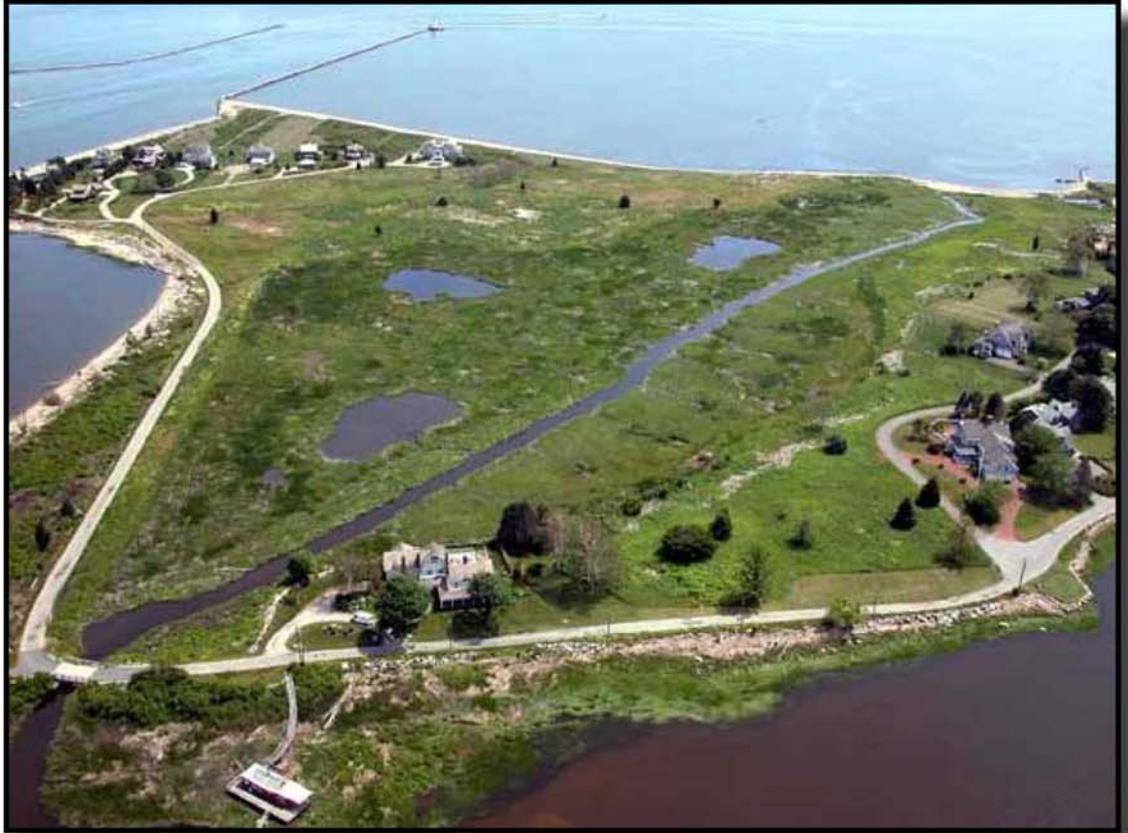
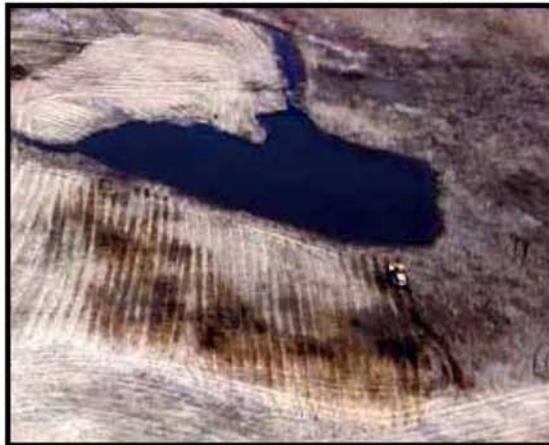
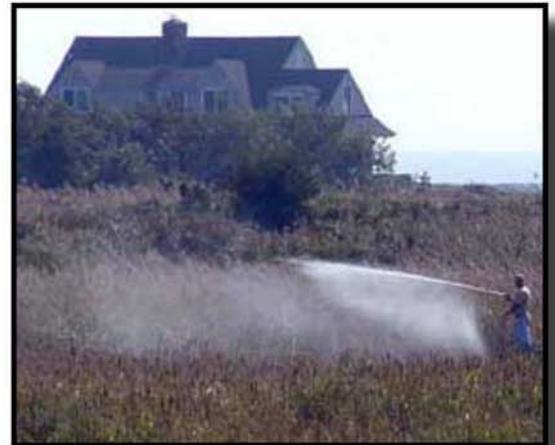
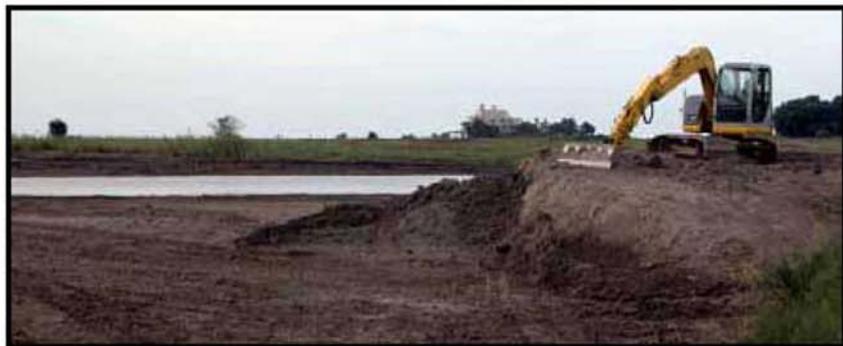
Cover Photos: Lynde Point Marsh, a restored tidal wetland in Old Saybrook: top = post-restoration view, while other photos show restoration activities: spraying and mowing of common reed stands and removal of dredged material and excavation of ponds.  
(CTDEEP photos)

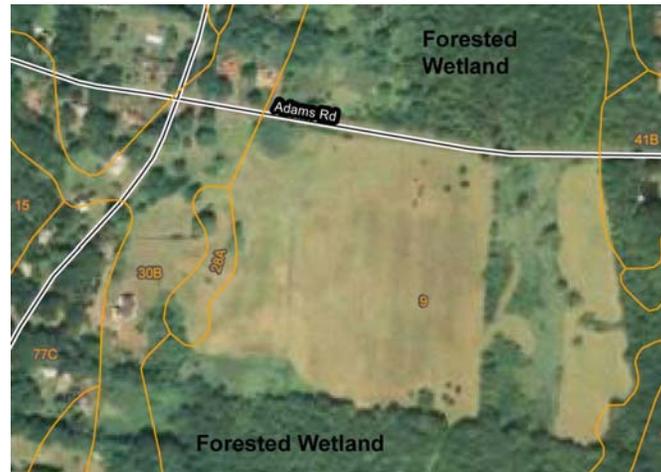
*Figure 1.* Type 1 site – a former palustrine forested wetland, now cropland on hydric soil (code 9 = Scitico, Shaker, and Maybid soils; Bloomfield). (Source: USDA web soil survey)

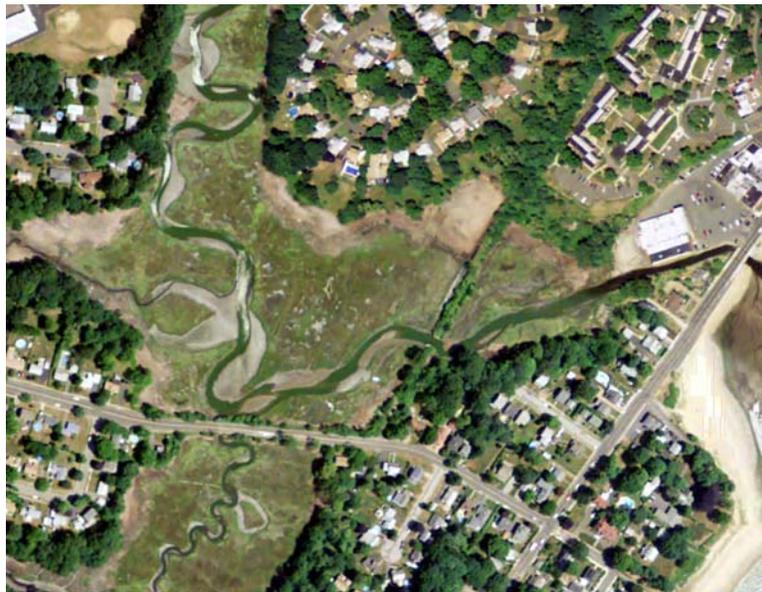
*Figure 2.* Estuarine wetland (salt marsh) that is tidally restricted by roads and former rail causeway (Milford). The light brown areas along the marsh edge appear to be mowed common reed (*Phragmites australis*) stands.

The enhanced wetlands inventory involved applying hydrogeomorphic and other descriptors to improve wetland characterization (Tiner et al. 2013). This work included adding new descriptors for identifying Type 2 sites that were tidally restricted wetlands. Along the coast, tidal flow is limited by roads (“td” modifier), railroad embankments (“tr” modifier), or by other structures, usually built-up land (“to” modifier) (Figure 2; Tiner 2011).

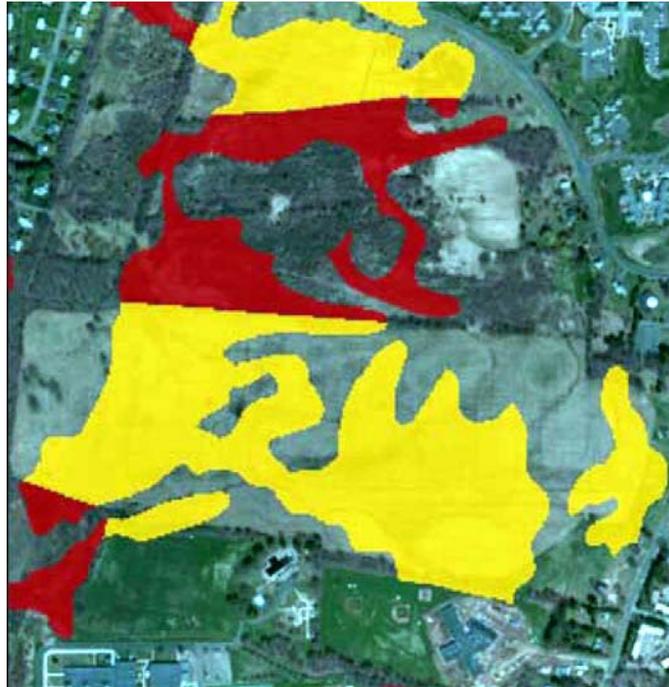
Figure 3. Type 1 sites identified in Bloomfield: top image showing Type 1 sites (yellow) and P-wet areas (red sites), while bottom image shows soils (code 9 = Scitico, Shaker, and Maybid soils; this soil unit is 85% hydric soil). The P-wet areas are in “natural vegetation” while the Type 1 sites are in agricultural use – pastures or hay fields that may be wet enough to qualify as wetland yet did not have recognizable wetland signature on the aerial imagery used in this survey. Most of the area surrounded by the P-wet area is a palustrine scrub-shrub wetland. (Sources: NWI+ web mapper and USDA web soil survey)

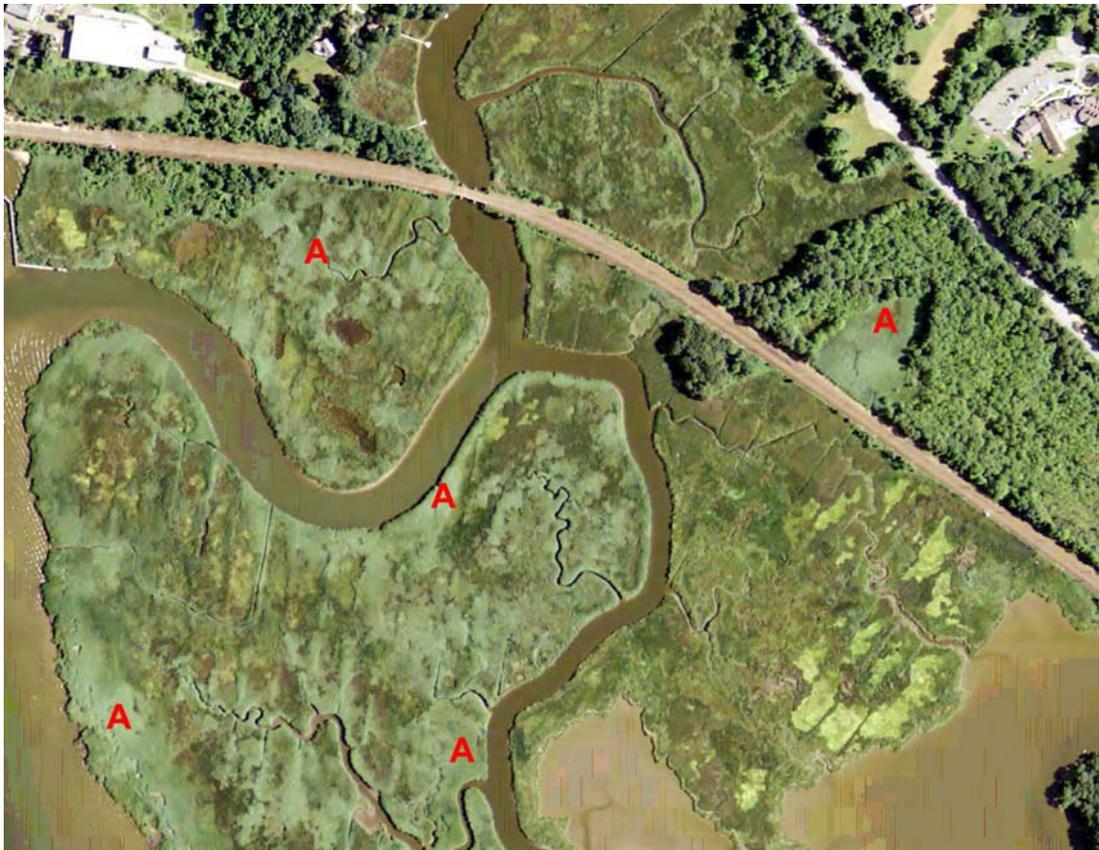
Figure 4. Aerial image showing photo-signature of common reed (*Phragmites australis*). Pure reed stands are the dull light green areas in the image; several are marked with the letter “A” but many others can be seen, some mixed with other marsh plants.

functions, their fish and wildlife value has been, in most cases, diminished or at least significantly changed for typical salt marsh fauna. Identifying invasive species is often impossible to do on aerial imagery, with some exceptions. Common reed is one exception; large stands of this species can be interpreted. Purple loosestrife (*Lythrum salicaria*) is another exception, but requires imagery captured during the peak blooming period for identification. Other invasives such as multiflora rose (*Rosa multiflora*), glossy or European buckthorn (*Frangula alnus*), and honeysuckles (*Lonicera* spp.) are among the many invasives that require identification through field surveys. The imagery used for this survey did allow identification of large common reed stands but was not suitable for detecting purple loosestrife. Many if not most of the common reed stands were identified as tidally restricted estuarine wetlands or partly drained tidal wetlands; they were not identified as a specific type. Other *Phragmites* marshes can however be identified by accessing the 2010 wetlands geospatial database and looking for the code “EM5” that was used to differentiate common reed stands from other marshes. Alternatively, one could examine aerial imagery for the characteristic signature of common reed (Figure 4).

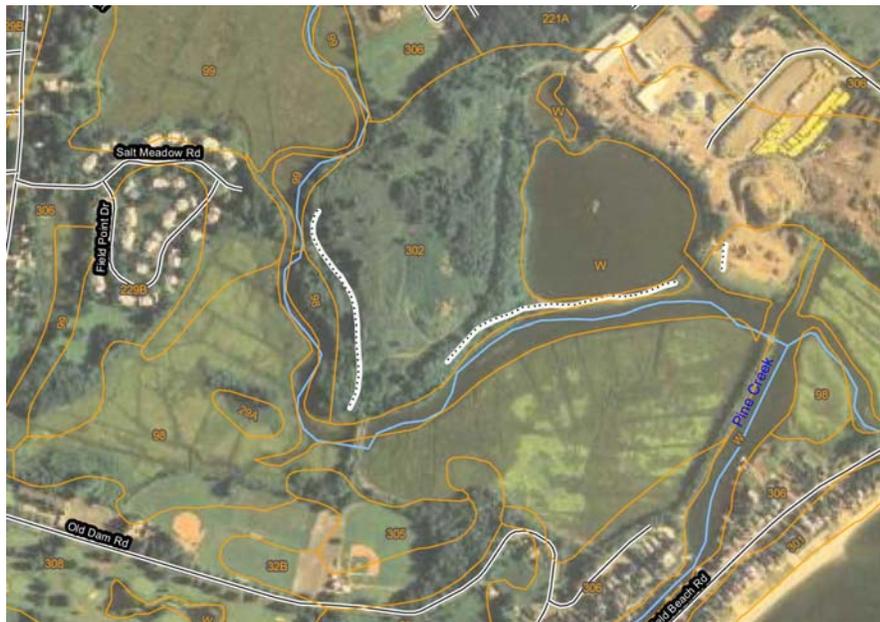
*Figure 5.* Example of a dump (code 302) built in a tidal wetland (Pine Creek, Fairfield).

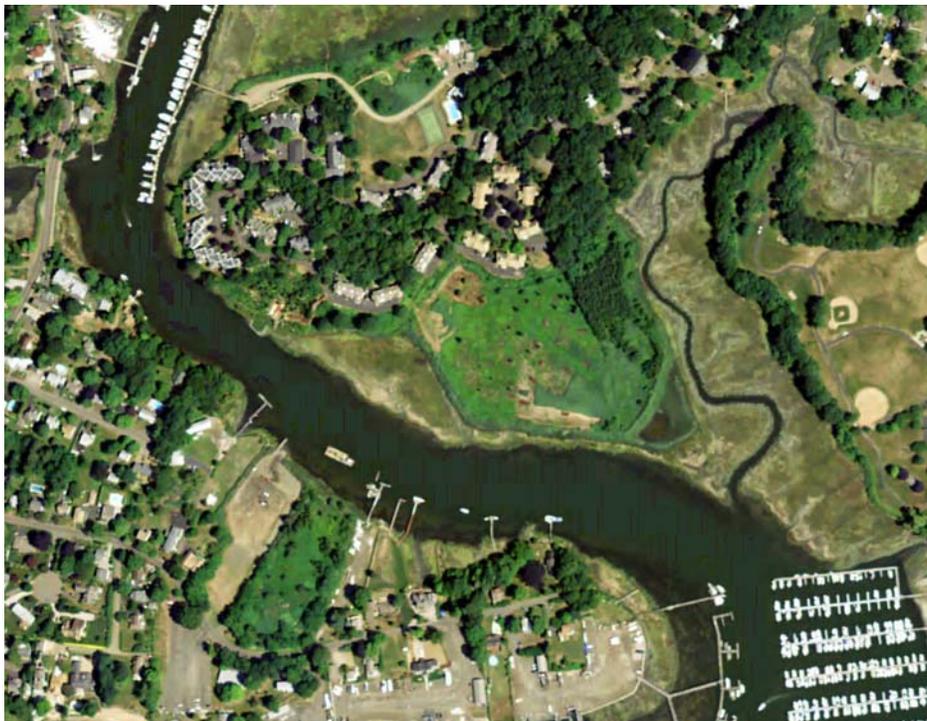
*Figure 7.* Example of dredged material disposal site identified as a Type 1 site along the Branford River. Subject area is green area in center of photo.

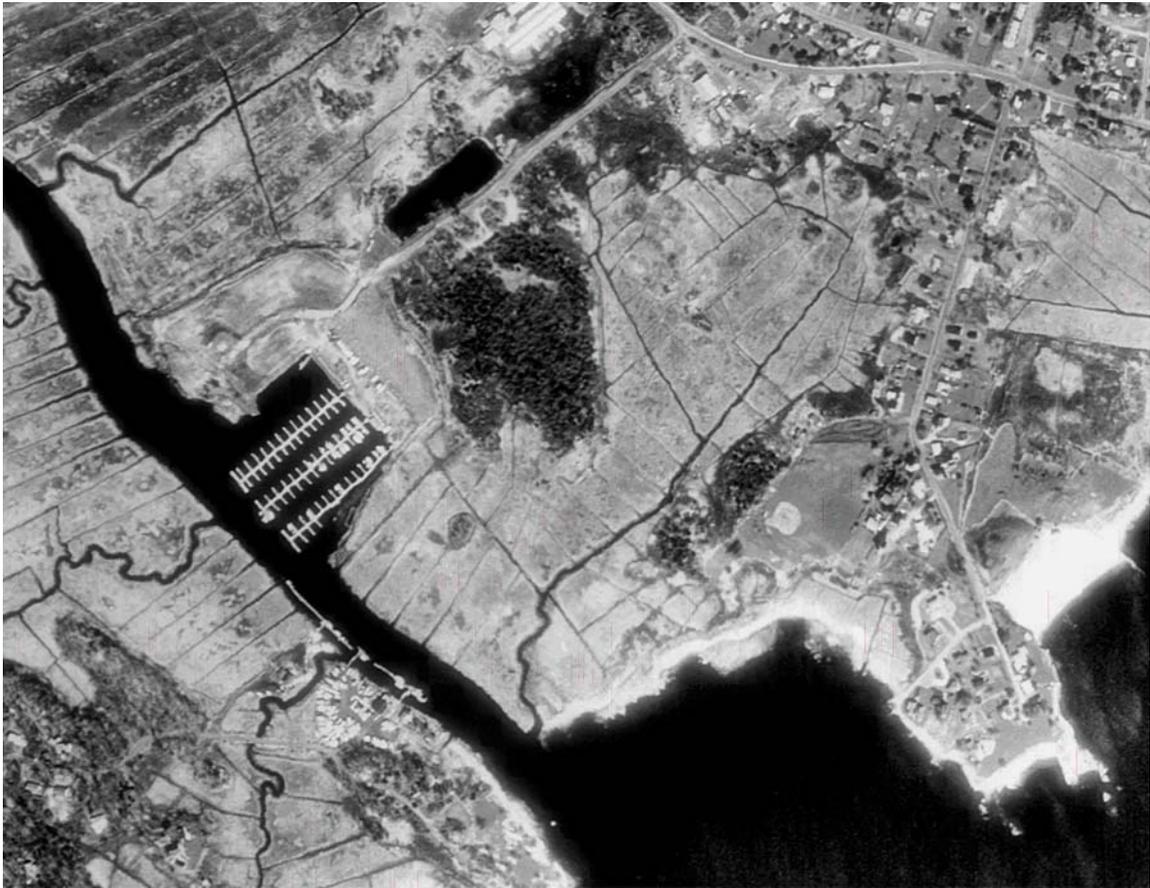
*Figure 8.* The hydrology of nearly all of state's tidal marshes has been adversely impacted by ditches; this image shows ditched marshes in Guilford. Also visible are excavated former wetlands forming the marina boat basin and filled areas associated with the marina.

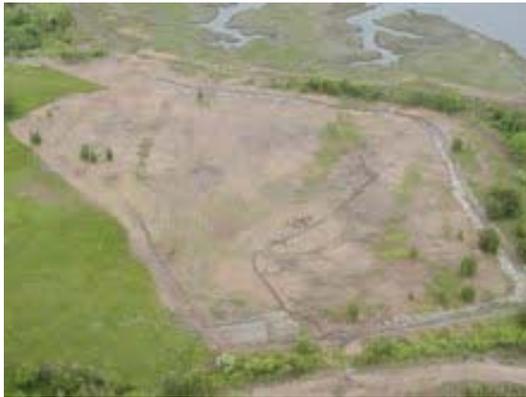
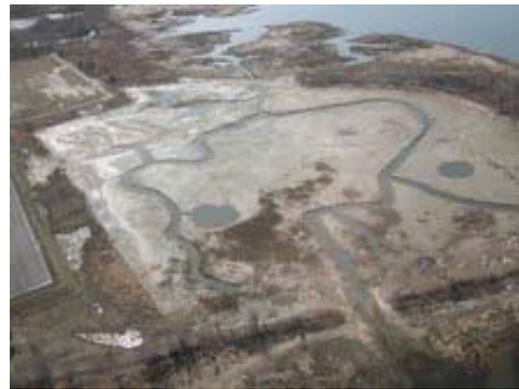
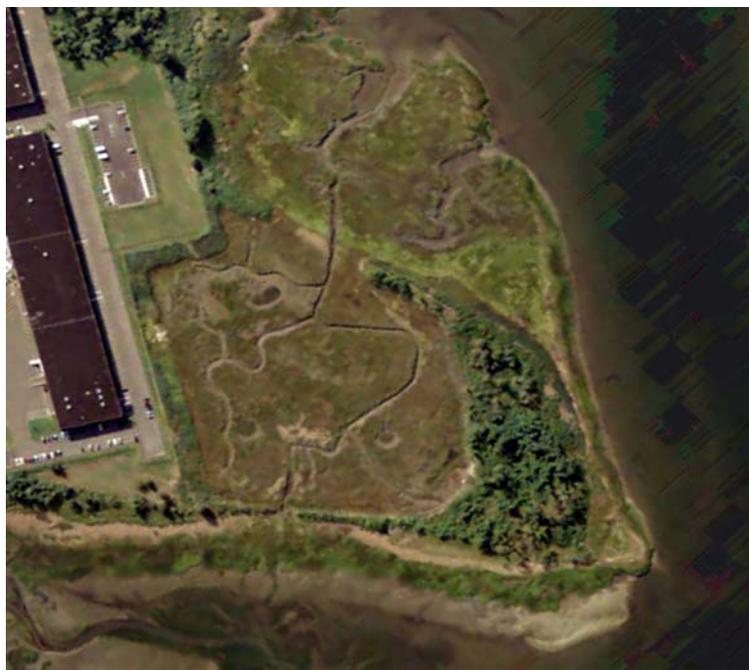
*Figure 9.* Salt marsh restoration project at Stewart B. McKinney National Wildlife Refuge: pre-construction condition (2004; top left; CTDEEP), during construction (2008; top right; CTDEEP) and restored marsh in 2011 (bottom). Today the restored area looks like the contiguous natural marsh.

During the past two decades there have been increased efforts to restore Connecticut's wetlands. Most of the projects involve rehabilitating or re-establishing tidal wetlands. Nearly all of the state's tidal wetlands were ditched at one time or another (Figure 8), while others have had their connection to tidal waters limited by road or railroad crossings or by development. Reviving more natural hydrology and controlling common reed to encourage growth by native species are prime restoration objectives. Re-establishment projects involve removal of fill and reconstructing a drainage network like was done at Stewart B. McKinney National Wildlife Refuge in Stratford and Hammonasset Beach State Park in Madison (Figures 9 and 10).

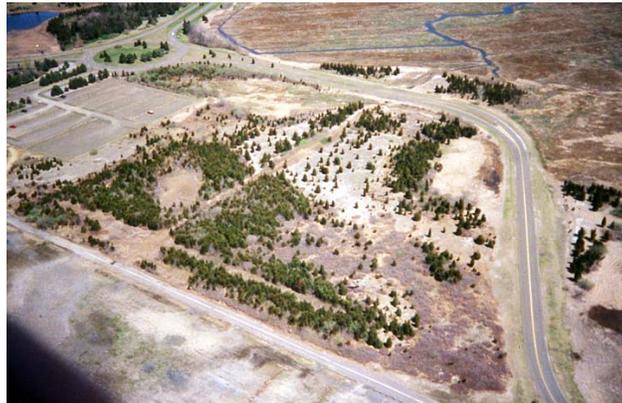
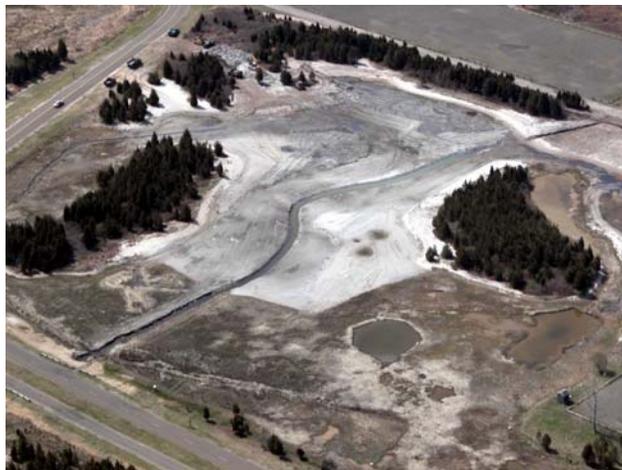
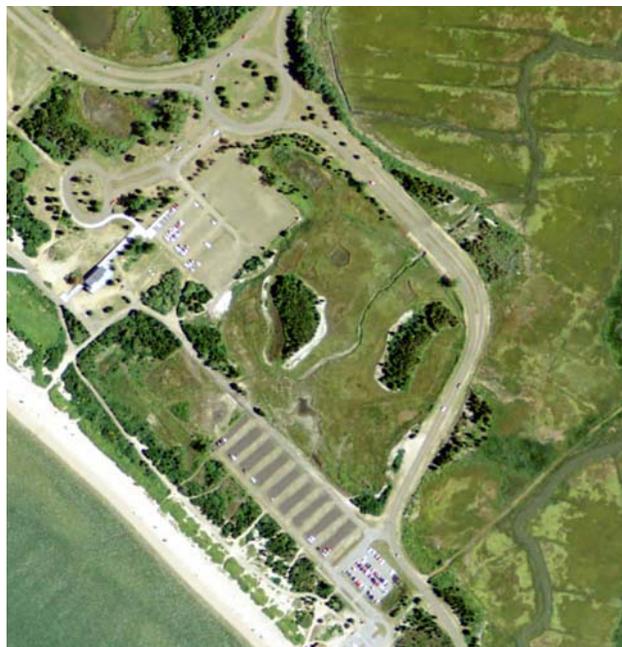
*Figure 10.* Restoration of a tidal marsh at Hammonasset Beach State Park, Madison: before (top – filled with dredged material from Clinton Harbor in the past), during (middle) and after (bottom) restoration in 2011. (Top two photos: CTDEEP)

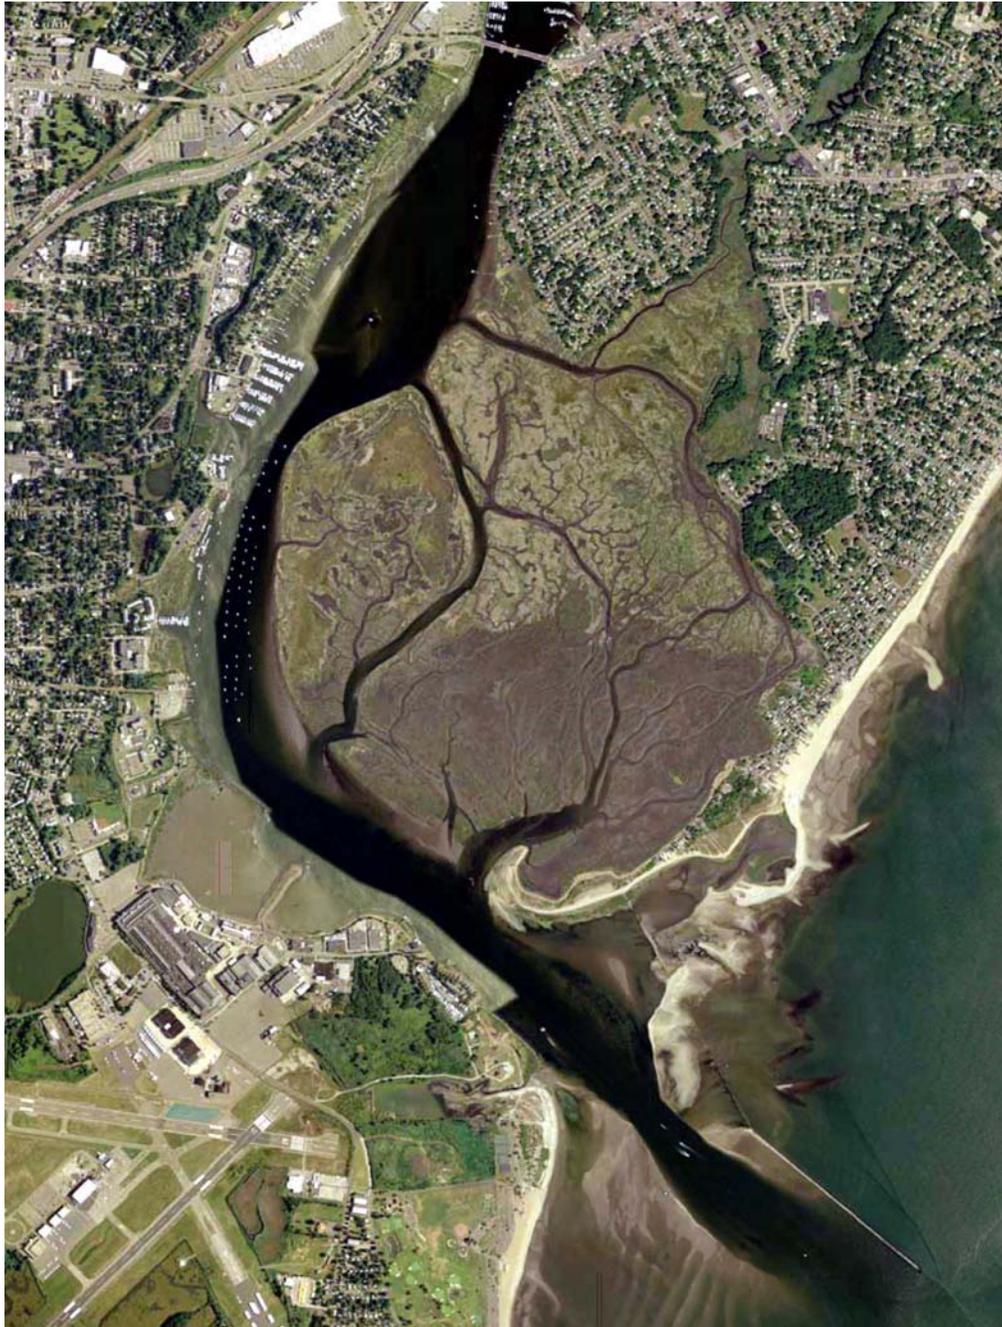
*Figure 11.* Nells Island marsh (Charles E. Wheeler Wildlife Management Area) at the mouth of the Housatonic River (Milford). Note the dendritic creek pattern.

If looking for reference wetlands for tidal wetland restoration, we came across few examples of nonditched tidal marsh: one located in Milford at the mouth of the Housatonic River (Figure 11), a pair of marshes at the mouth of the Black Hall River in Lyme (Figure 12), and portions of the Lordship Cove marshes in Stratford (Figure 13).

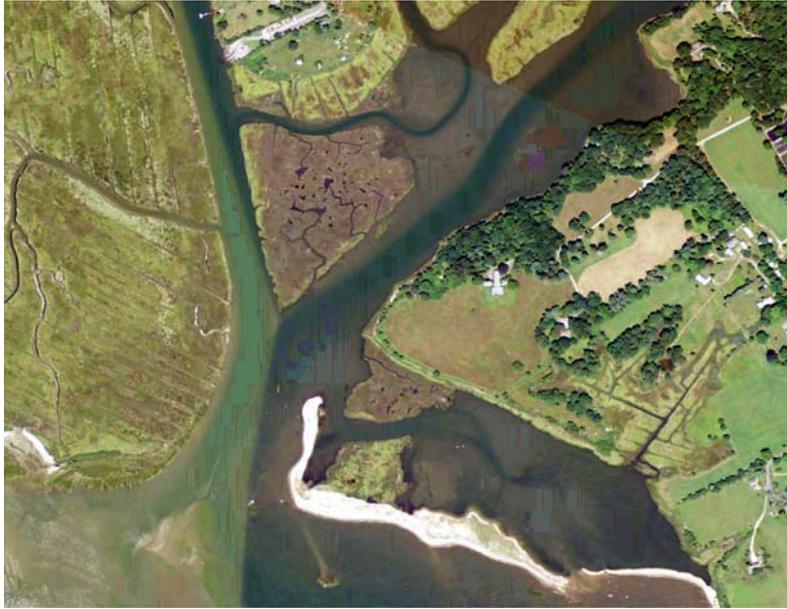
*Figure 12.* Two nonditched tidal marshes at the mouth of the Black Hall River (Lyme). Note the abundance of ponds and pools in these marshes (brown-colored) compared to the ditched marshes (green) nearby.

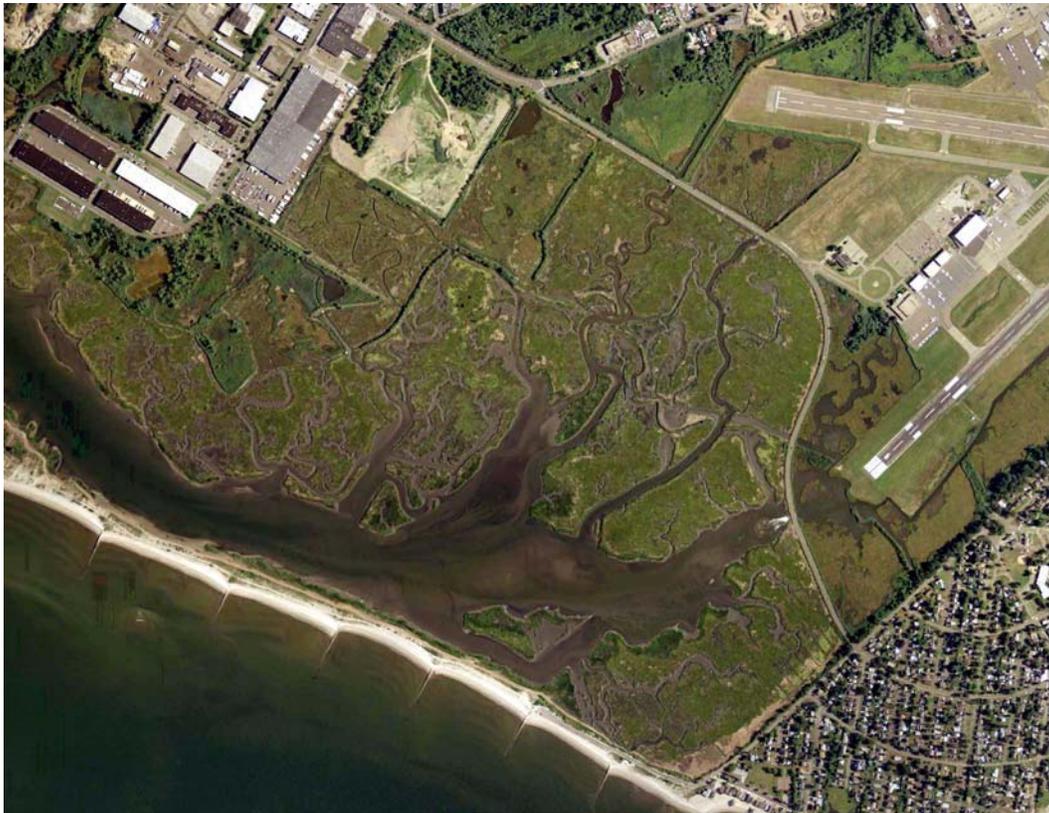
*Figure 13.* Portions of the Lordship Cove marshes in Stratford were never ditched; some sections were ditched or cut off by roads and others filled. (See Appendix, Figure A-3)

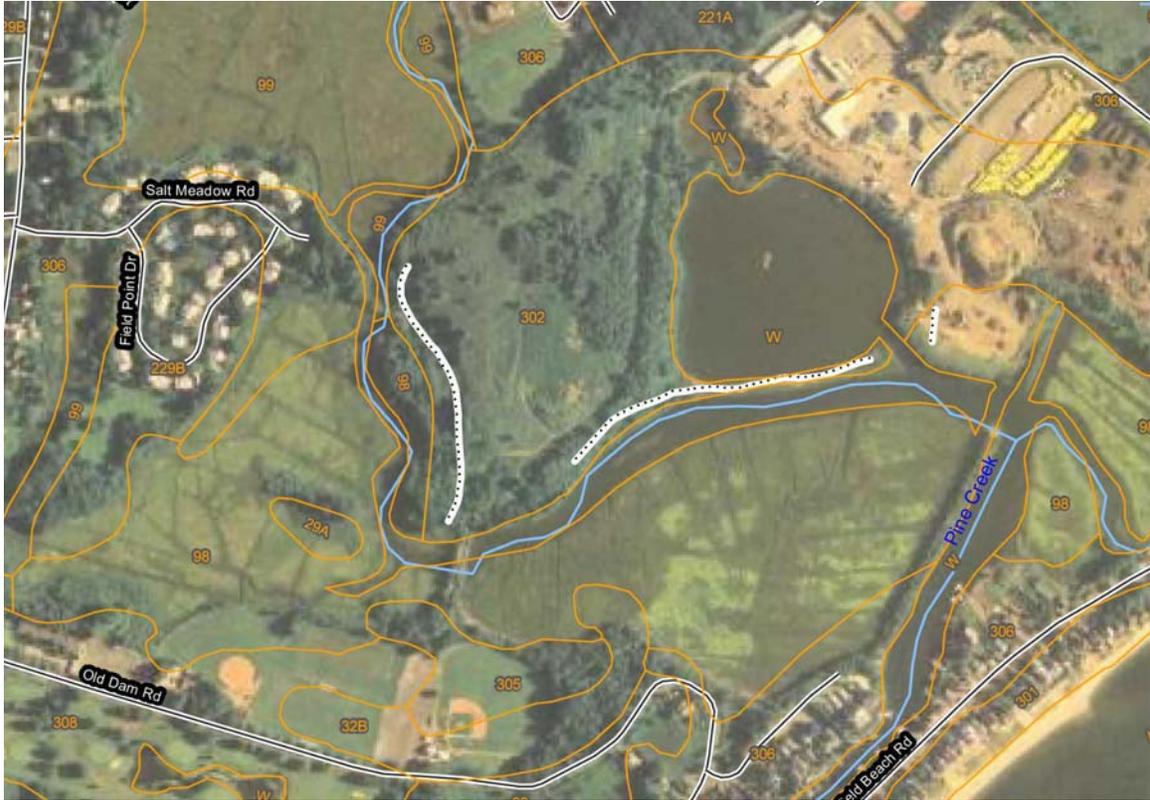
Figure A-1. Former dump (code 302) now part forest and meadow built at least in part from tidal marsh along Pine Creek in Fairfield (see 1892 USGS topographic map below). Also note that excavated waterbody and exposed soil with buildings to right of dump was also tidal marsh. (Source: USDA web soil survey)

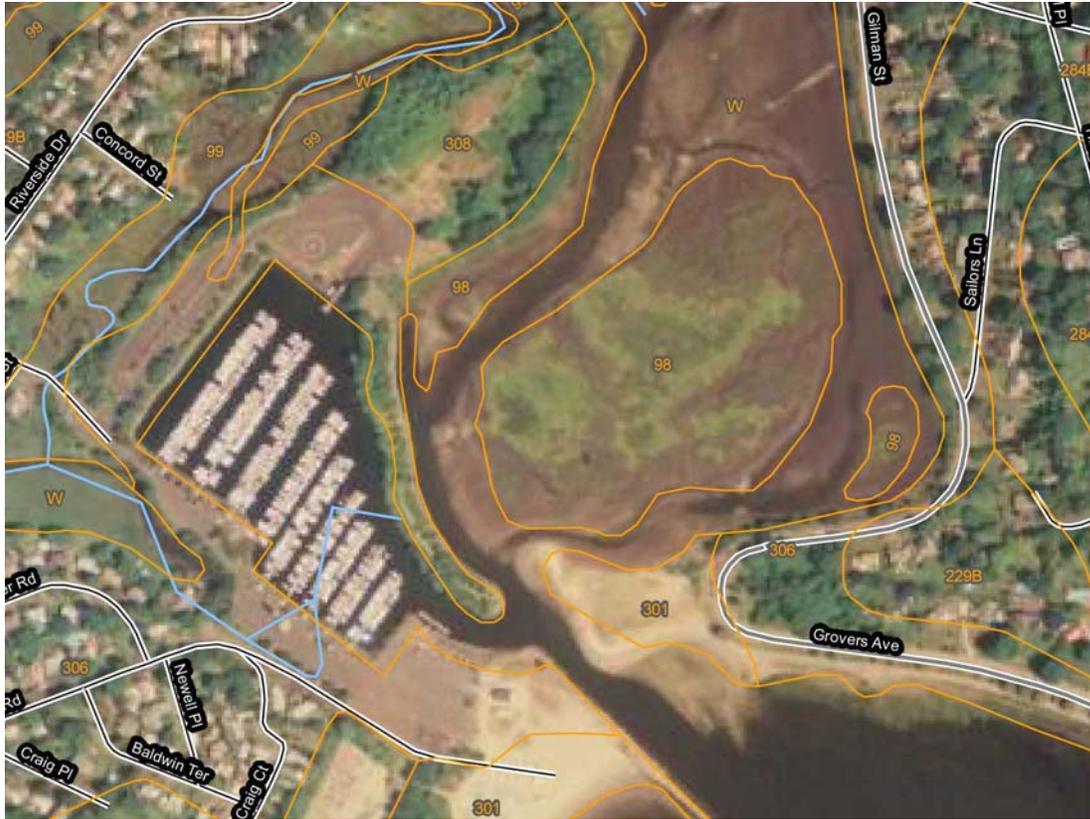
Figure A-2. Ash Creek, Fairfield County. Soil type 308 (Udorthents, smooth) is a fill site that may have impacted tidal marsh (see 1891 USGS topographic map below). It is located above the marina which may also have been constructed in tidal wetland. (Source: USDA web soil survey)

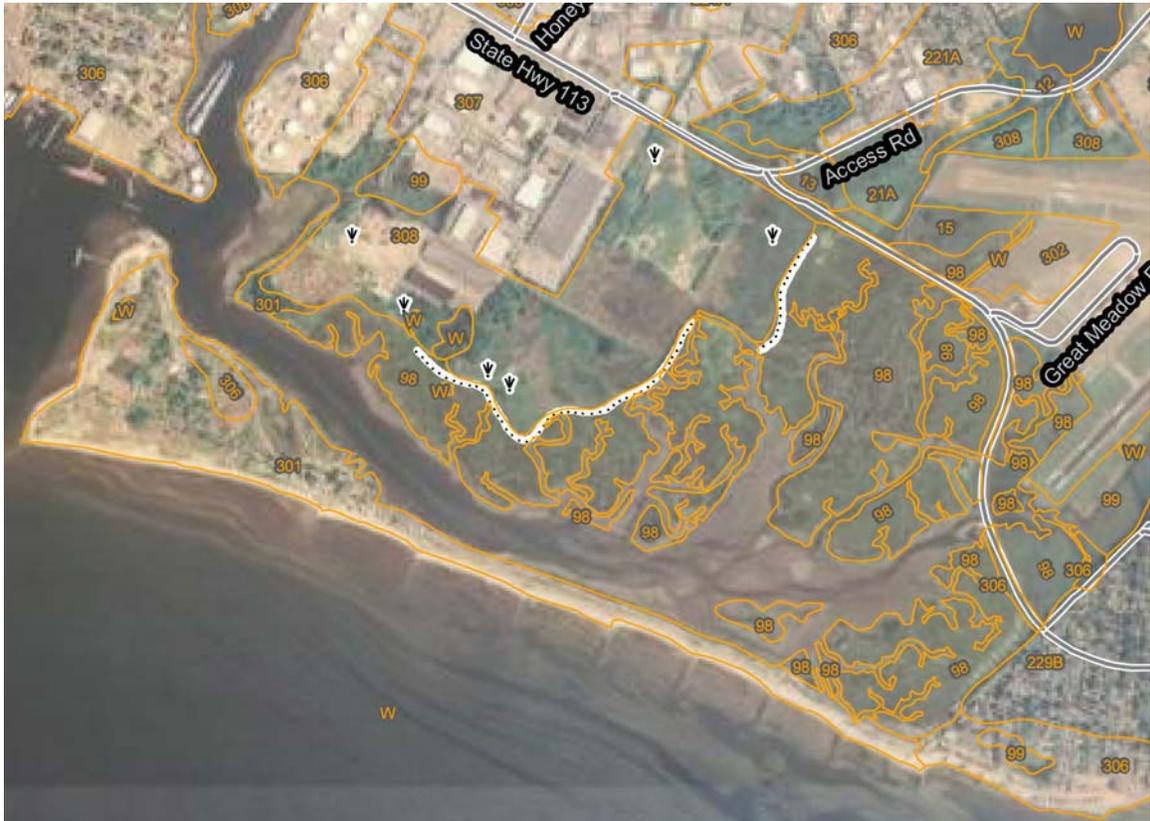
Figure A-3. Lordship Cove, Stratford in Fairfield County includes the Stewart B. McKinney National Wildlife Refuge. Originally the area contained one of the largest salt marsh complexes in the state, but much filling has taken place since 1891 (see USGS map below). Soil code 308 (much of it behind the white line) represents fill sites. Today this area is an active site for salt marsh restoration. (Source: USDA web soil survey)

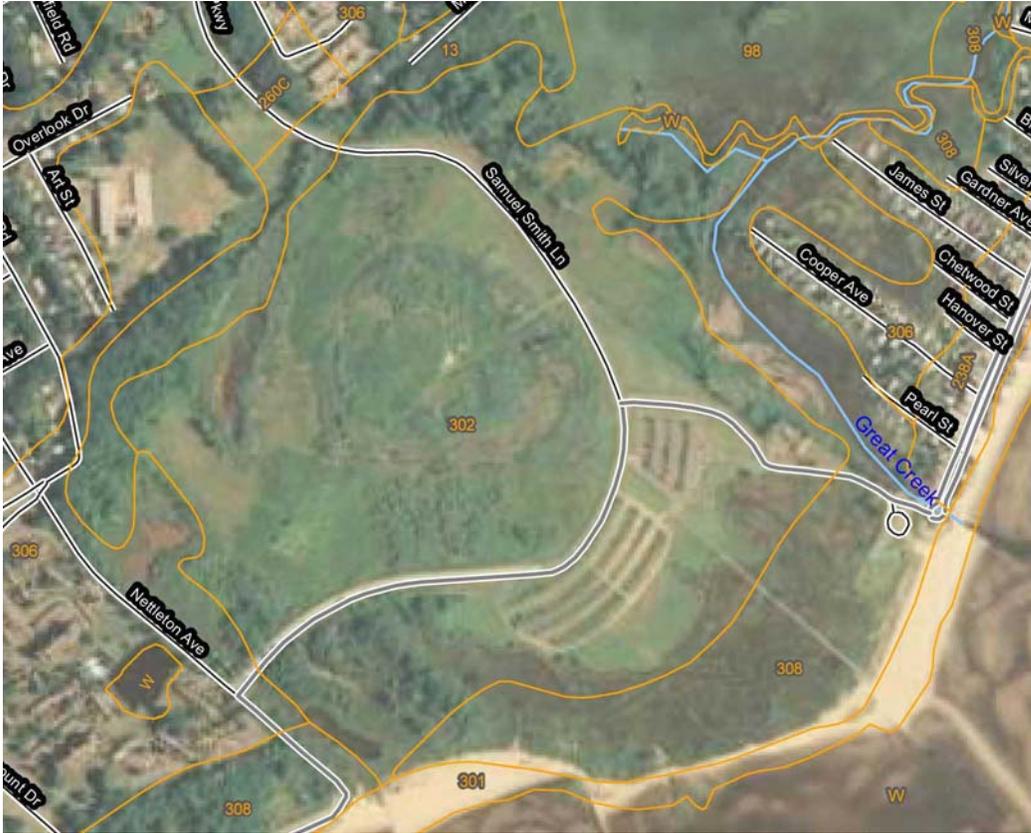
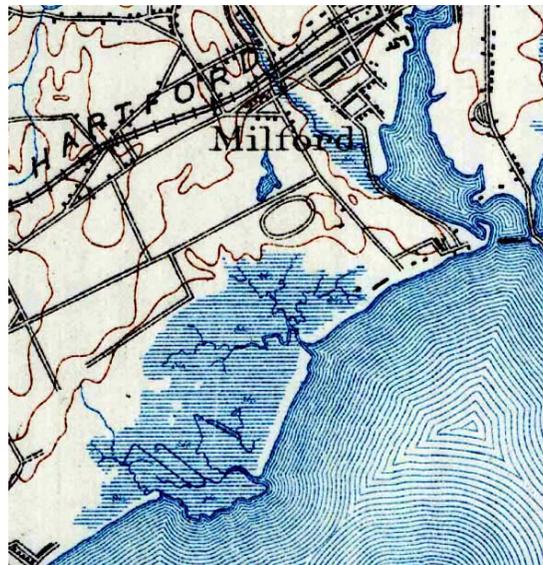
Figure A-4. Former dump (code 302) along Great Creek in Milford (Silver Sands State Park) that was built in tidal marsh (see 1891 USGS topographic map below). (Source: USDA web soil survey)

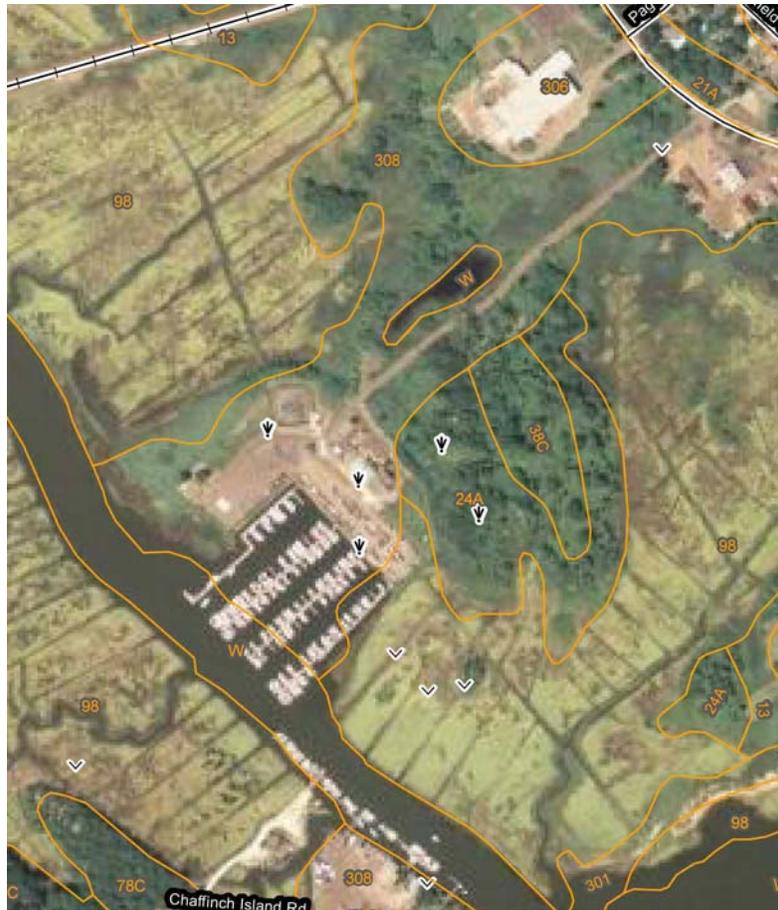
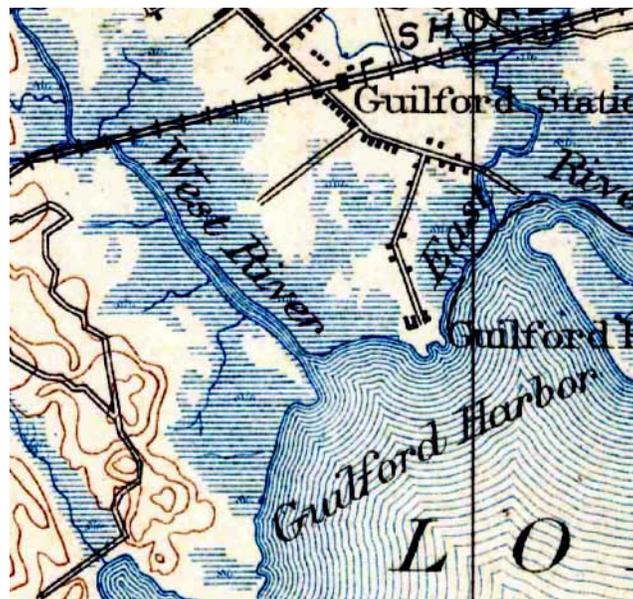
Figure A-6. Fill site (code 308) that includes some former tidal marsh located along the West River in Guilford (see 1893 USGS topographic map below); also note marina constructed from tidal marsh. (Source: USDA web soil survey)
