Beaver Creek Canyon

in Troutdale, east of and parallel to Beaver Creek Lane between Chapman and 21st Street; project site is within the first stream mile, approximately 2,400 stream feet from the mouth

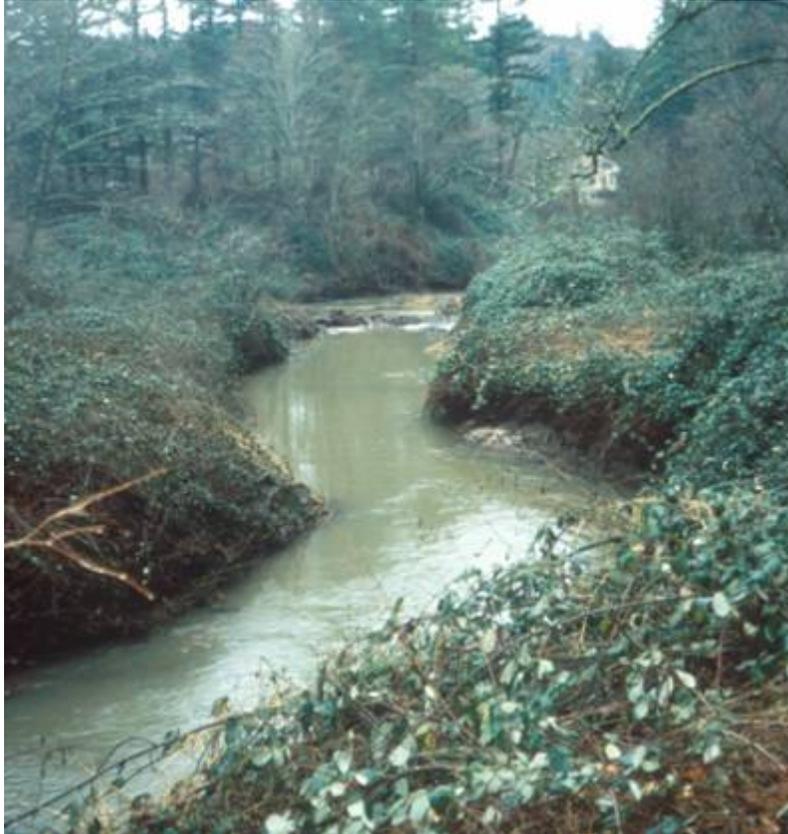
BEFORE

Invasive Himalayan blackberry covers the banks of Beaver Creek

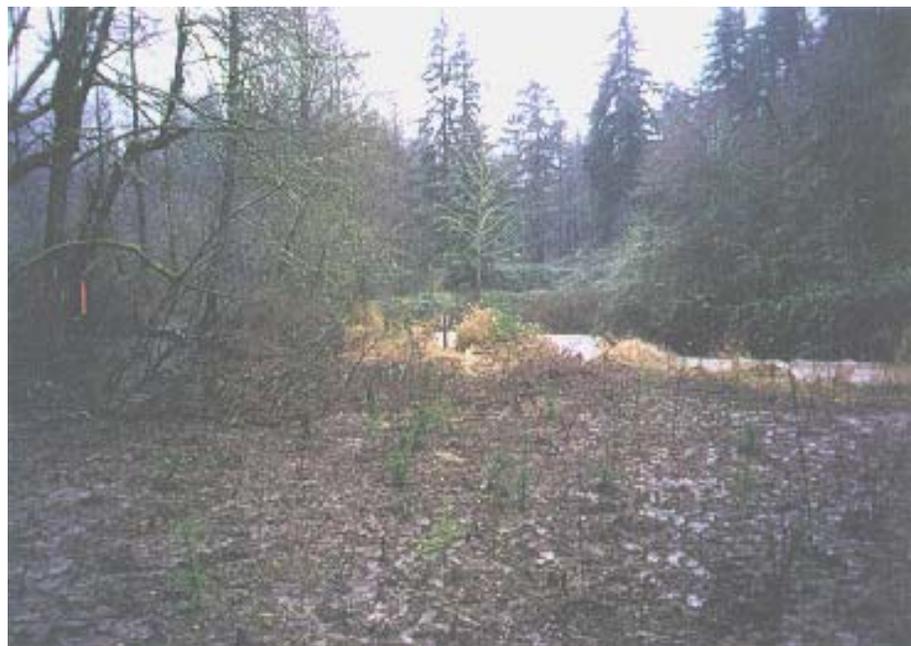
AFTER

Blackberry vines removed and native seedlings planted to stabilize bank and restore riparian functions

A restoration specialist was contracted to develop a design to stabilize the creek banks. He considered the findings of a stormwater drainage study that the City of Troutdale commissioned for the Beaver Creek sub-basin. He also observed the restoration site over several seasons and determined that the stream's channel, course, velocity, and other characteristics would continue to change significantly and frequently over time due to urbanization in the watershed. The steep canyon walls made the project site inaccessible to heavy equipment, and existing conditions did not call for efforts to stabilize banks along the creek. The proposed action was to focus on and stabilize the area beyond the banks themselves. Specific recommendations included moving the trail 30 to 50 feet uphill away from the creek; discontinuing the bridge site, which was at-risk of being swept away during flood events; removing Himalayan blackberry, which do not hold soil during high water conditions; and replanting with native plants for increased soil stability and other riparian functions. Several different plants were used to reestablish a diverse native plant community. Those plants included seedling Douglas firs, red alders, western red cedars, and vine maples.
